# Remediation of a Fuel Release in Steeply-Sloping Terrain Adjacent to a River

## Prince George, BC

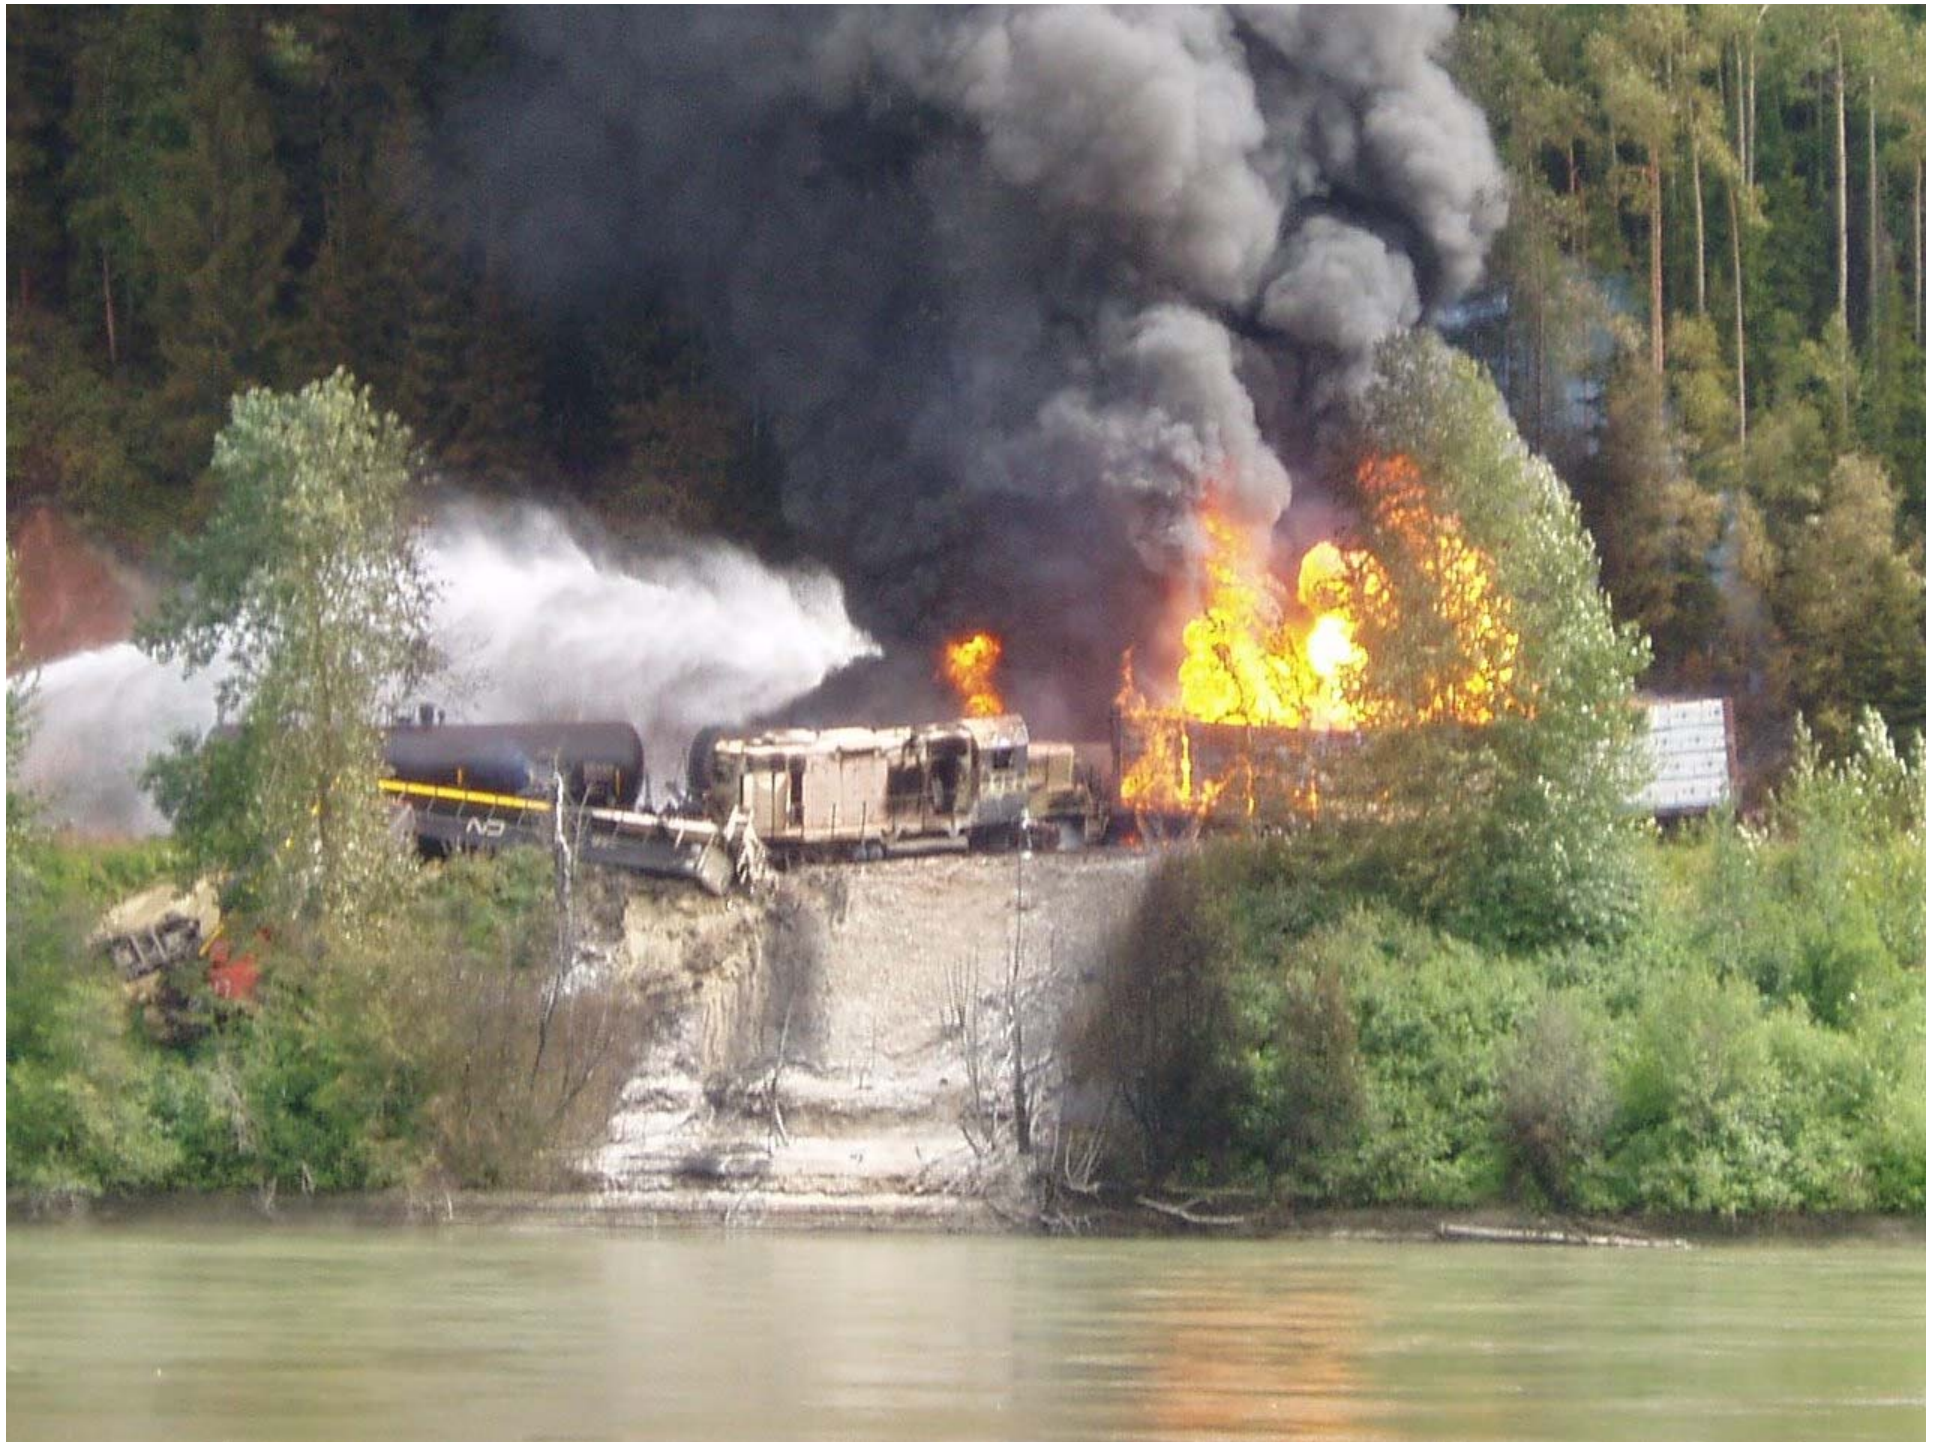
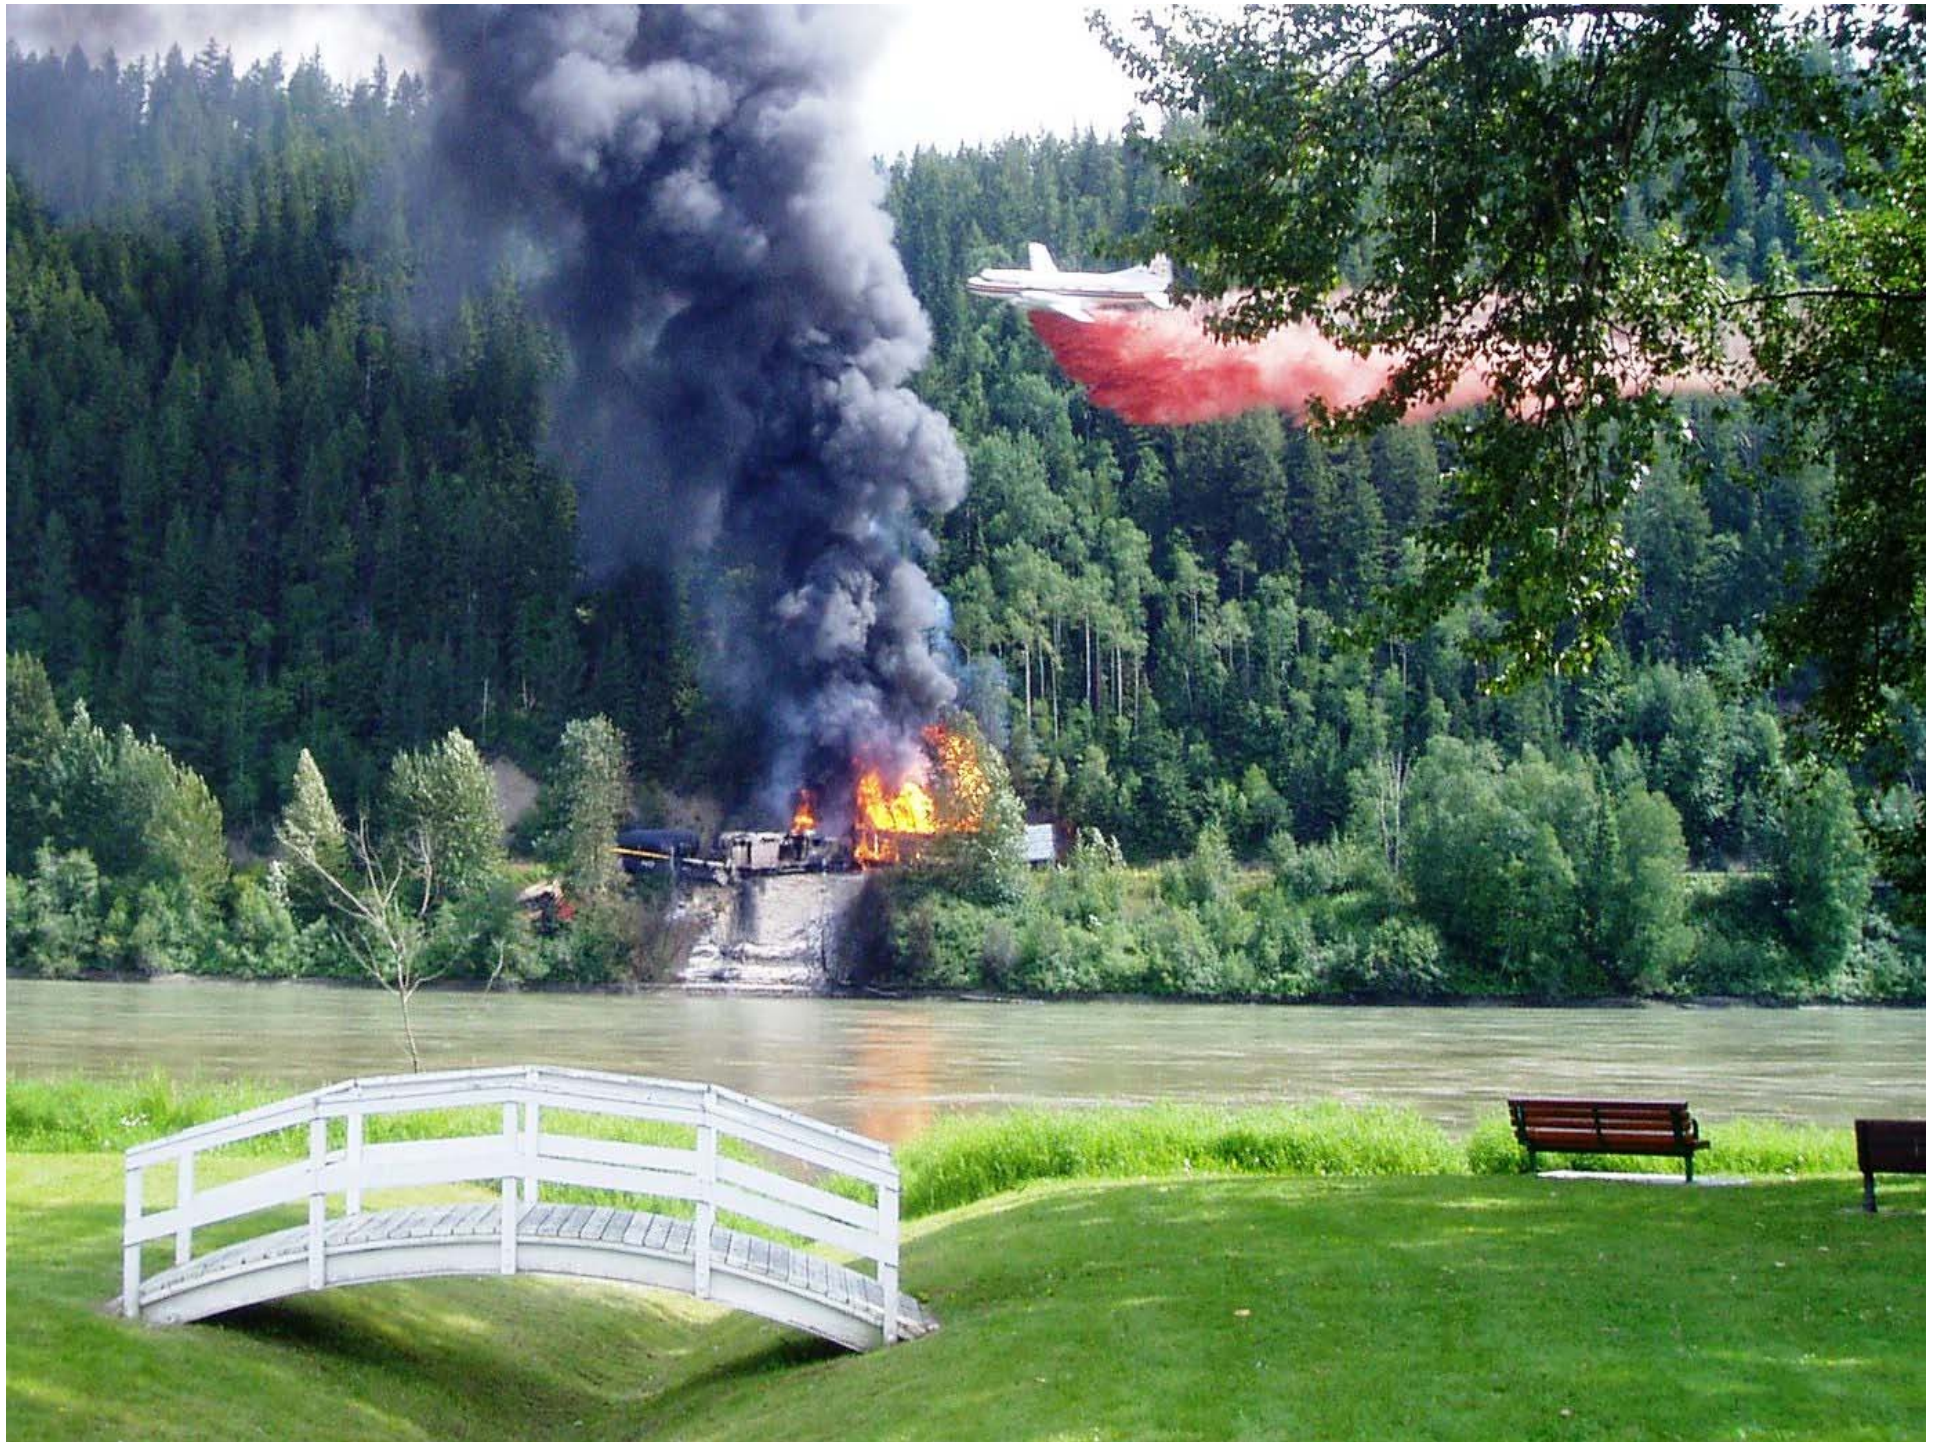
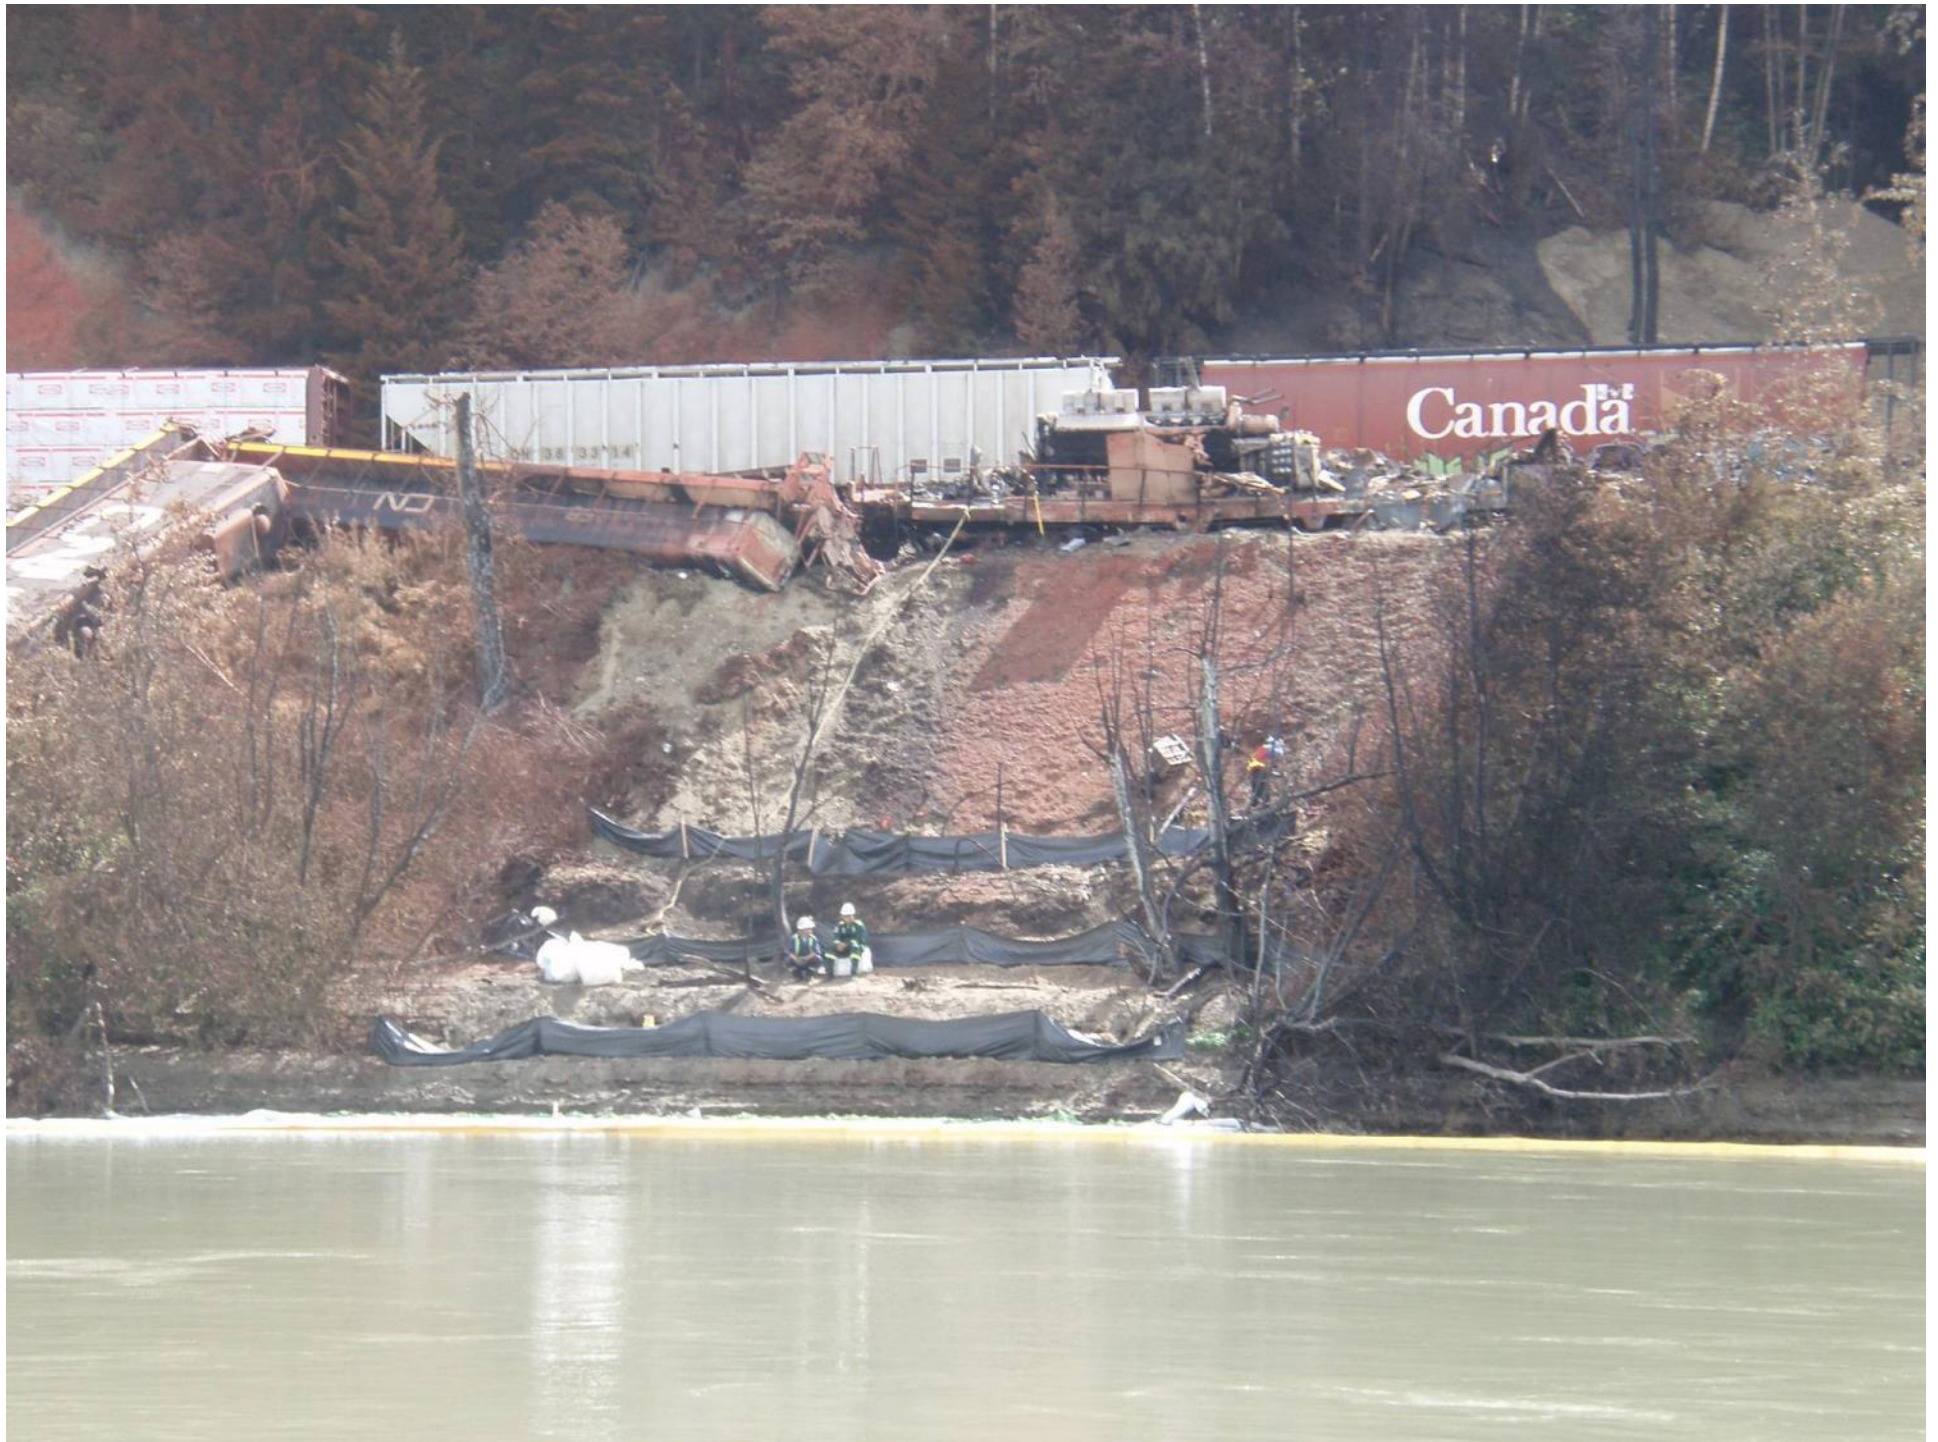
- ◆ On August 5, 2007, two trains collided at Mile 464.3 of the Chetwynd subdivision at CN's Prince George Terminal
- ◆ Approximately 171,500 L of gasoline, 1,600 L of diesel and a small volume of lubricating oil were lost
- ◆ A fire that resulted from the collision burned off an unknown volume of fuel at the time of the incident

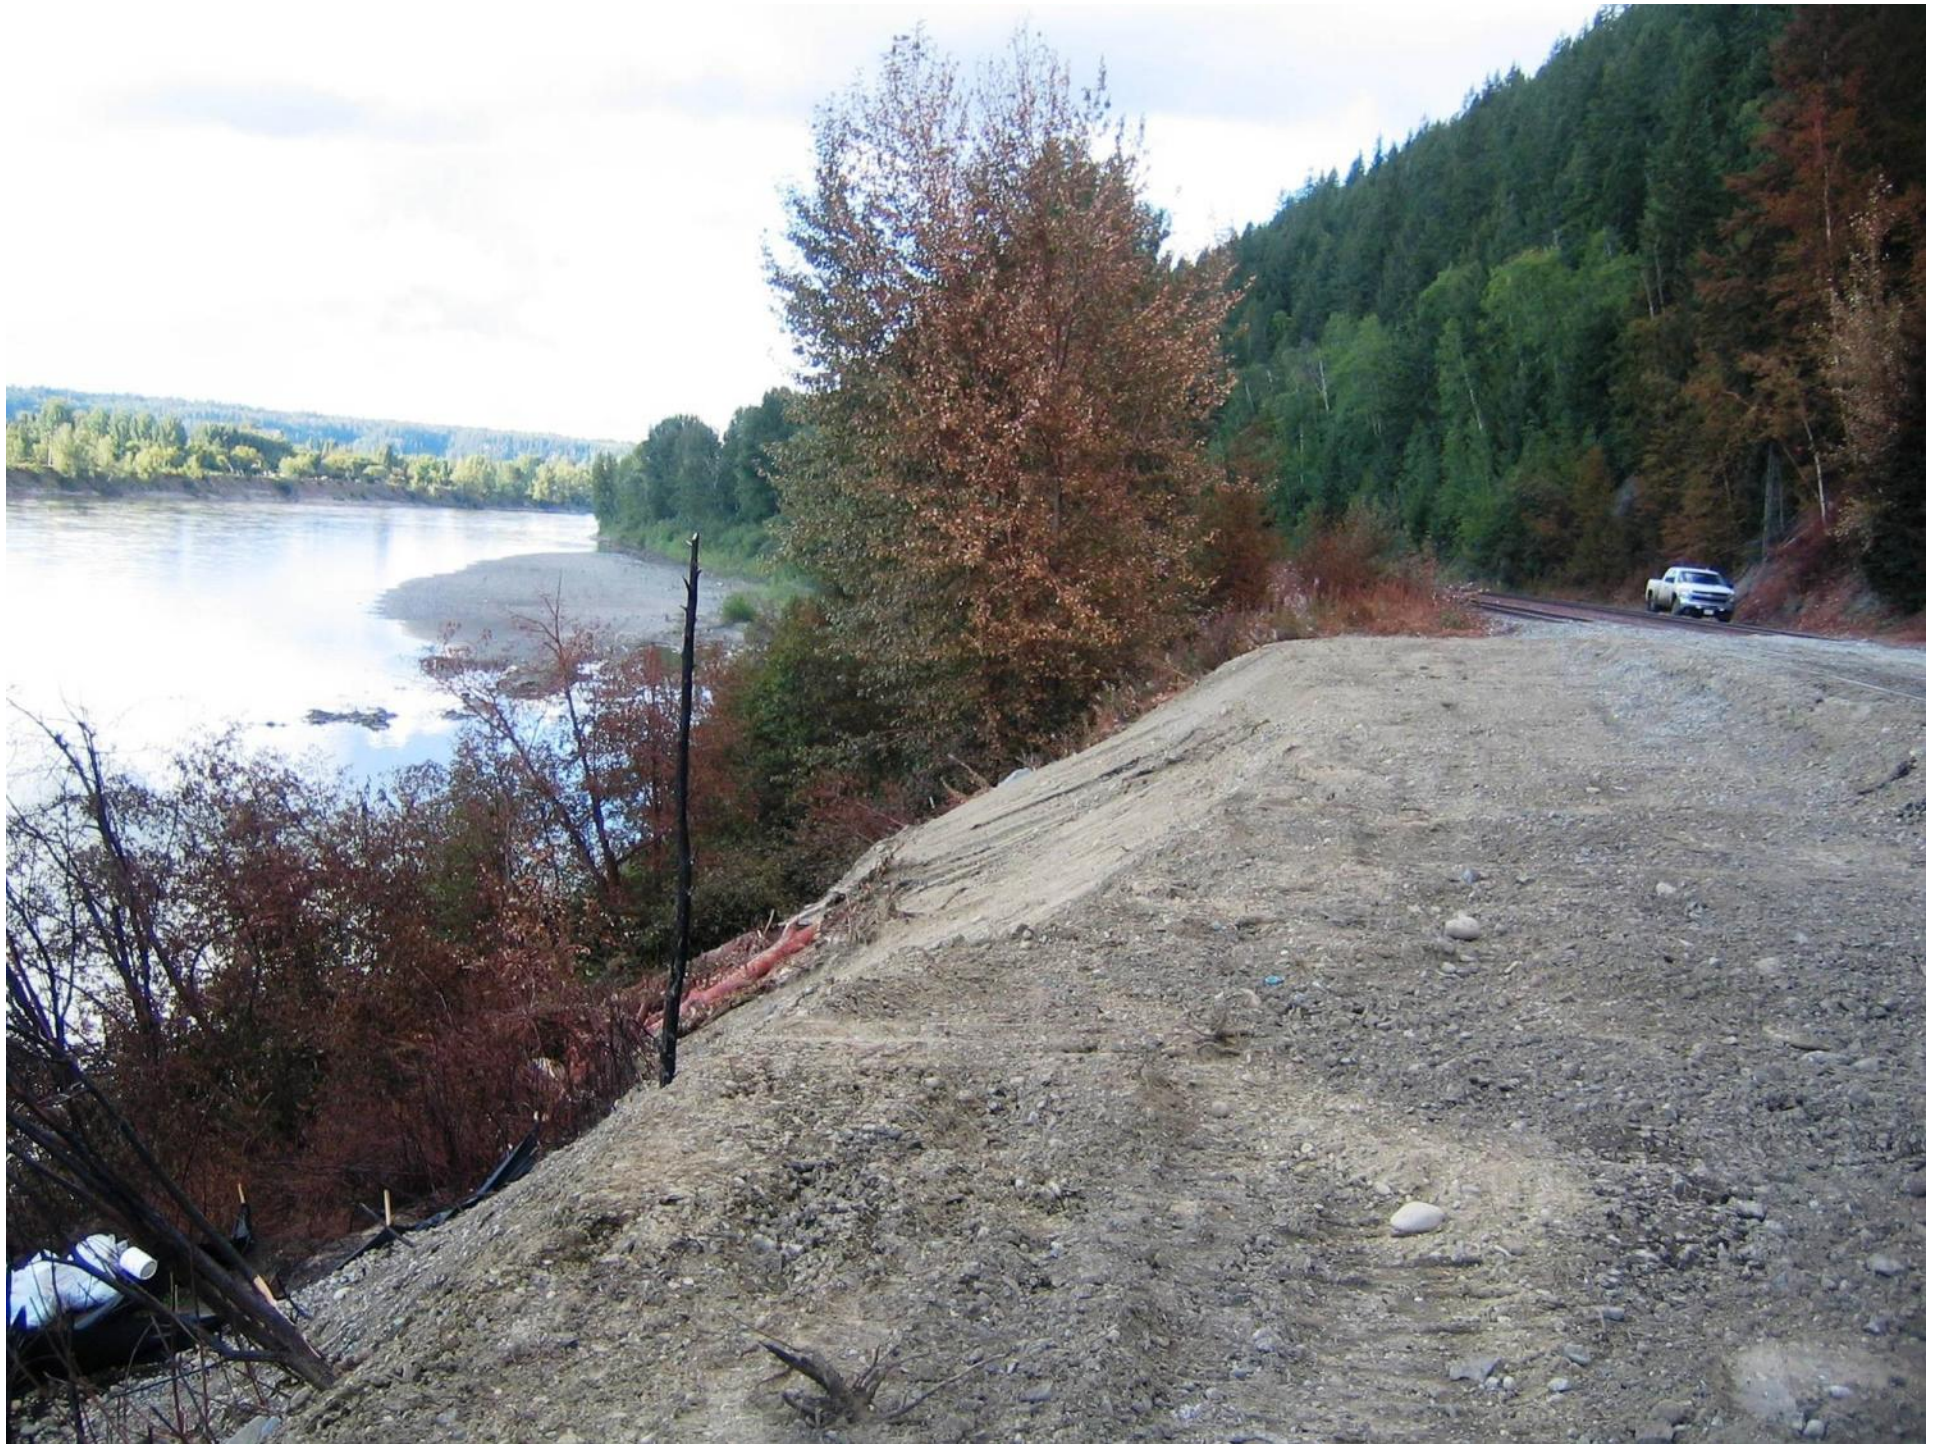
- ◆ Located adjacent to the Fraser River immediately east of Prince George
- ◆ Spill area approximately 0.2 ha in size
- ◆ The topography slopes steeply down to the Fraser River, located about 12 m below the tracks
- ◆ Access along the slope is very difficult

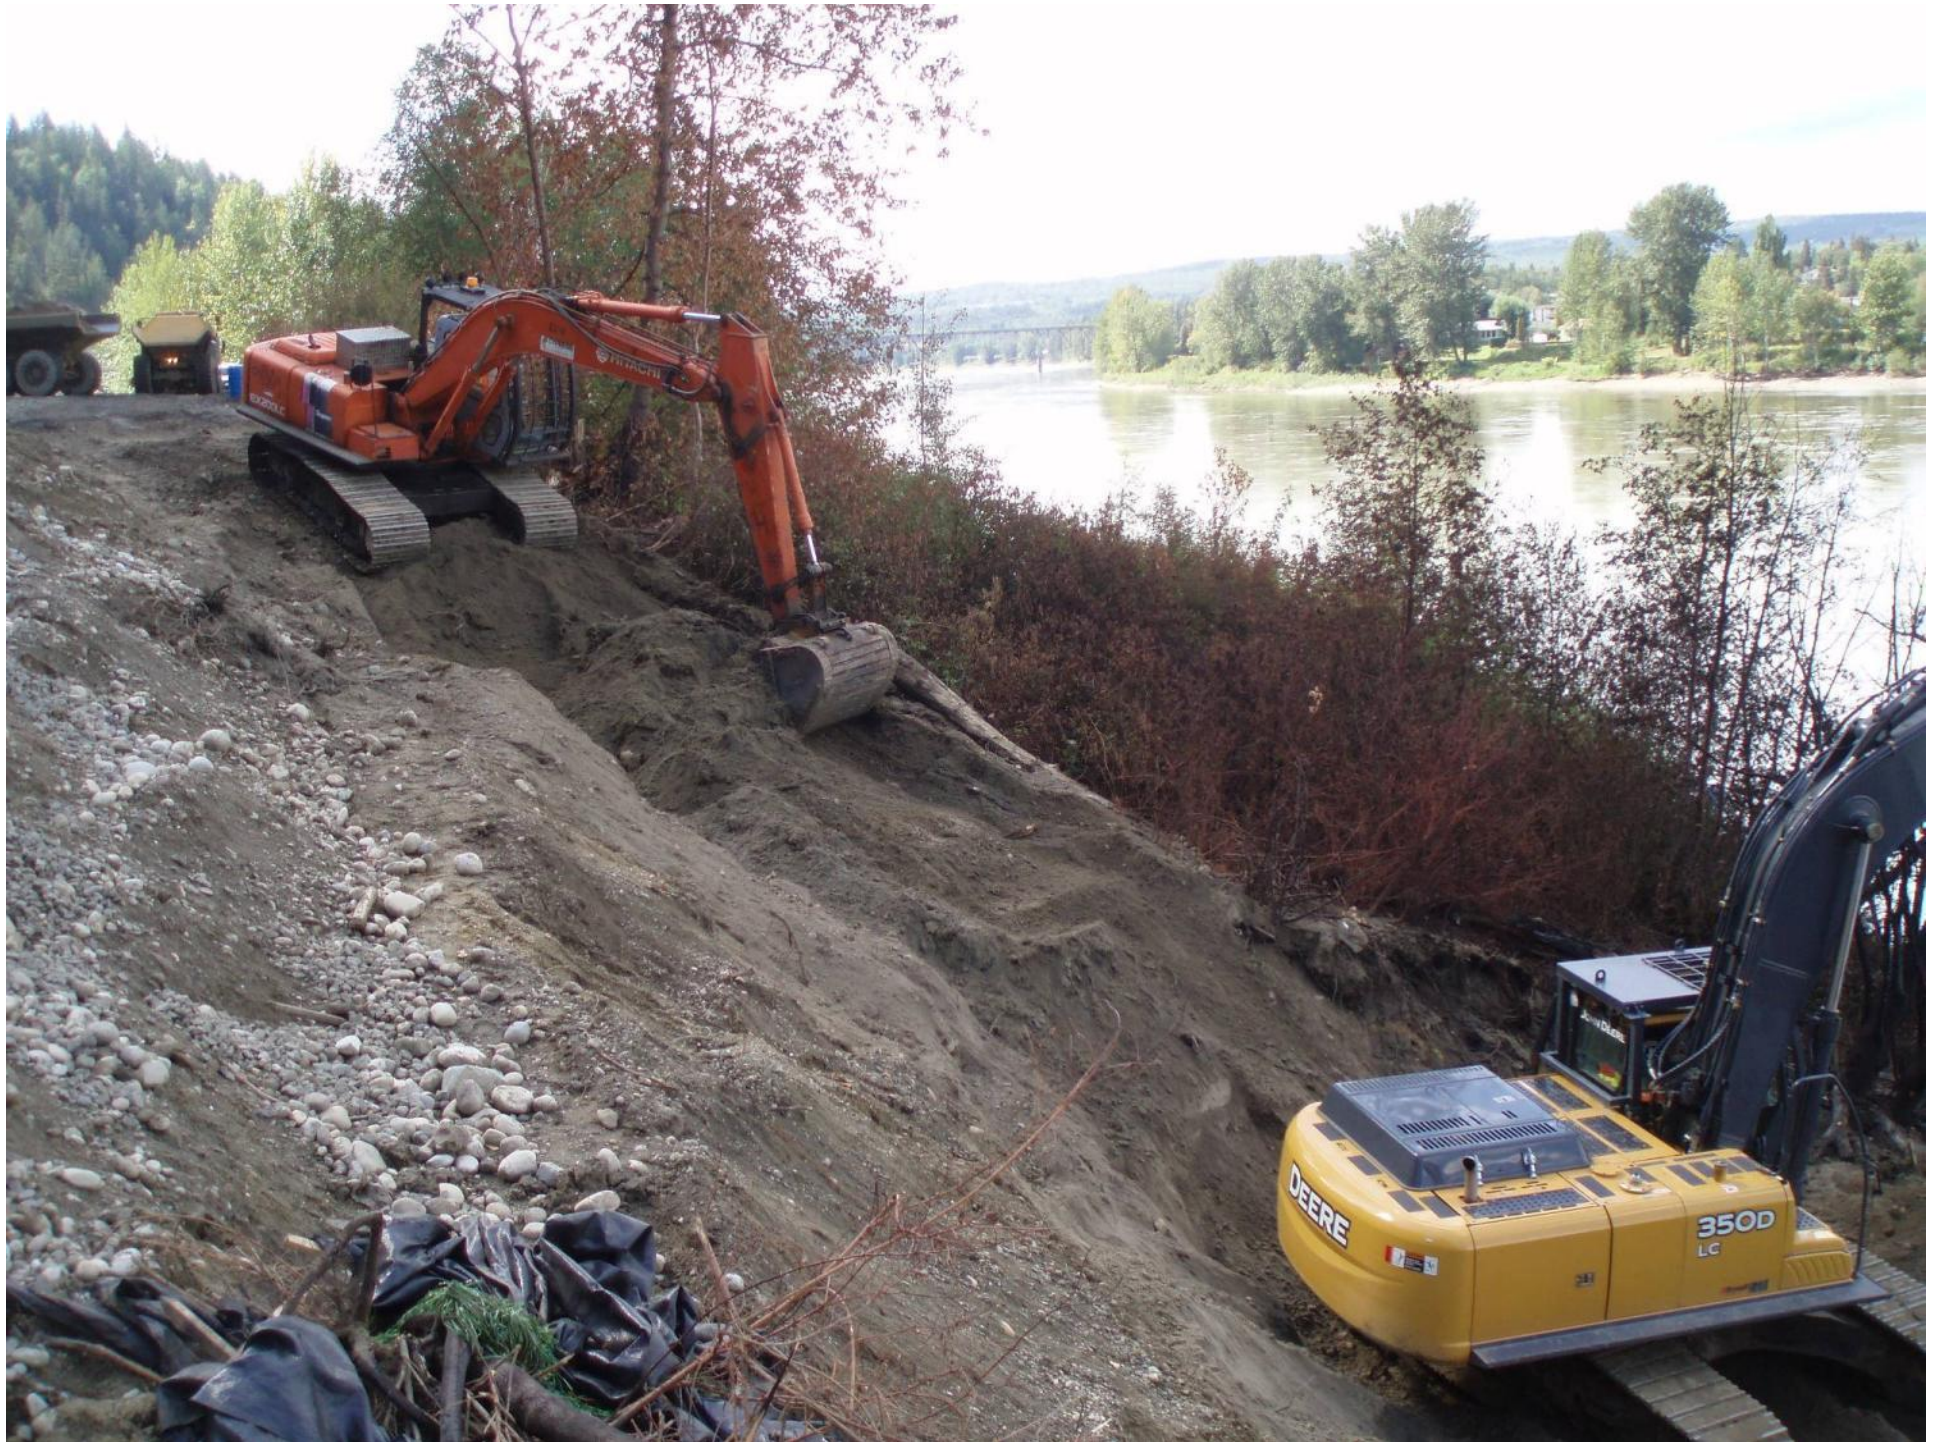
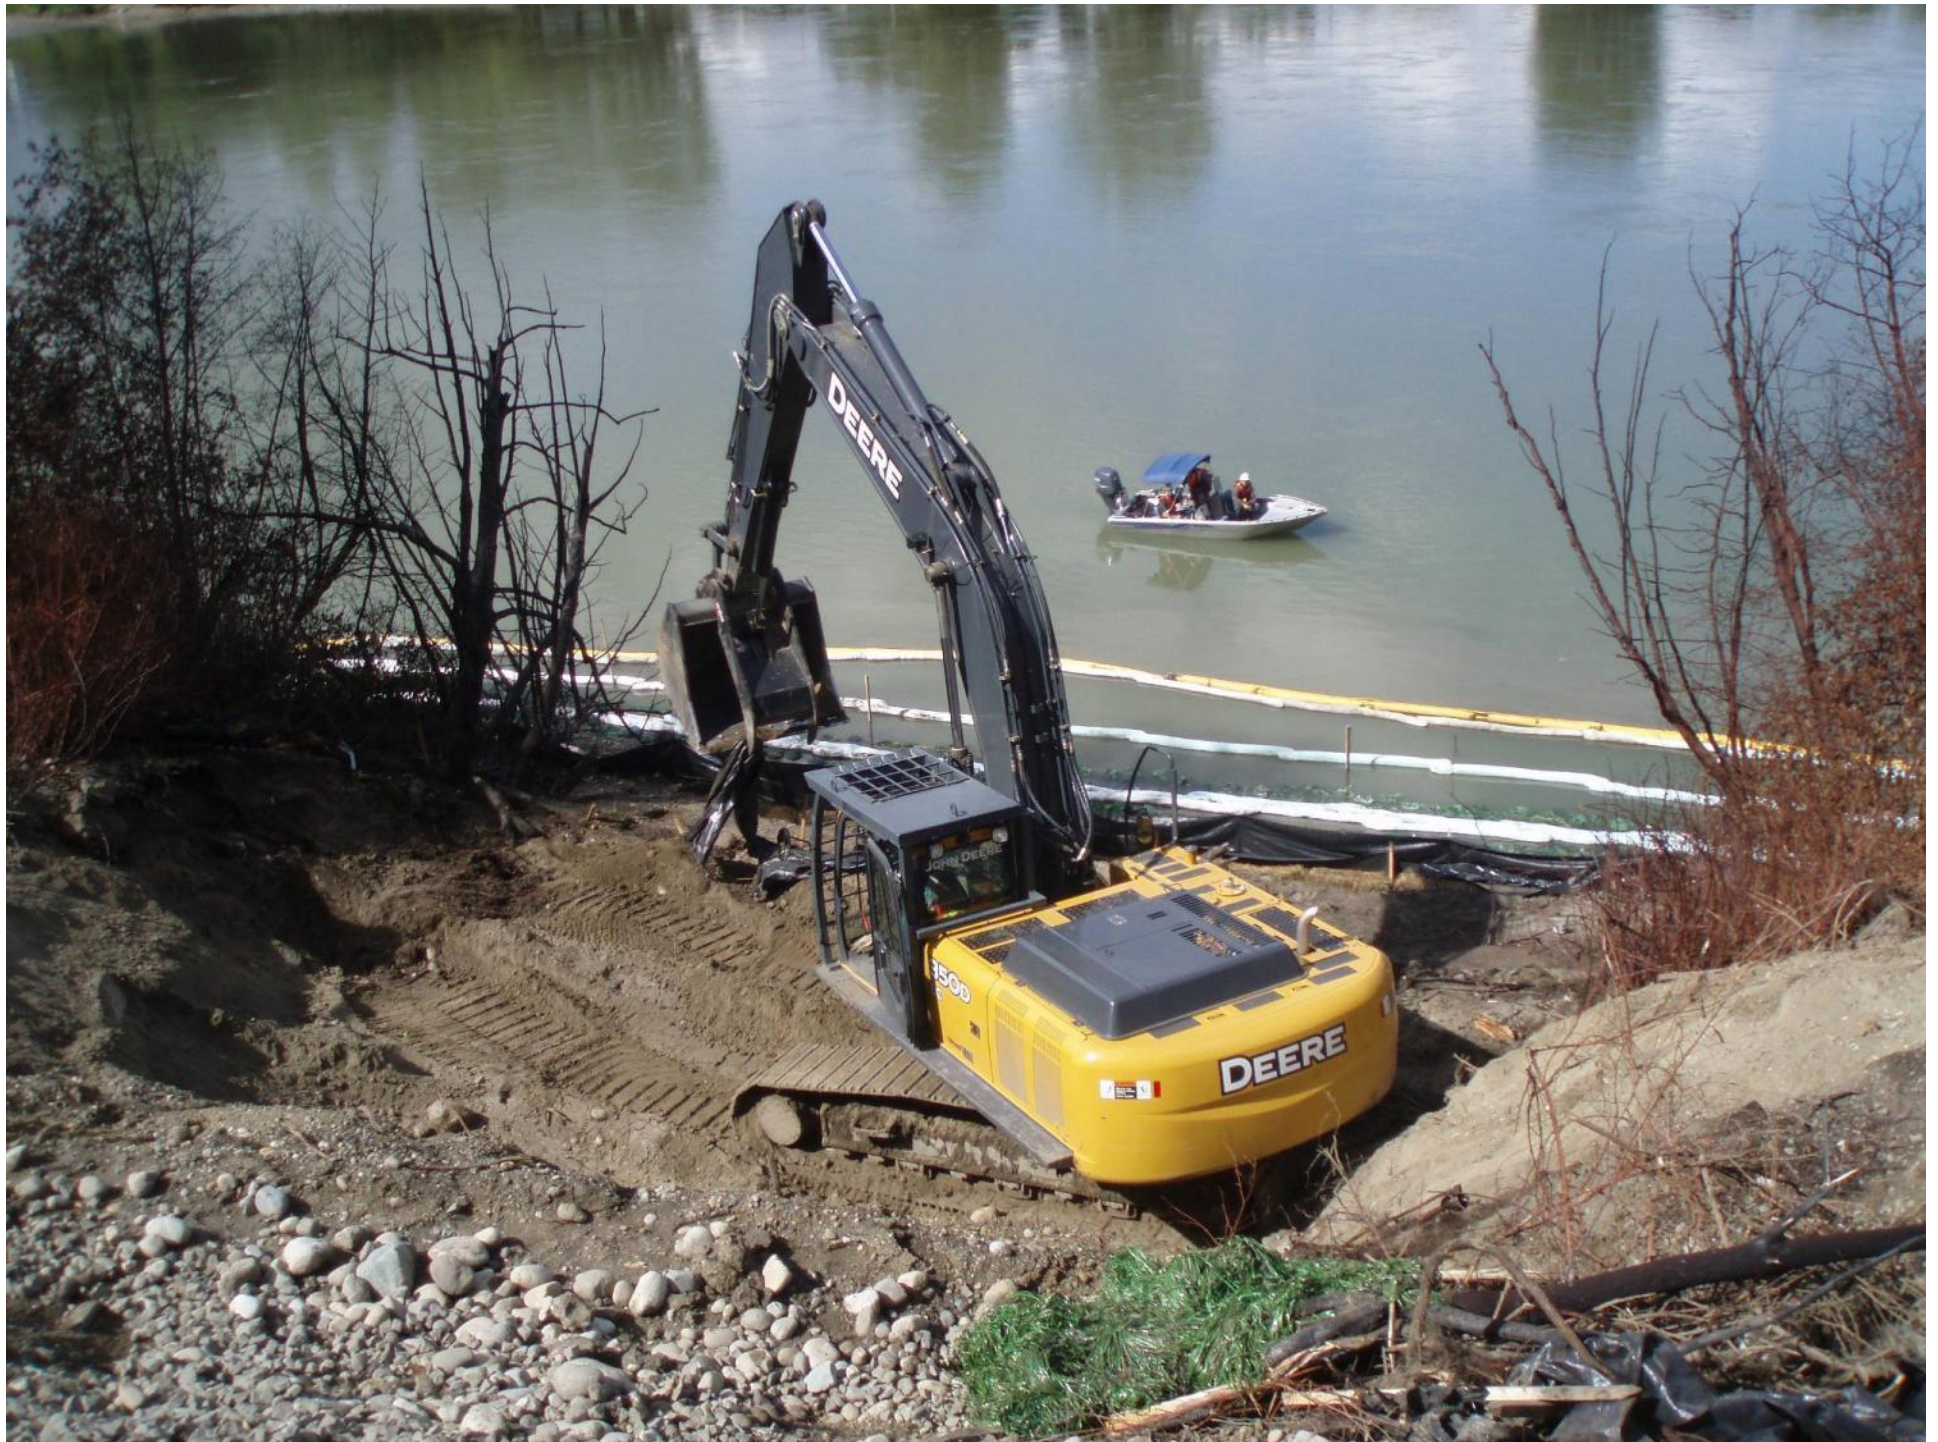
- ◆ Two remedial excavations were completed covering the area of the fuel release down the slope to the Fraser River foreshore
- ◆ Approximately 2,000 m<sup>3</sup> of soil was removed
- ◆ Shortly after release, LNAPL globules began to appear in the Fraser River on the foreshore
- ◆ Booms and absorbents were placed in the foreshore area to control hydrocarbons

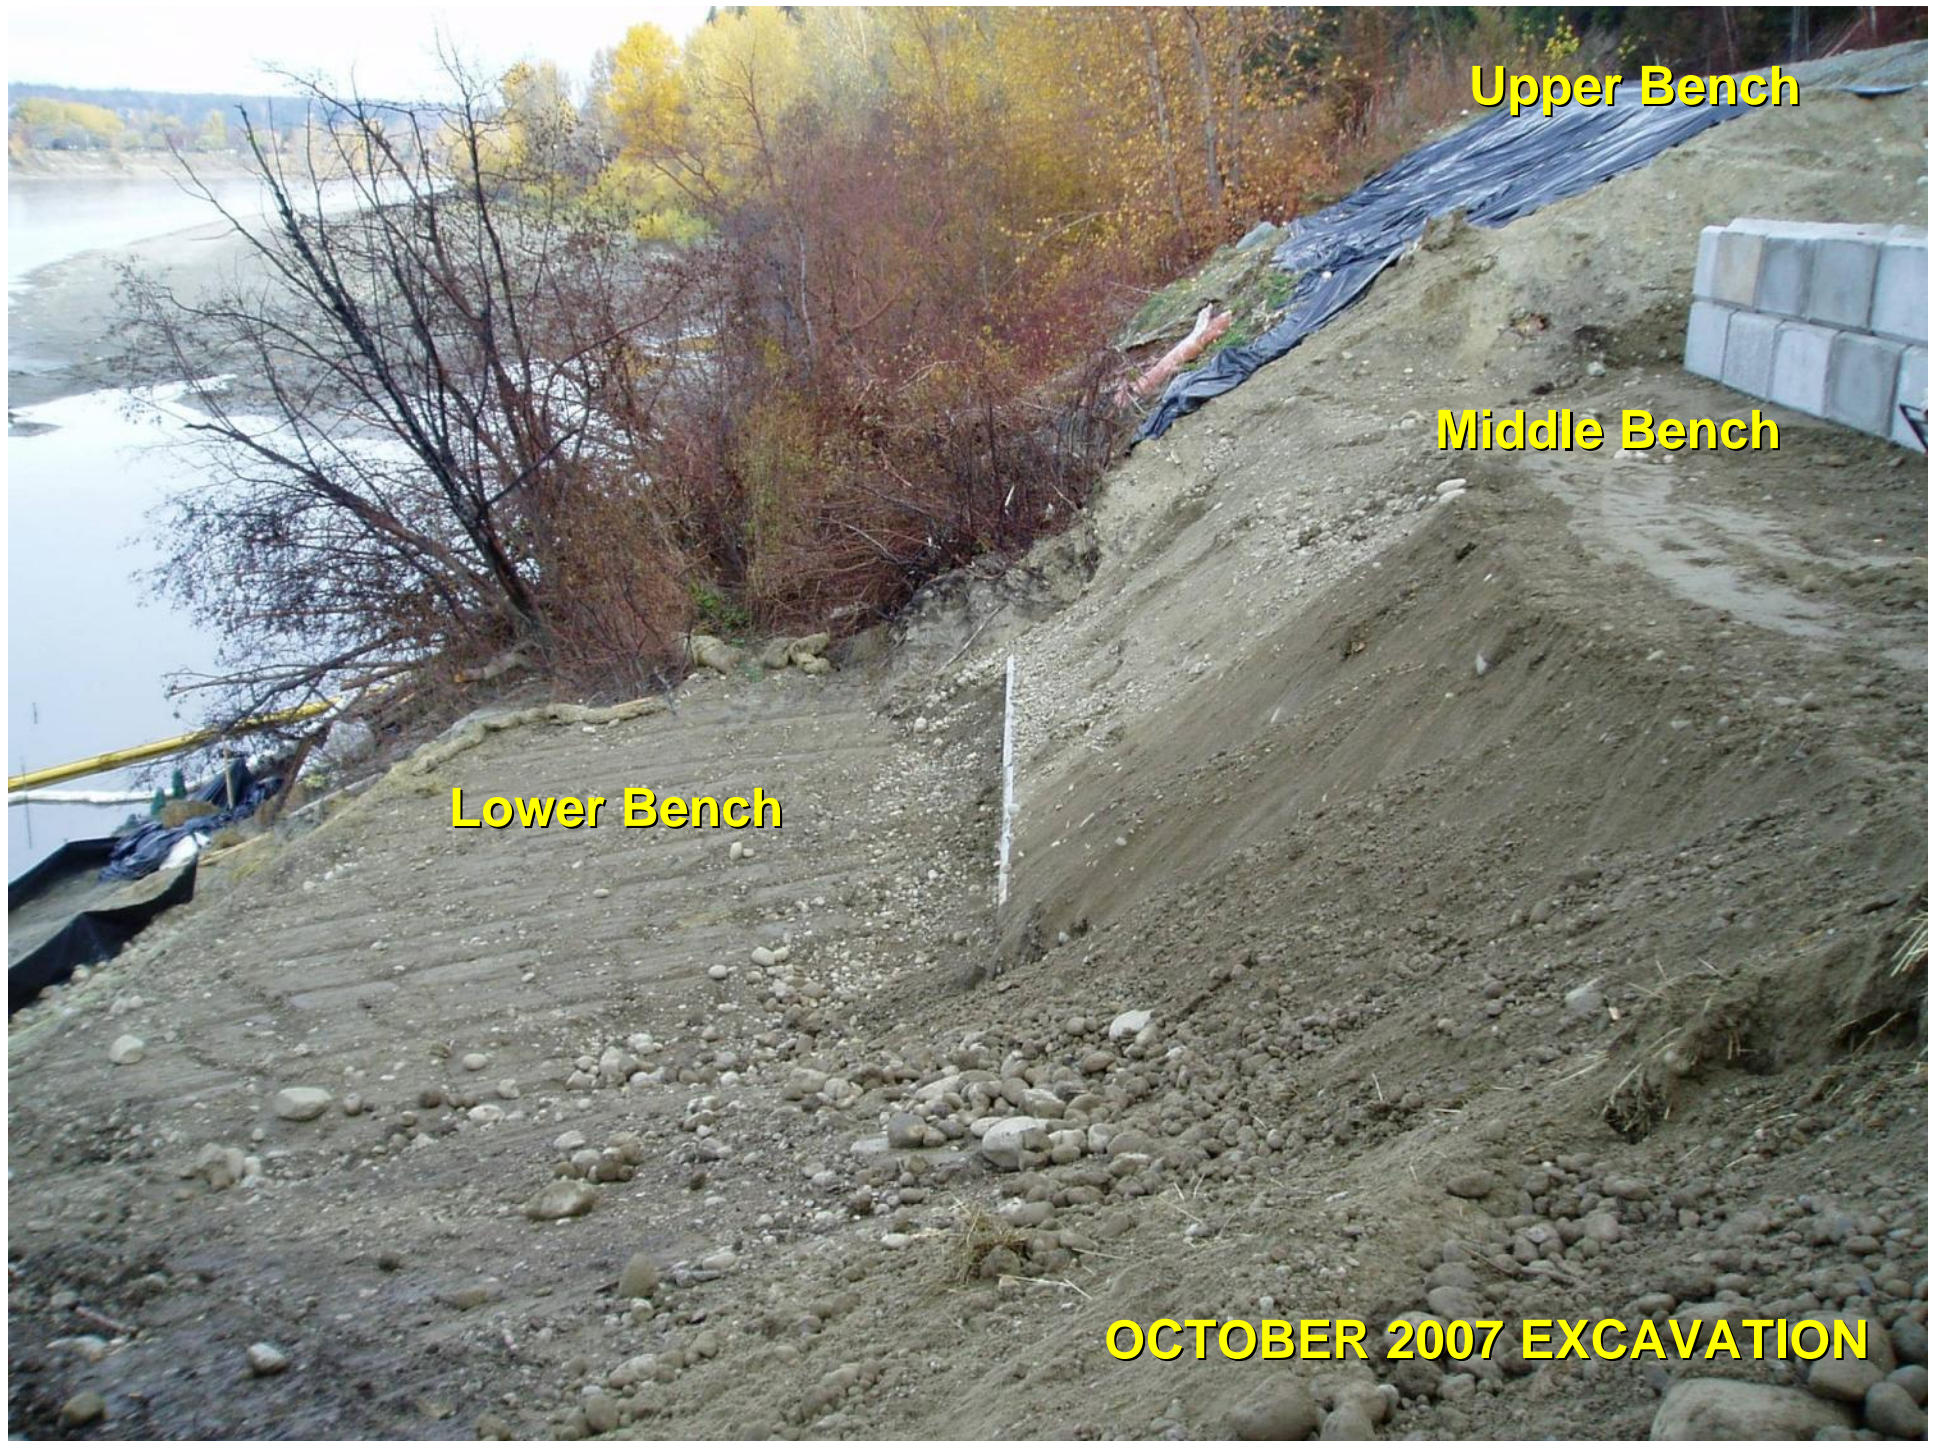
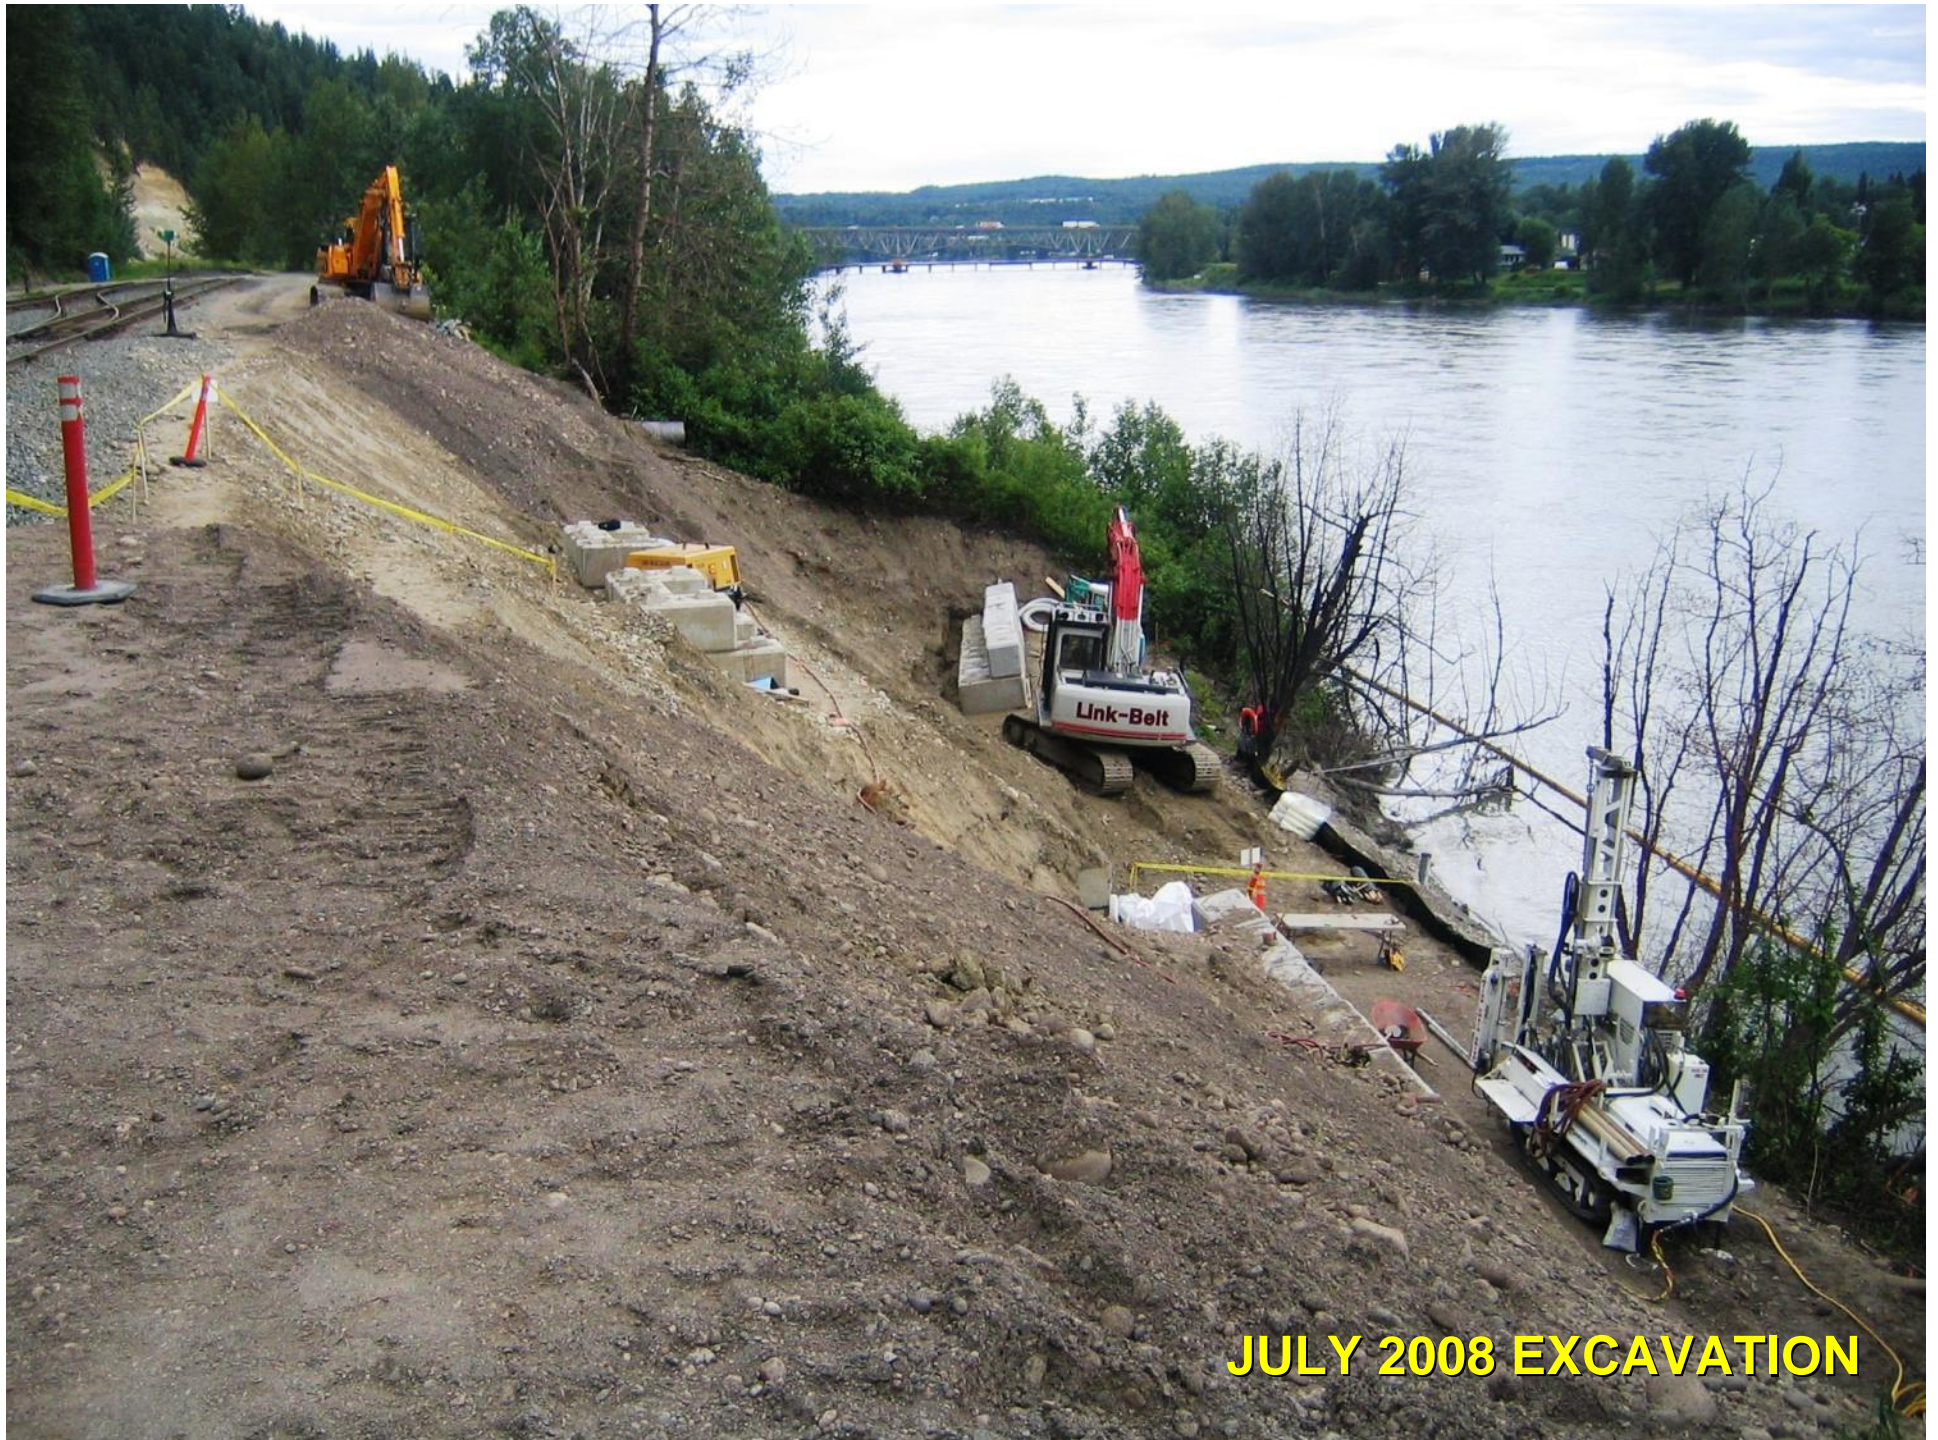
**JULY 2008 EXCAVATION**

- ◆ Lock blocks installed to stabilize slope
- ◆ Middle and lower benches constructed to allow for drill rig access
- ◆ Ramp constructed to provide access down the slope
