# Remediation of a Fuel Release in Steeply-Sloping Terrain Adjacent to a River

## Prince George, BC

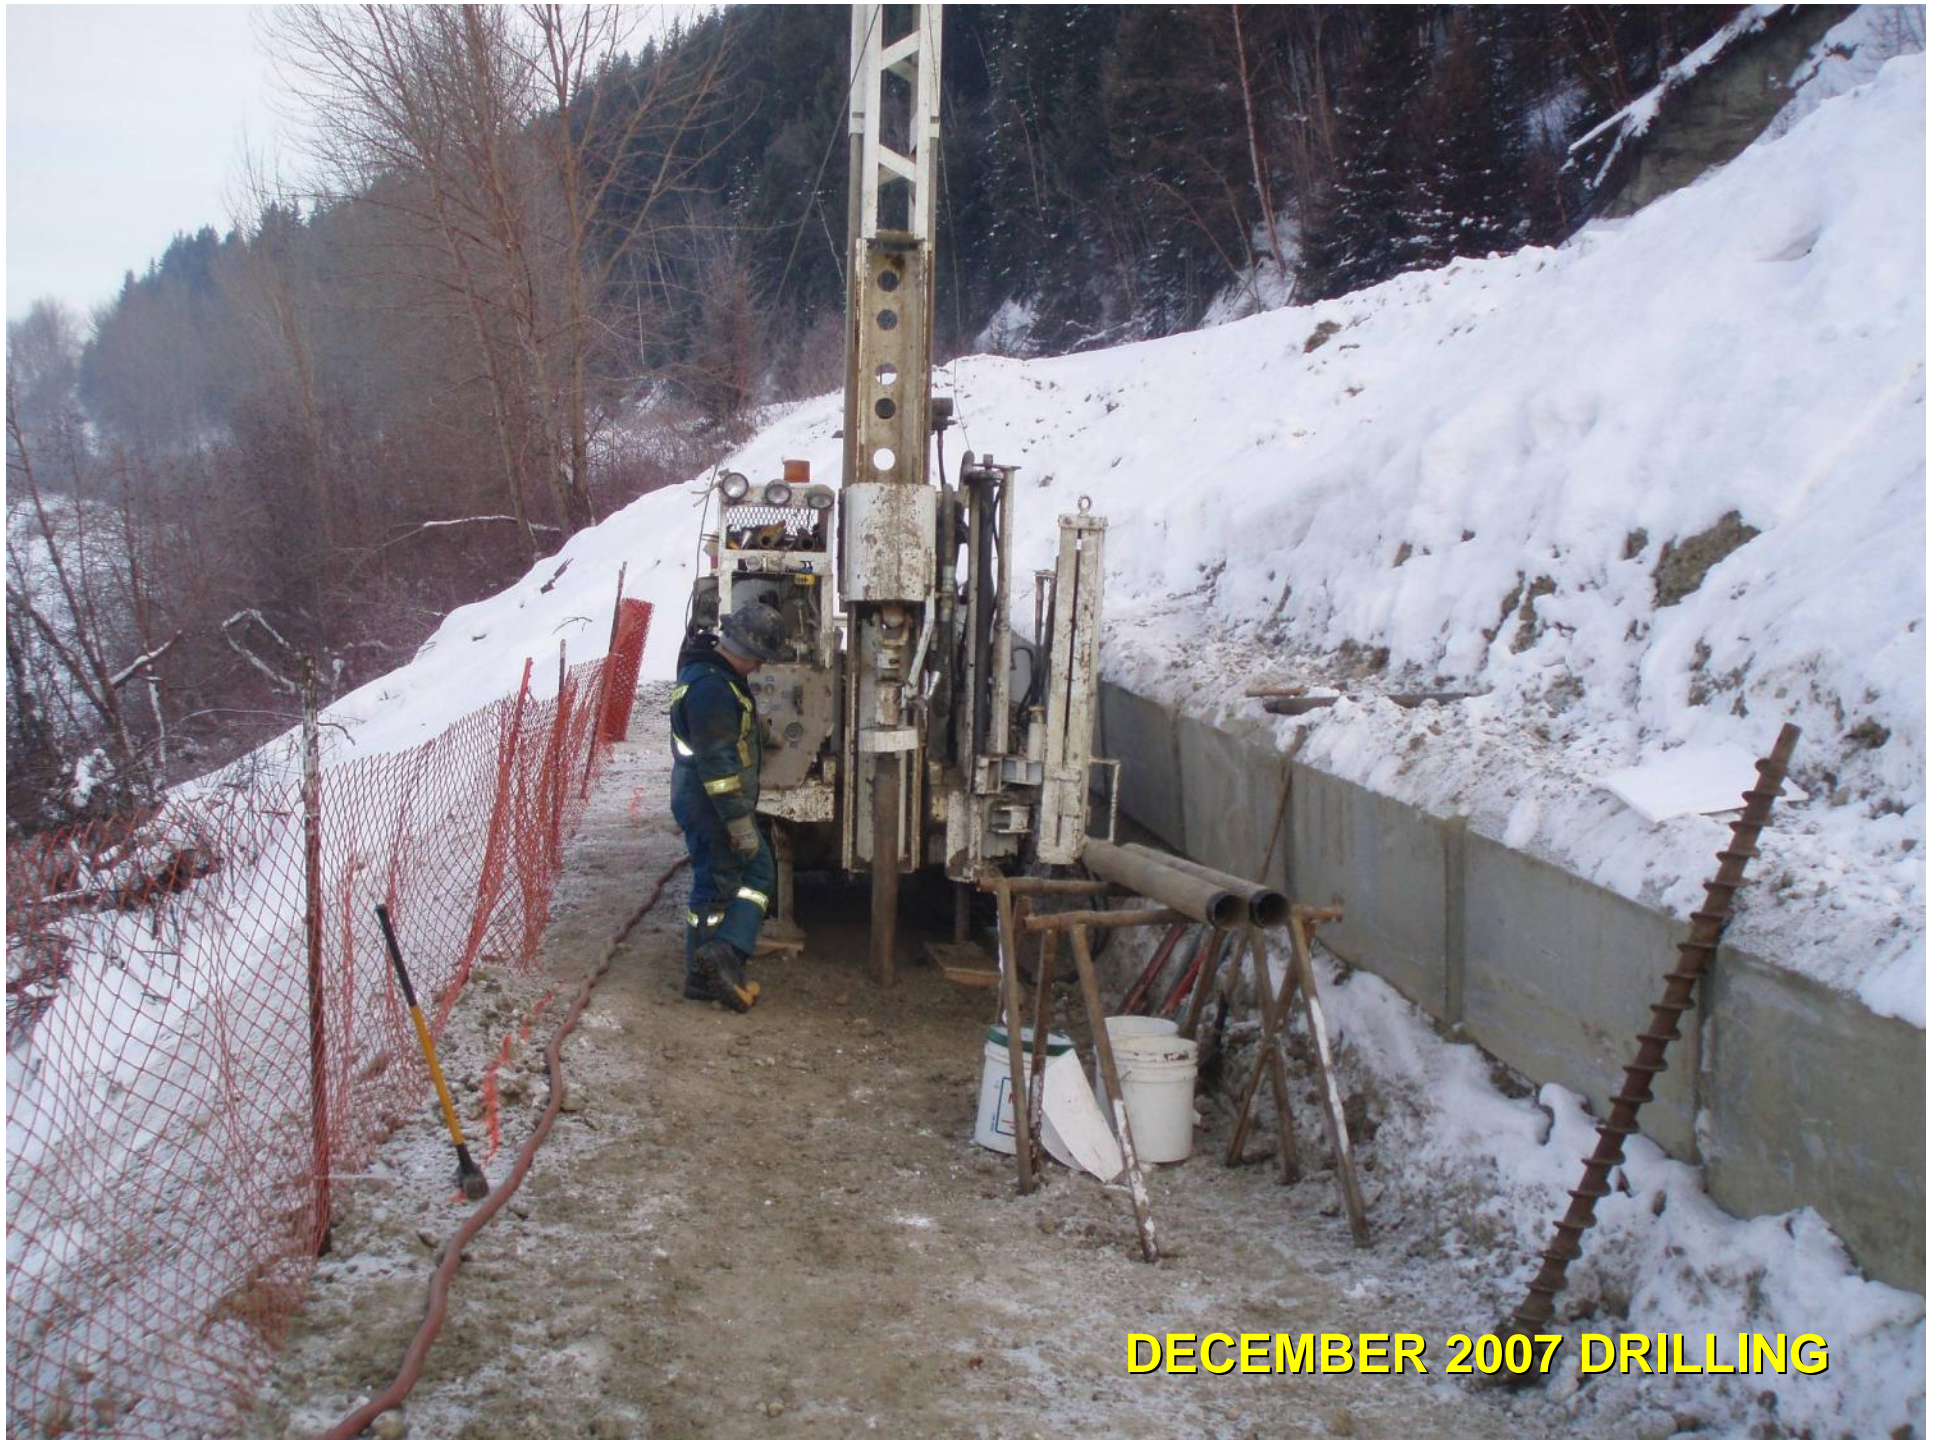
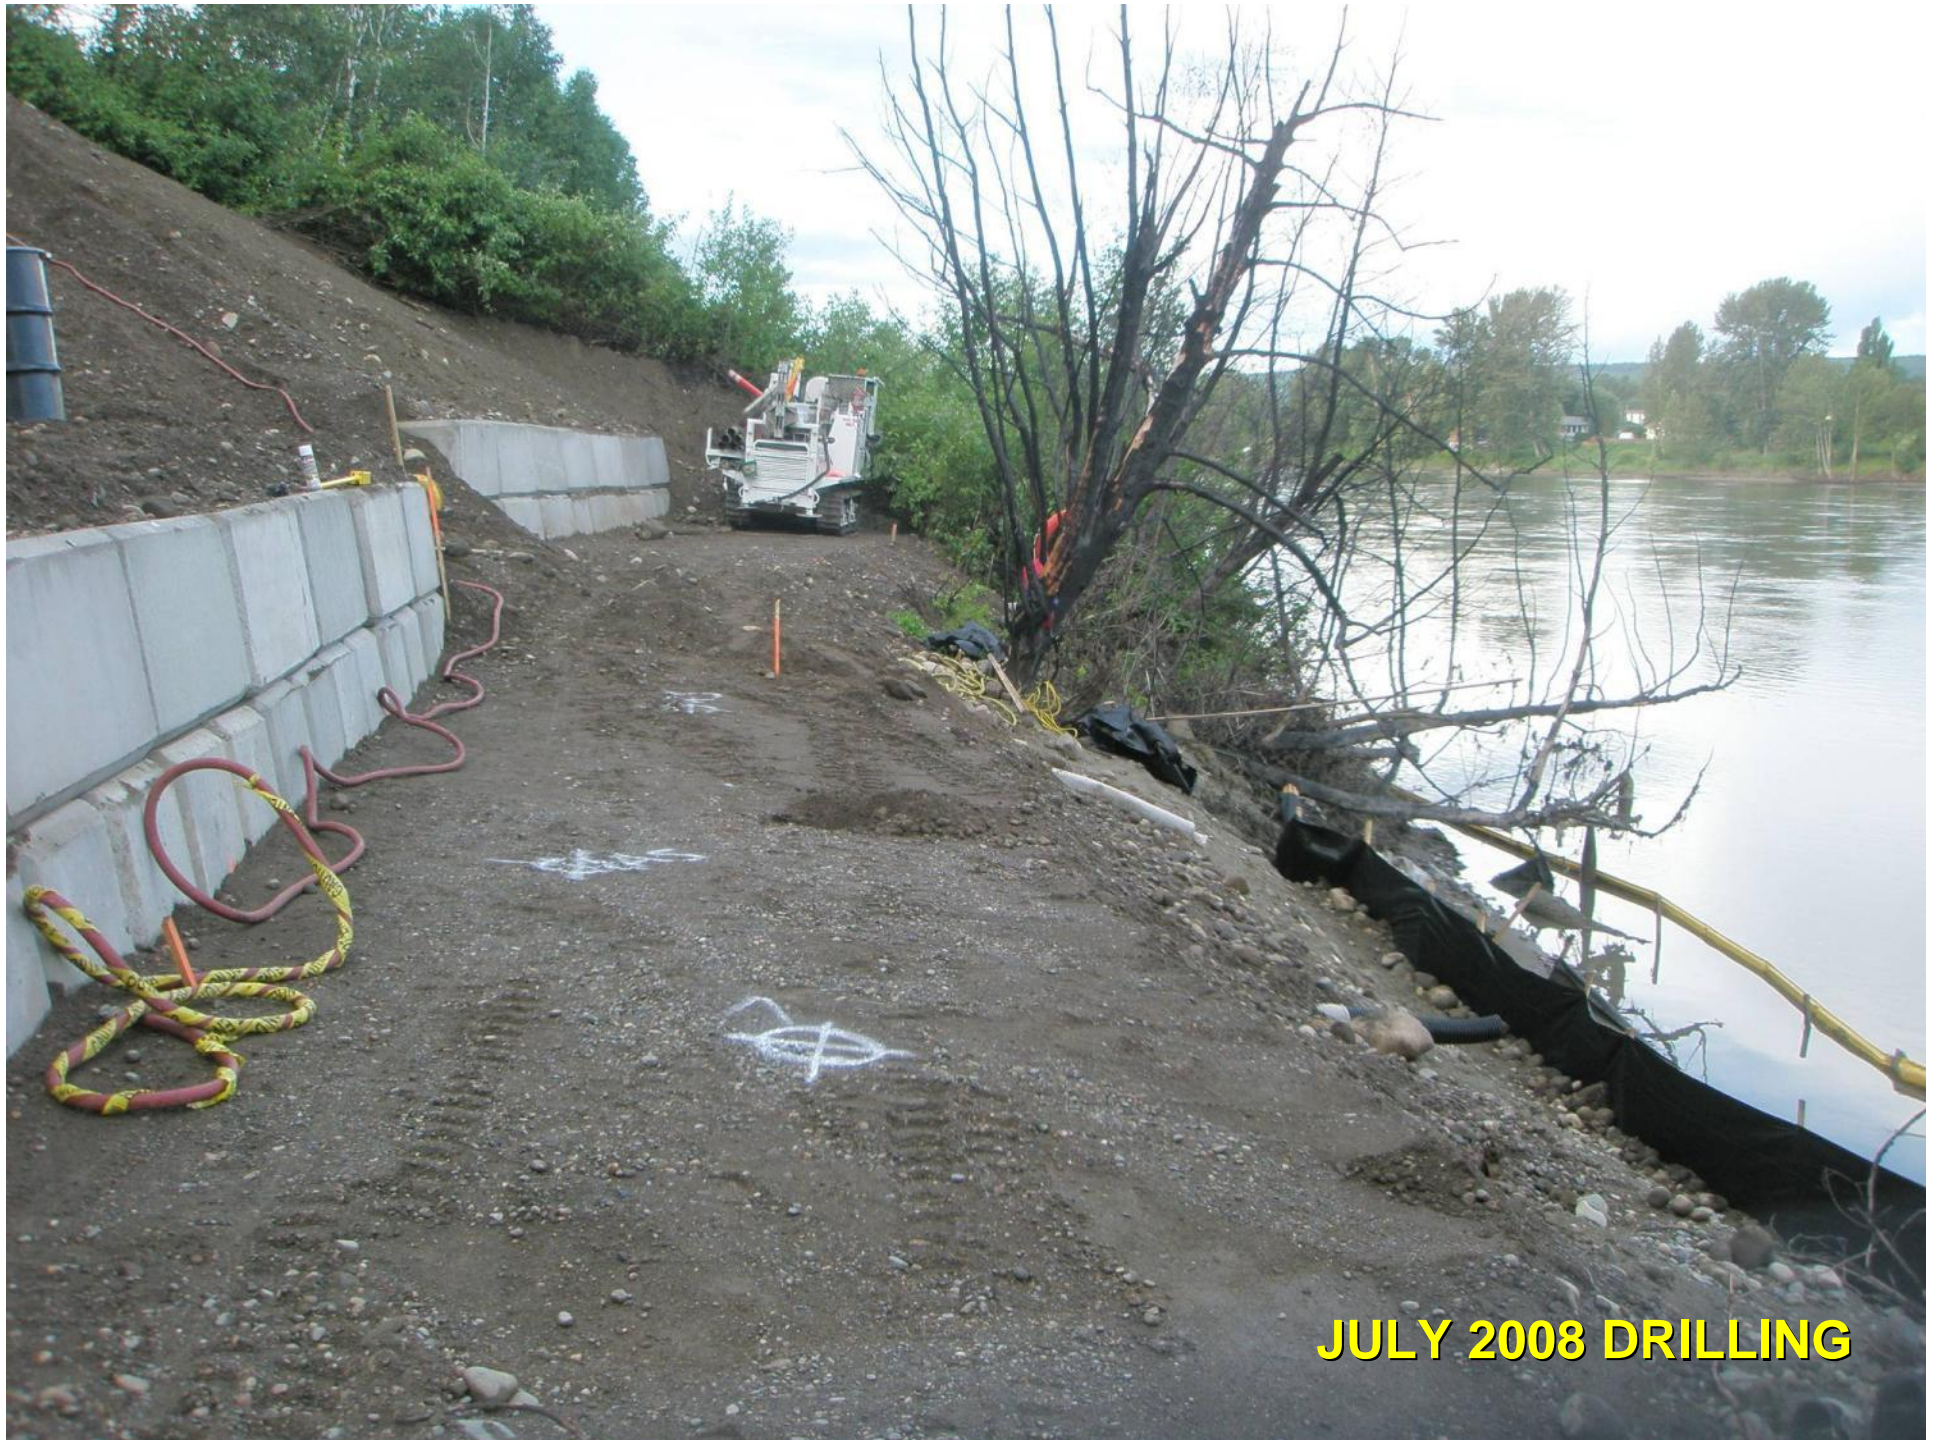
**DECEMBER 2007 DRILLING**

- ◆ Investigate soil and groundwater conditions in the area of the fuel release
- ◆ Delineate soil and groundwater contamination in the spill area
- ◆ Installation of 16 groundwater monitoring wells, 7 soil vapour wells, and 2 contingency air sparge wells

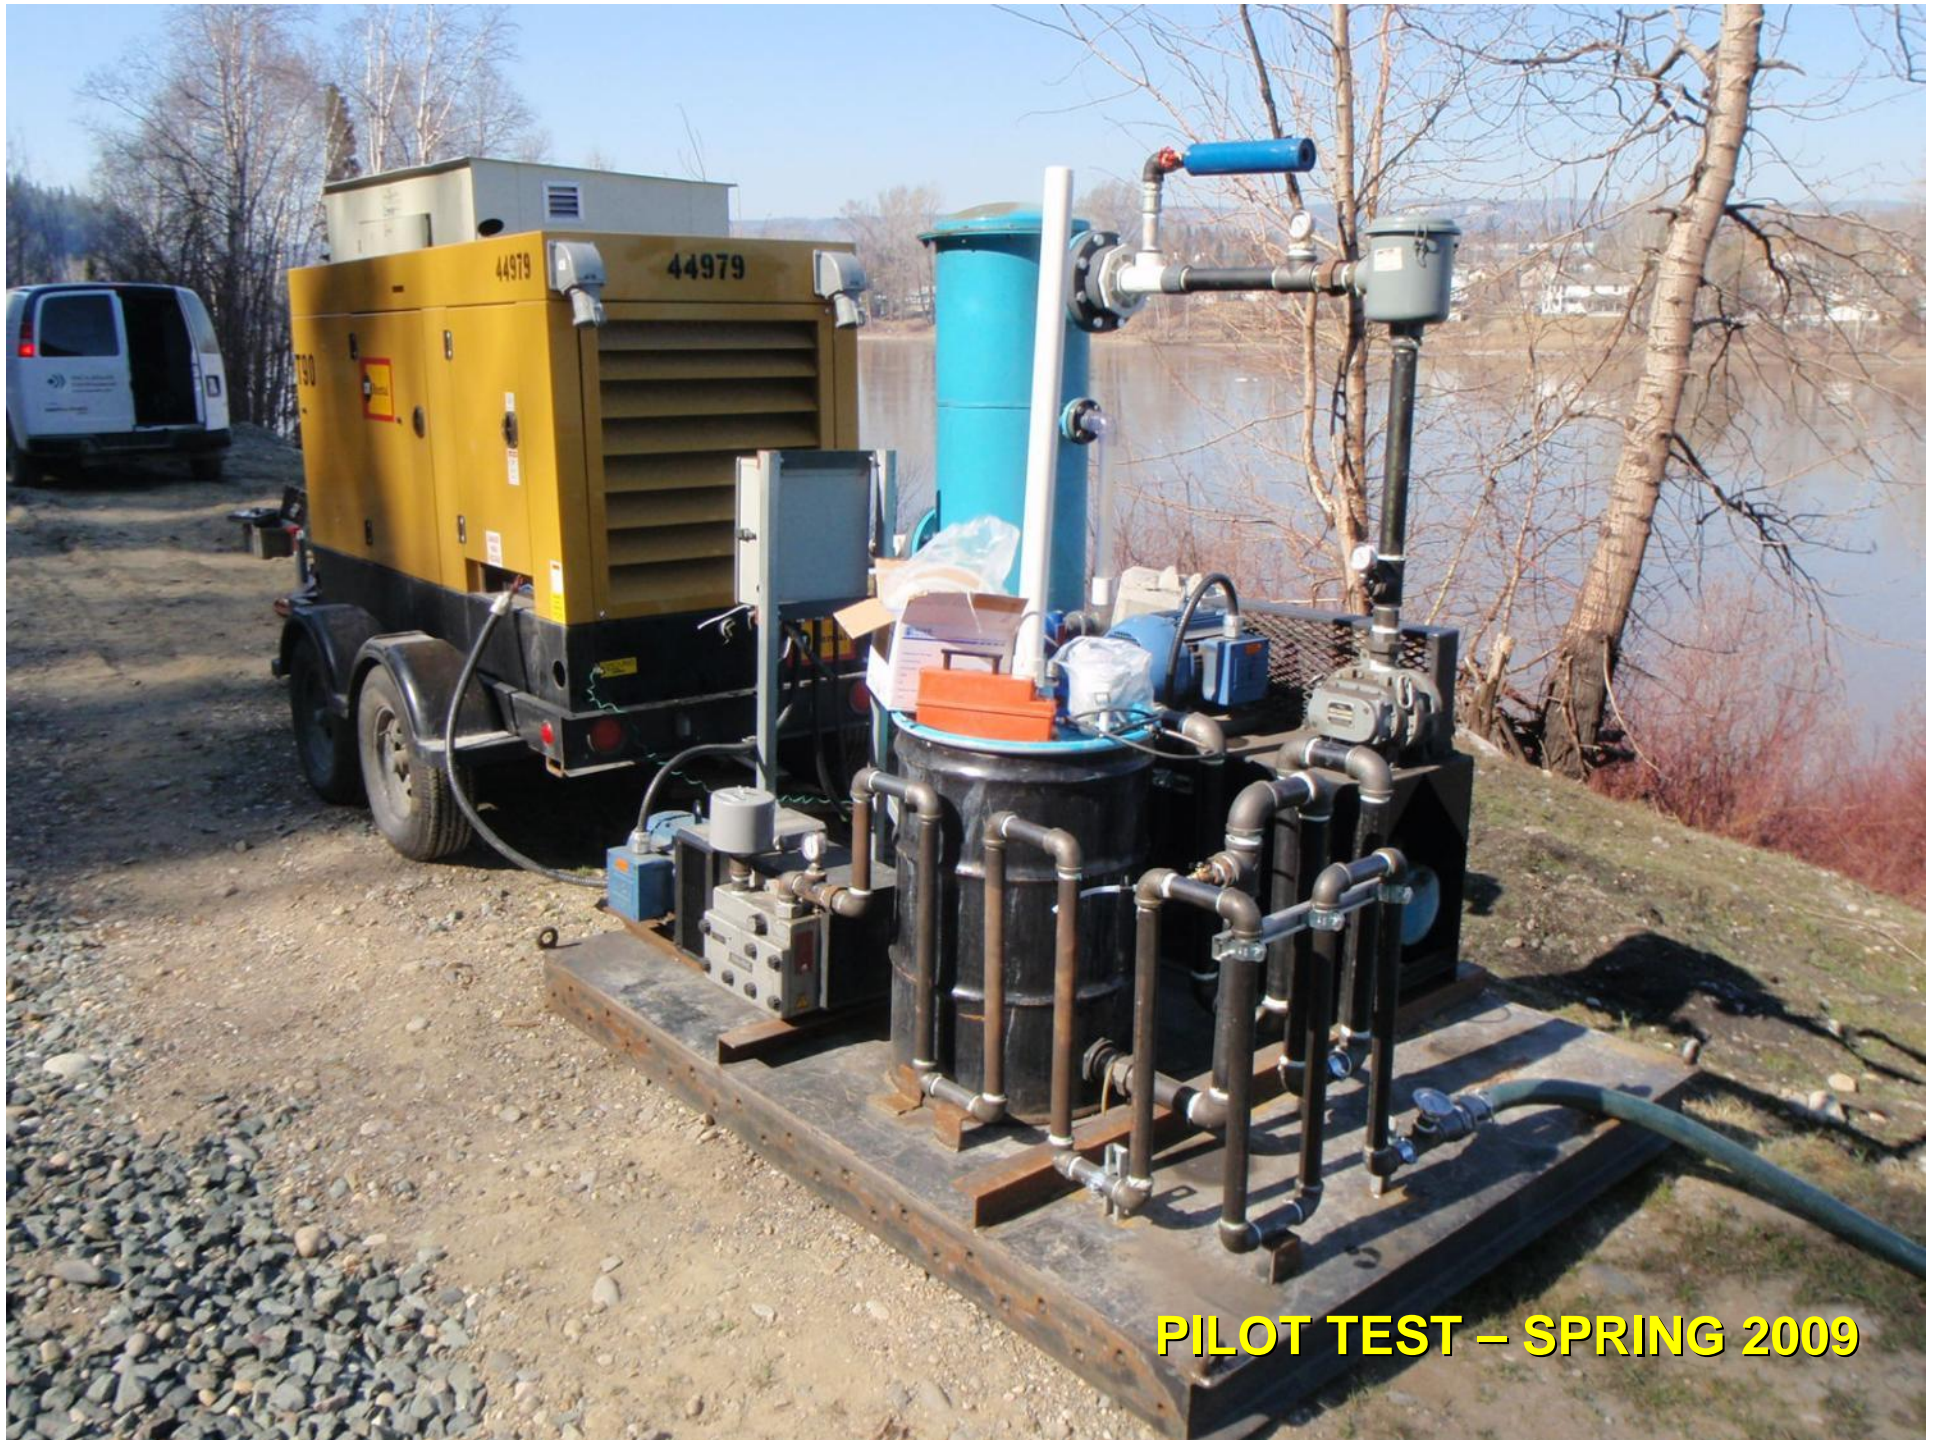
**PILOT TEST – SPRING 2009**

- ◆ Air sparge/soil vapour extraction pilot test completed in Spring 2009
- ◆ Evaluated extracted vapour concentrations, flowrates, and radius of influence from existing monitoring wells
- ◆ Evaluated air injection flowrate, injection pressure and radius of influence for air sparging

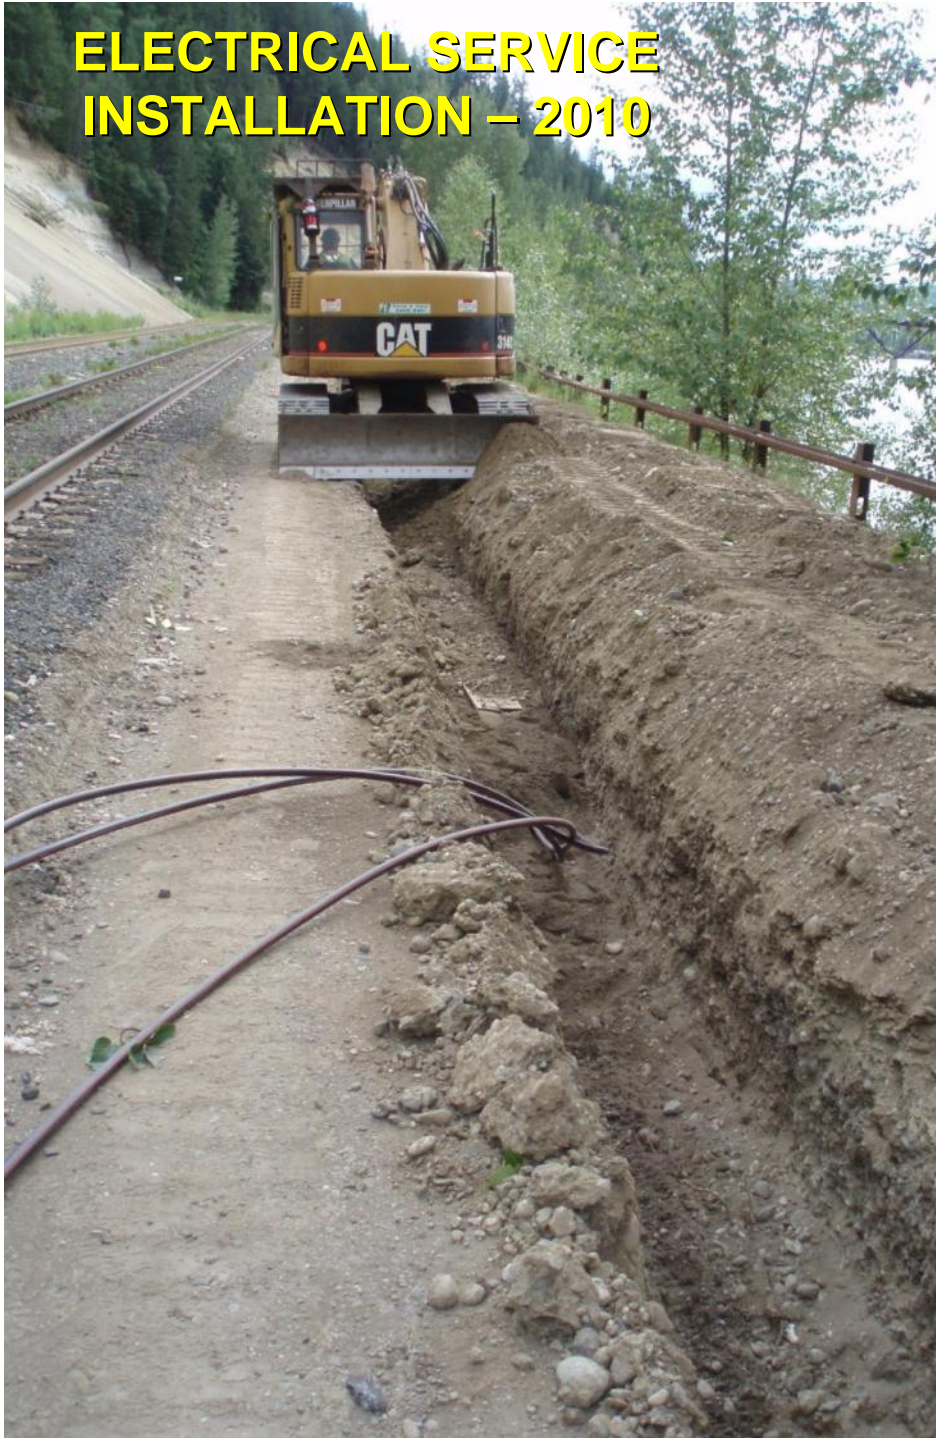
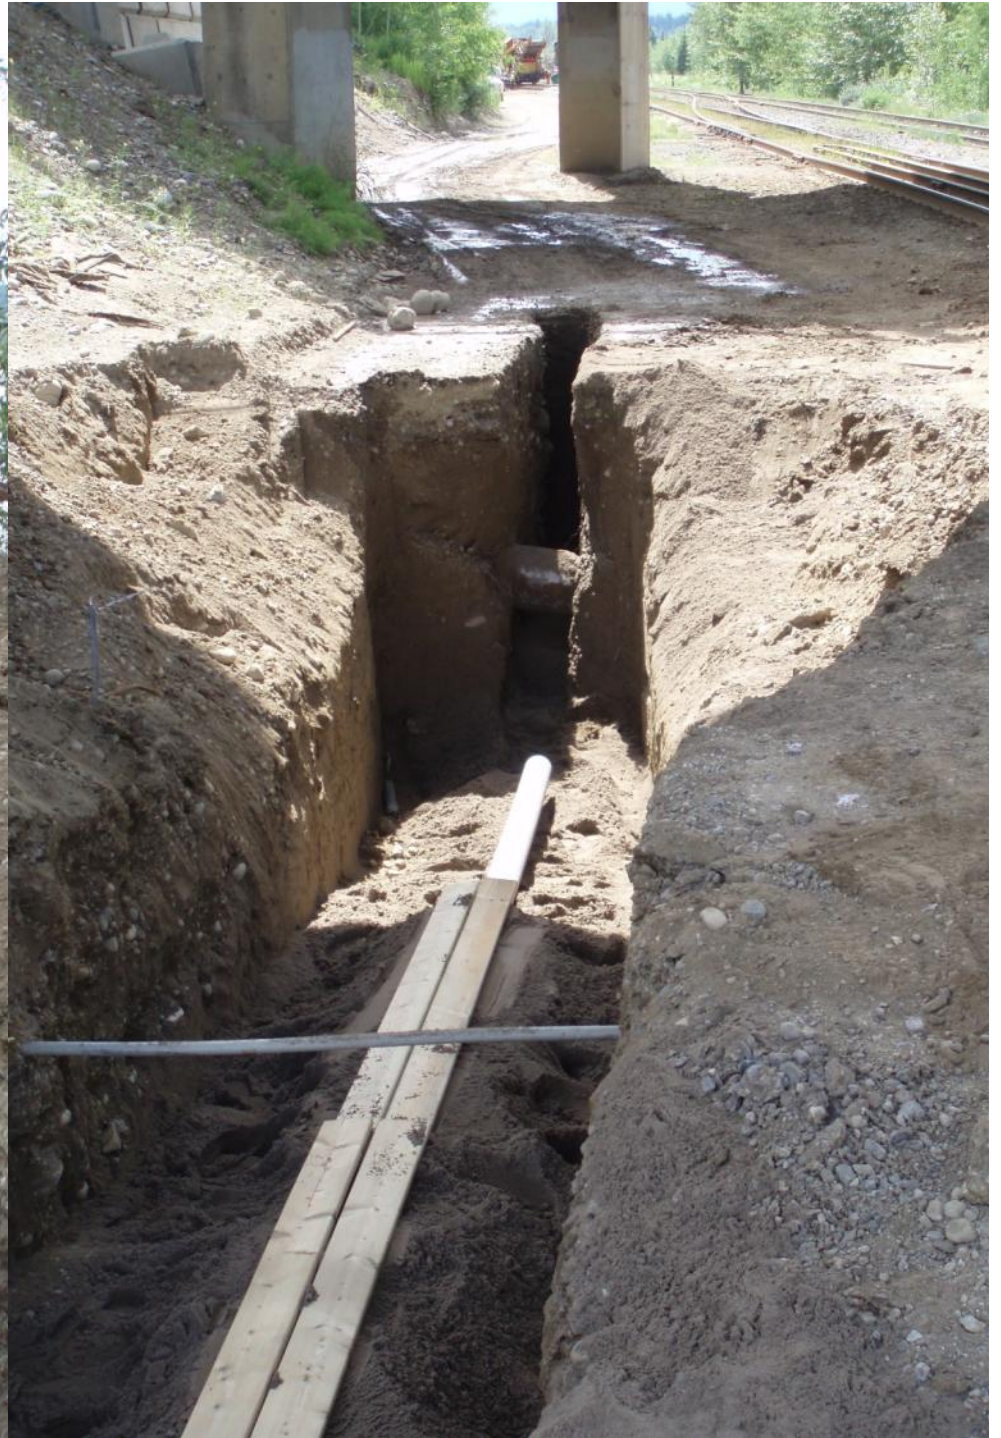
# ELECTRICAL SERVICE INSTALLATION – 2010

- ◆ Installation of a dedicated electrical service was identified as the most suitable method for powering AS/SVE equipment and electric oxidizer
- ◆ 1.8 km 25 kV 3 ph. direct buried cables were installed in August 2010
- ◆ Installed along CN's maintenance road

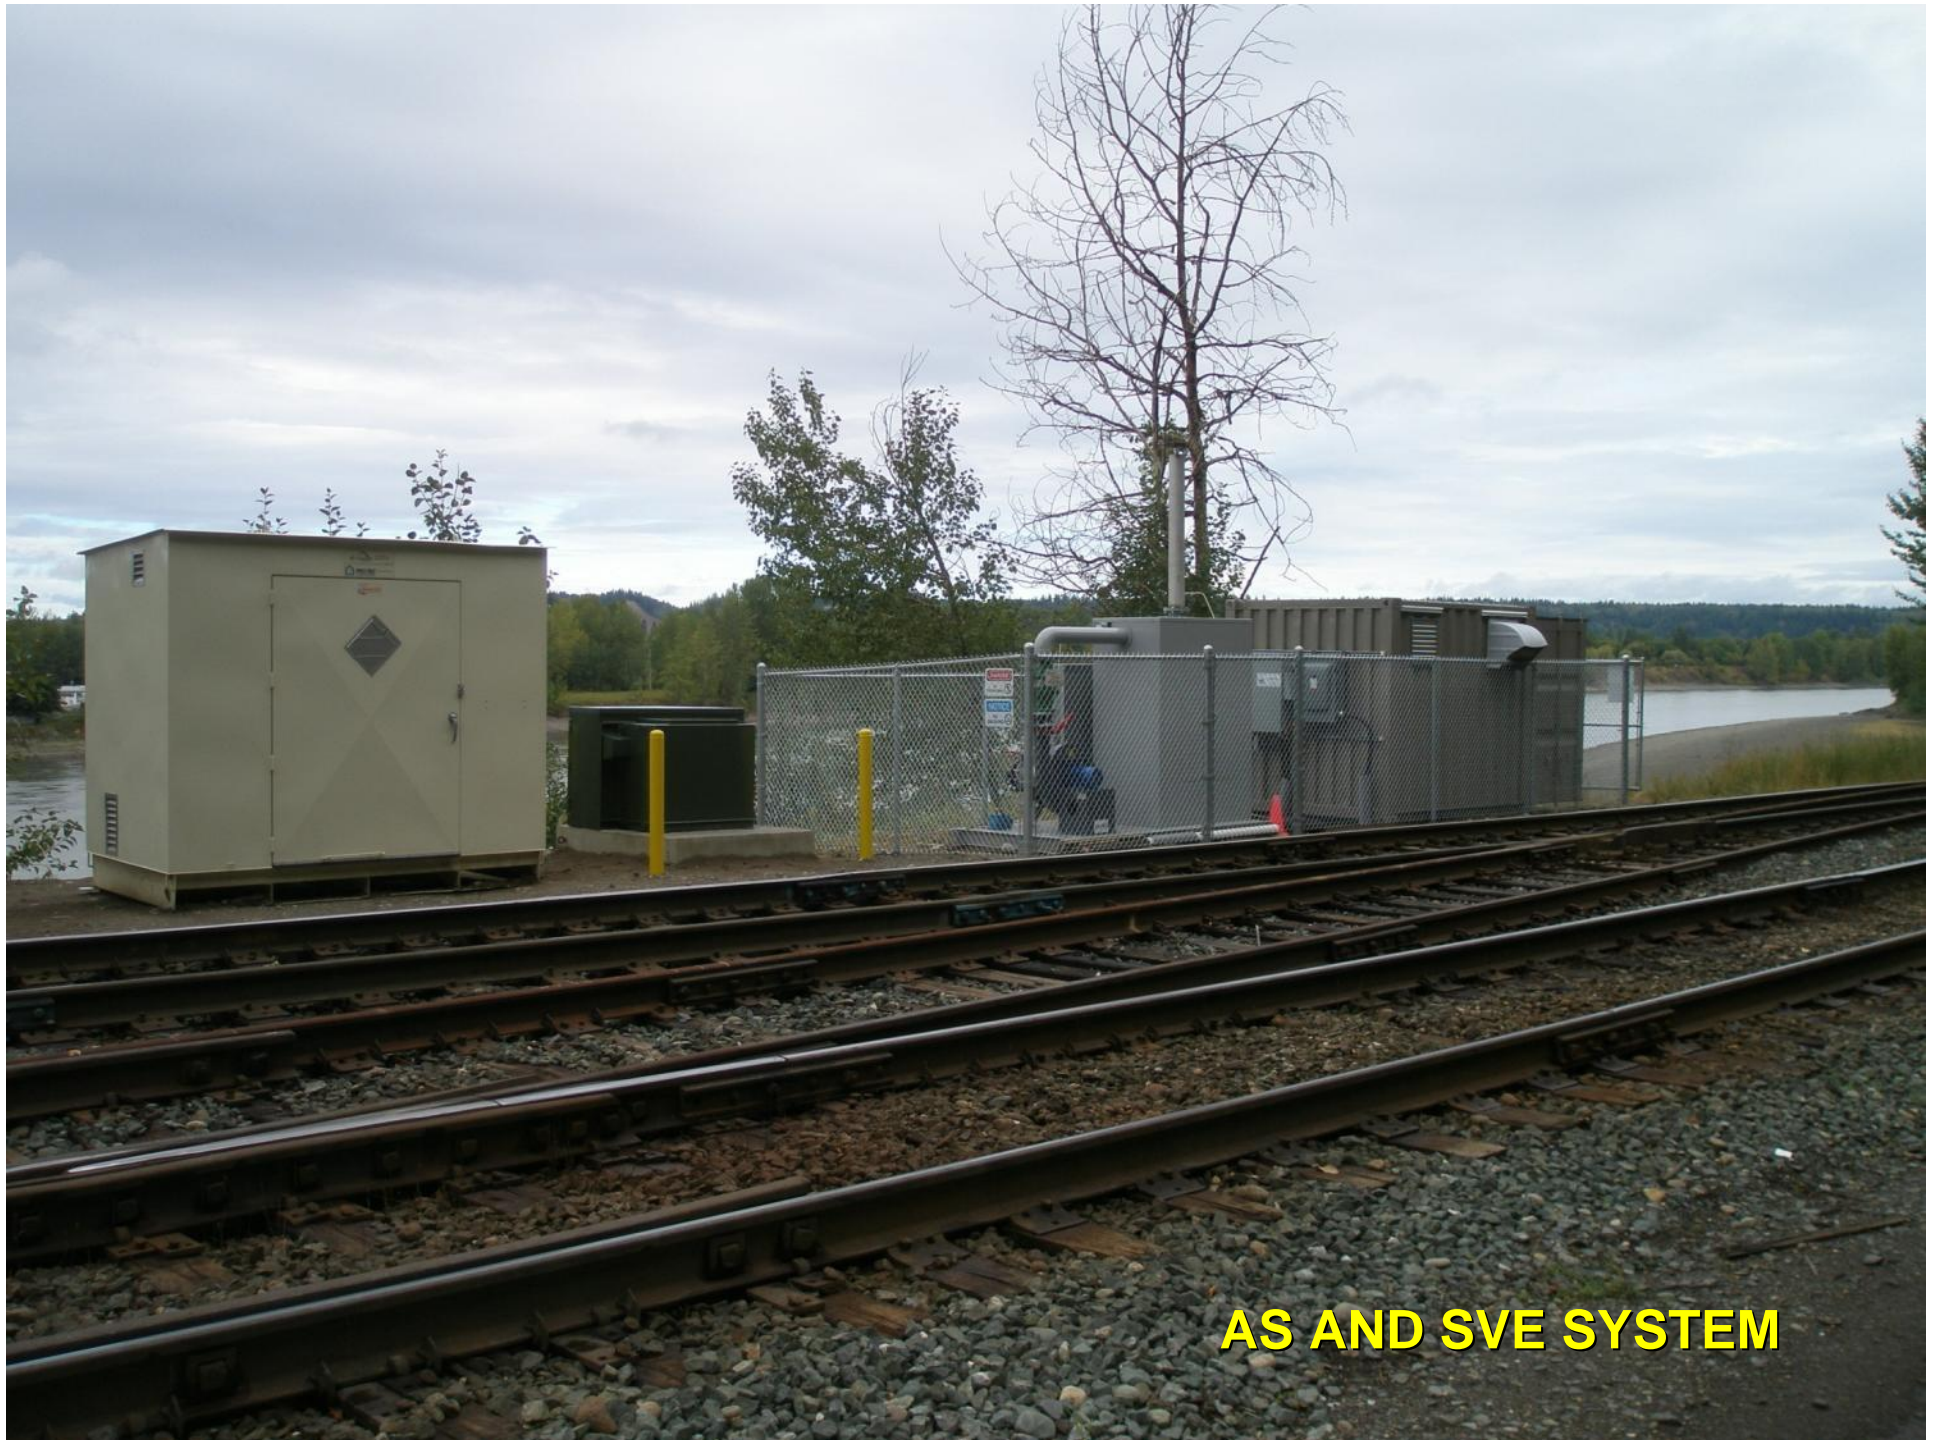
**AS AND SVE SYSTEM**

- ◆ Installation and commissioning of AS/SVE system, electric oxidizer, and associated aboveground infrastructure completed in September 2010
- ◆ Extracted vapours from individual wells were monitored regularly. Vapour extraction was focused on the most heavily impacted wells to optimize remediation.
- ◆ Extracted vapour concentrations from the SVE well network remained at or near the maximum vapour processing capacity of the catalytic electric oxidizer through March 2011

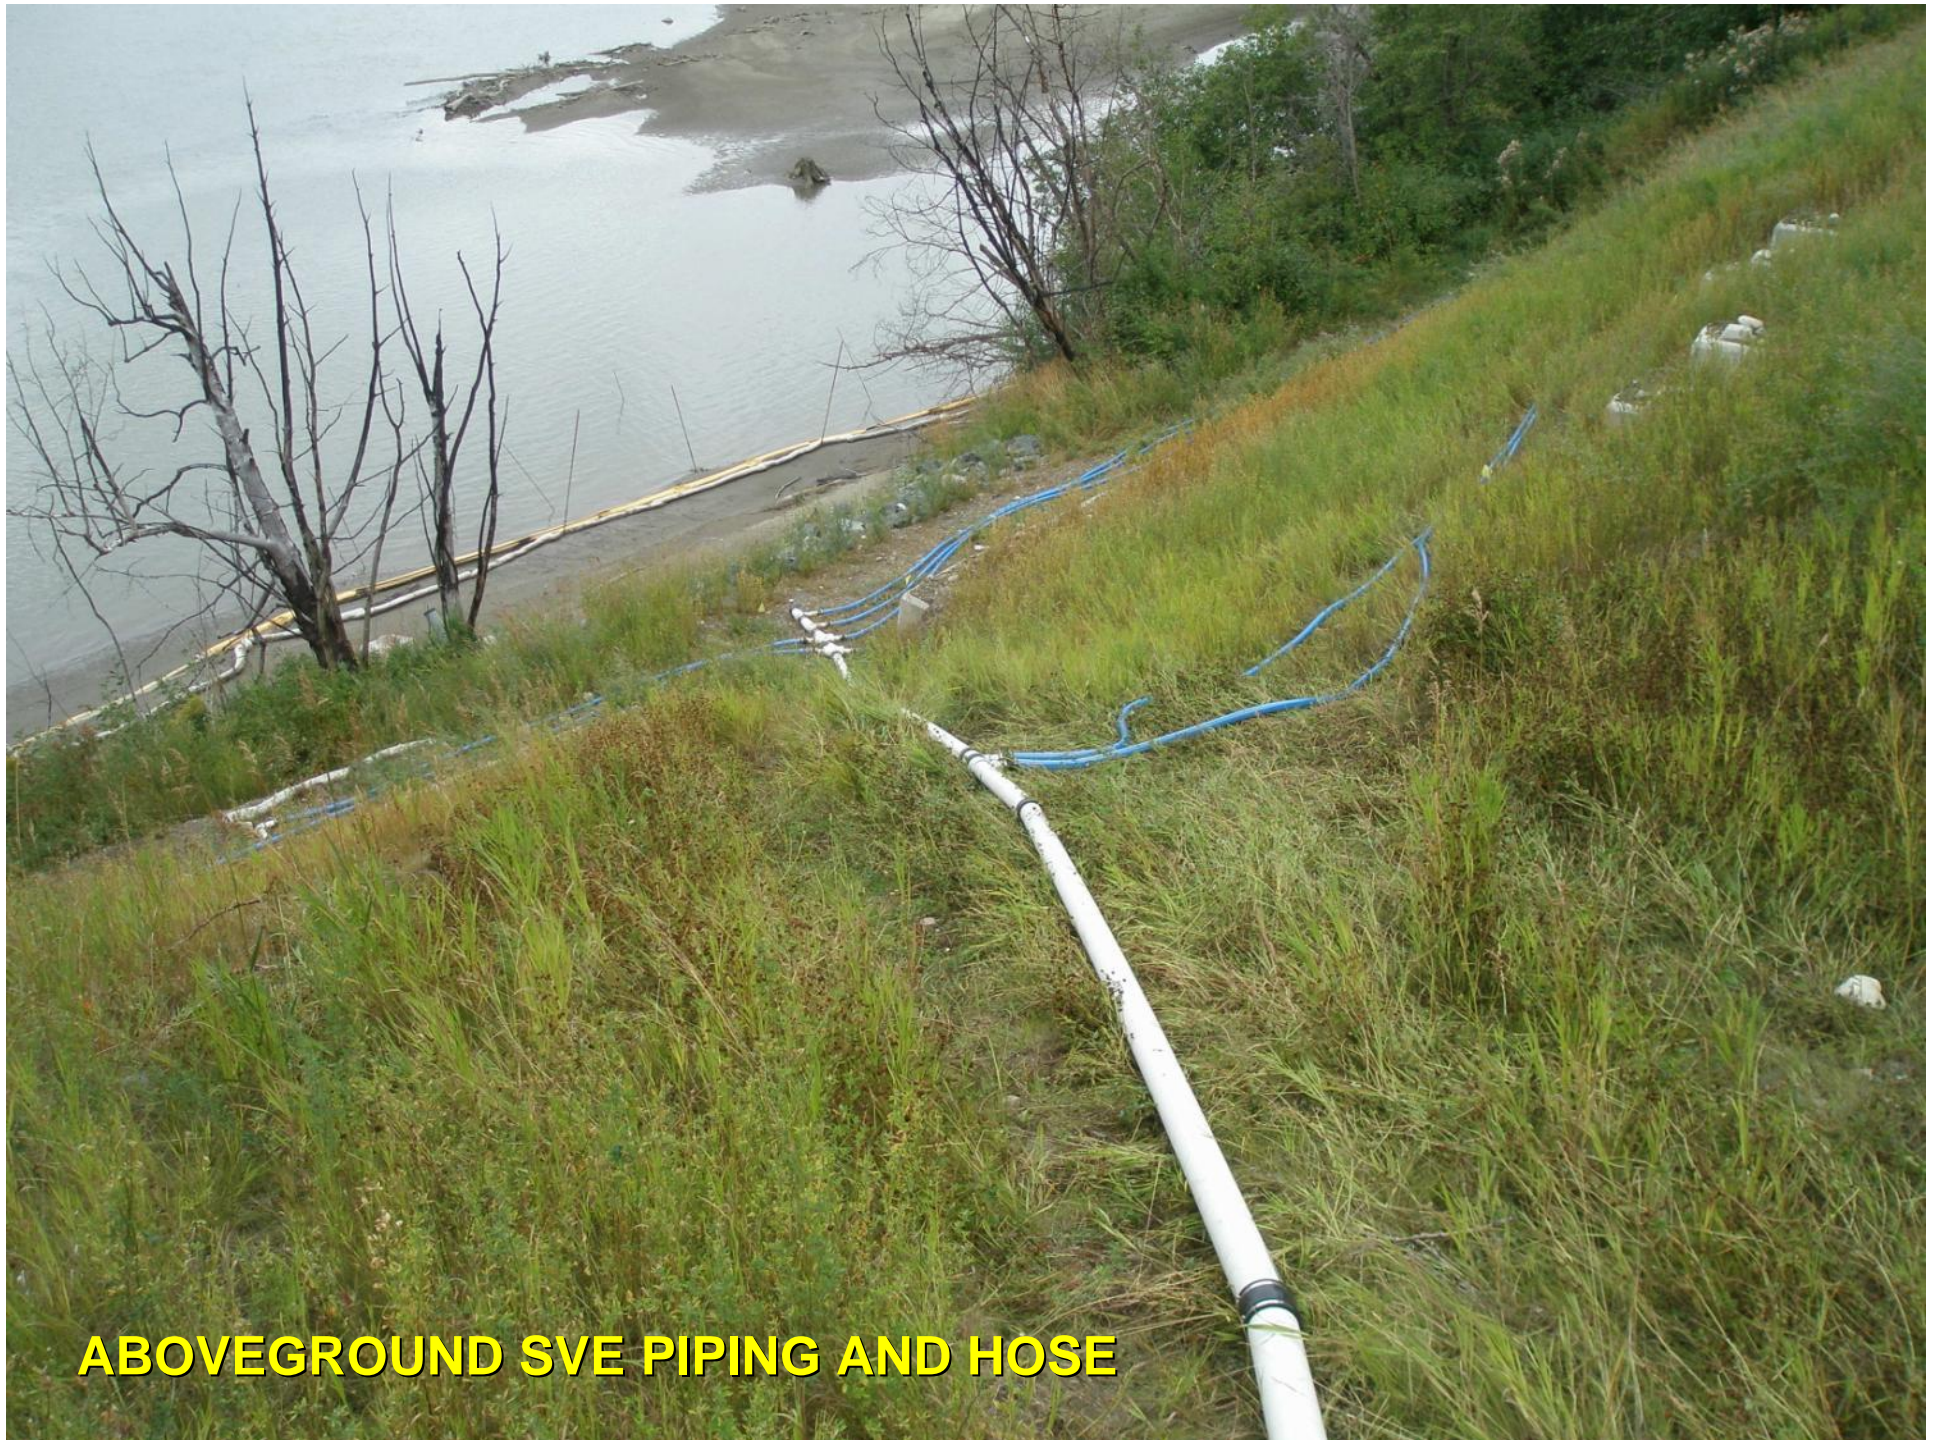
**ABOVEGROUND SVE PIPING AND HOSE**

- ◆ Air sparging was started in May 2011 to enhance soil vapour extraction and reduce dissolved phase hydrocarbon impacts
- ◆ System uptime near 100% since commissioning
- ◆ An estimated 9,500 kg of hydrocarbons removed through SVE to date
