# First Remediation of an Arctic Drilling Sump

Jeff Whitter, P. Eng.

October 21, 2011

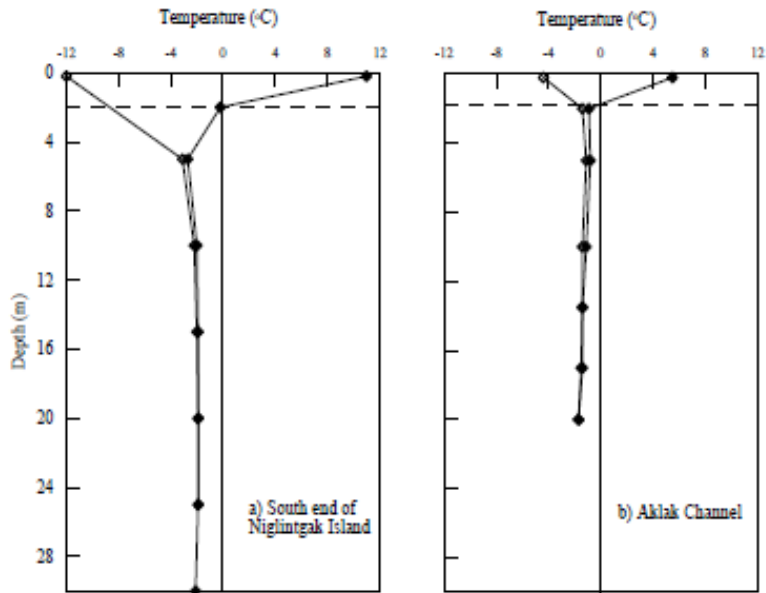
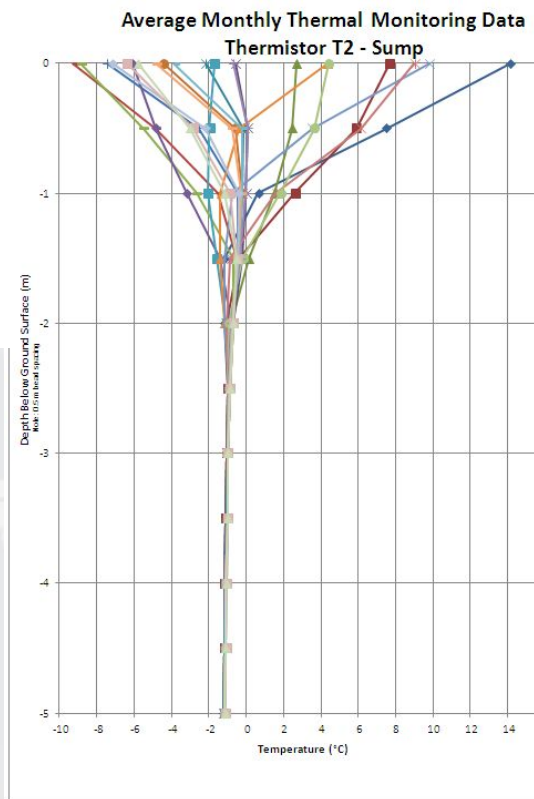
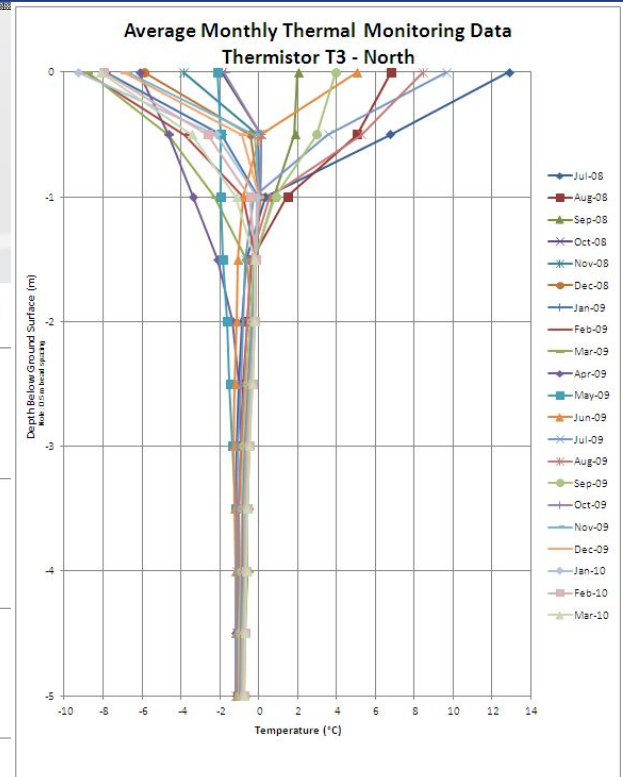
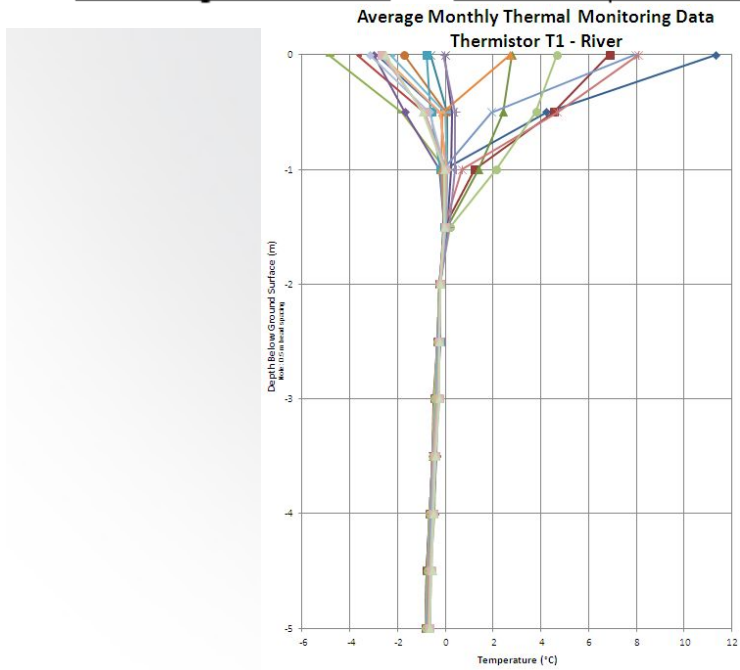
# Thermal Conclusions

- 100 boreholes/8 monitoring wells
- 3 thermistors – temperature profiles
- 2 river channel benchmarks
  - Identified ~6500 m<sup>3</sup> of PHC affected soil
  - Sump volume ~1600 m<sup>3</sup>
  - Frozen soils at all locations
  - River's thermal influence is limited

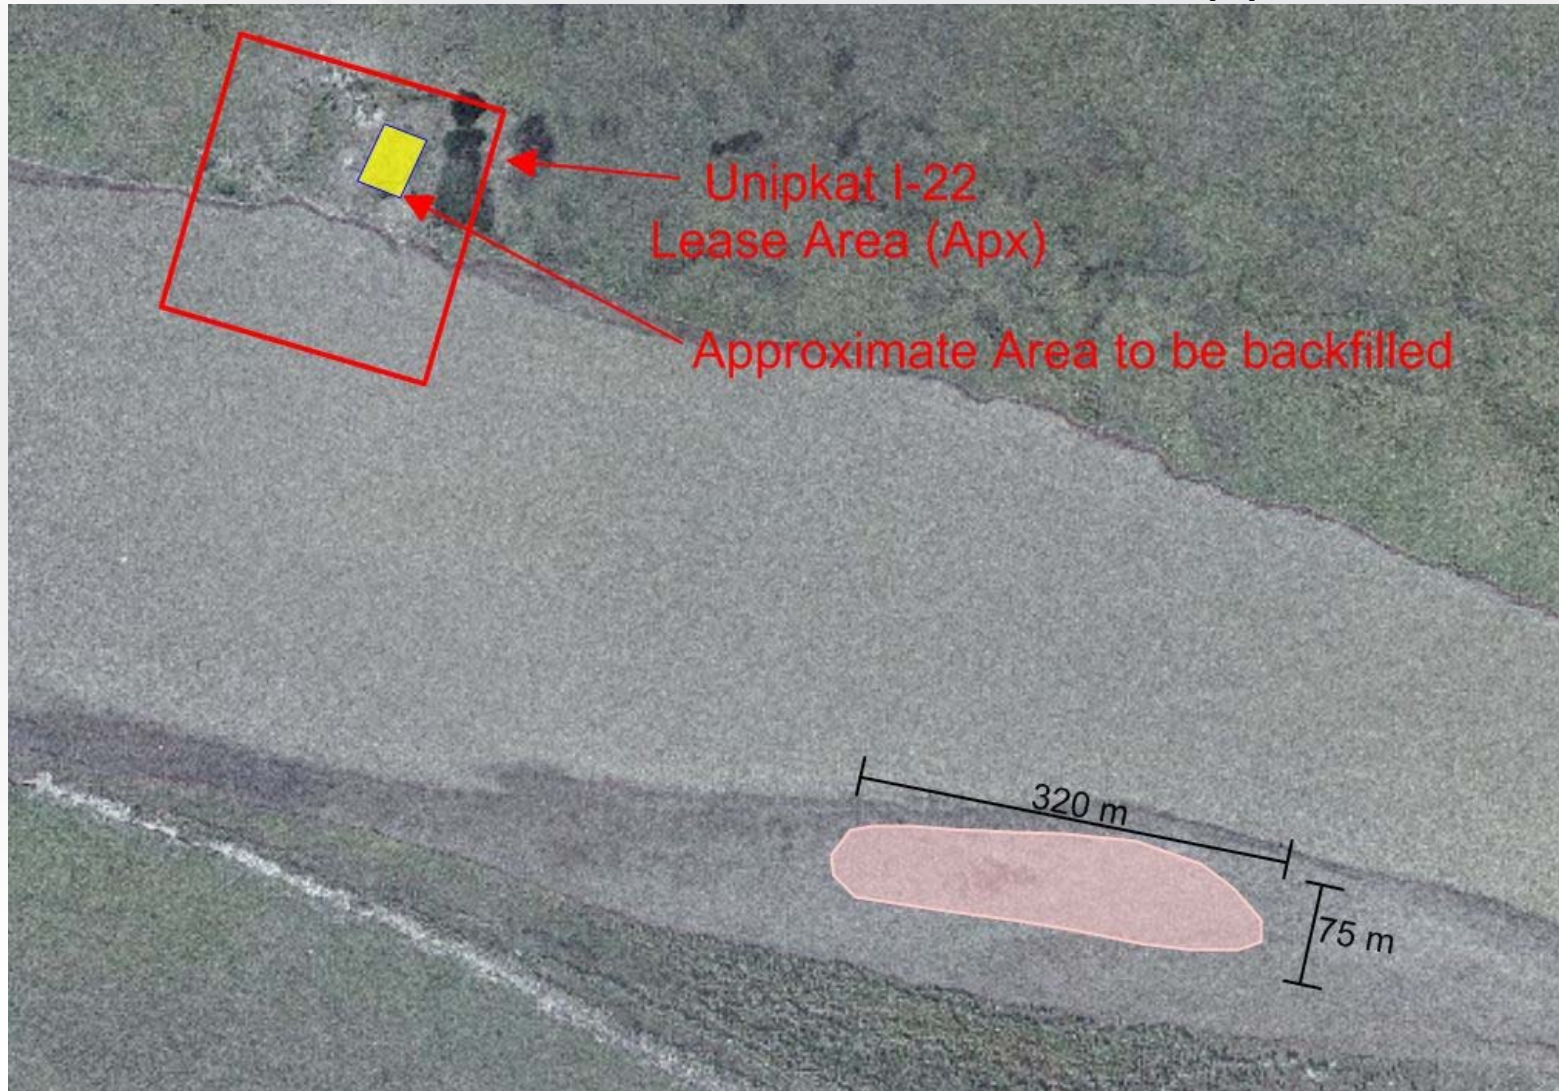
Change in methodology – backfill of excavation, transport all soil to landfill.

Backfill source? - local arsenic issues

- Innovative backfill source with DFO approval.

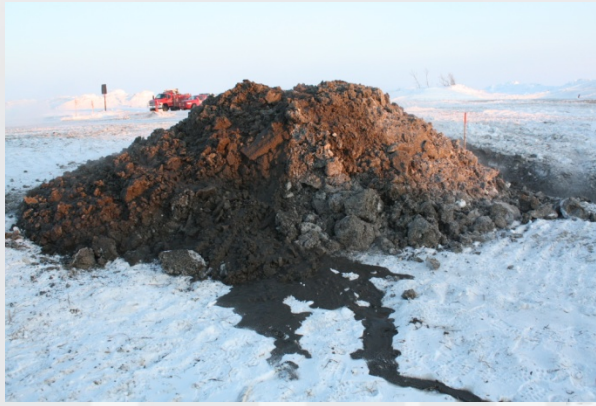
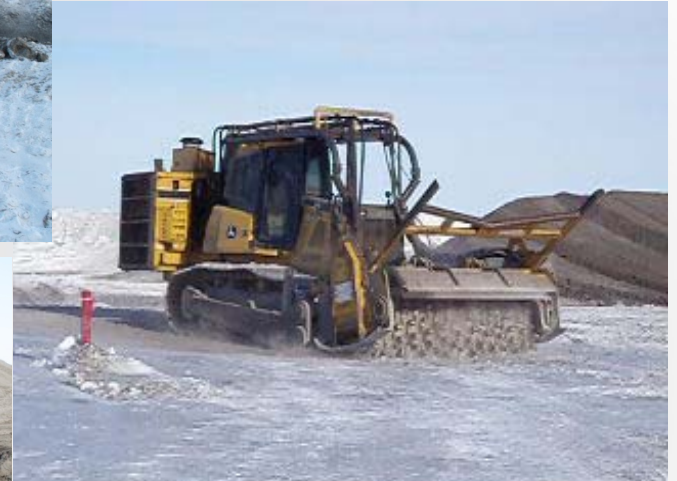
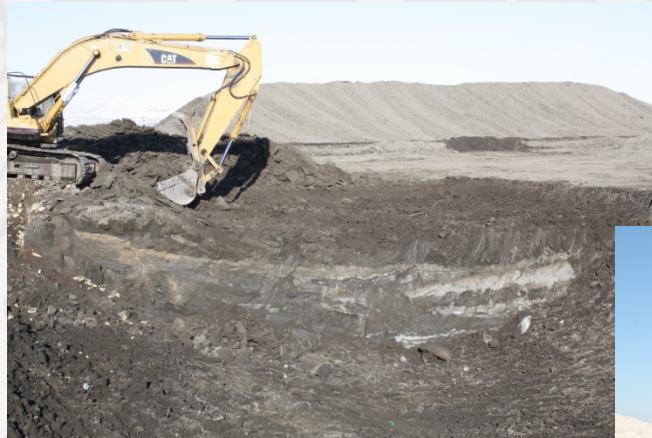
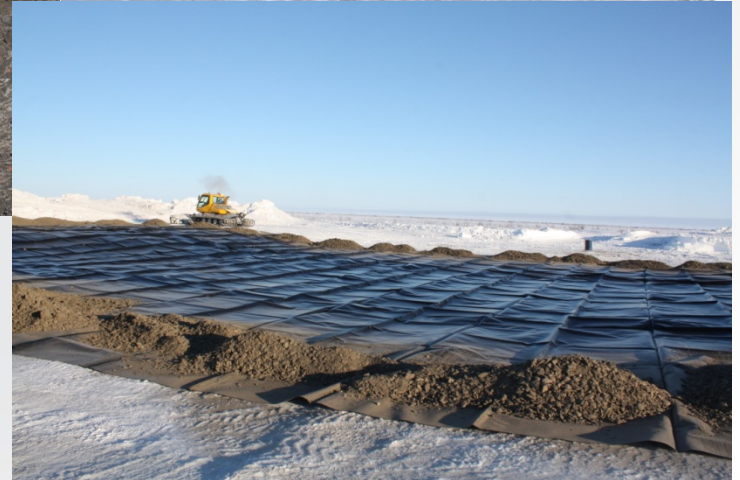
# Site Work - Sump

## Sump work:

- Site clearing
- Testpit
- Site stripping
- Excavation
- Stockpile
- Hauling
- Sampling
- Backfill
- Drilling
- Storage
- More hauling
