Arctic Sites Phase 1 ESA & Remote Sensing Pilot Project

Reagen Stoddart, Imperial Oil & Steve Adam, WorleyParsons

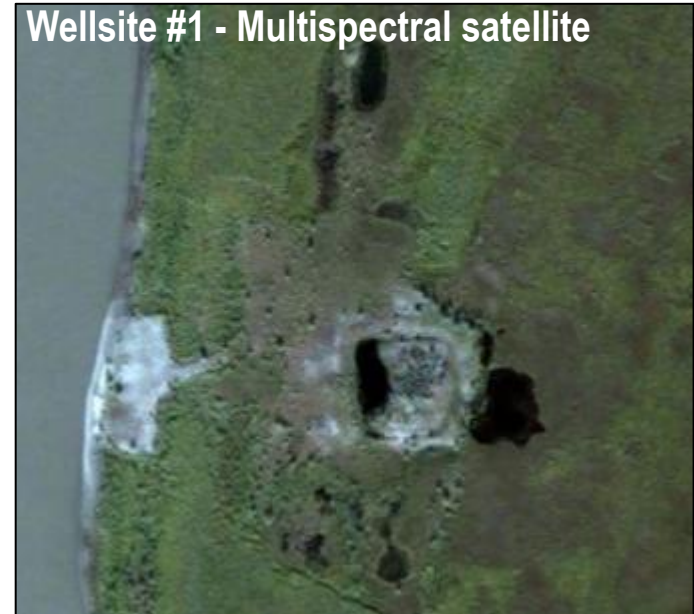
Wellsite #1 - Multispectral satellite

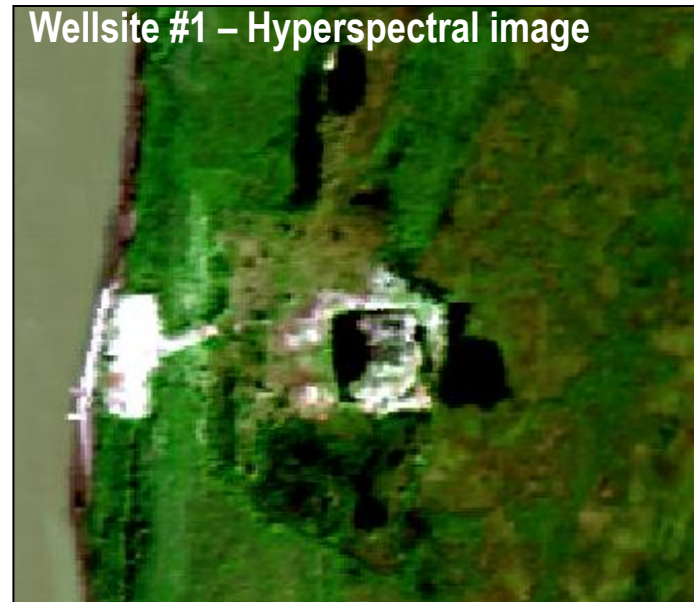
Wellsite #1 – Hyperspectral image

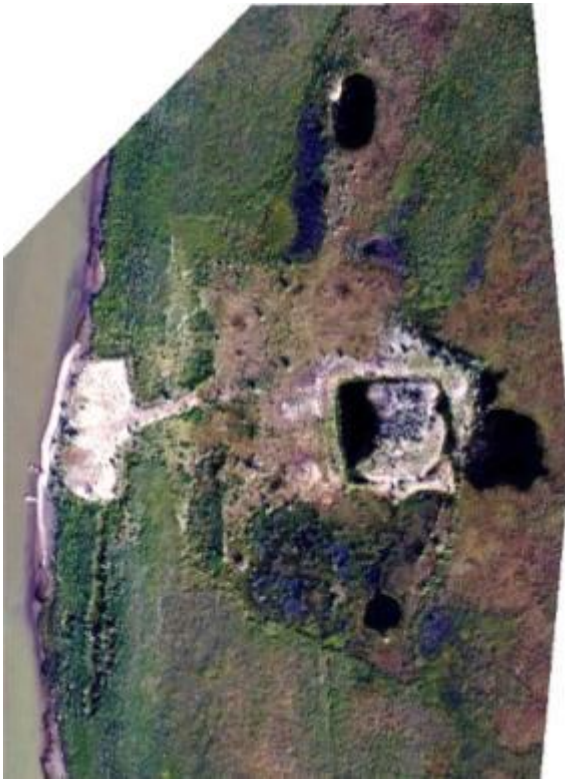
Ortho-image

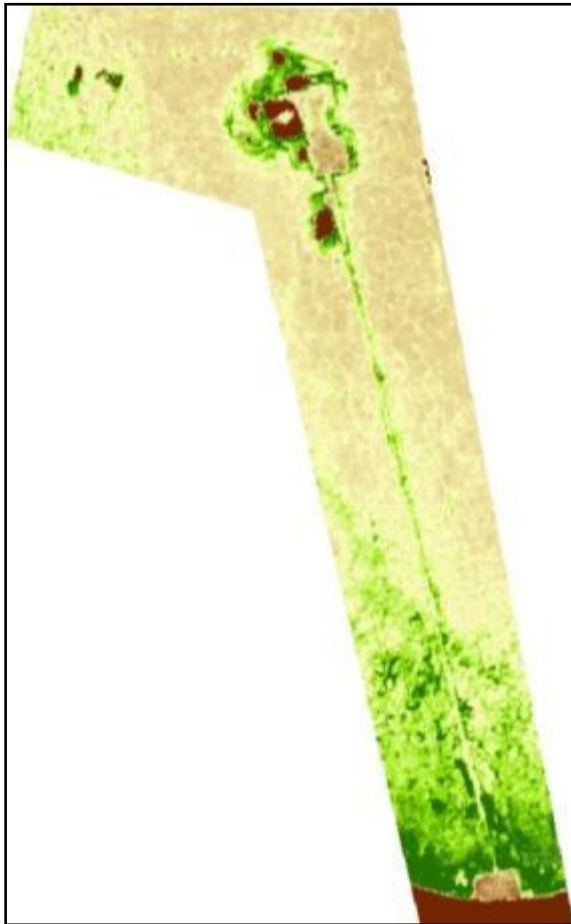
Hyperspectral

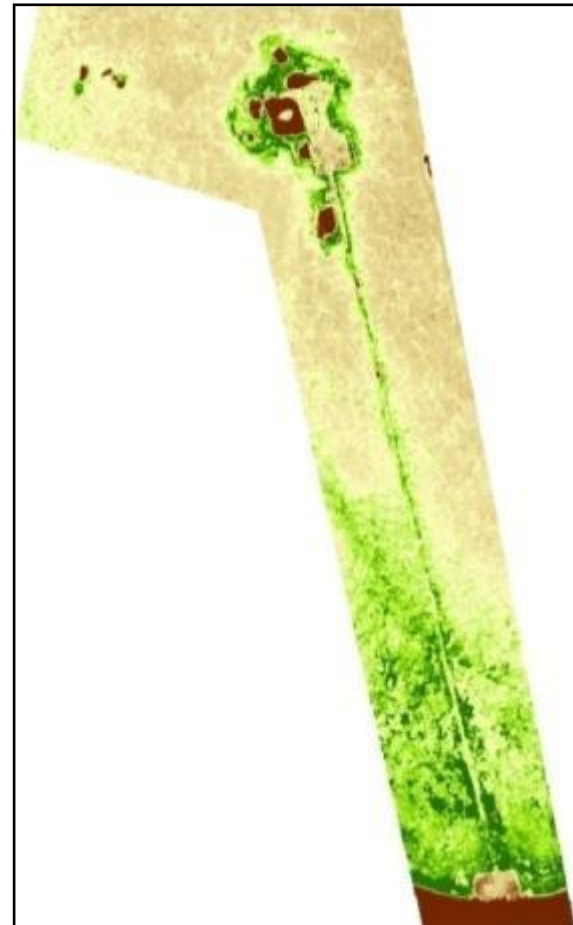
WorldView 2

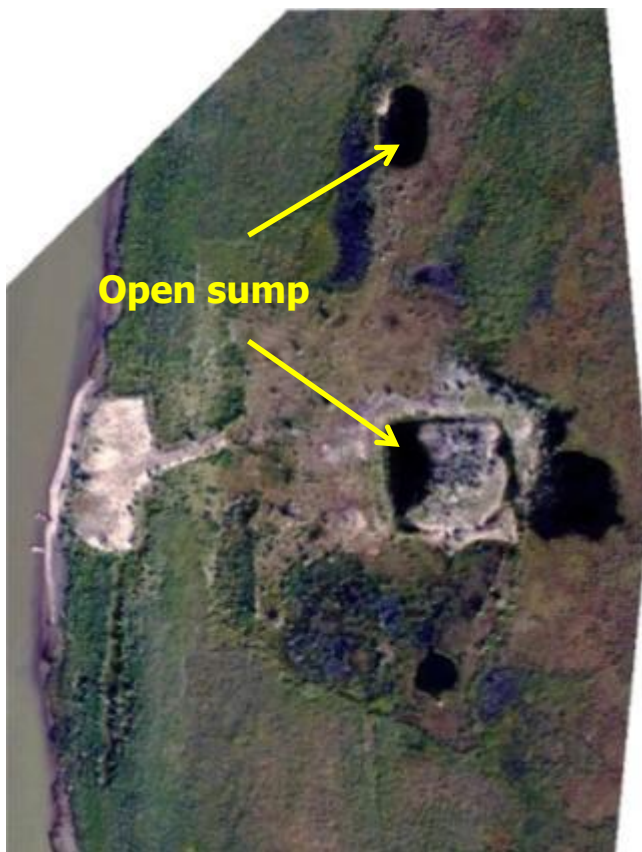
- looking for open water and sump collapse

Air photo

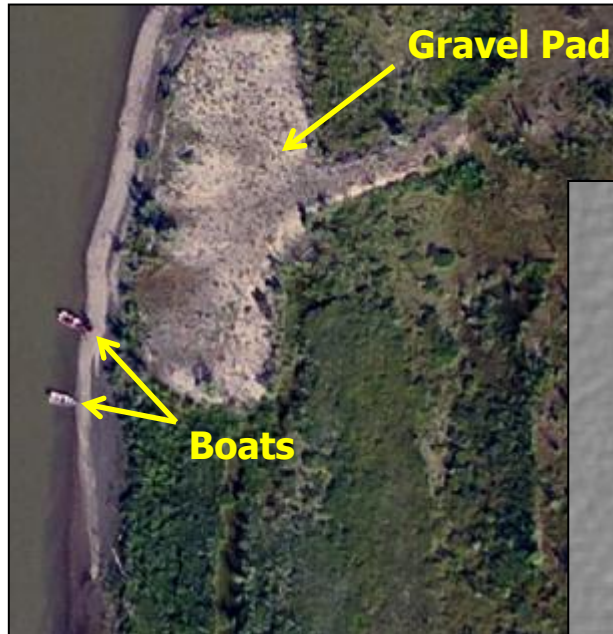
Wellsite #1 – Ortho image

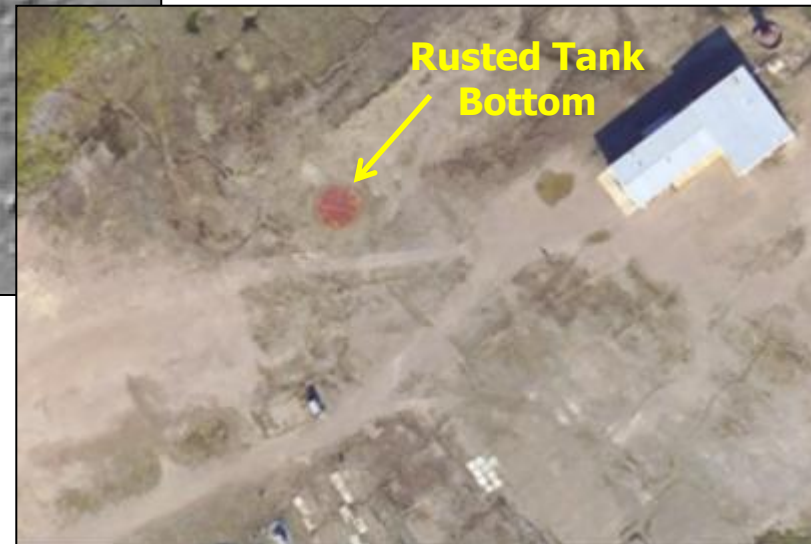
Staging Area #1 – Air photo

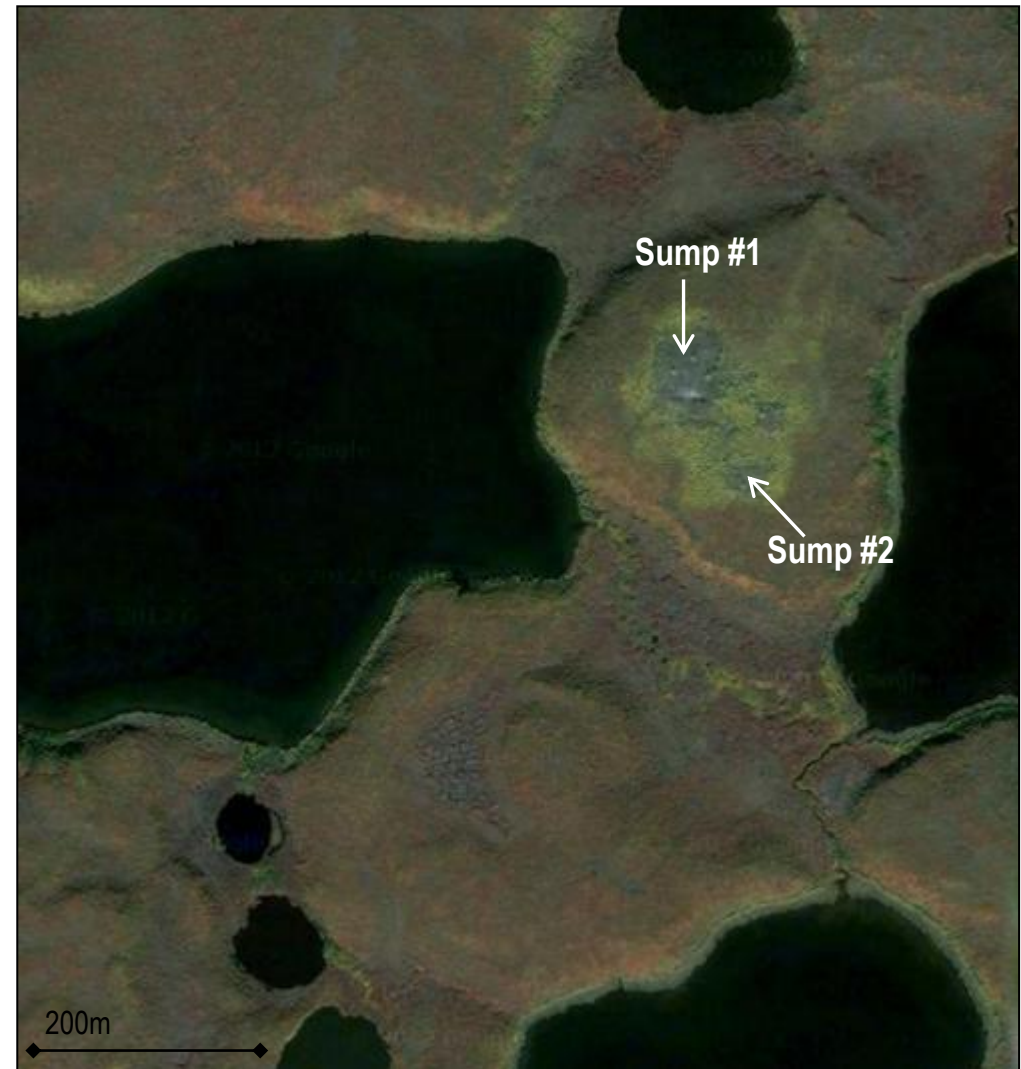
- no debris, physical hazards
- no hazardous materials
- no water ponding
- drilling muds not an issue
- evidence of sump freeze-back
- in a less sensitive area
- vegetation re-growth
(higher density, vigour, type)
- flat slopes
- no potential for erosion

Wellsite #5 – Lower Priority

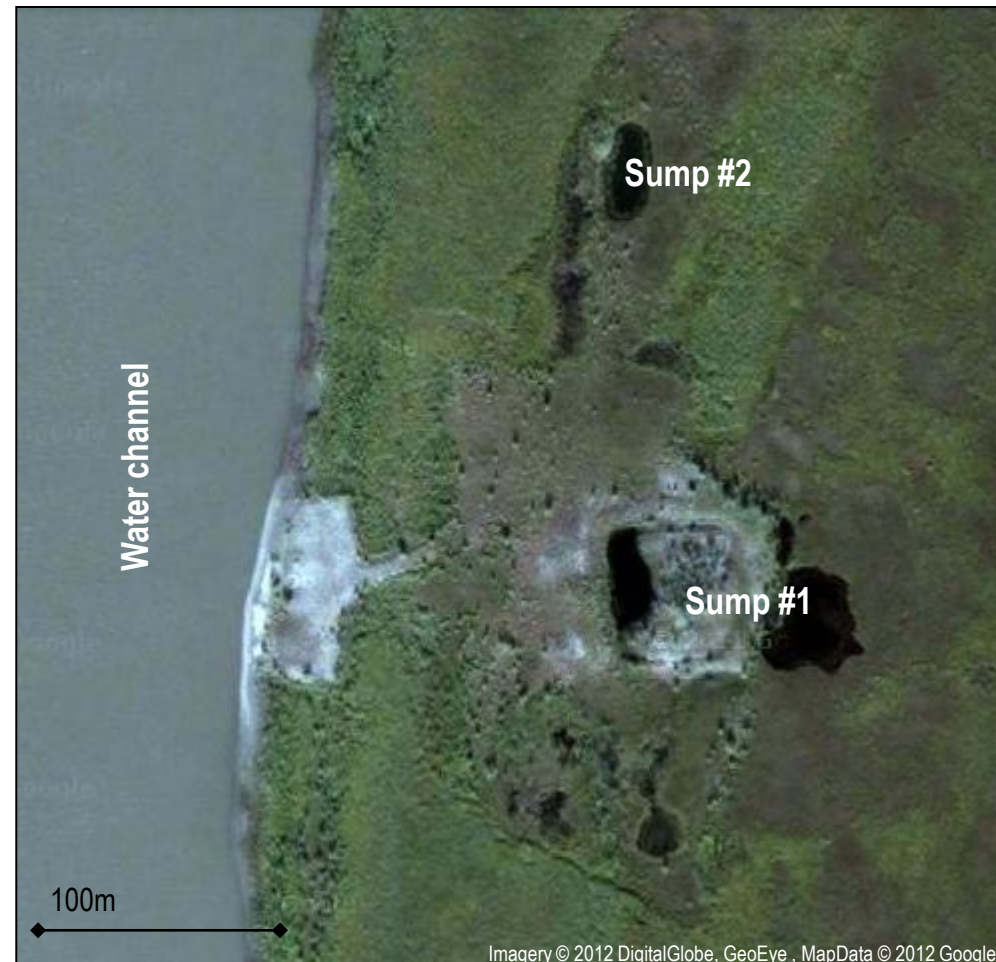
- potential erosion by water
- sump migration / contact with the environment
- pathway receptor for drilling mud
- physical hazards (ex. pilings, debris, sump heaving)
- located in a sensitive area
- uptake potential for wildlife
- negative community perception

Wellsite #1 – Higher Priority

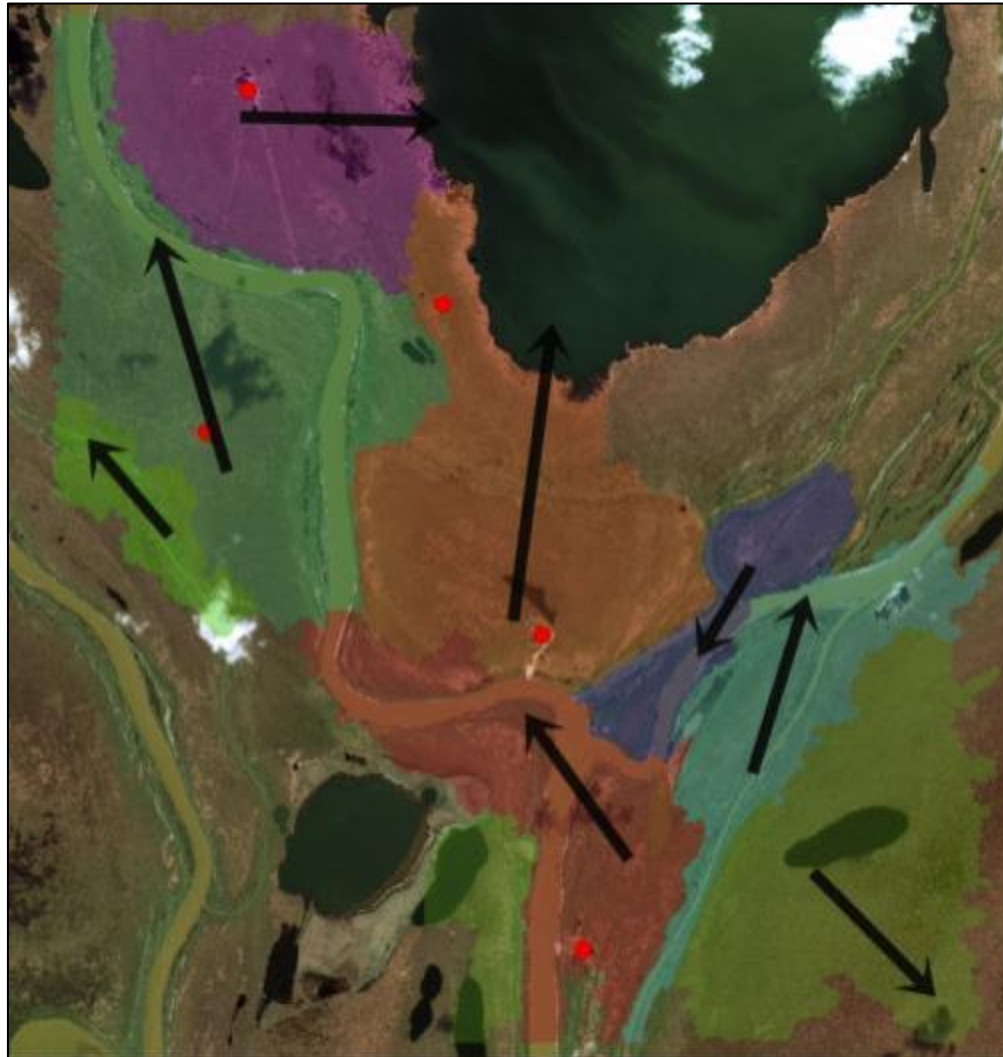
Pathways – identifying regional flow basins using satellite topography

→ flow direction
● wellsite location

Satellite derived topographical image of wellsites

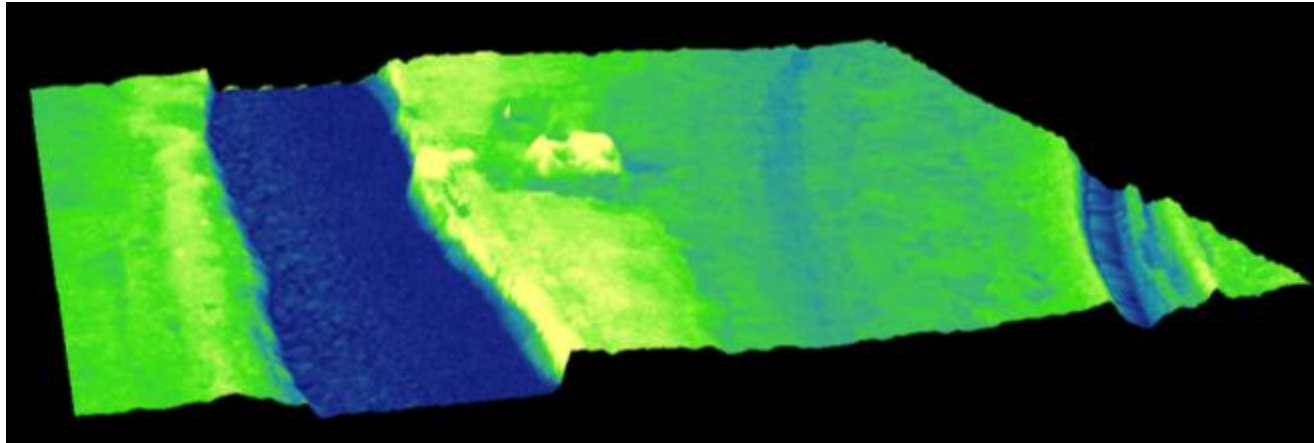
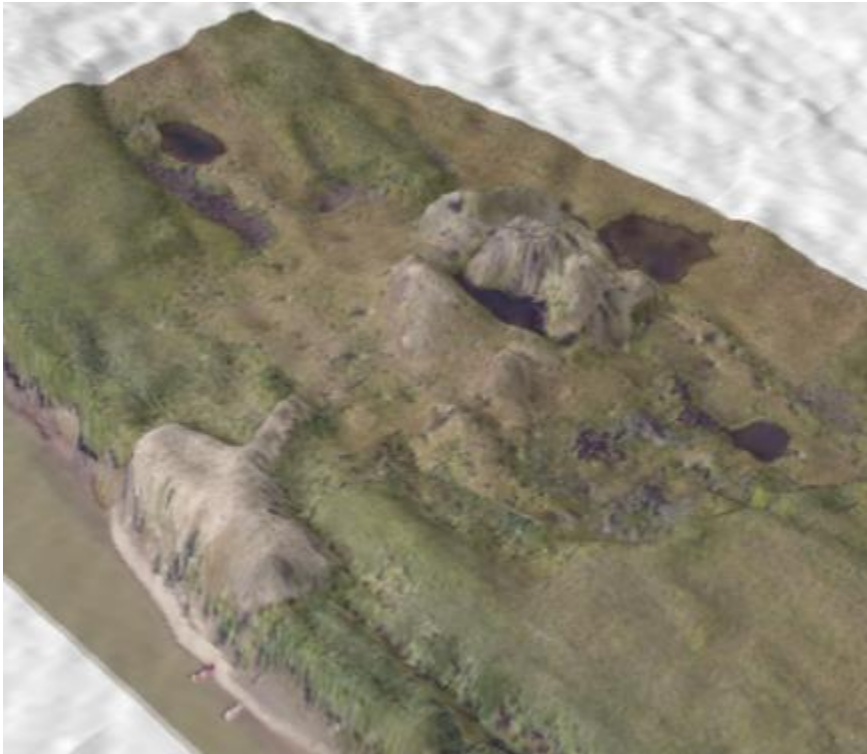
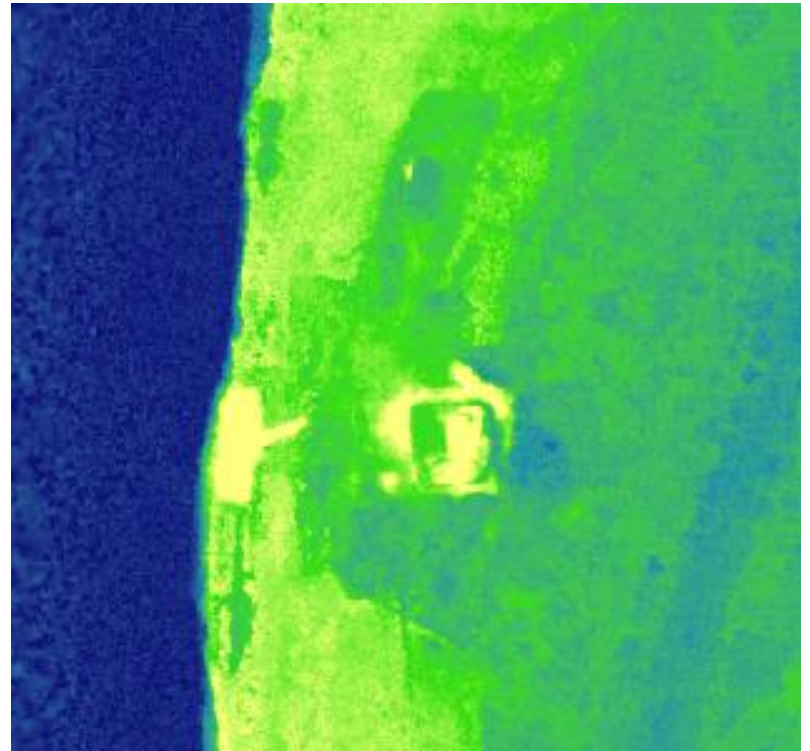
- Assessing sump morphology using LiDAR
