Successful Response and Remediation of a Remote Crude Oil Release in the Canadian North

Presented by Chaymie Hintz and Greg Milne
RemTech 2013 | Banff, Alberta | October 2013

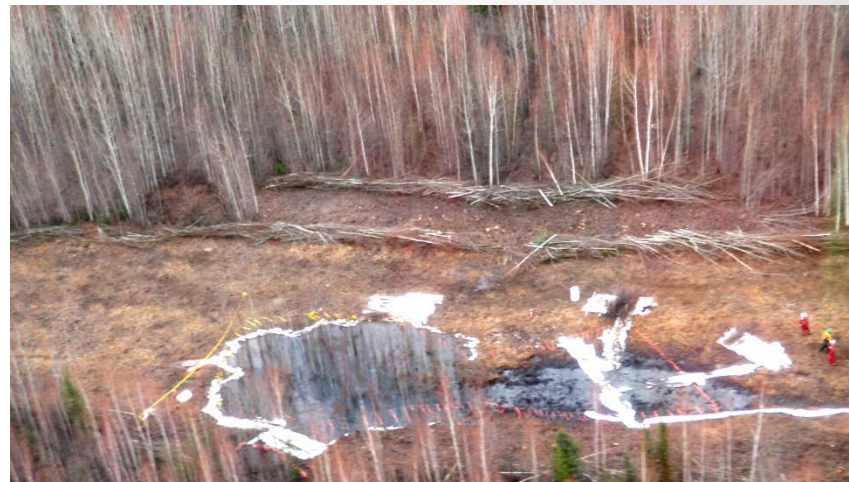
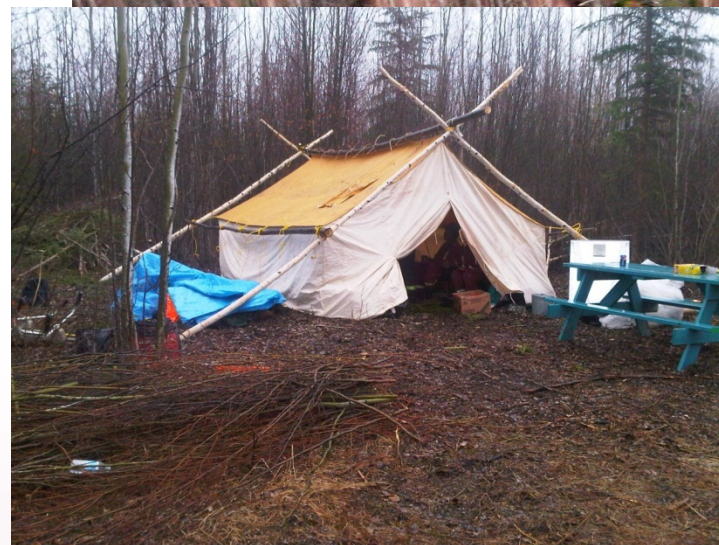
Initial Response

- Emergency response plans implemented using ICS
- Resources mobilized
- Containment
- Monitoring program
- Wildlife management
- Initial Clean-Up Plan (ICP) developed for NEB

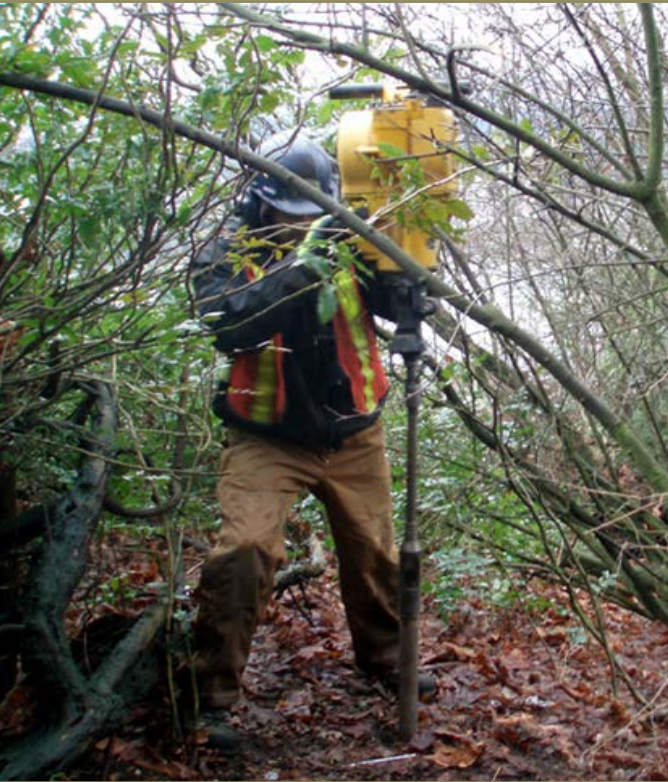
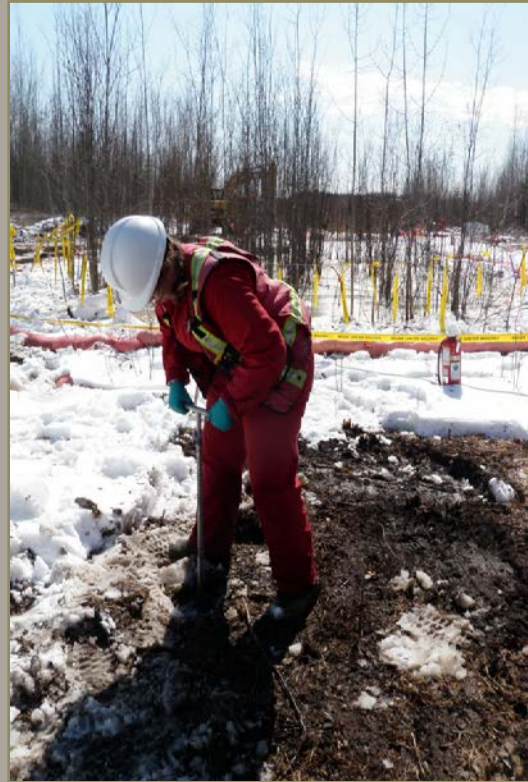
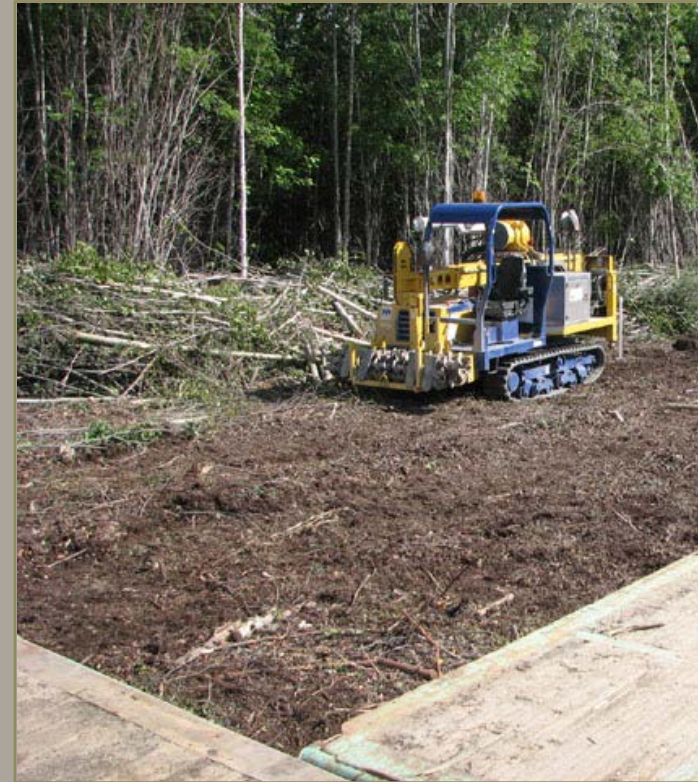
Site Assessment

- Investigation included
 - 54 boreholes and 34 monitoring wells
 - 47 test pits
- Supported delineation and volume estimate

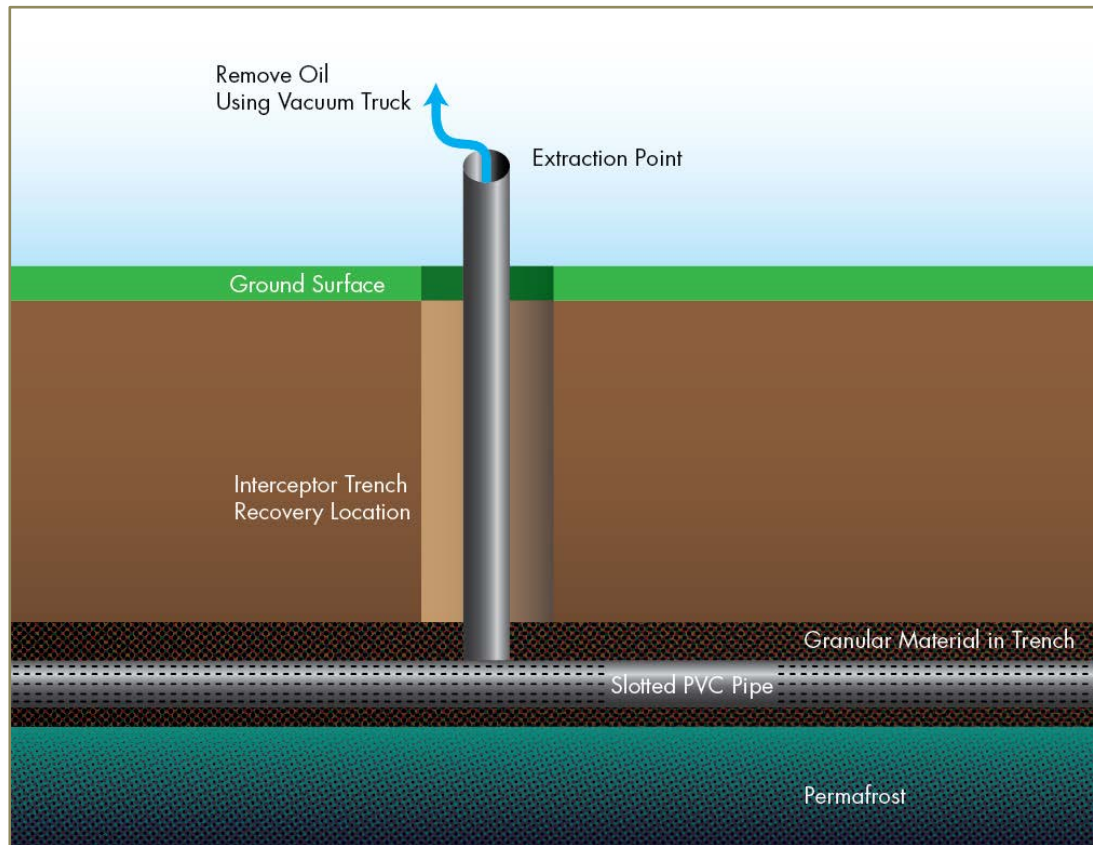
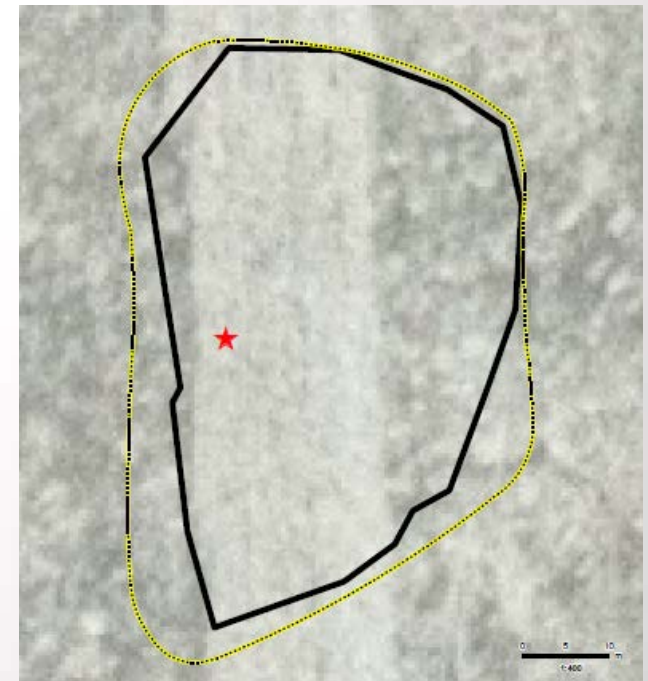
Containment

- Trench keyed into permafrost
- Slotted PVC placed horizontally in trench
- Vertical riser placed for monitoring and recovery

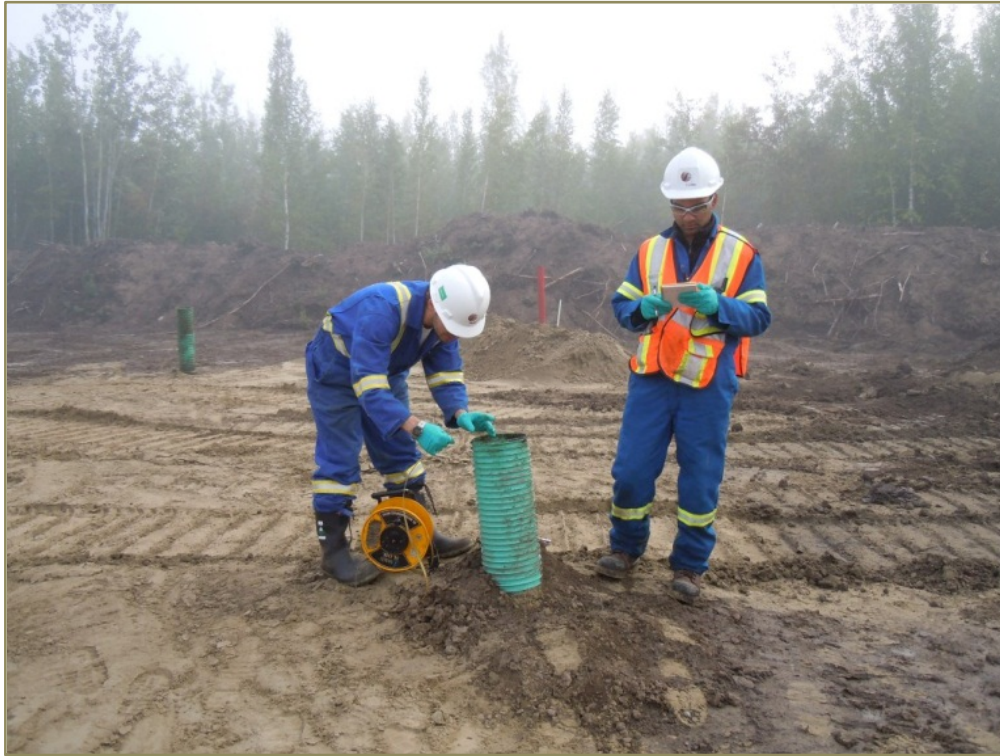
Oil Recovery

- Where significant quantities of free product observed – recovery well constructed
- Product measured daily
- Vacuum truck recovered measured product

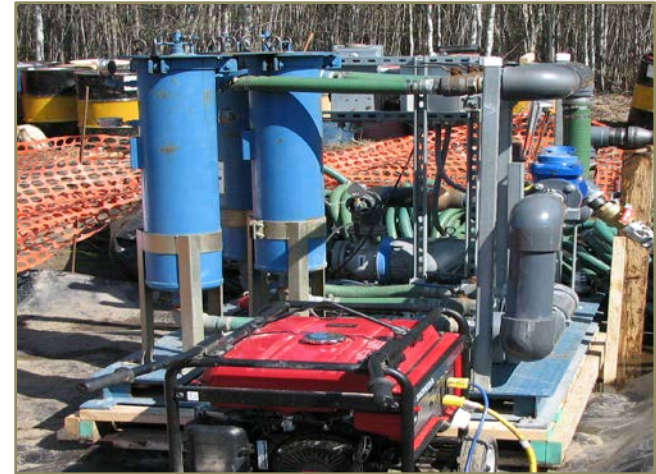
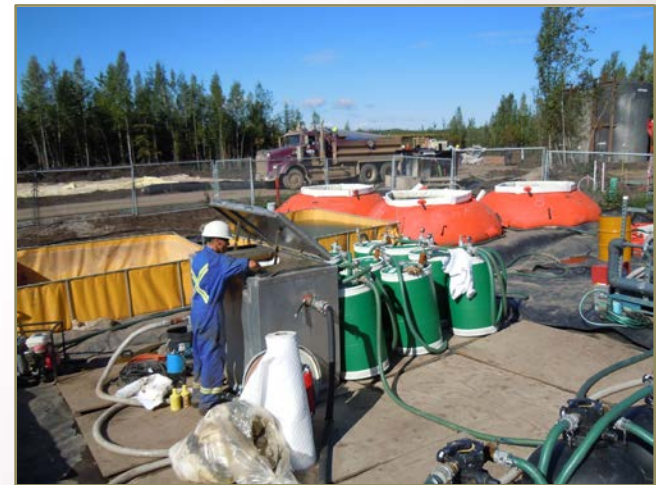
Water Management

- Water treatment system, assembled on-site
 - settling tanks
 - oil water separator
 - granulated activated carbon vessels
 - sand filters
 - holding tanks
- Discharges approved by NEB and INAC (AANDC)

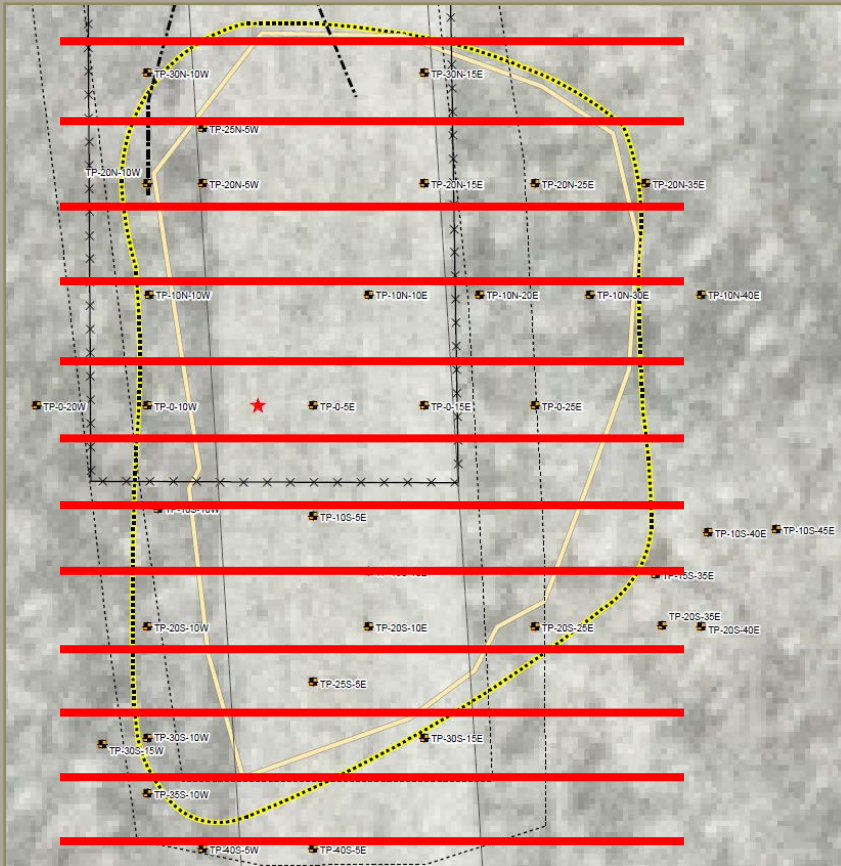
Oil Volume Estimate

Cross-sections used to calculate representative soil volumes

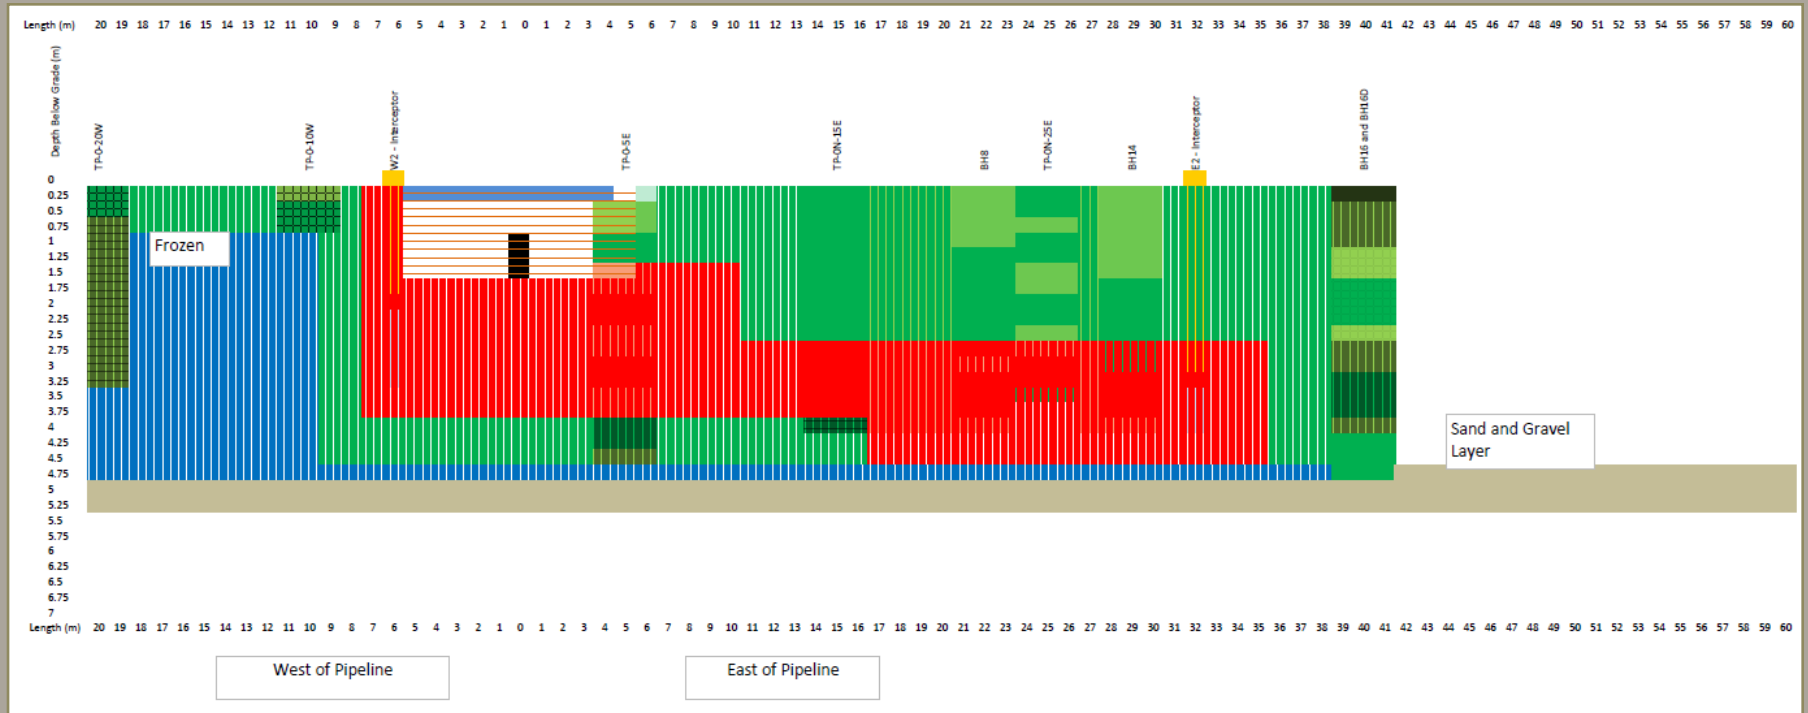
Oil Volume Estimate

$$\text{Volume of oil} = \frac{\text{volume of soil} \times \text{soil density} \times \text{concentration of oil in soil}}{\text{Density of oil} \times \text{conversion factor}}$$

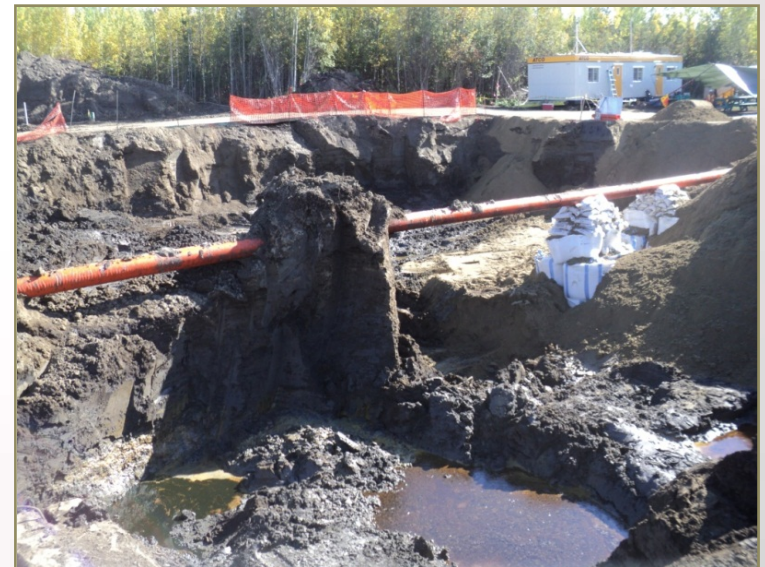
Site Remediation

- Site-specific criteria established to identify the most applicable guidelines to use as remediation targets.
- Combination of federal (CCME) and provincial (Alberta and Ontario) guidelines.

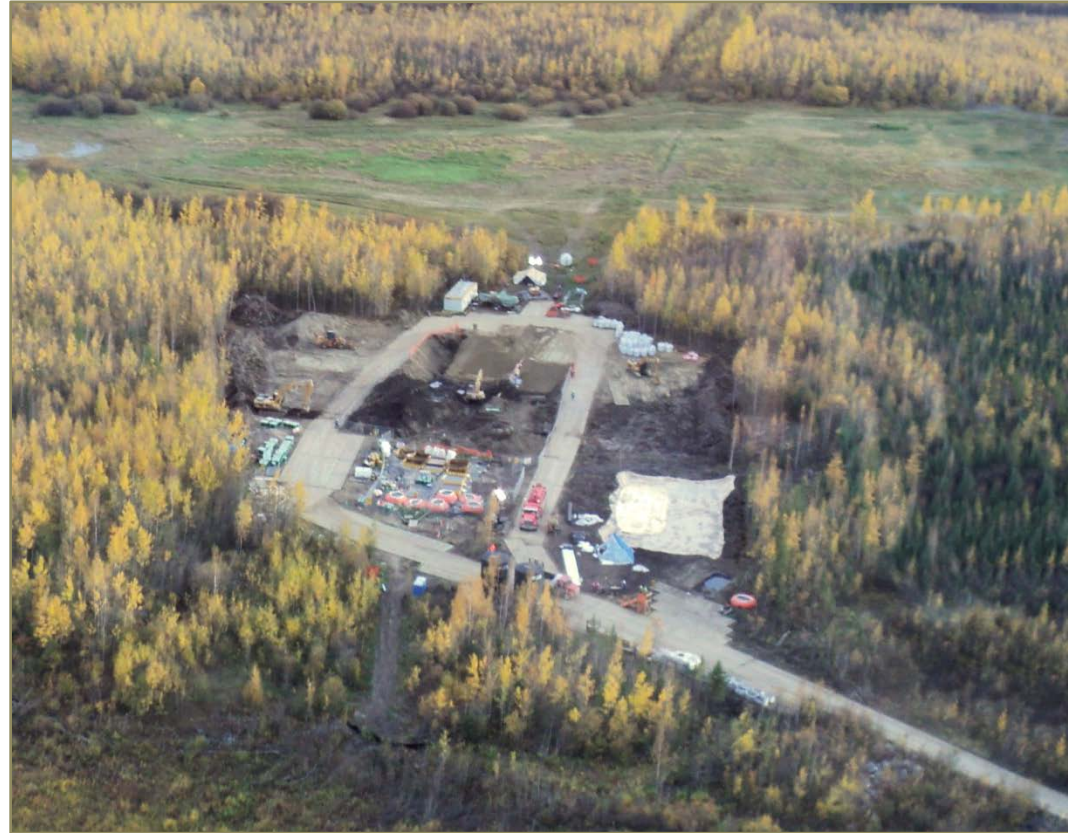
Remedial Summary

- Remedial criteria met
- 260 m³ (1600 barrels) of oil recovered
 - 75 m³ as free product
- 500 m³ of water treated
- 12,800 m³ of soil hauled off-site

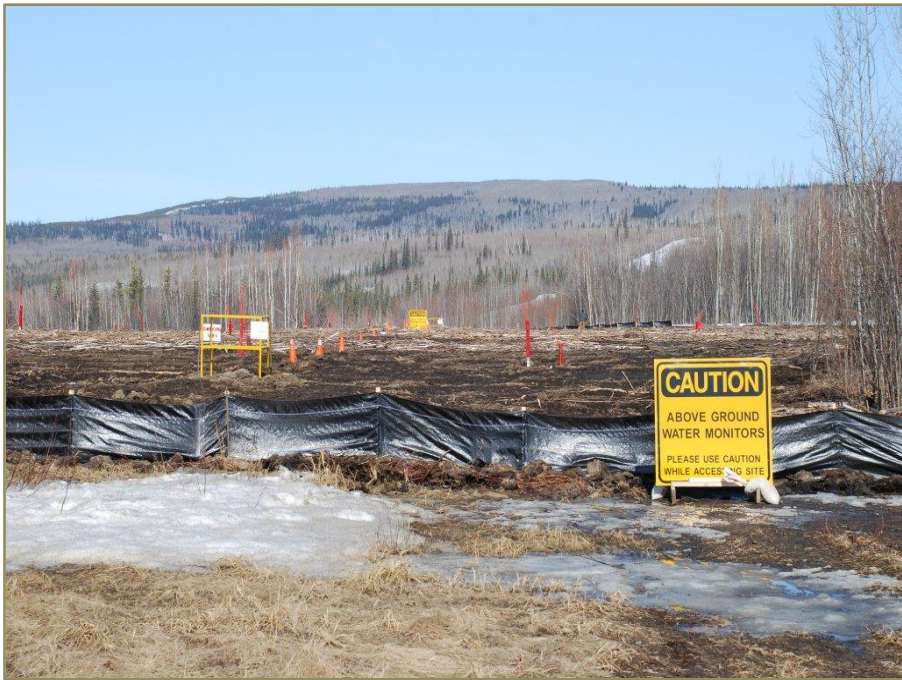
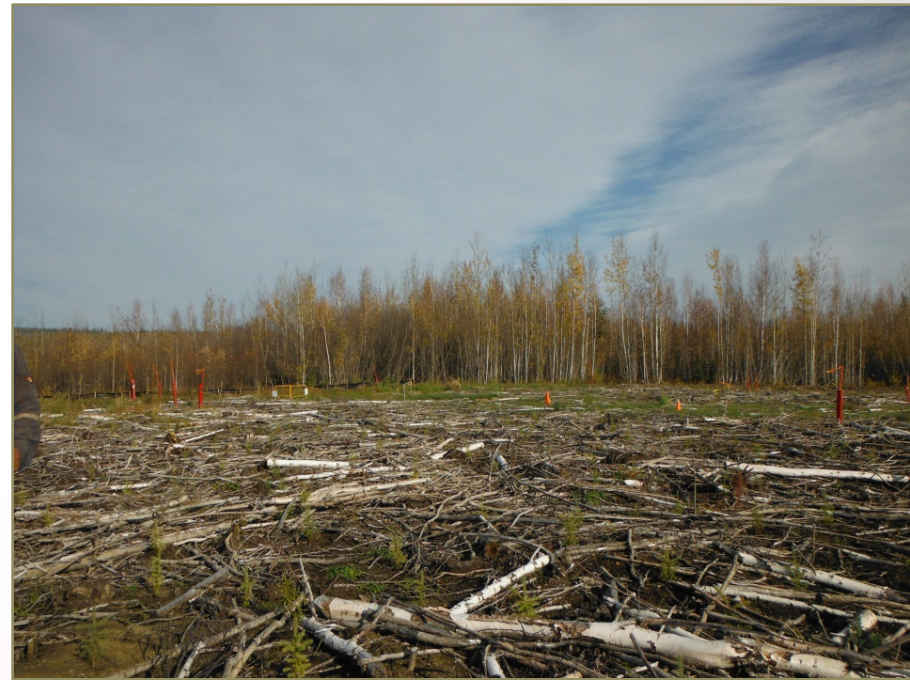
Reclamation

- Aggregate area used as borrow source
- Salvaged topsoil, trees, and shrubs replaced

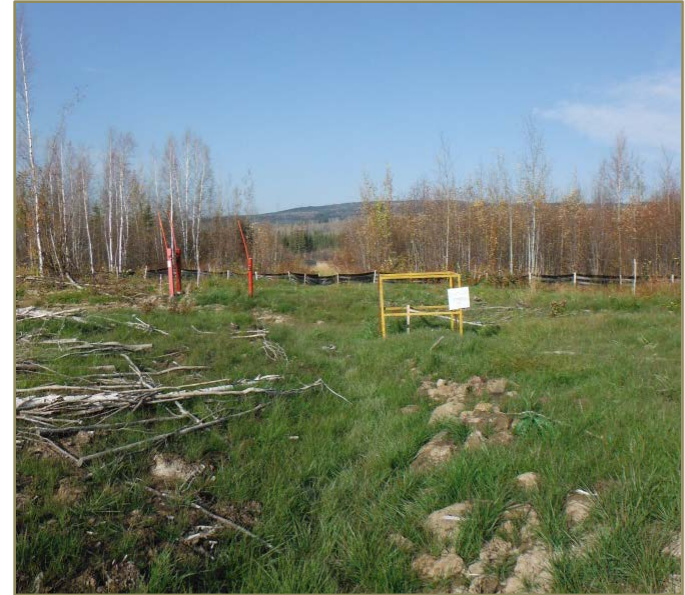
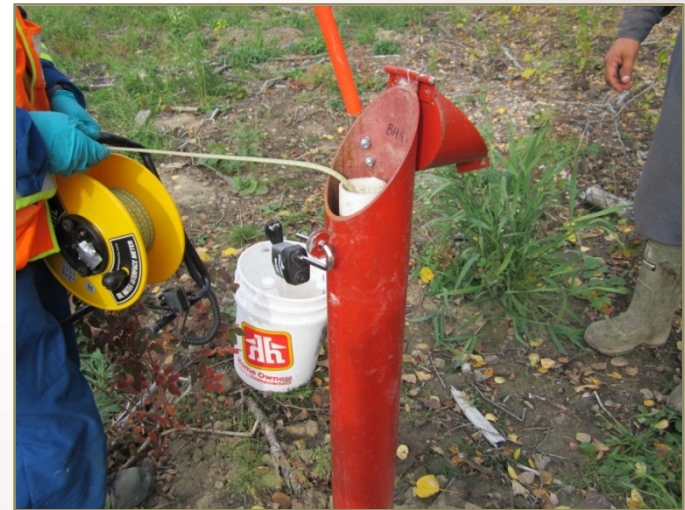
Site Status: 2013

- Post-remediation monitoring program underway
- Hydrocarbons have not been detected in groundwater
- Post-reclamation monitoring program underway
- Additional work to address settlement scheduled for fall 2013
