Sydney Tar Ponds
Remediation, NS

A Strong Quality Program Imperative to Environmental Remediation Success

Solidification/Stabilization of the Sydney Tar Ponds Project

2013
Remediation
technologiesymposium

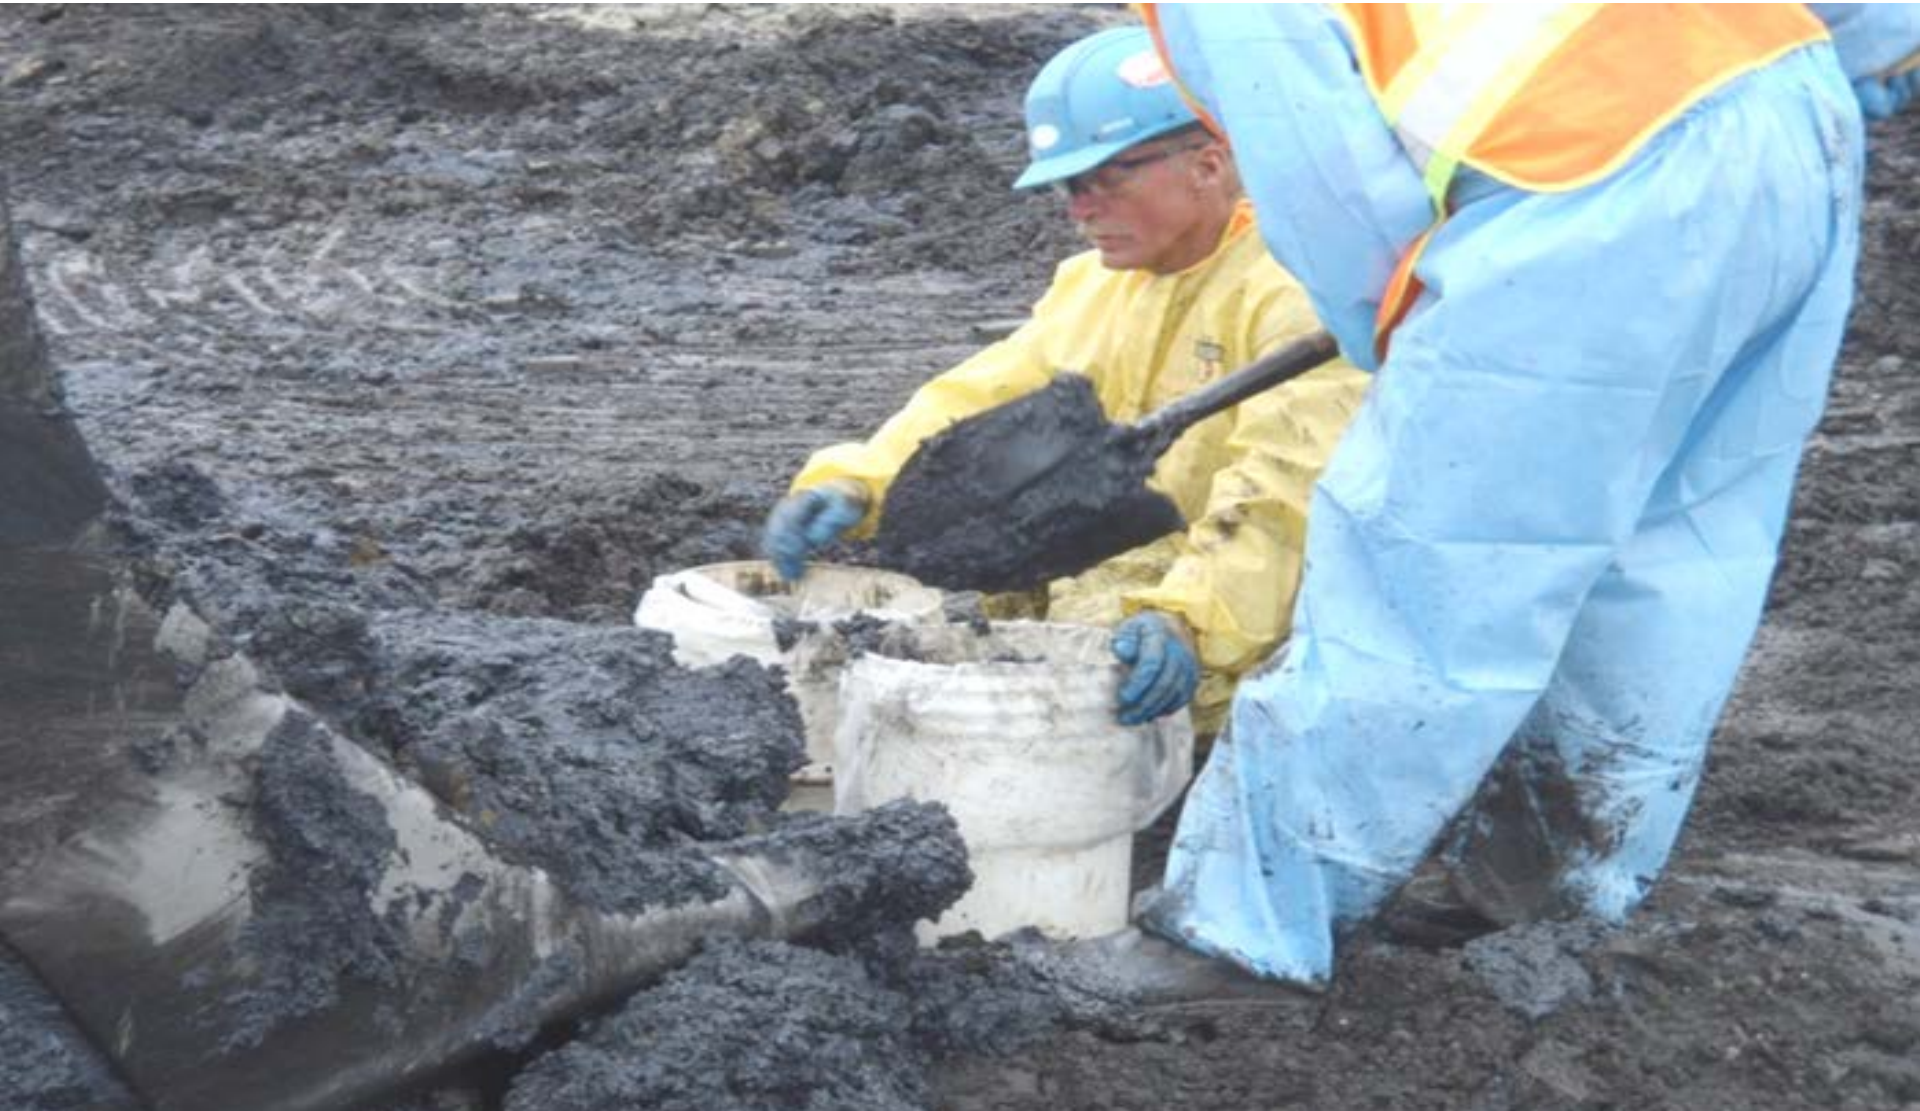
Sample Collection

At the cell – Inside exclusion zone in full tyvek.

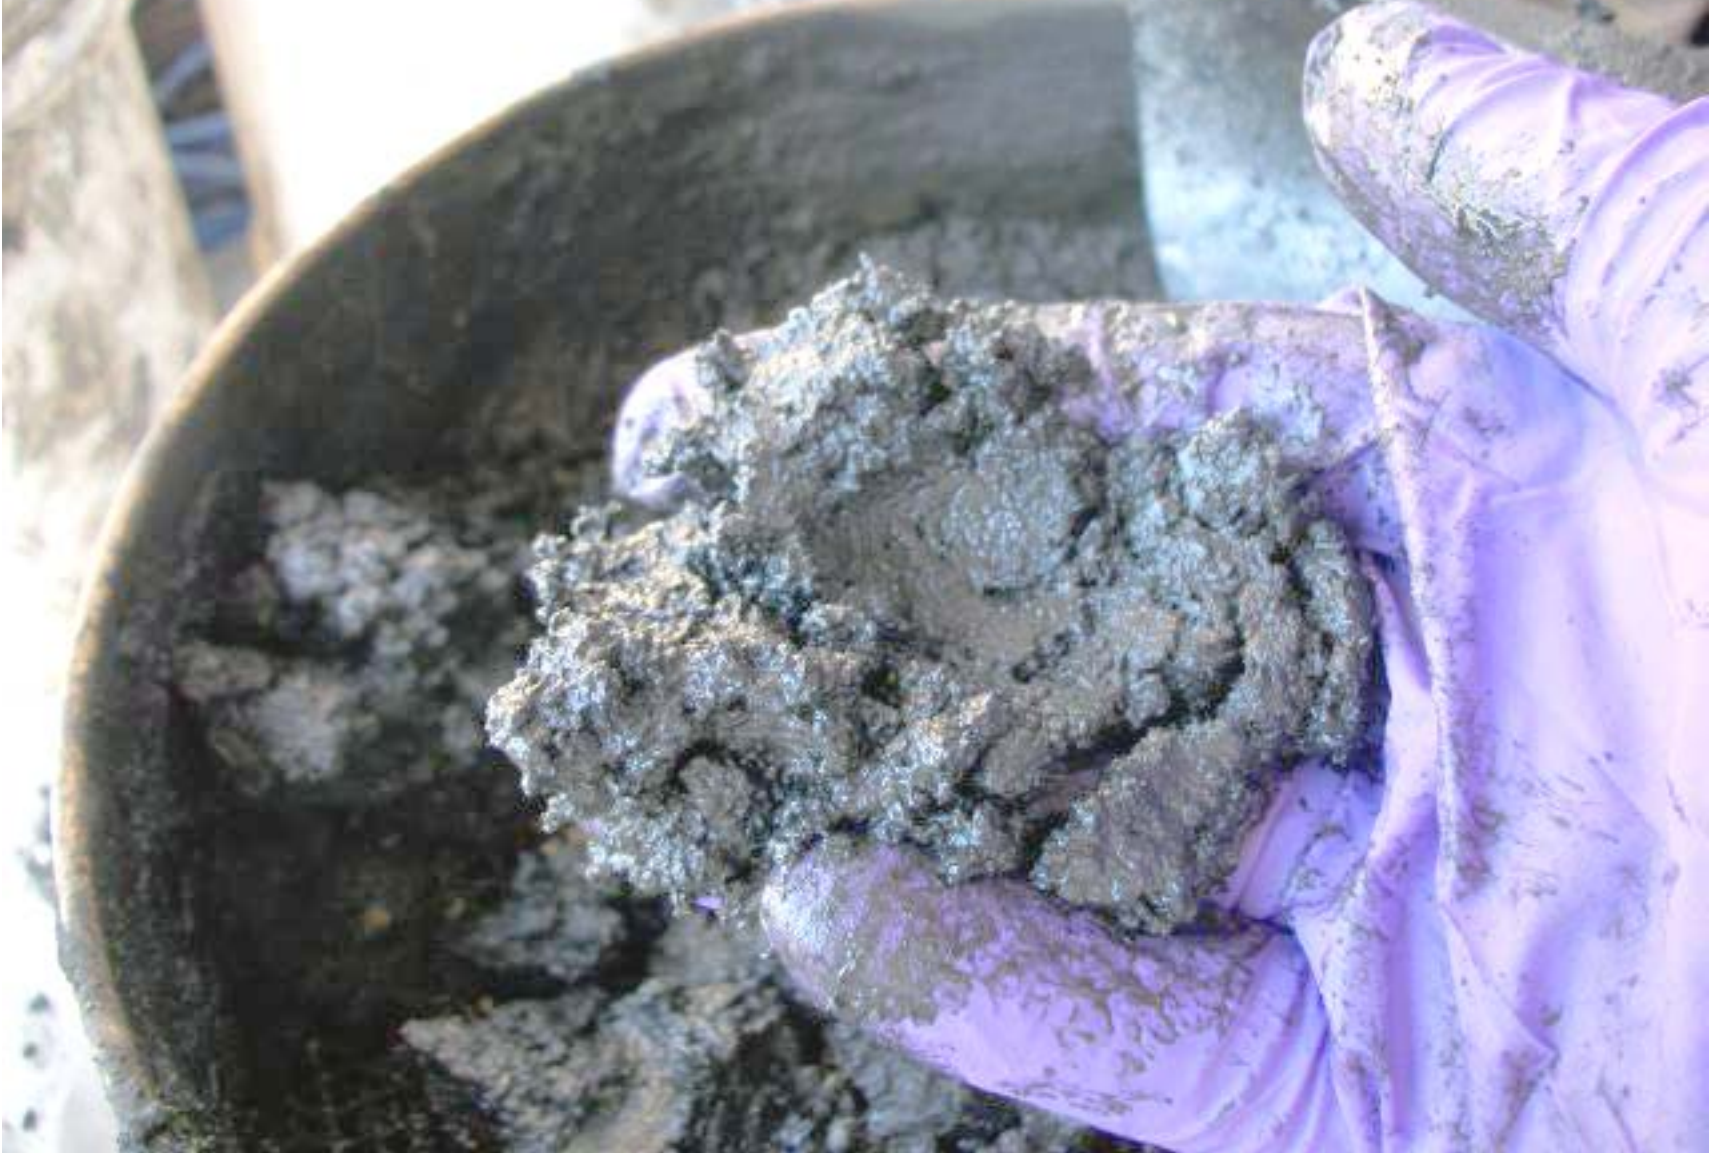
QA Preparing Specimens

UCS

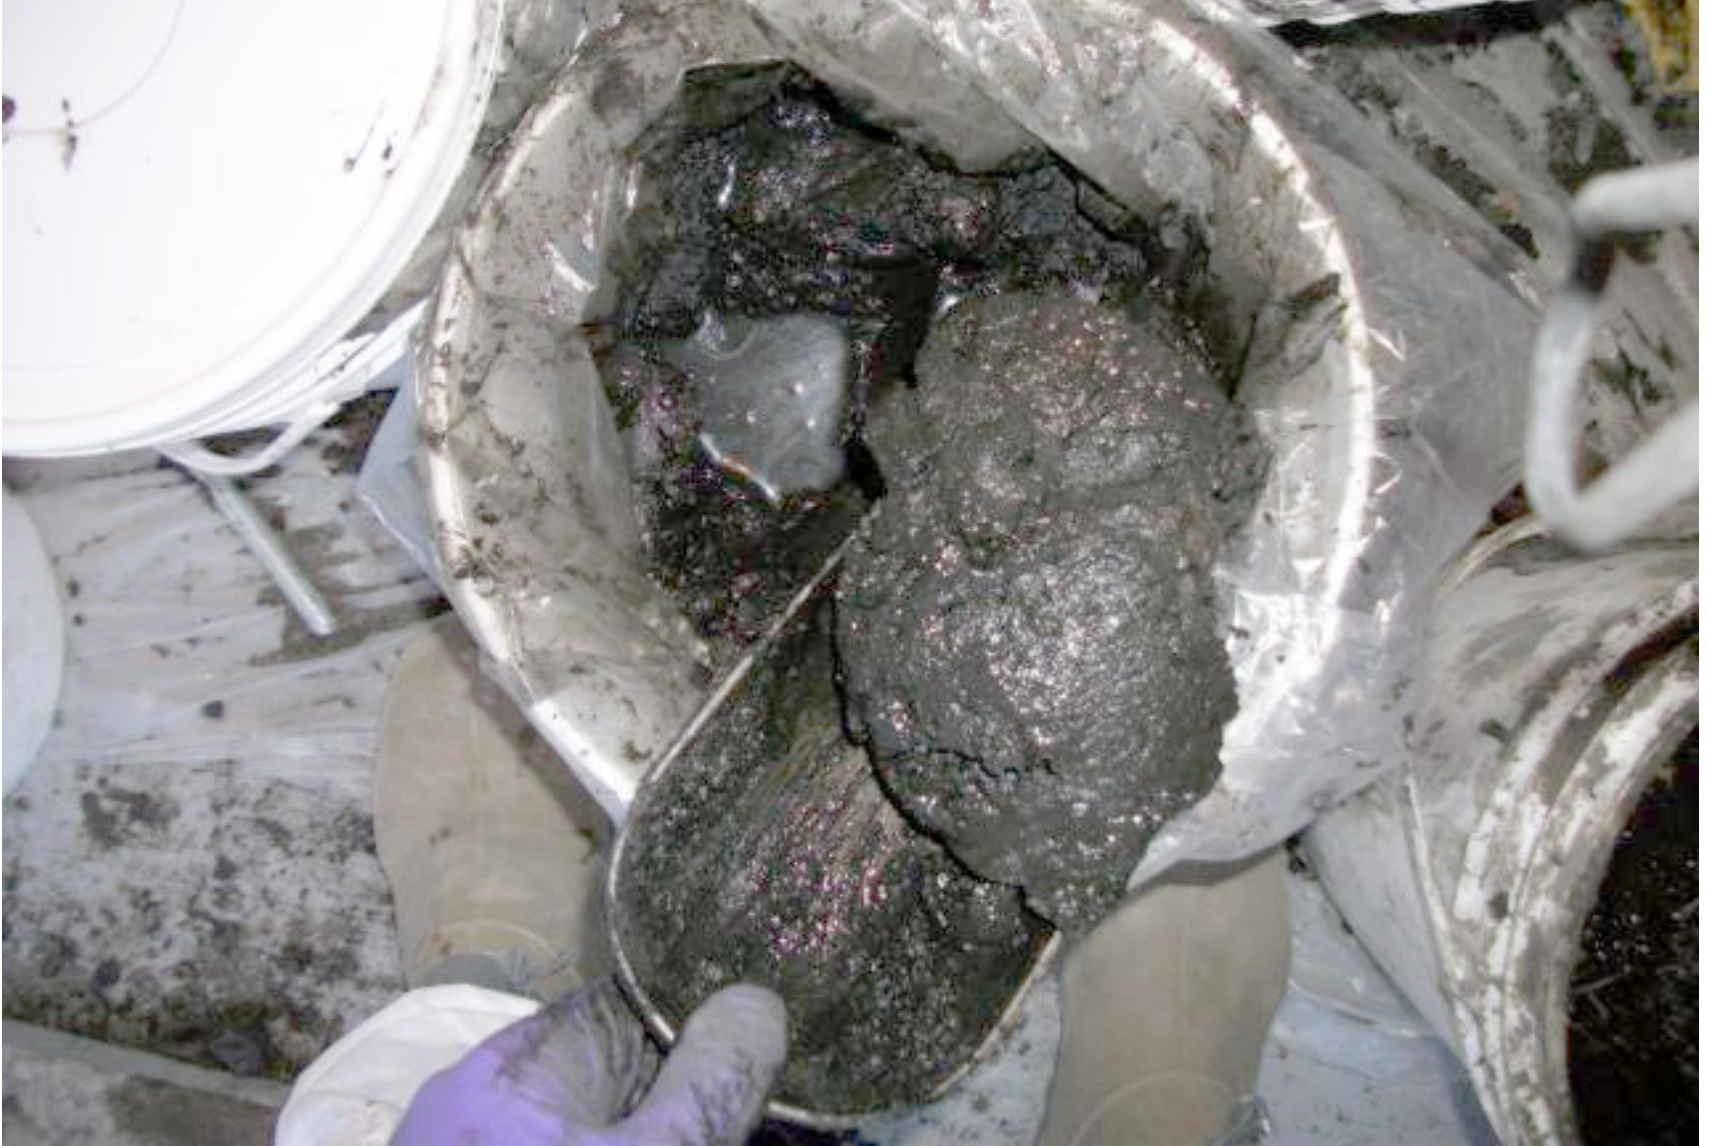
Close up of material
QA

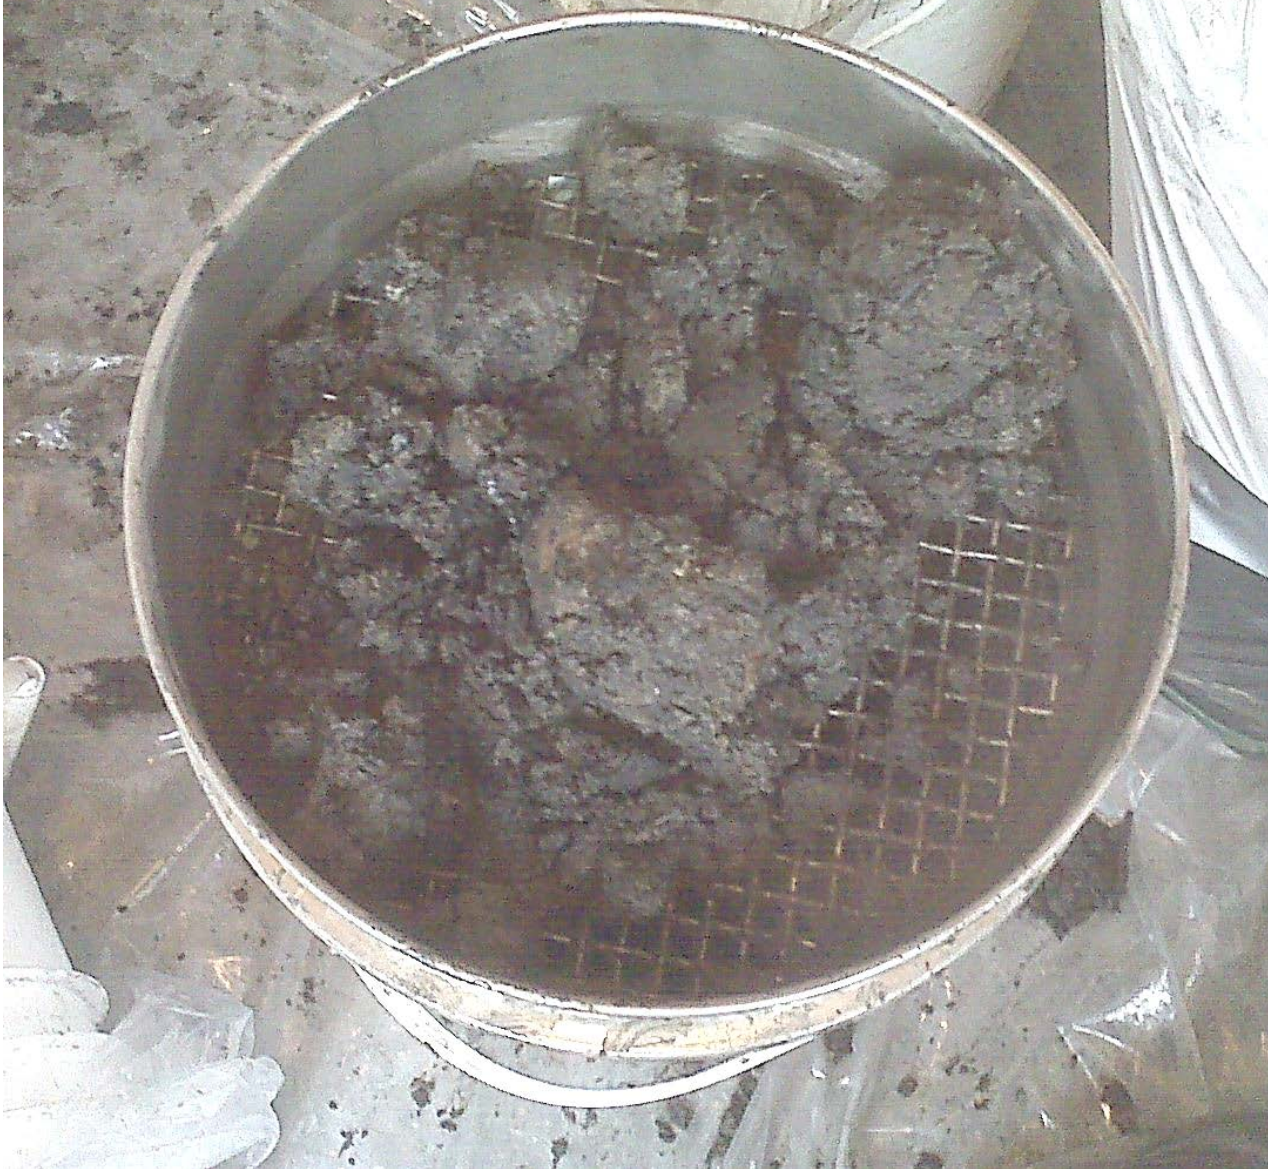
S-0502-TOP-Crew2-28June10

Dry sample material

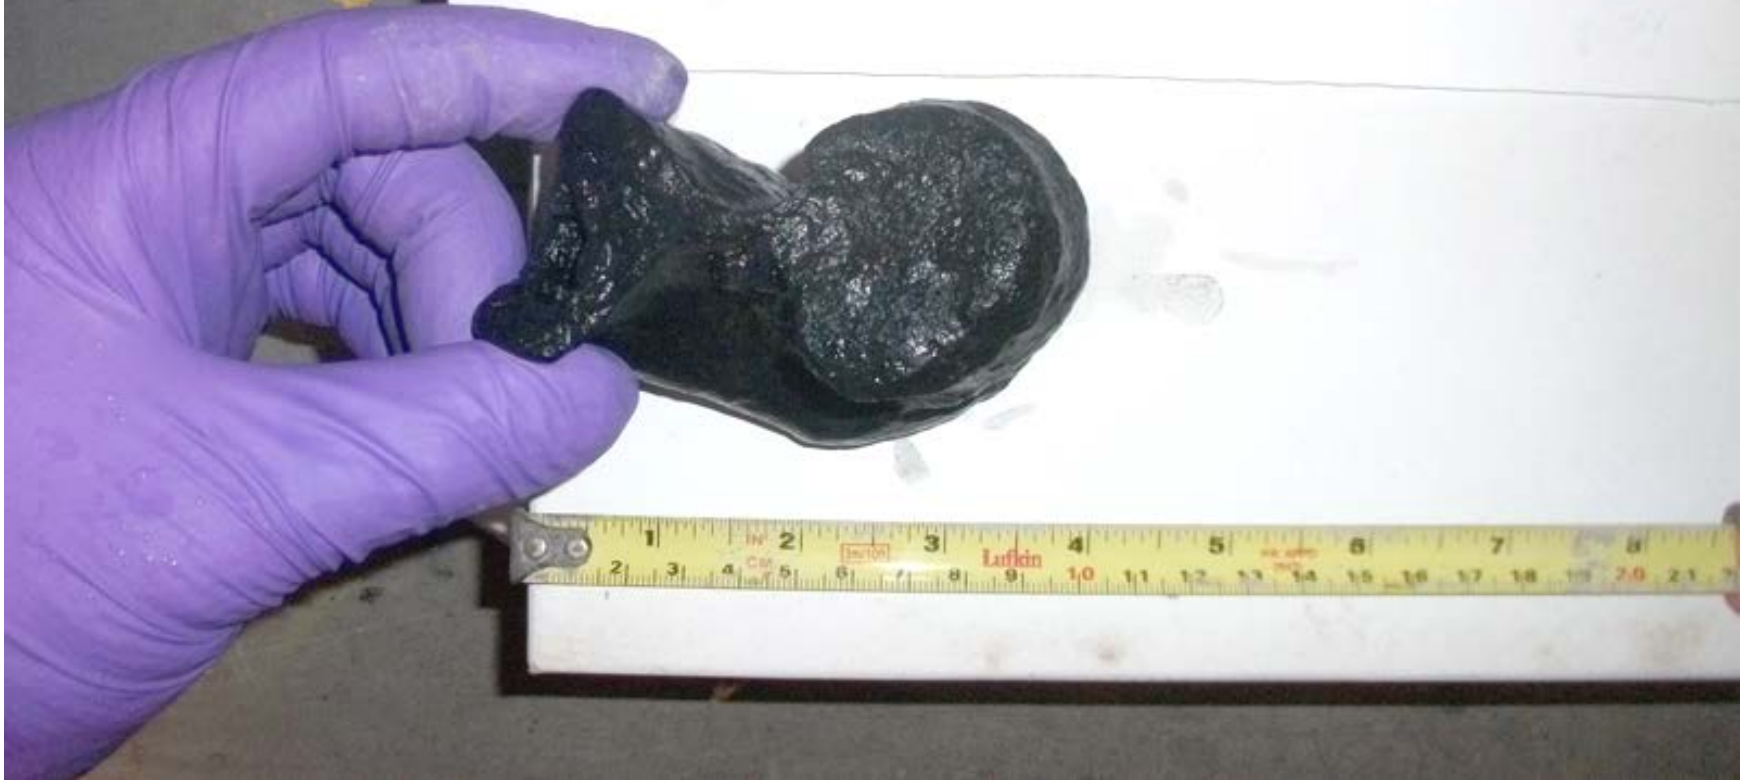
Bone found in material (cow)

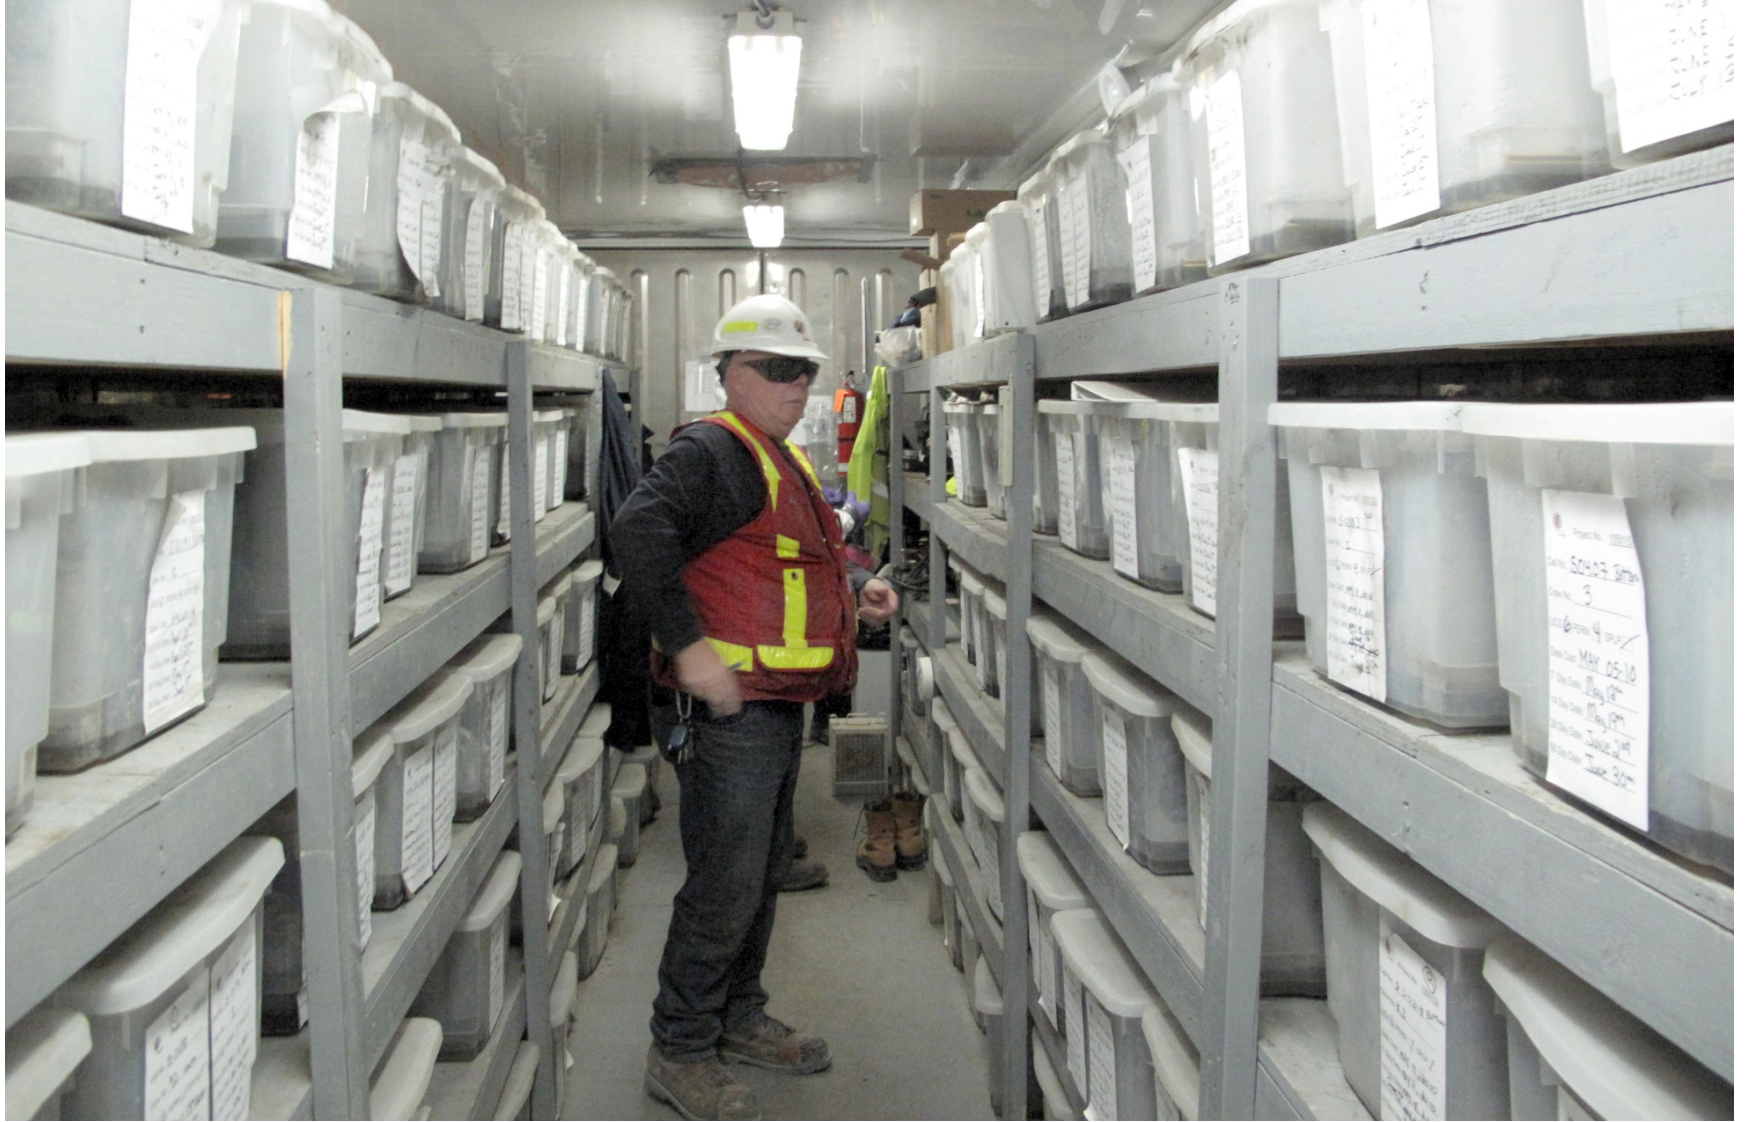
S0003-UCSX-BOT-A-9-O-9NOV09

On site geotechnical lab

Storage totes used by QA

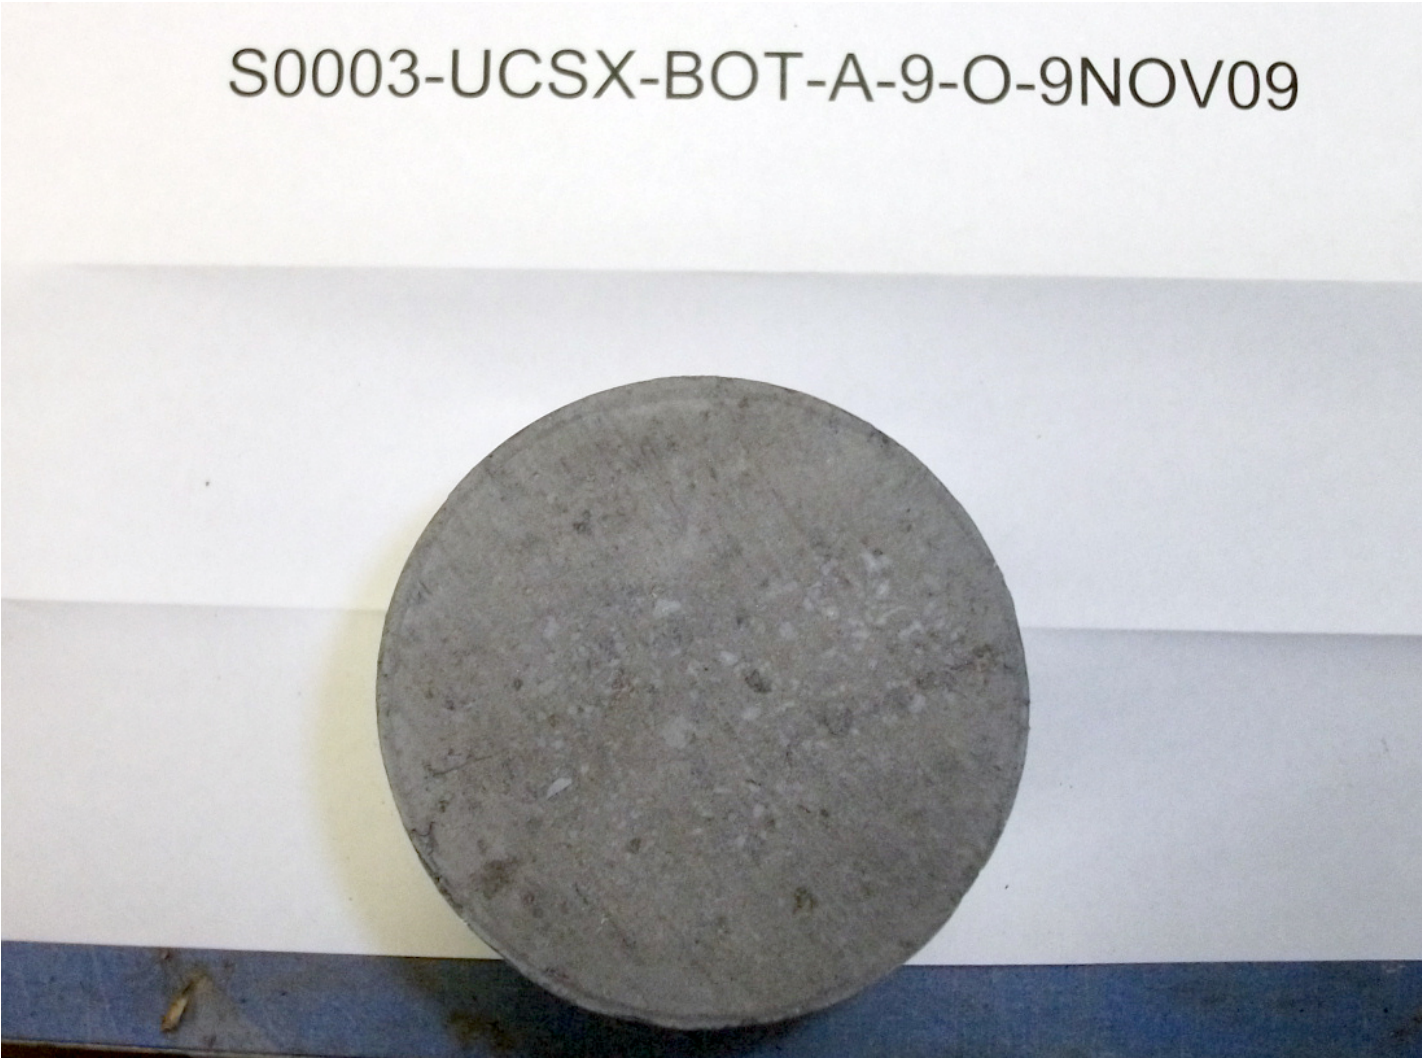
UCS cross section from cell 3

Material from bottom of cell - QA

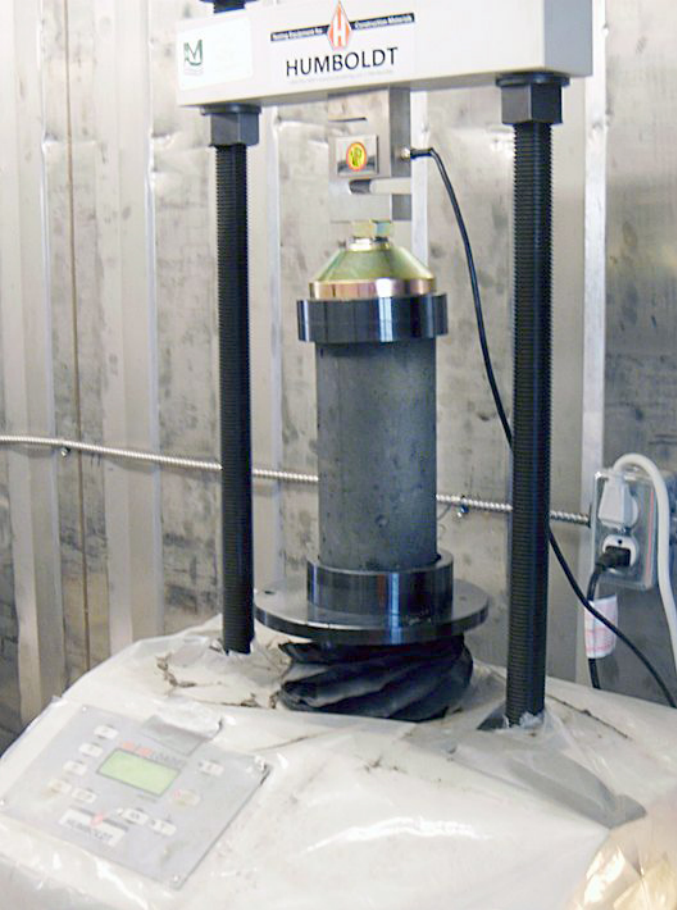
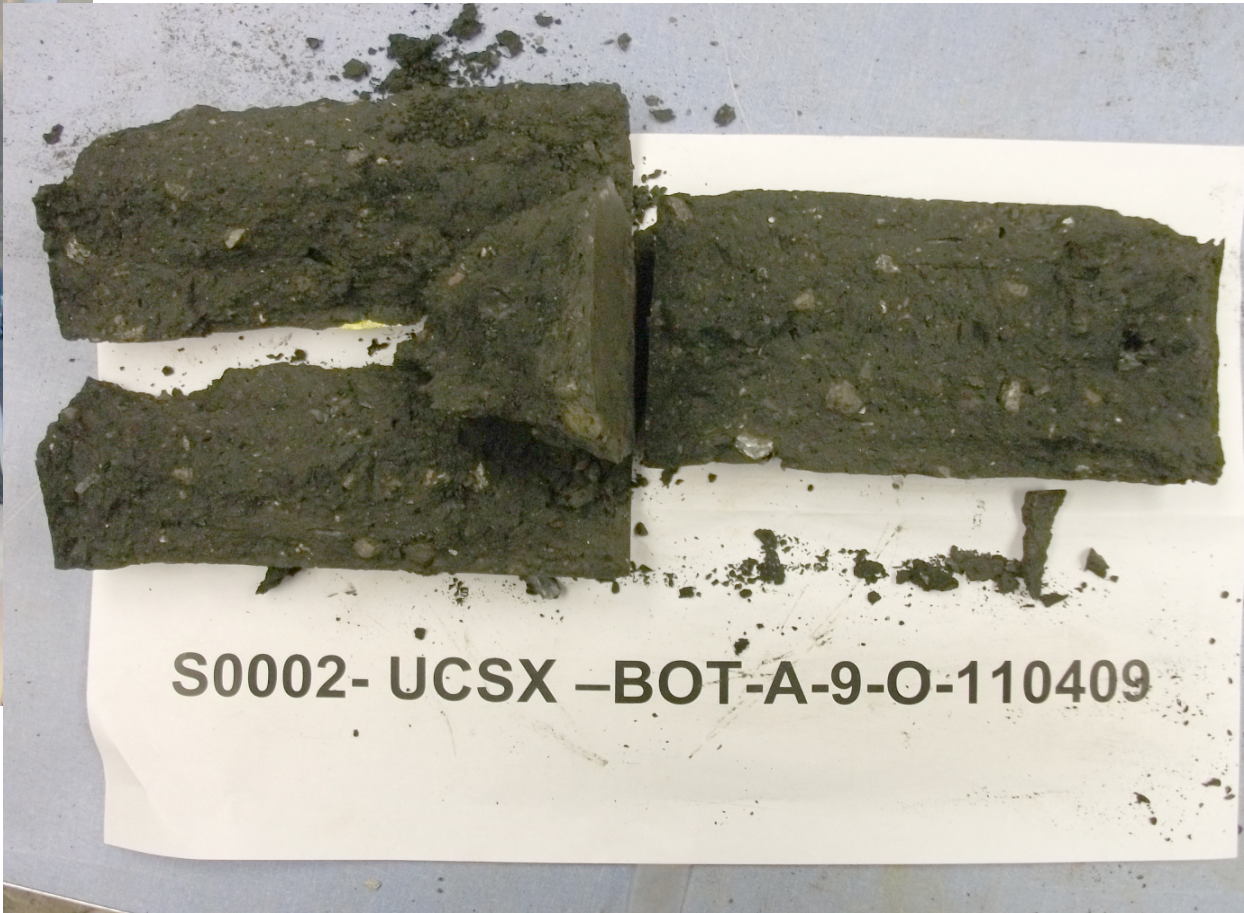
S0002-PERM-COM-A-9-O-4NOV09

UCS break for cell 2

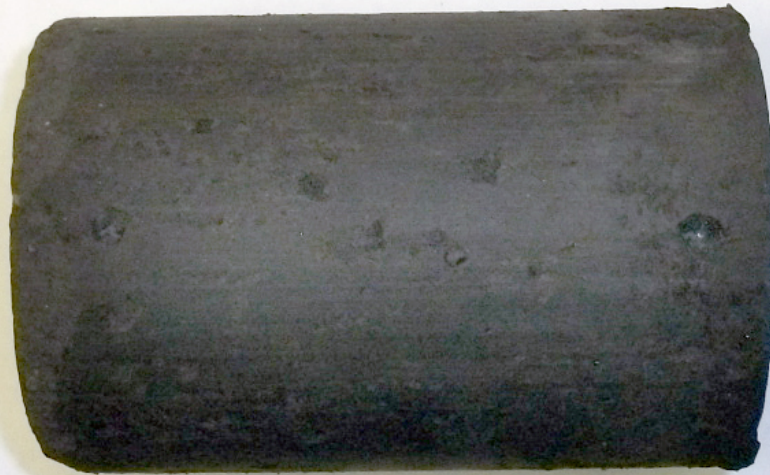
PERM specimen for cell 2

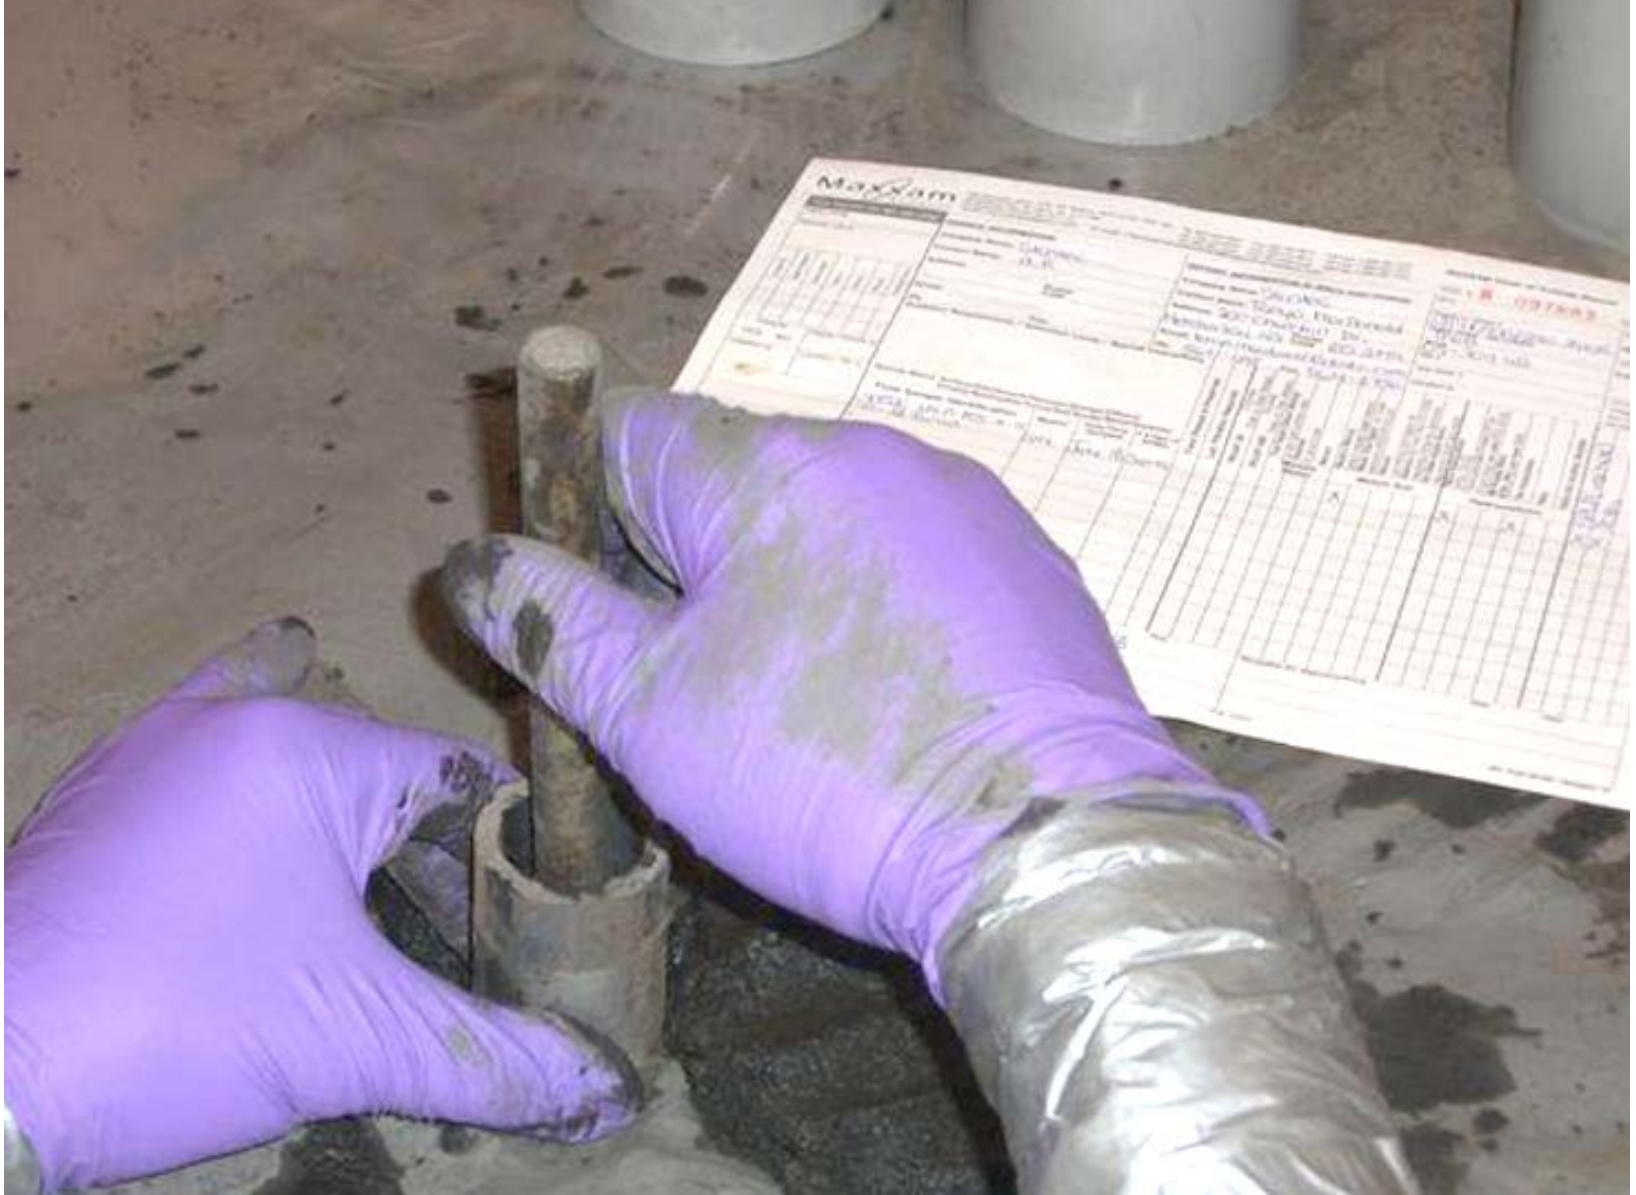
Tamping SPLP specimen into mold

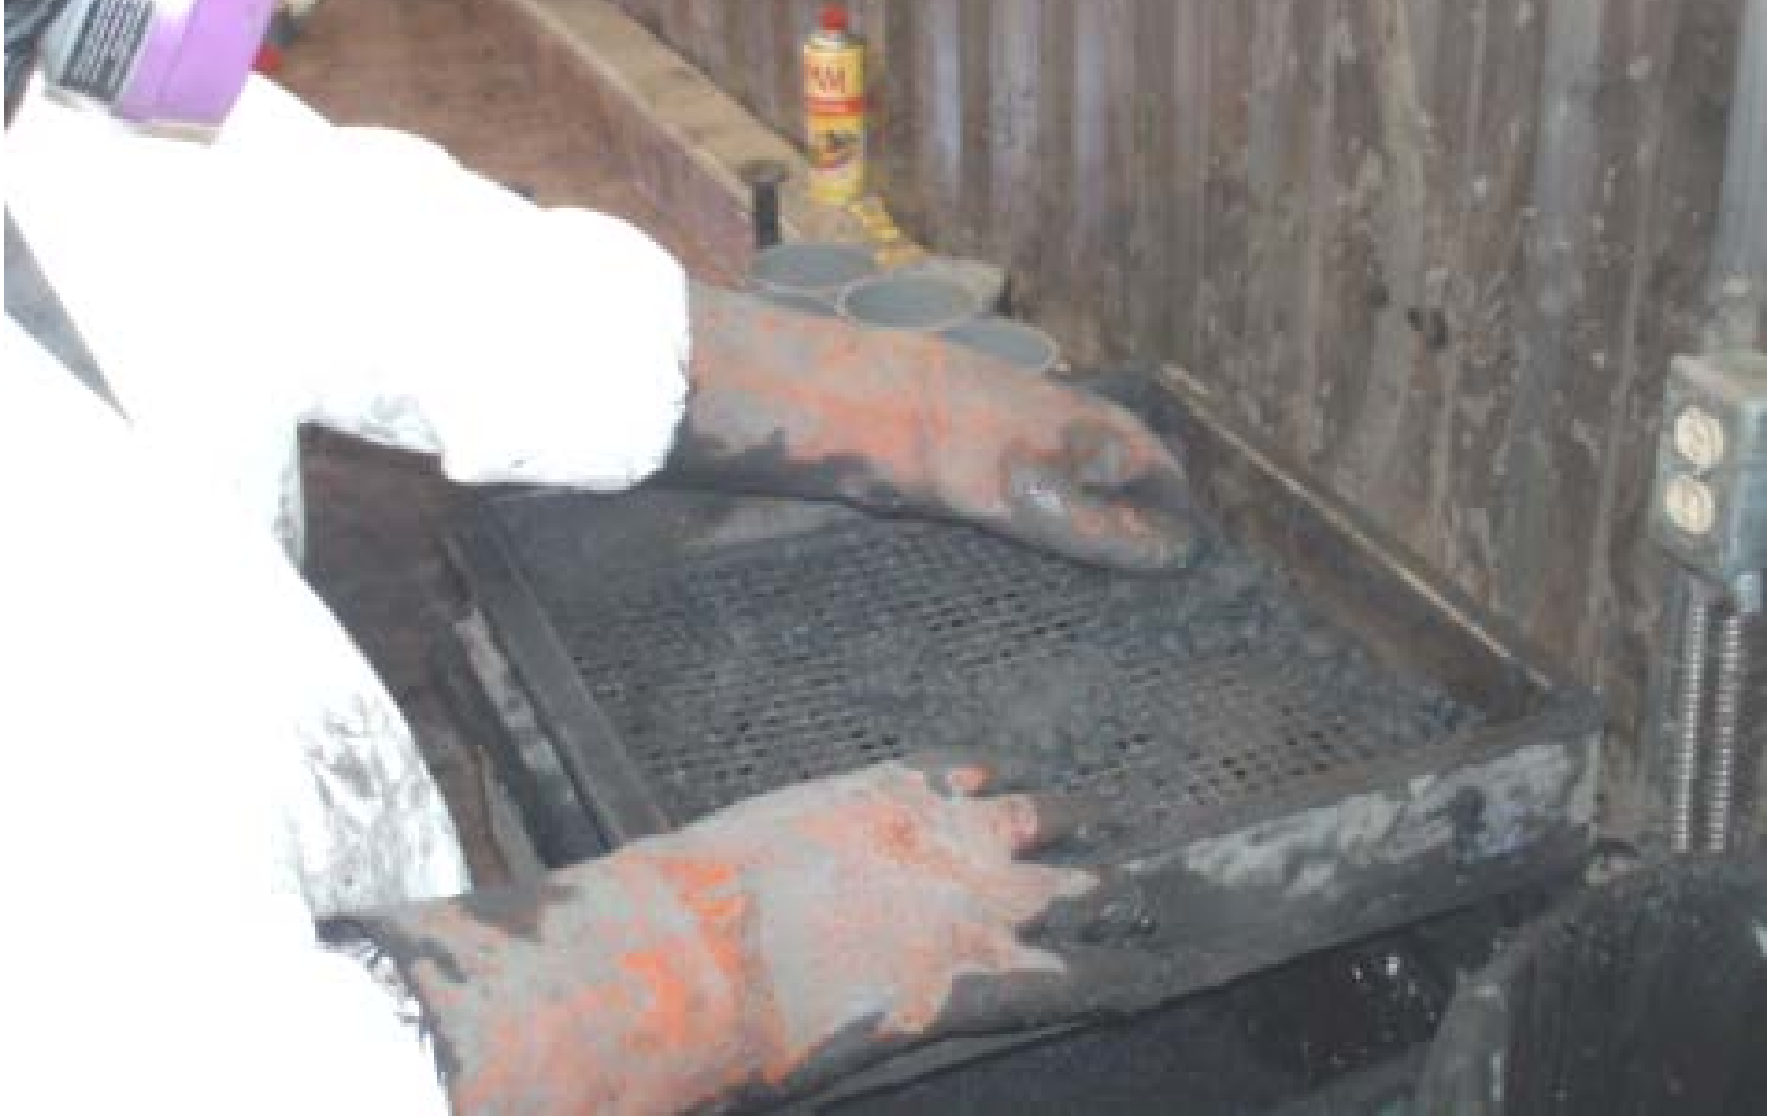
QC Geotechnical Lab

Manual screening of material following SOP

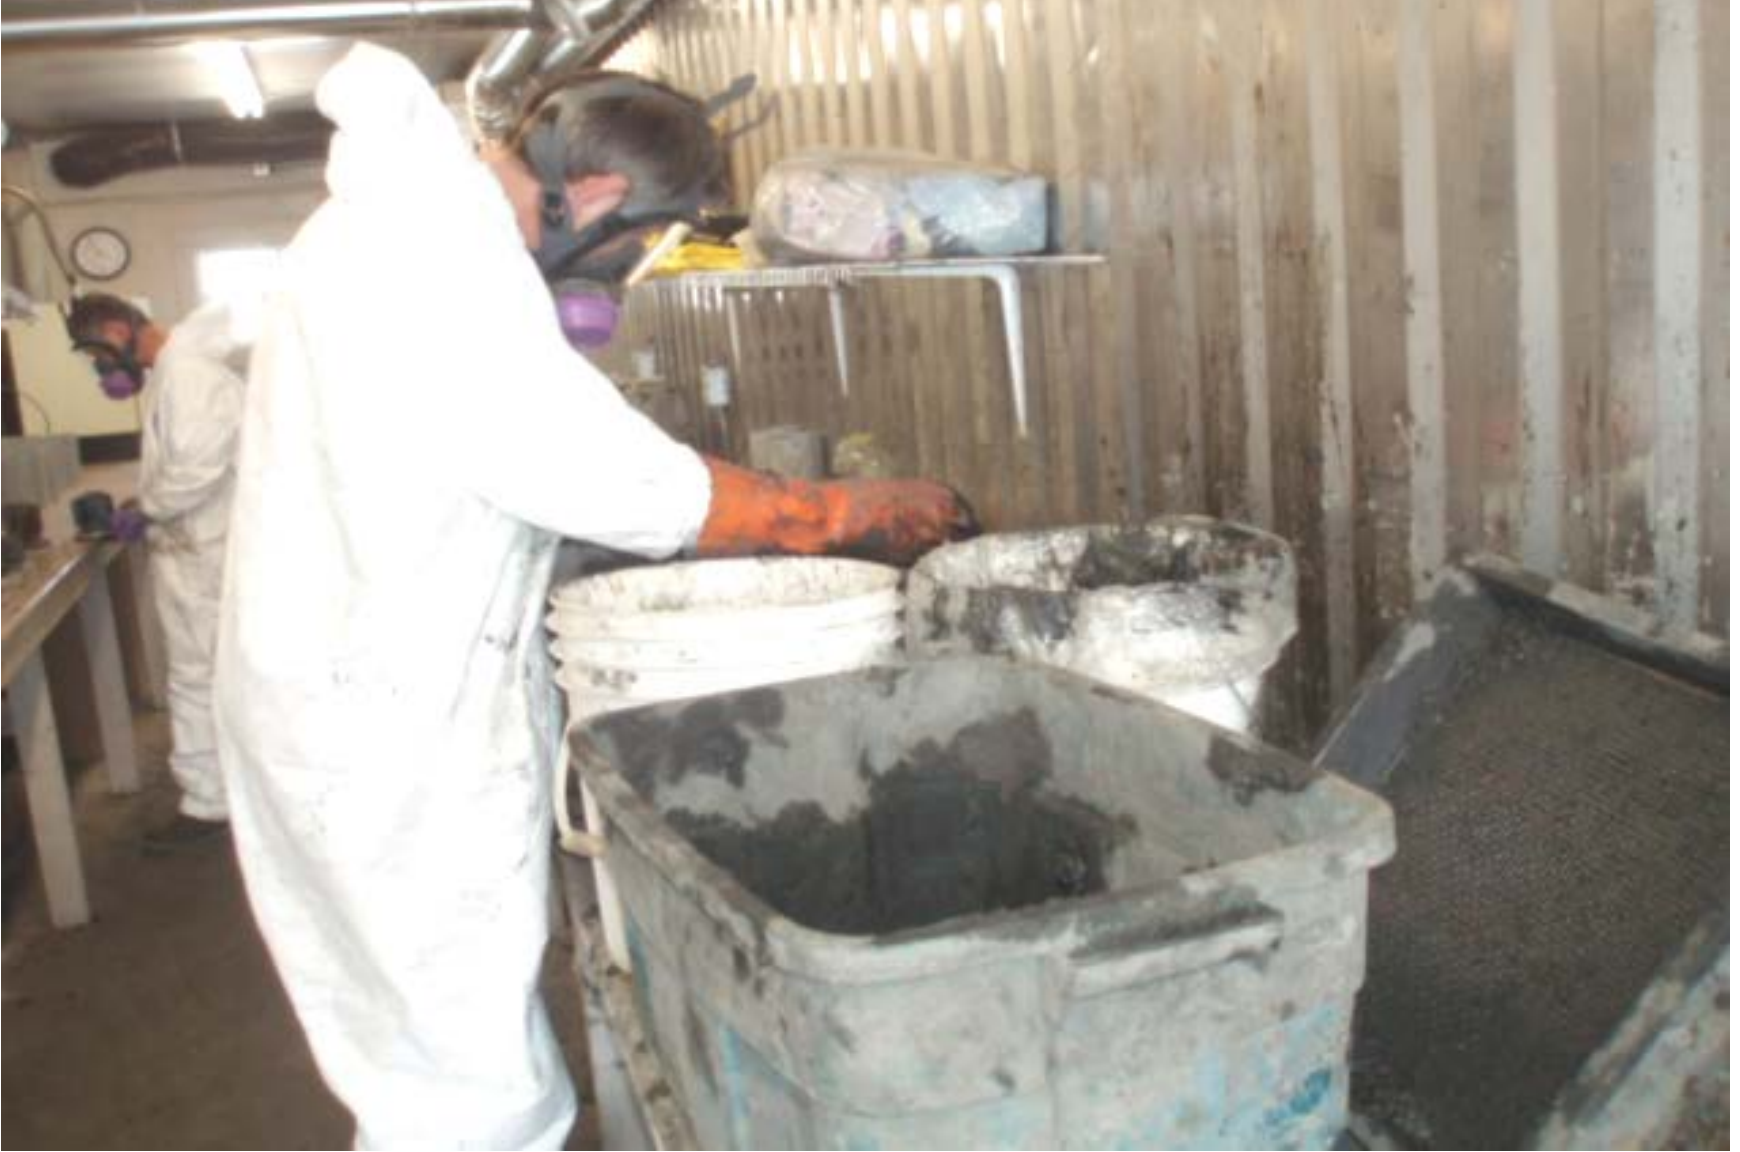
QC Geotechnical Lab

Sample Preparation following SOP

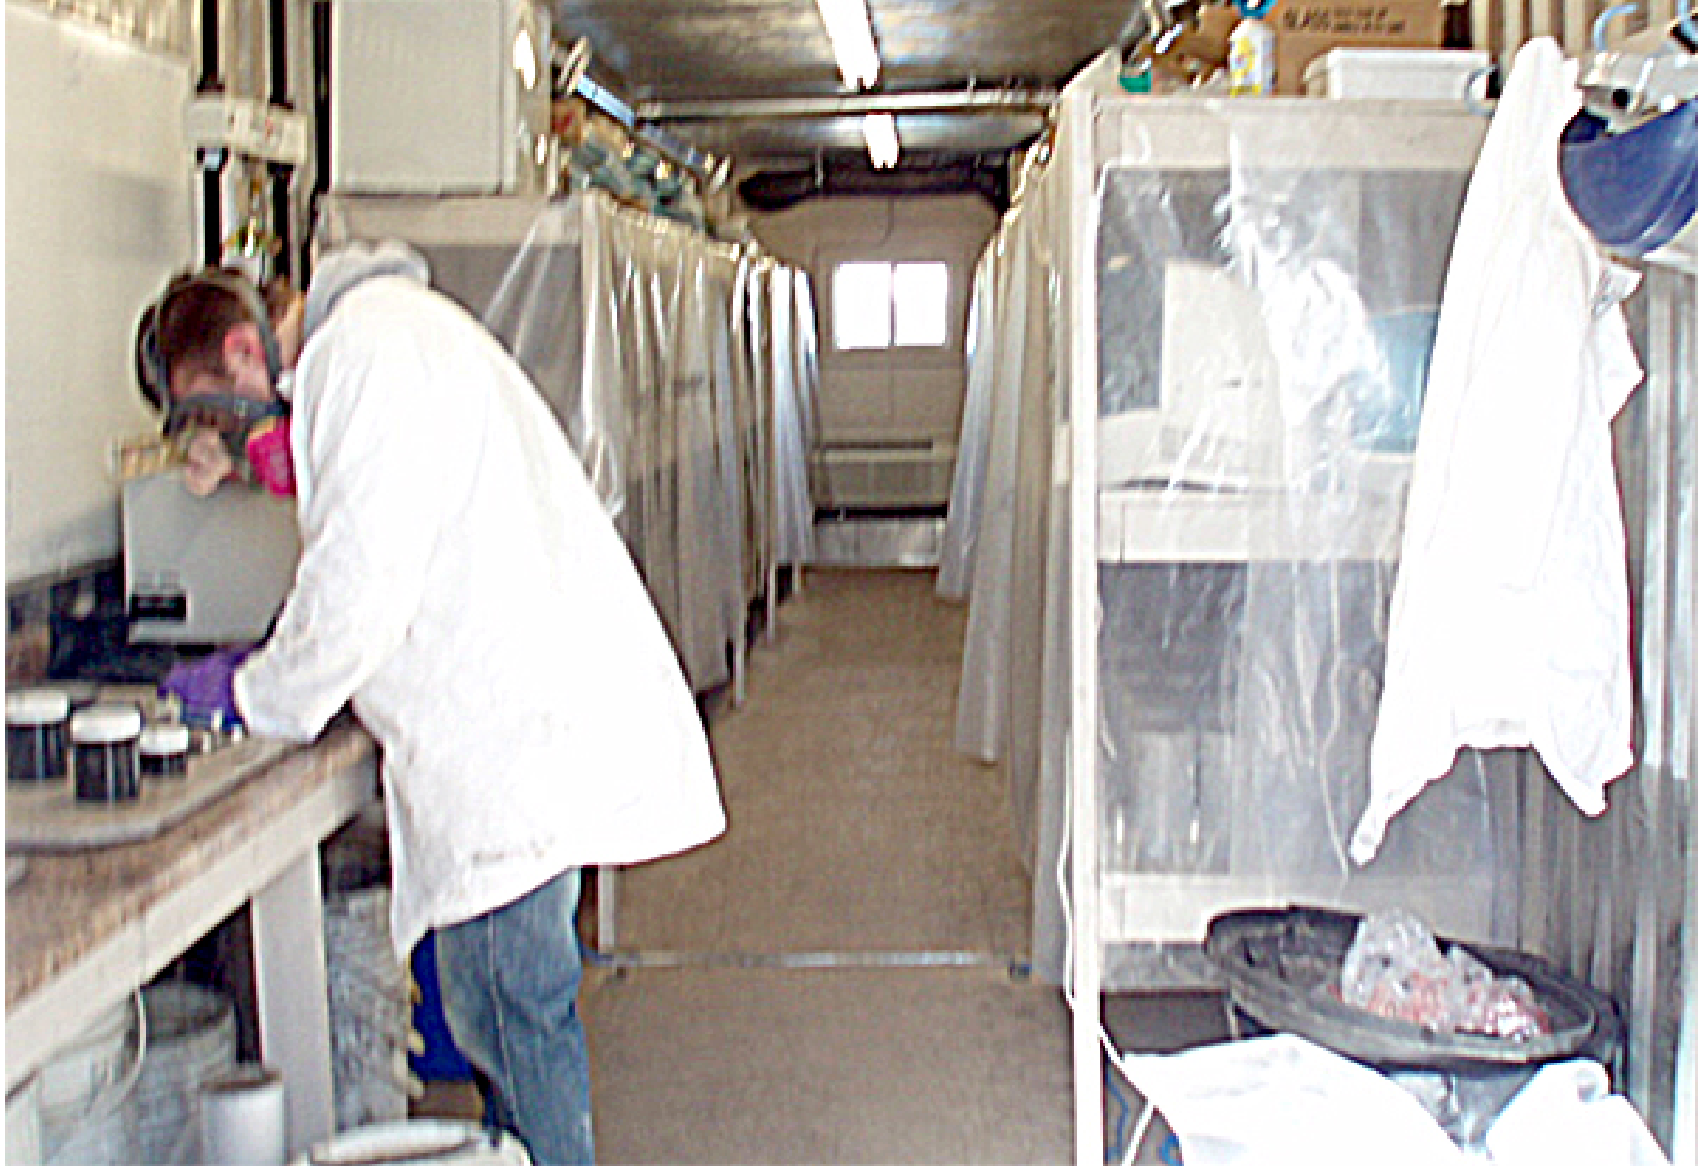
QC Geotechnical Lab

Sample Preparation following SOP
