Sydney Tar Ponds
Remediation, NS

A Strong Quality Program Imperative to Environmental Remediation Success

Solidification/Stabilization of the Sydney Tar Ponds Project

2013
Remediation
technologiesymposium

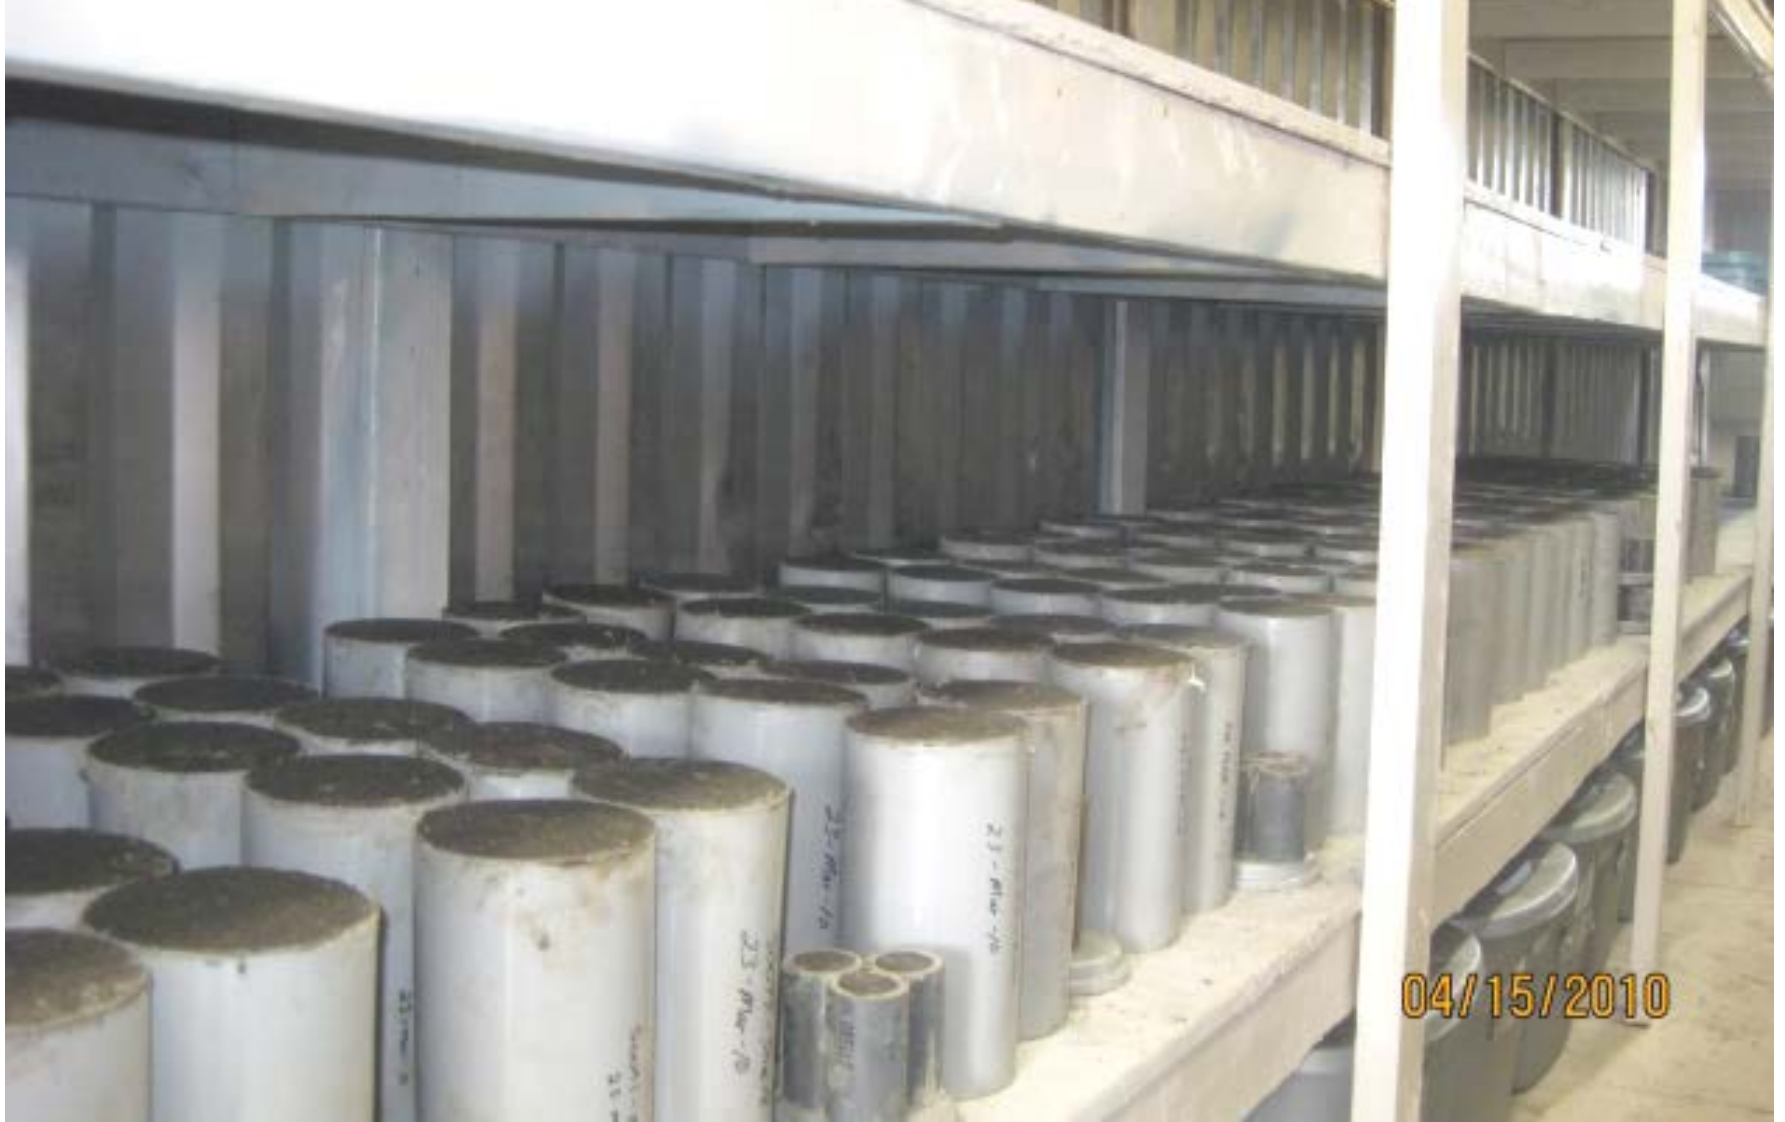
QC Geotechnical Lab

Specimen

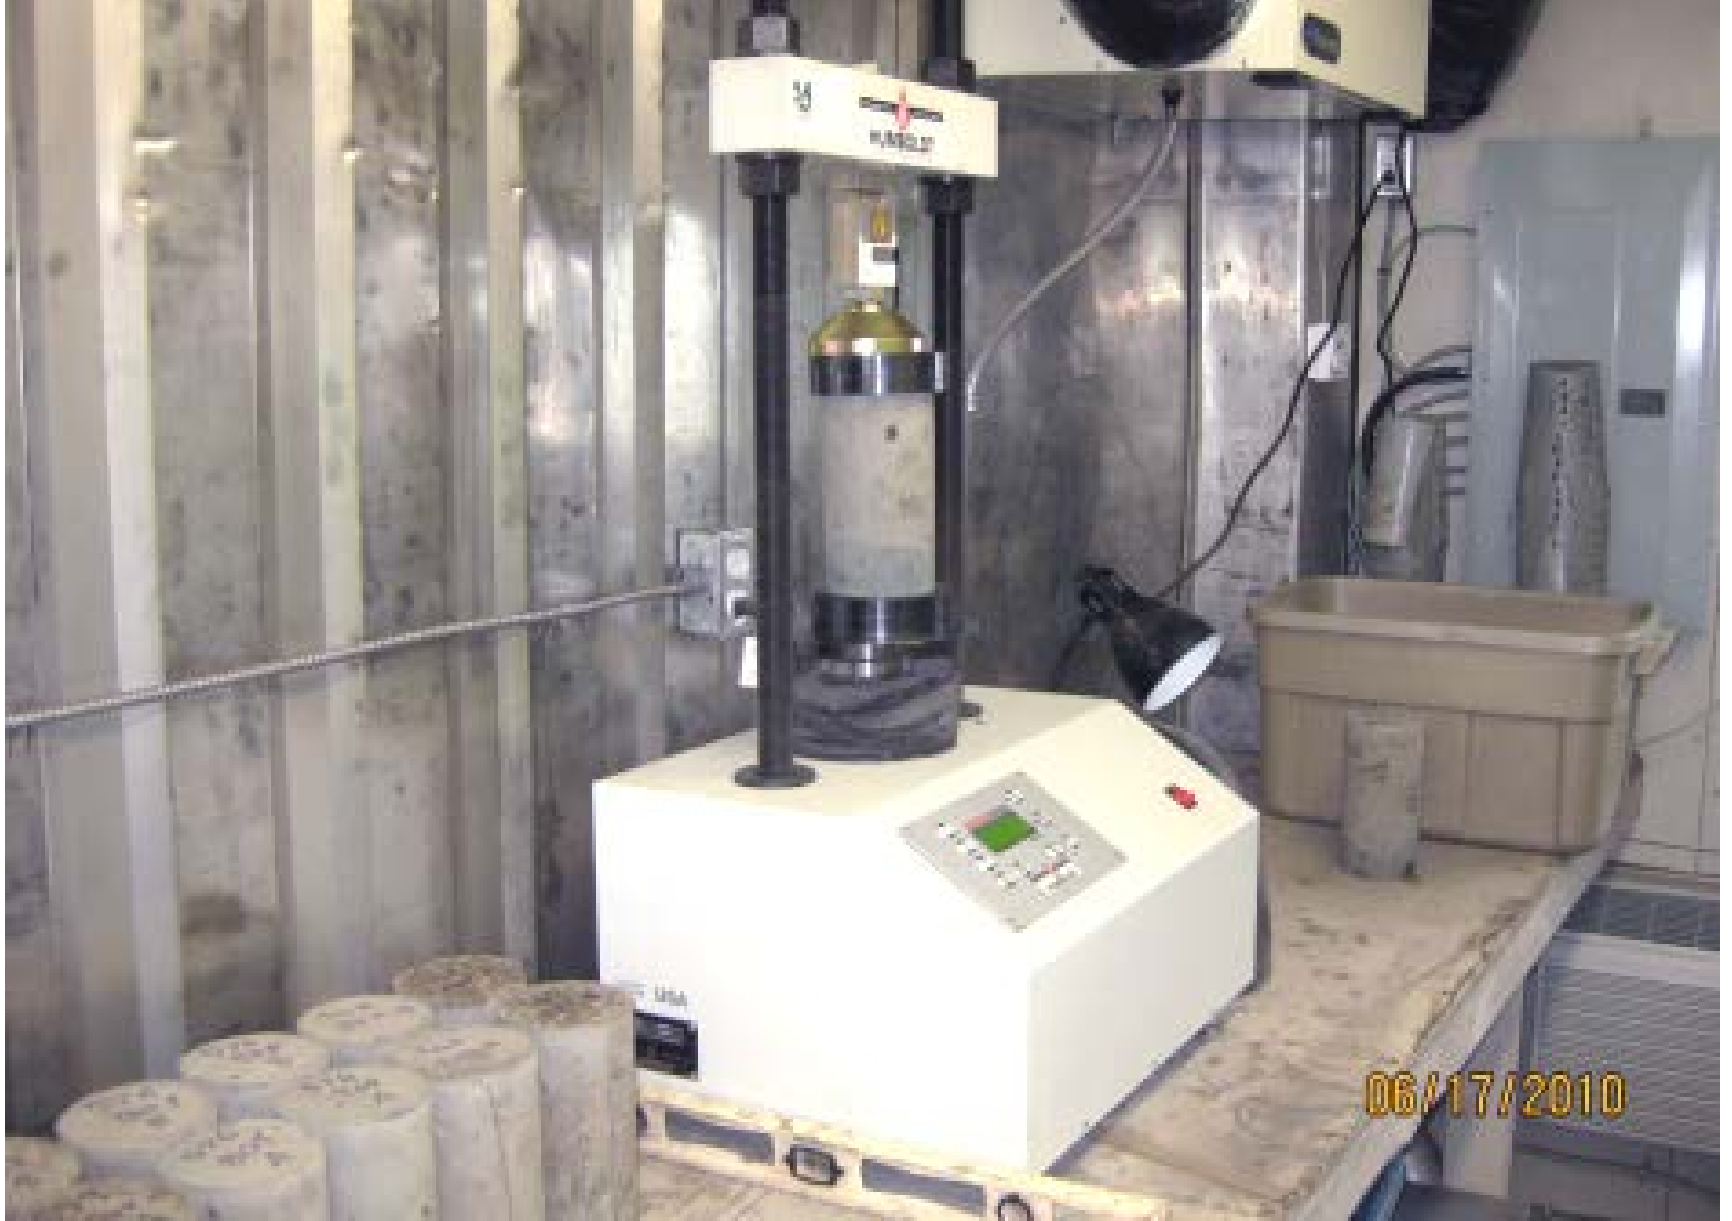
QC UCS

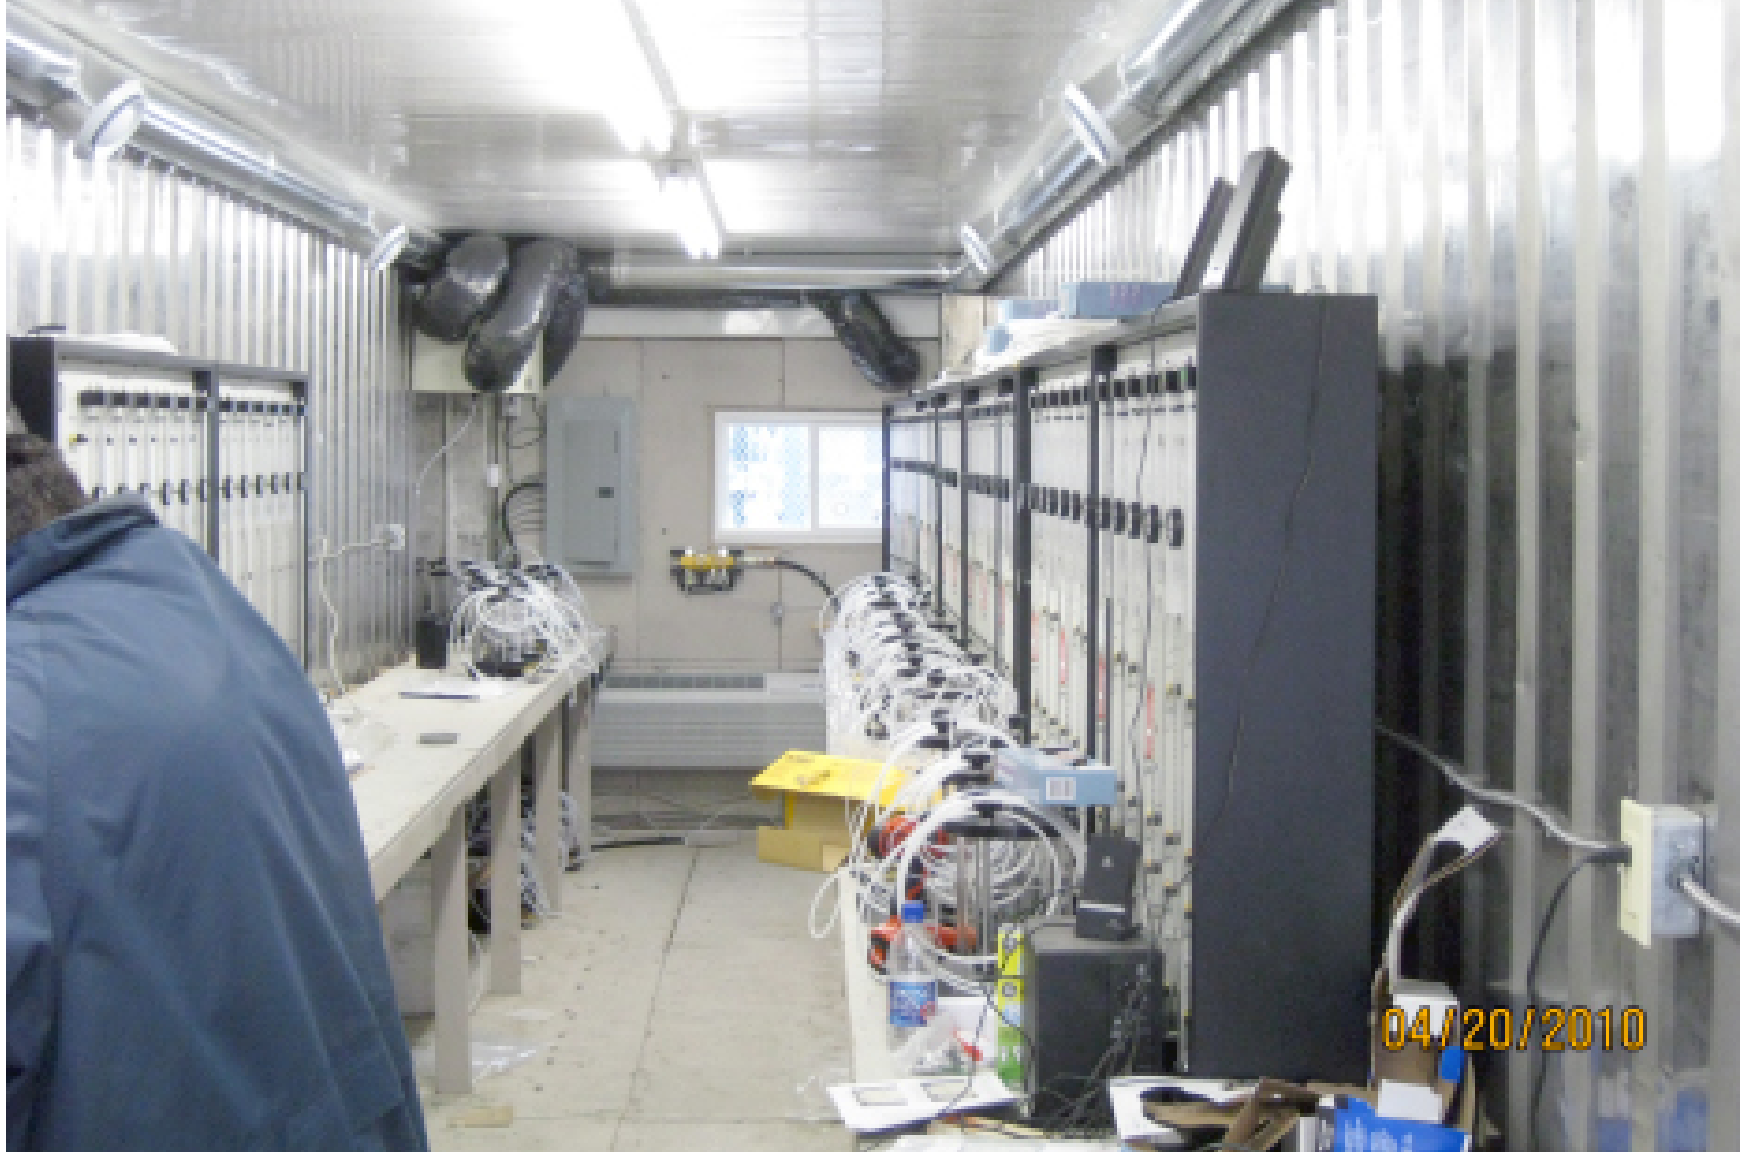
QC PERM boards

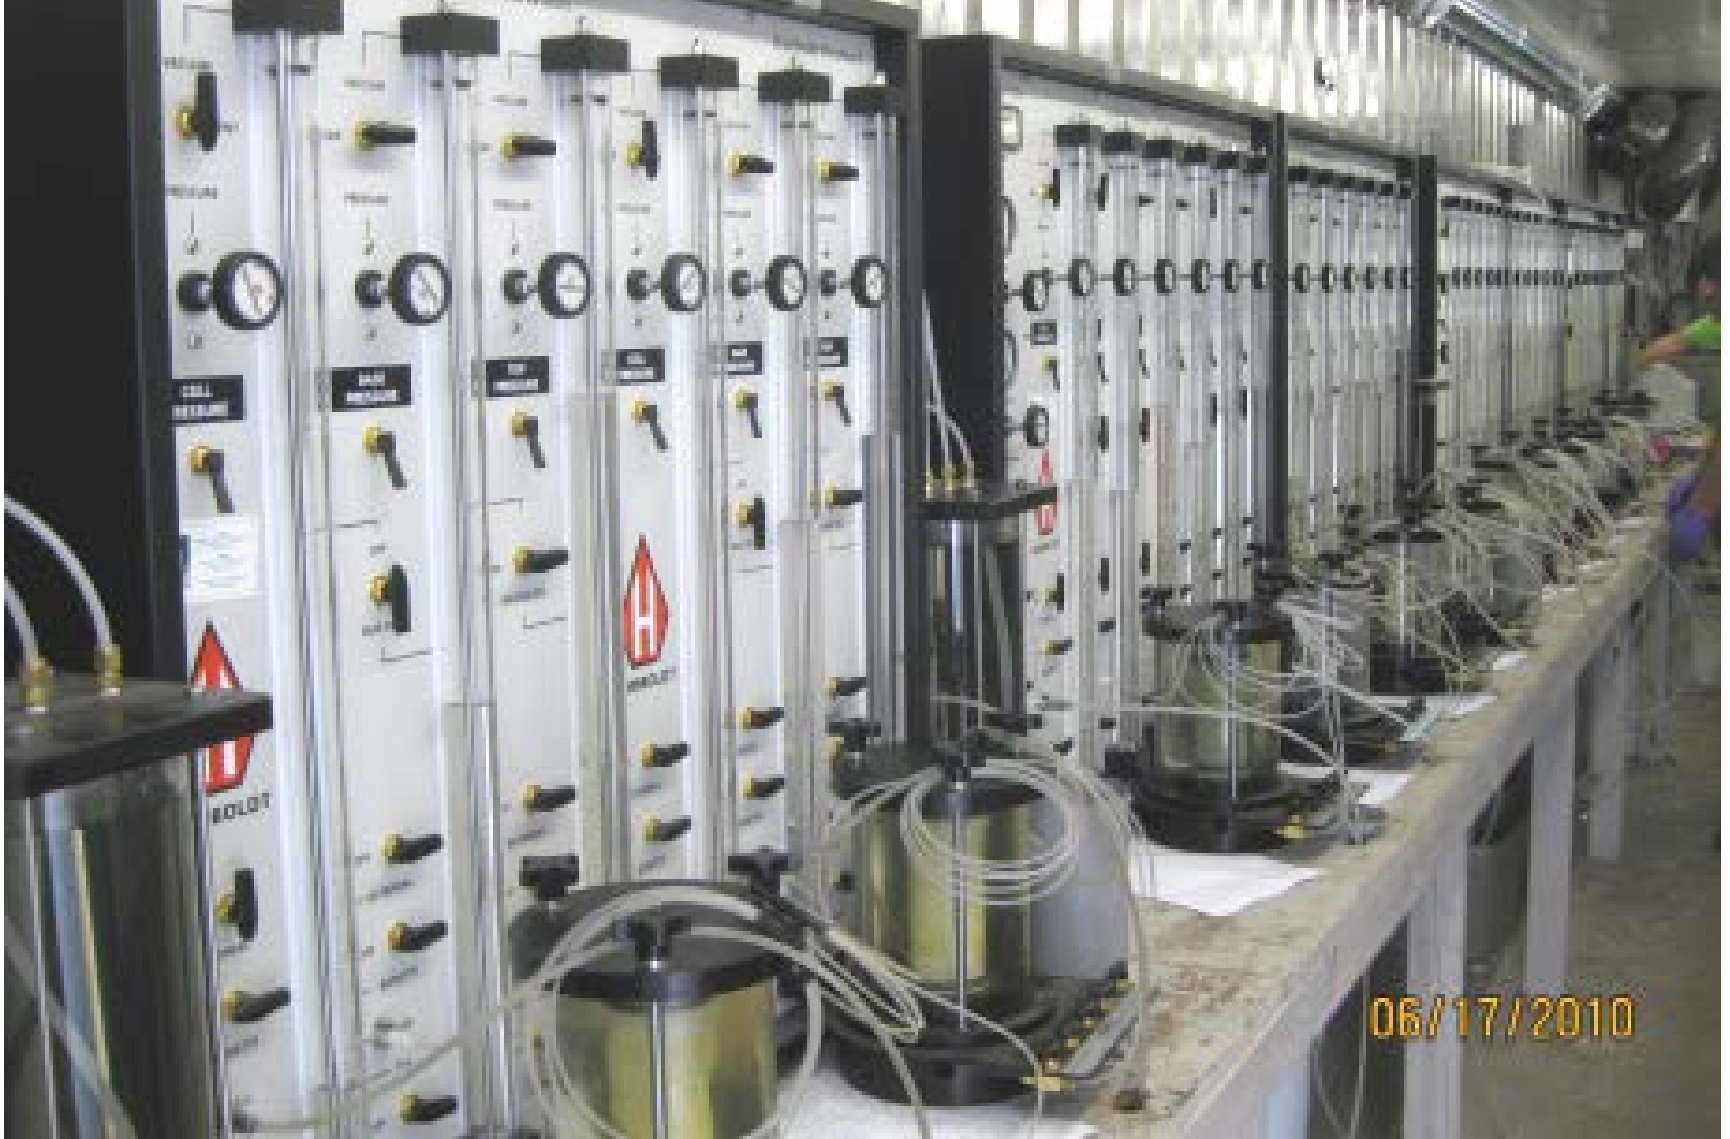
QC PERM boards

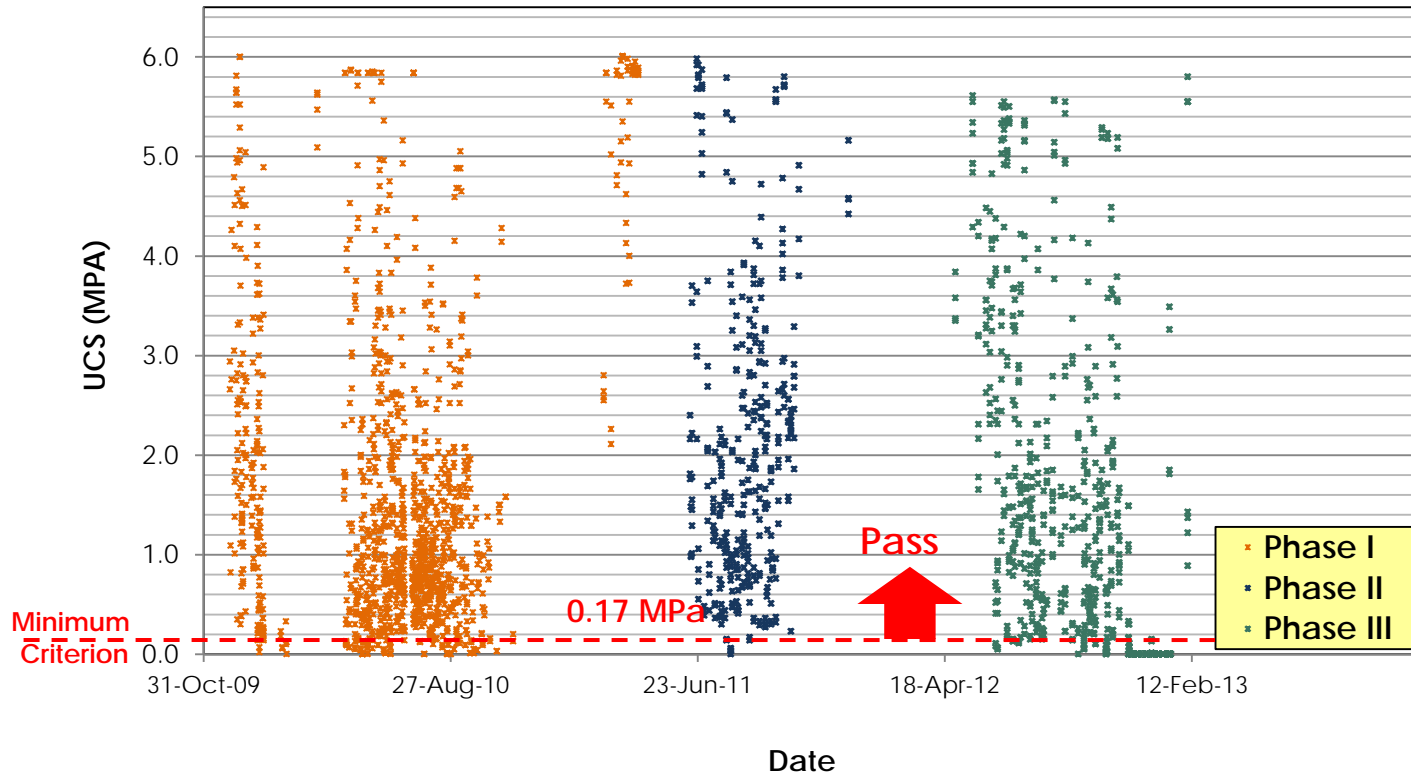
IQAC UCS Results

- 89% passing rate during Field Trial
- 97% passing on the first try in Phase I (after review & refinement of processes)
- 98% Passing on the first try in Phase II
- 86% passing on the first try in Phase III
- No cells failed after the second try in any phase

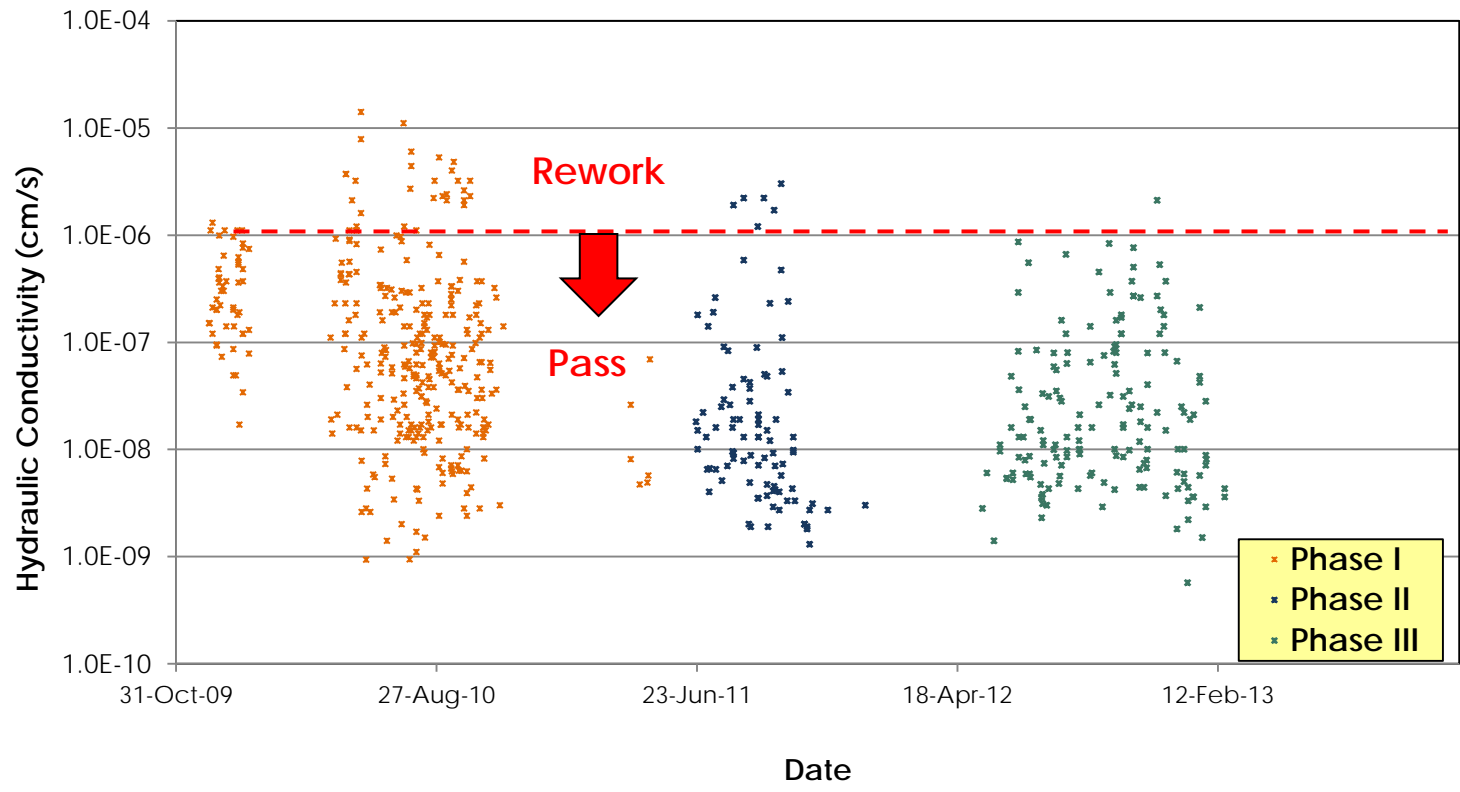
IQAC Perm Results

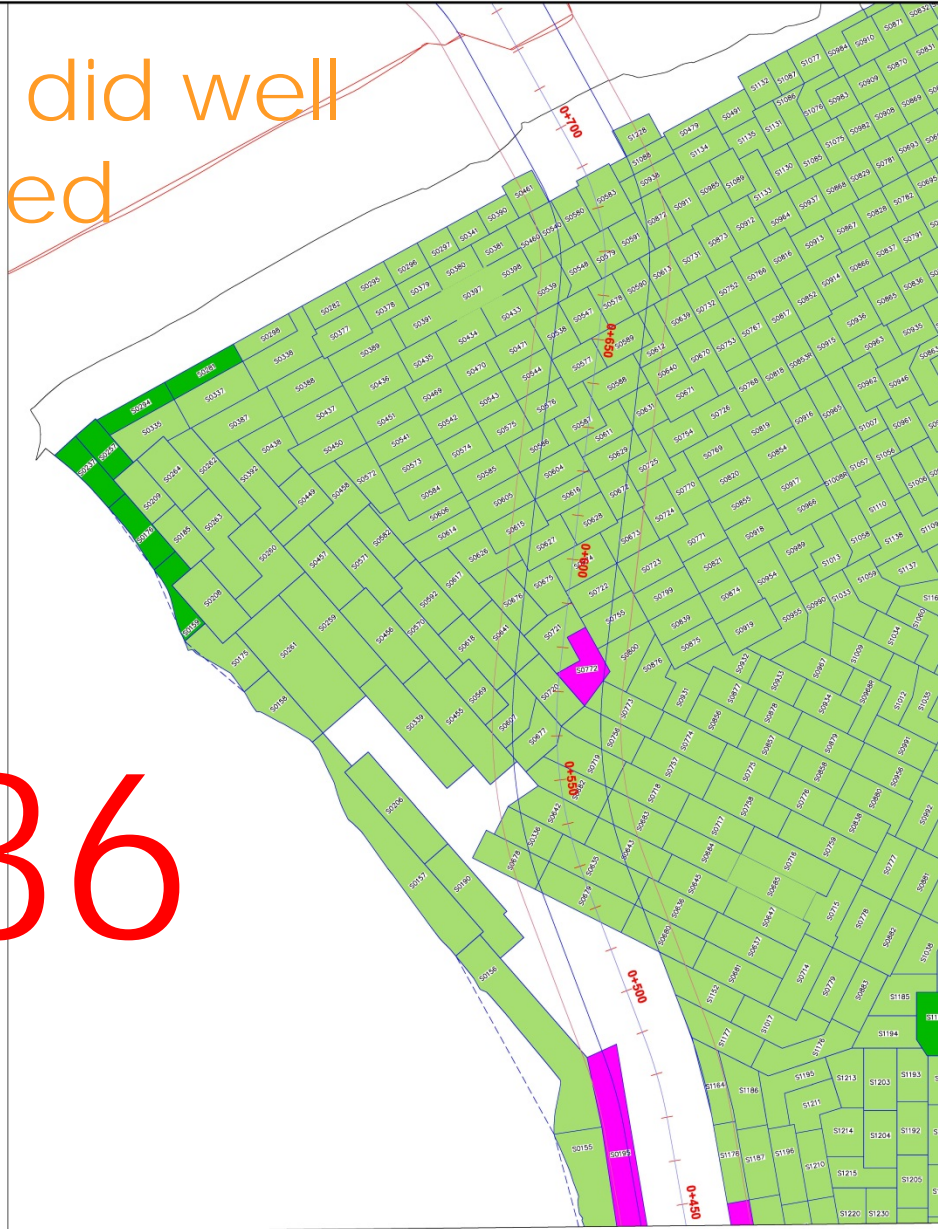
Proof we did well Cells S/S'ed

Channel shows the center line, bottom and top of channel at 1.30m. For excavation purposes, the top of channel width plus rip/rap & crusher dush width also should be considered

Cell Testing Status Report
for JUNE 20-24, 2011

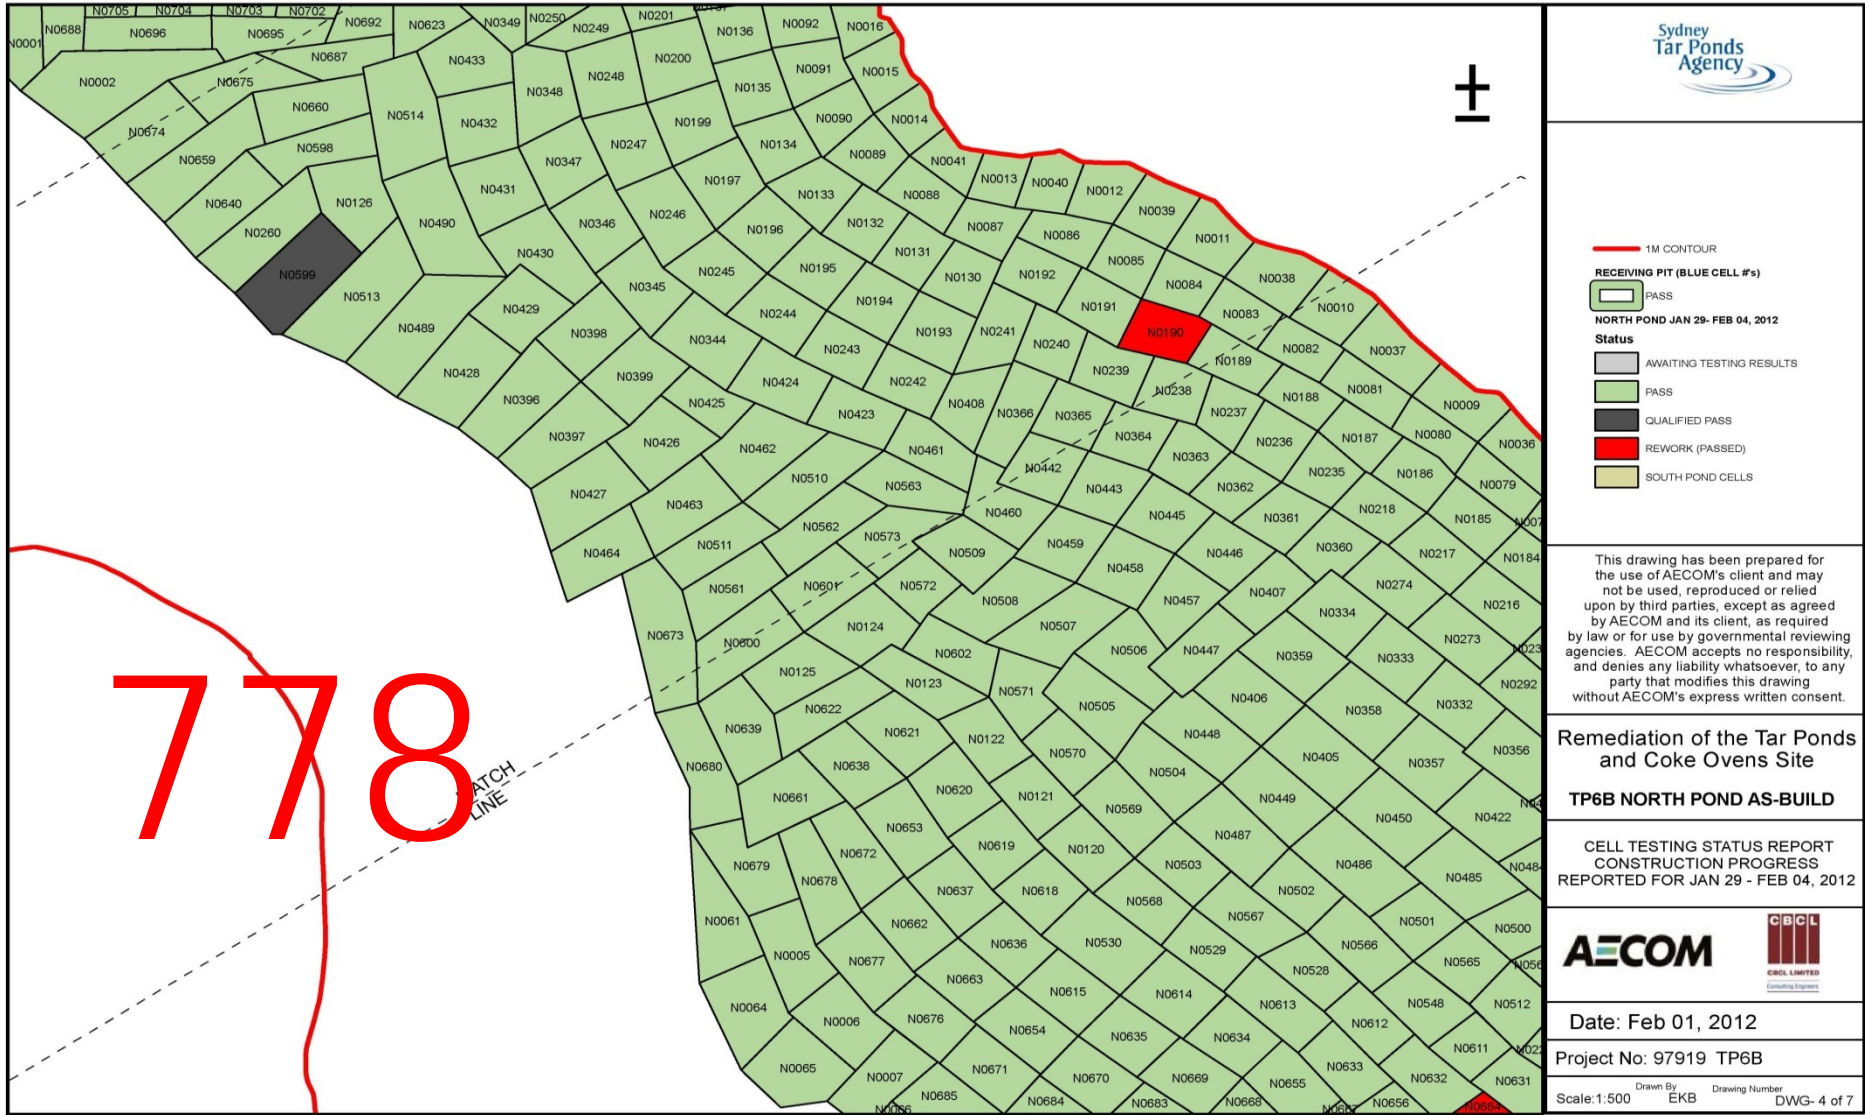
Proof we did well – cells S/S'ed

CONSTRUCTION PROGRESS OVERALL CELL STATUS MAP
March 3 to March 9, 2013
