In-situ Phytoremediation of PCB Contamination Limited by Contaminant Concentration

Jilczy Nelson-Mamani, TransCanada

Mike Francis and Elton Lawes, NOVA Chemicals

RemTech 2013 – Oct 17, 2013

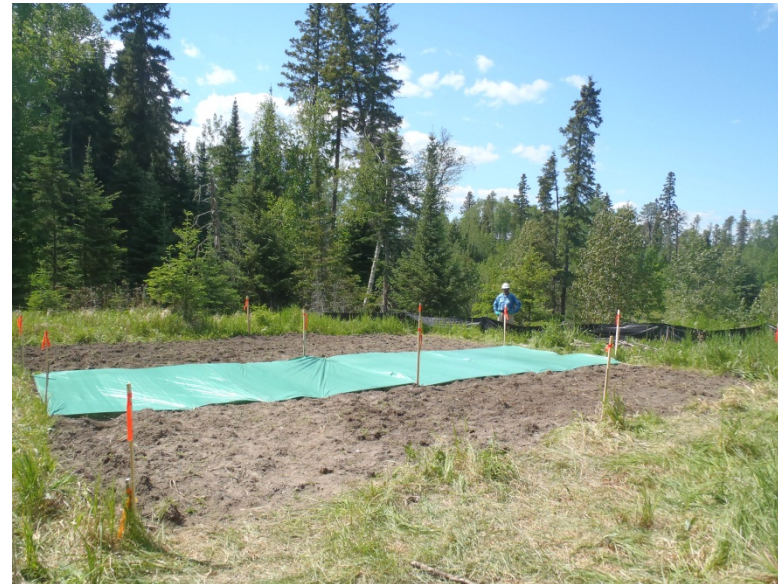
Outline of the Test Plots

- Plot 1: control – no treatment,
- Plot 2: nitrogen + phosphorus nutrients and covered with a tarp to induce semi-anaerobic conditions,
- Plot 3: nitrogen + phosphorus nutrients + aerobic conditions,
- Plot 4: nitrogen + phosphorus nutrients and seeded with reed canary grass – aerobic conditions
- Plot 5: nitrogen + phosphorus nutrients + molasses covered with a tarp to induce more anaerobic conditions ,
- Plot 6: nitrogen + phosphorus nutrients and seeded with alfalfa – aerobic conditions.

- **Sampling locations – 5 points per plot**
- **Fertilized with nitrate and phosphorus over the summer periods for two years.**
- **Nitrogen and phosphorus added to achieve carbon:nitrogen:phosphorus ratio = 100:1.0:0.1**
- **Nitrogen and phosphorus added monthly June to November**
- **Monitored monthly over the summer periods**
 - Microbial numbers
 - PCB concentrations
 - Nutrient levels
 - Groundwater well also monitored to ensure no contamination migration to the groundwater and moving offsite

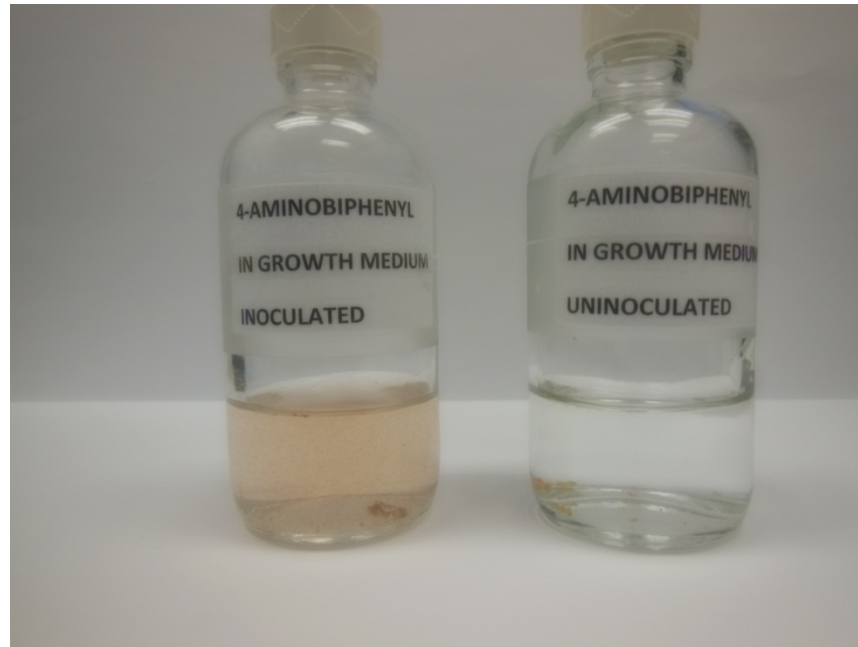
- Microbial numbers were enumerated with the most probable number dilution series technique
- Microbes were tested for growth on 4-aminobiphenyl: orange/yellow and insoluble, monitor turbidity and production of orange, soluble dinitrobiphenyl to indicate growth.

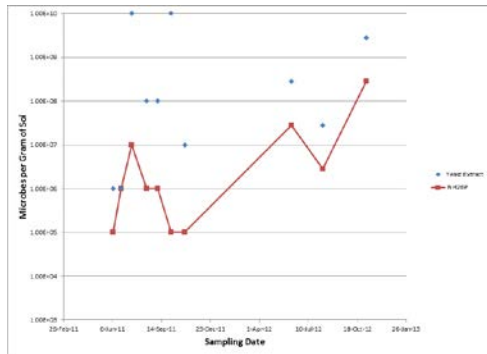
Plot 1

- Microbes including PCB degraders increased in all plots over the two years of the study. This occurred even in the control plot which received no nutrient supplements.
- However the increase in numbers of PCB degrading microbes was greatest in Plot 4 which received nutrients and Reed Canary Grass.

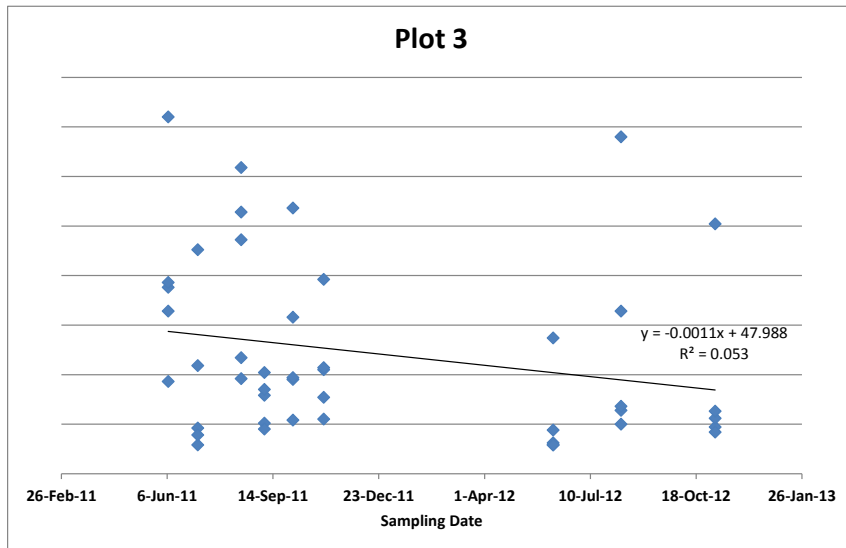
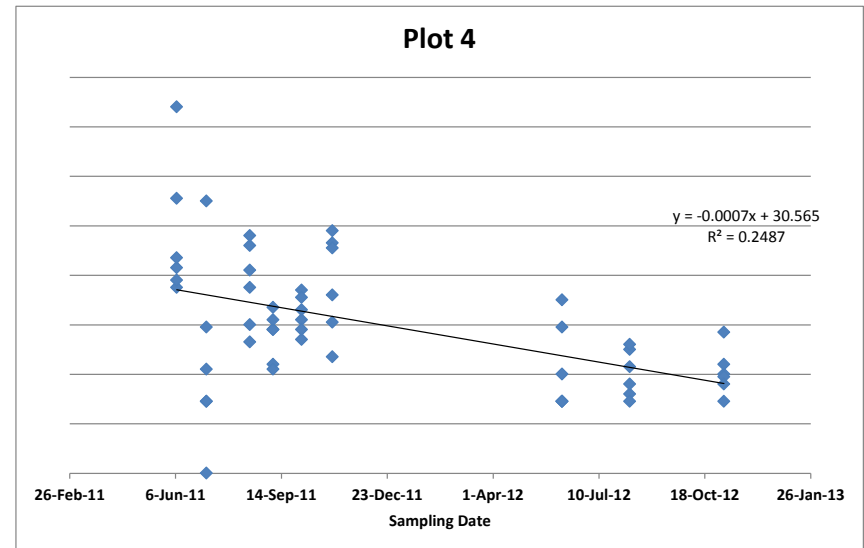
PCB Concentration Reduction

Statistical analysis of PCB concentrations in the test plots over the two years did not support a statistically significant PCB removal. The scatter in the data at each sampling point was too large to allow significance. Only in Plot 4 was the PCB loss marginally significant. The correlation in Plot 4 was 5 - 10 x better than in other plots.

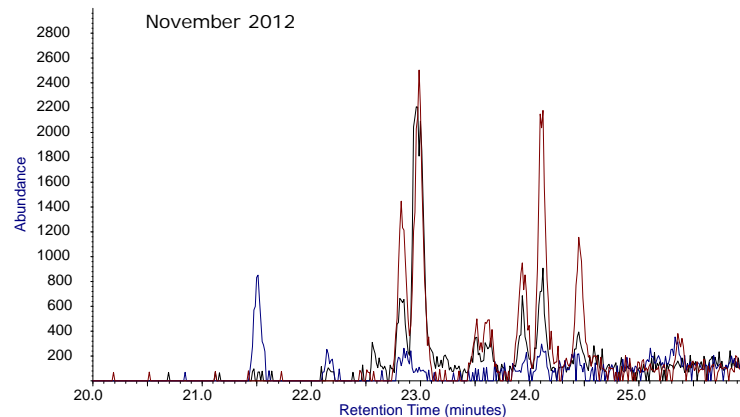
Loss of individual PCB congeners in gas chromatograms

Examination by GCMS of PCB congeners in extracts of the soil from the test plots did not show losses of individual PCB congeners over time in Plots 1, 2, 5 and 6, implying that no PCB degradation was occurring in these locations. See data for Plot 5 below.

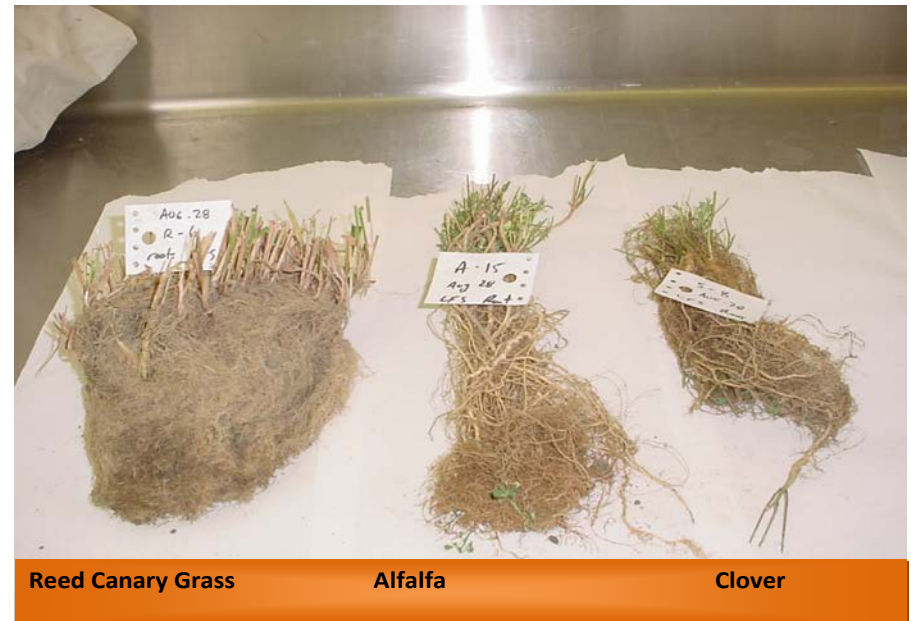
Comparison of root mass of Reed Canary Grass, Alfalfa and Clover

- Reed canary grass has an extensive root system.
- Root system provides exudates for microbial growth and stimulation.
- The root system provides colonizing sites for microbial growth.
