## Risk Assessment, Remediation and Redevelopment: A Brownfield Success Story in Oshawa

Tony Windsor, M.Sc., P.Eng.  
Practice Lead, Brownfield Risk  
Assessment

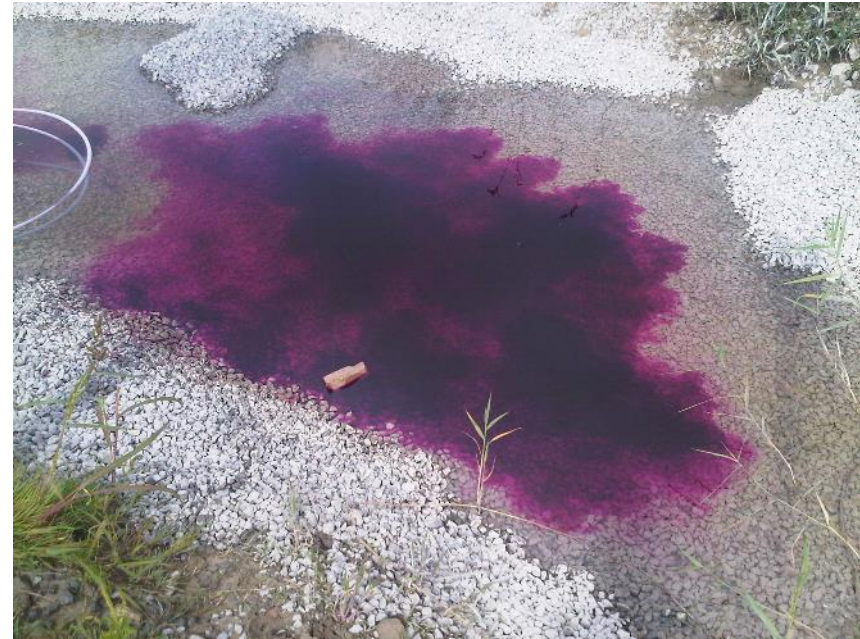
- Limited source removal and chemical oxidation to meet Property Specific Standards (PSS)
- Two rounds of treatment required to reduce cis-1,2-dichloroethene from 11,000 ug/l to <1,600 ug/l
- Round 1 used Potassium Permanganate
- Round 2 used Sodium Permanganate
