ARSENIC SPECIATION, MOBILITY AND TREATABILITY AT A FORMER INDUSTRIAL SITE IN EDGEWATER, NEW JERSEY

David Winslow, P.G, Ph.D. & Brett Engard, P.G.

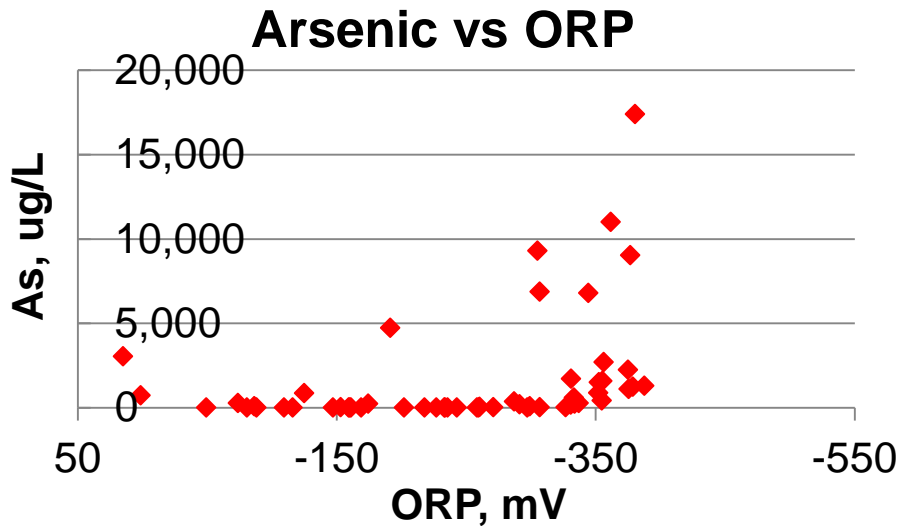
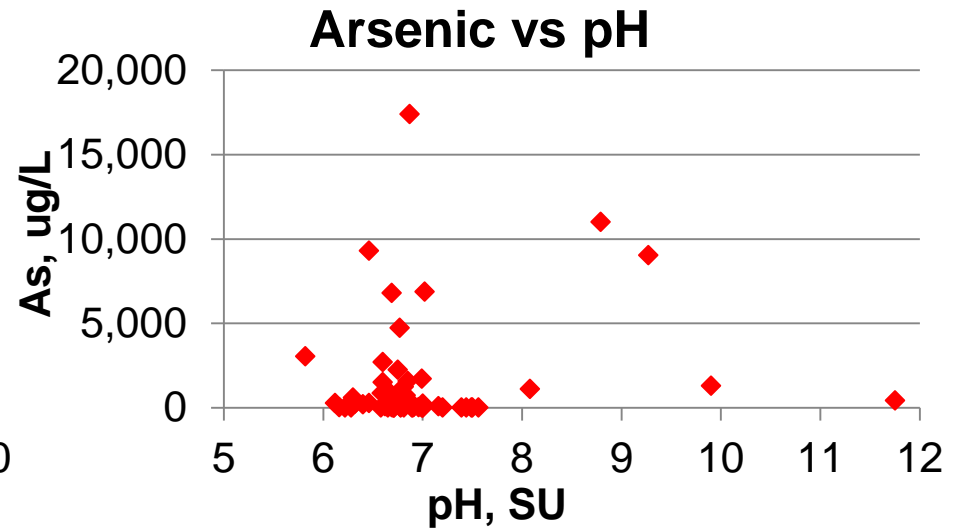
- Found Different Geochemical Zones Corresponding with Dissolved Arsenic
 - Low Eh / High pH (Zone 1)
 - High Eh / Low pH (Zone 2)

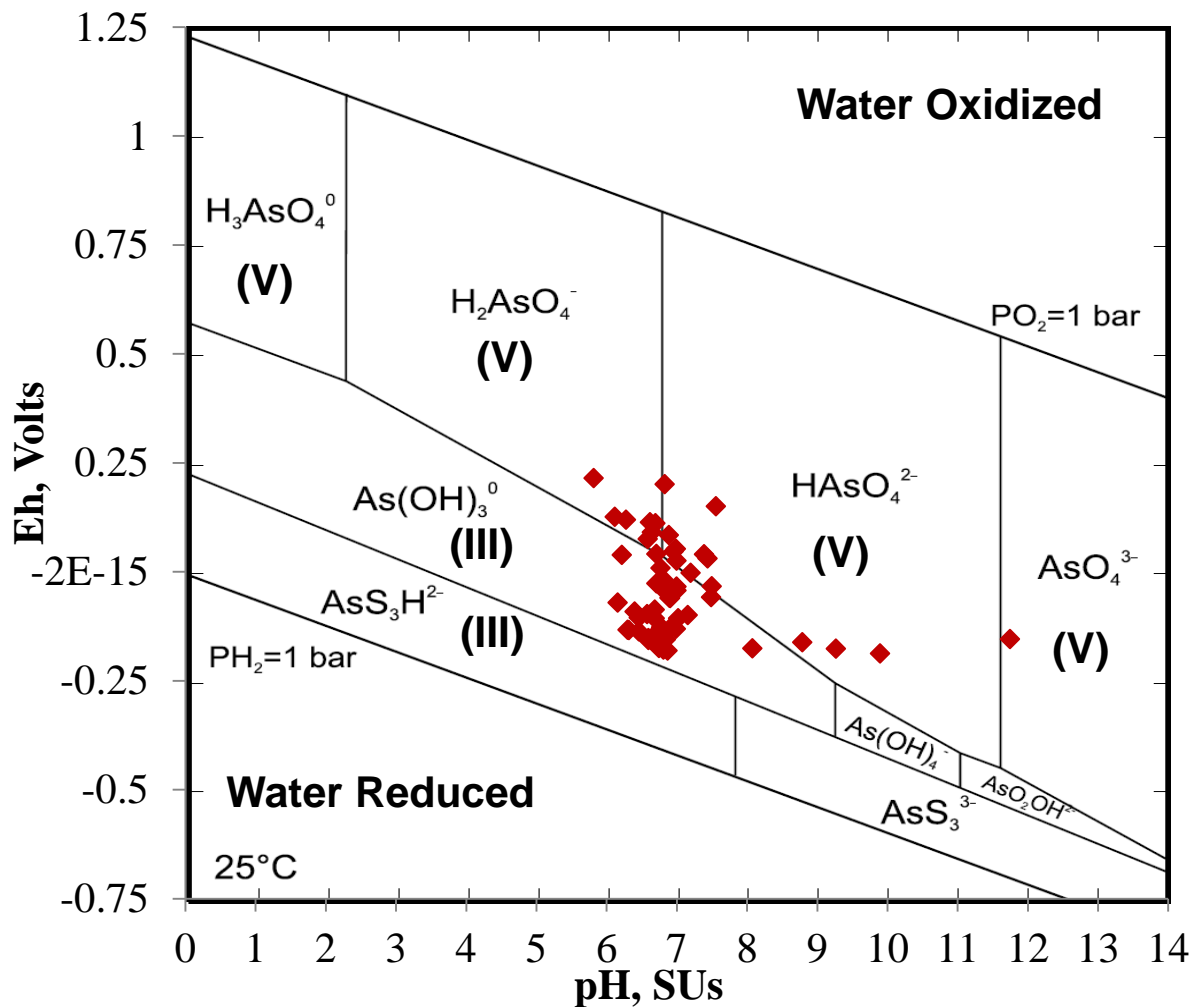
- Eh/pH range indicated groundwater zones straddled the Arsenite (As[III]) stability field

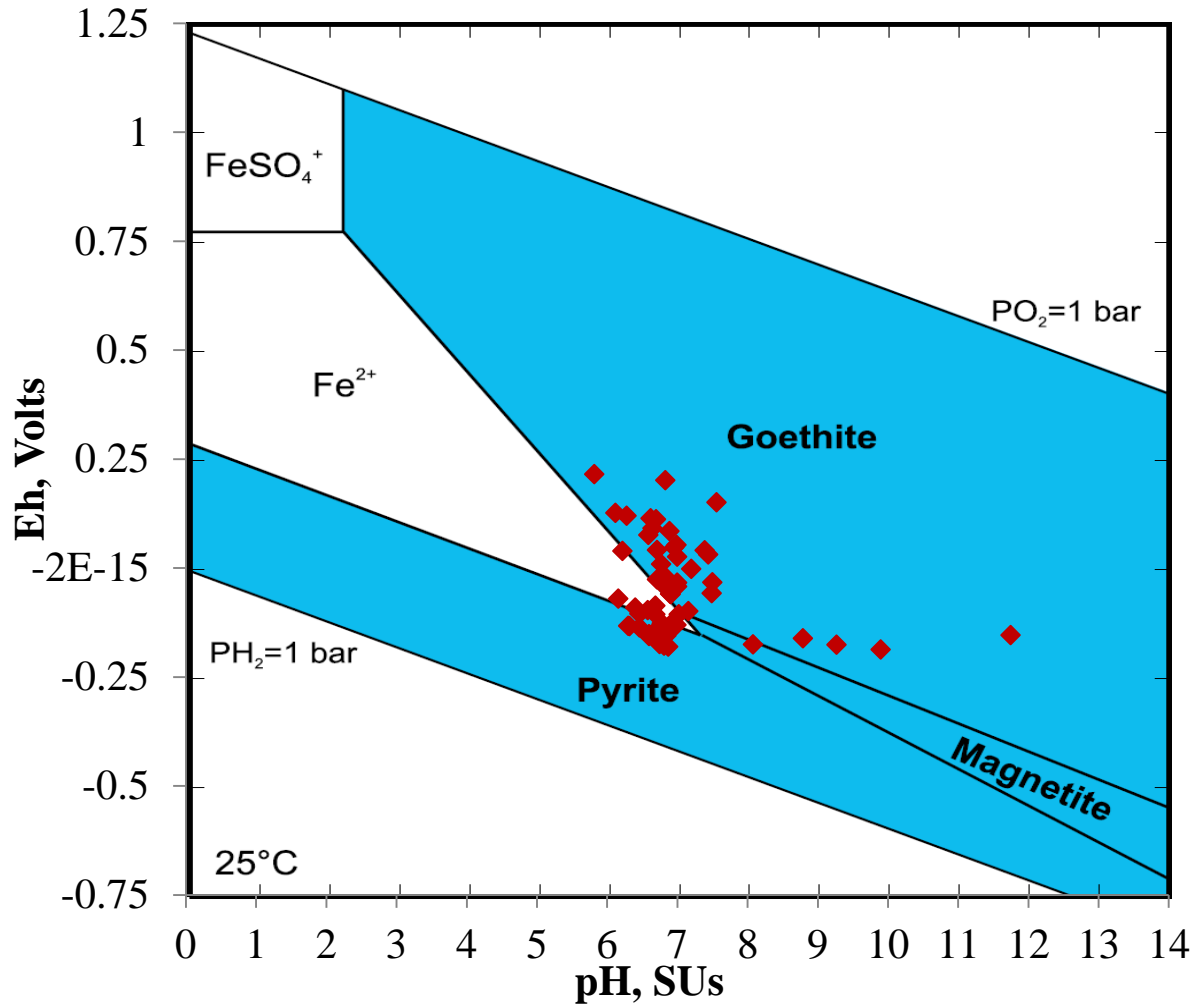
- Eh/pH range indicated groundwater in two zones fell outside iron oxyhydroxide stability field

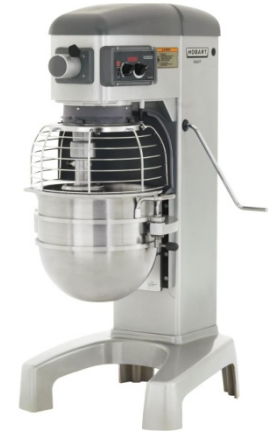
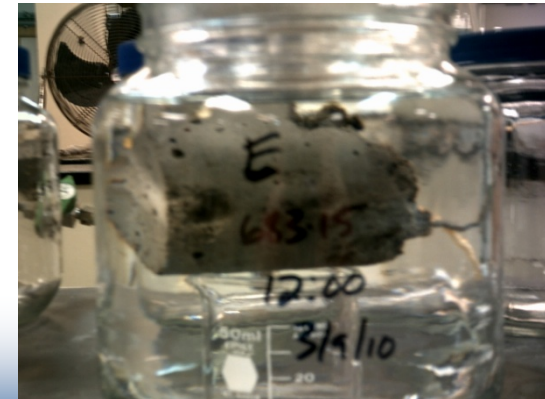
- Prepared Standard Operating Procedures
- Mixture Designs Applied
 - Type I Portland Cement
 - Addition rates of 10%, 7.5%
- Bench scale Hobart type mixer
- 4-inch diameter plastic cylindrical curing molds
- Cured for 28 days

- PAHs and VOCs Passed NJDEP Default Leachate Criteria
- Compressive Strength Strong
- Low Permeability
- Leachate Results
 - Lead Present in One Sample
 - Arsenic Present In Leachate

- Arsenic Present as Arsenite, Soluble Under Reducing Conditions
- Add Ferric Sulfate to Increase Oxidation State of Arsenic Yielding Arsenate
- Ferric Sulfate Resulted in Formation of Iron Oxyhydroxides Promoting Arsenic Bonding
