**Kishon River Remediation,
Haifa, Israel**

Philippe Gingras, Englobe Corp.
RemTech, October 17, 2014

Large-Scale Remediation in a Complex Environment: Some Key Points

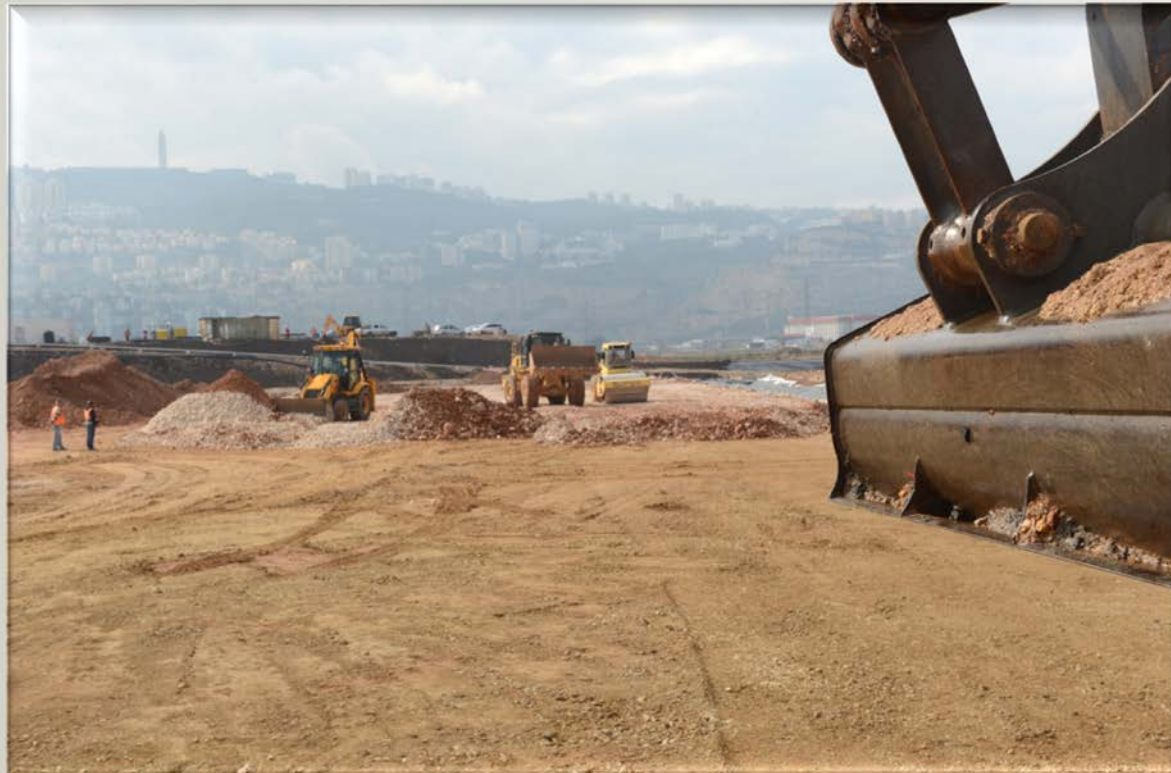
Density
Tests every
200 mm
layer plus
2 layers of
Geogrid

42,000 m^2
of HDPE to
complete
'waterproof
ing' of the
site

Over 3.5 km
of Roads
Constructed
with
Geotextile
protection

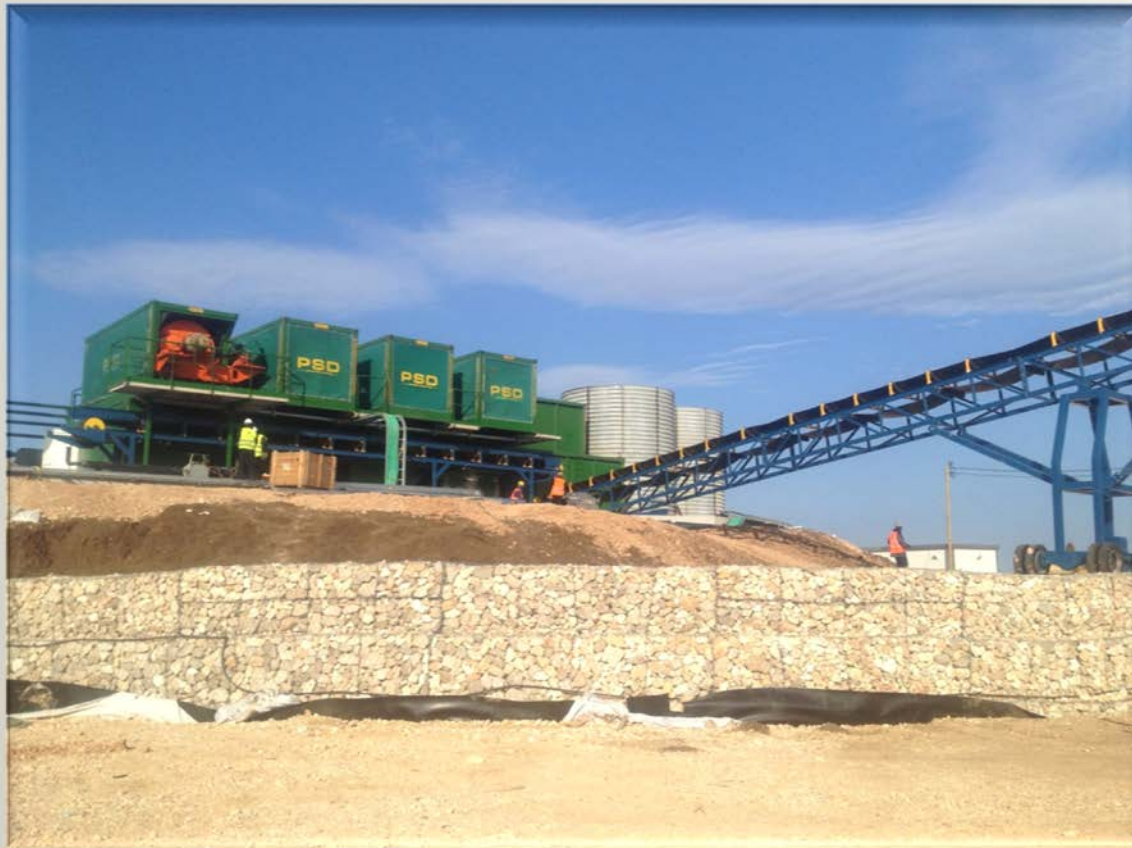
In-let
screen
with 2 No.
450 m³
discharge
pumps

6,000 m³
Retention
Lagoon with 4
Mixers &
2 Slurry Pumps

250 m³
Settlement
Tank and
associated
Flocculent /
Coagulant
dosing tanks

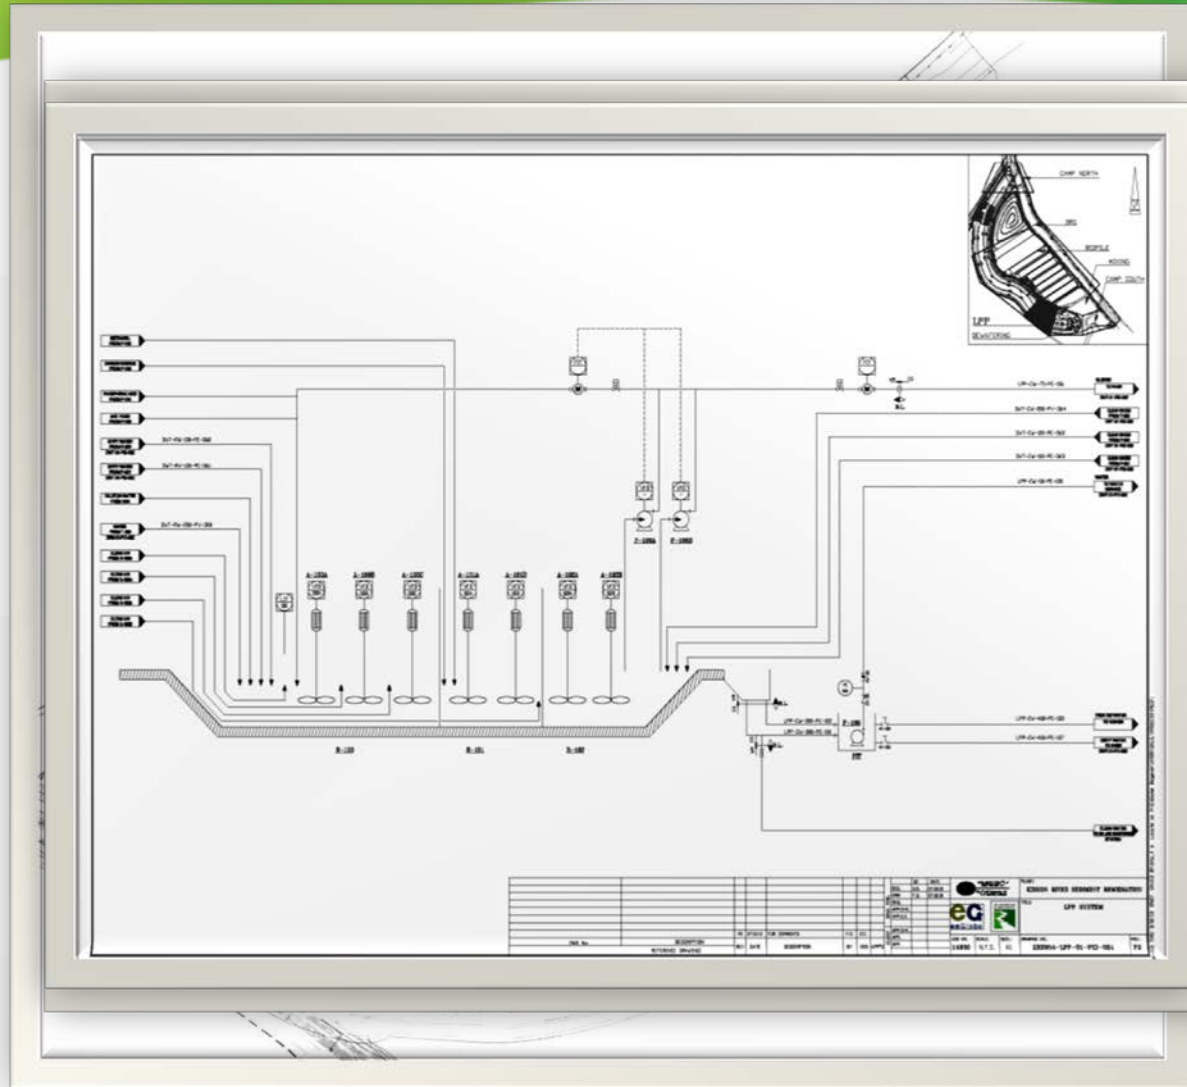
4 No.
Dewatering
Centrifuges

Conveyors
for
Dewatered
Sediments

11,000 m³
LPP Lagoon
with 4 Mixers

Aerobic
nitrification
Zone
(Ammonia to
Nitrates)
followed by
anaerobic
de-
nitrification
(nitrates to
Nitrogen)

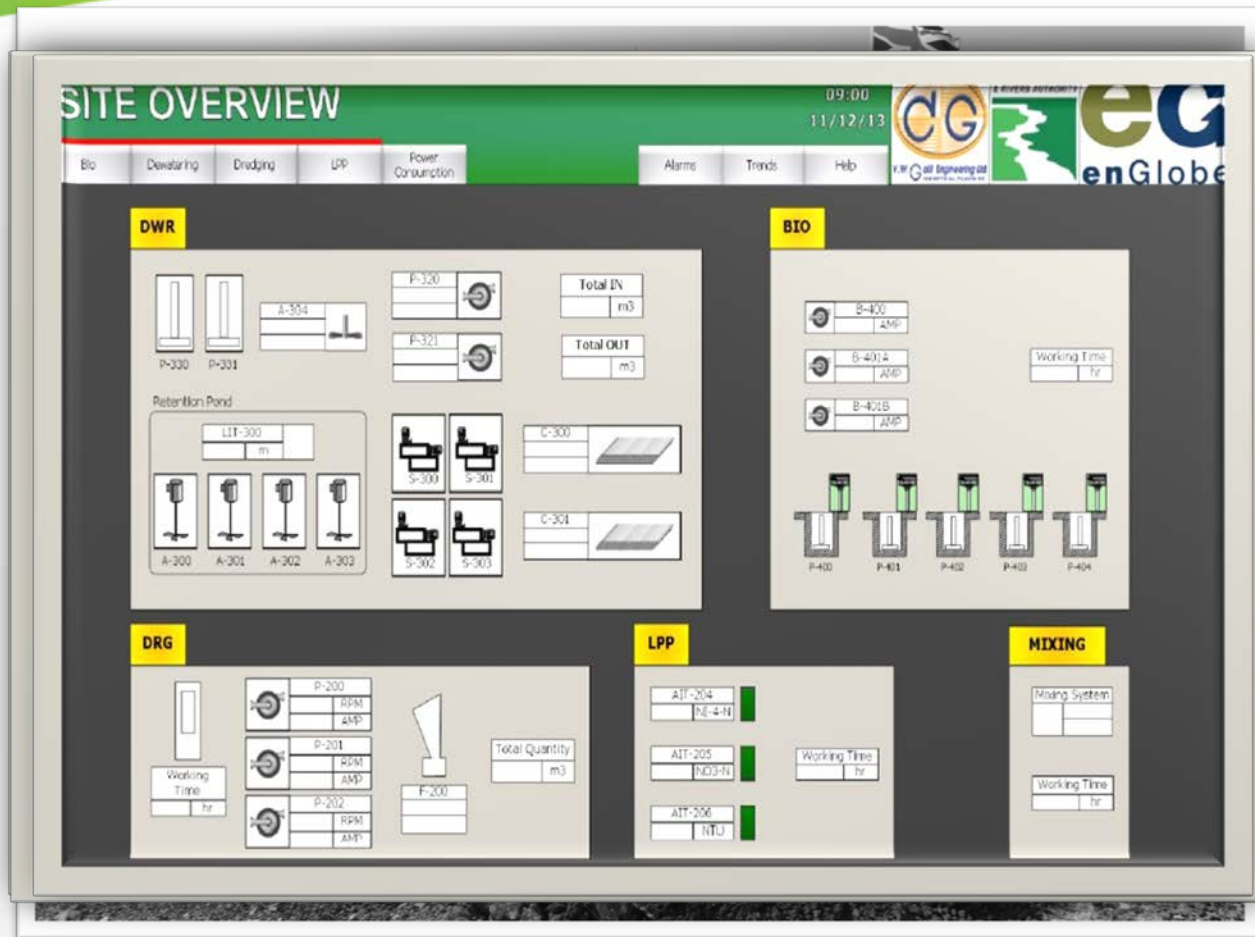
Operations controlled from Management Offices

And from Engineers Offices in the South Camp

With control information routed via the Main Control Centre

And displayed by HMI software

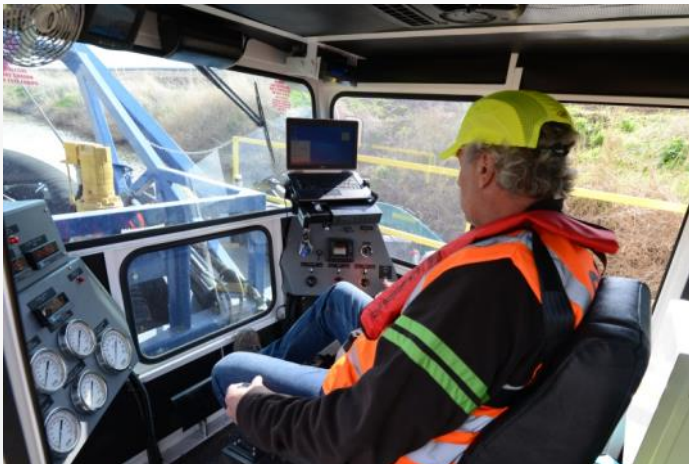
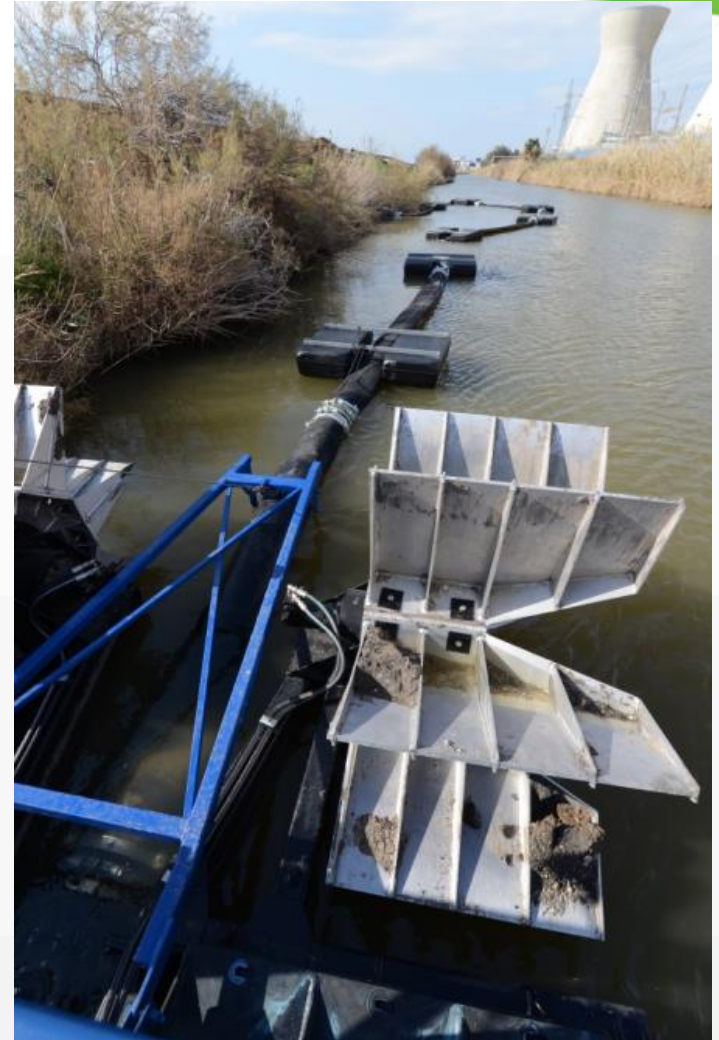
Dredging

- IMS 7012 dredger on site and in the water
- Licensed
- Connected to pipework and Operational Qualification OQ passed

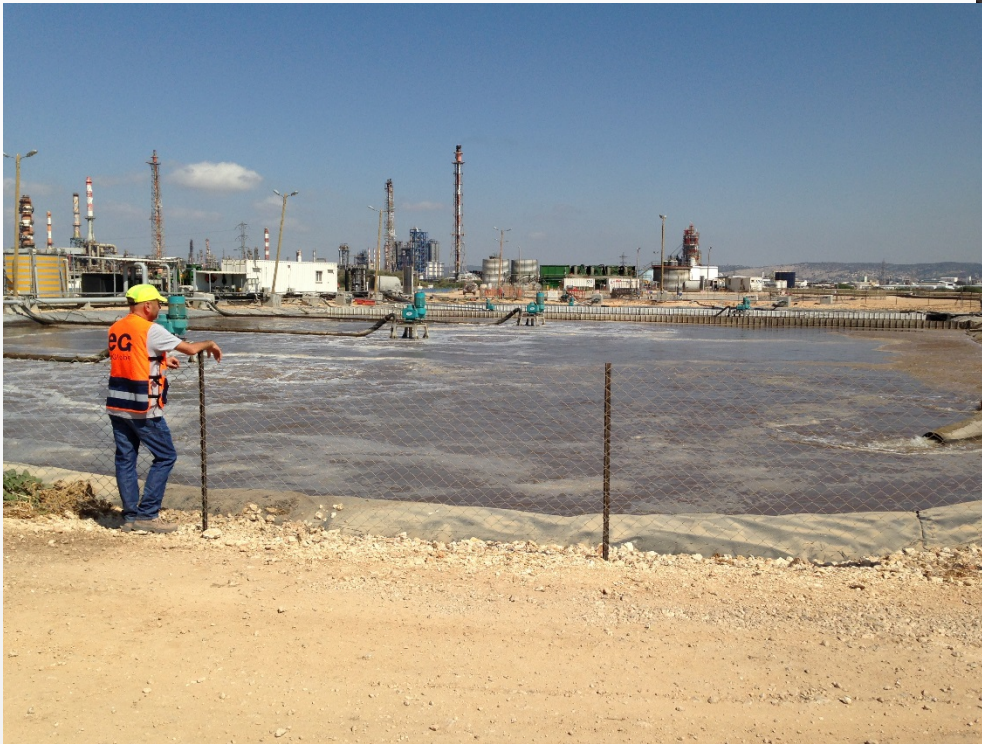
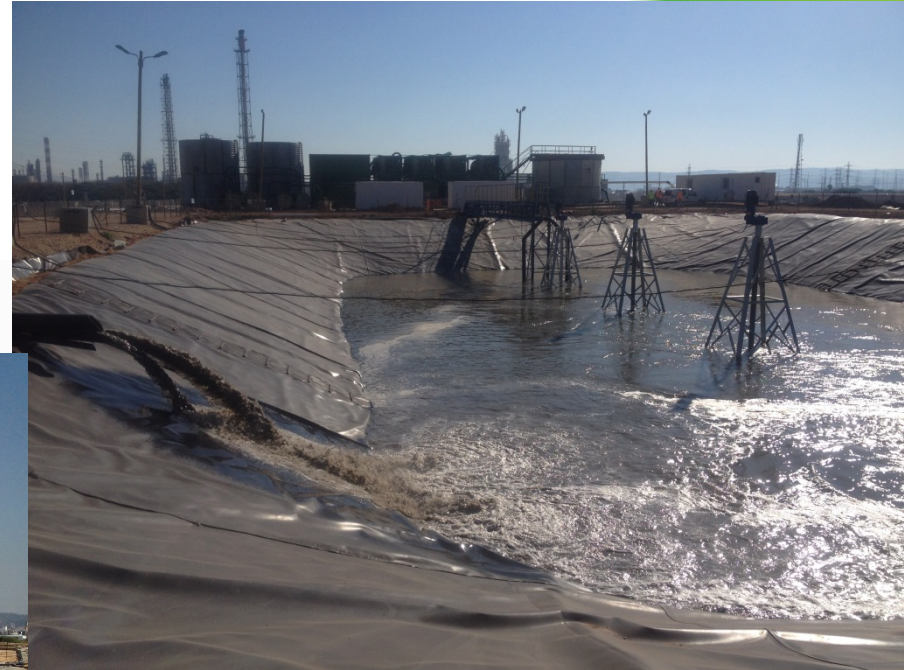
Dredged Sediment Slurry pumped into a
8,000 m³ retention pond:
To maintain a sediment suspension & 24-hour LPP

Initial Slurry Pumping Rates:

- 400 m³ of slurry/hour
- Gradually optimizing
- High sediment variability encountered

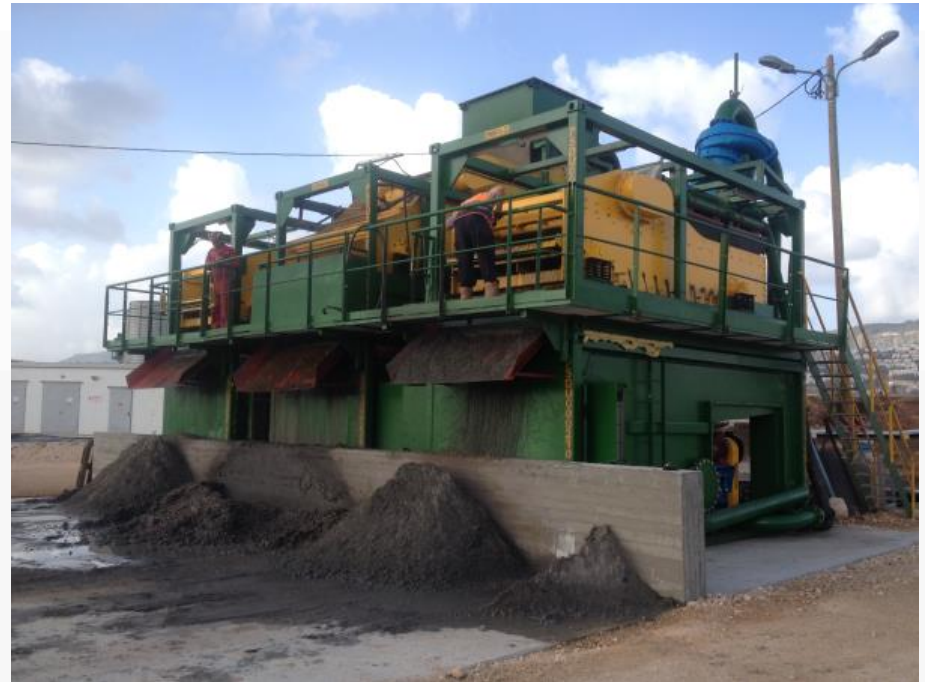
Inlet Filters:

1. Screen oversize to < 6mm
2. Hydrocyclone de-sanders removing particles to 0.5 mm

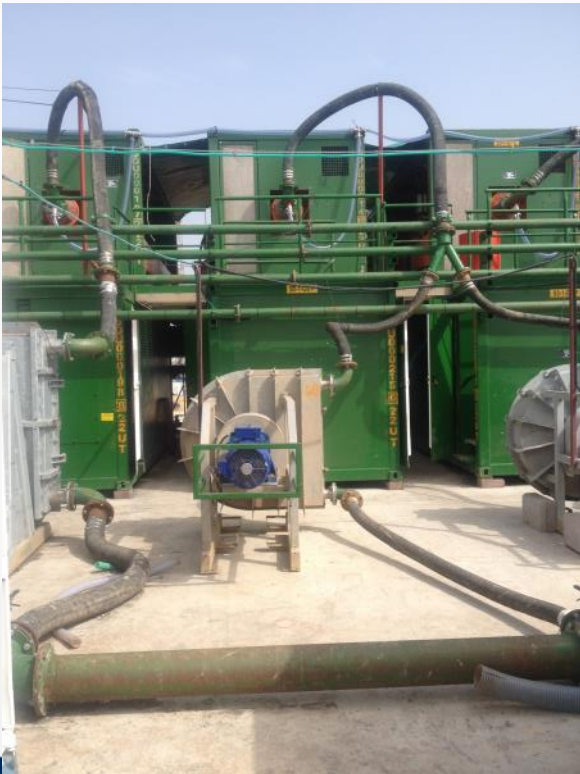
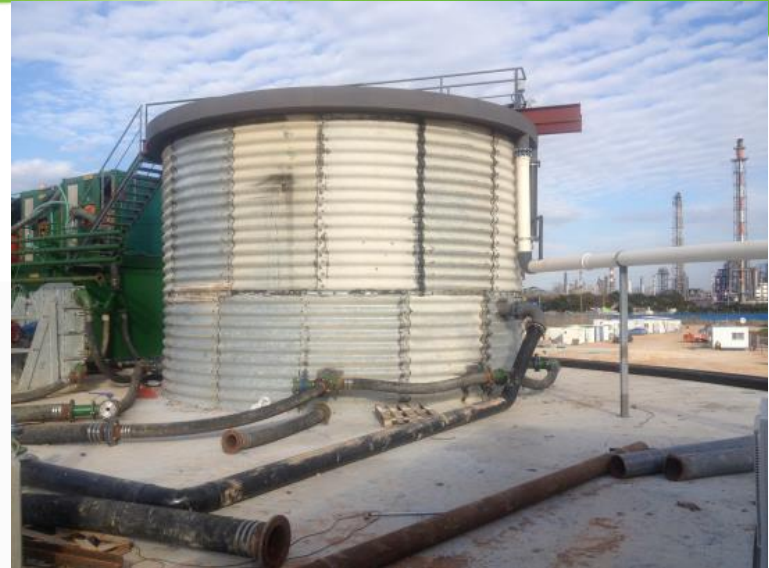
Dewatering performance

- Yields $>500 \text{ m}^3$ cake/day

Dewatering includes 4 large centrifuges

- Continuous optimization of polymers and flocculants
- Extension of operating times to increase production

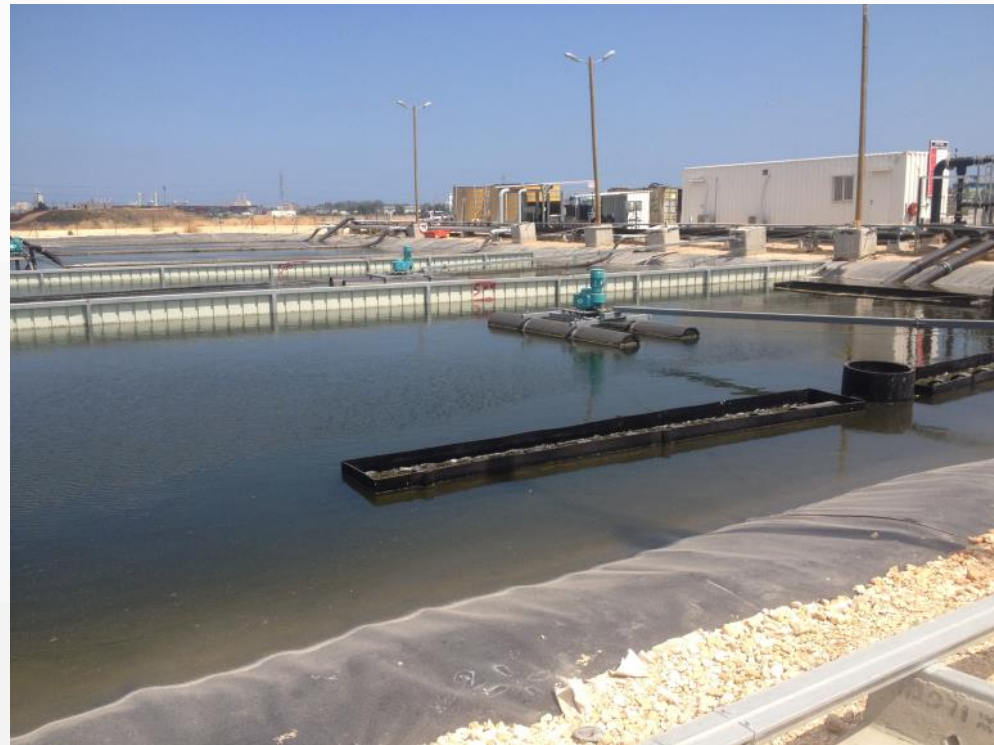
The centrate water is sent to a treatment lagoon where the water is subjected to a 2-stage biological treatment to remove nitrogen:

- Ammonium – Nitrate (aerobic)
- Nitrate – Nitrogen gas (anaerobic)

To date achieving:

- 0.9 mg/l Ammoniacal N (*<5 mg/l*)
- 9 mg/l total N (*<20 mg/l*)
- 60mg/L TSS (*100 av; 200 max*)

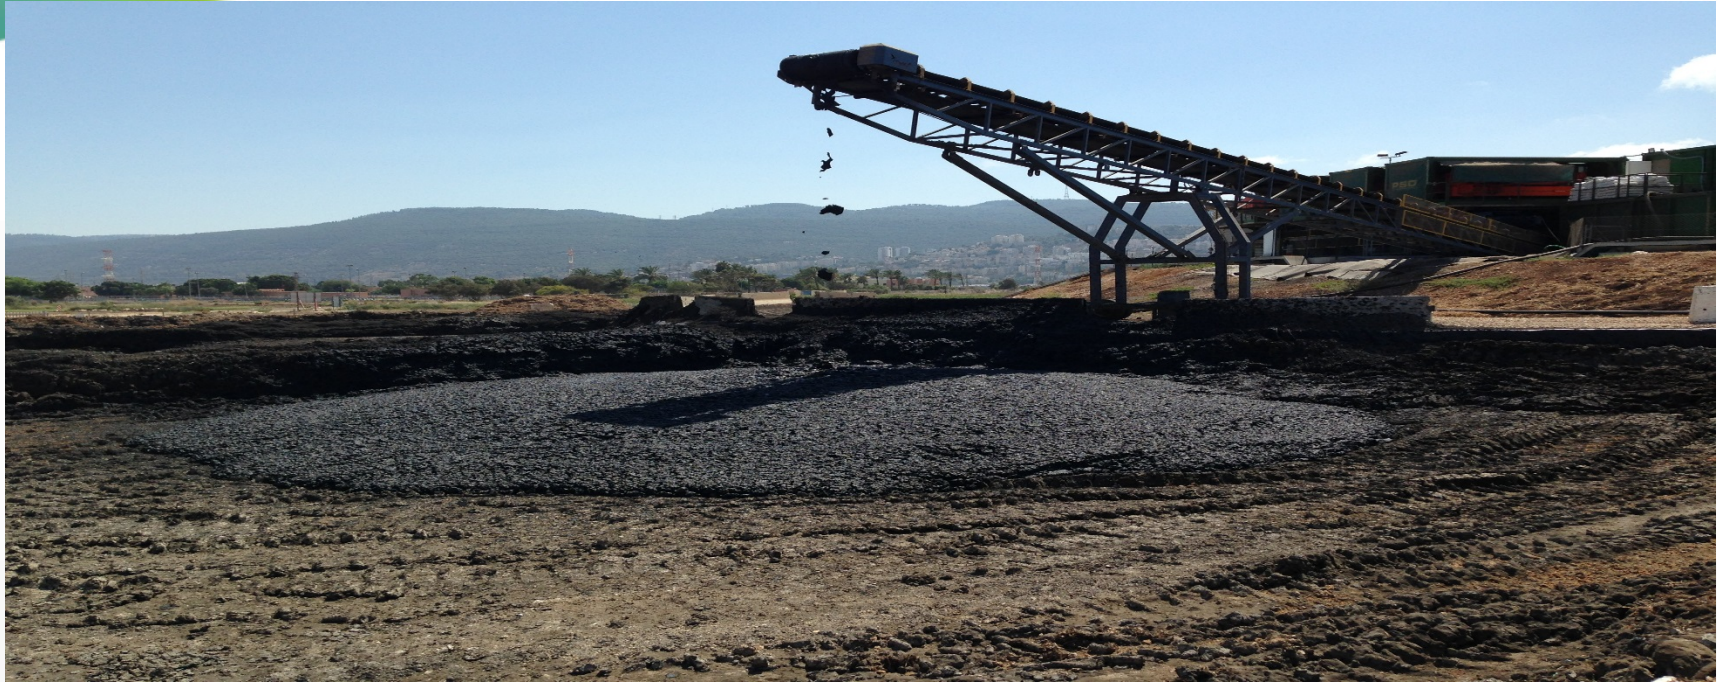
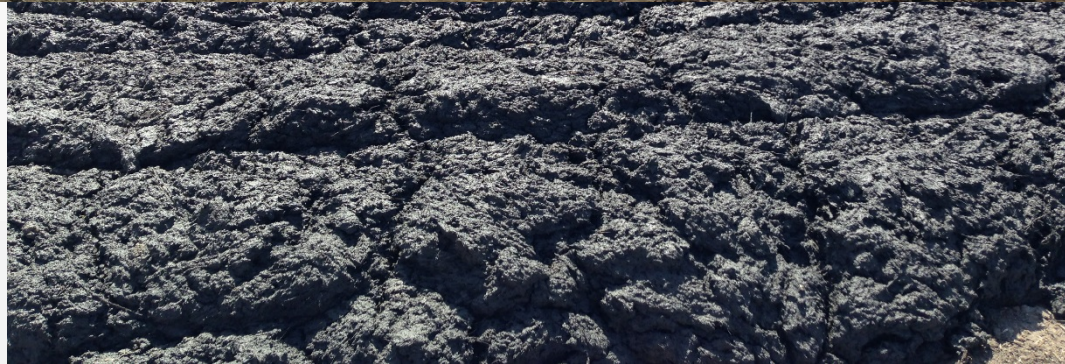
Additive Mixing Plant Mix sediments with organic and inorganic additives

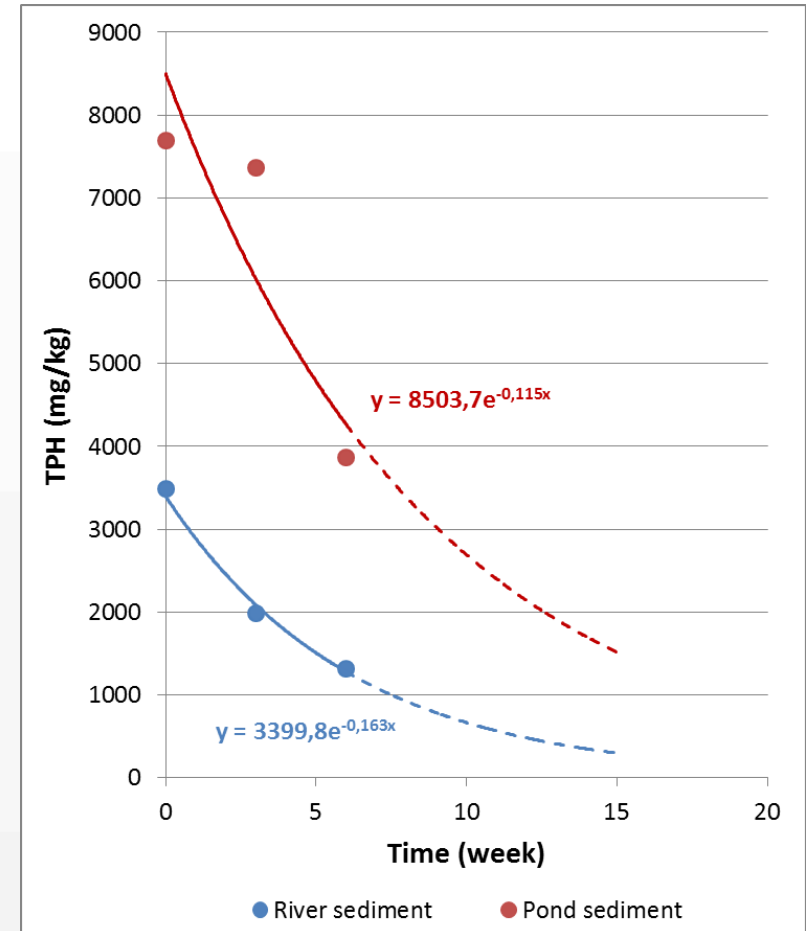
- Windrow initial treatment
