Bio-remediation of 6,000 m³ Solvent Impacted Soil

Raymond, Alberta

Jamie Lamontagne, Matt DiMarino, Frans Hettinga
Tetra Tech EBA Inc.

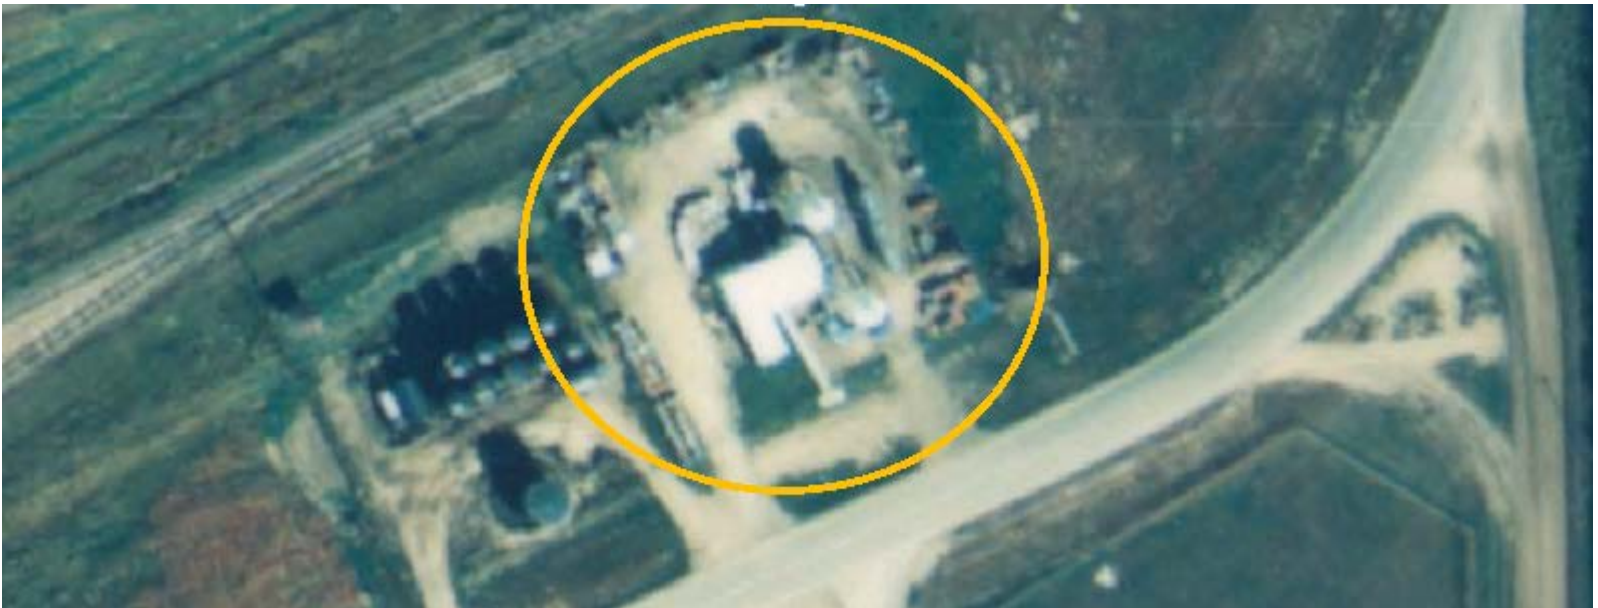
1980s

- Technisol, Inc. (TriWaste) initiated operations as a solvent recycling facility in 1986
- Predominantly dealing with distillable paint wastes

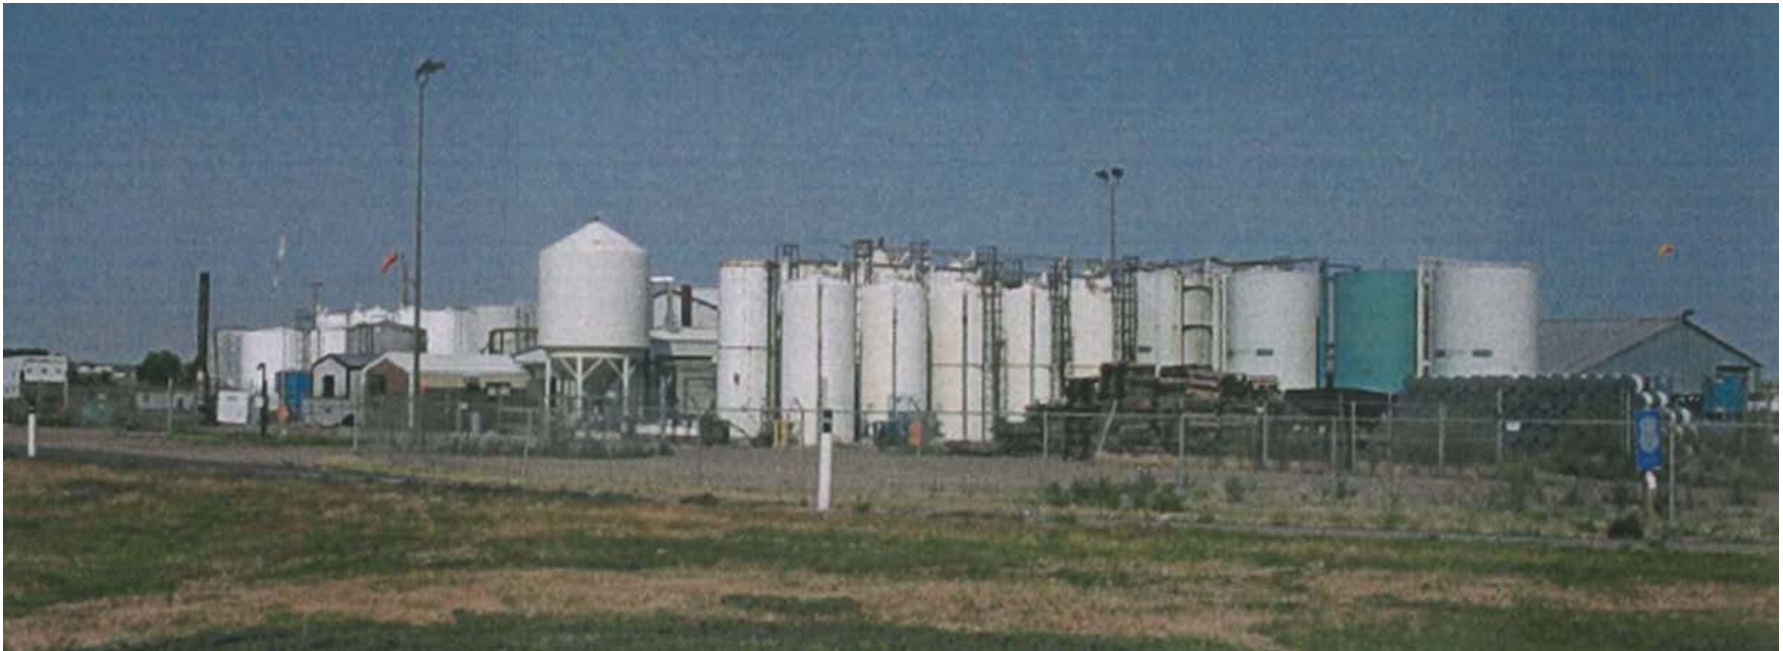
1990s

- Plant expanded in 1992
- Ownership transferred to Newalta Corporation in 1996
- Ongoing compliance soil and groundwater monitoring

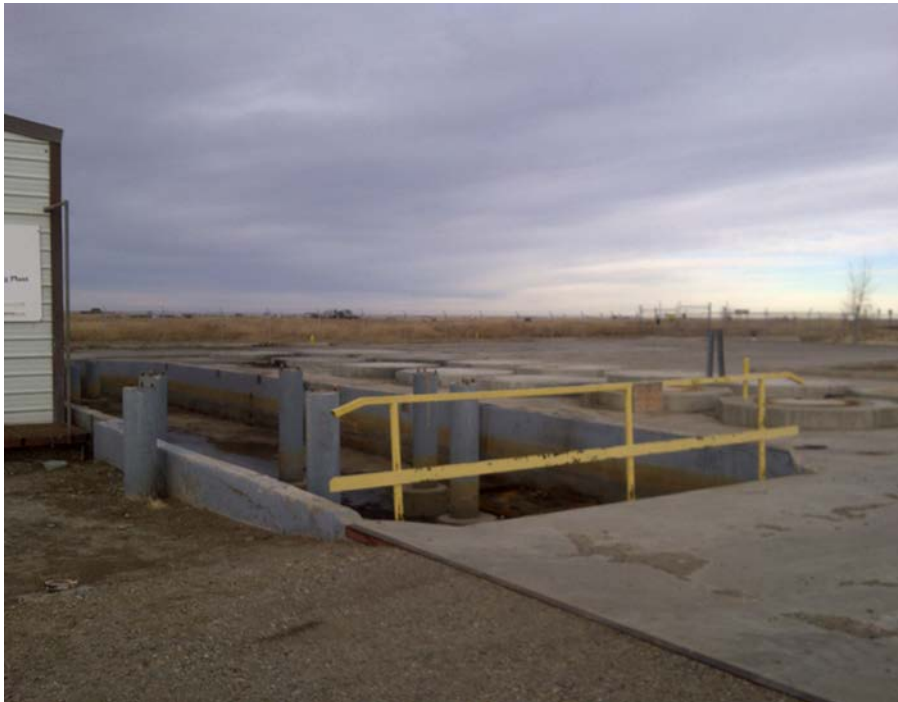
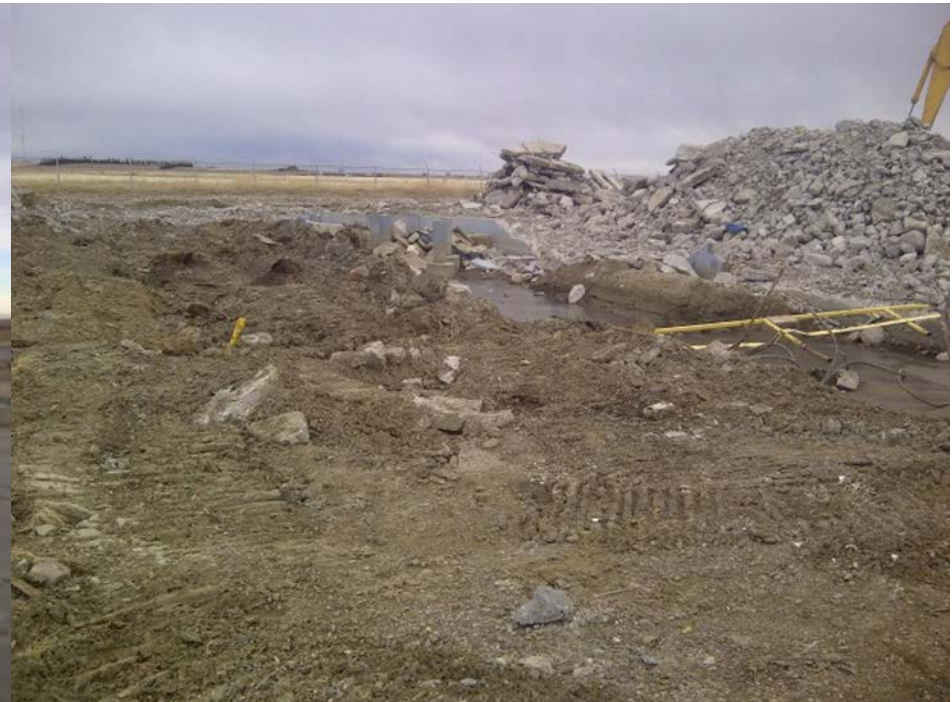
- Changed conceptual RAP to treatment on-site in covered bio-piles
- Rationale: anticipated lower costs; a more sustainable option; and no need to transport low-flashpoint soil
- Initiated removal of above and underground infrastructure, railway spur
- Submitted plan for pilot testing
- Crushed and stockpiled concrete/rebar (floors, foundation elements, berms)

- Landfilled the crushed concrete
- Initiated pilot test in vacant building

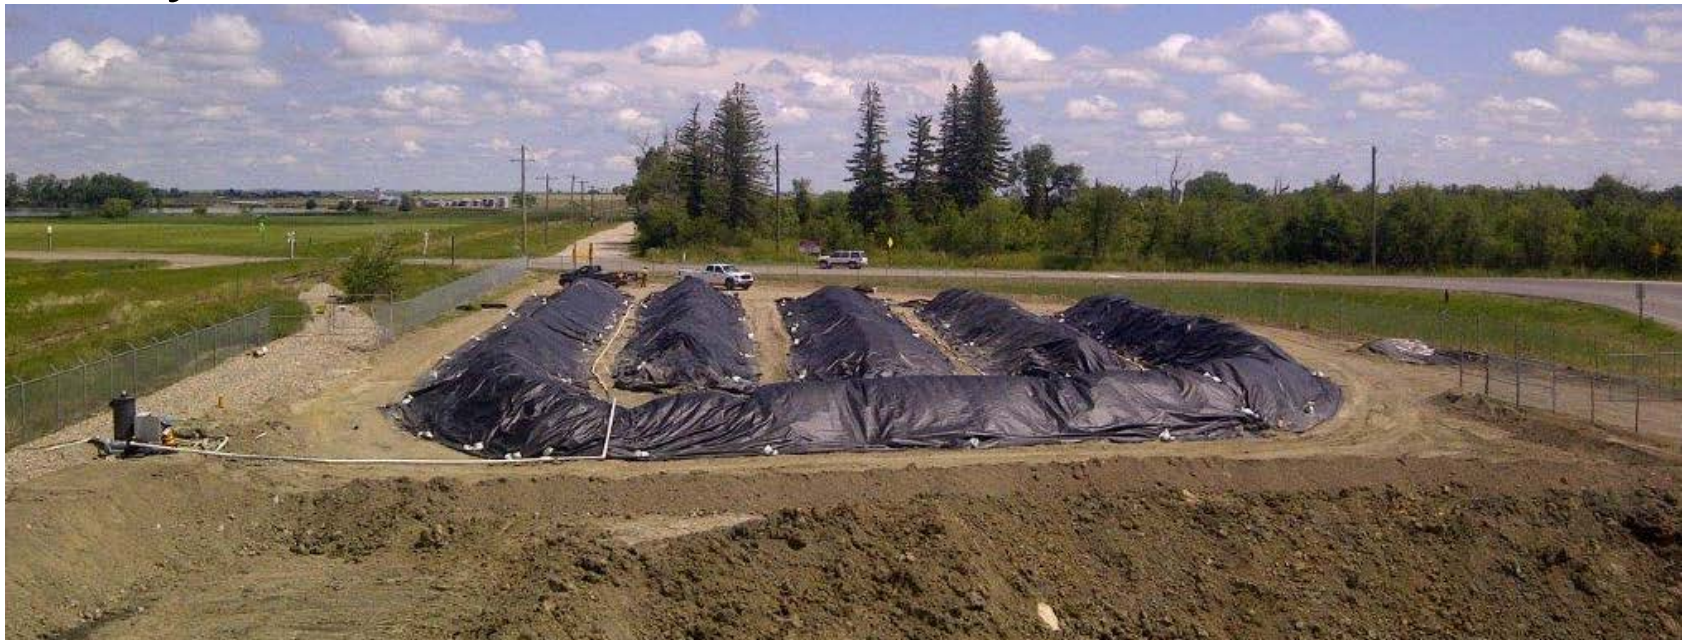
- Tier 2 assessment (DUA and FAL exclusion)
- Decommissioned monitoring wells in work area
- Prepared site for remediation
- July – December: excavate, treat, test, backfill

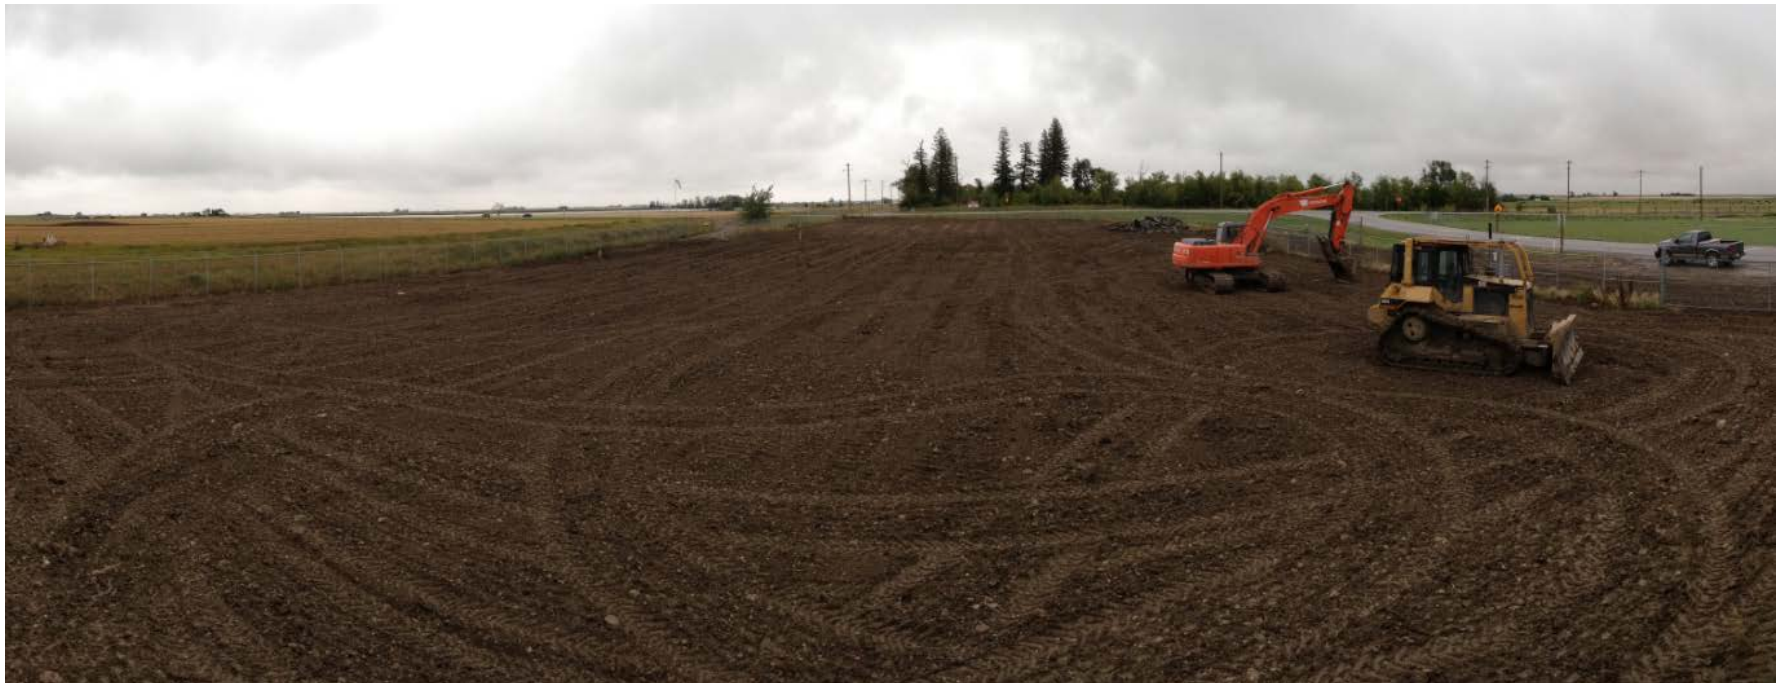
- Finished treatment of remaining bio-piles
- Removed piping, blower, liners, grading
- Reporting

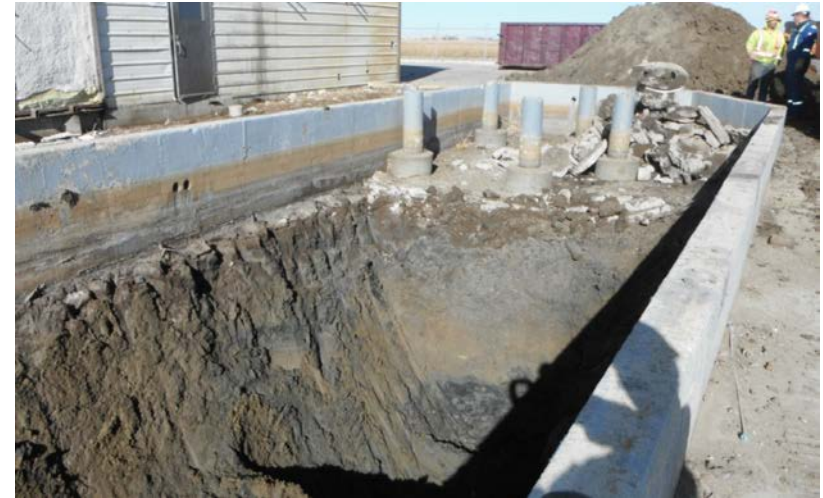
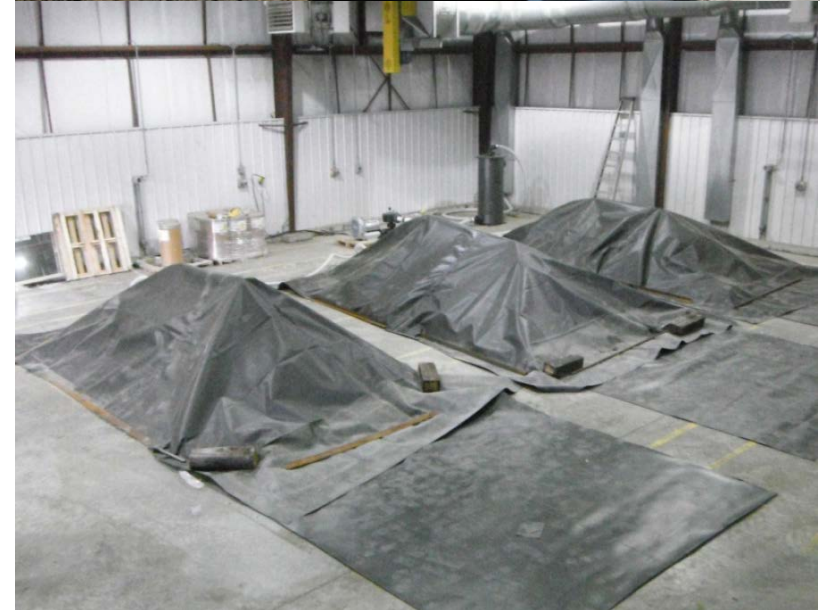
Pilot Testing

- Excavated 20 m³ impacted soil
- Placed in covered piles in controlled environment
- Three piles:
 - a. Nutrients
 - b. Oxygen release compound
 - c. No amendments
- Vapour recovery/ treatment
- Periodic mixing and sampling

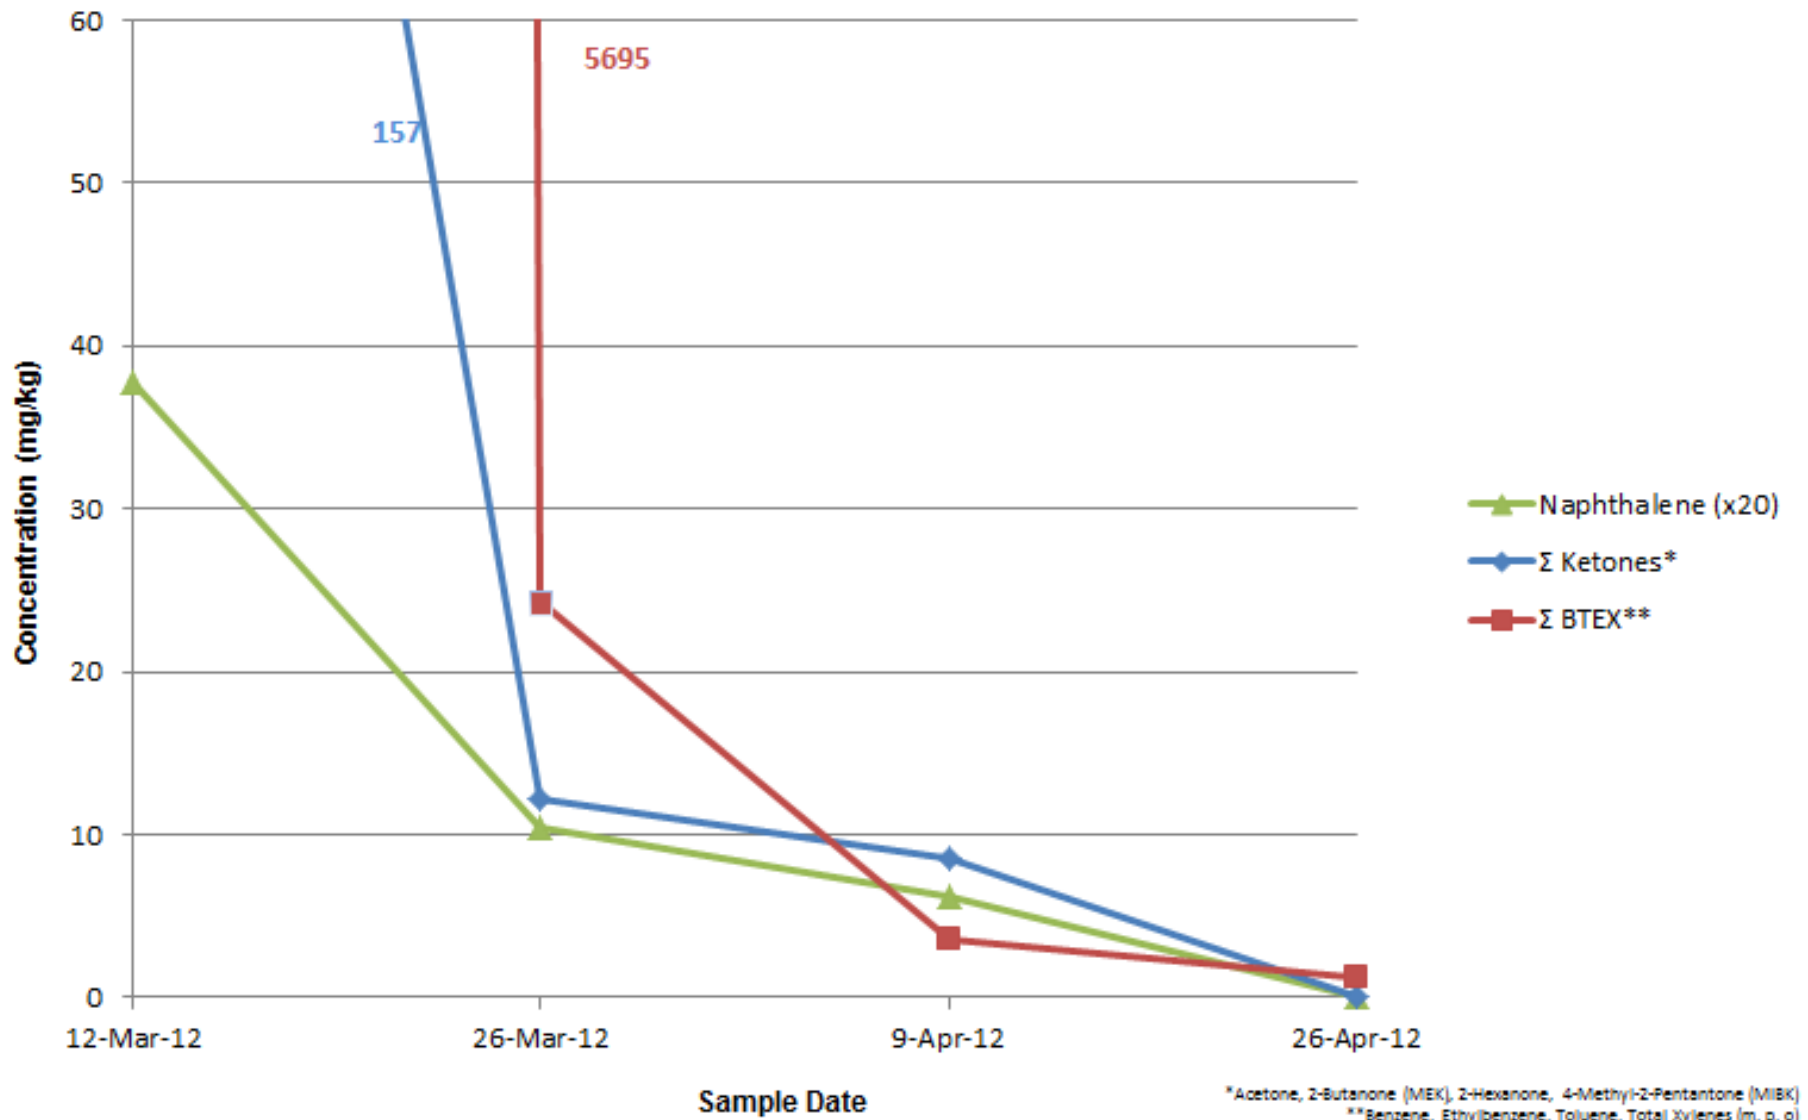
Graph 1 : Bio-pile Treatment Pilot Test - Treatment Cell #1 (Nutrients)

*Acetone, 2-Butanone (MEK), 2-Hexanone, 4-Methyl-2-Pentanone (MIBK)
 **Benzene, Ethylbenzene, Toluene, Total Xylenes (m, p, o)

Pilot Test Results

- VOCs decreased in all three piles
- Sharpest decrease with nutrients
- Recalcitrant VOCs were naphthalene (expected) but also methanol and glycols (not expected)
- Vapour treatment was effective

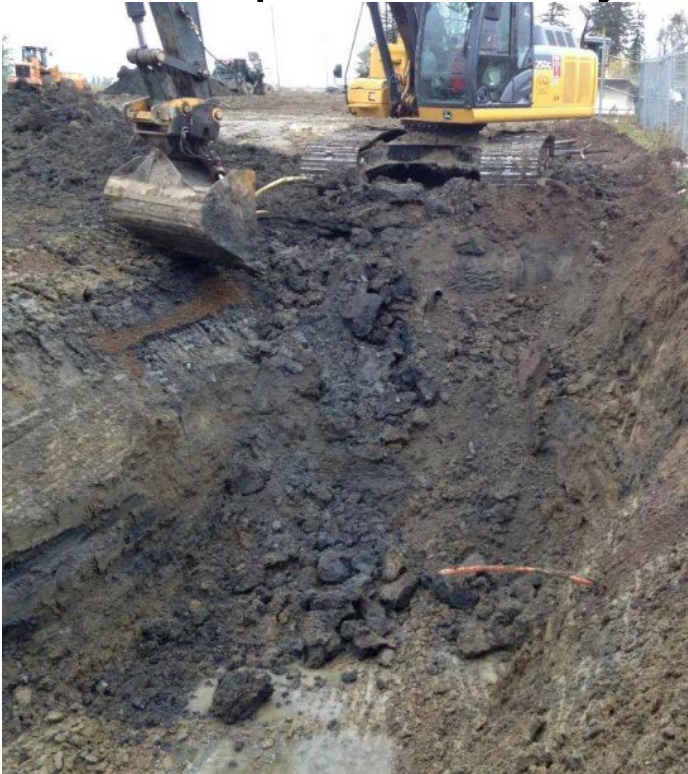
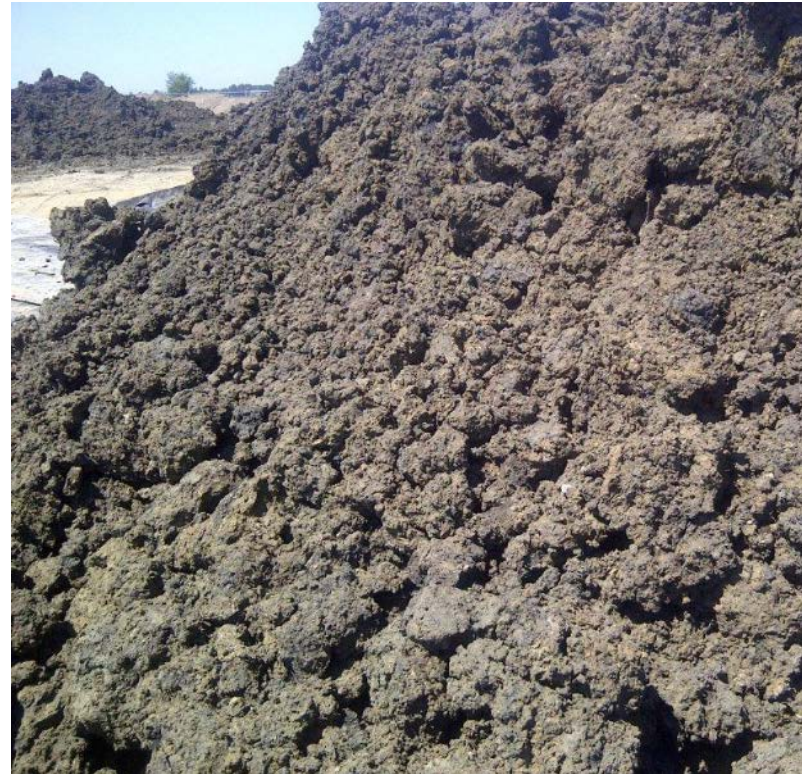
July 2013 Start

- Site preparation complete
- Rough/wet start – Needed to remove 130 m³ water first; ARVE unit clogged due to wet clay
- Plan B – place directly in windrows

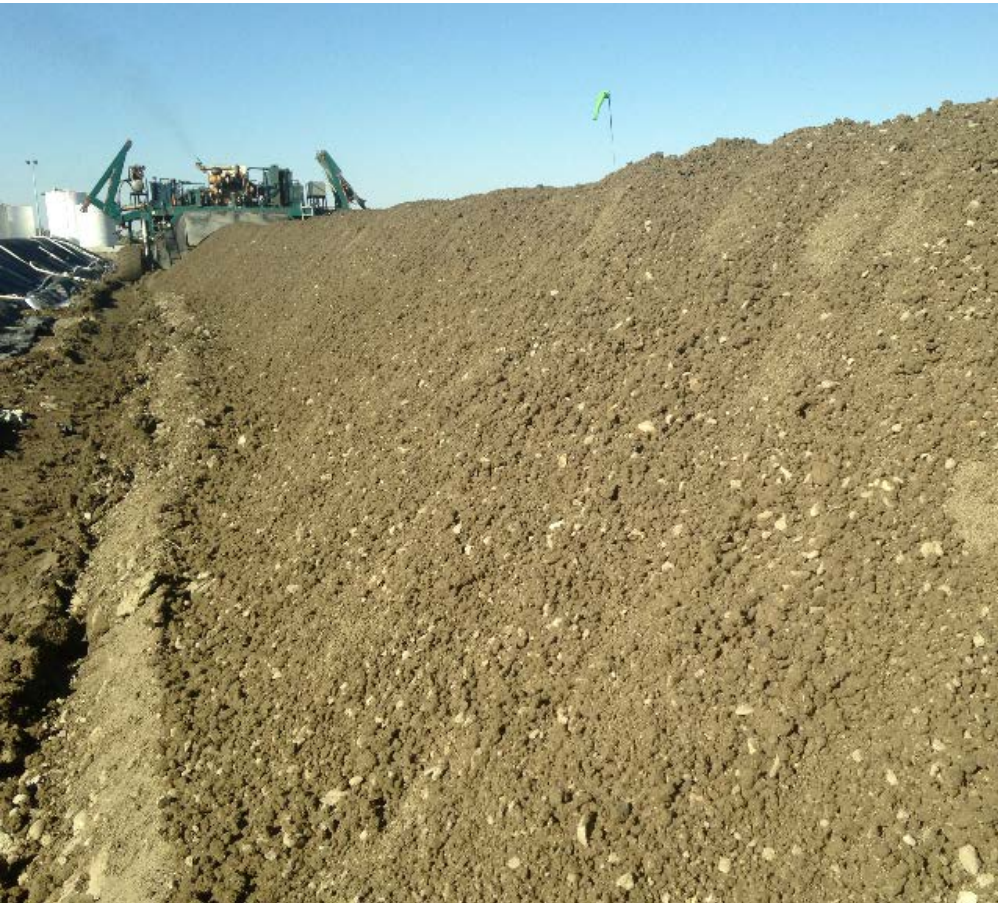
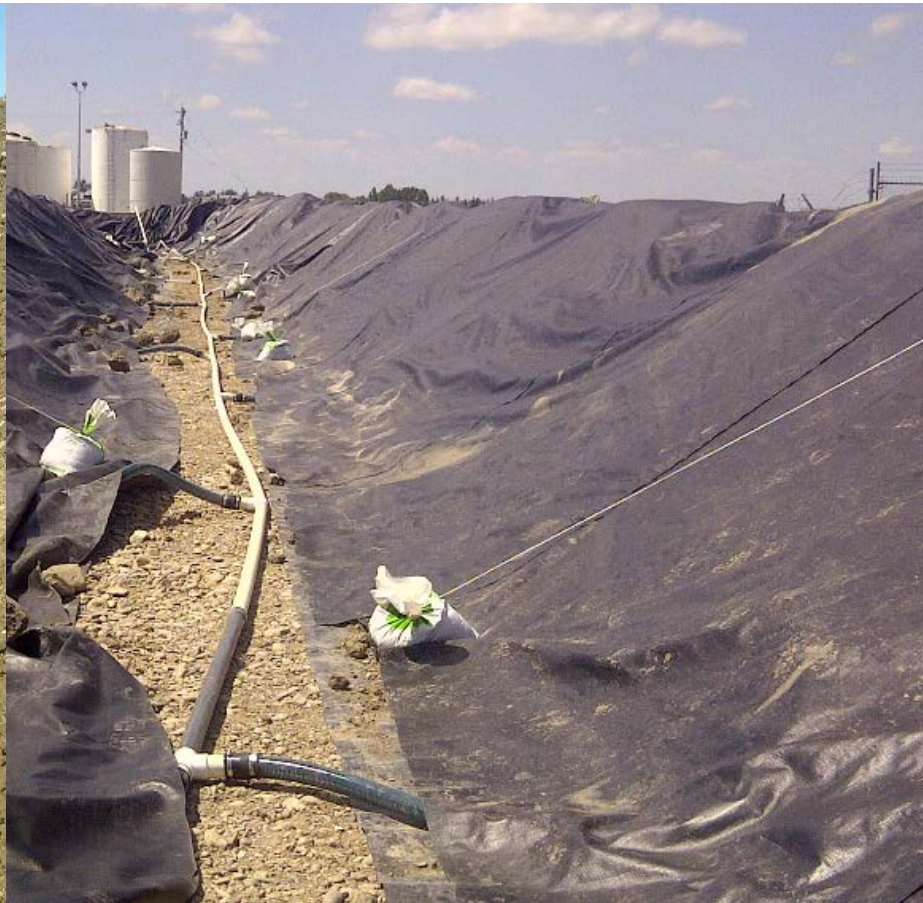
Four batches treated; ~6,000 m³
