Surfactant Flushing and Enhanced Remediation at a Remote Site in Northern BC

Raman Birk, MSc.

Manager of Contaminated Sites , PWGSC - Pacific Region

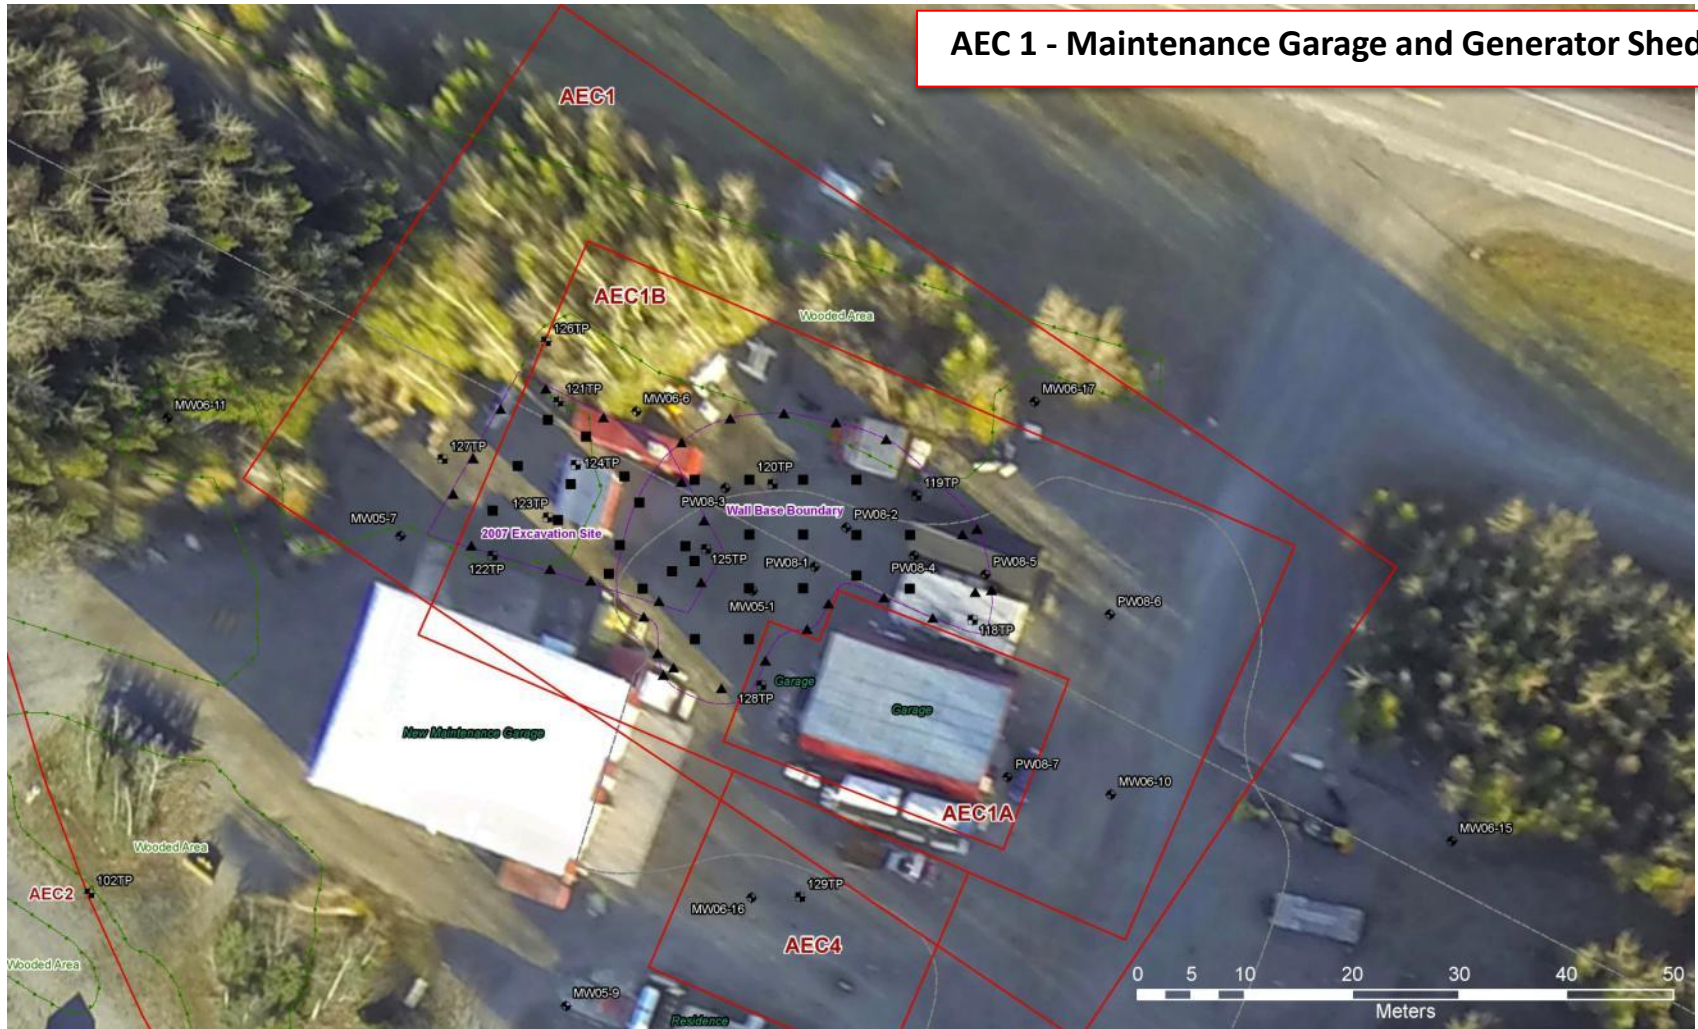
Site Plan – AEC 1

AEC 1 - Maintenance Garage and Generator Shed

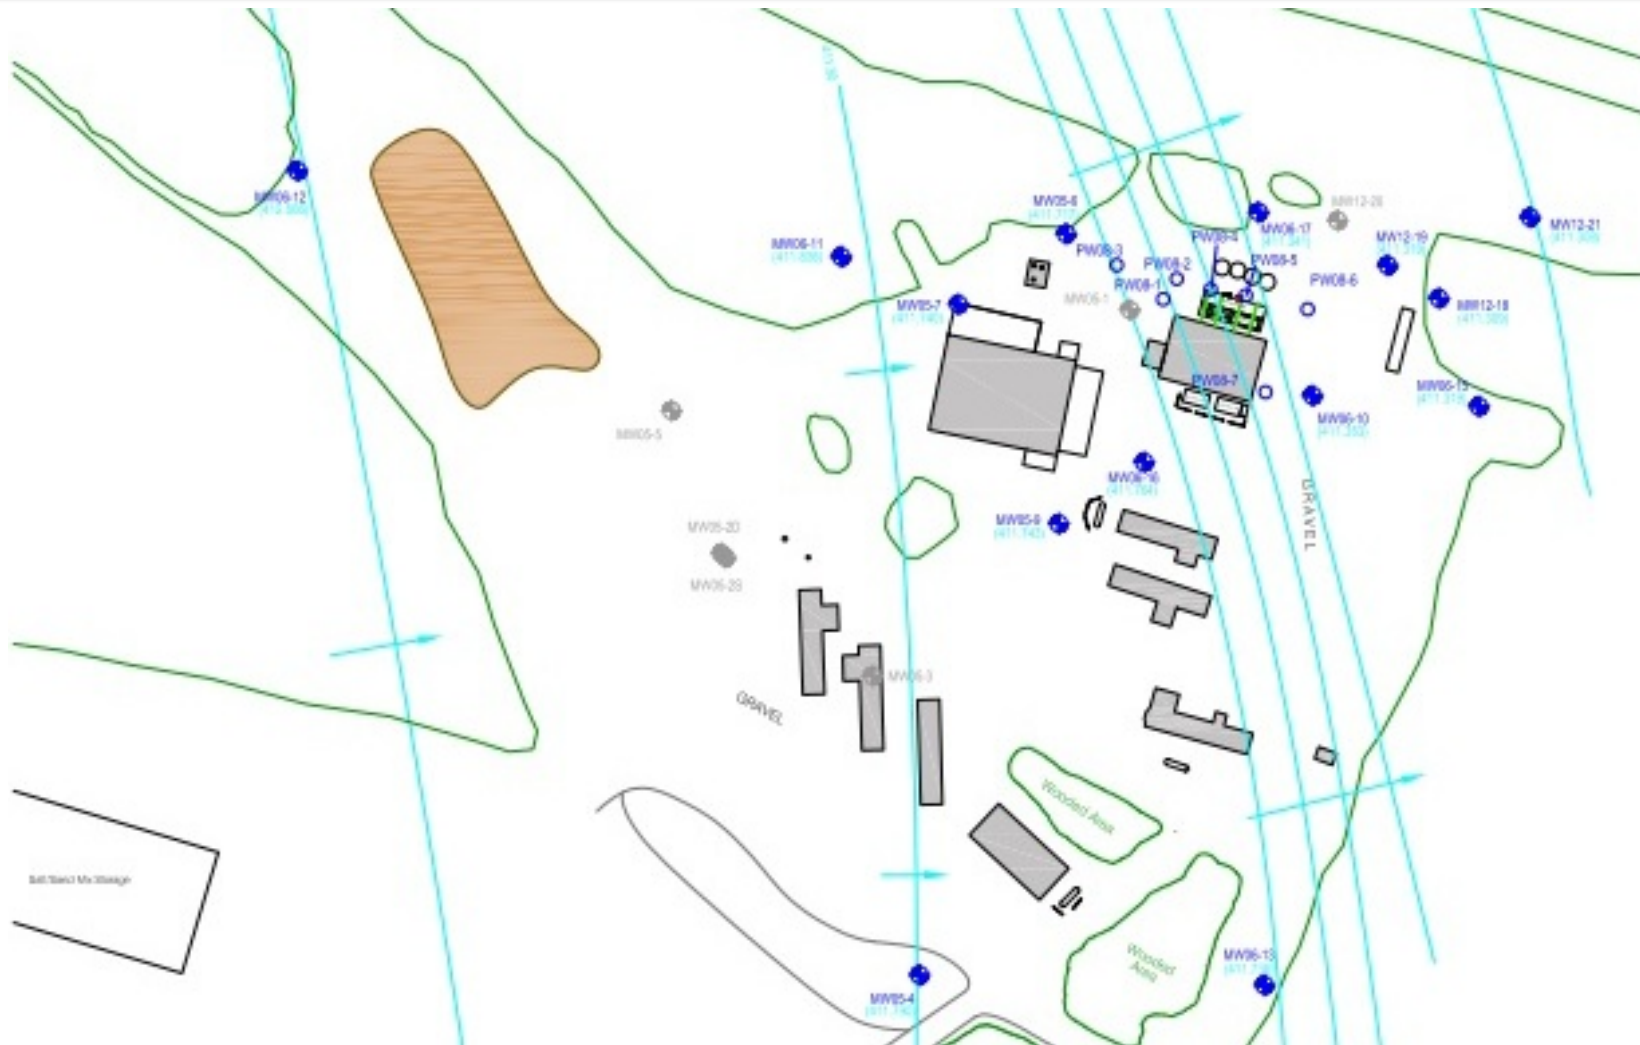
Background #5 – Site Stratigraphy / Groundwater Flow

- Stratigraphy:
 - Surface to 22m - unconsolidated sand and gravel, with layers of cobbles and traces of silt. Silt and sand lenses.
 - No wells have encountered bedrock.
- Groundwater Flow:
 - Groundwater levels:
 - Spring ~ 16.5 mbgs (meters below ground surface)
 - Winter ~ 18.5 mbgs
 - Inferred flow direction: Varies from north to north-east, towards the Liard River

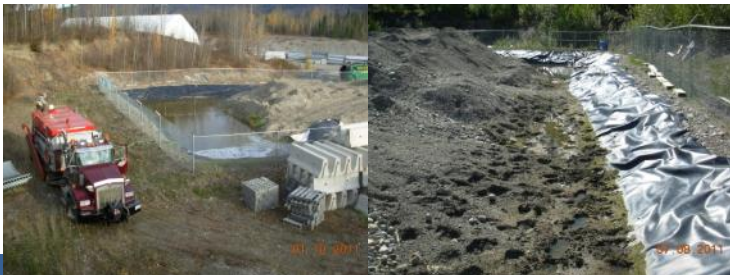
- 2007 / 2008: Excavation of 4,600 m³ hydrocarbon contaminated soil from areas adjacent to the new and old maintenance garages (AEC* 1) and at discrete areas (AEC 2 and 4)
- On-site treatment in an LTF
- Approximately 50 m³ hazardous waste soil and 25 m³ of soil contaminated with Molybdenum and Zinc was transported offsite

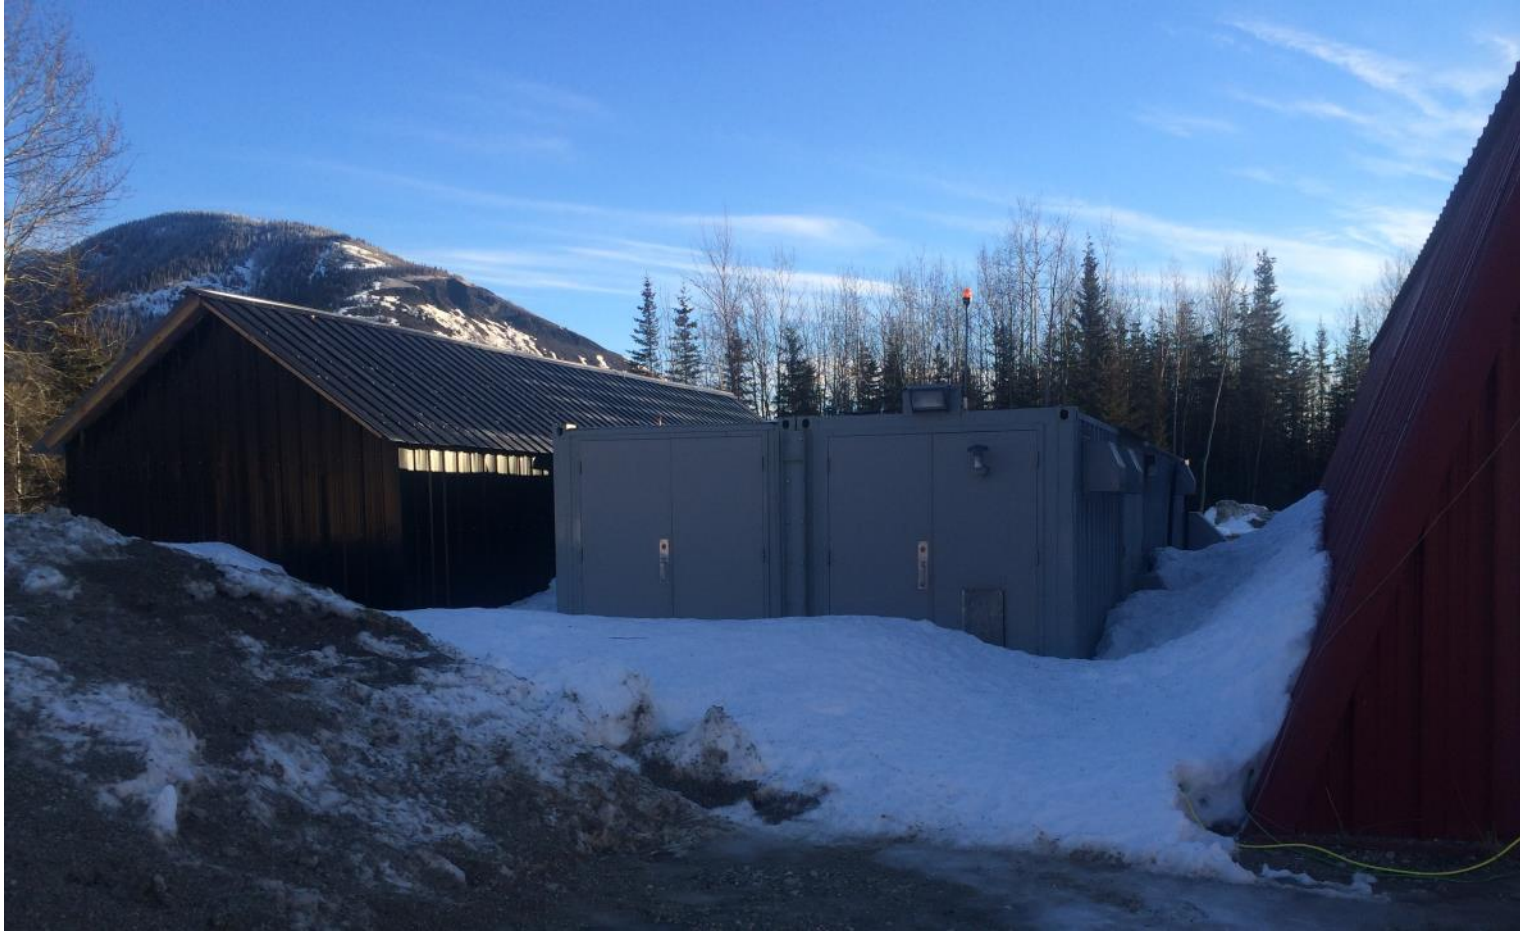
Challenges in Remediating the Site

- Very Deep – 18 to 21 mbgs.
- Partly under a building, including a significant shallow impacted zone.
- Power – not available.
- Active maintenance yard.
- Large target area – 50m x 30m.
- Extremely cold in the winter (lowest reported temp approx -50C, 2007 by the Onsite Operator).
- Logistic and Personnel Support.
