Environmental Investigations at a Former Industrial Property

- In late 2009/early 2010, XCG conducted a Supplemental Subsurface Investigation (Investigation) at a former industrial property in Guelph, Ontario for due diligence purposes in preparation for the purchase of the subject property.
- The purpose of the Investigation was to further investigate potential and confirmed environmental impairment issues previously identified in Phase I and II Environmental Site Assessment (ESA) reports previously completed for the subject site.

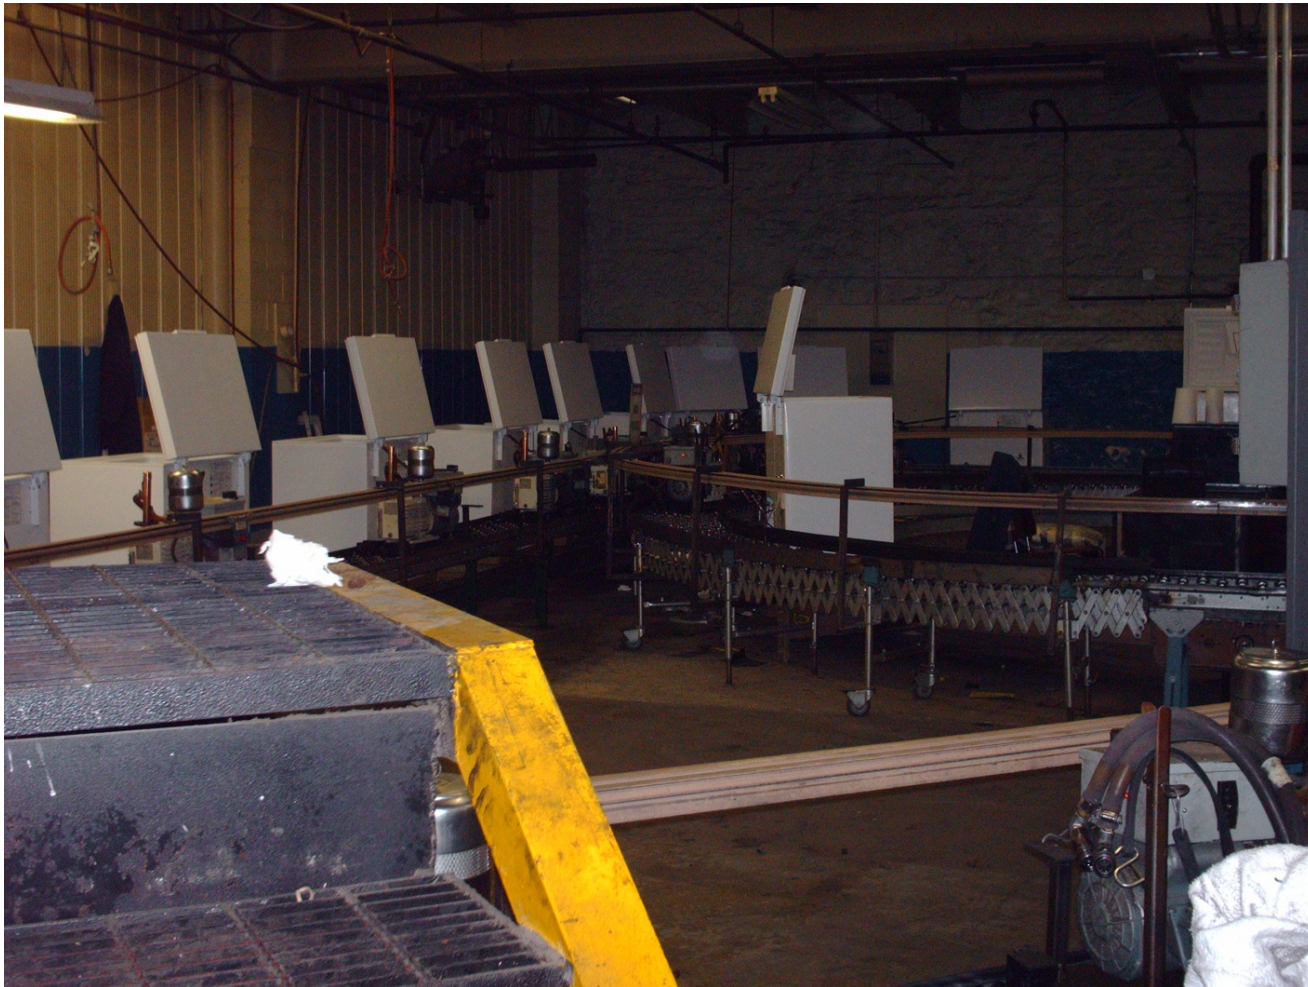
Freezer Line

- The subject site historically manufactured farm equipment, tools, and freezers.
- Former W.C. Wood site in Guelph, Ontario.
- Manufactured and assembled freezers.
- Press shop fabricated the sheet metal liners, casings, and lids using heavy stamping machines.
- Units move along three main assembly lines.
- Cavity is filled with urethane foam in four foaming stations.

- Freezers liners and casings are finished in two electrostatic powder coating rooms.
- The assembled freezers are tested and packaged for storage in the warehouse.

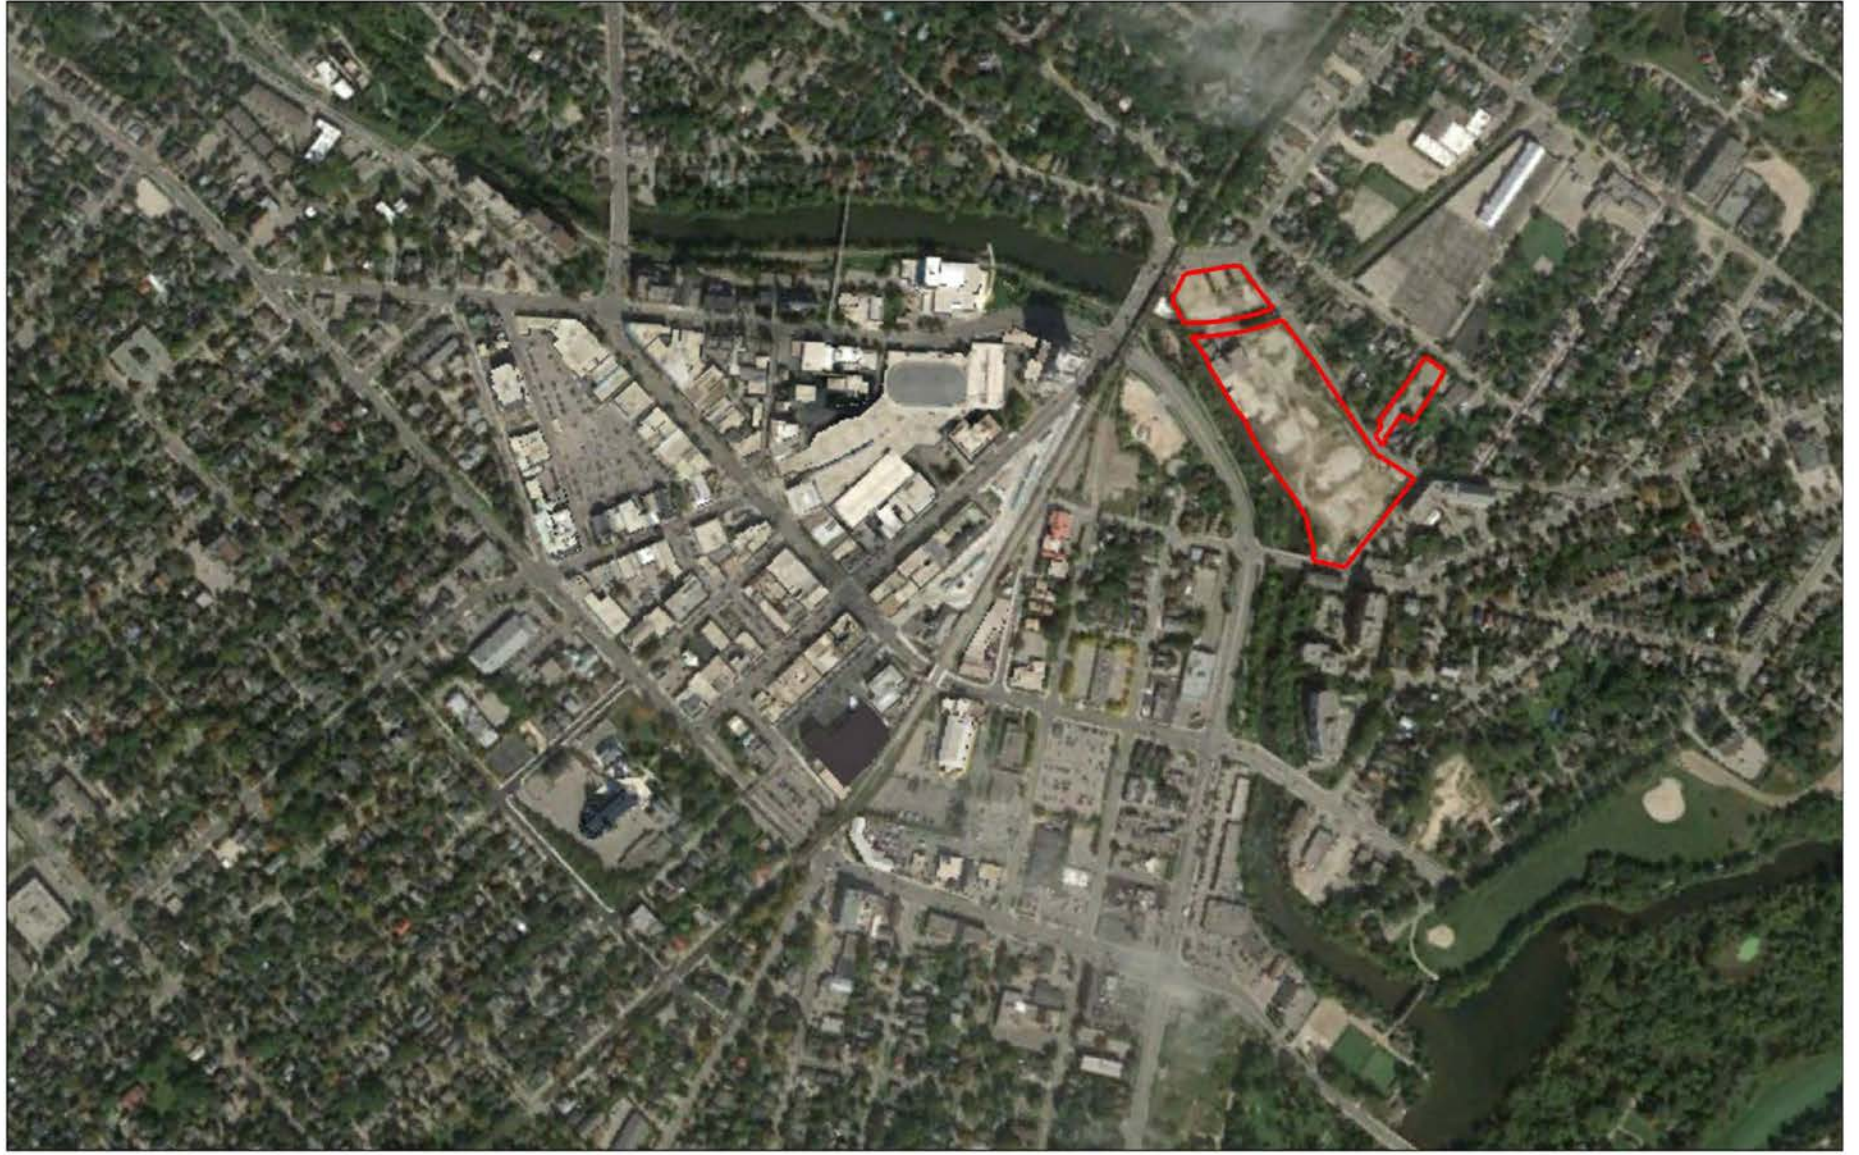
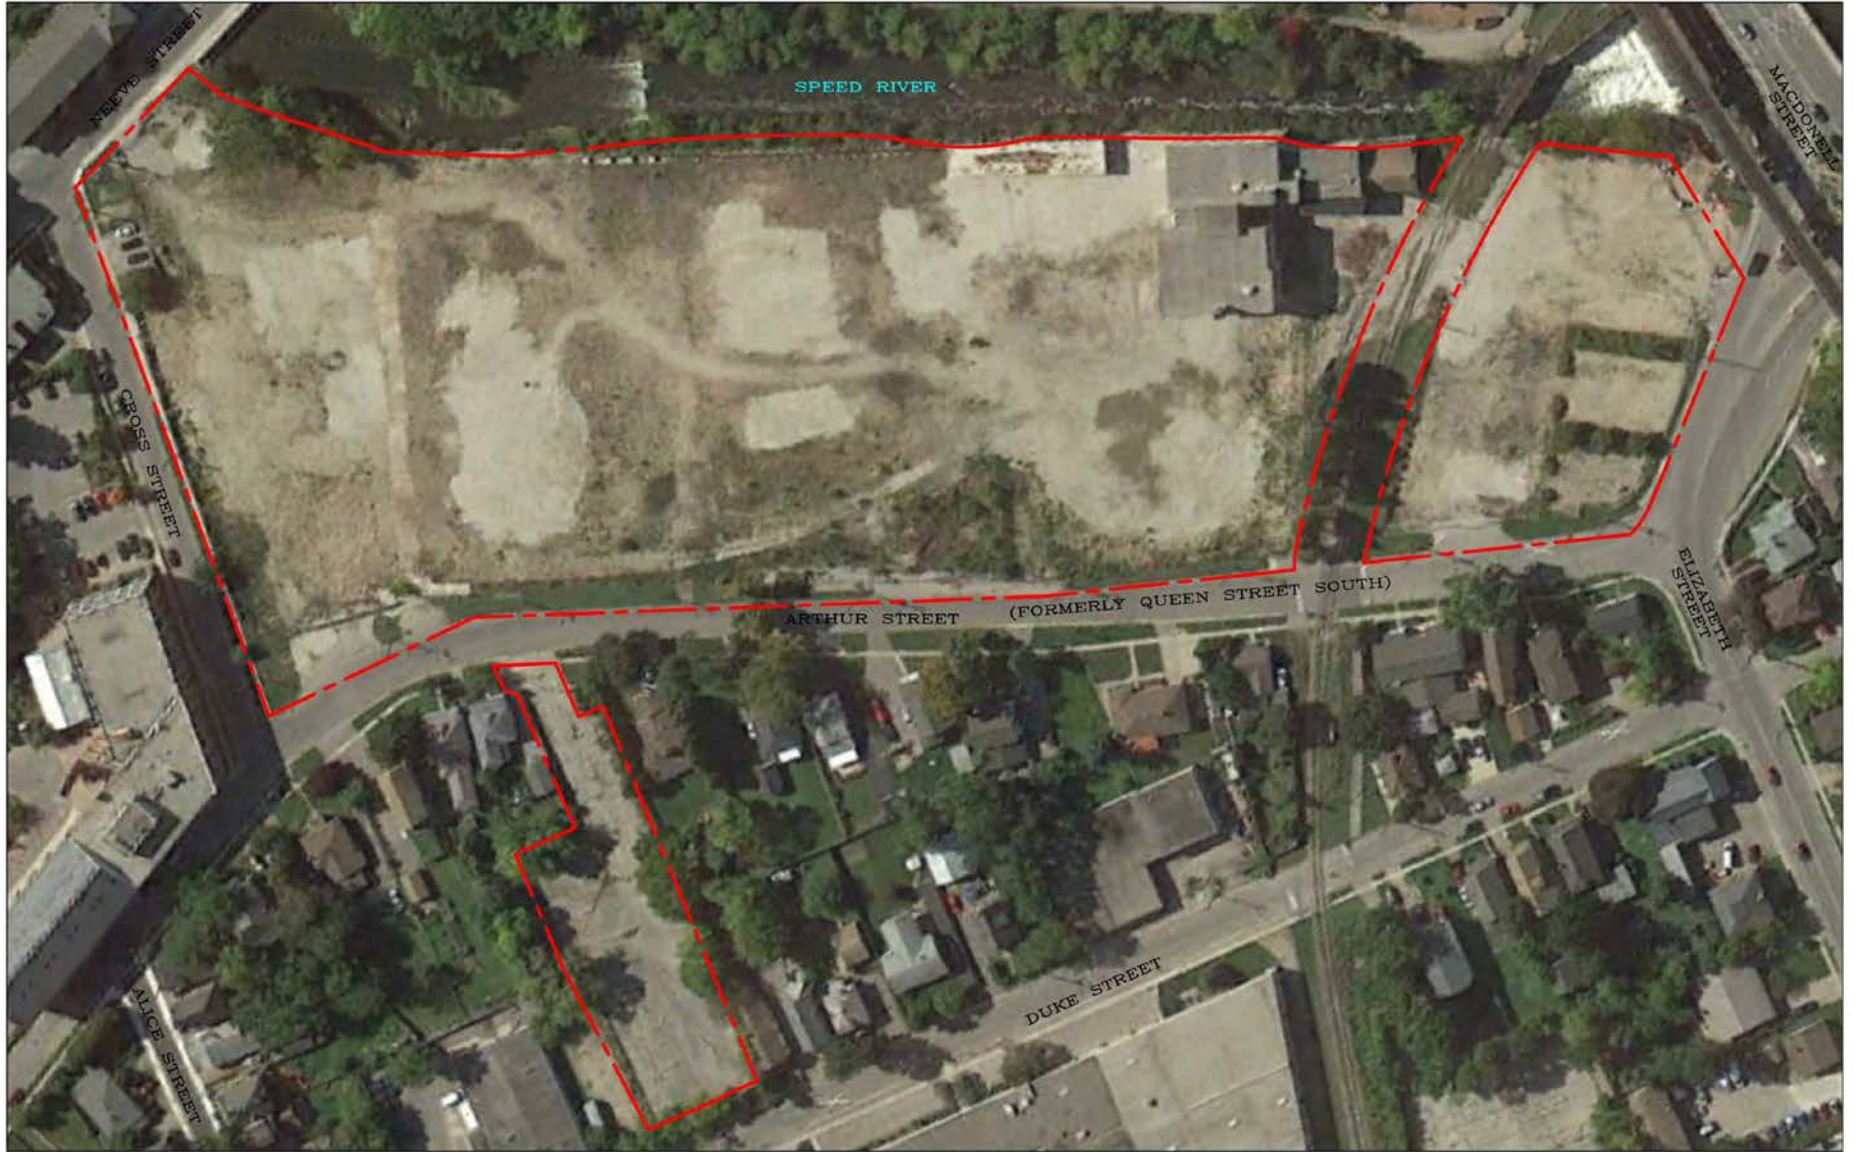
- Plant is on municipal water supply.
- Bounded on the west by the Speed River.
- Total of approximately 22 buildings.
- Reception, Offices, Cafeteria – 1850.
- Offices – 1920.
- Metal Fabrication, Warehouse, Machine Shop – 1940.
- Assembly, Finishing, Press Shop, Punch Presses – 1960s.
- Assembly, Warehouses – 1970s.

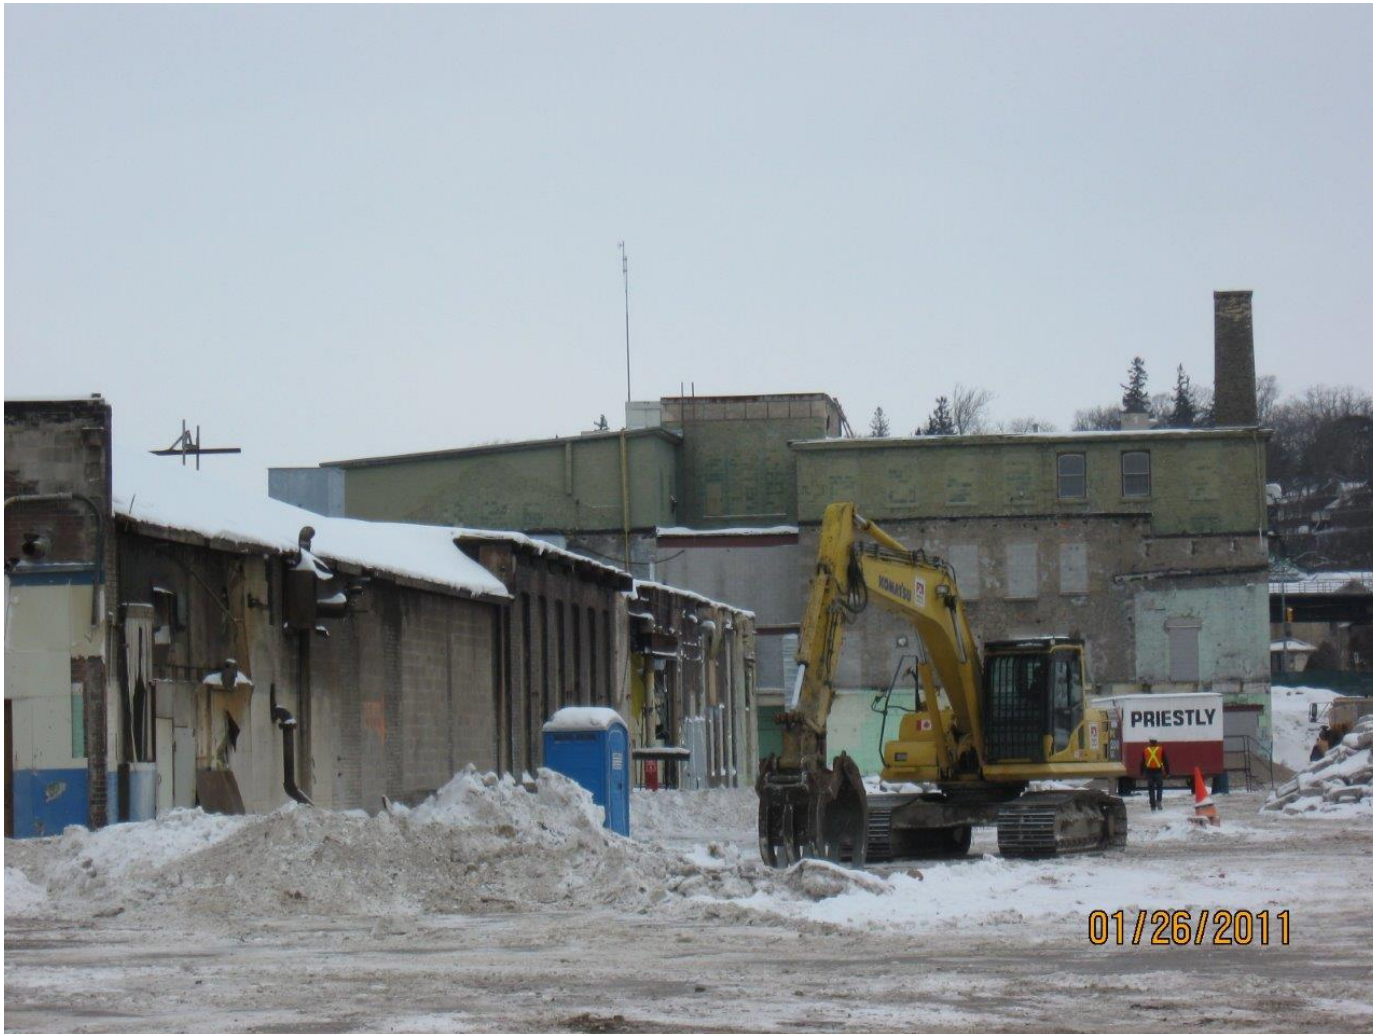
Demolition Activities

- Several buildings in the north portion of the property were preserved, which were deemed to have cultural/historical/ architectural significance.
- The demolition activities included removal of the majority of the above-grade site structures, removal of the majority of the concrete floor slab of the former industrial facility, and removal of all subsurface features associated with the industrial activities (i.e. press pits, sumps, foundation walls, etc.).

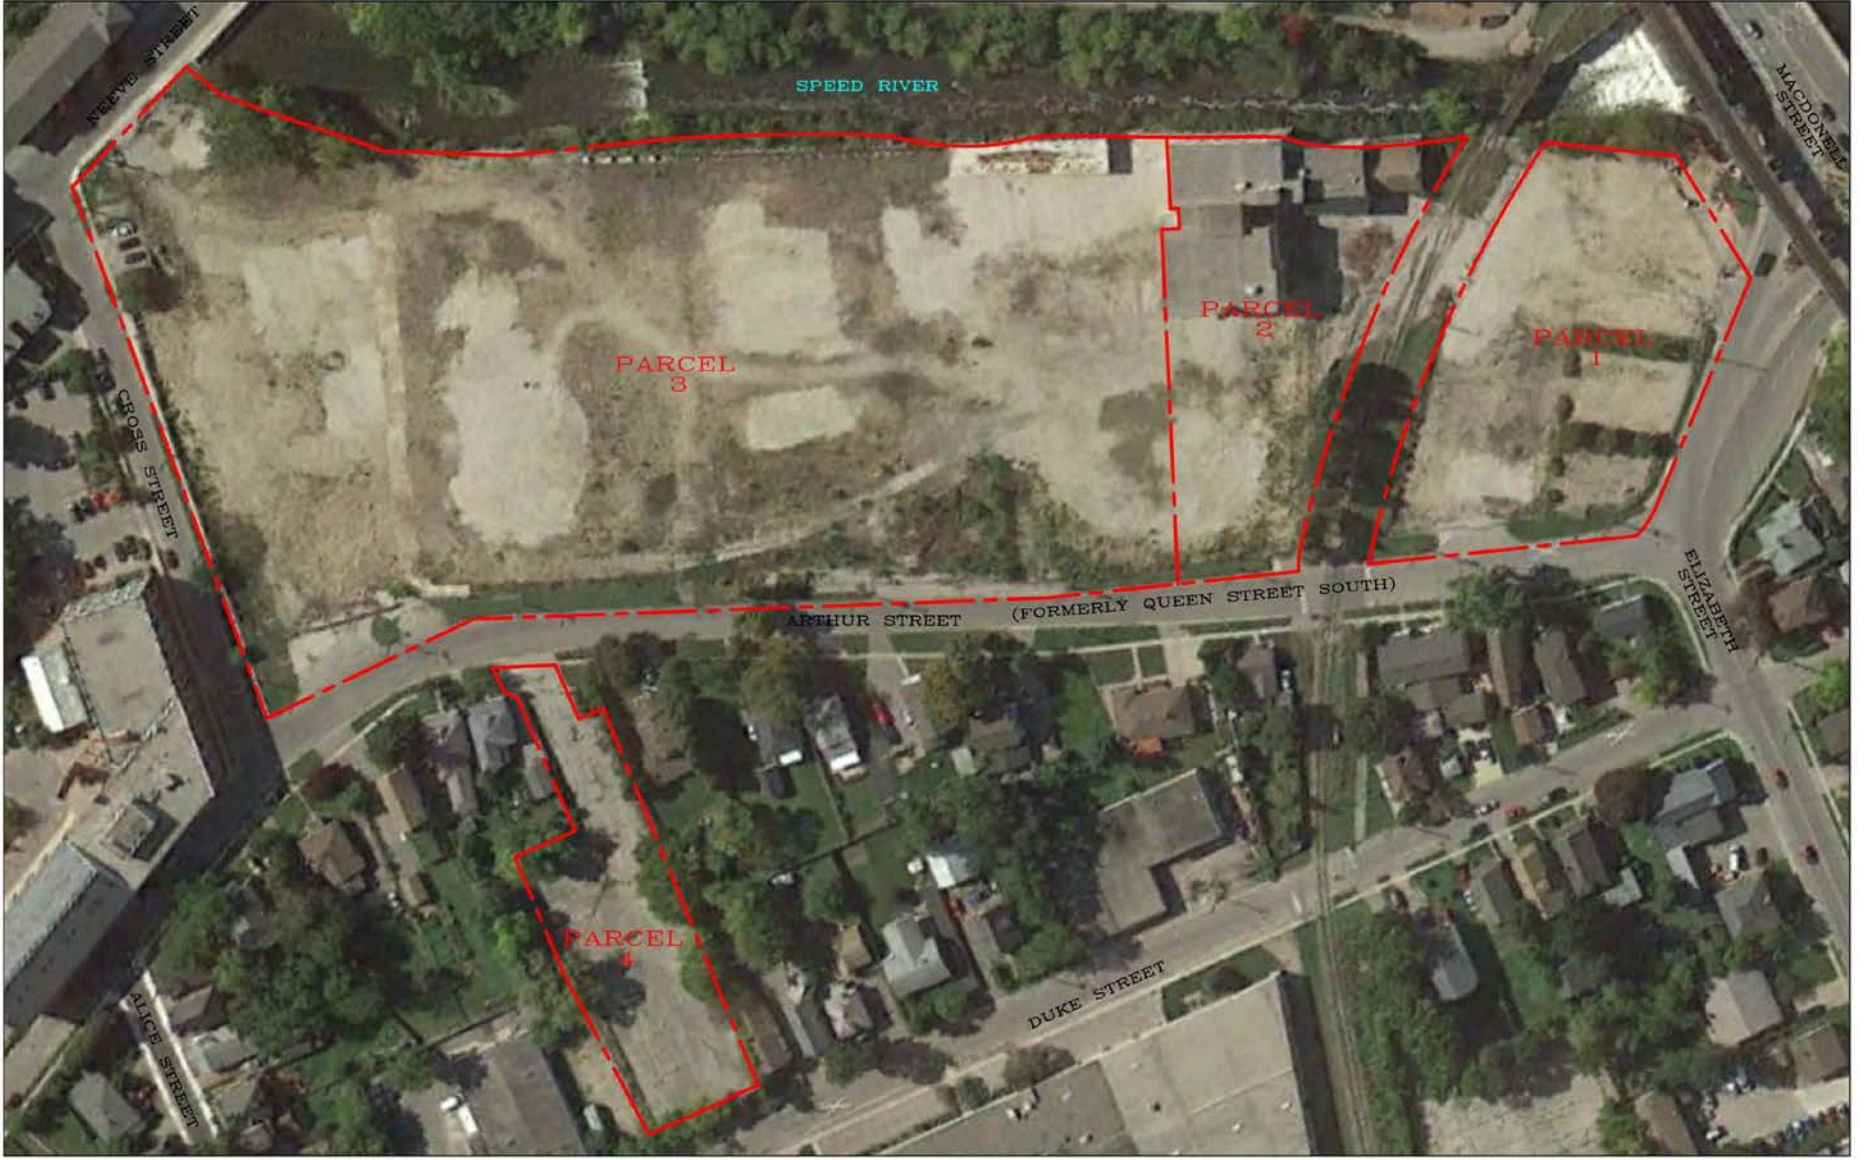
- XCG submitted all of the appropriate documentation in order to obtain a Record of Site Condition (RSC), which was required as part of the agreement of purchase and sale.
- As part of the RA approval and included in the RSC application process, a Certificate of Property Use (CPU) was issued for the subject site (Parcel 3).
