John LaChance | October 15, 2015

Maximizing Your Potential for Meeting Remedial Goals: The Importance of Electrode Design and Installation at a Site with Varying Treatment Depths

Case Study: ET-DSP[™] Site Boston, MA

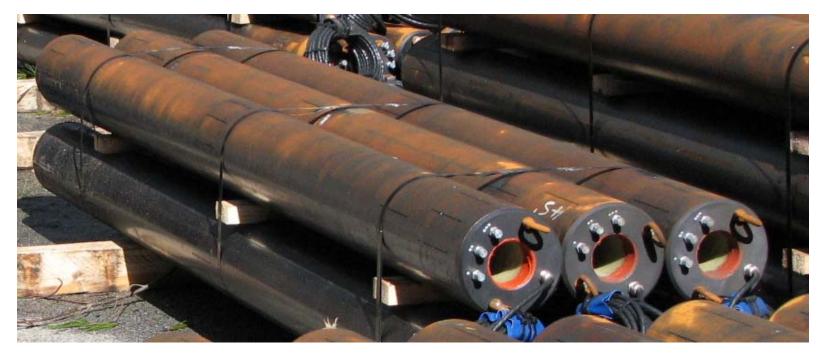
ET-DSP™ Electrode Design

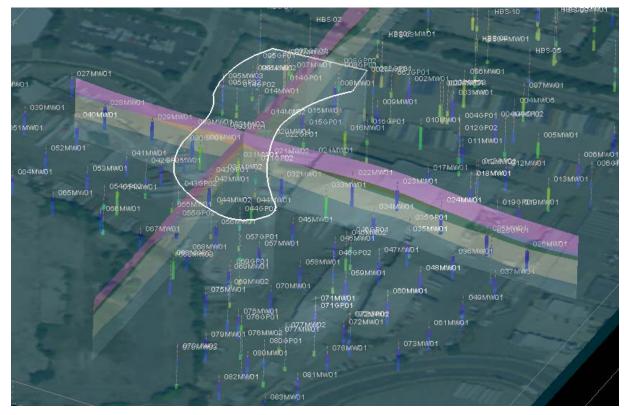
Site Geology

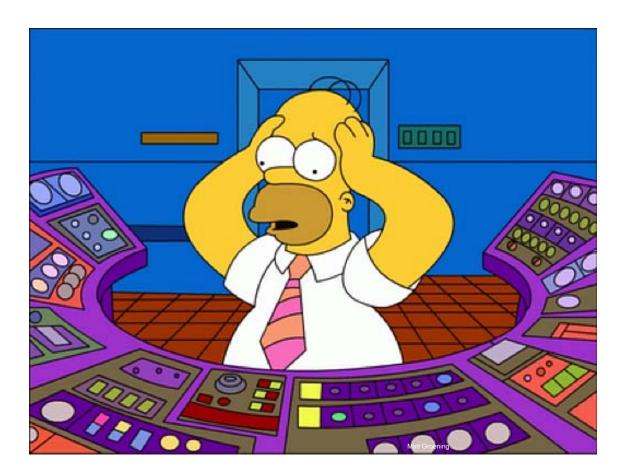
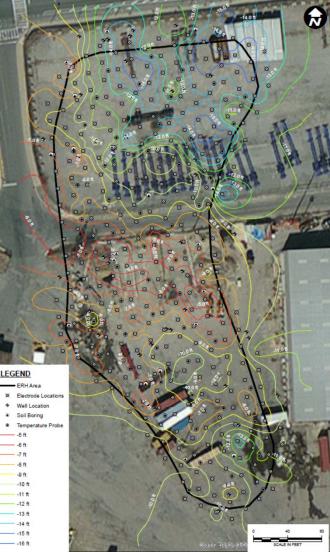
Site conditions more variable than anticipated

Required custom electrode configurations

Design and manufacture in real-time!

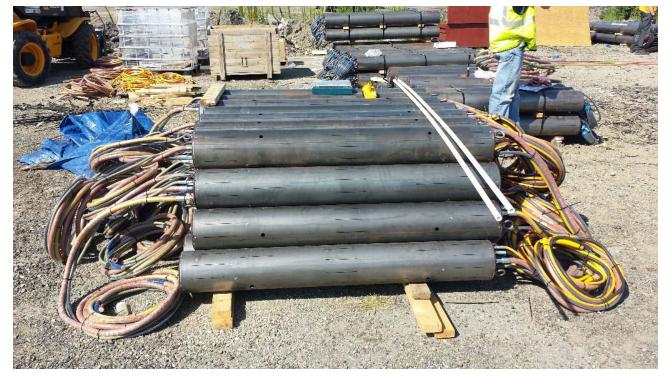
Electrodes

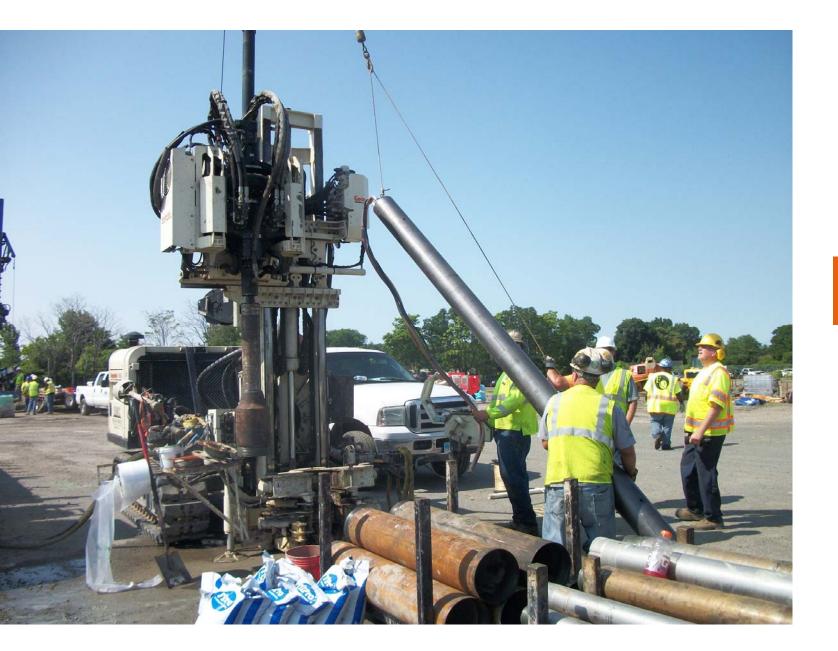
Installation of Electrodes

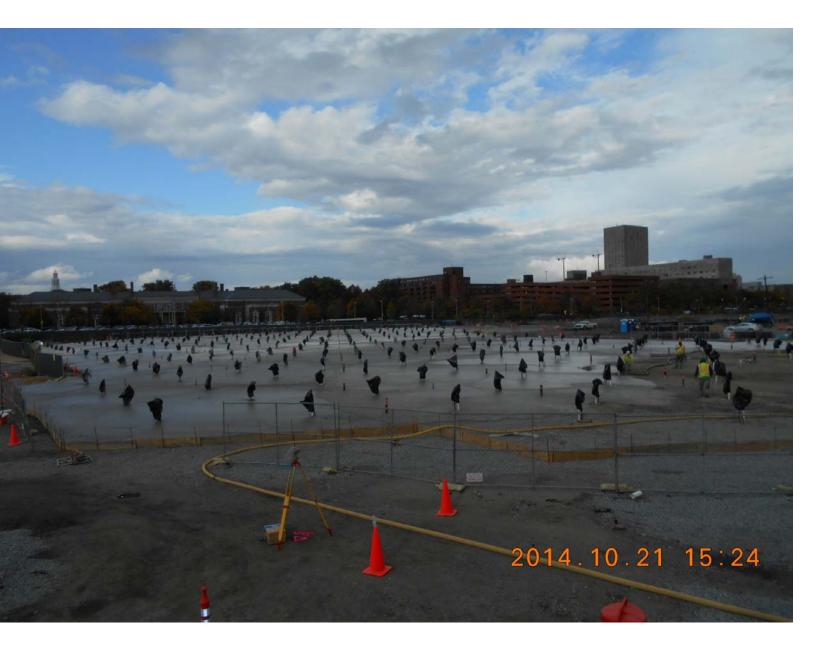
Completed Well Field and Vapor Cover

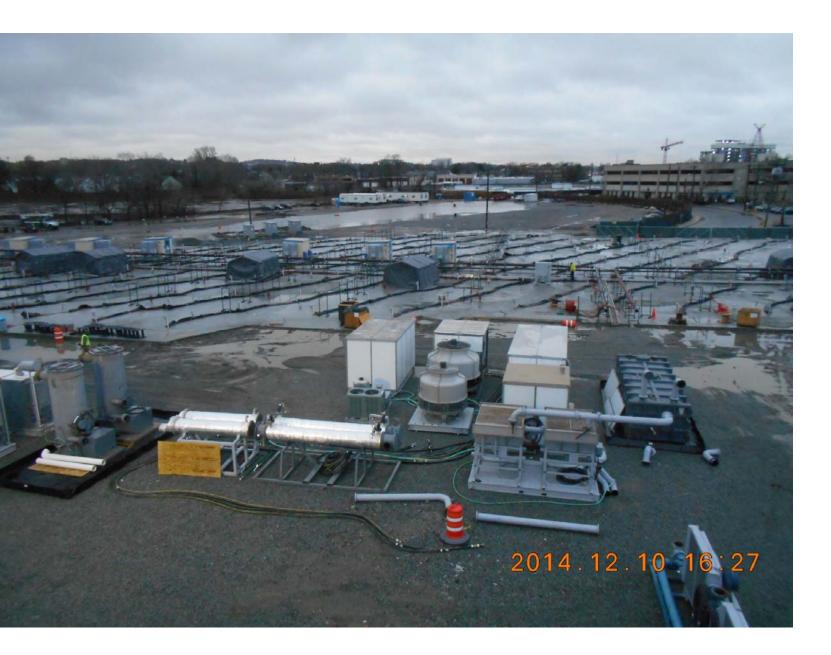
Extraction and Treatment System

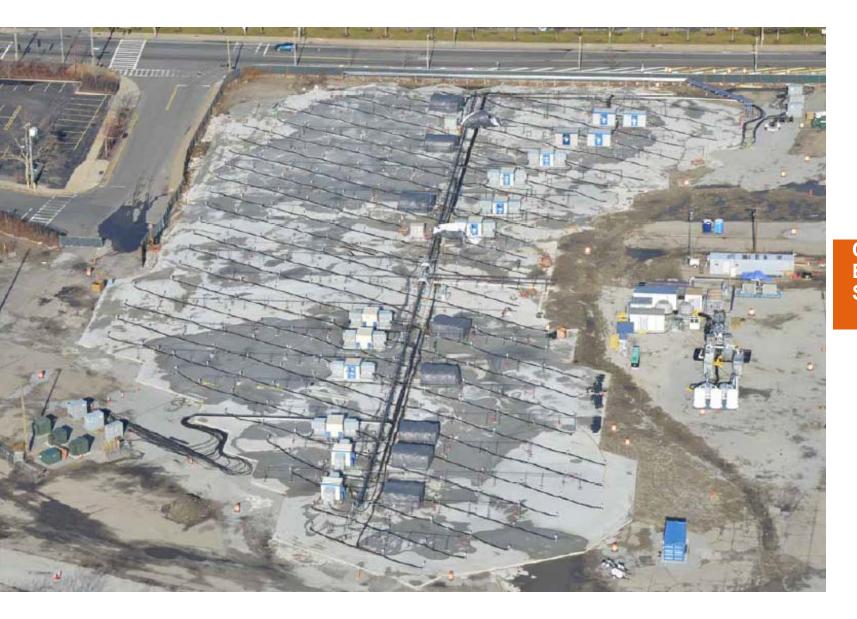
Completed ET-DSP™ System

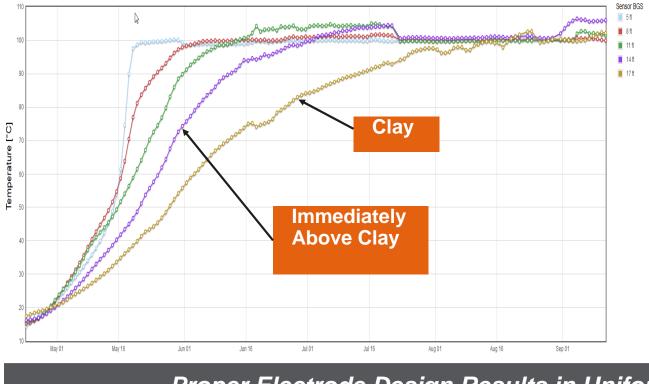
Observed Temperatures After 170 Days of Heating

Proper Electrode Design Results in Uniform Heating

Be prepared to modify design if required based on actual field conditions to preserve design aspects critical to success. Temp goals achieved in <180 days: 100% >90C (394 sensors) >90% > B.P. (355 sensors)
