Obtaining a Remediation Certificate using a Multifaceted Approach to Site Cleanup

RemTech 2015

Heather Sturm, P.Eng.
Geo Tactical Remediation Ltd.

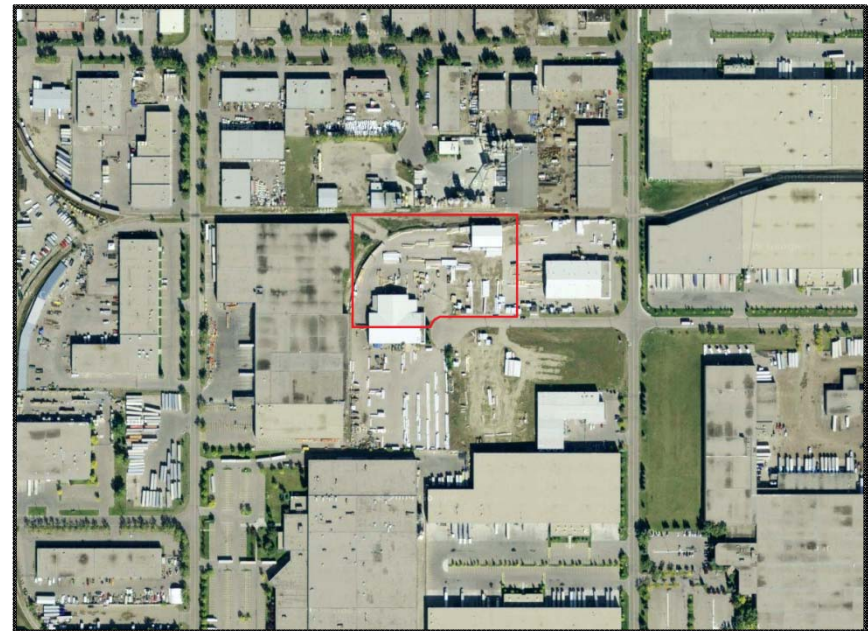
- Site operated as a manufacturing facility since the early 1980's
- Gasoline underground storage tank (UST) onsite
- In 1999 UST was decommissioned
- Determined that the tank had been leaking
- COCs are refined PHCs
- Soils onsite are fine grained

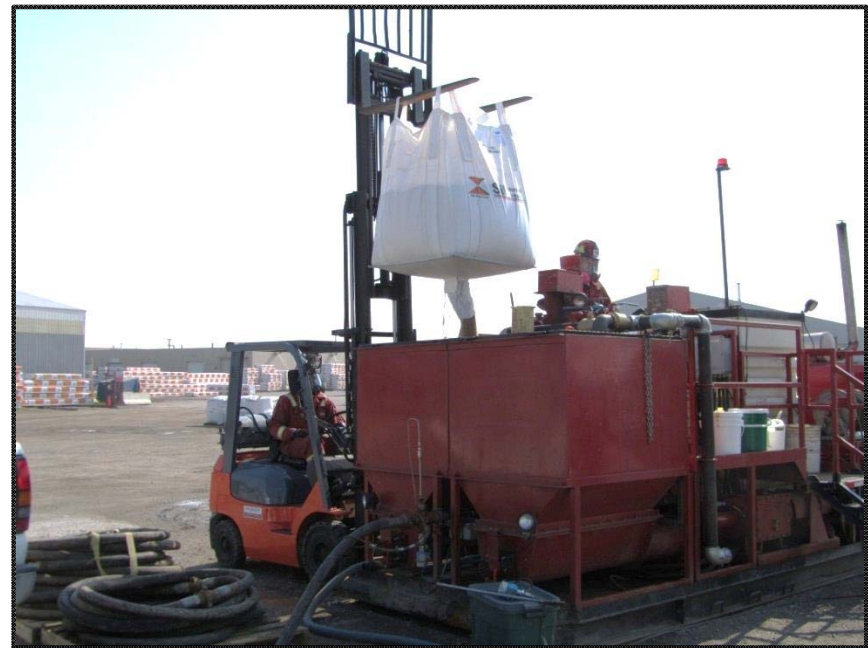
- Environmental fracturing to enhance bulk permeability of fine grained soils
- Incorporate surfactant into frac slurry to increase the availability of trapped PHCs
- Install dedicated injection wells
- Inject chemical oxidants to oxidize PHCs

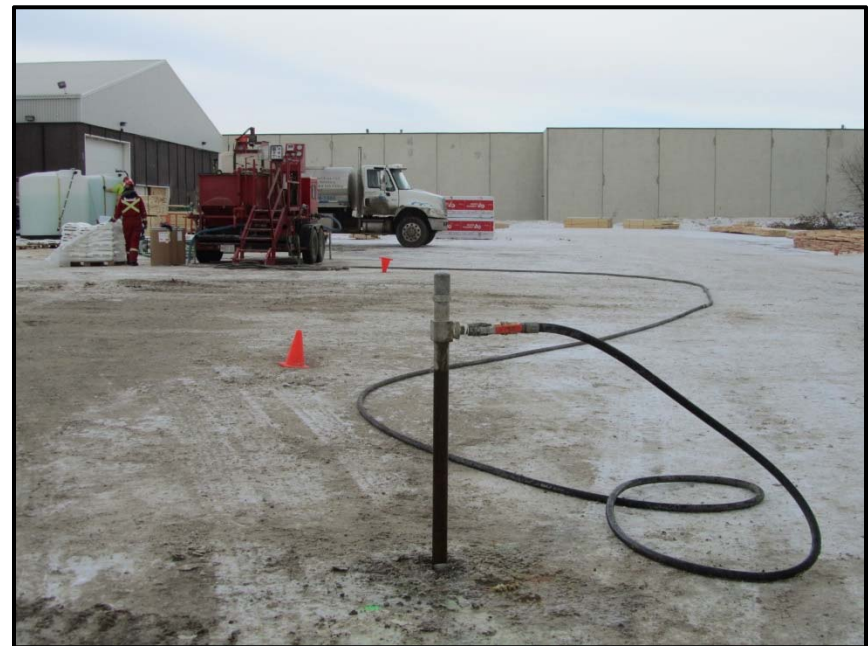
7 Month Remedial Program Details	Mass
Fracture Emplace Sodium Persulfate	3,025 kg
Fracture Emplace Calcium Peroxide	570 kg
Potassium Persulfate Canisters	10 Canisters

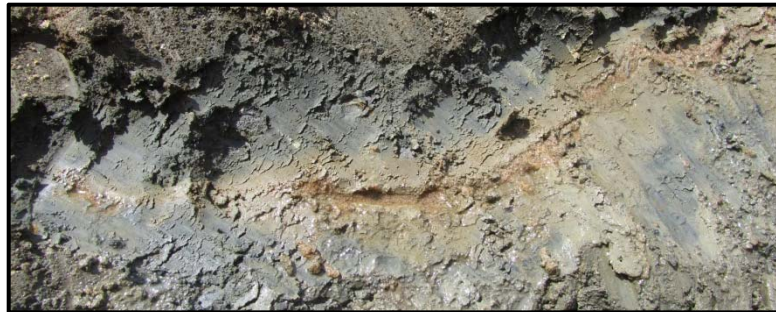
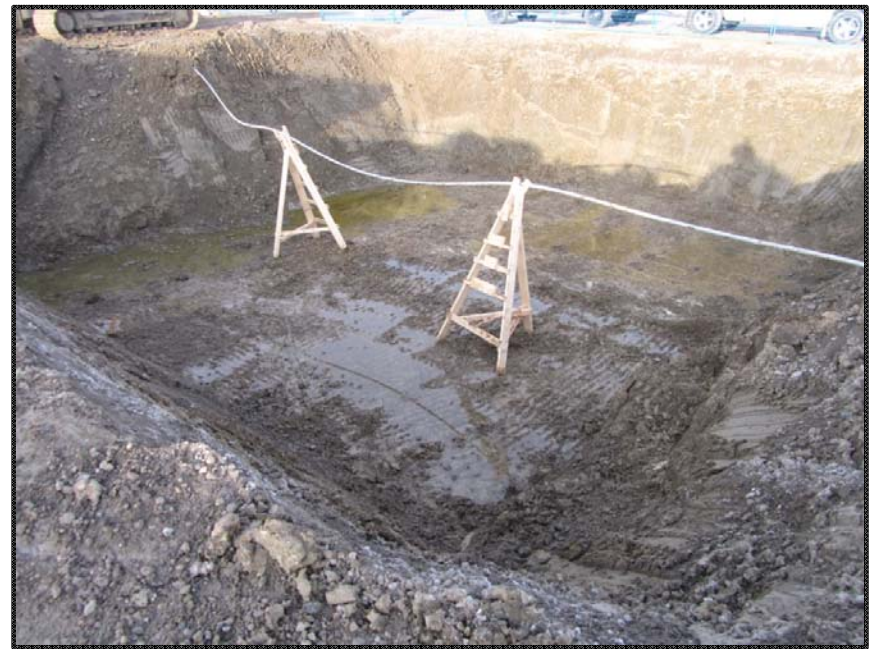
- 900 tonnes of contaminated soil was disposed
- 15 x 15 m
- 1.25 to 3.5 m bgs

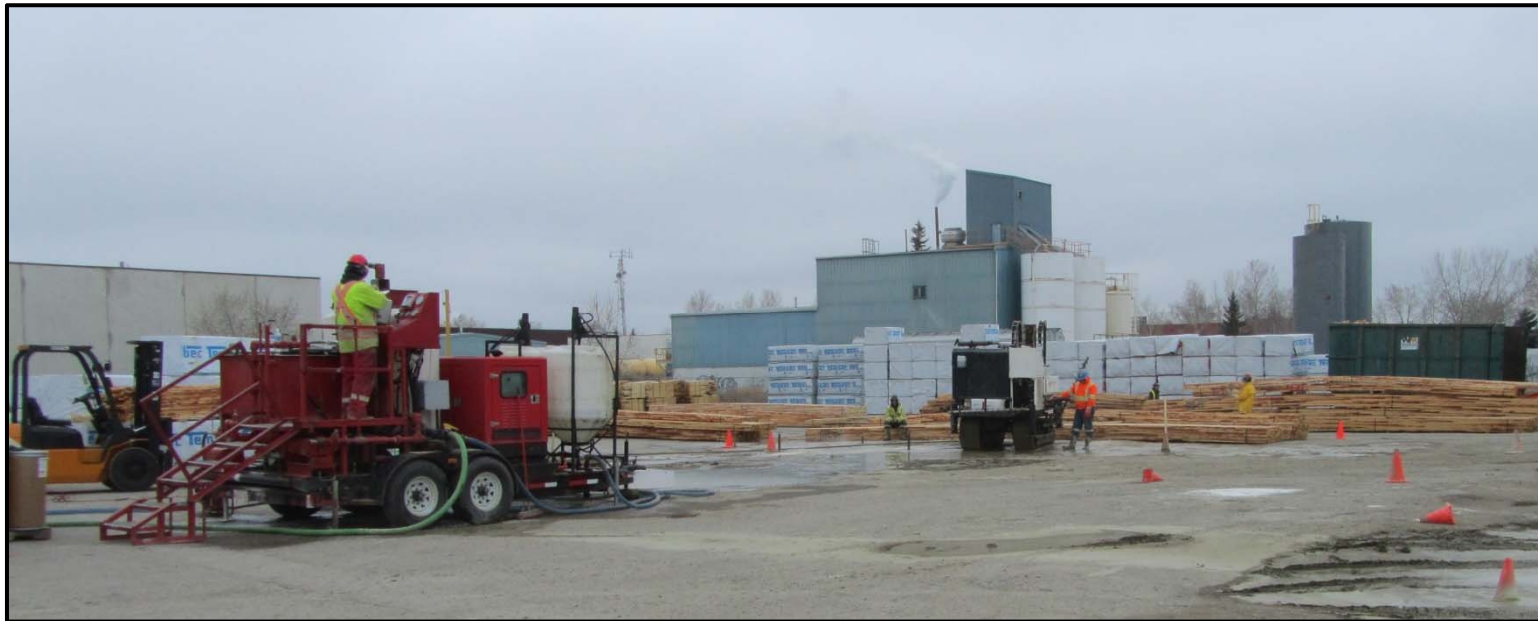
Remedial Description	Mass
Hydrogen Peroxide Injection (12 – 20%)	400 kg
Hydrogen Peroxide Fracture Emplace (12 – 20%)	11,600 kg
Calcium Peroxide Fracture Emplace (30 – 35%)	1,270 kg

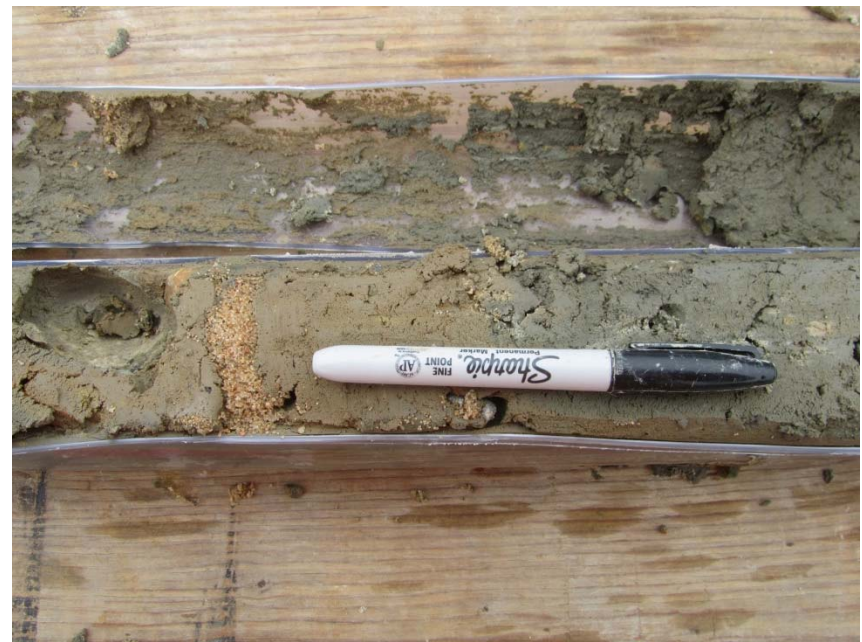
- The excavation boundaries were below Tier 2
- All other soil samples were below Tier 2
- The remaining issue on the site is a groundwater issue

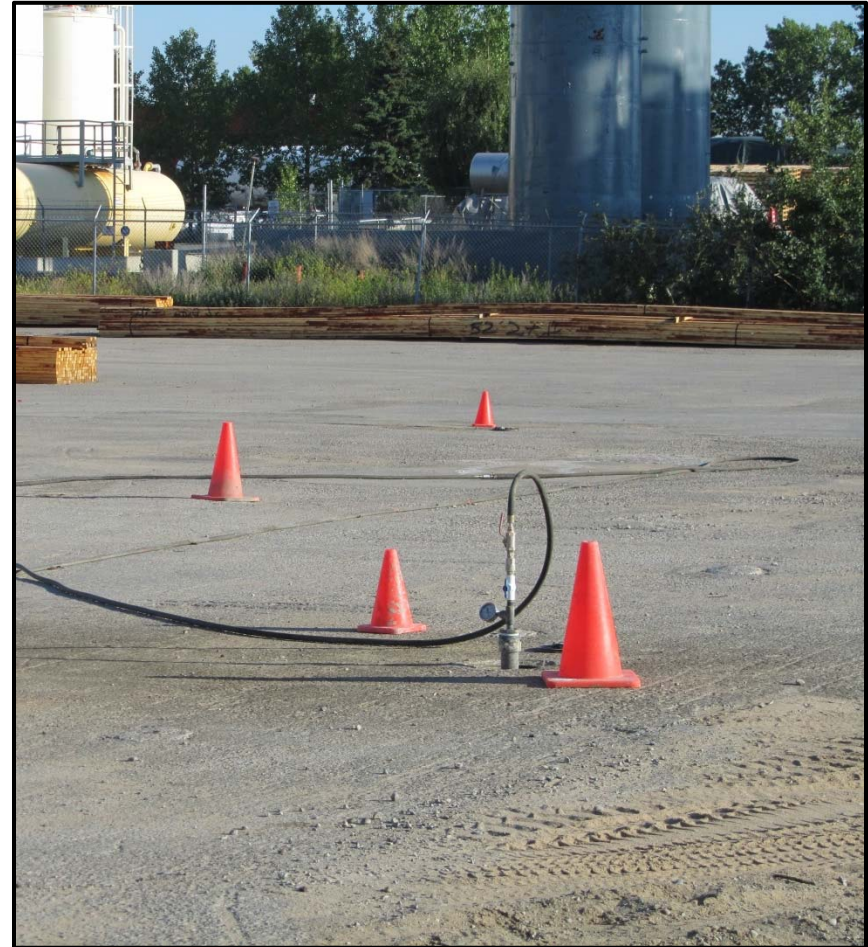
- Groundwater Sampling showed 4 wells above Tier 2
- Targeted injection around this area of the site
 - 30% sodium persulfate solution injected (150 kg)

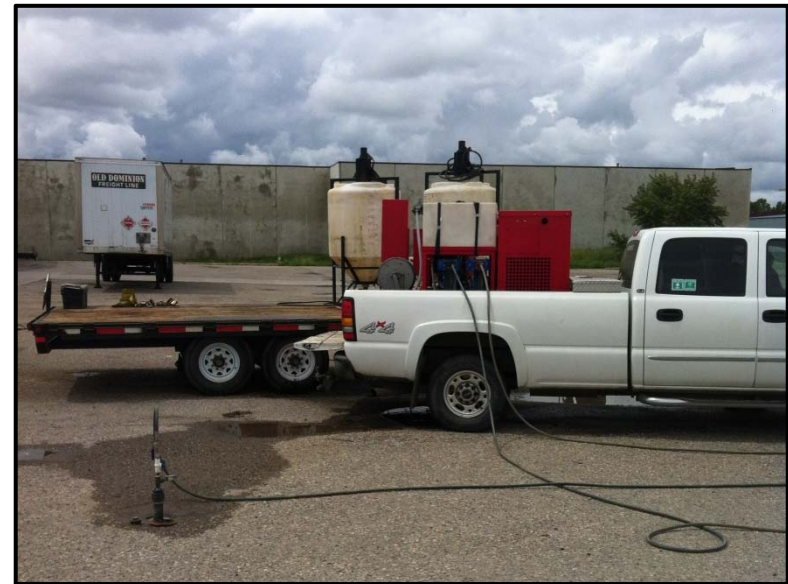
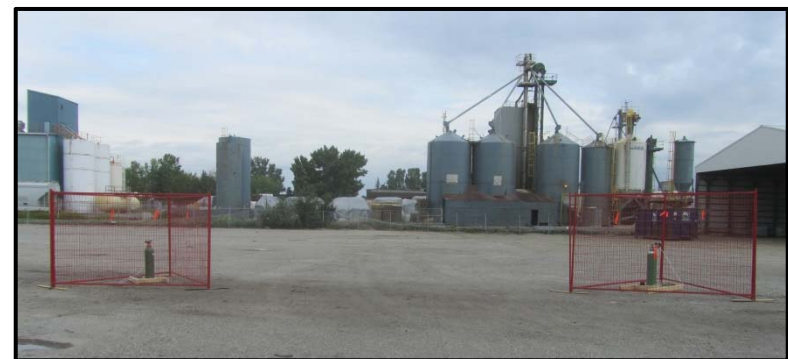
- Groundwater samples (1 year 10 months) showed concentrations above Tier 2 present at only two locations in the centre of the plume

Remedial Program Details	Amount
Injection of sodium persulfate with alkaline activation	525 kg
Oxygen diffusers	3 L/day
