A CASE FOR IN-SITU REMEDIAL SYSTEMS

John R Taylor | RemTech
Senior Engineer / Partner | October 14-16, 2015

Outline

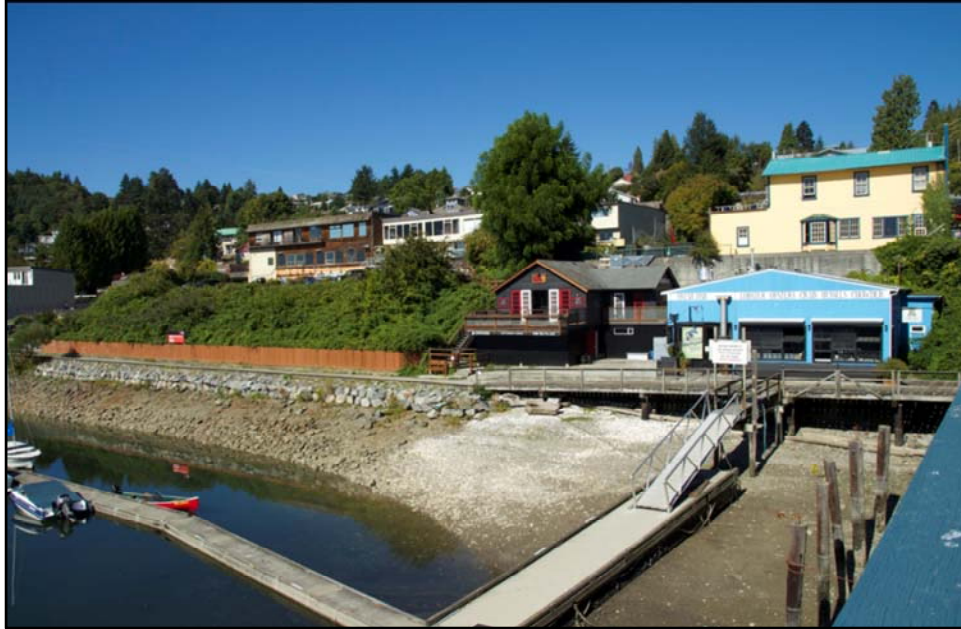
Site Setting

We had no idea this was a terraced site or a steep slope???

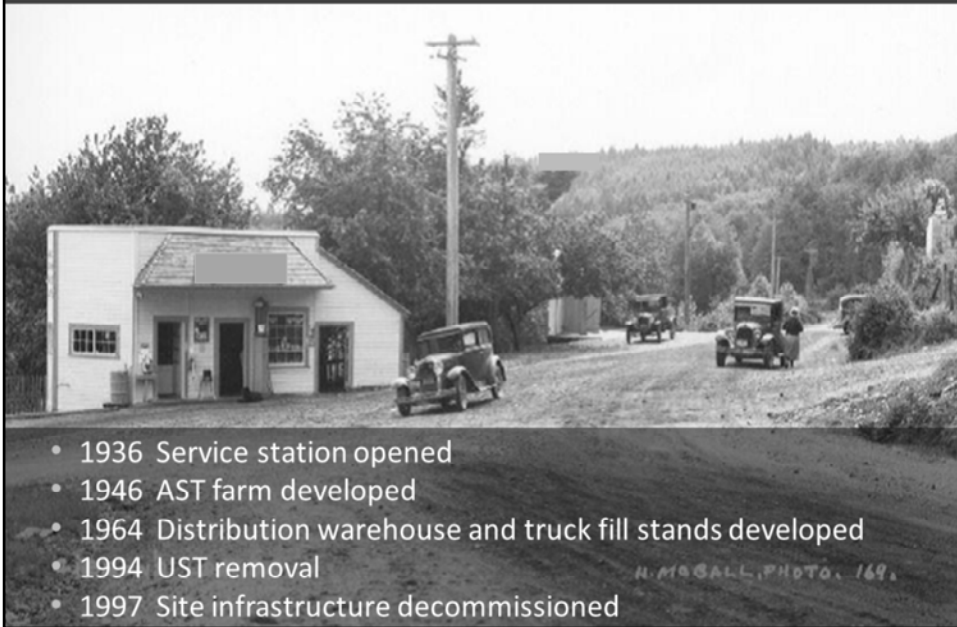
Site History

- 1936 Service station opened
- 1946 AST farm developed
- 1964 Distribution warehouse and truck fill stands developed
- 1994 UST removal
- 1997 Site infrastructure decommissioned

Mention off site impacted properties, multiple stakeholders
Fuel pumped from the wharf to AST farm for distribution throughout Sunshine Coast

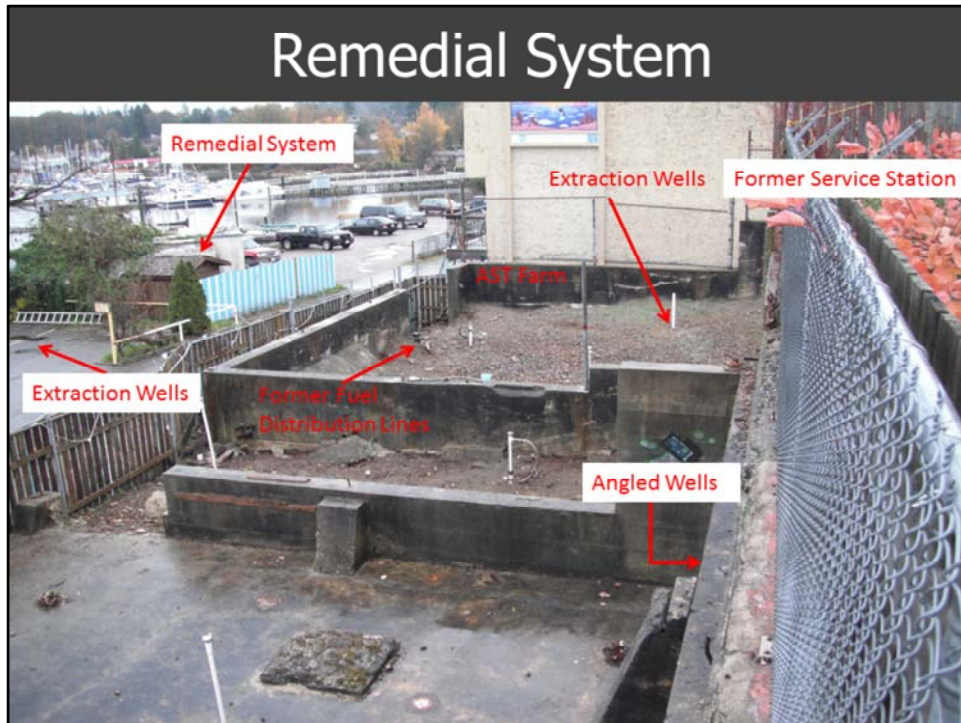
The site map illustrates the Remedial System layout. Key features include:

- GIBSONS QUAY** and **MOLLY'S LANE** (top left).
- ELECTRICAL SHED** (center left).
- VAPOUR PHASE CARBON ENCLOSURE** and **WATER PHASE CARBON ENCLOSURE** (bottom left).
- CATALYTIC CONVERTER AND VAPOUR DISCHARGE** (bottom left).
- LRB ENCLOSURE** (bottom center).
- MOLLY'S REACH RESTAURANT** (bottom right).

The remedial system directly recovered 5,080 kg of hydrocarbons, and 5,890 m3 of groundwater. It was estimated that 6,500 kg of hydrocarbons degraded in-situ as result of remedial system operation.

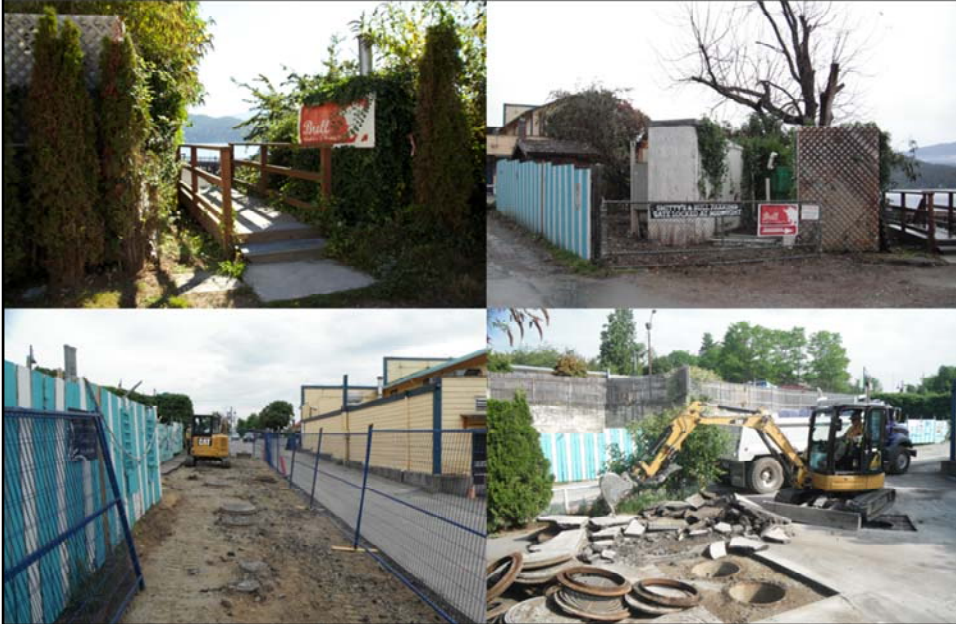
Remedial System

Angled wells drilled through retaining walls to target contamination at depth that could not be excavated

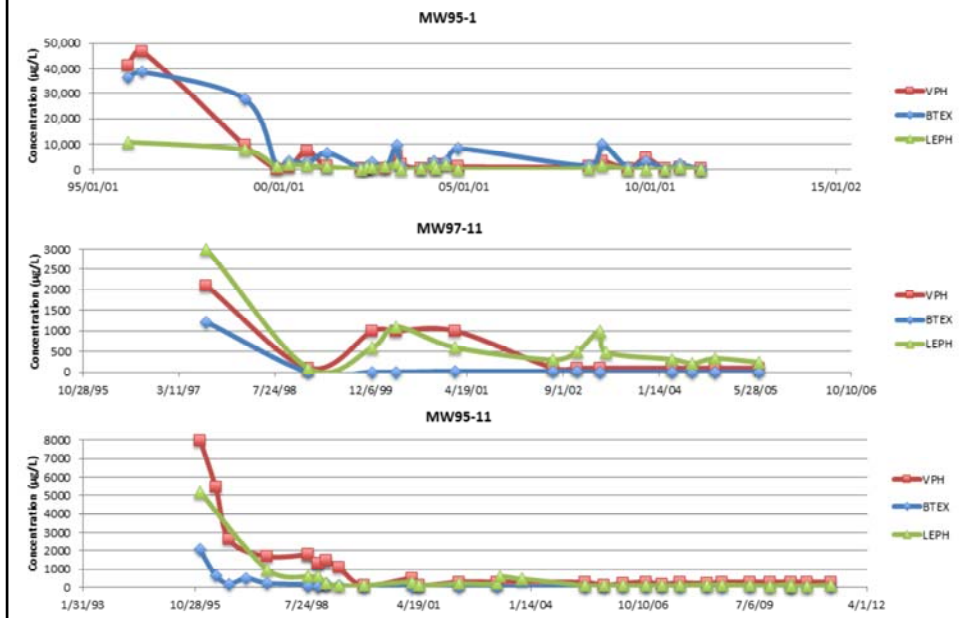
Groundwater Concentrations Declining

Large part of this project was going through the large amount of data and demonstrating the the plume (DW) was attenuating.
