## Use of a Conceptual Site Model to Evaluate, Communicate and Support Discussion of Petroleum Hydrocarbon Impacts on Subsurface Receptors

**Presentation by  
Tetra Tech EBA Inc.**

October 2015

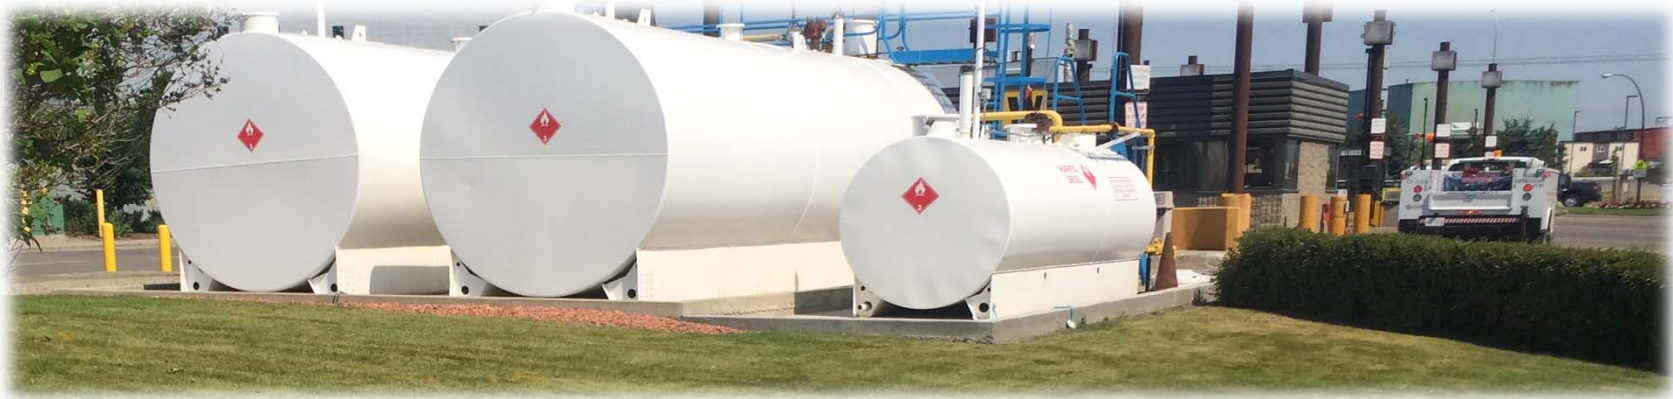
# Most Likely Suspect - Fueling Facility

- The Fueling Facility is located west of the Commercial Building.
- Historically contained four underground storage tanks (gasoline and diesel) which were removed in the mid 90s.
- Three above-ground storage tanks (gasoline, diesel, and marked diesel) were installed after the USTs were removed, and currently operate.

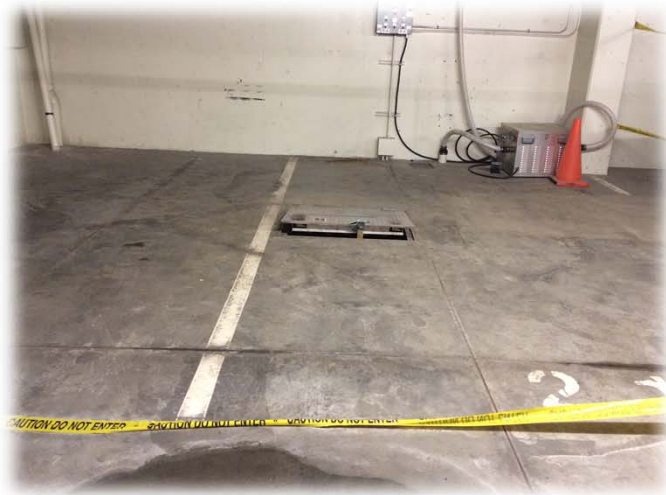
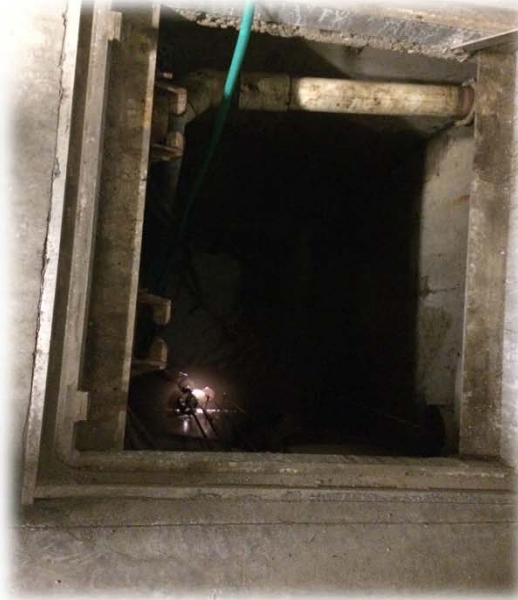
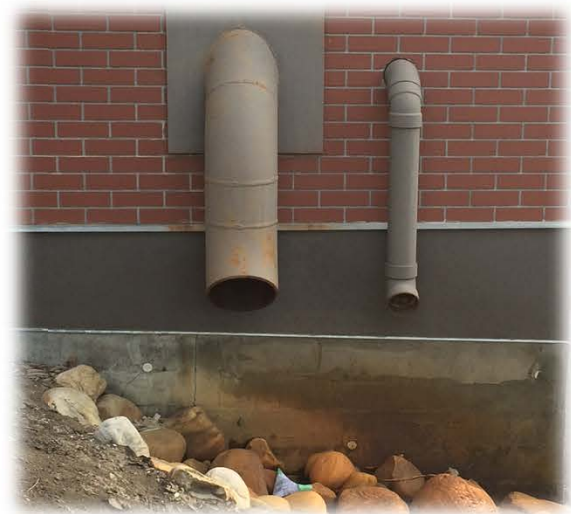
## Other Potential Concerns - Building Weeping Tile and Underground Parkade Sump

- Groundwater is managed through the weeping tile system surrounding the building.
- The groundwater is collected in a sump located in the underground parkade.
- The water sampled from the sump contained concentrations of PHCs greater than regulatory guidelines.

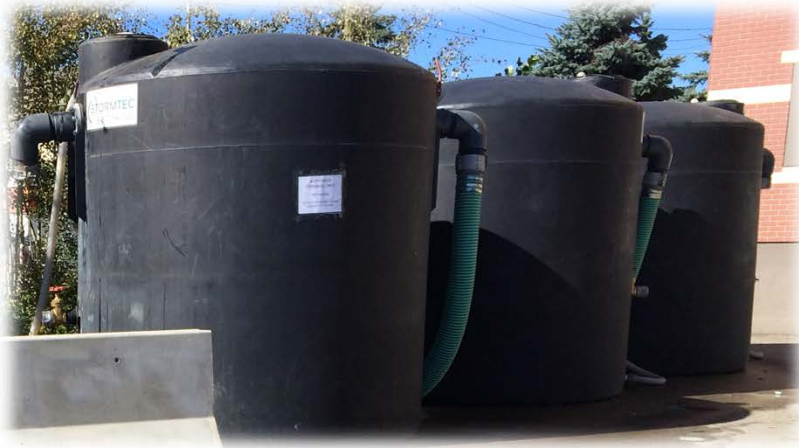
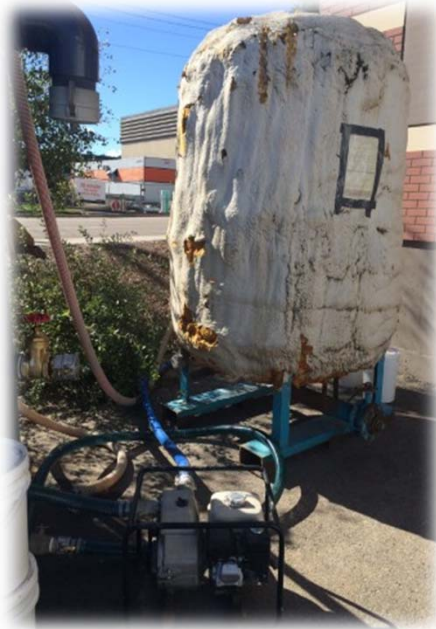
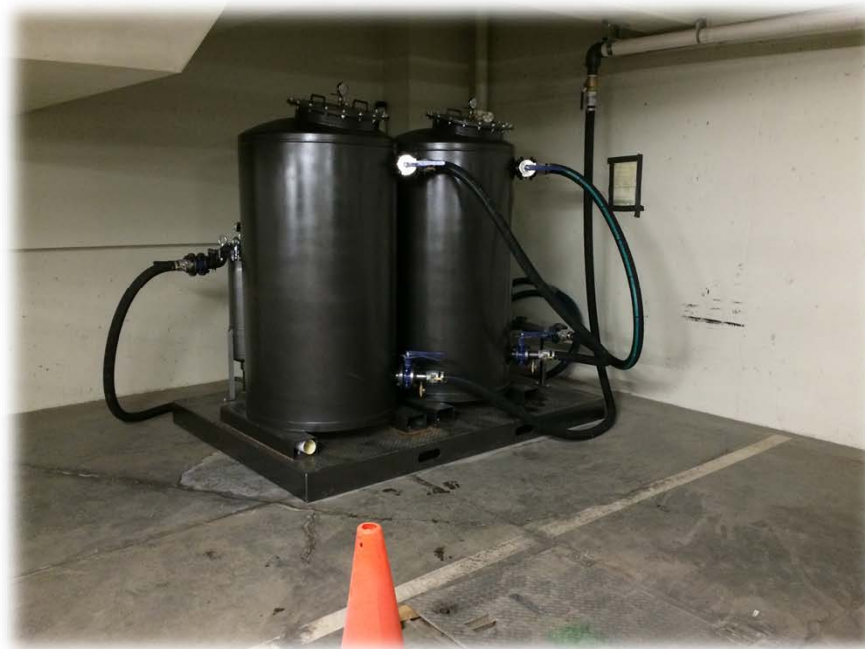
## Sump Water Management

- Several methods were employed to contain and treat the impacted water.

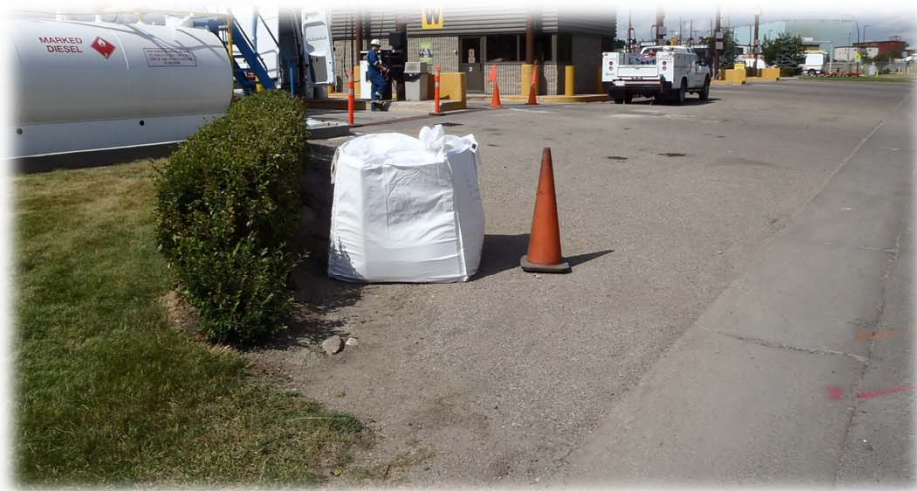
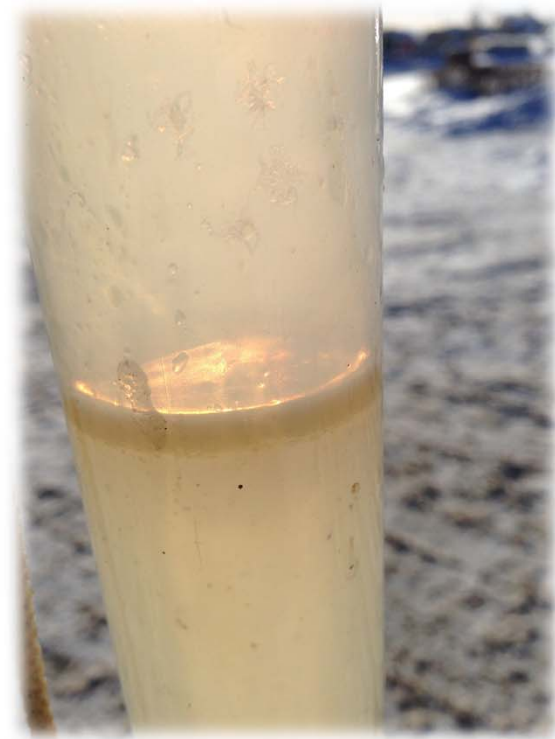
## Let's Investigate More - Phase II Environmental Site Assessment

A Phase II environmental site assessment (ESA) was conducted near the fueling area and commercial building:

- Four boreholes were advanced and groundwater monitoring wells were installed.
- Groundwater samples were collected from the newly installed and existing monitoring wells.
