Decontamination and Deconstruction of the Giant Mine Roaster Complex: Risks, Challenges, Lessons Learned and Successes

Gordon Woollett, P.Eng. - AECOM Canada Ltd.

Sarah Preston, G.I.T. - Parsons Canada Ltd.

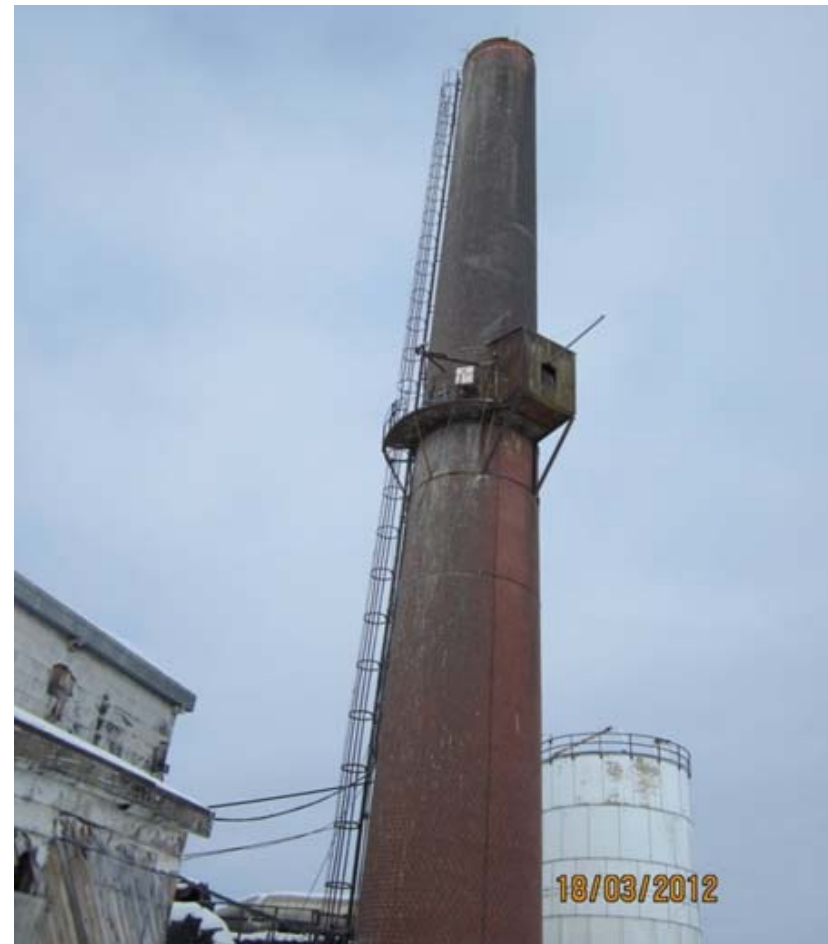
- Roaster Complex
Decontamination and
Deconstruction
 - Part of Advanced Site
Stabilization Plan (SSP)
 - Driver: risk of physical
injury and of contaminant
exposure to on-site
workers, neighbouring
communities and the
environment

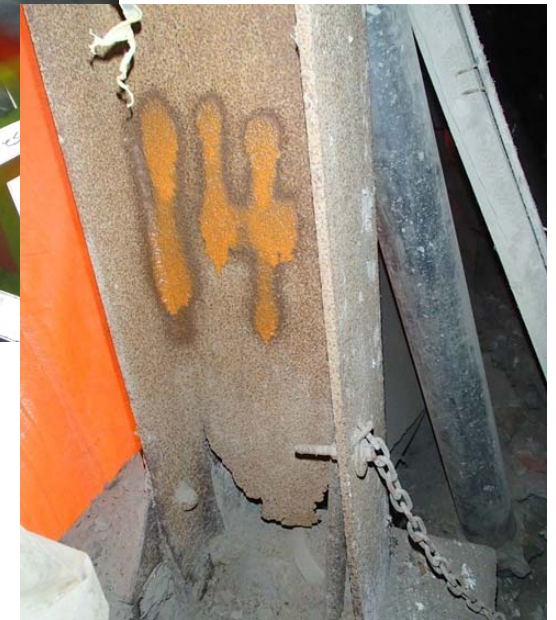
- Emergency work done in the winter.
- Exposure (arsenic trioxide, asbestos, cyanide)
- Exposure (cold)
- Limitations imposed by structural conditions
- Darkness

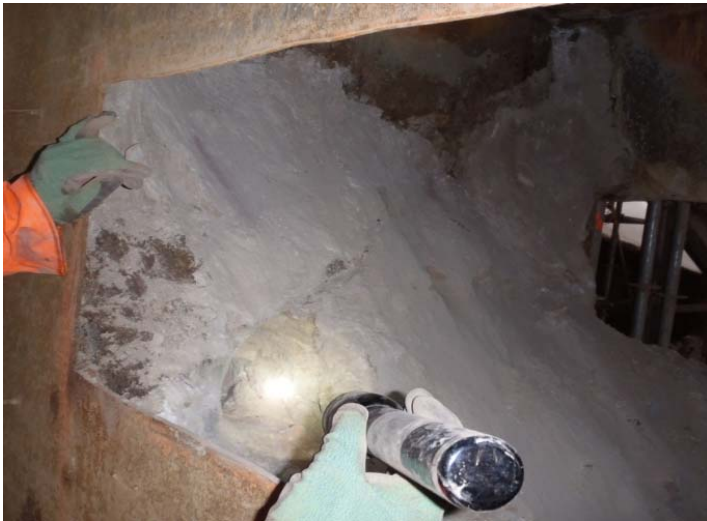
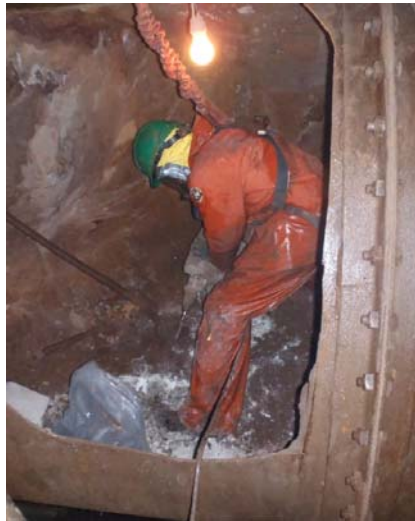
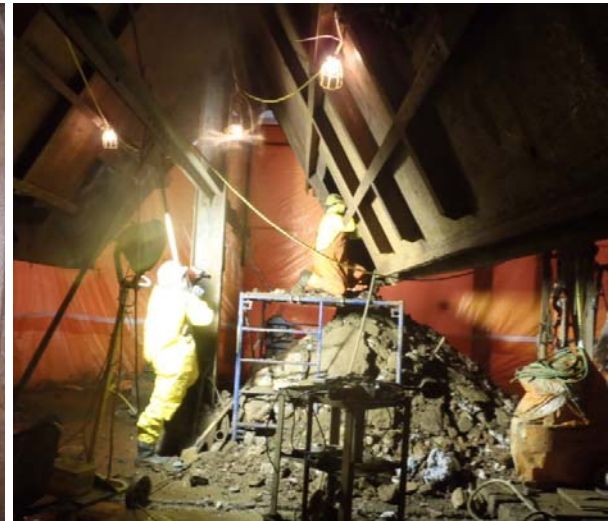
Decontamination: Risks and Challenges

- Hazardous Materials Abatement: Arsenic, Cyanide, Asbestos
- Worker Protection
- Waste Volume and State

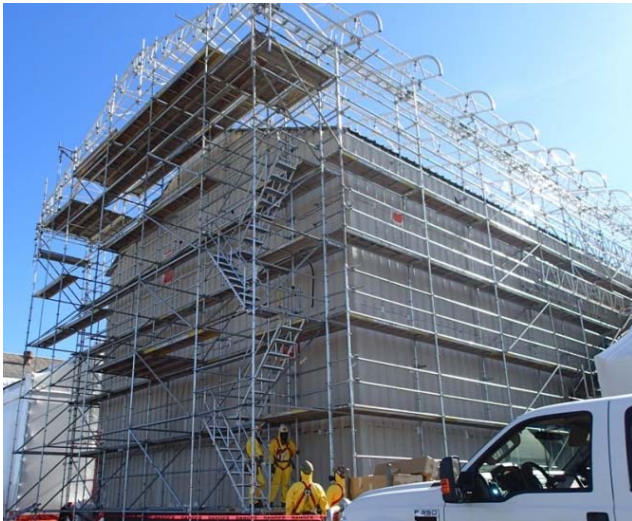
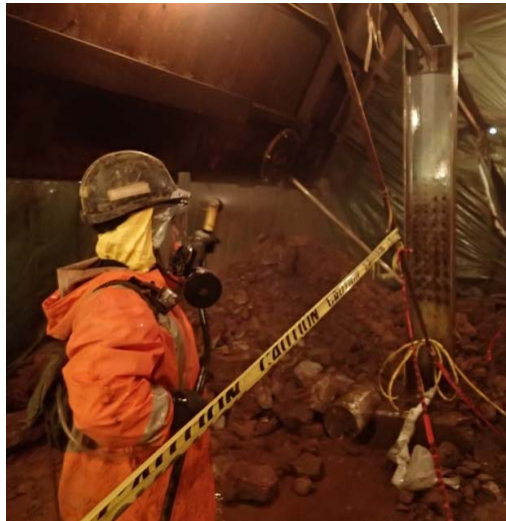
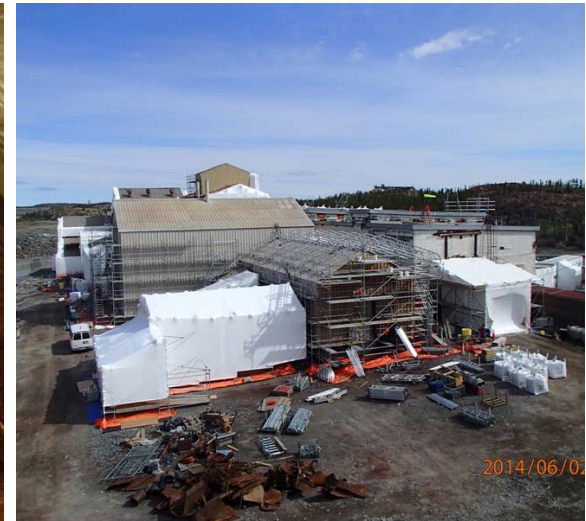
Decontamination: Lessons Learned

- Established controls for simultaneous abatement of arsenic, asbestos and cyanide
- Increased PPE Standards
- Dust Suppression

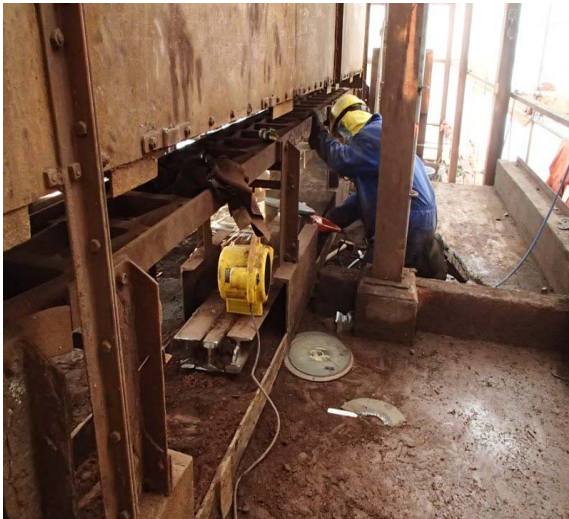
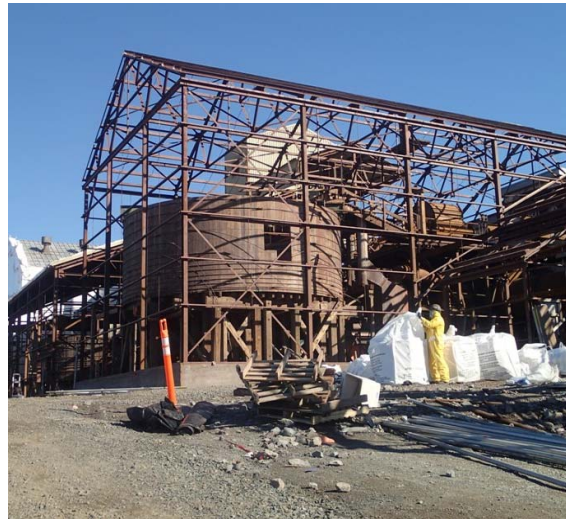
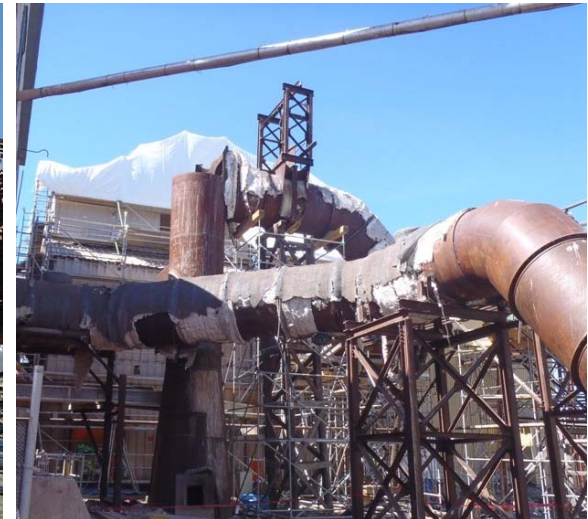
Deconstruction: Risks and Challenges

- Structural Disrepair
- Chimney Stack (46 m)
- Internal Equipment

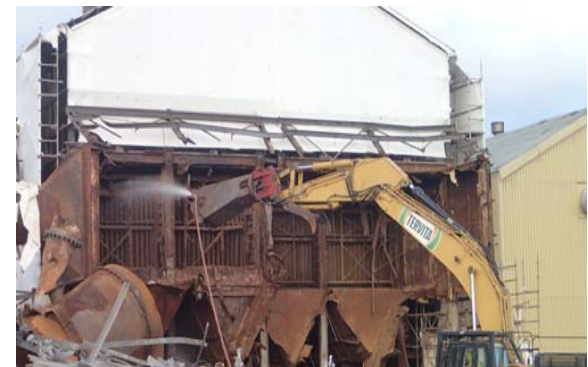
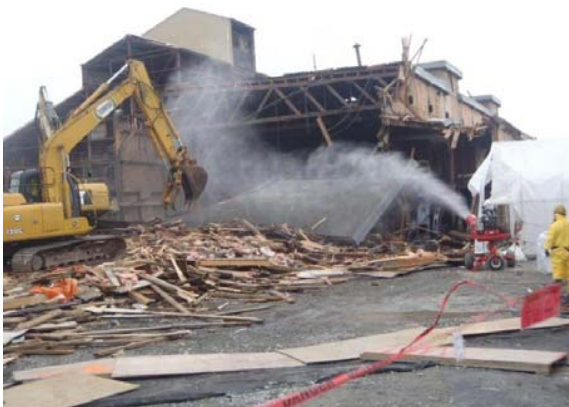
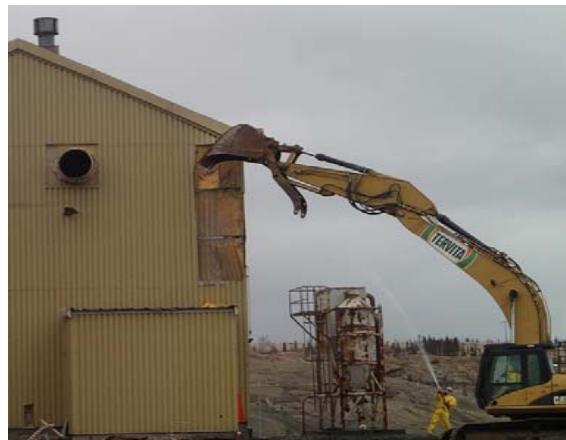
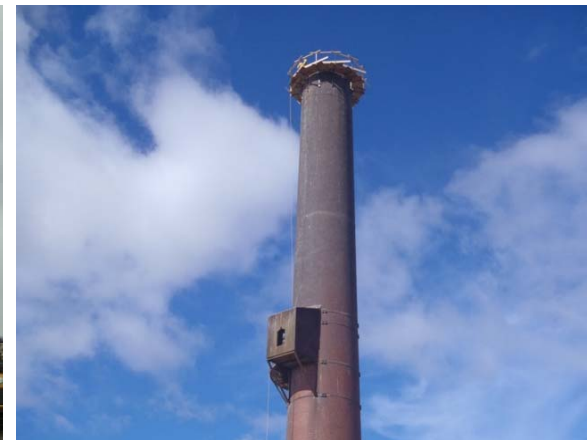
Deconstruction: Lessons Learned

- Engineered Plans and Innovative Approaches
- Modified Deconstruction
- Secondary Decontamination
