# Assessment and Remediation Gwawaenuk First Nation, Hopetown, BC

ESAA – RemTech

October 13, 2016

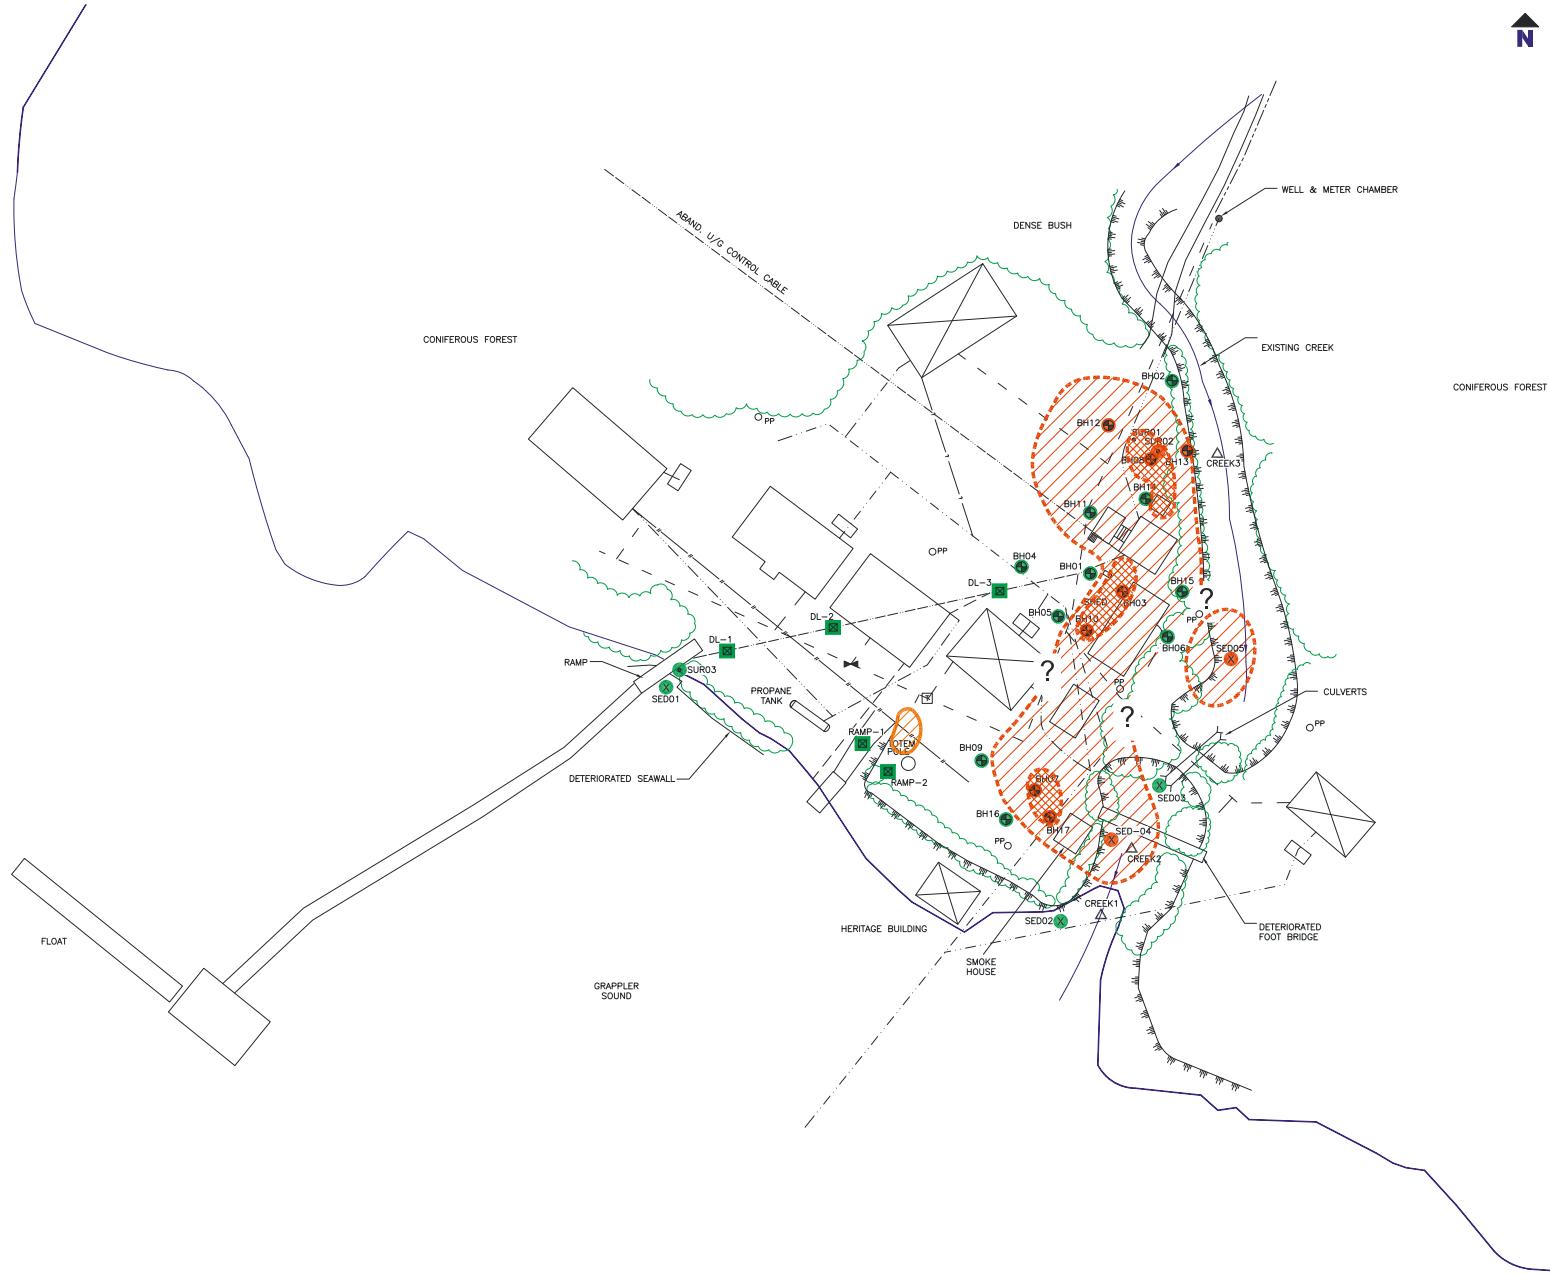
Drawing No.: 1

- Soil, groundwater and sediment impacts were found and the project required the removal of  $\sim 1,600 \text{ m}^3$  of soil and  $\sim 6,000$  litres of impacted water
- Soil impacts included petroleum hydrocarbons, PAHs, and metals above CCME RL Guidelines to greater than 3 metres below grade
- Sediment samples exceeded CCME Guidelines for metals
- Groundwater samples exceeded the dissolved metals applicable CCME Guidelines

ESTIMATED AREA OF EXCAVATION
