Unique Technical Issues and Solutions related to Redeveloping a Major Urban Shopping Centre in Victoria

By: Diane Zorn, P.Eng., CSAP - Project Director, Hemmera

Date: Thursday, October 13, 2016

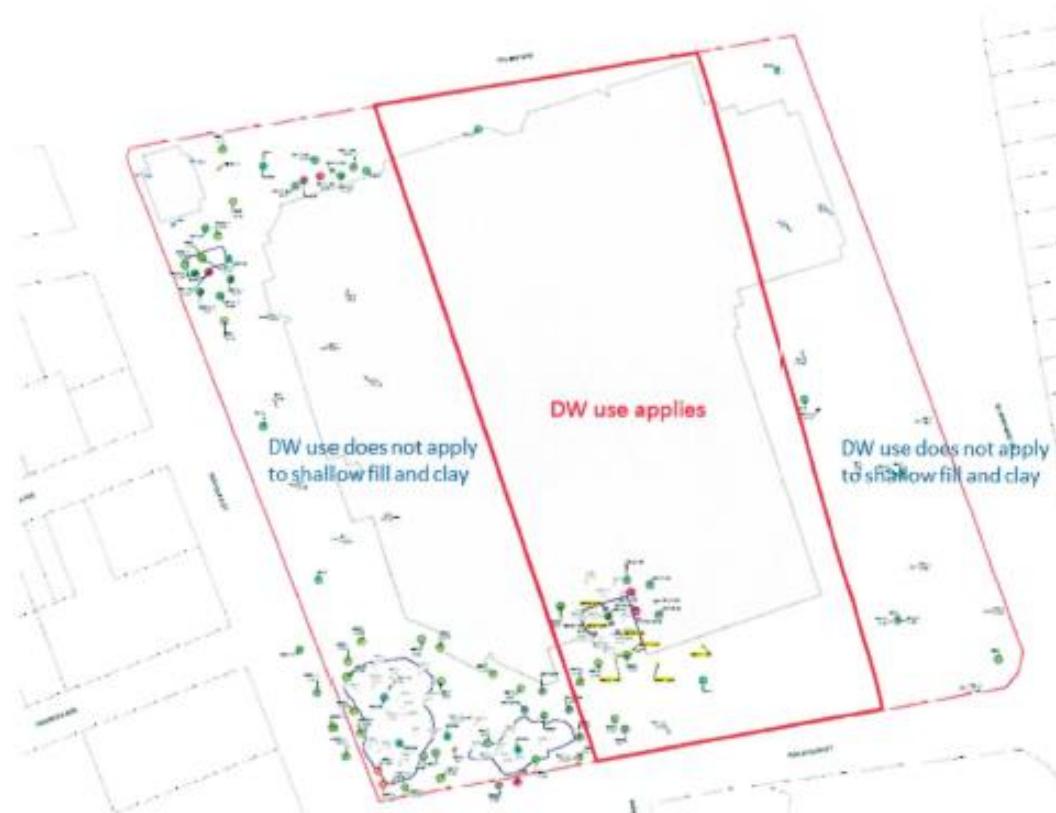
Figure 1. Water Use Boundary

Groundbreaking DW Determination

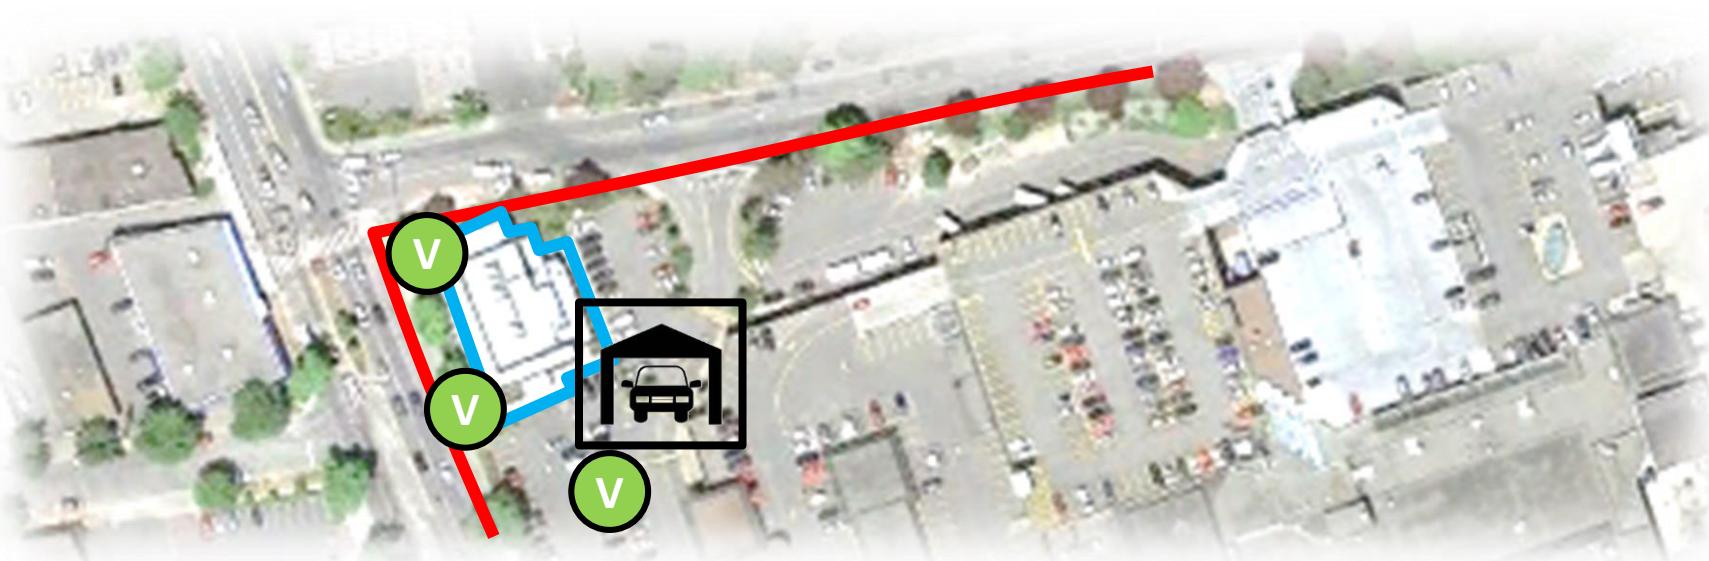
Challenge & Solution: Physical Obstacles

- Concrete slab prevents drilling at APEC
- Current building prevents drilling down-gradient of APEC

Creative SV probe scheme

Substitute soil vapour data for
soil, groundwater data

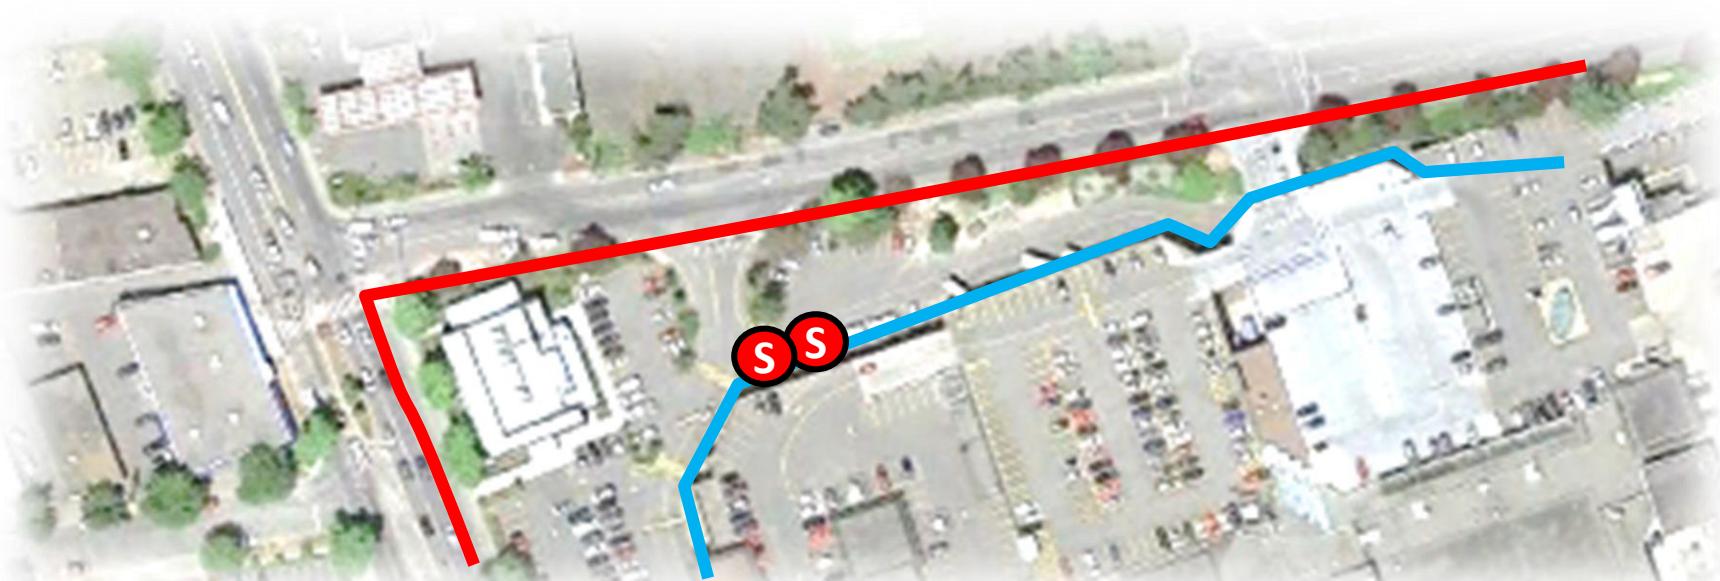
Challenge & Solution: Delineating Zinc

- Zinc exceeding CL in soil
- Not delineated to the south
- Costly to drill inside mall

Identified mall and bedrock as physical barriers and argued delineation complete

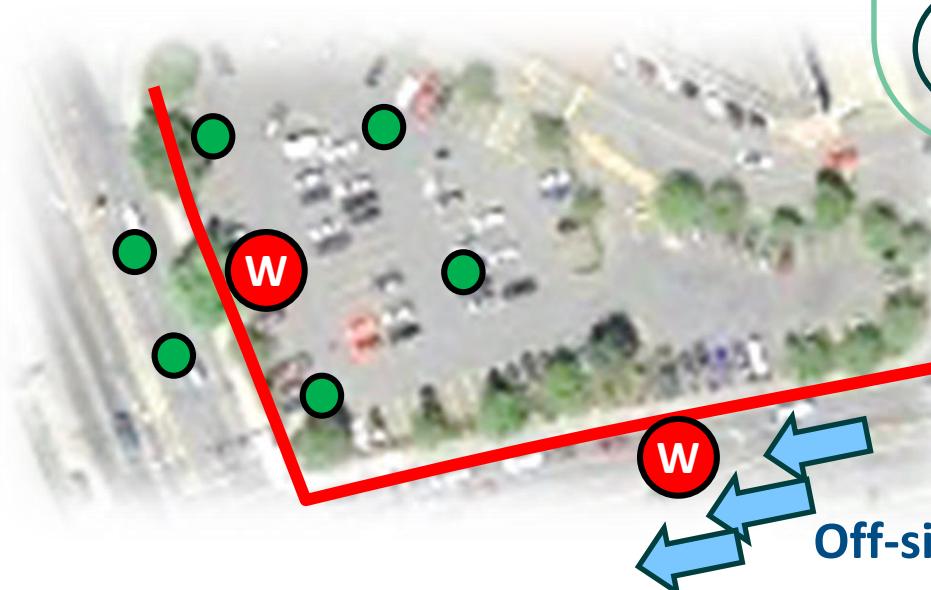
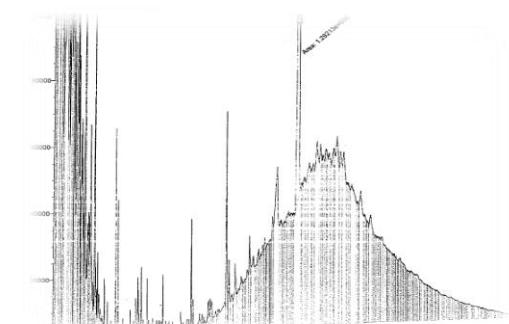
Challenge & Solution: Groundwater at PL

Hydrocarbon impacts in on-site and off-site wells adjacent to property lines

Evaluated contaminant characteristics

Used existing MW network

Avoided off-site drilling

Avoided Off-site Management Area

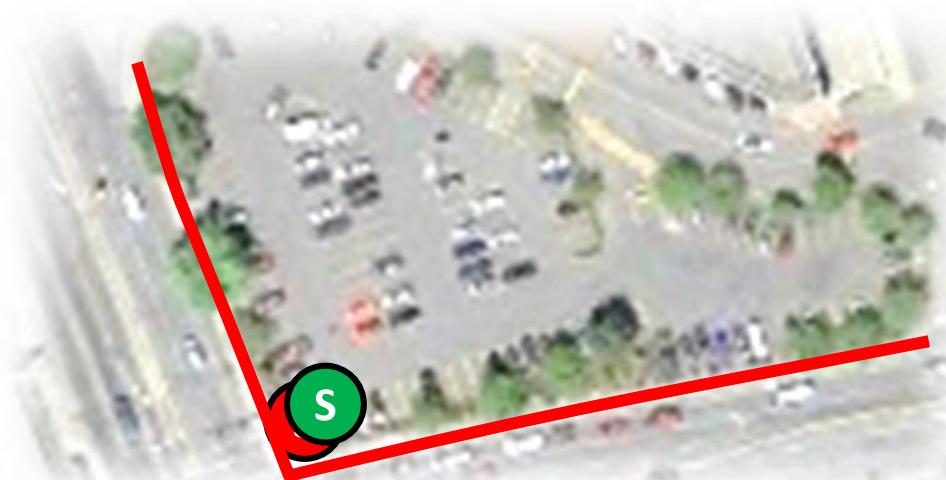
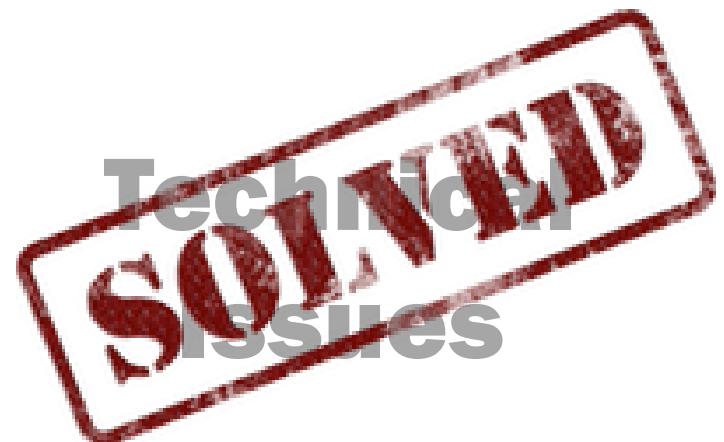
Challenge & Solution: Soil Impacts in SW Corner

- Historically non-exceeding soil sample became an exceedance under current standards. Surprise!

Replaced soil sample as per
TG12

Avoided off-site drilling
