# Remote Northern and Dryland Phytoremediation of Contaminated Soil

Earthmaster Environmental Strategies  
and the \*University of Waterloo

# Large Scale Phytoremediation

# Site 1 - Nota C-17 Pre-deployment 2008

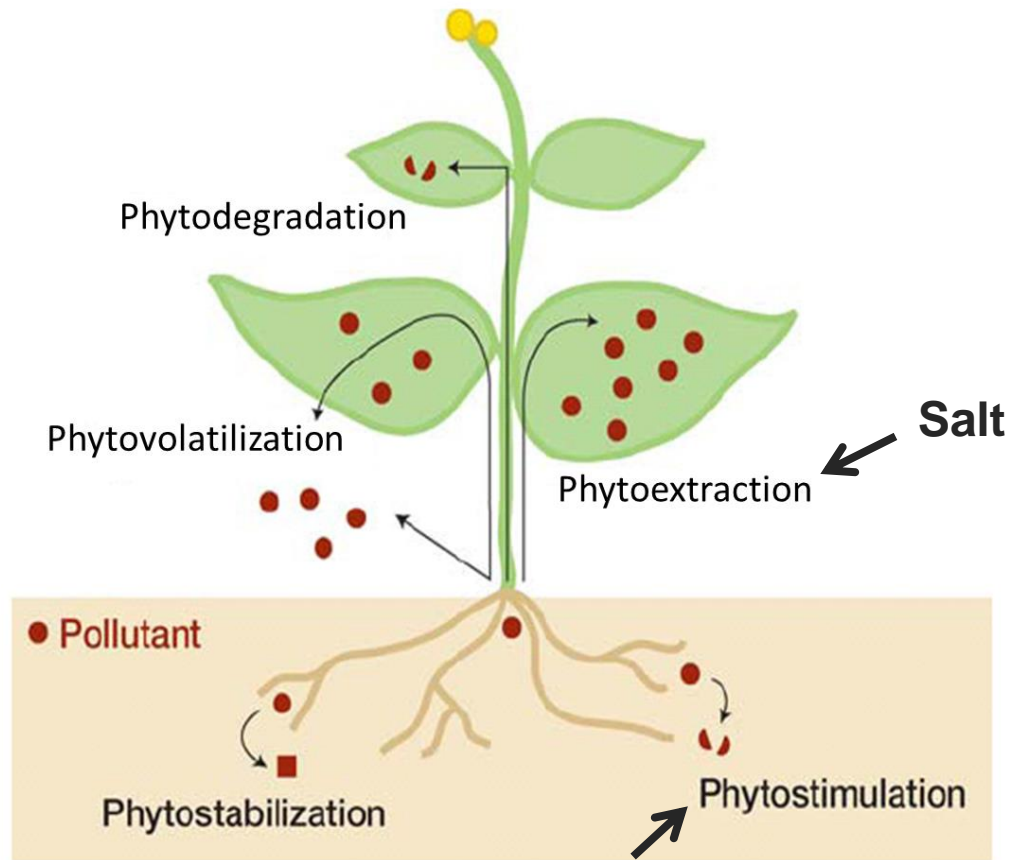
Rhizodegradation – Petroleum Hydrocarbons

- Improved rhizosphere
  - Soil
  - Organic matter
  - Bacteria
  - Water
  - Roots
  - Contaminants
- Rhizodegradation
  - Petroleum Hydrocarbons
- Phytoextraction
  - soil → root → foliage
  - Salts
  - Metals

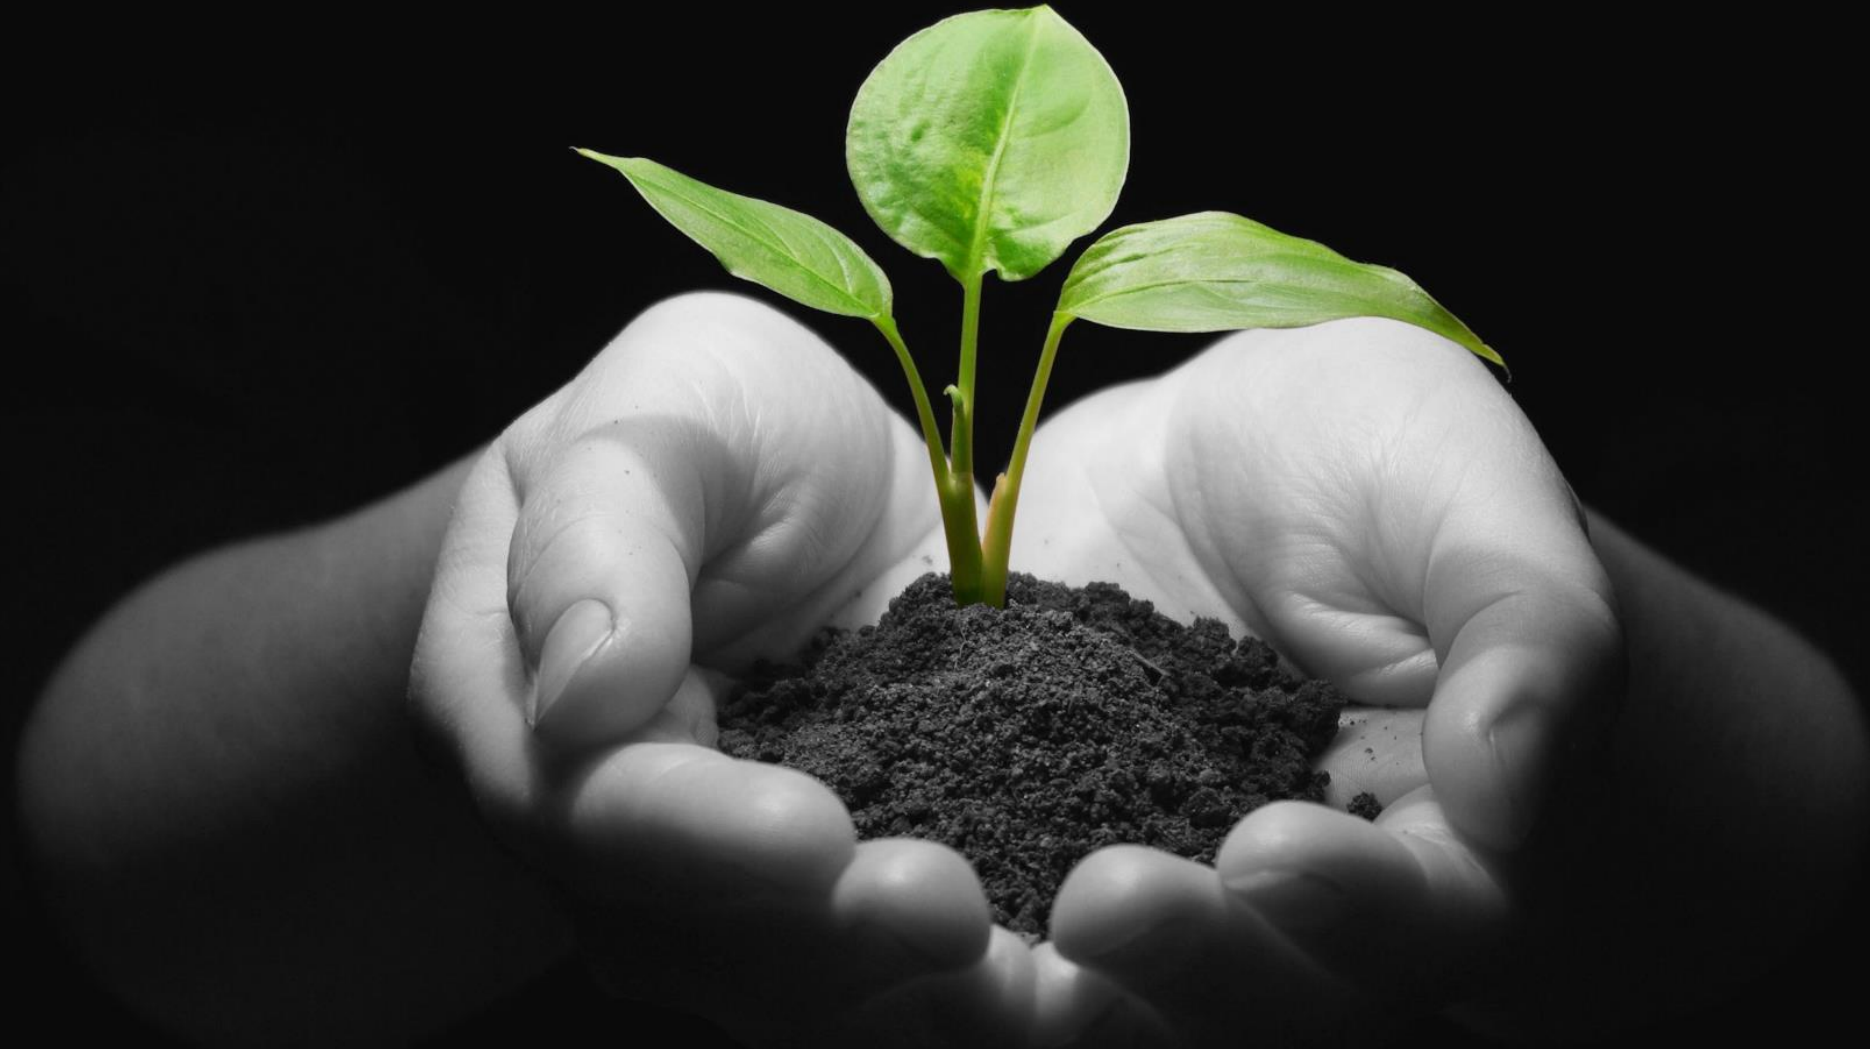
# PEPSystems: Plant Growth Promoting Rhizobacteria (PGPR) - Enhanced Phytoremediation Systems

- Developed through collaboration between Dr. Bruce Greenberg of the University of Waterloo and Earthmaster for contaminated site clean-up.
- Earthmaster has assumed control of the PEPSystems technology and now manages all PGPR testing, selection, seed treating, and overall site specific remediation system design in Calgary. Dr. Greenberg continues to collaborate on PEPSystems.
- Earthmaster continues to conduct research on how to improve PEPSystems for remediation of contaminated sites or other applications such as to enhance plant growth on marginal or poor quality soils.

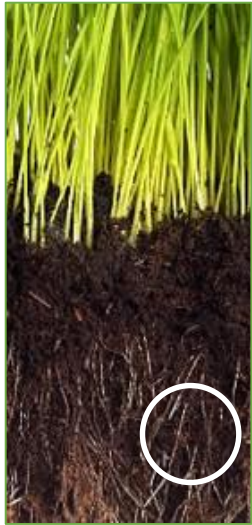
**Active rhizosphere:**  
PGPR co-localize with developing roots

- ↓ Stress ethylene
- ↑ Plant vigor
- ↑ Root development
- ↑ Rhizobacteria
- ↑ Leaves
- ↑ Salt and metals uptake
- ↑ Degradation of PHC

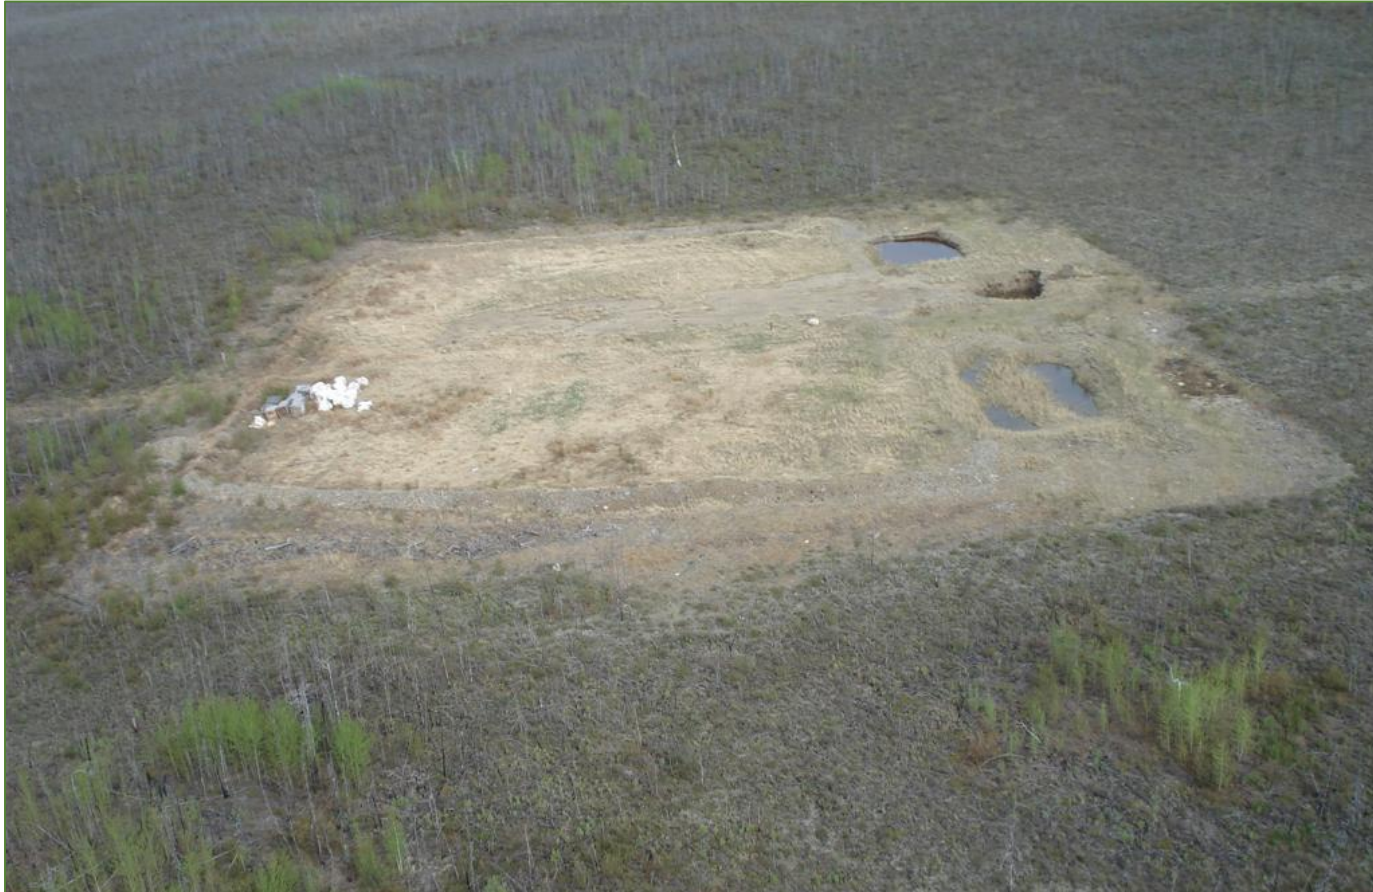
Approximately 5,800 m<sup>3</sup> of material were excavated from former pits and sumps onsite to be treated for PHC contamination resulting from historical drilling activities:

- Land use – industrial
- Soil texture – coarse
- CCME remediation guideline values F2:
  - surface soil – 260 mg/kg
  - subsoil – 320 mg/kg
- Seed – Arg, Prg, TF
- PGPR – *Pseudomonas corrugata* and *P. marginalis*.
- **Lift #1** T=0 June 2008
  - Surface soil treated for salt and PHC.
  - Completed in July 2011 and left in place.
  - Additional material was excavated and placed on top of Lift #1 for treatment.

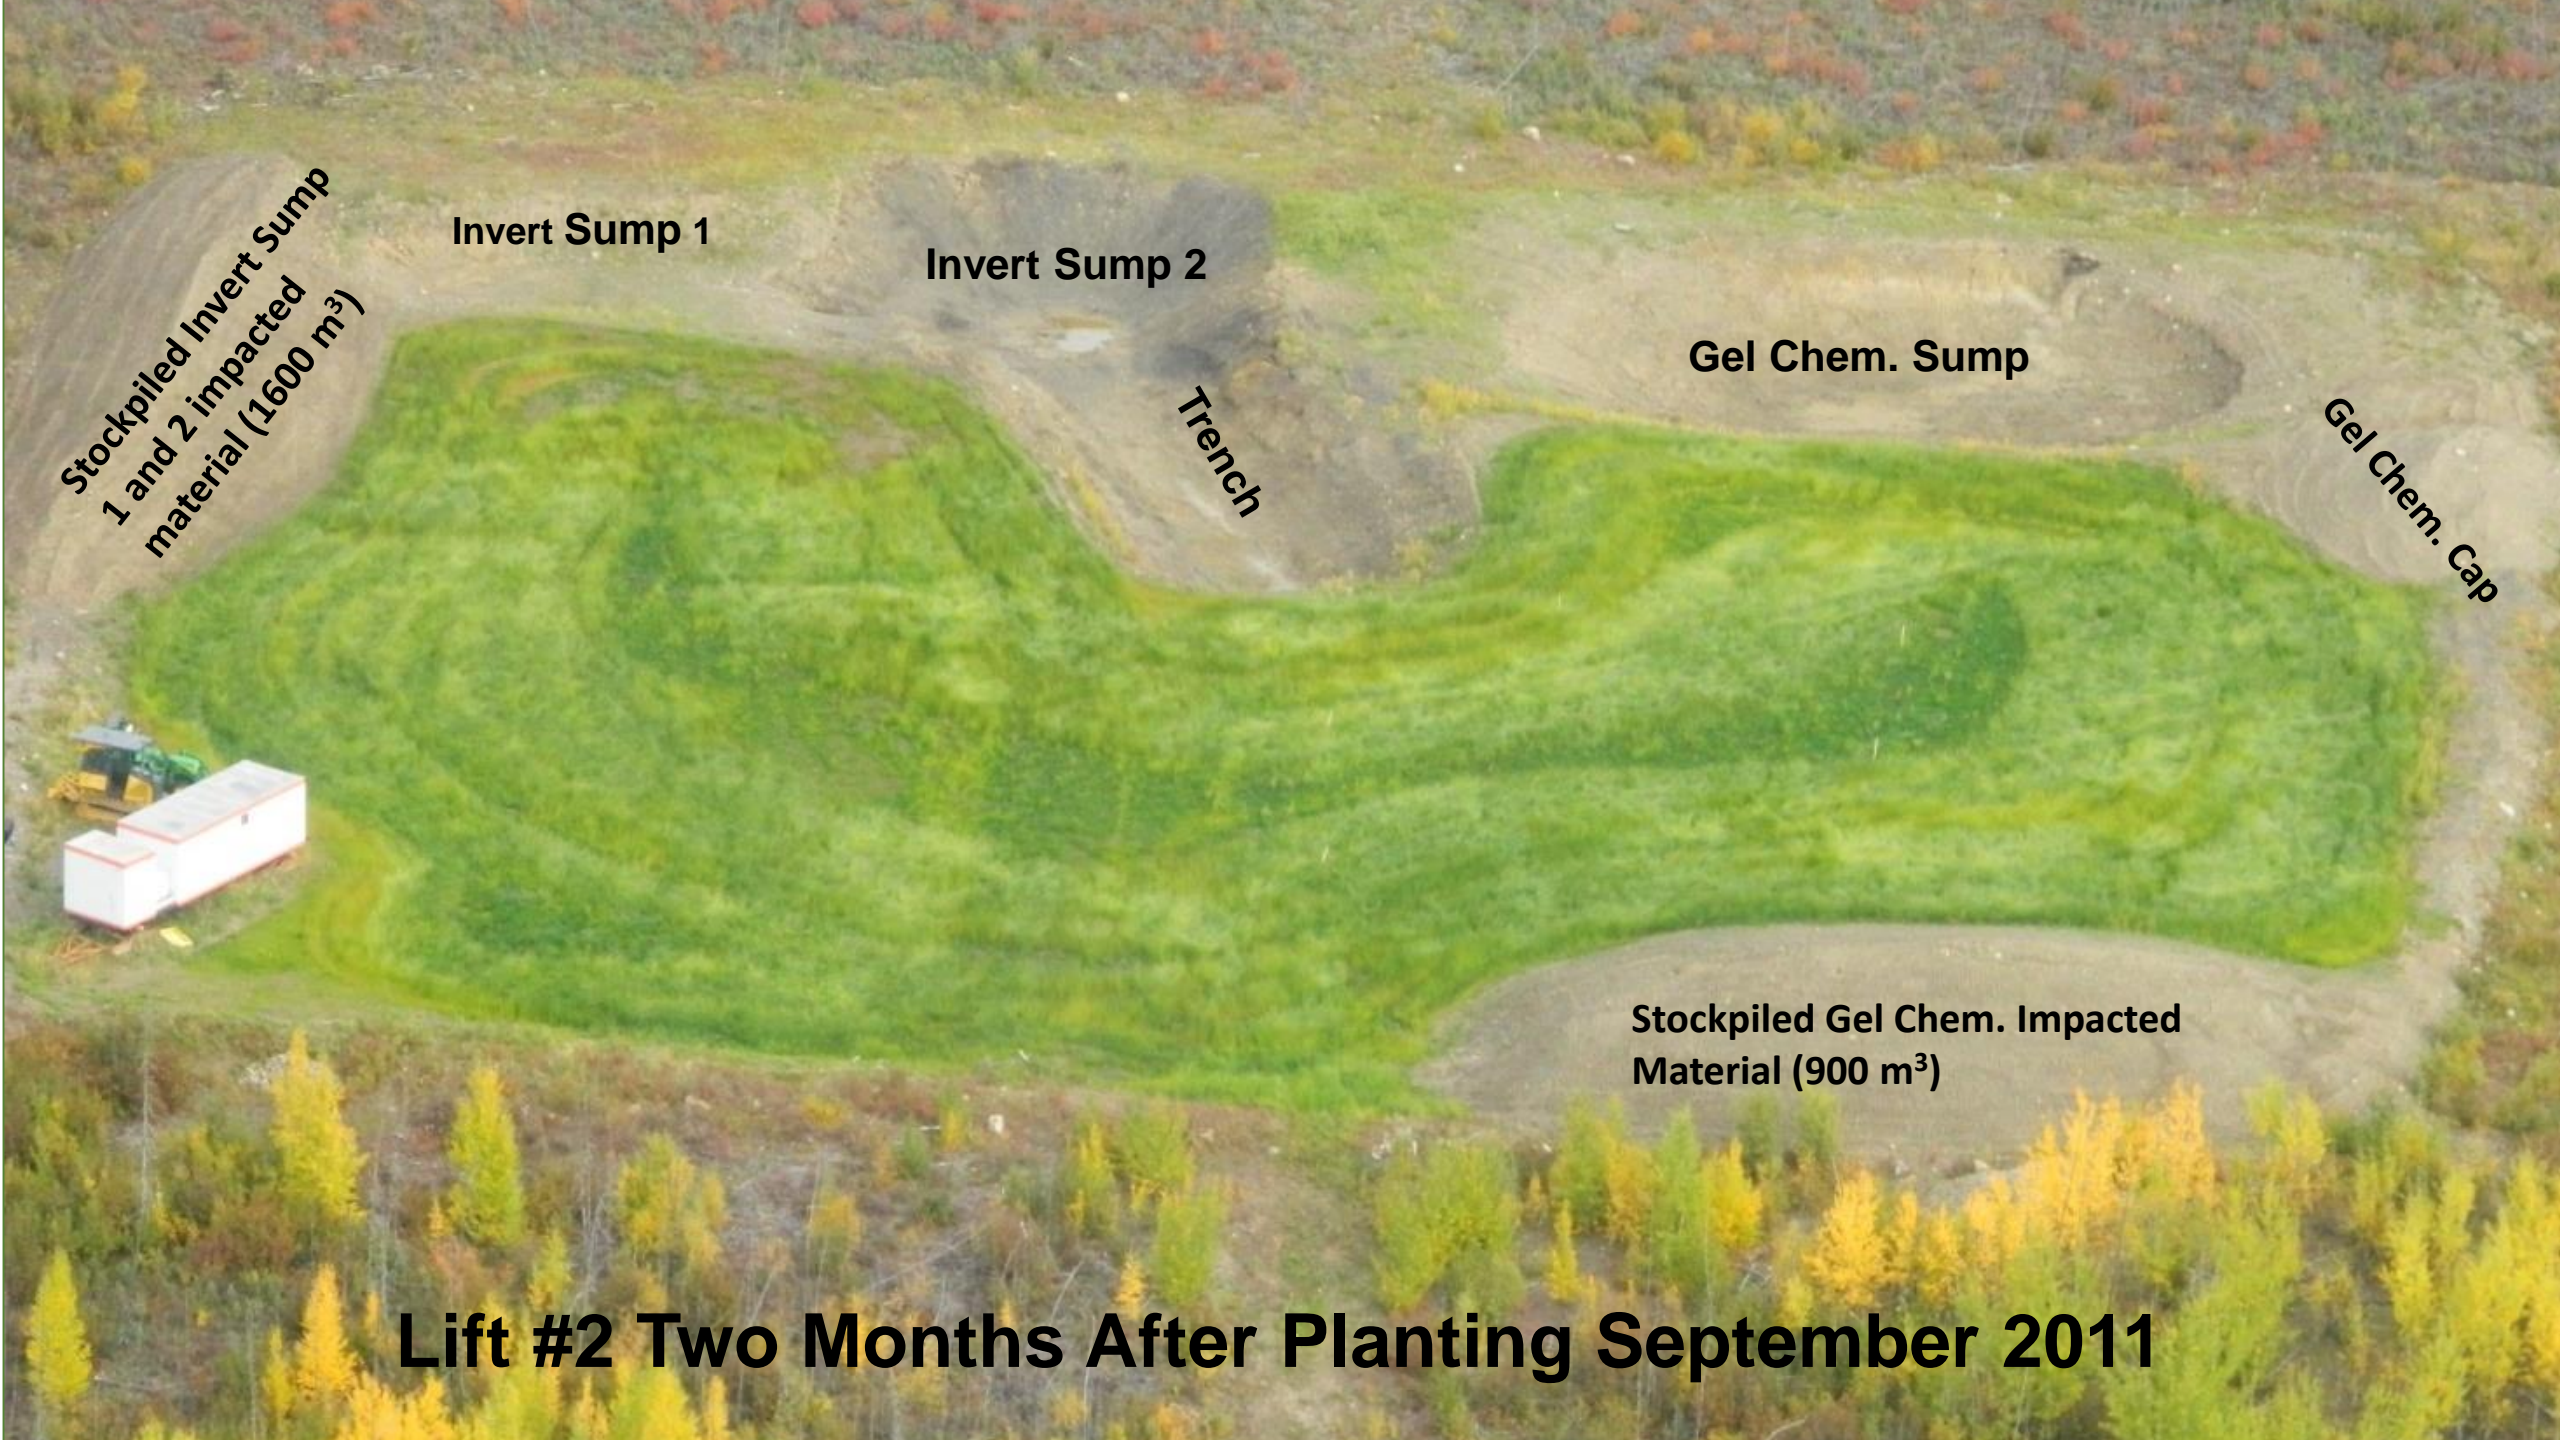
**Lift #2 Two Months After Planting September 2011**

**Stockpiled Invert Sump  
1 and 2 impacted  
material (1600 m<sup>3</sup>)**

**Invert Sump 1**

**Invert Sump 2**

**Trench**

**Gel Chem. Sump**

**Gel Chem. Cap**

**Stockpiled Gel Chem. Impacted  
Material (900 m<sup>3</sup>)**

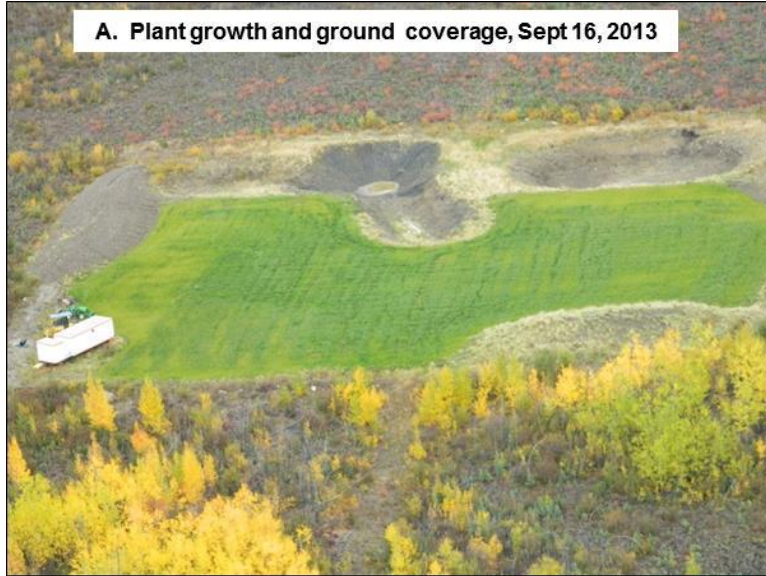
A. Plant growth and ground coverage, Sept 16, 2013

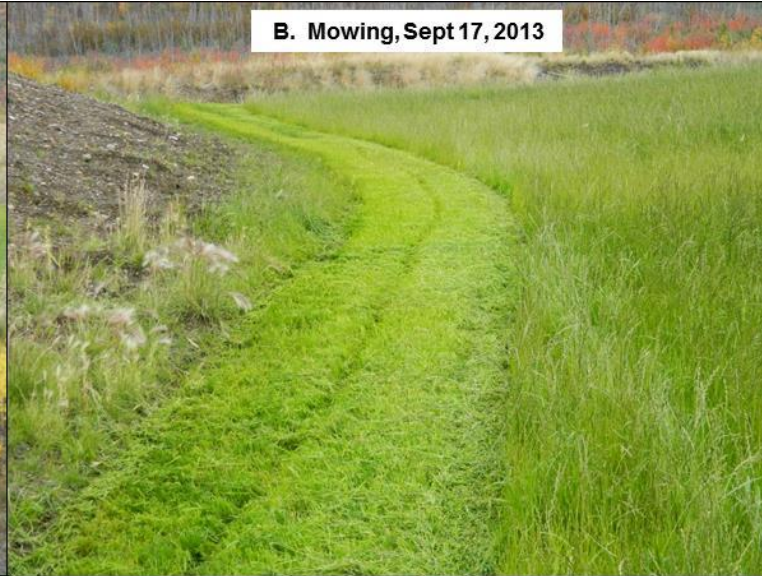
B. Mowing, Sept 17, 2013

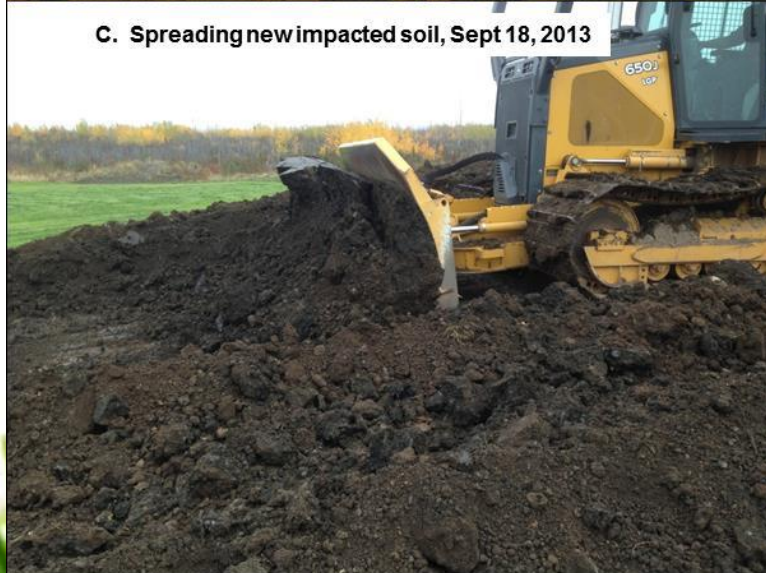
C. Spreading new impacted soil, Sept 18, 2013

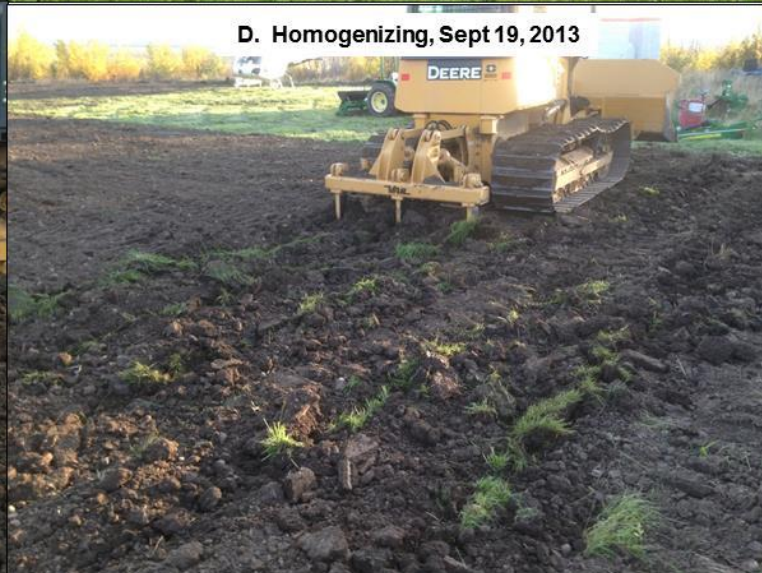
D. Homogenizing, Sept 19, 2013

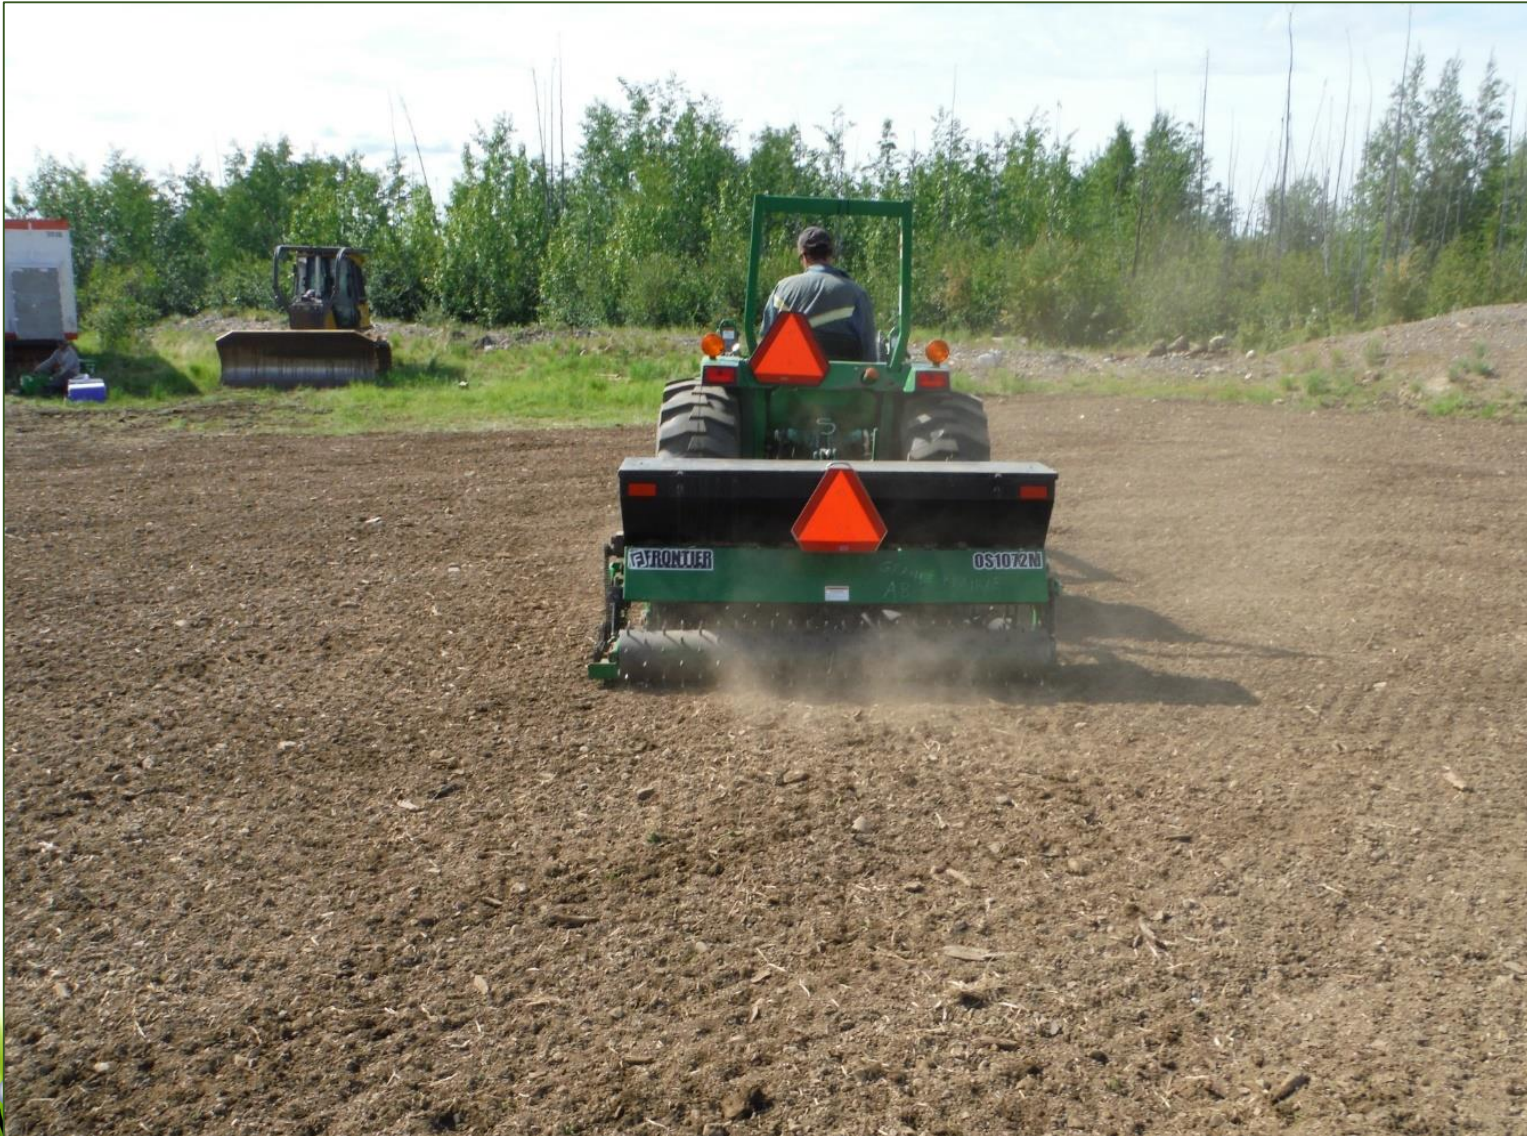
# Lift #3 Seeding June 2015

Using the September 2013  $C_0$  value:

Depth	T=0 ( $C_0$ )	x yrs	$C_{2.1 \text{ yrs}}$
0.00-0.30 m	1417	3.8	275

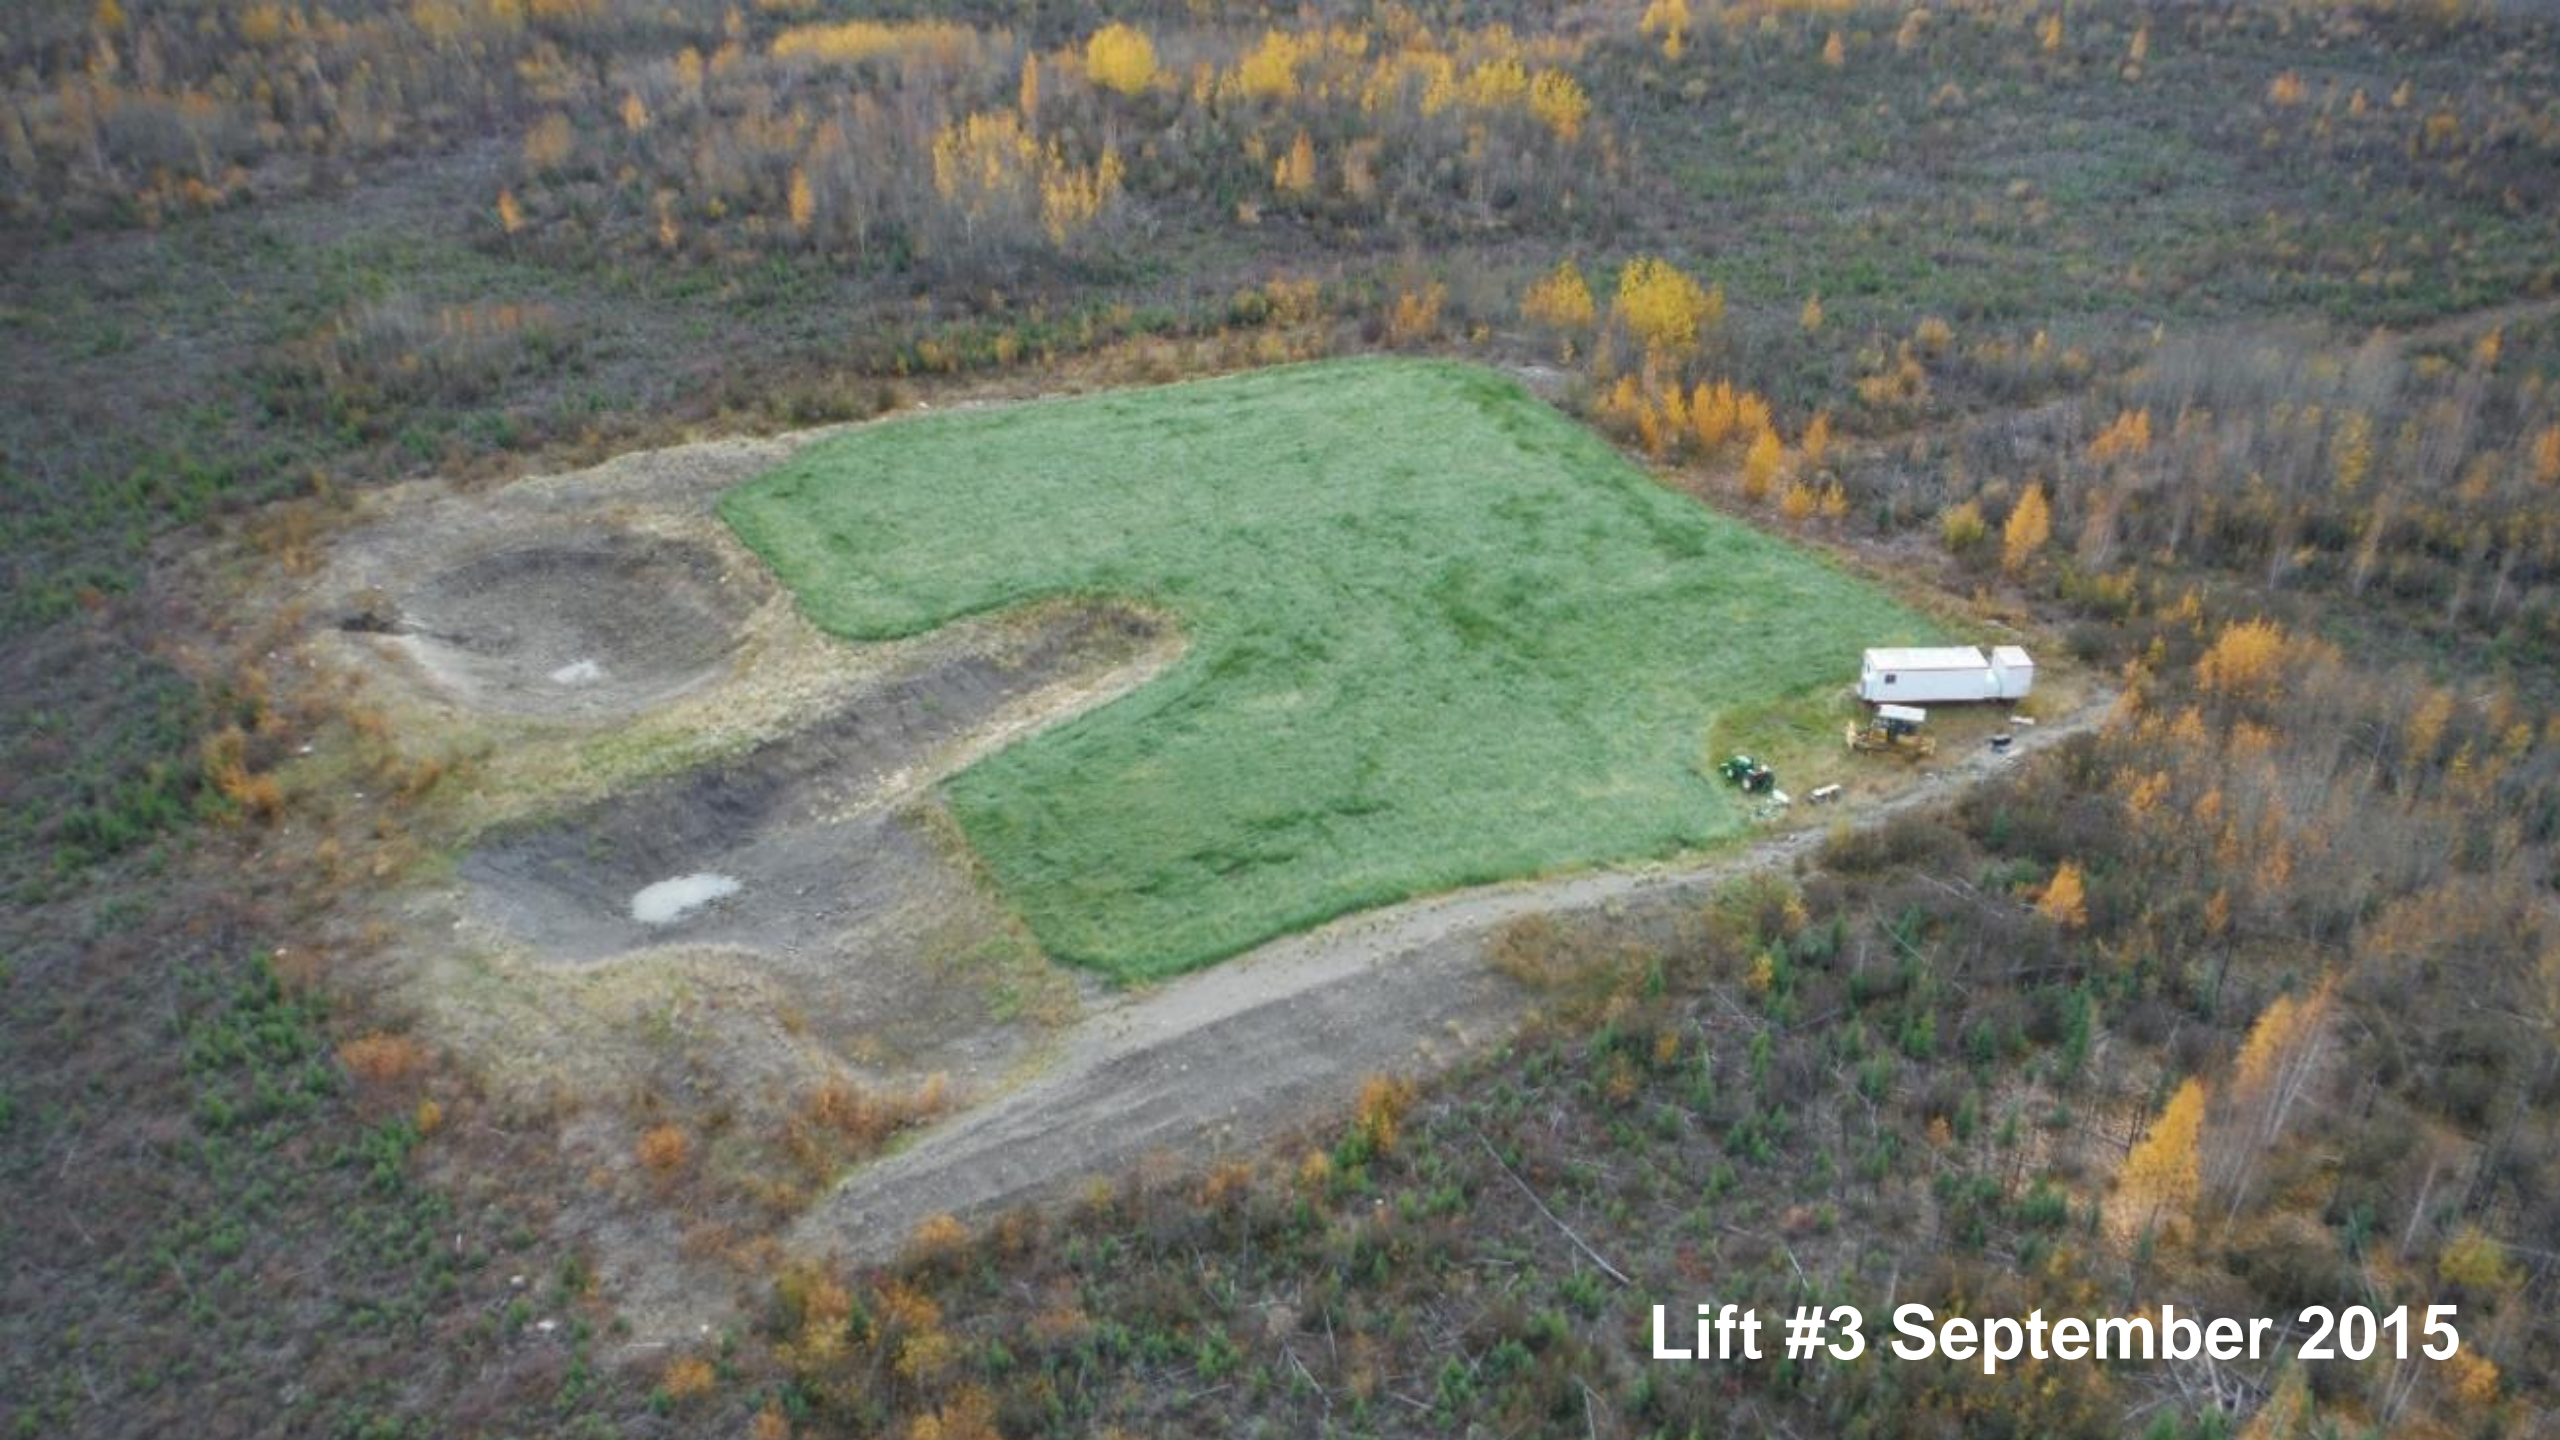
**Lift #3 September 2015**

**Lift #3:**  
Earthmaster assumed  
control of the site in 2015.

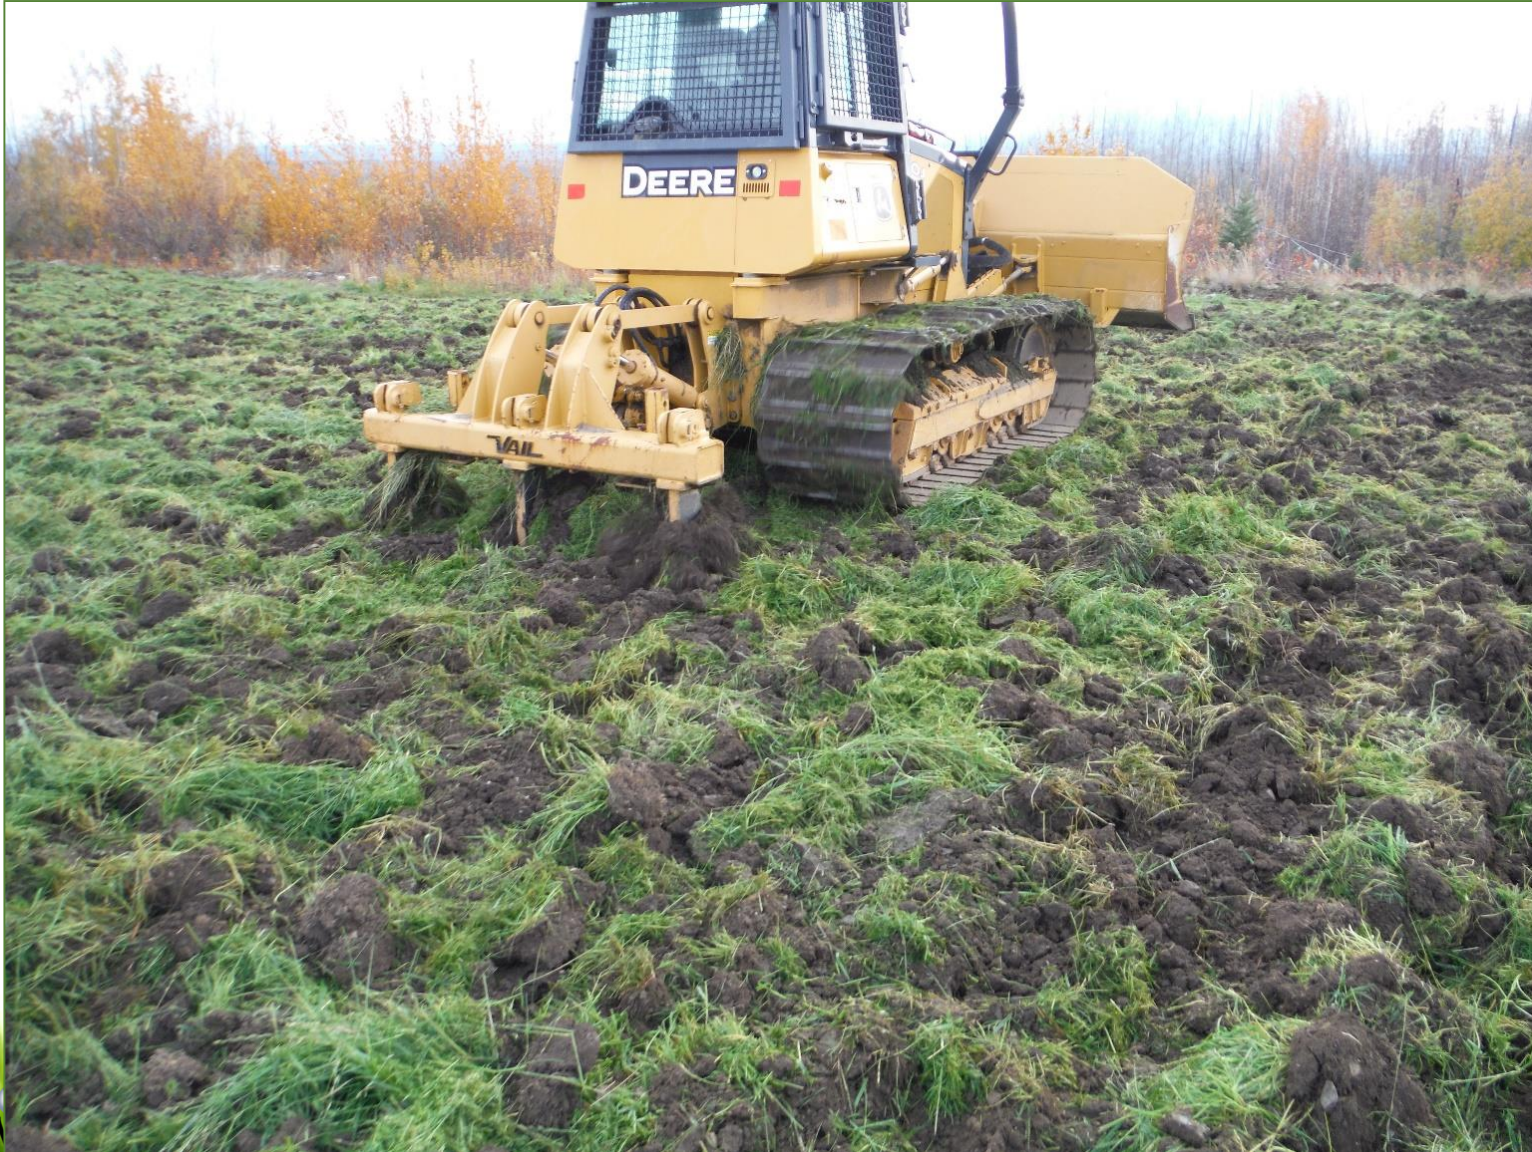
# Lift #4 – Ripping to Incorporate Organics

## **Lift #3:**

End of growing season (September 2015) and preparation for lift #4.

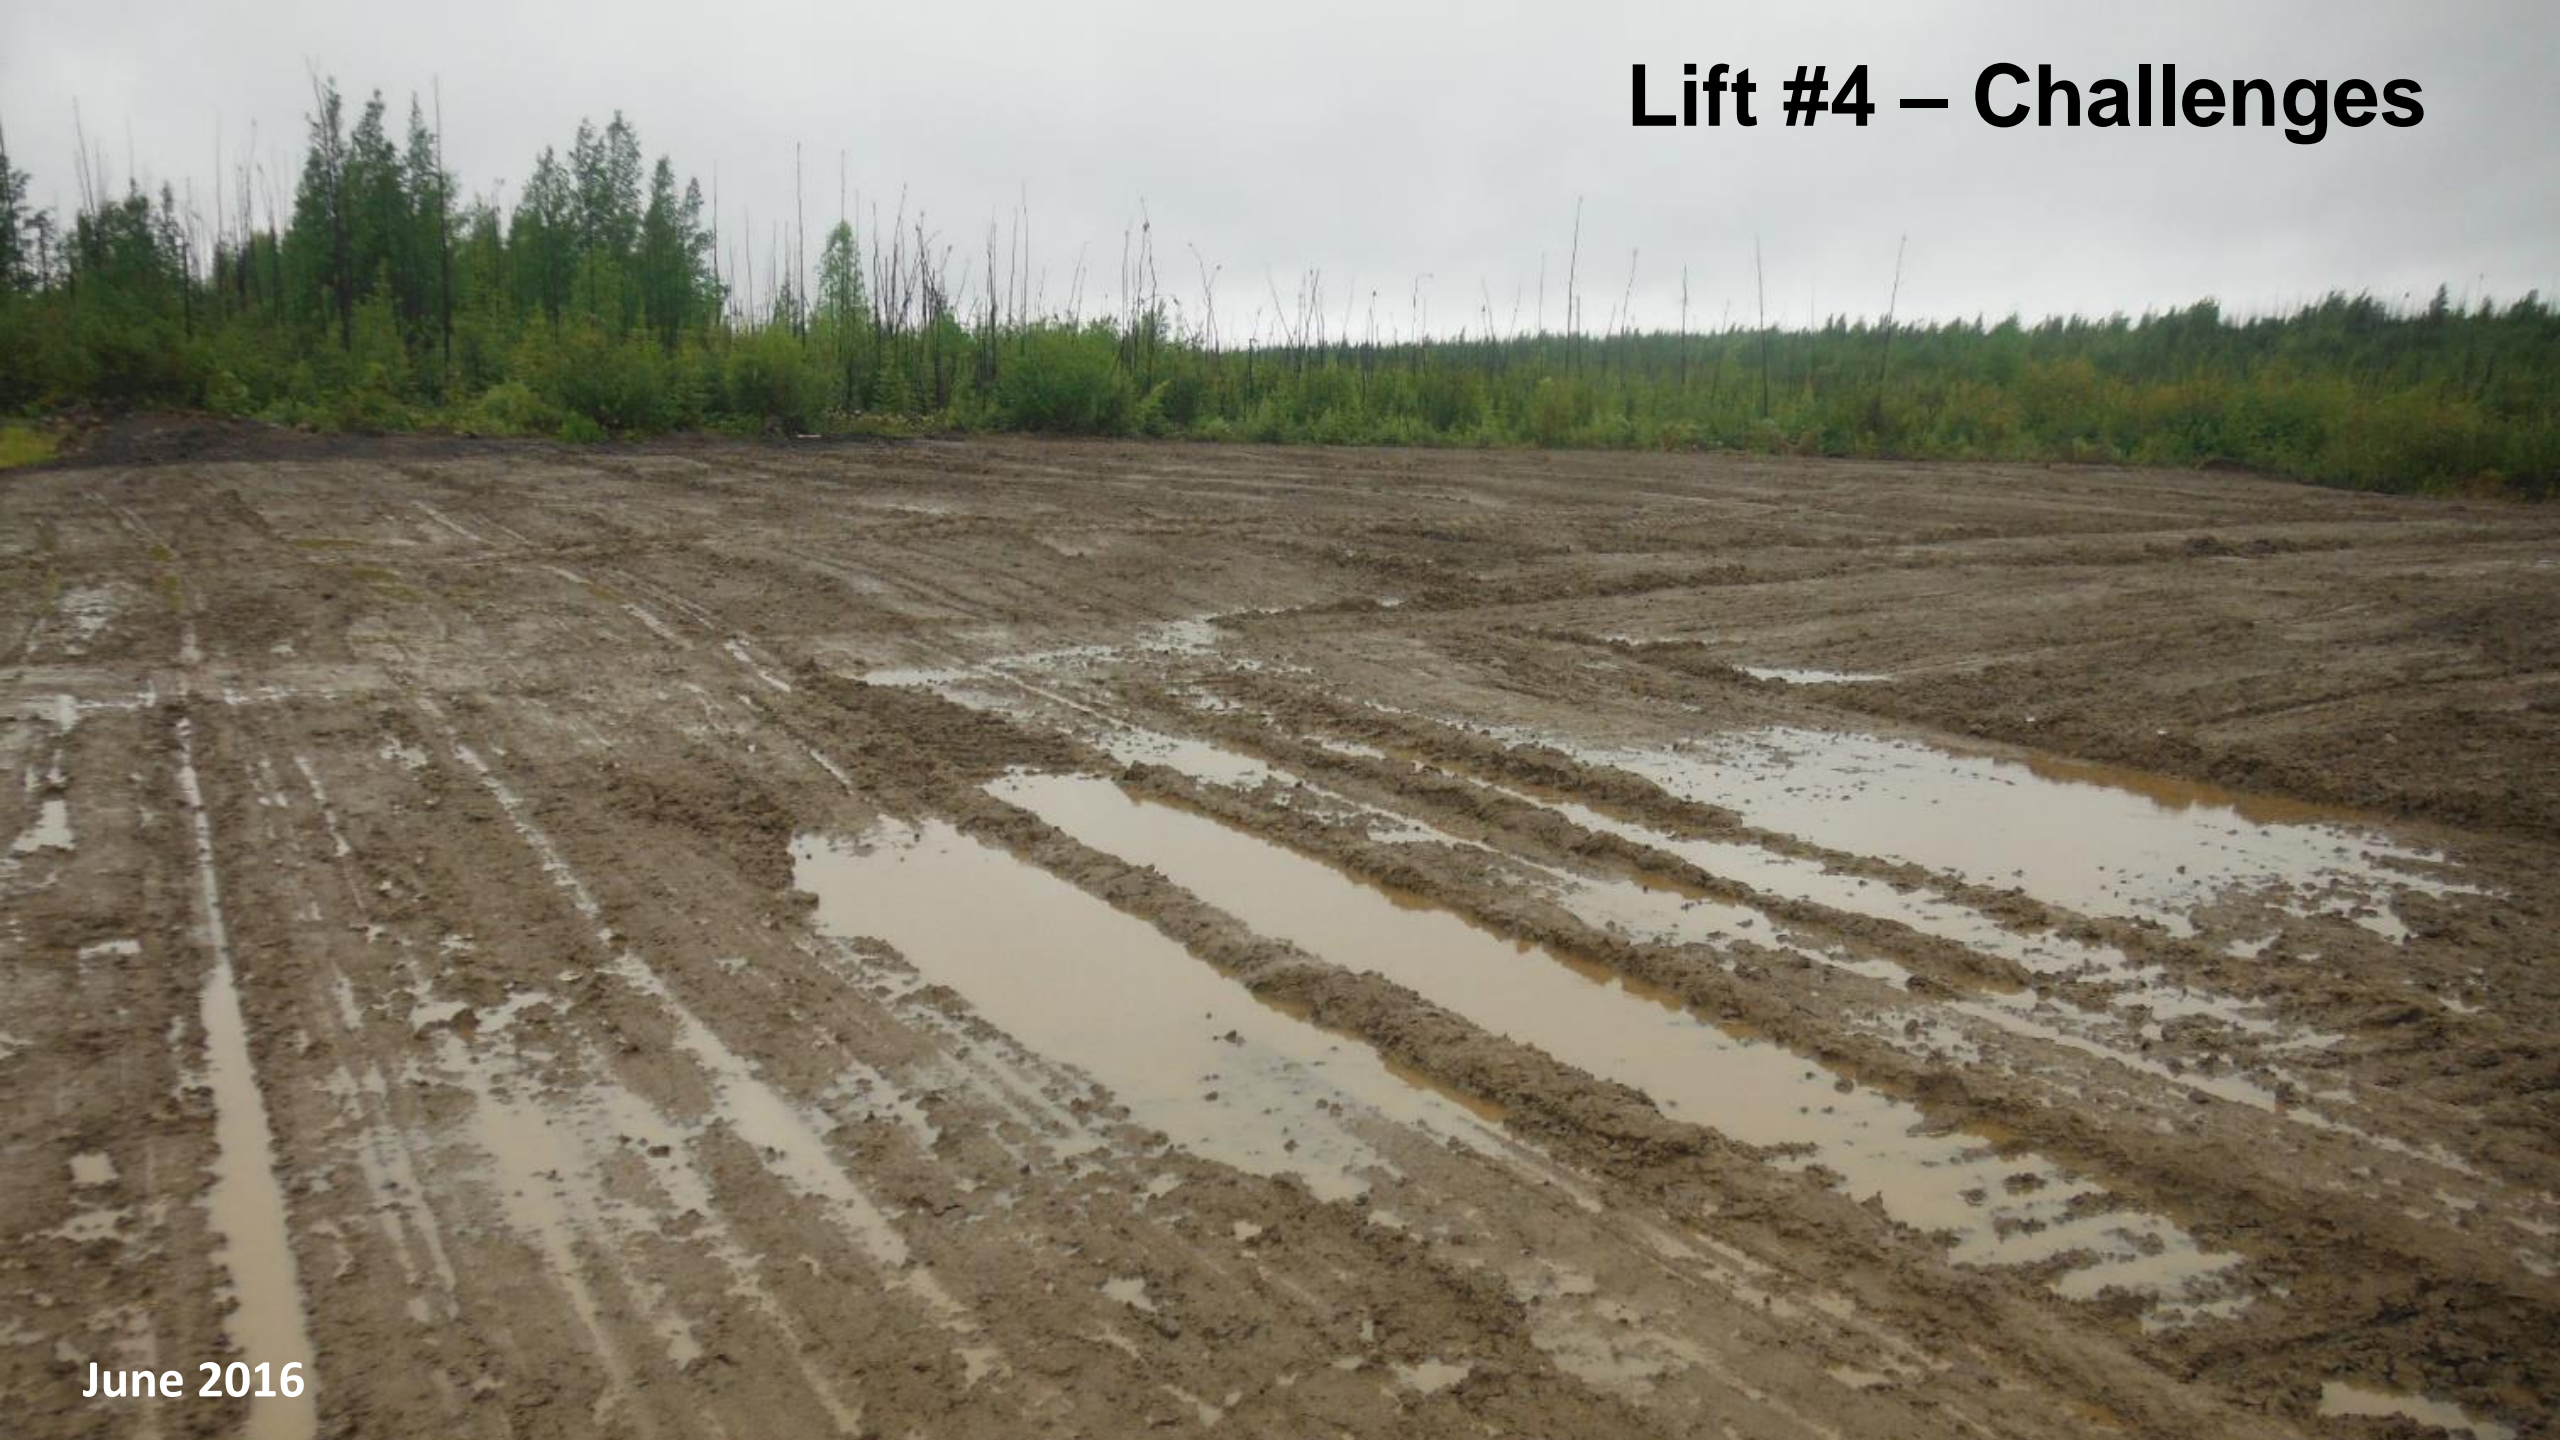
June 2016

# Lift #4 – Challenges

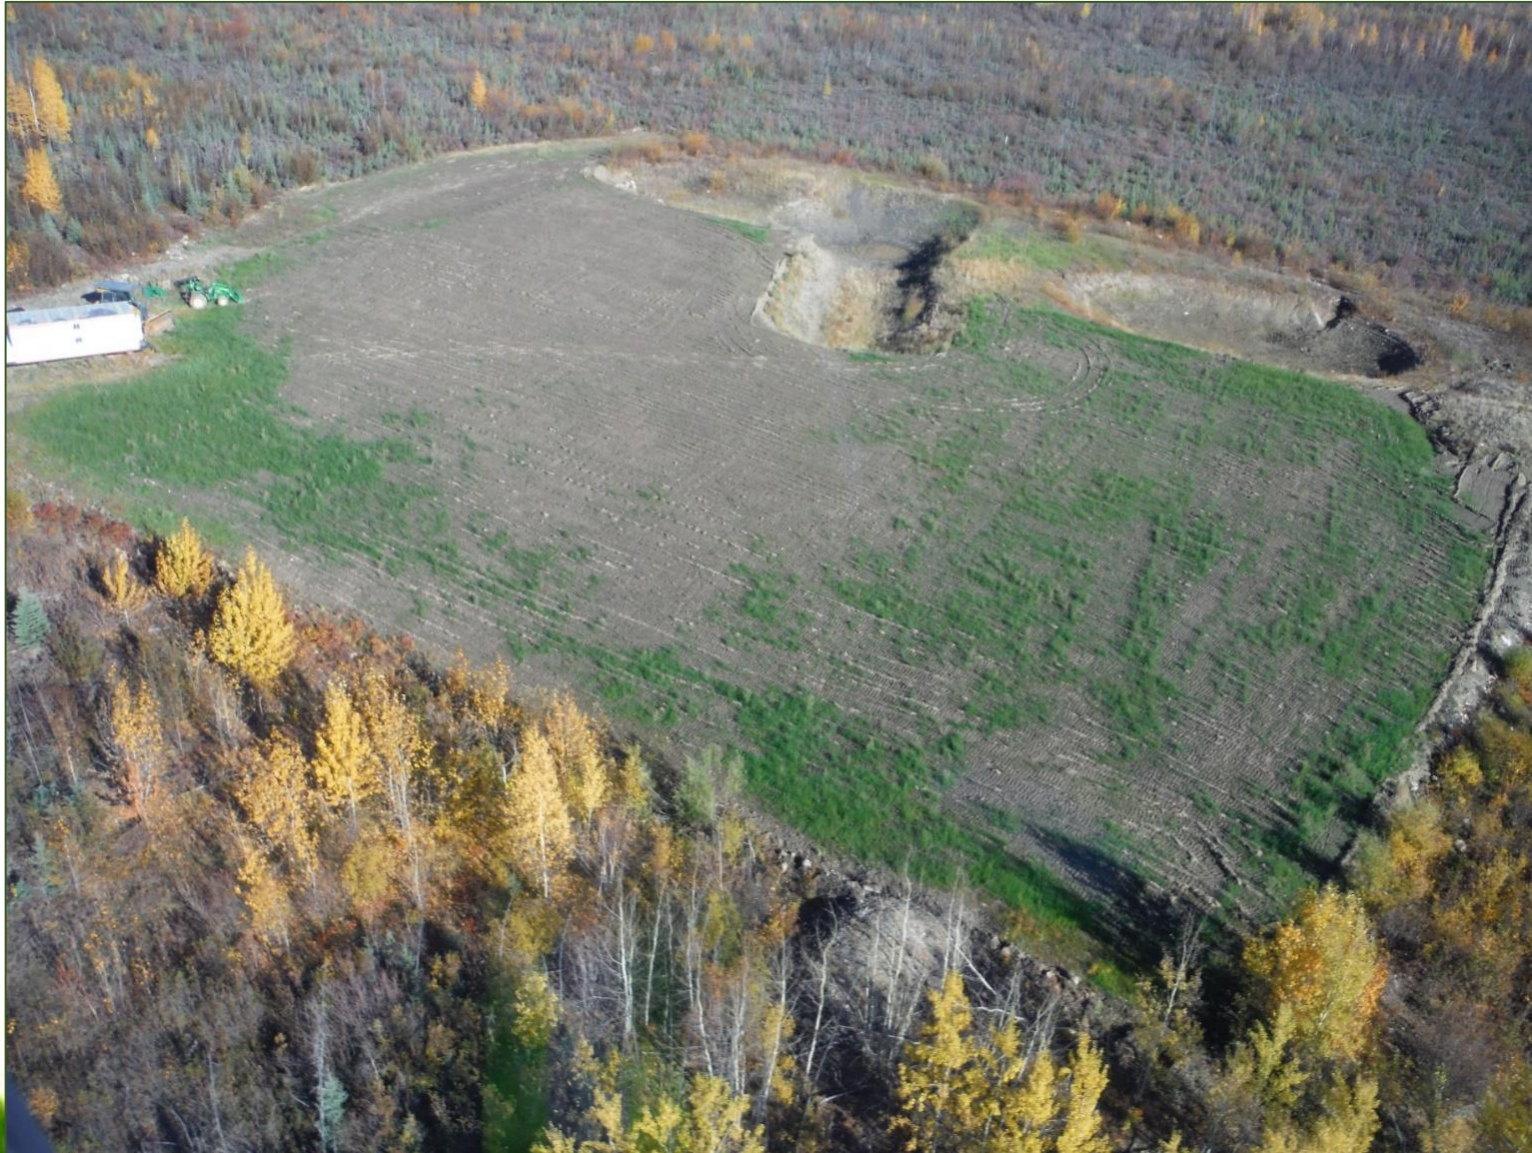
# Lift #4 September 2016

## Lift #4:

1,600 m<sup>3</sup> were spread on lift #3 and treated for PHC F2 contamination. 1,250 m<sup>3</sup> were stripped in June 2017 and placed in an excavation.

Lift #4 Sample Chemistry T = 0				
Depth	PHC	Jul 2016		
		# samples	range	average*
0.00-0.30 m	F2	23 of 25	268-1350	644±73

Depth	T=0 (C <sub>0</sub> )	x yrs	C <sub>0.3 yrs</sub>
0.00-0.30 m	644	2.0	360
