# Remote Northern and Dryland Phytoremediation of Contaminated Soil

Earthmaster Environmental Strategies  
and the \*University of Waterloo

# Large Scale Phytoremediation

# Site 1 - Nota C-17 Pre-deployment 2008

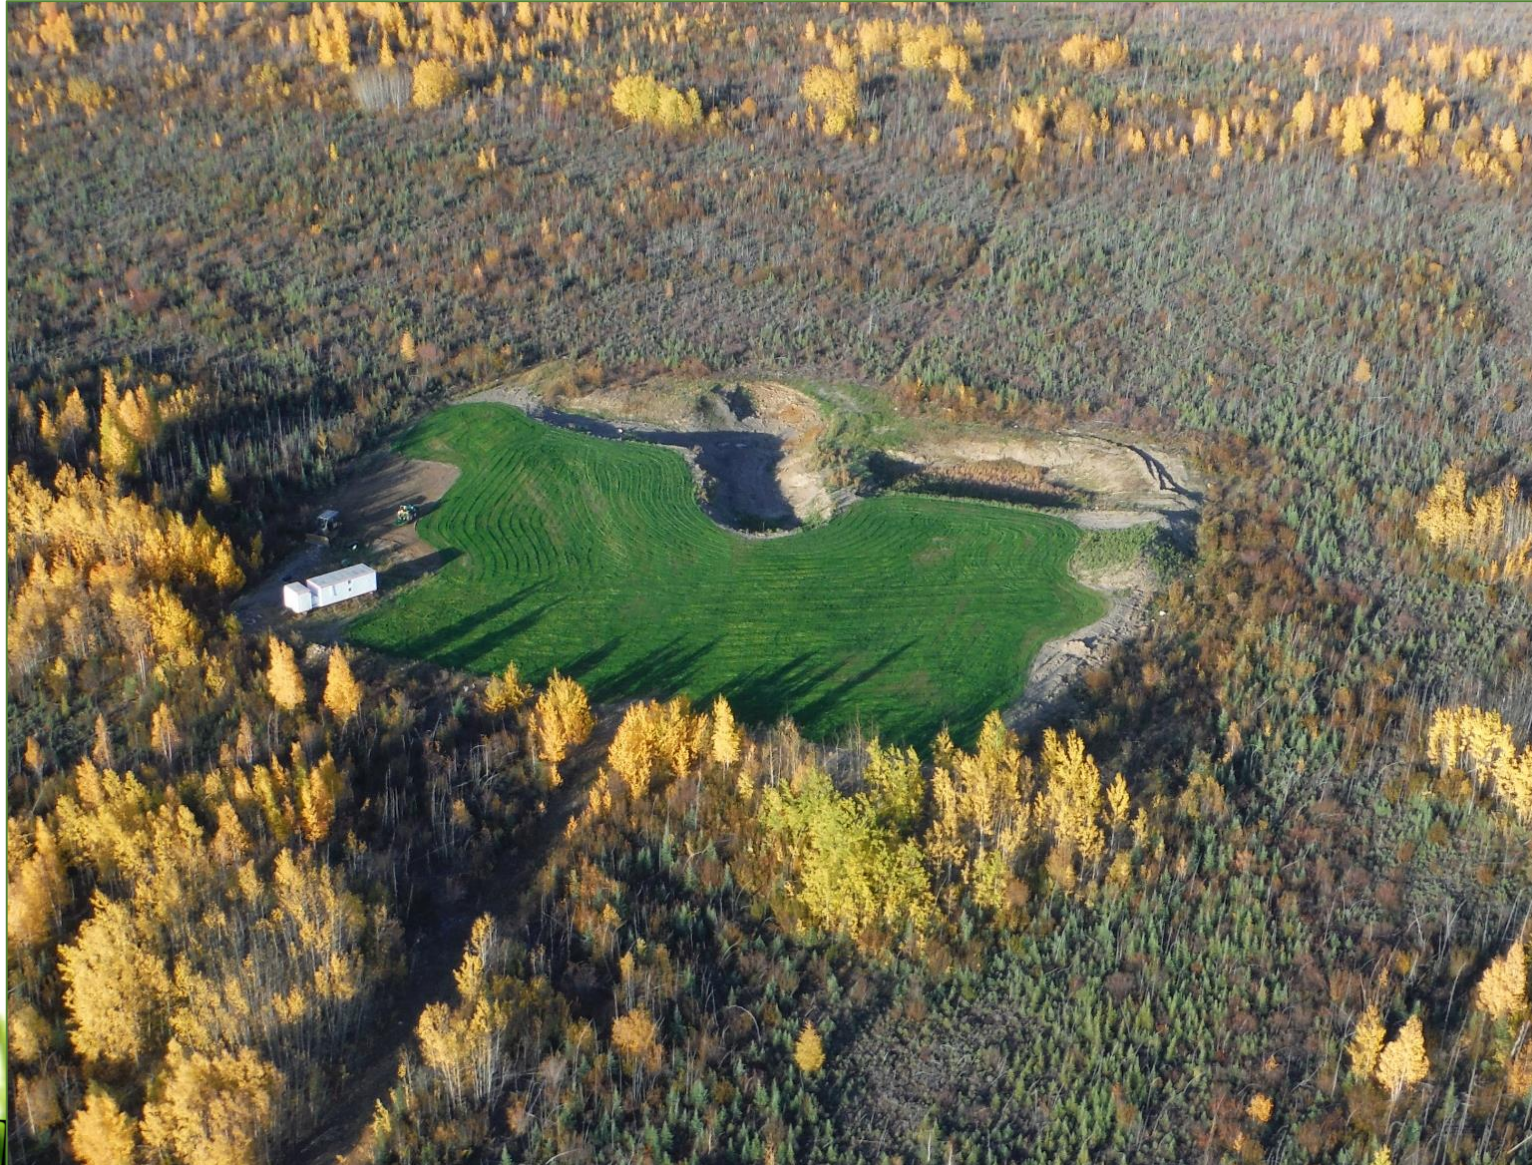
# Lift #5 - September 2017

## Lift #5:

350 m<sup>3</sup> from lift #4 were mixed with 750 m<sup>3</sup> of additional soil. Lift #5 was treated for PHC F2 contamination starting in June 2017.

Lift #5 Sample Chemistry T = 0				
Depth	PHC	Jun 2017		
		# samples	range	average*
0.00-0.30 m	F2	21 of 25	263-826	385±41

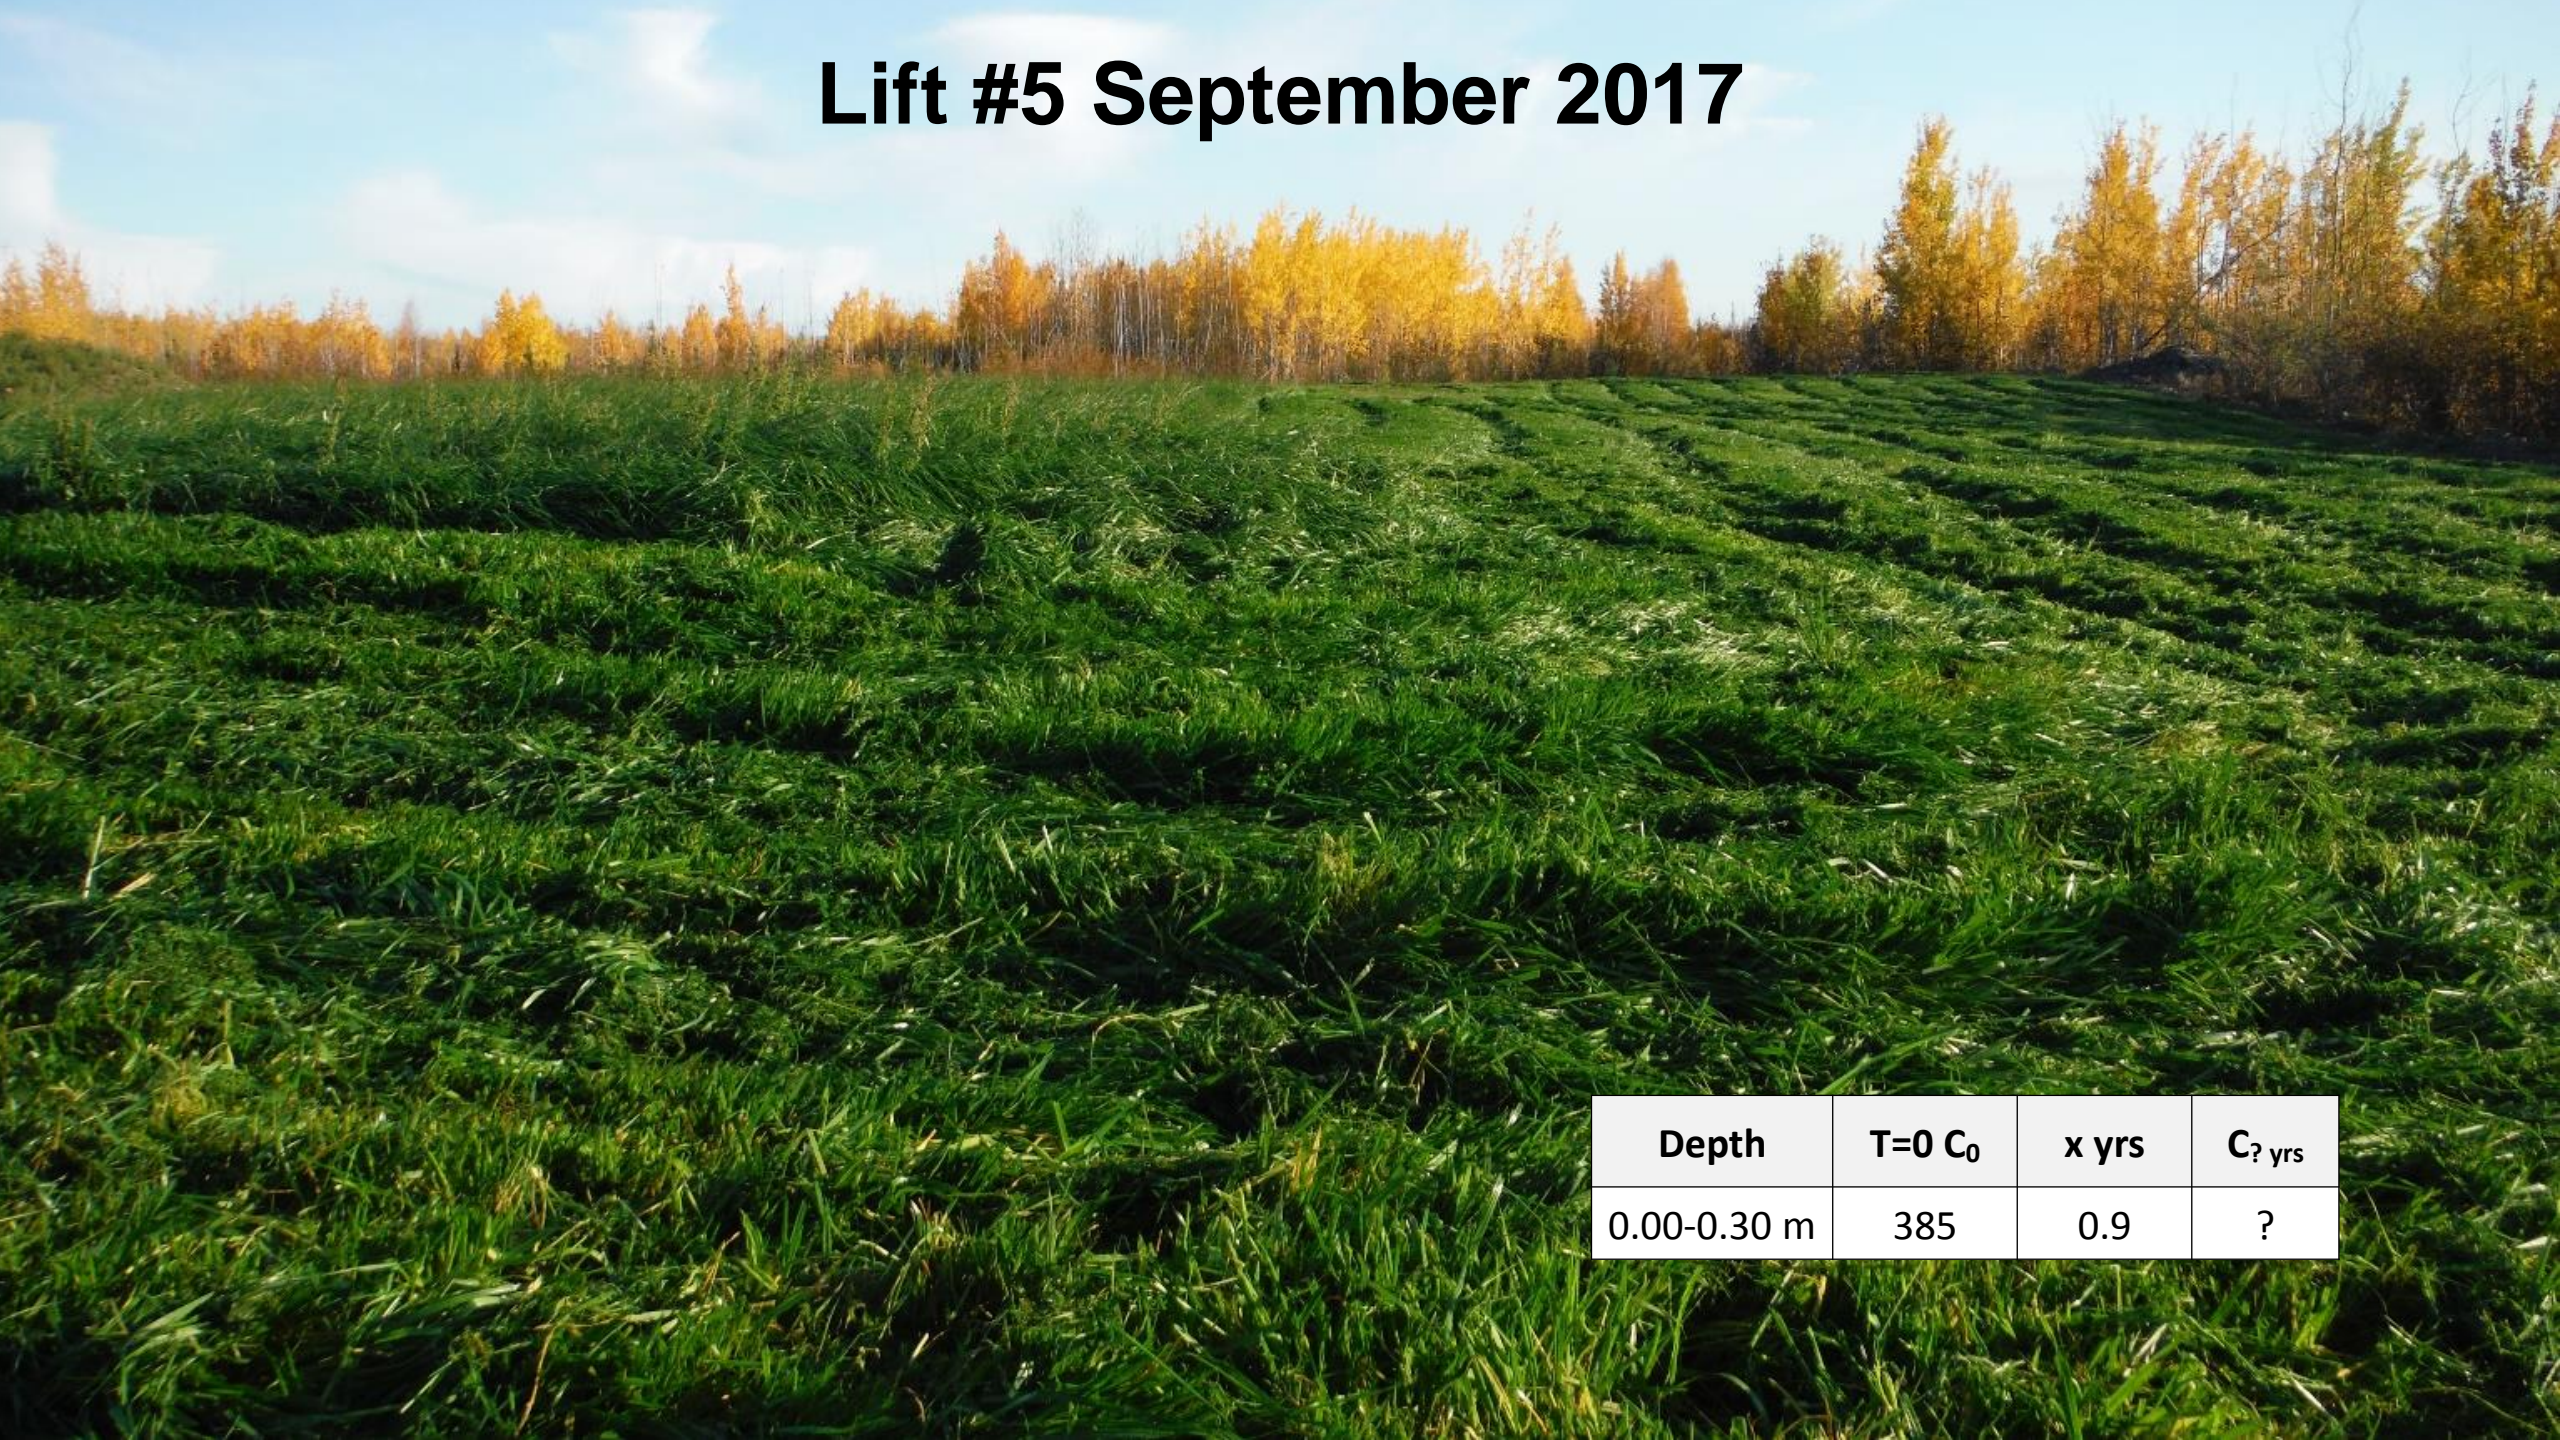
# Lift #5 September 2017

Depth	T=0 C <sub>0</sub>	x yrs	C <sub>? yrs</sub>
0.00-0.30 m	385	0.9	?

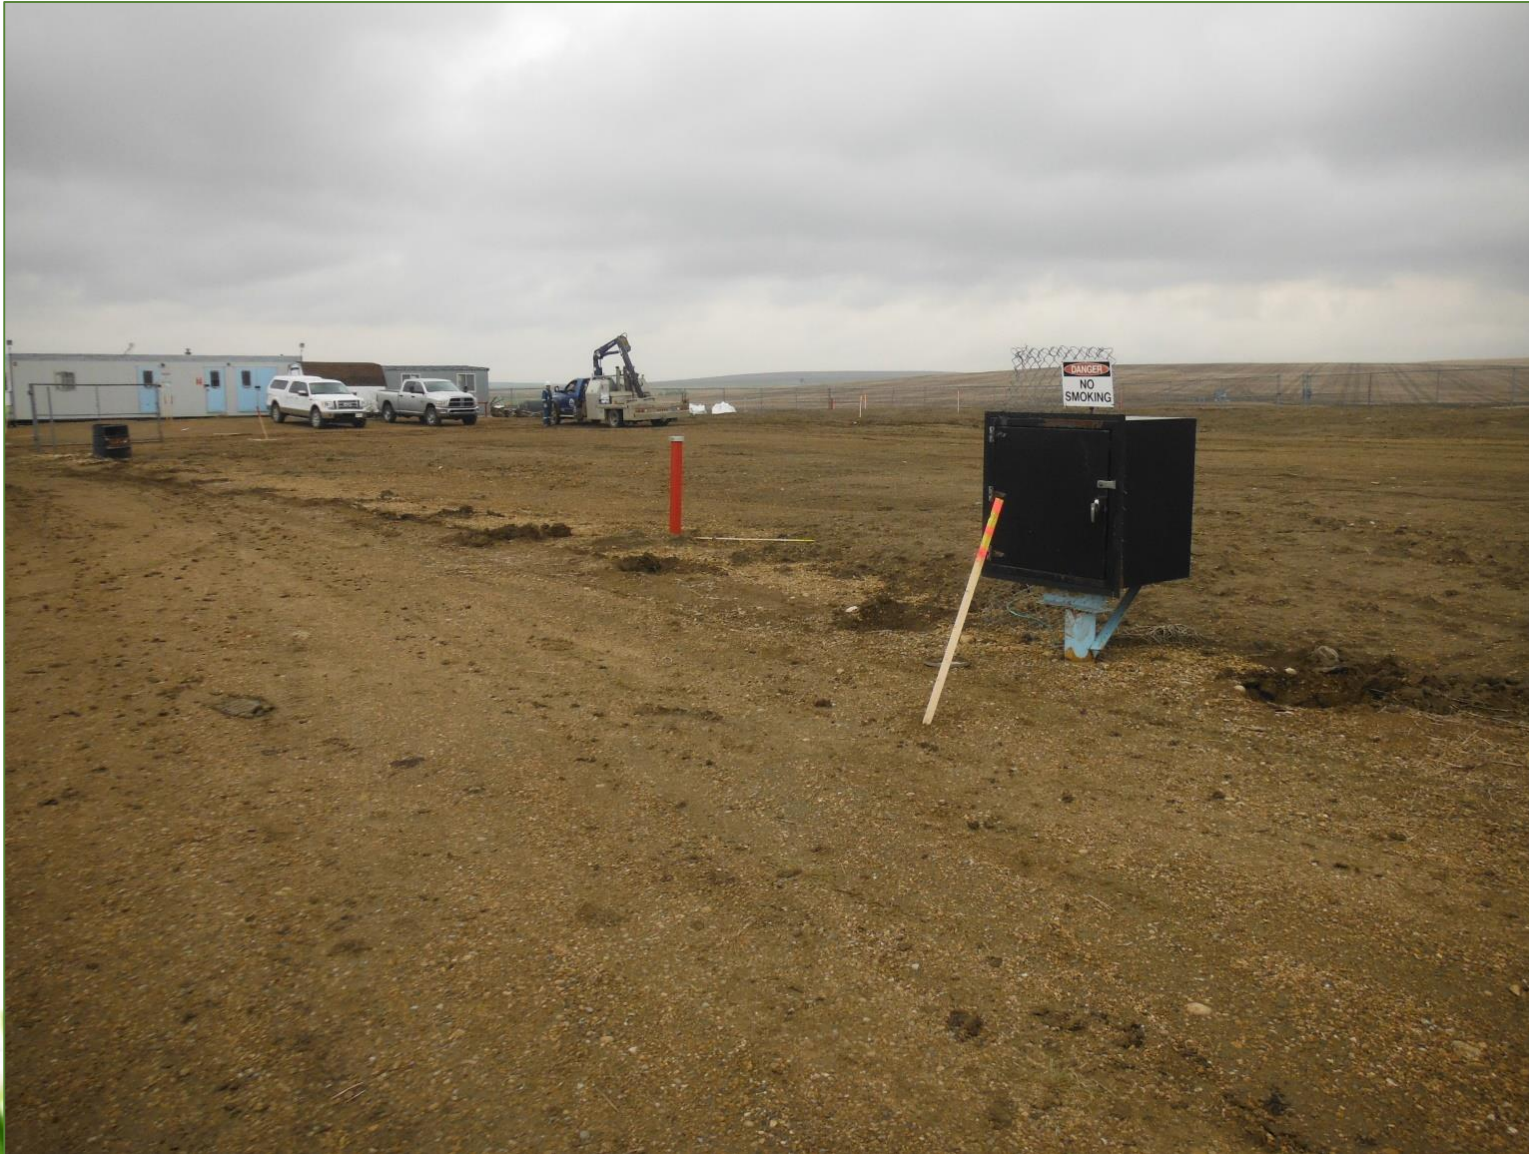
# Site 2 – Craigmyle Pre-deployment May 2015

Former gas plant site with PHC F1 to F4 and BTEX contamination:

- Some site infrastructure needed to be removed.
- A one-time soil treatment facility needed to be constructed.

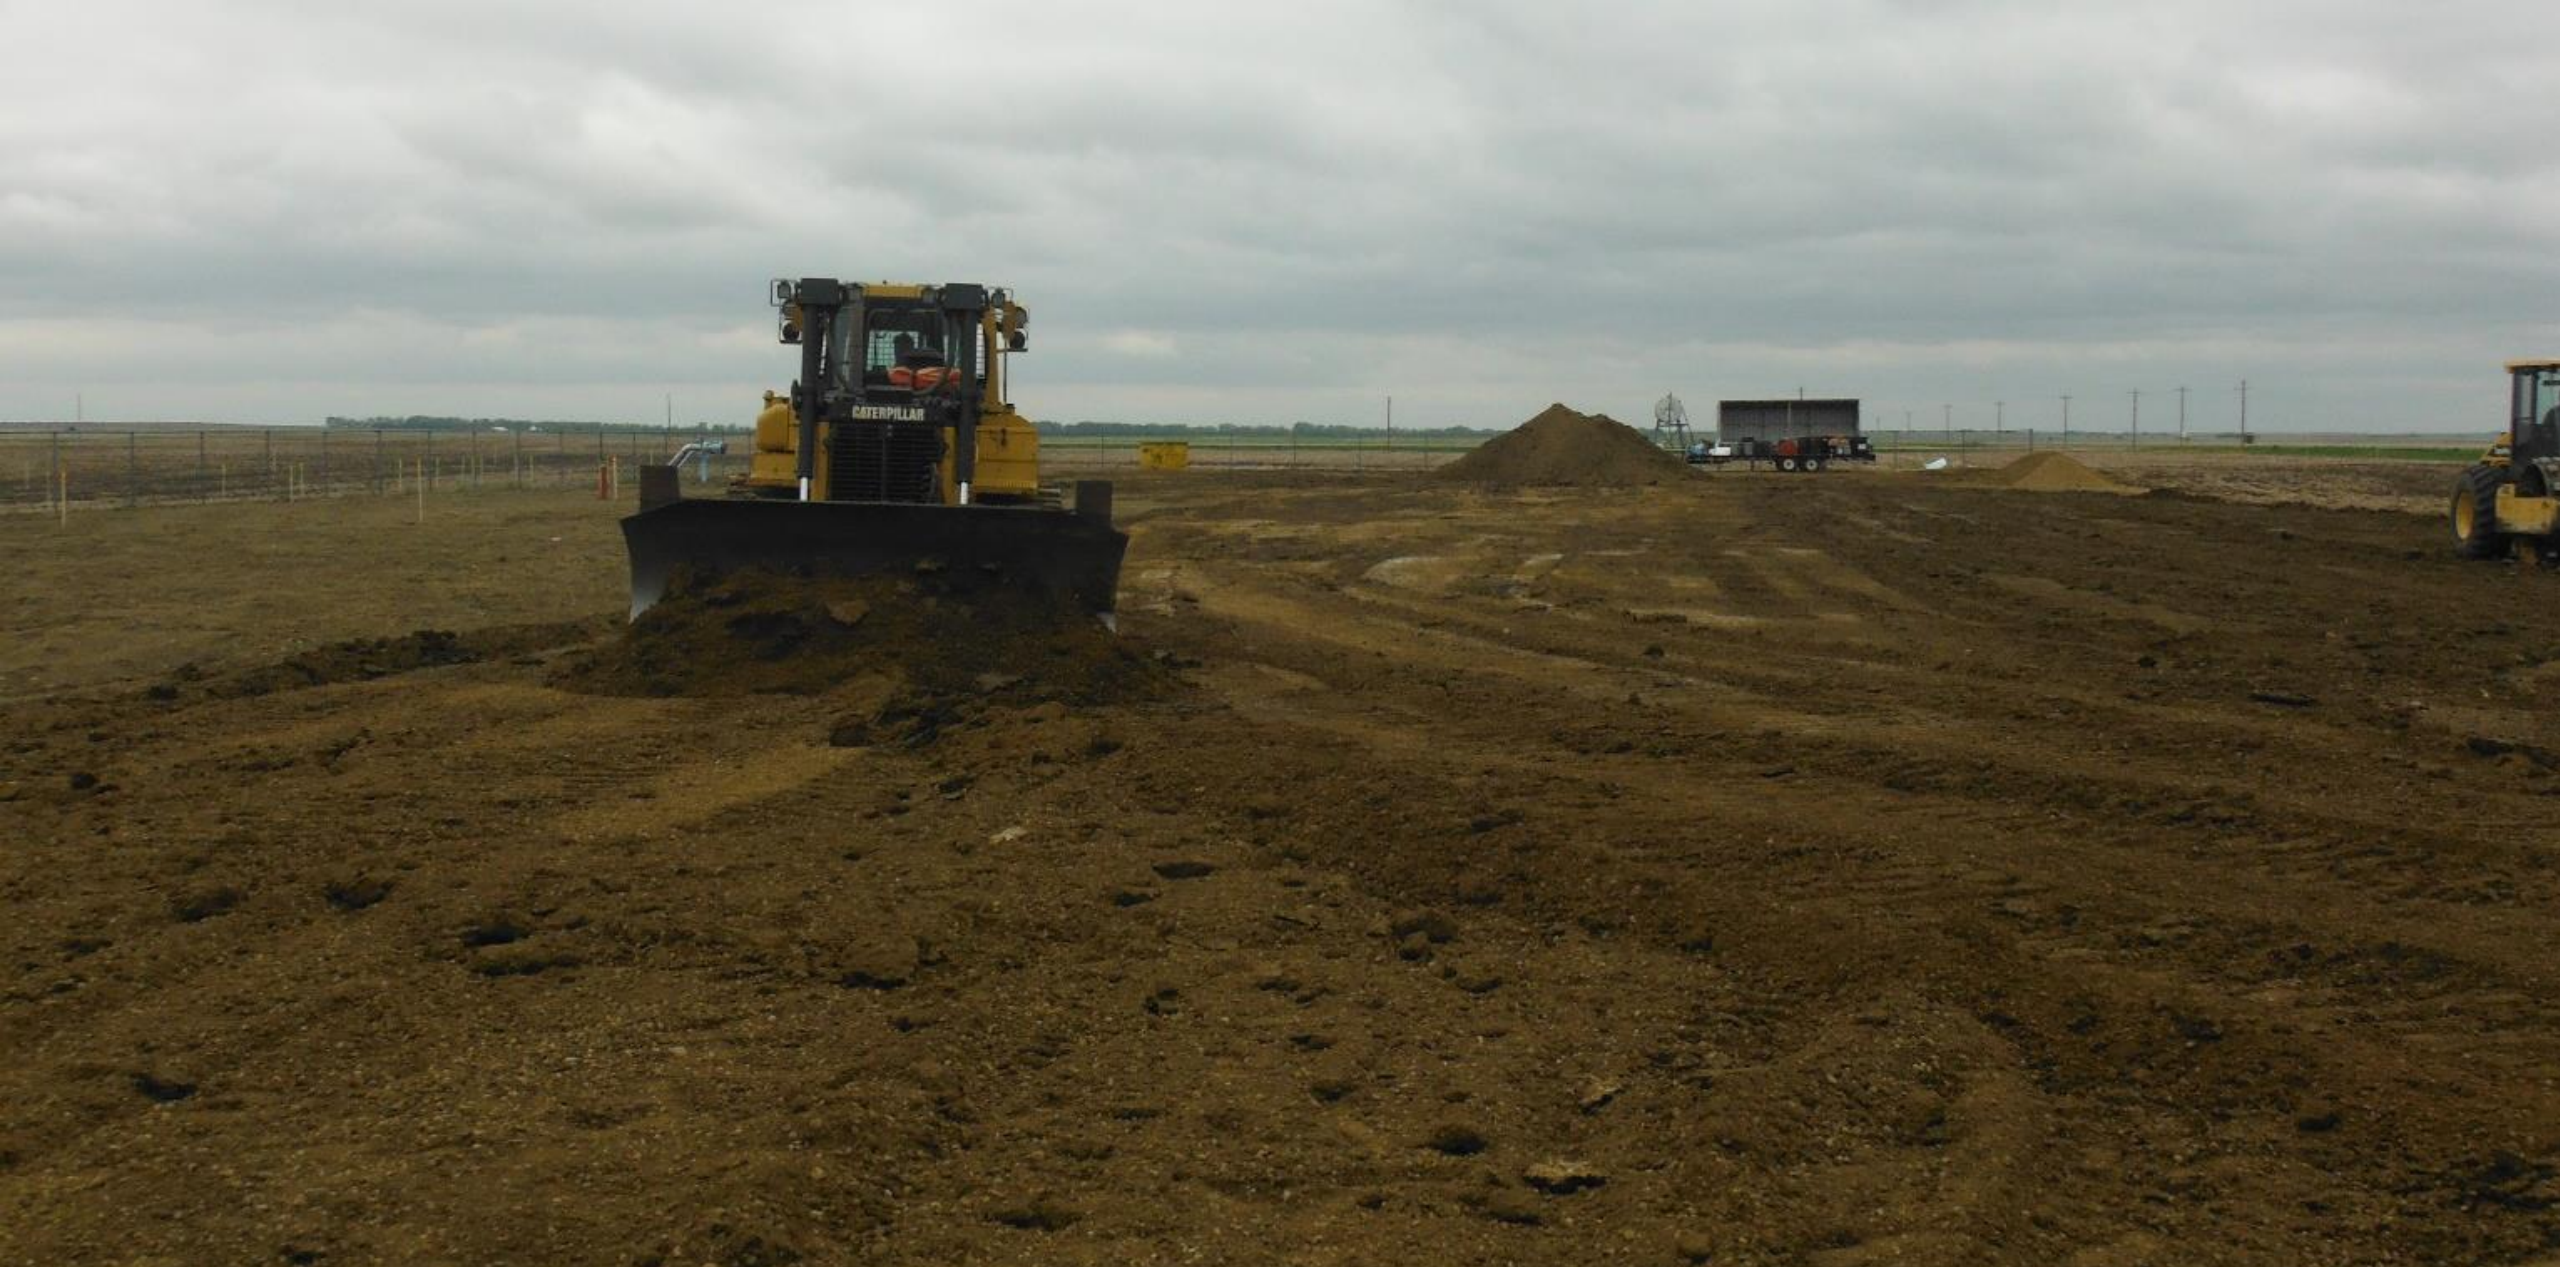
**Infrastructure Removal and Site Preparation**

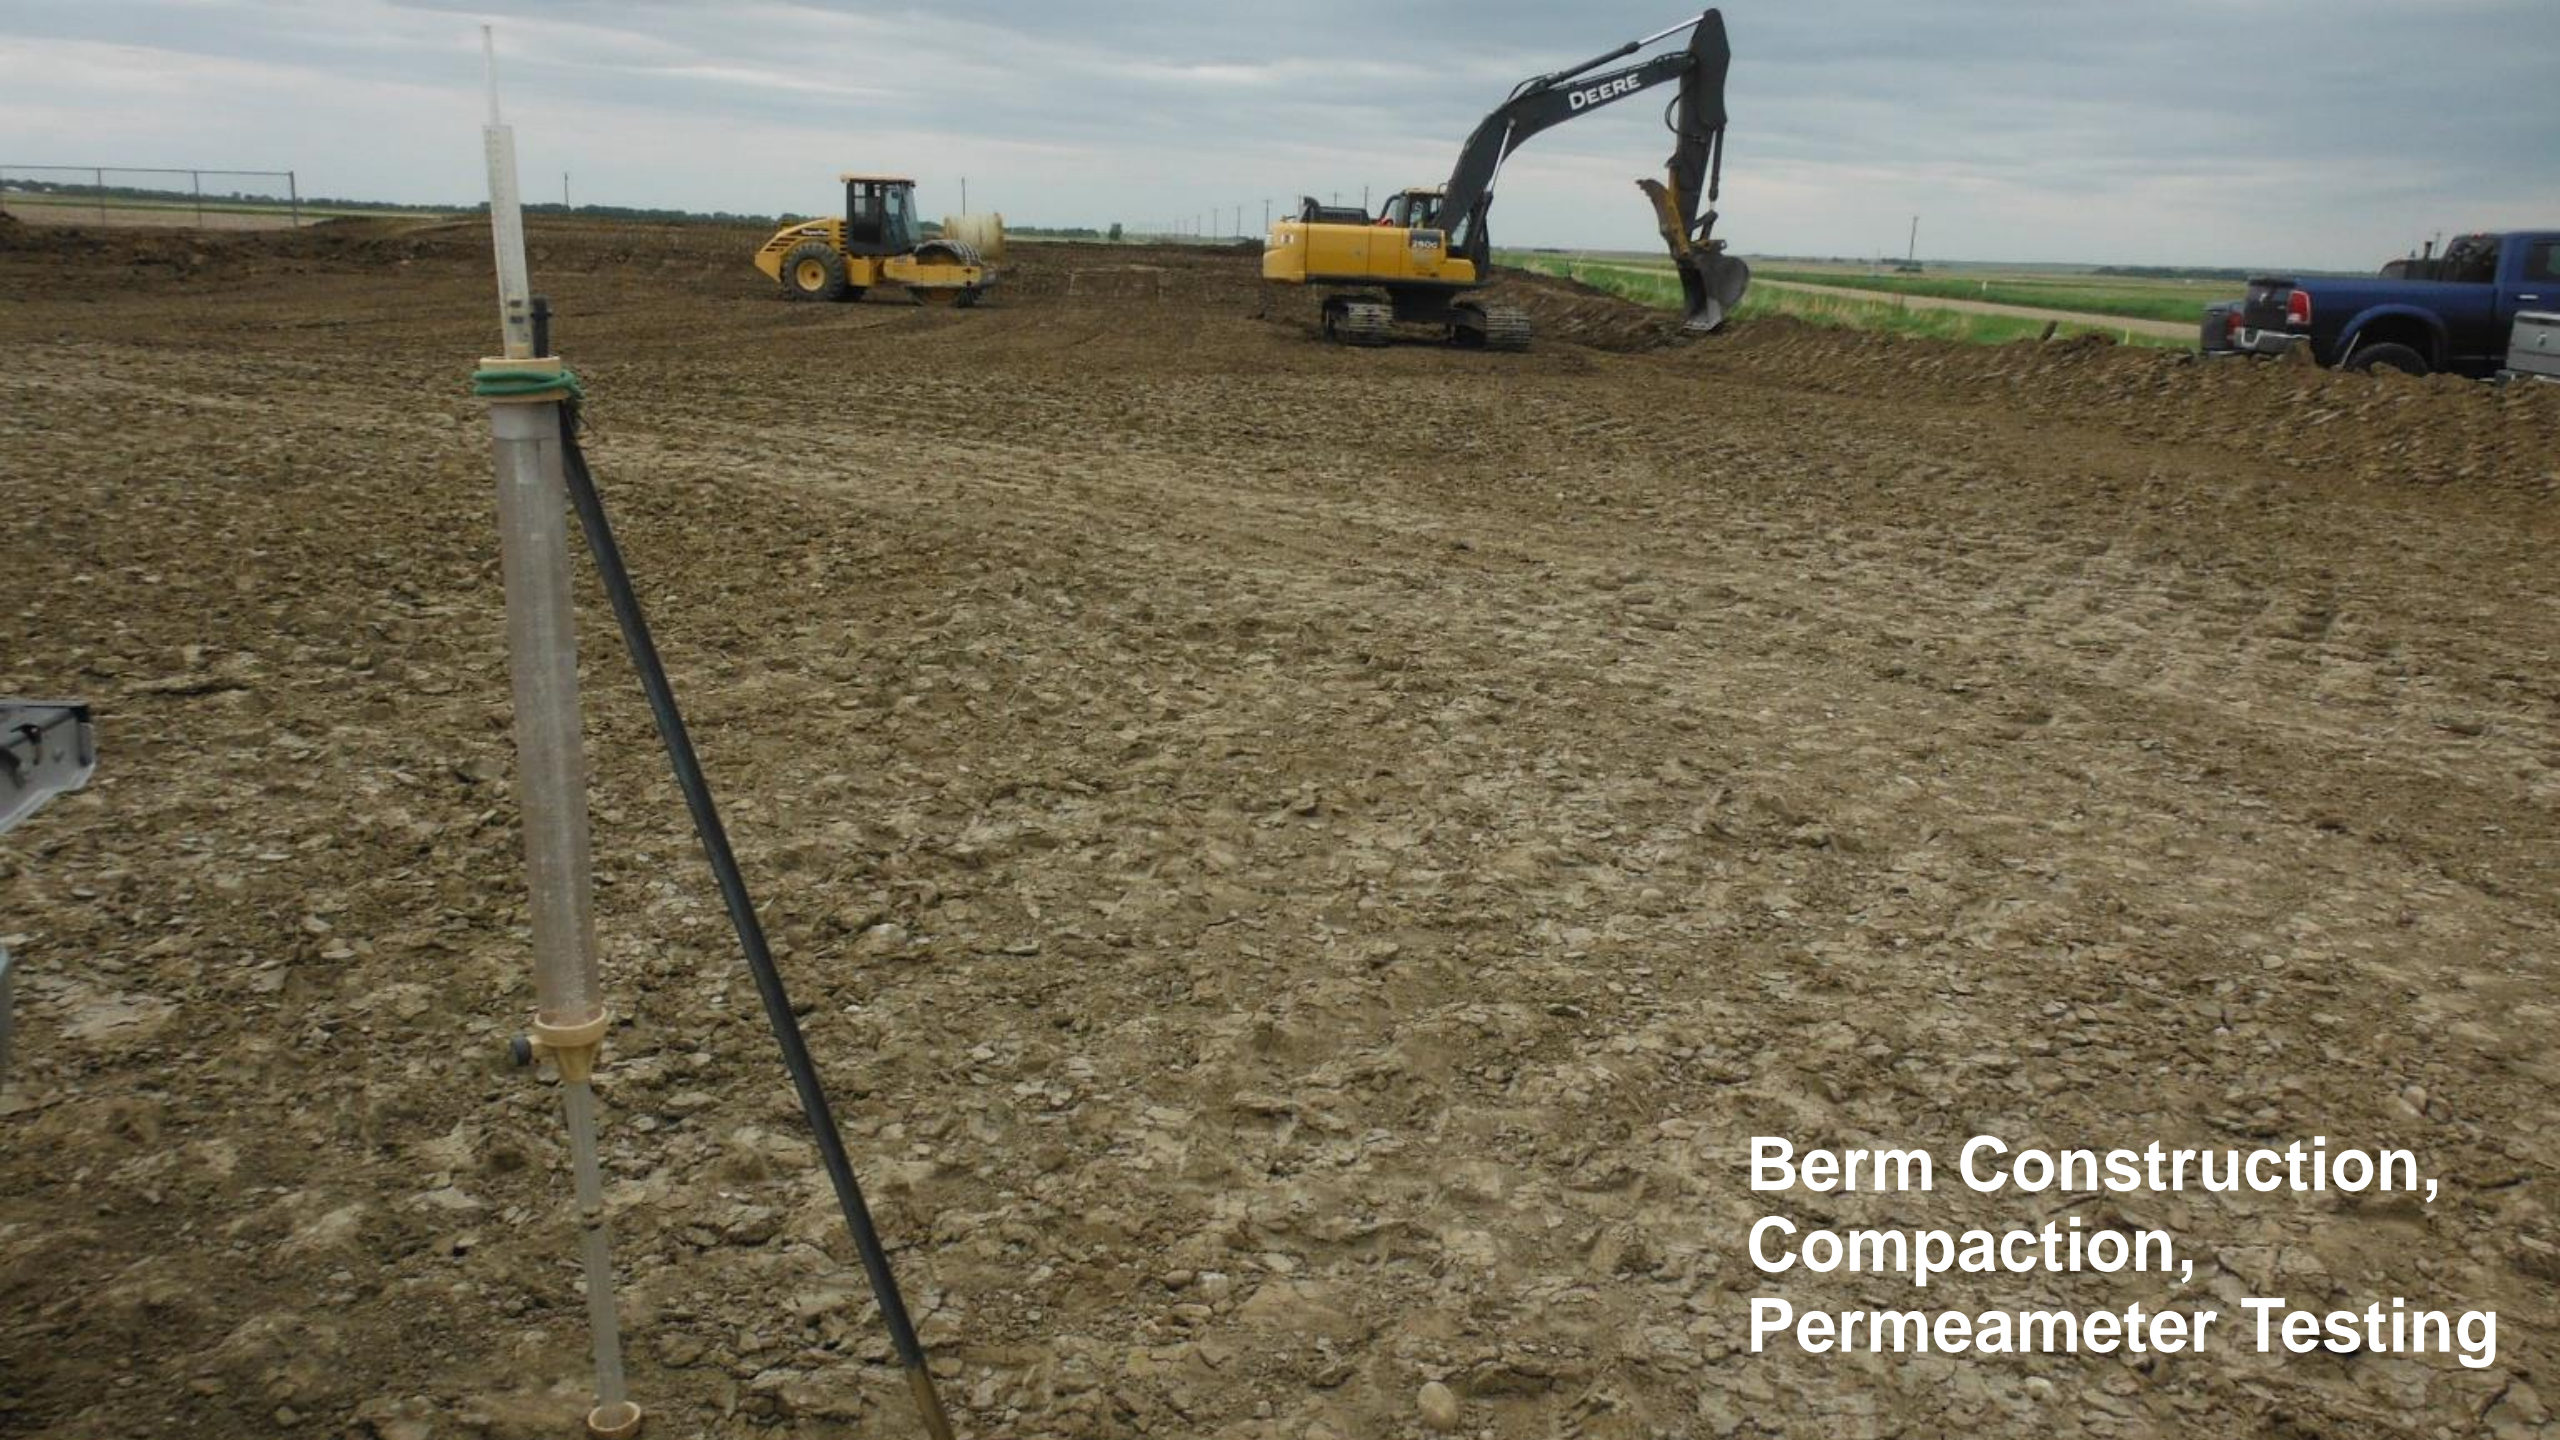
**Berm Construction,  
Compaction,  
Permeameter Testing**

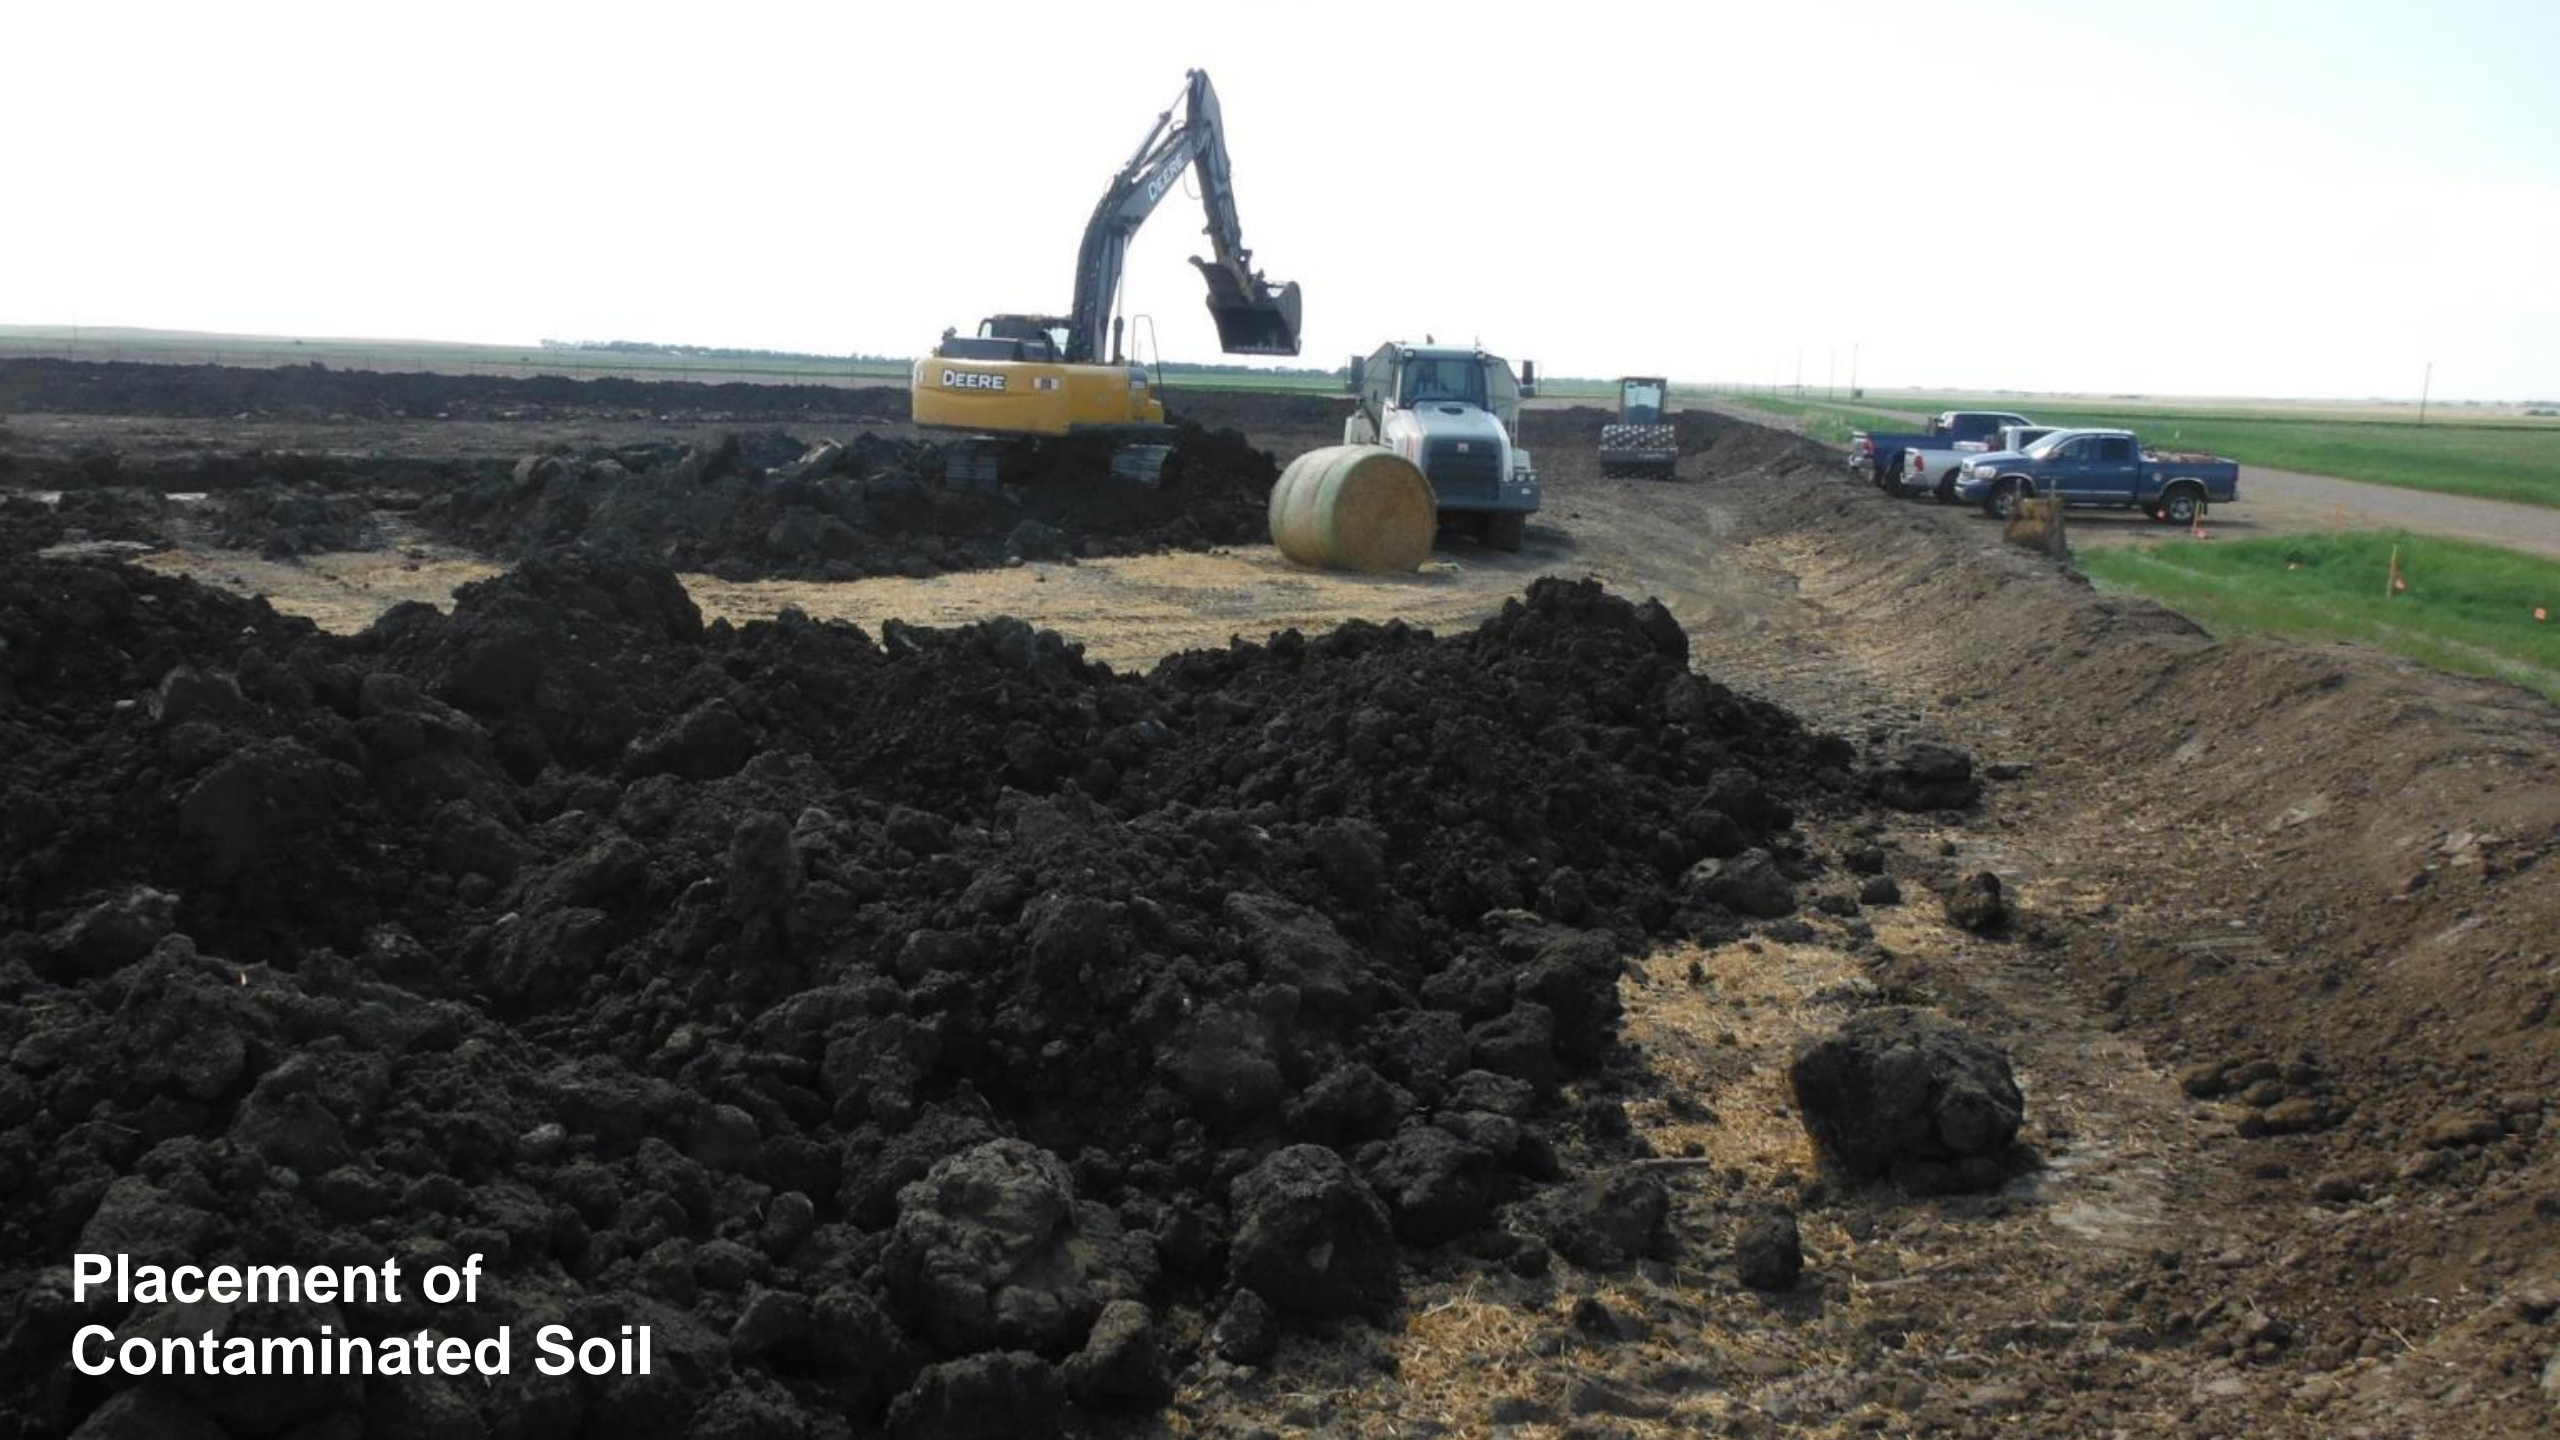
**Placement of  
Contaminated Soil**

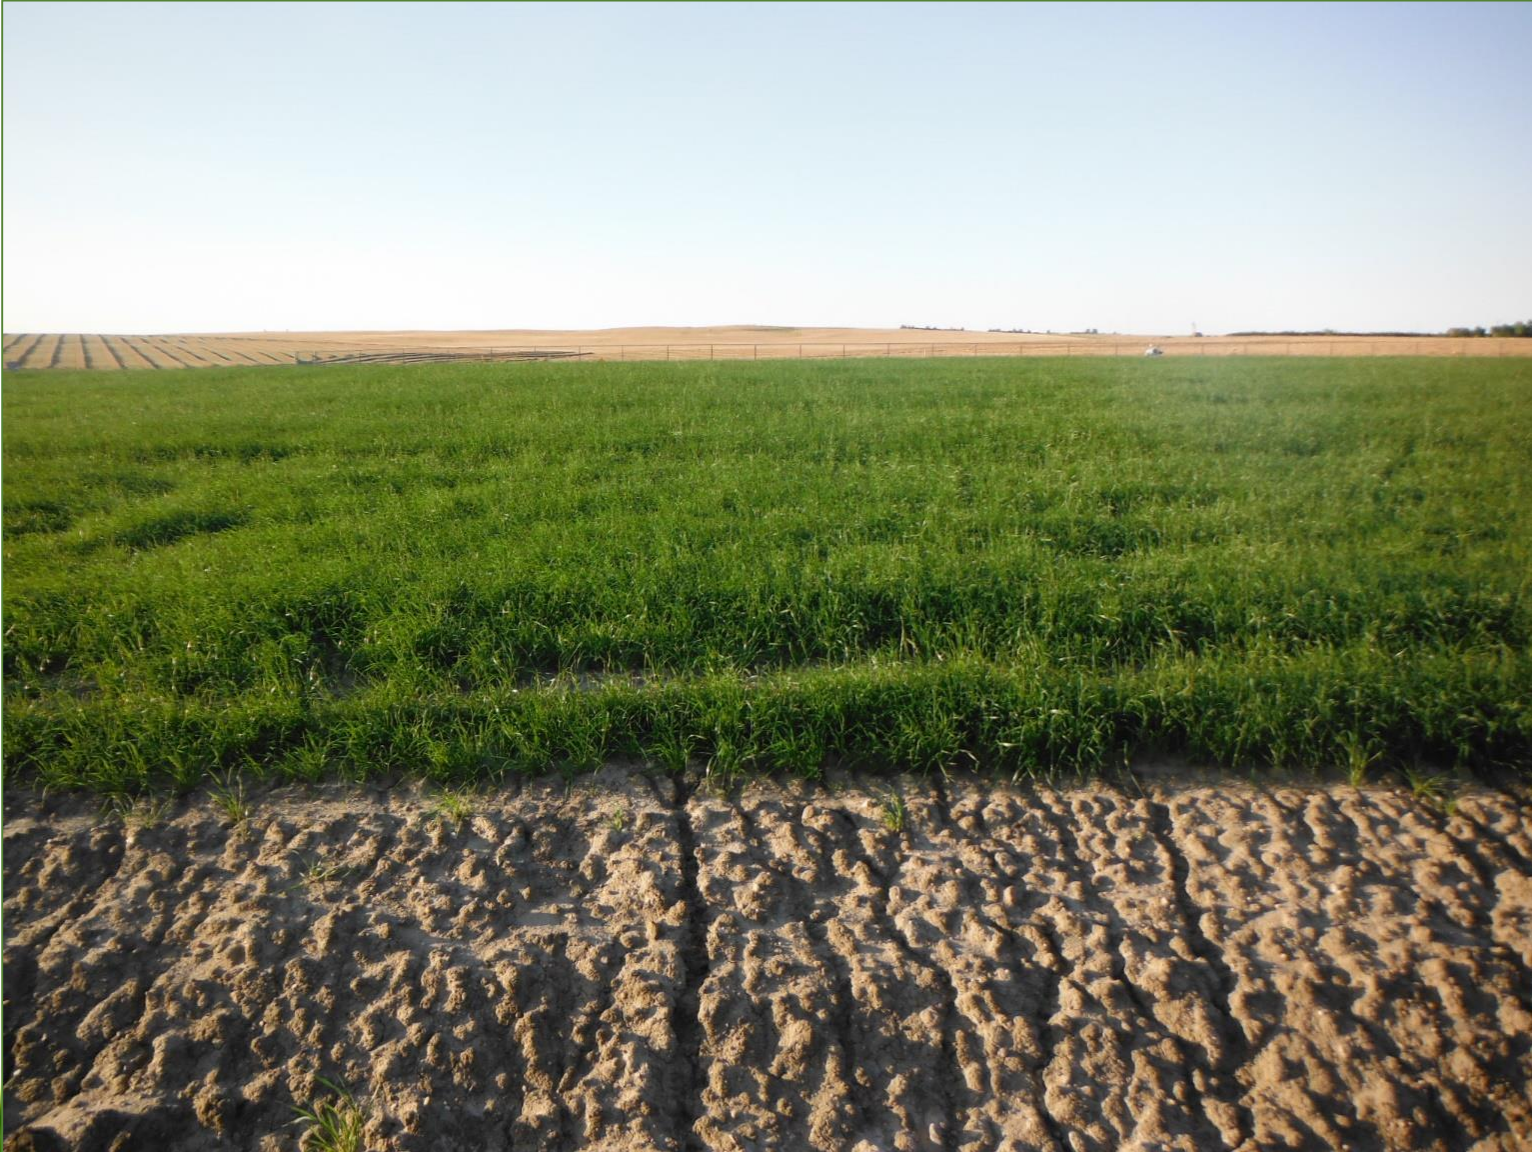
# Lift #1 September 2015

## **Lift #1:**

Treatment for PHC F2 contamination was completed in September 2015. 1,200 m<sup>3</sup> were stripped and placed back in the open excavation. 1 grid was excluded.
