# Remote Northern and Dryland Phytoremediation of Contaminated Soil

Earthmaster Environmental Strategies  
and the \*University of Waterloo

# Large Scale Phytoremediation

# Site 1 - Nota C-17 Pre-deployment 2008

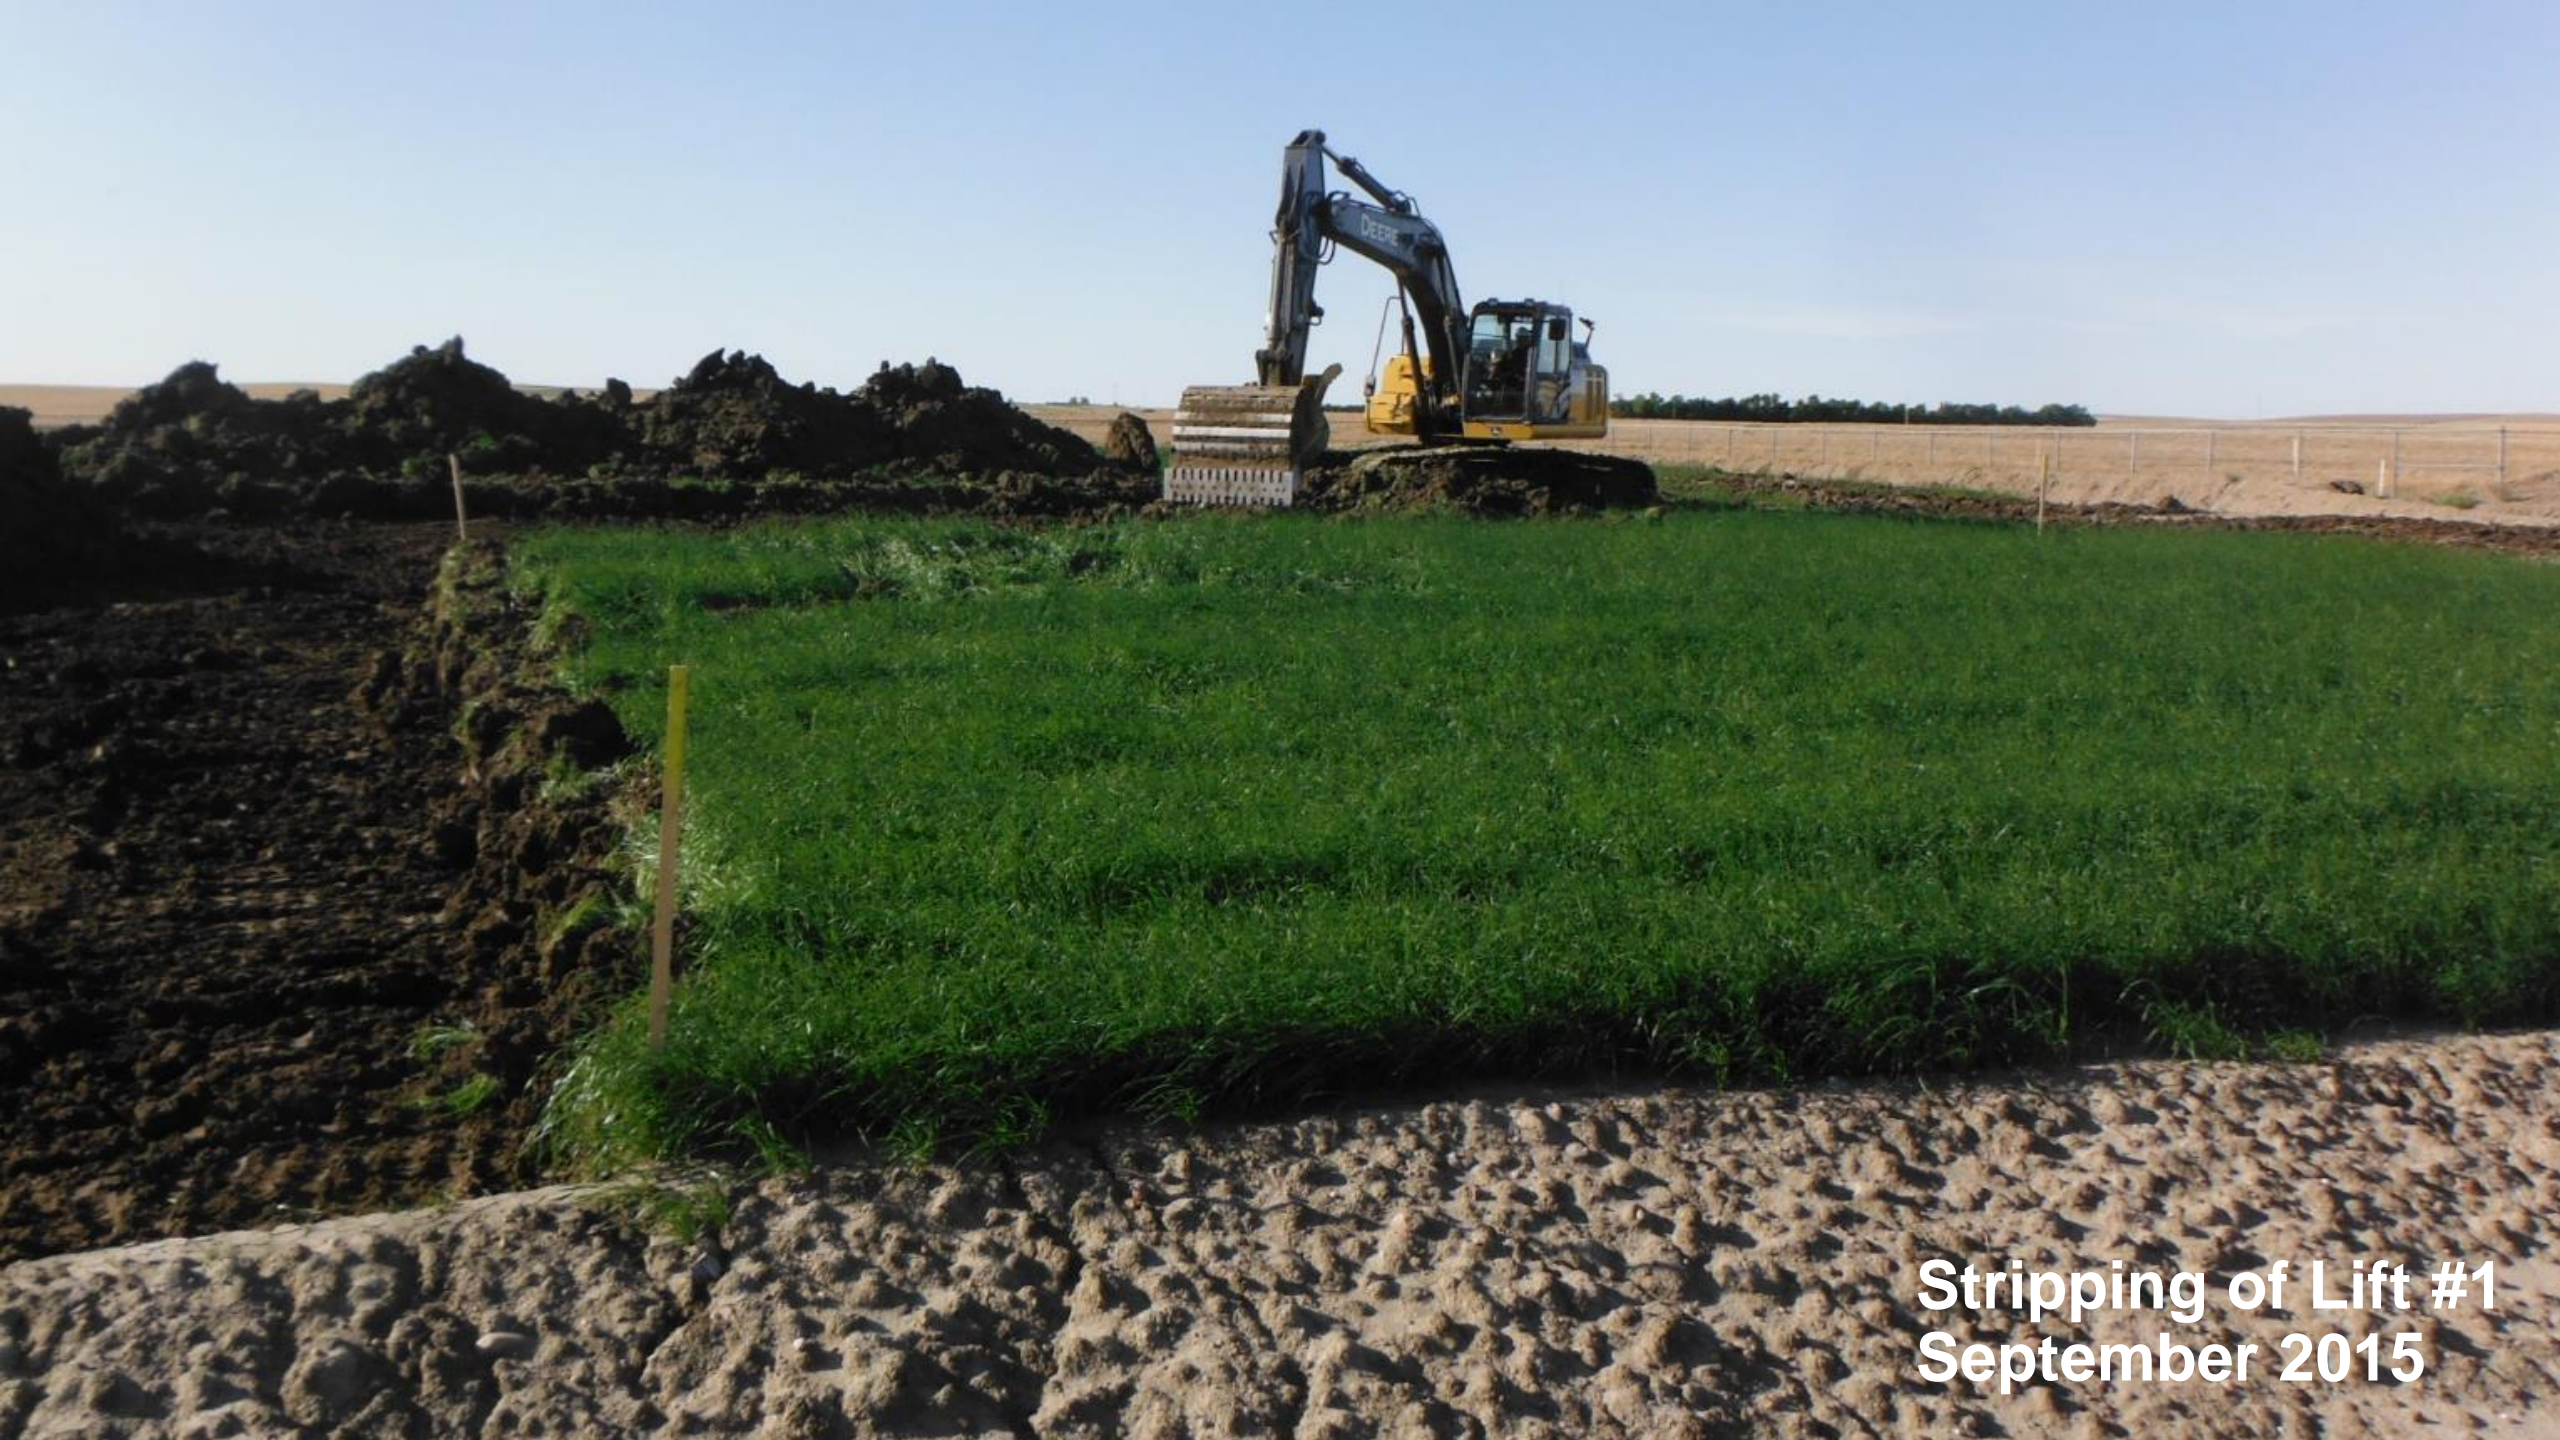
Stripping of Lift #1  
September 2015

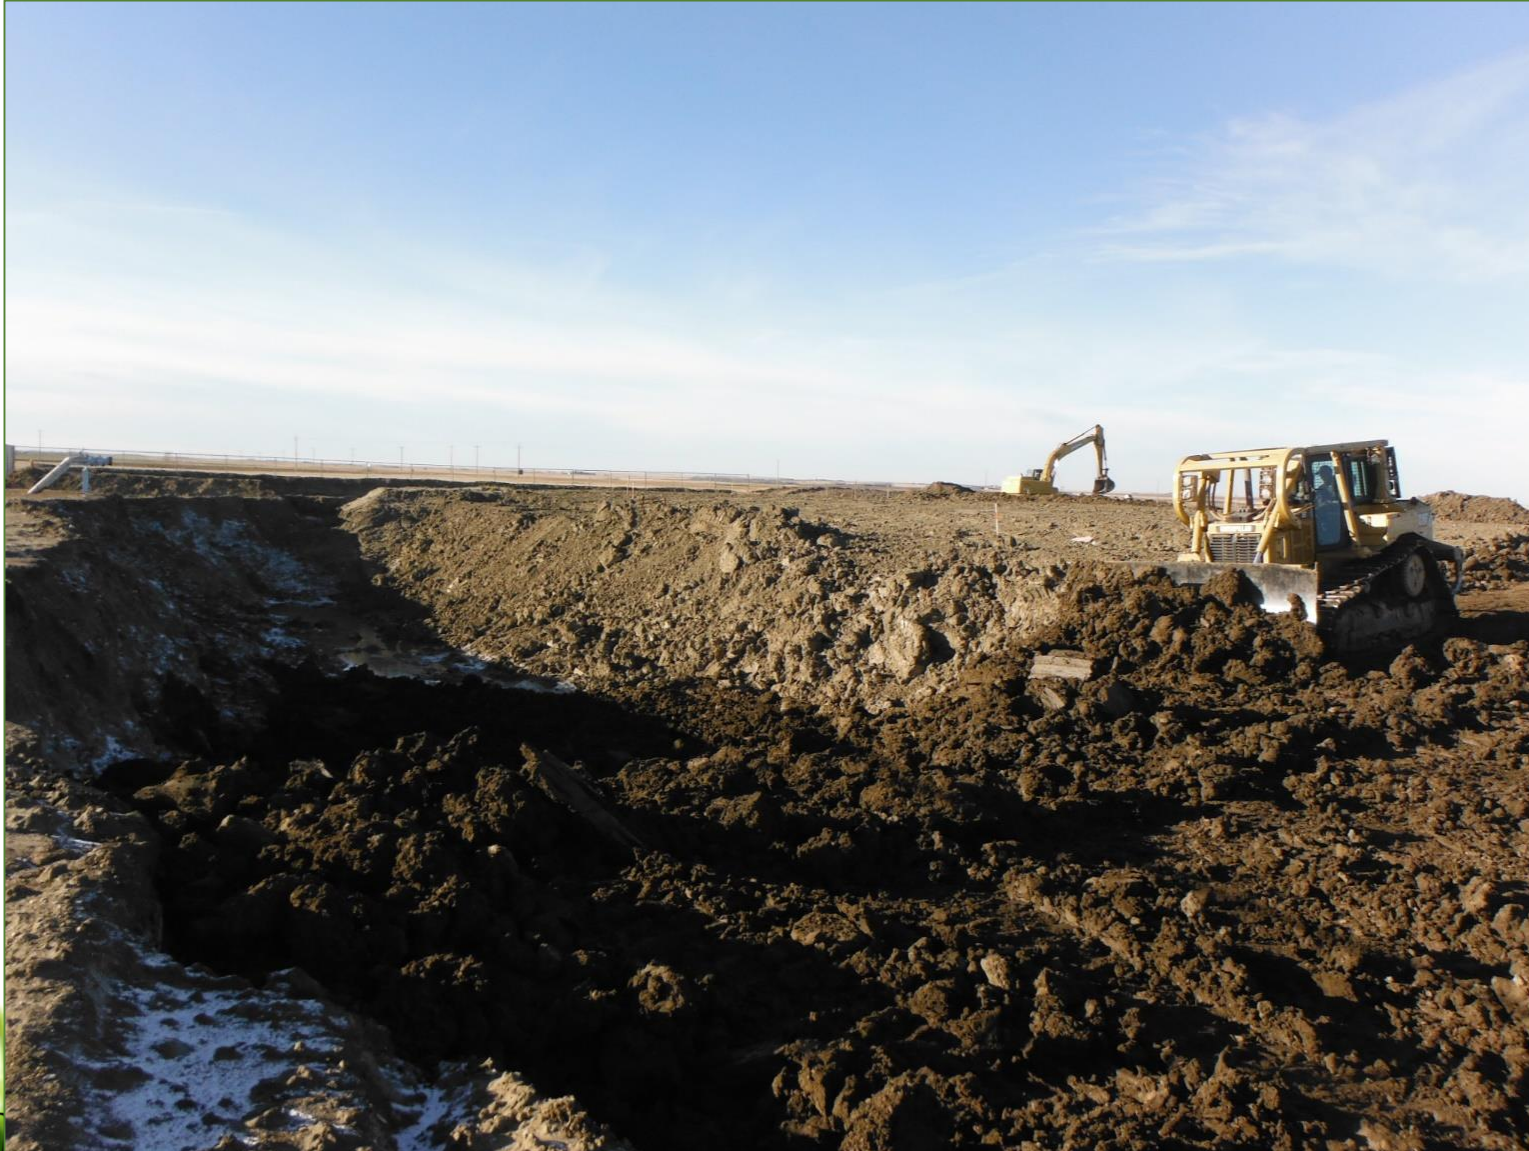
# Lift #2 Stripping November 2015

## Lift #2

Completed in November of 2015. 800 m<sup>3</sup> (depth of 0.25 m) were stripped from the site and placed into the open excavation. 2 grids were excluded.

**Summary of Treatment Area Lift #2 Sample Chemistry Not Complying with Surface Soil Guideline Values**

Depth	PHC	Sep 2015		
		# Samples	Range (mg/kg)	Average†
0.00 - 0.25 m	F2	1 of 16	180	30.1±12.1
	F3	1 of 16	1400	227±82
	benzene	1 of 16	0.27	0.026±0.016
	ethylbenzene	2 of 16	0.51-0.59	0.092±0.045

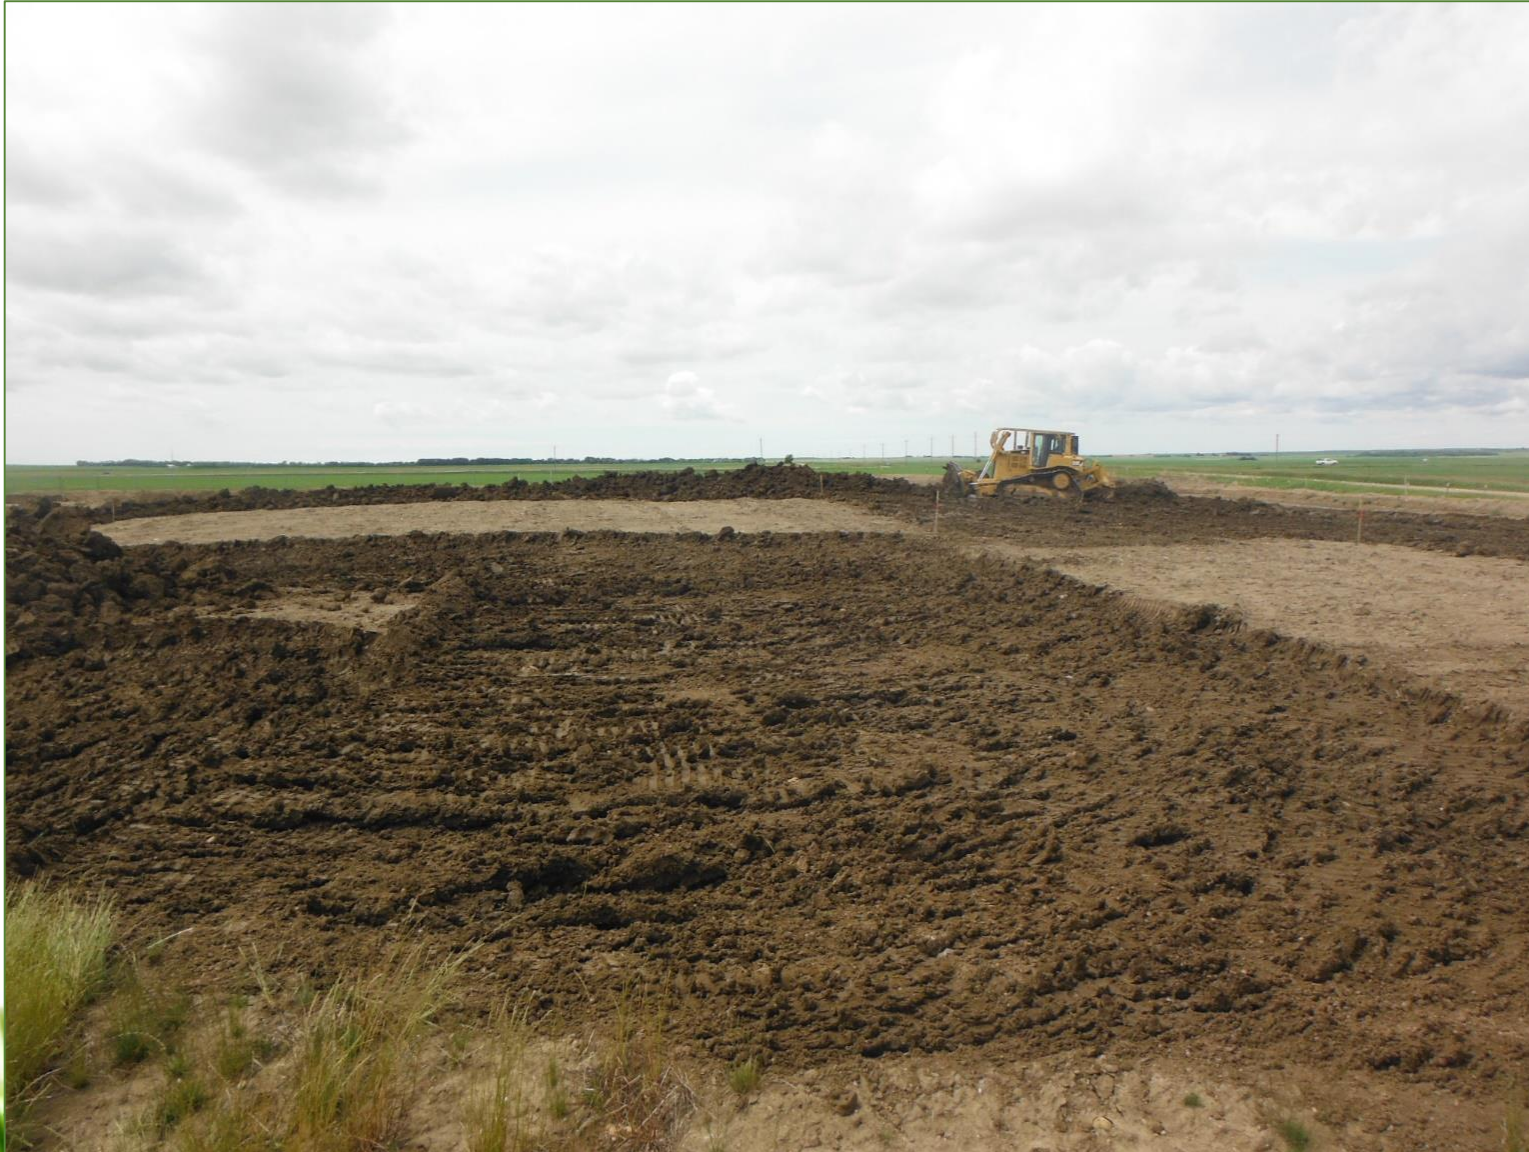
# Lift #3 June 2016

## Lift #3

Completed in June 2016. 1,000 m<sup>3</sup> (depth of 0.20 m) were stripped from the site and placed into the open excavation. 3 grids were excluded.

**Summary of Treatment Area Lift #3 Sample Chemistry Not Complying with Surface Soil Guideline Values**

Depth	PHC	Nov 2015		
		# Samples	Range (mg/kg)	Average†
0.00 - 0.25 m	F1	1 of 16	220	42±16.8
	benzene	3 of 16	0.052-0.38	0.044±0.024
	ethylbenzene	2 of 16	0.60-1.1	0.146±0.073

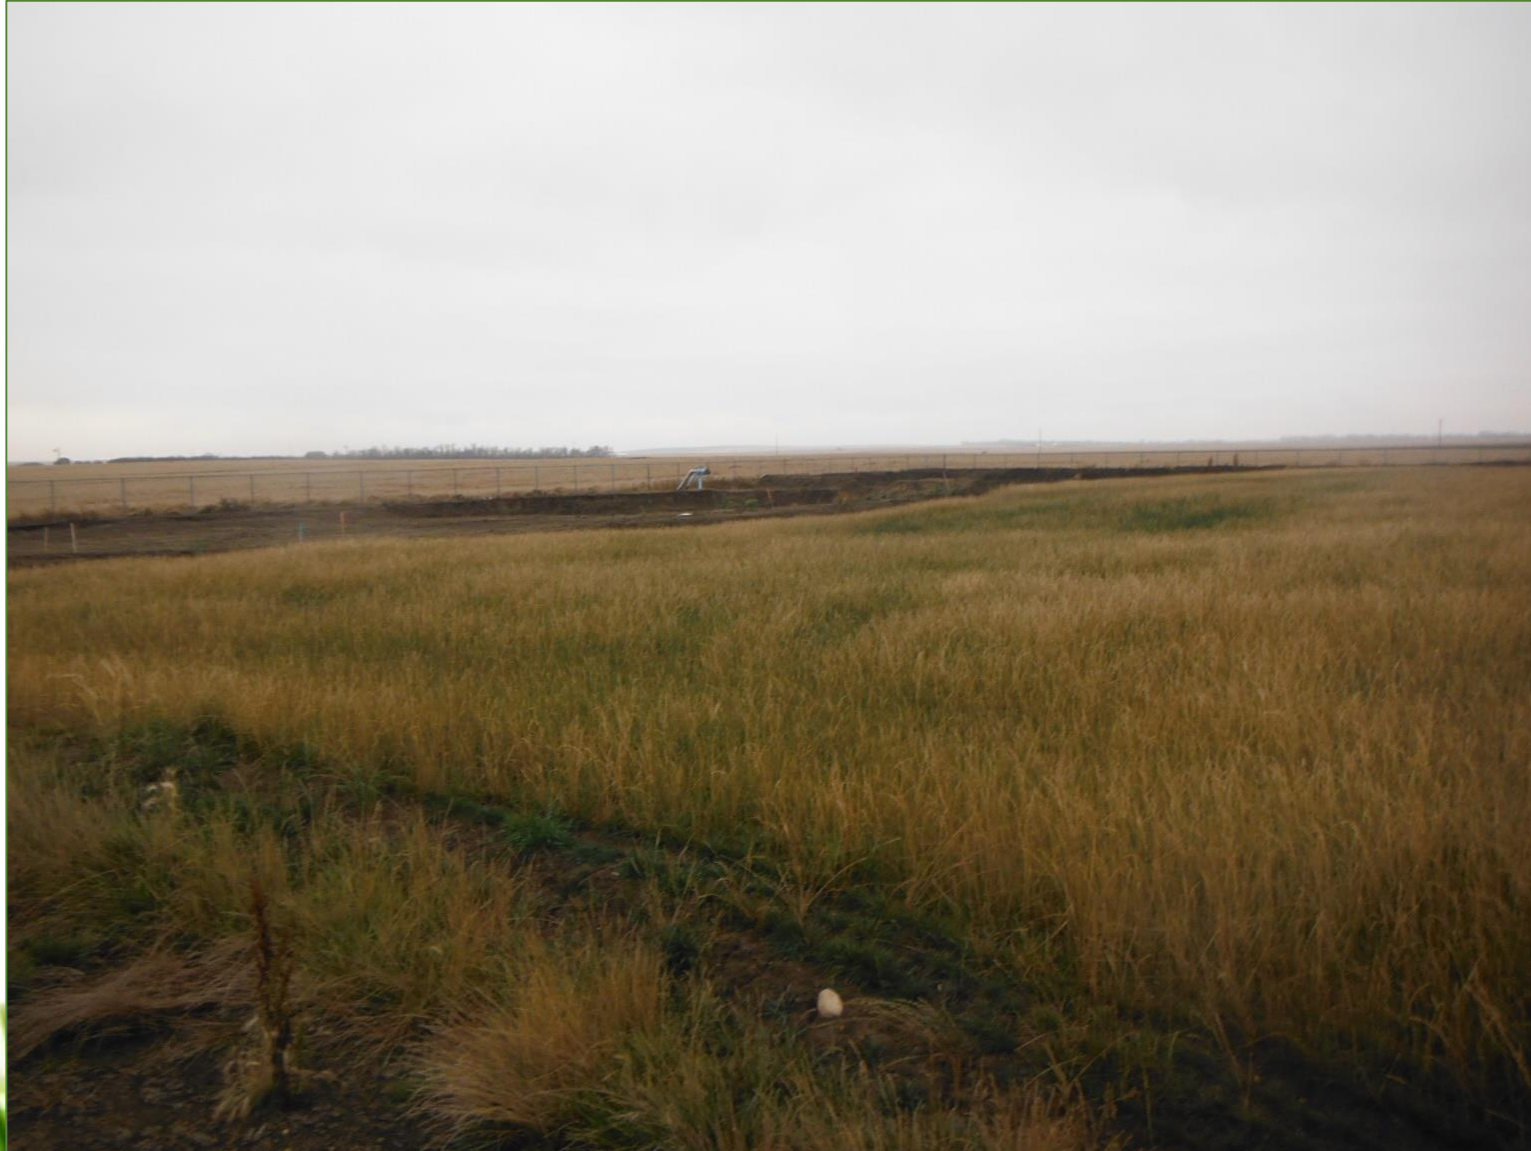
# Lift #4 October 2016

## Lift #4

Completed in October 2016. 1,900 m<sup>3</sup> (depth of 0.35 m) were stripped from the site and placed into the open excavation. 3 grids were excluded.

**Summary of Treatment Area Lift #4 Sample Chemistry Not Complying with Surface Soil Guideline Values**

Depth	PHC	Jun 2016		
		# Samples	Range (mg/kg)	Average†
0.25 – 0.50 m	F3	1 of 20	1400	341±83
	benzene	2 of 20	0.058-0.73	0.044±0.036
	ethylbenzene	1 of 20	0.69	0.048±0.034
	xylenes	1 of 20	2.6	0.185±0.128

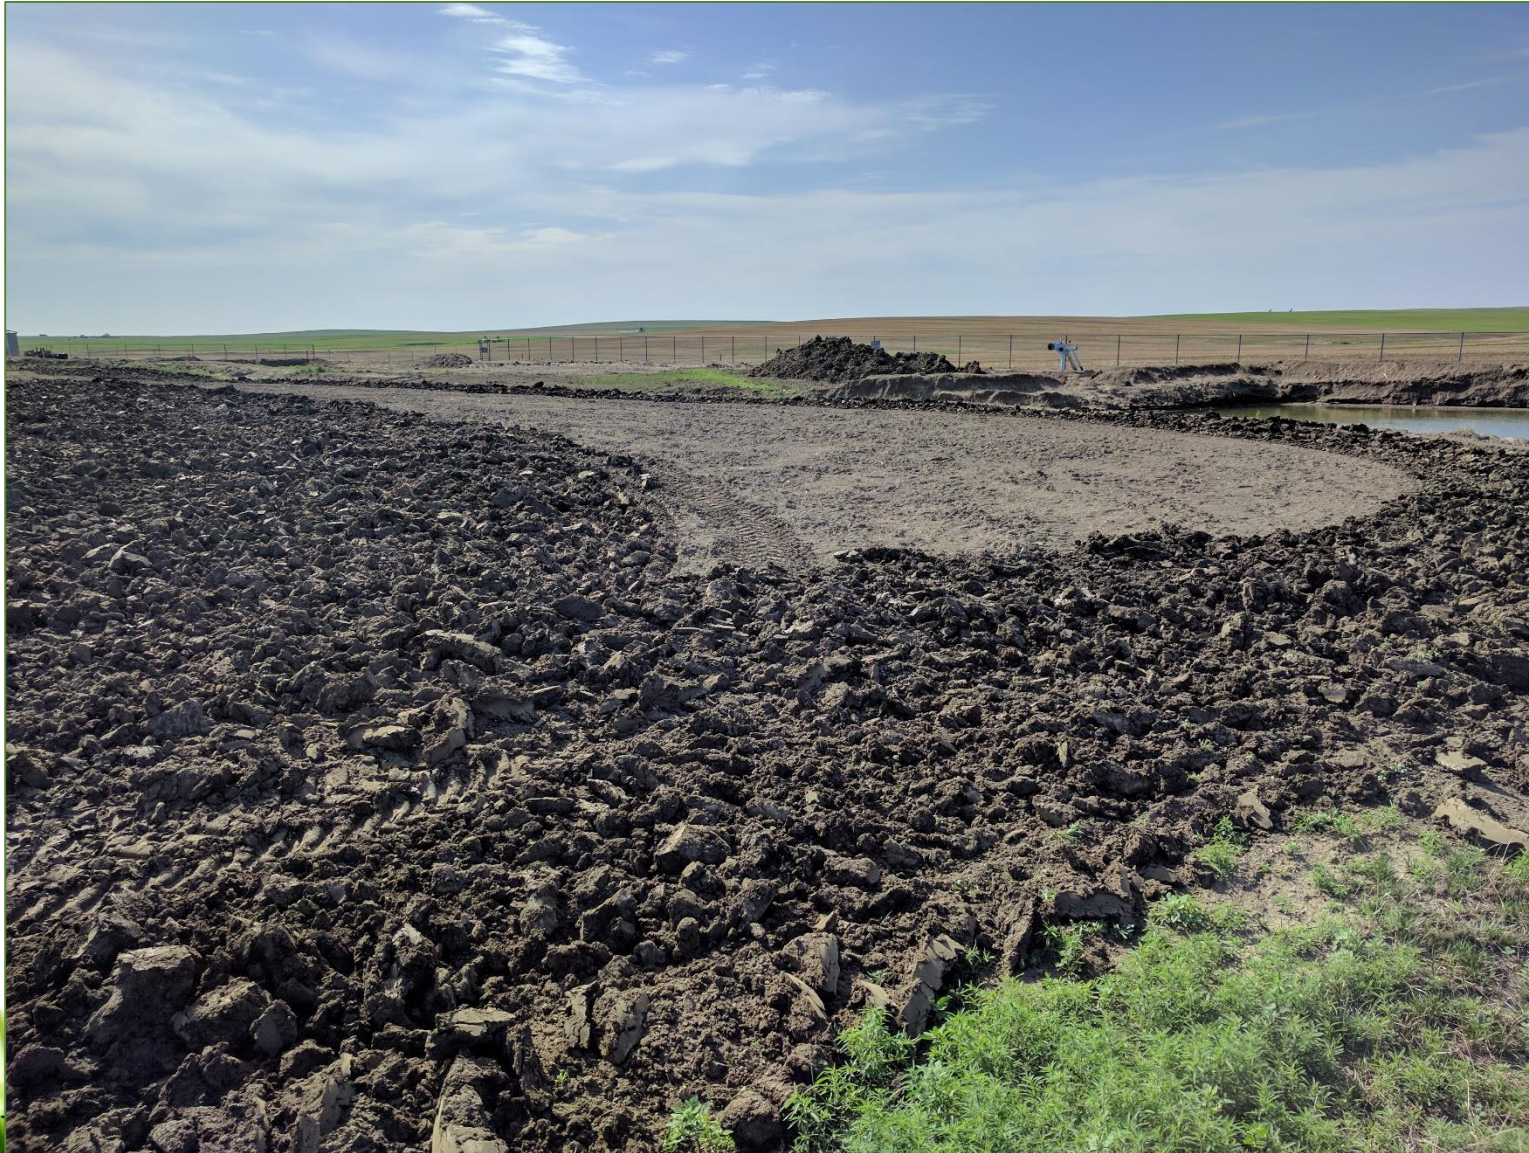
# Lift #5 September 2017

Summary of Treatment Area Lift #5 Sample Chemistry Not Complying with Surface Soil Guideline Values				
Depth	PHC	Oct 2016		
		# Samples	Range (mg/kg)	Average†
0.00 - 0.25 m	F1	1 of 16	240	46±16
	F2	2 of 16	210-320	58±21
	ethylbenzene	2 of 16	0.095-0.18	0.029±0.012
0.25 - 0.50 m	F1	2 of 16	280-380	62±27
	F2	2 of 16	420-530	79±39
	F3	3 of 16	2000-2900	590±230
	benzene	2 of 16	0.056-0.42	0.037±0.026
	ethylbenzene	4 of 16	0.15-2.4	0.225±0.151
	xylenes	2 of 16	1.0-2.1	0.246±0.137

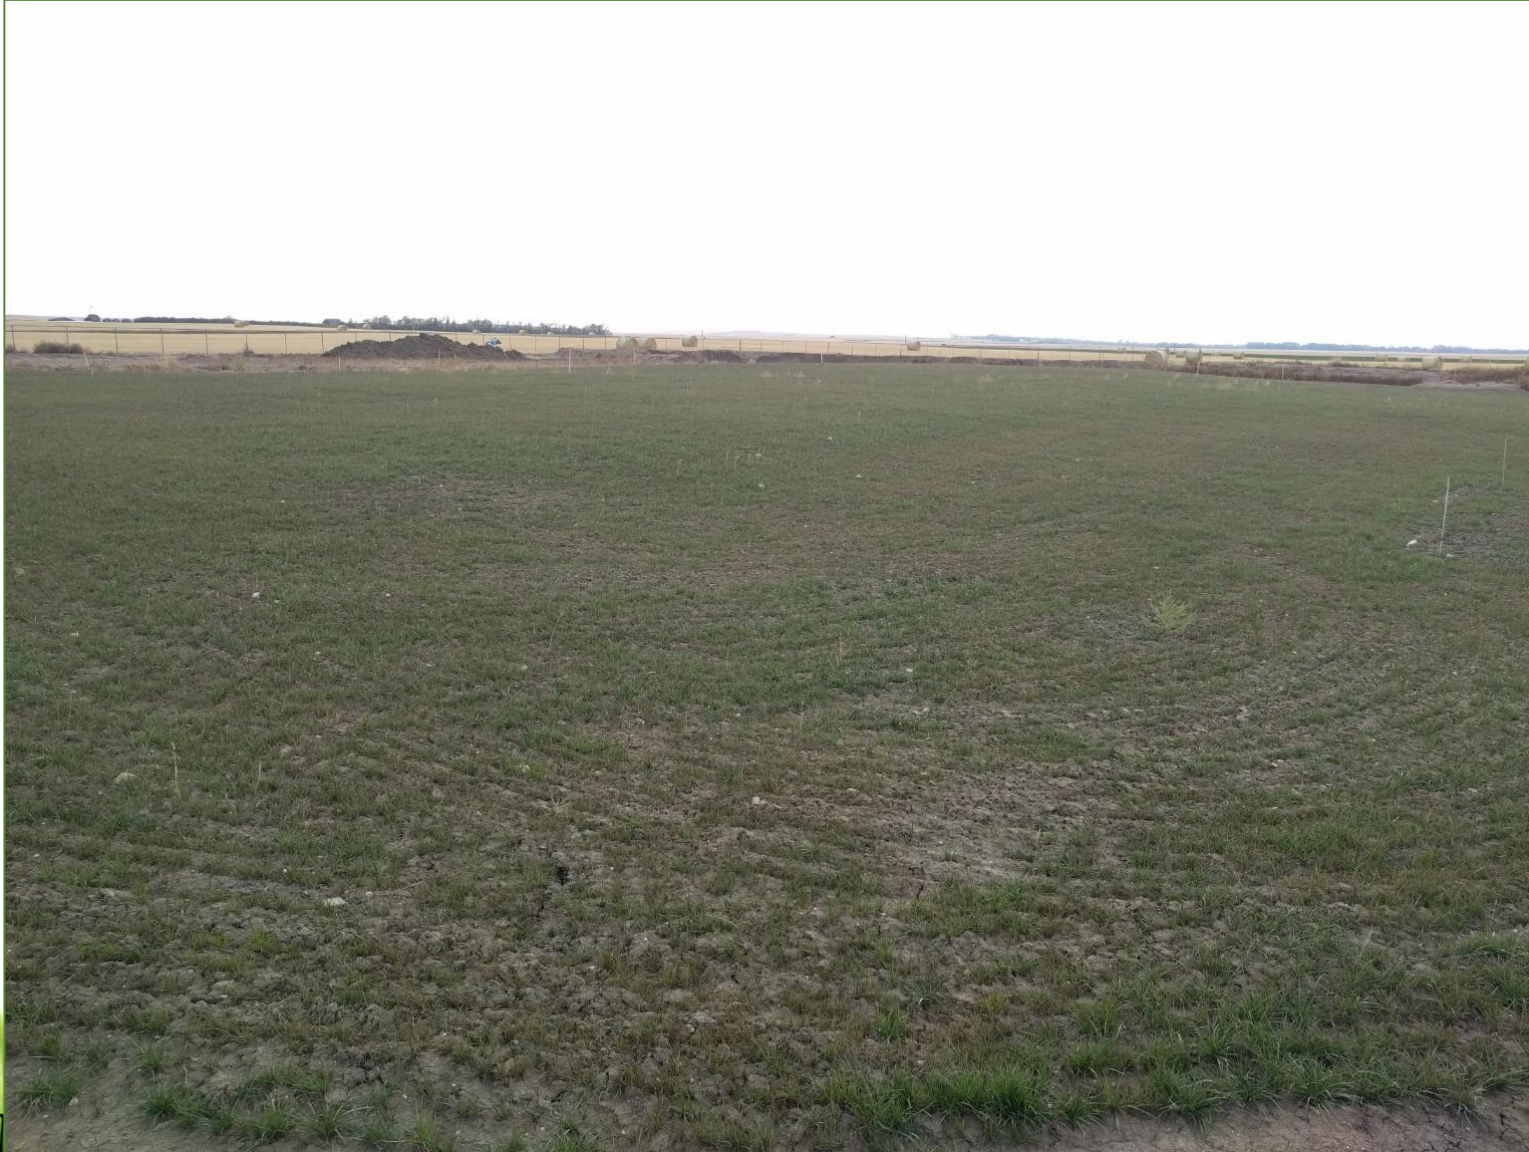
# Lift #5 September 2017

## **Lift #5**

Completed in September 2017 and 1,700 m<sup>3</sup> (depth of 0.50 m) were stripped from the site and placed into the open excavation. 2 grids were stripped to a depth of 0.25 m.
