In-Situ Thermal Remediation: Advances and Lessons Learned at Multiple Sites – 2000 to present

RemTech 2018 Fairmont Banff Springs Hotel Banff, Alberta

Presented by: Jay Dablow ERM, Irvine, California

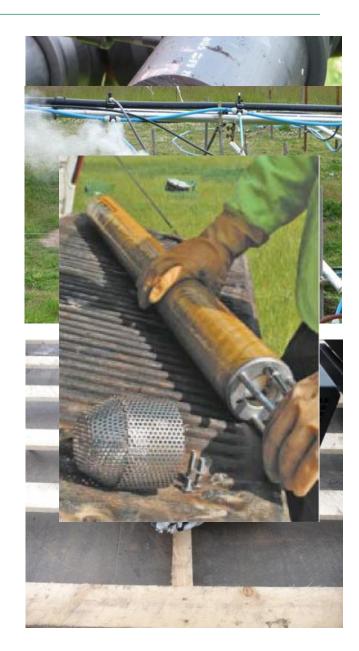
Robust HAZID/HAZOP during the design process

- System construction consistency.
- Connection point failure analysis.
- □ Temperature capable materials and equipment.
 - Blowers
 - Downhole pumps.

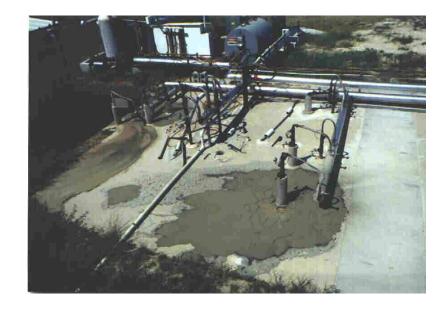
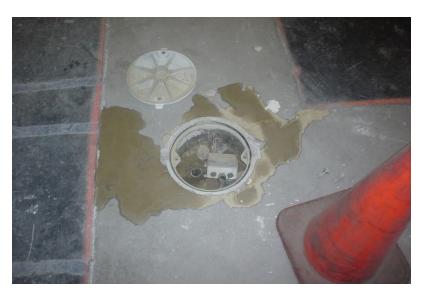
Problem - Well Seal Failures

- □ Typical well seal materials
 - Bentonite grout
 - Bentonite cement mixtures
 - Bentonite chip intermediate seals
- □ Thermal impacts
 - Bentonite loses structural integrity
 - □ Fractures and failure paths develop
 - Gaps form between borehole wall and seal
 - Gaps form between hot well materials and seal

All seals in contact with high temperature materials are constructed using Type G or H high temperature grout.
No bentonite allowed in seals.

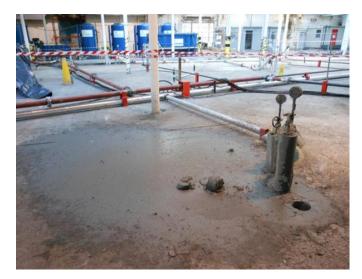
Problem – Existing PVC monitoring wells

- □ Short circuit to surface.
- □ Short circuit between lithologic units

- Abandon by over-drilling and grouting with high temperature grout.
- Re-purpose wells to temperature monitoring points.

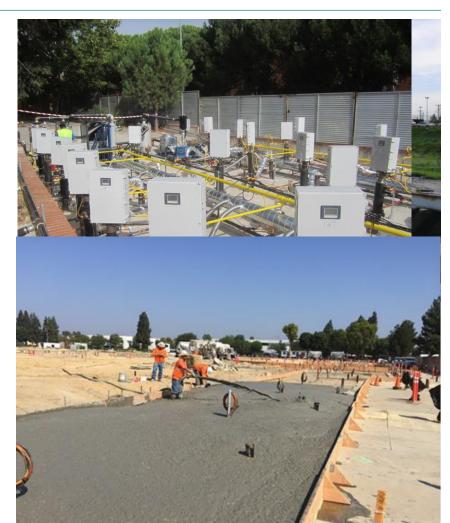
Problem – Ineffective thermal and /or infiltration barrier

- □ Case 1 TCH for PCBs in Spain
 - □ Thin HDPE vapor barrier. Minimal thermal insulation
 - □ Effective heating to target (300°C), 2 to 3 m bgs.
 - □ Target temperature not met 1 m bgs.
- □ Case 2 Hot air injection for Diluent in Long Beach
 - □ Thin HDPE vapor barrier. Ineffective well seals.
 - □ Heat loss to rainfall infiltration.

Lightweight concrete as dual purpose thermal and vapor barrier

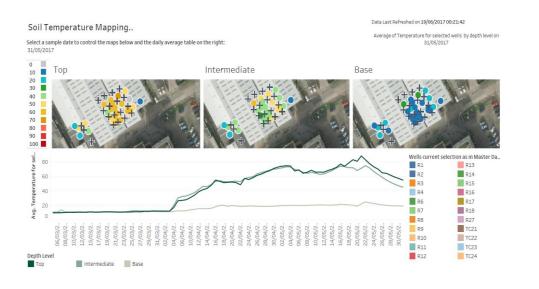
Implementation Results

- Steam injection raised soil temperatures to above modelled mobilization temperature – 70°C.
- □ Asymptotic mass recovery achieved.
 - Mainly TPH (kerosene) 4,160 kg recovery estimated.
 - 7.5kg of pesticides recovered as free, dissolved phase and 'sludge'

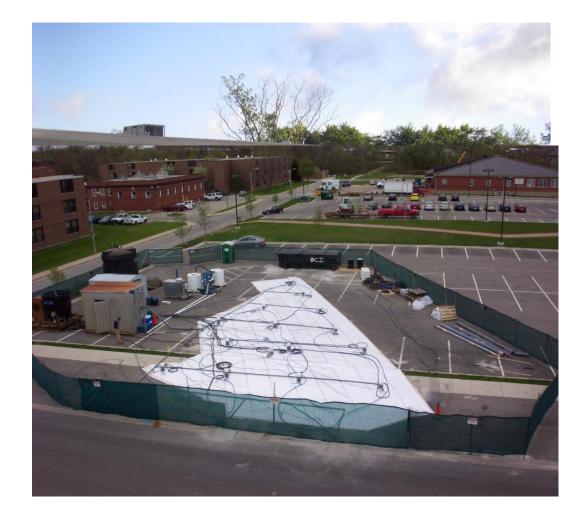
Former electronics manufacturer in Illinois

- Plant closed, site being redeveloped
- Site impacted by 1,1,1-trichloroethane and trichloroethene NAPL
- Remediation Goal:
 - Remove NAPL
 - Reduce groundwater concentrations to < 1% of aqueous solubility
- ERH implemented to volatilize and recover contaminant mass from fine-grained silts and clays.

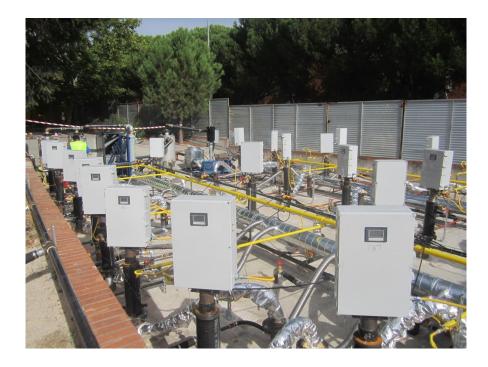
□ Site used for servicing of motors and transformers.

- Site investigation identified Polychlorinated Biphenyls (PCBs) at concentrations of up to 27,700mg/kg within underlying low permeability silts and clays.
- Based on the results of a Quantitative Risk Assessment - Site Specific Target Level (SSTL) for PCBs of 4.4mg/kg in soil was set.

- Design estimated 1050 kg of PCBs recovered. 250 kg destroyed in situ.
- □ 1550 kg recovered, 390 destroyed in place.

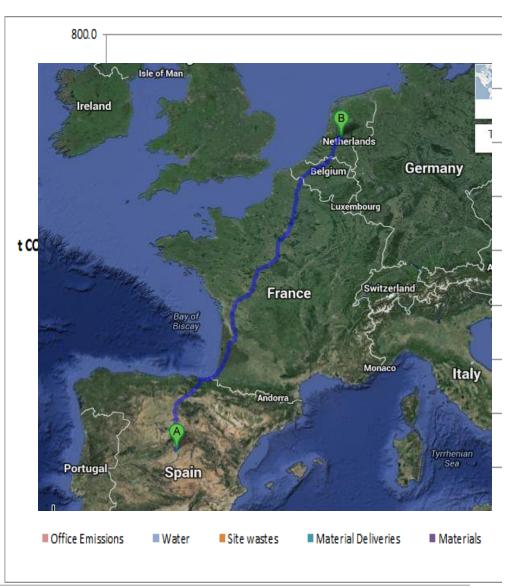
Carbon footprint sustainability evaluation

- Predominantly Environmental and Economic – reflecting nature of site
- Protection of human health key social metric along 700 km truck route in addition to fuel consumption.

The carbon footprint of thermal treatment was roughly 50% of the traditional dig and haul approach.
