# **Case Studies: Overcoming Annoying Contaminant Rebound Using Adsorptive Technologies**

RemTech – Banff, AB  
October 11, 2018  
Kevin French

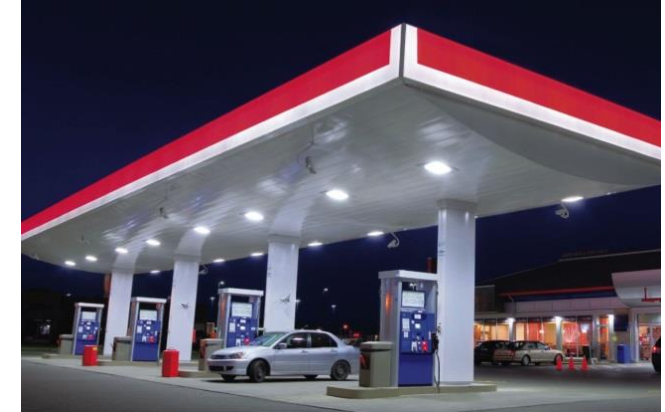
LNAPL

Gasoline  
 $0.75 \text{ g/cm}^3$

- **Petroleum Hydrocarbons (PHCs)**

- Lighter than water (“floaters”, LNAPL)
- Gasoline, diesel, motor oil, fuel oil, etc.

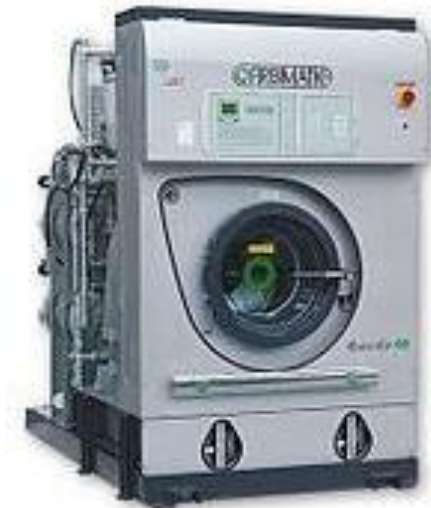
DNAPL

TCE  
 $1.46 \text{ g/cm}^3$

- **Chlorinated Solvents (cVOCs)**

- Heavier than water (“sinkers”, DNAPL)
- Tetrachloroethylene (PCE), trichloroethylene (TCE), 1,1,1-trichloroethane (TCA), etc.
- Were commonly used for dry cleaning, degreasing, etc.

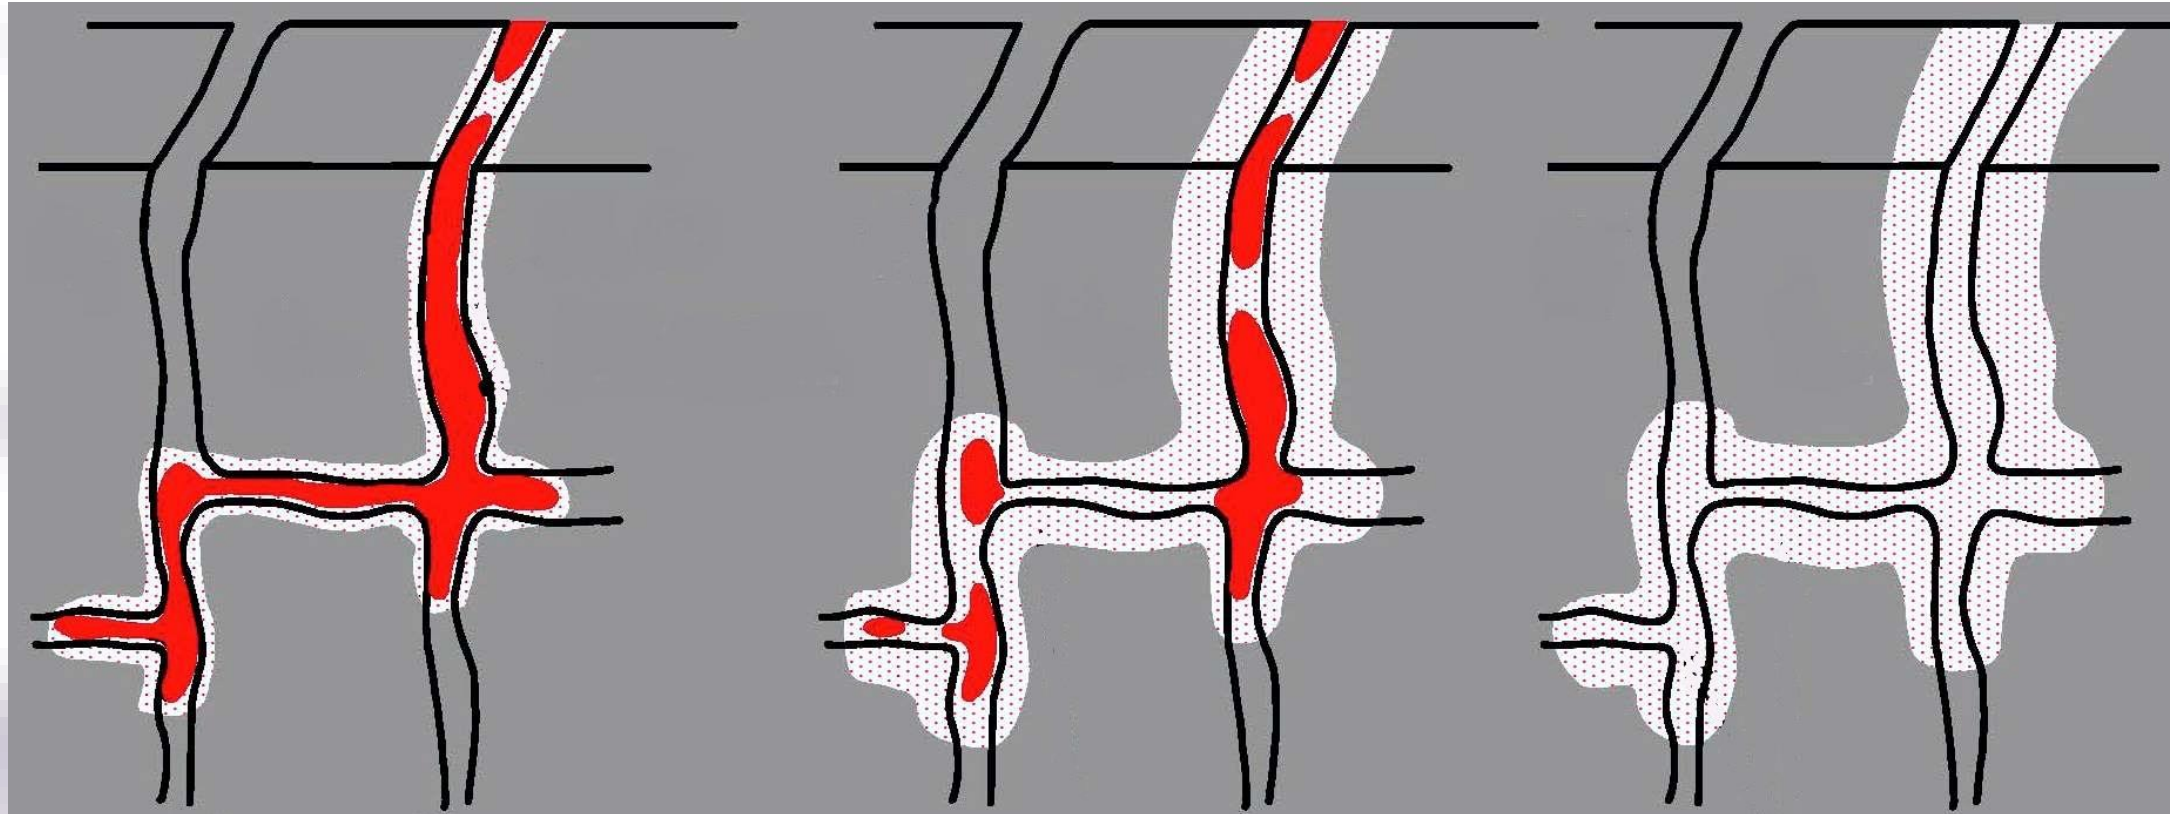
Early Time

Intermediate Time

Late Time

**Diffusion into the Soil or Bedrock Matrix  
During Remediation – Back Diffusion**

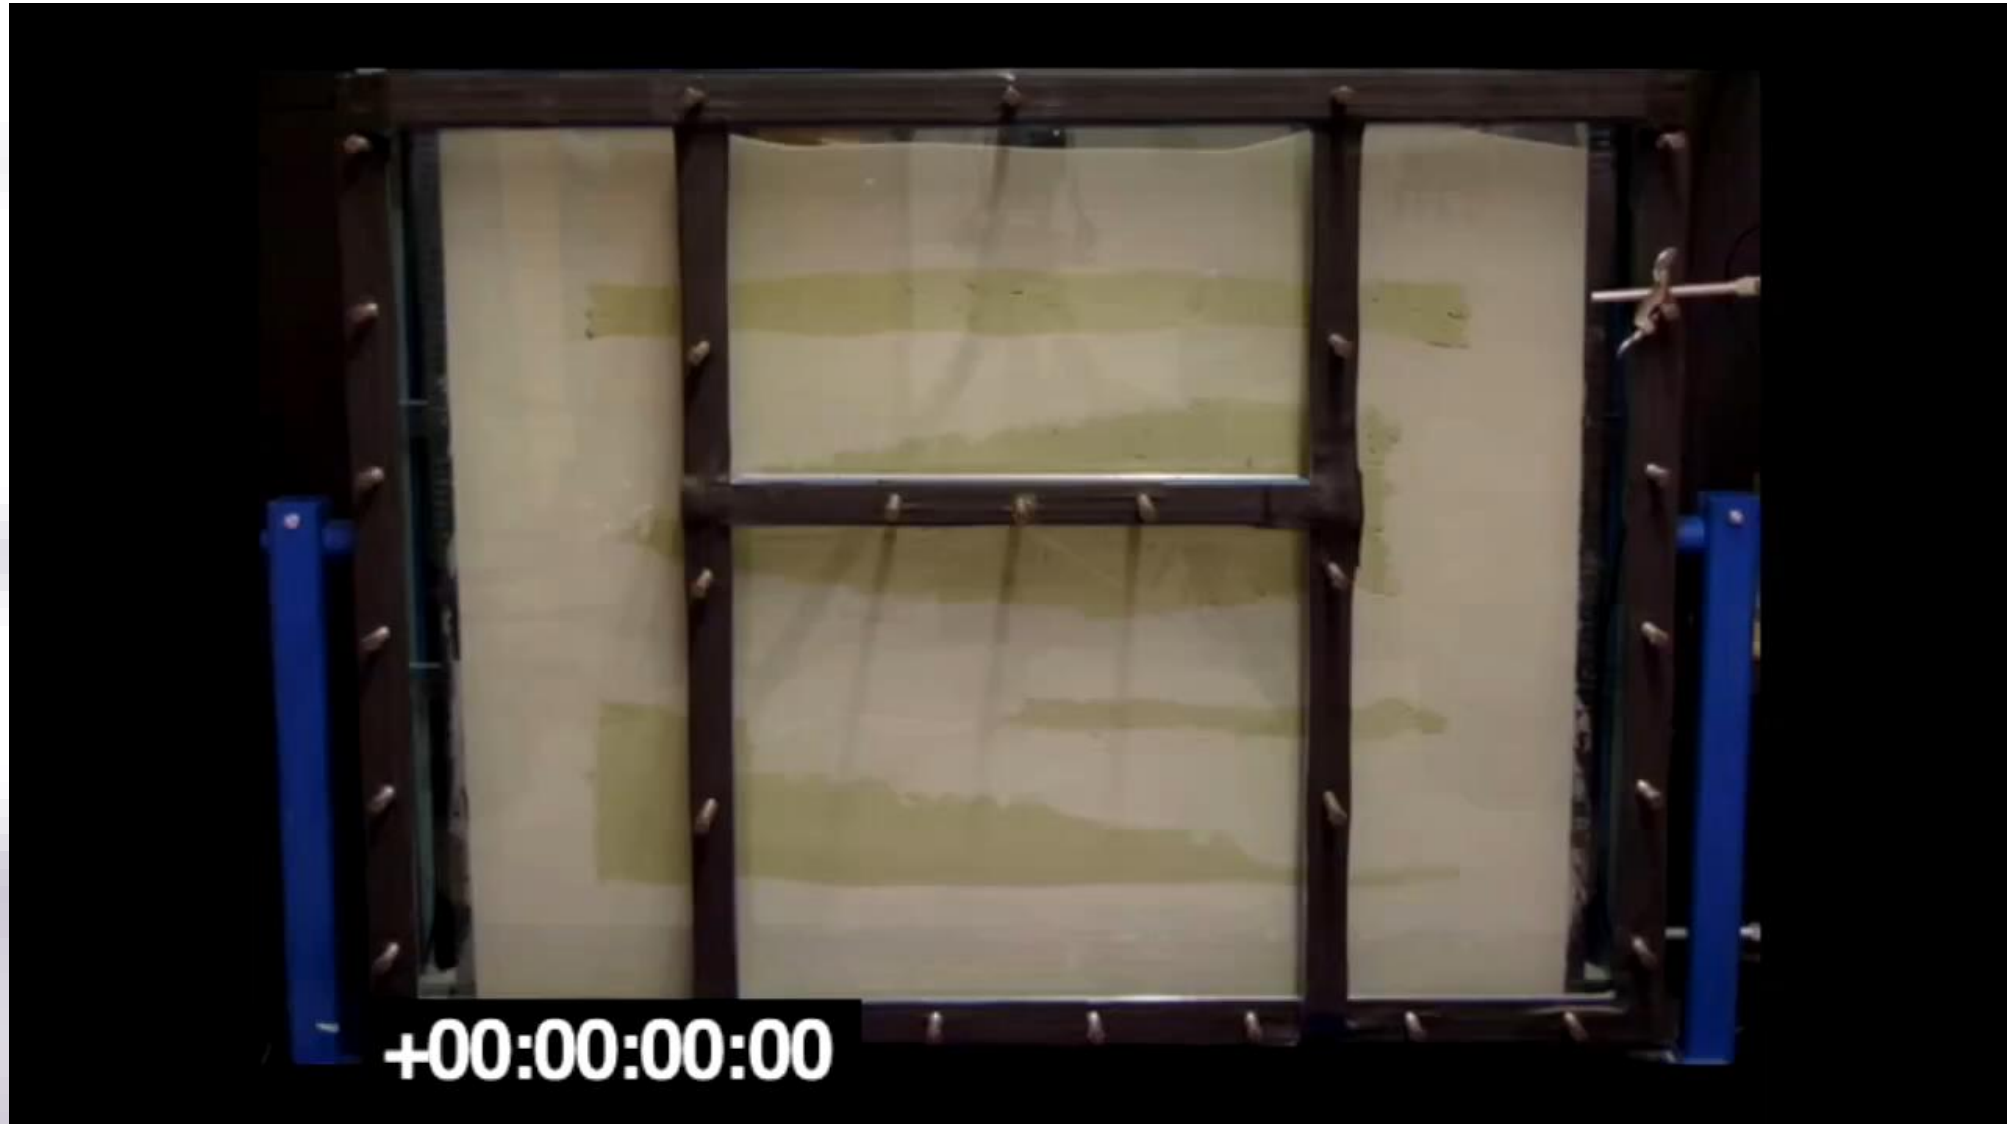
Contaminant Back Diffusion (cause of “rebound”)

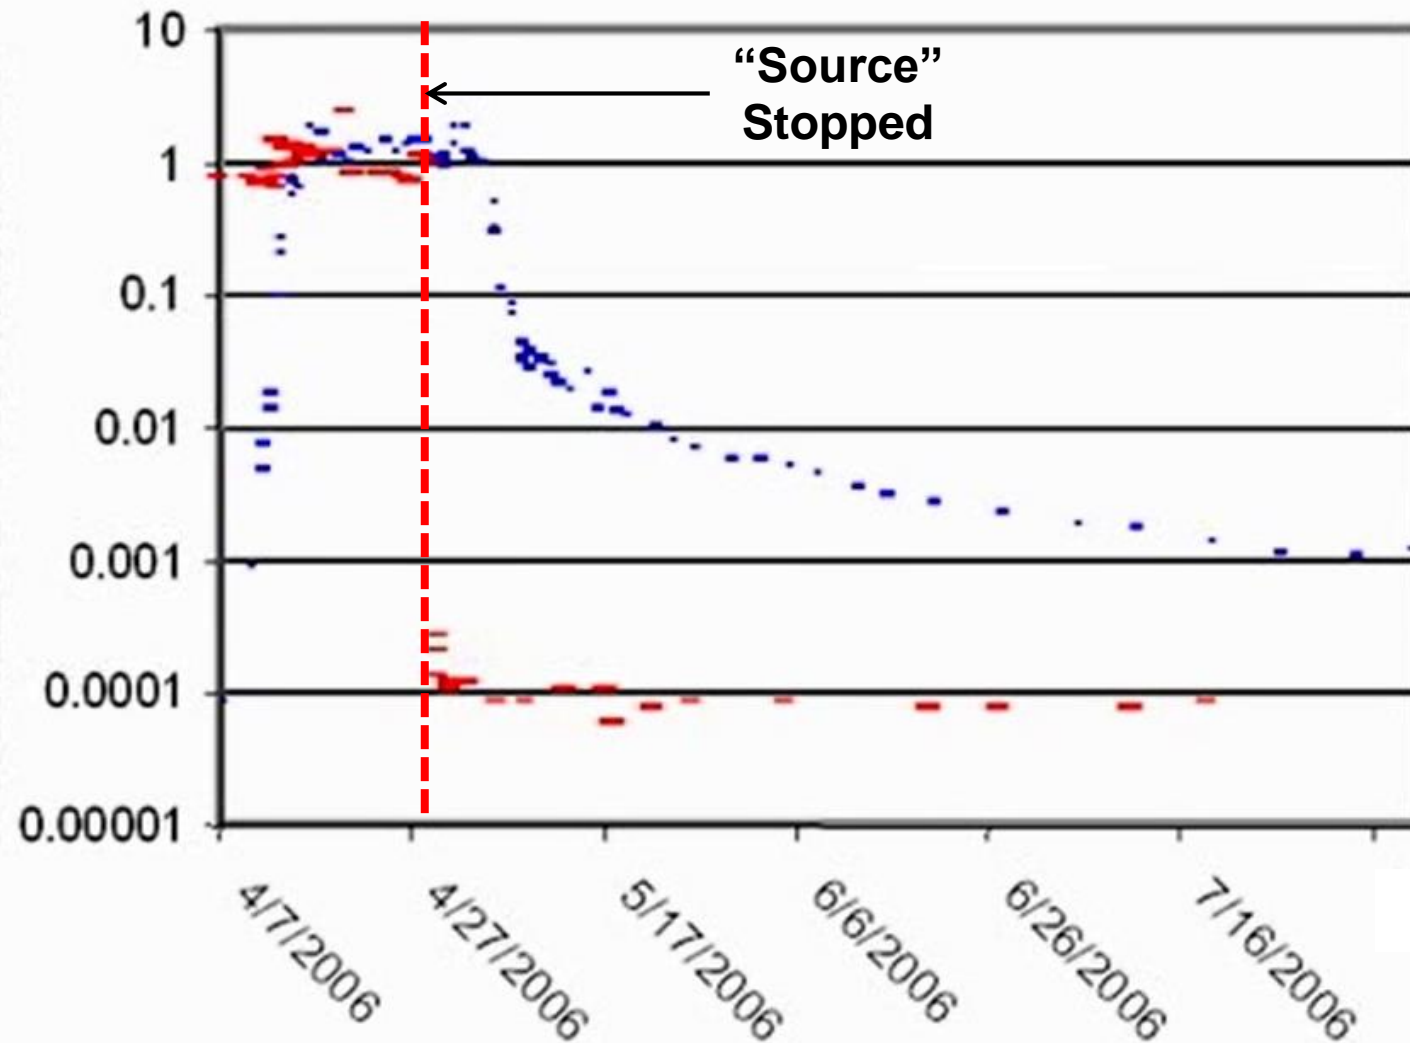
Effluent

Influent

Difference caused by back-diffusion = "rebound"

Contaminant Back Diffusion (cause of "rebound")

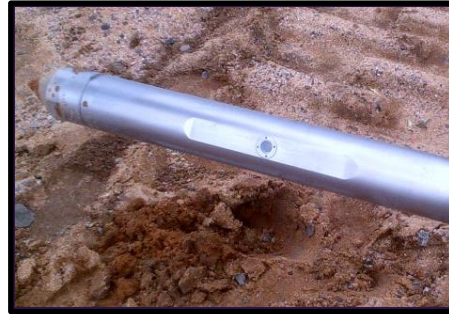
**LIF**

## Laser Induced Fluorescence (LIF)

- Free Phase PHCs / LNAPL

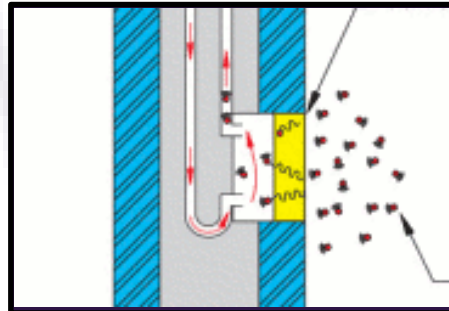
**MIP**

## Membrane Interface Probe (MIP)

- Dissolved Phase PHCs and VOCs

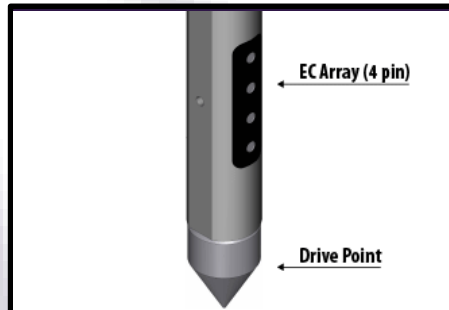
**HPT**

## Hydraulic Profiling Tool (HPT)

- Subsurface Permeability and Conductivity Est.

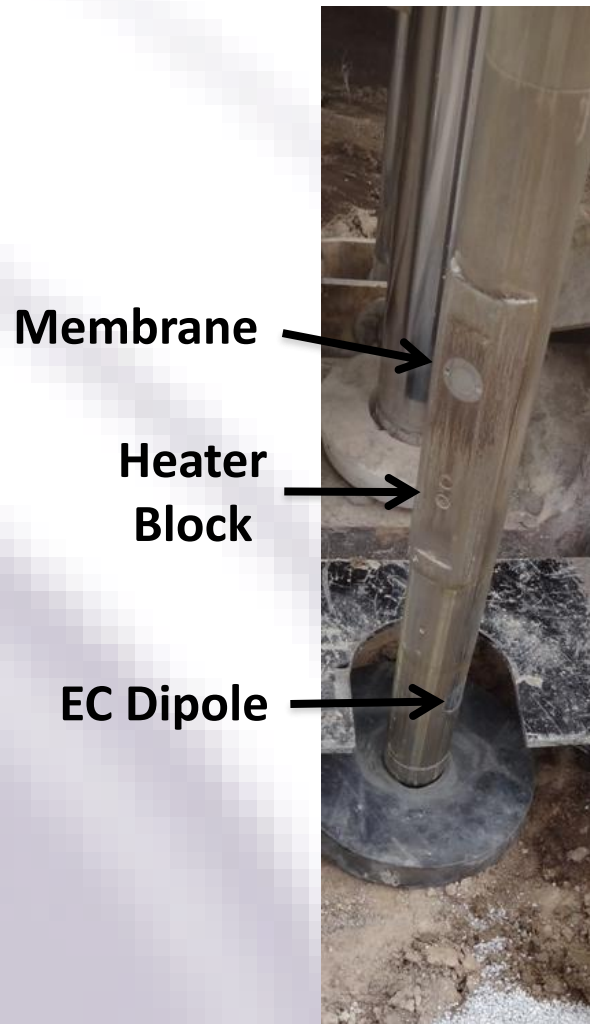
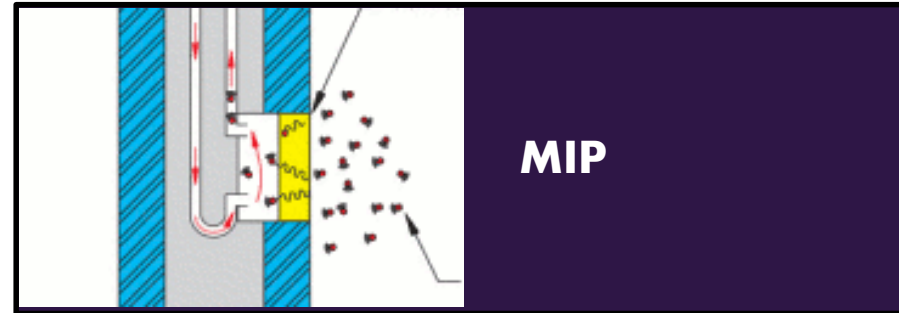
## Membrane Interface Probe (MIP)

- Three detectors:
  - Photoionization Detector (PID) **PHCs cVOCs**
  - Flame Ionization Detector (FID) **PHCs**
  - Halogen Specific Detector (XSD) **cVOCs**
- Detection of VOCs:
  - Petroleum Hydrocarbons (BTEX, PHCs)
  - Chlorinated Solvents (TCE, PCE, TCA, etc.)
- Electrical Conductivity
  - Classify soil

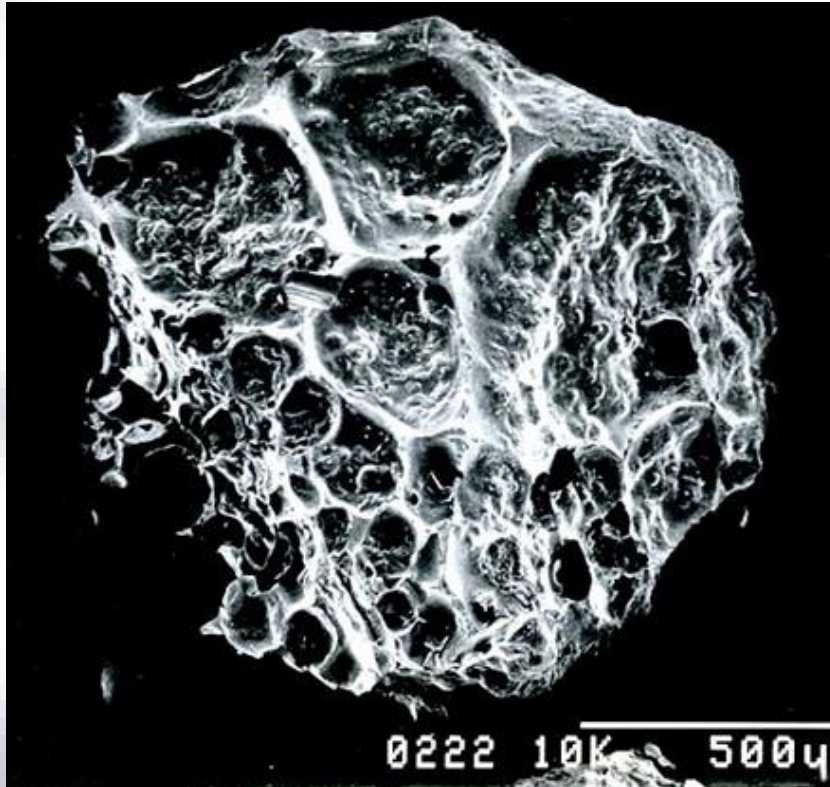
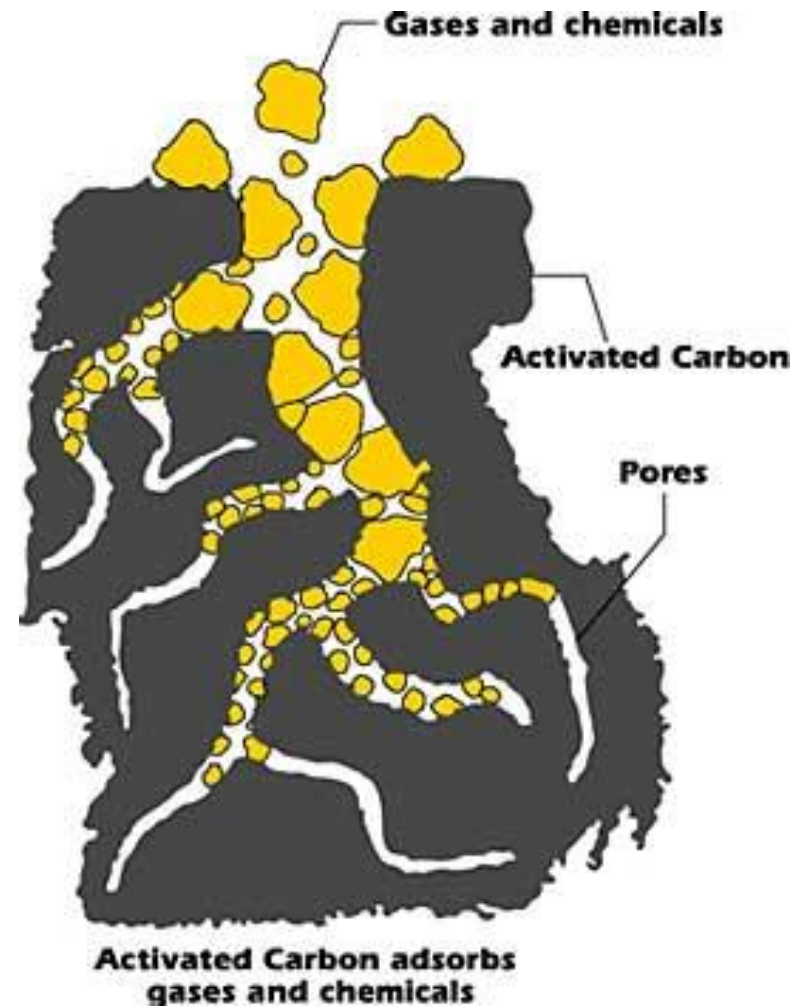
Activated Carbon Adsorption

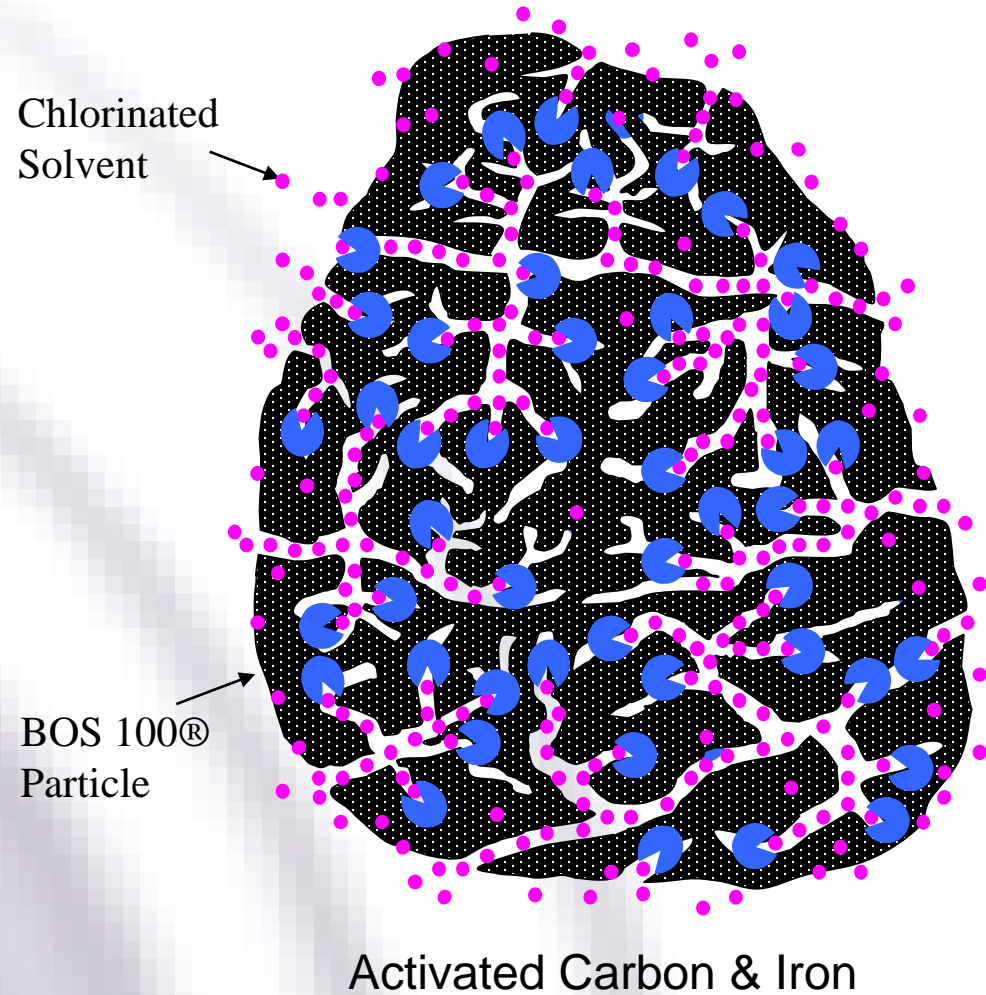
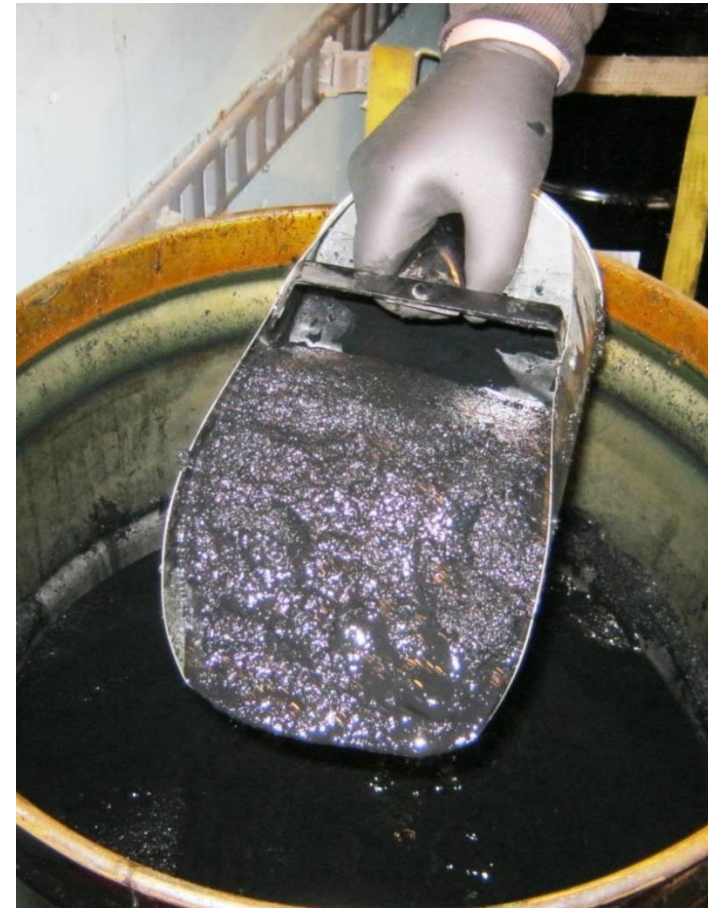
BOS 100® - for cVOCs

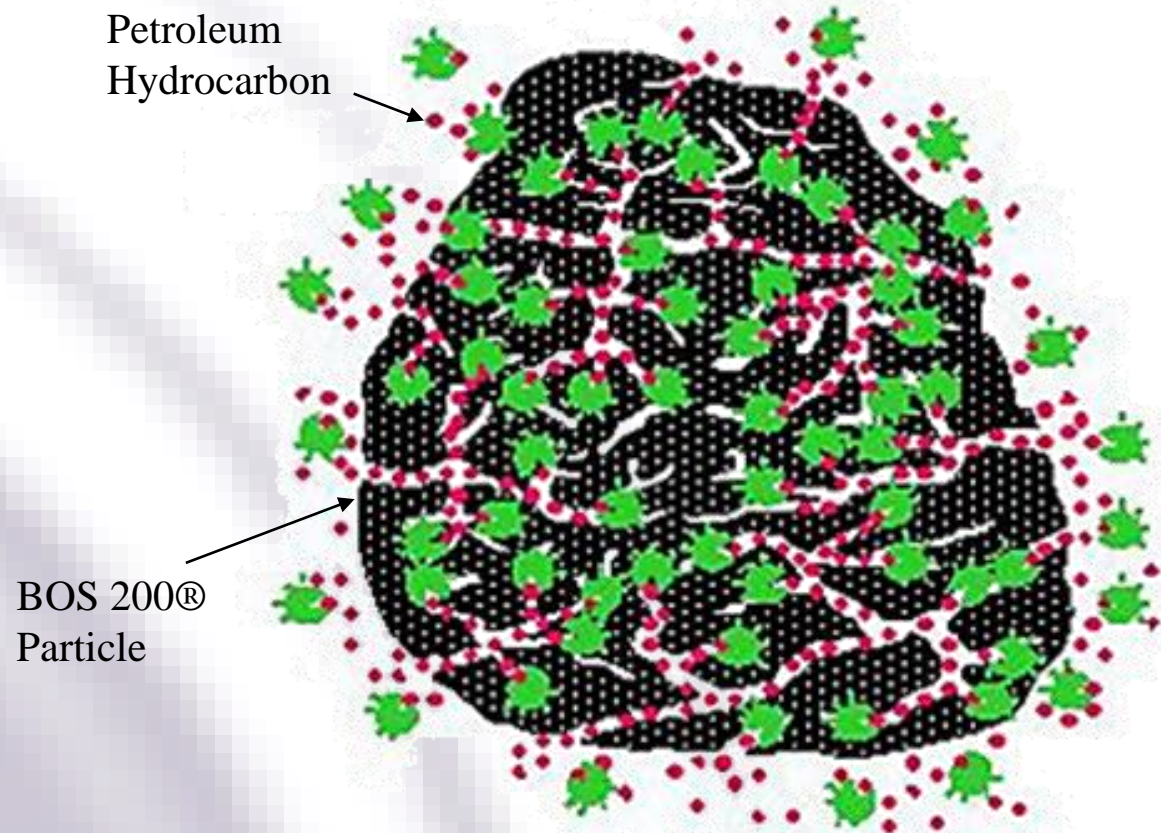
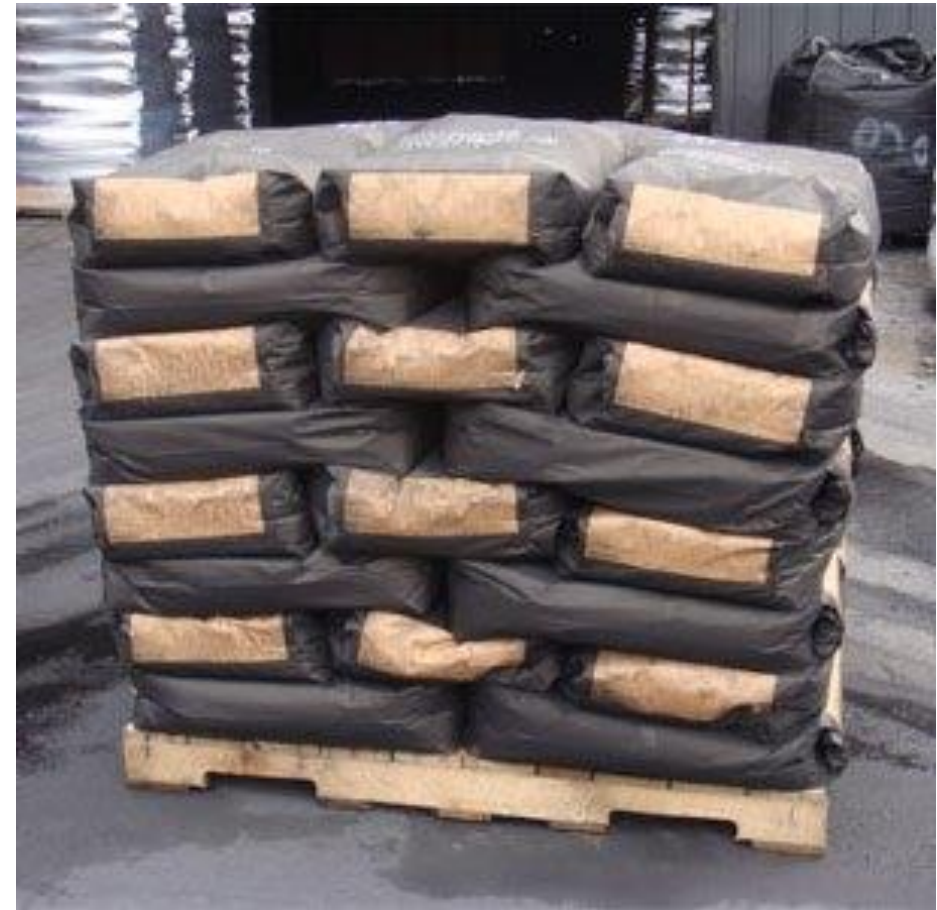
BOS 200® - for PHCs

Activated Carbon & Nutrients & Microbes

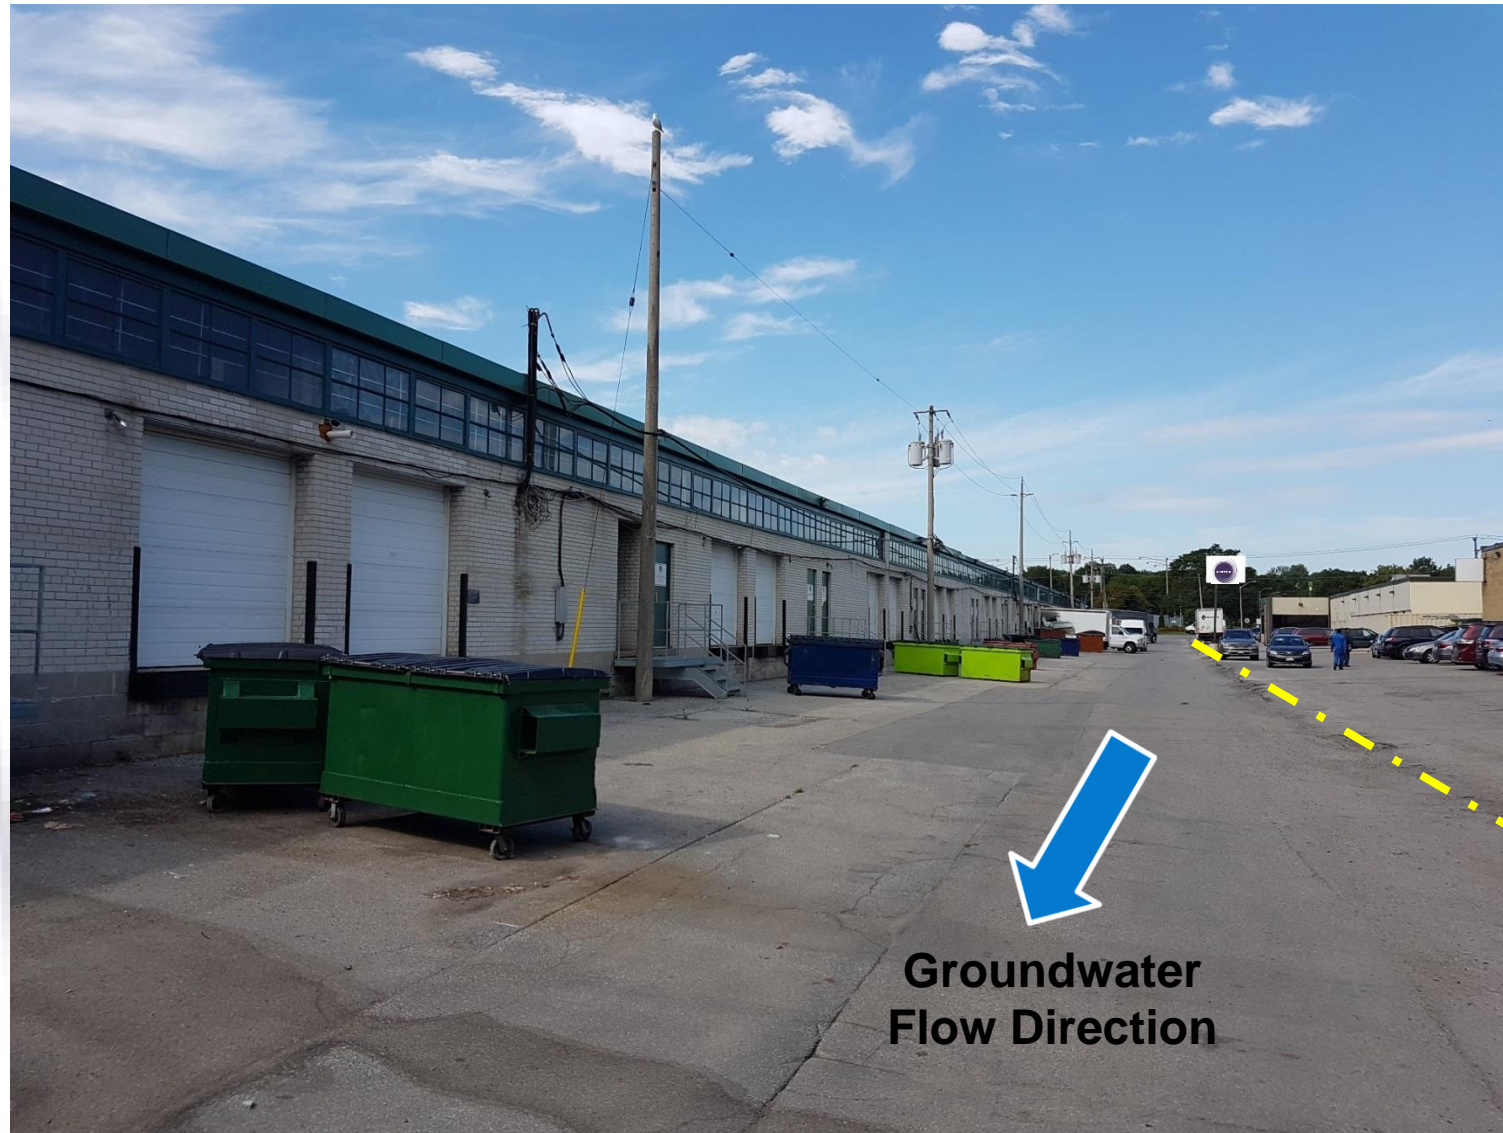
**Source  
Property**

**Property  
Line**

**Groundwater  
Flow Direction**

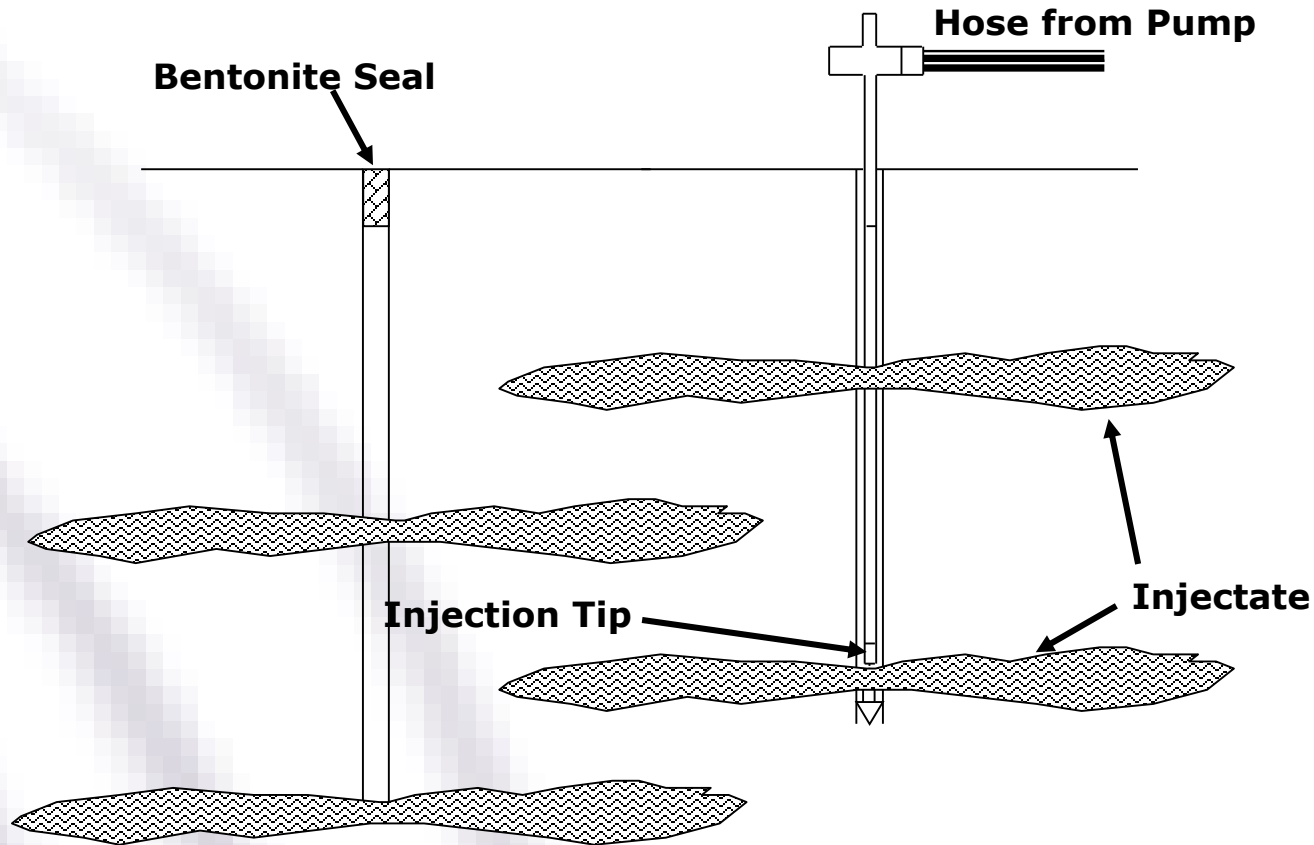
- Direct Push Injection
- Trap and Treat ® BOS 100®
- Top-Down Approach

Injectations using top-down approach

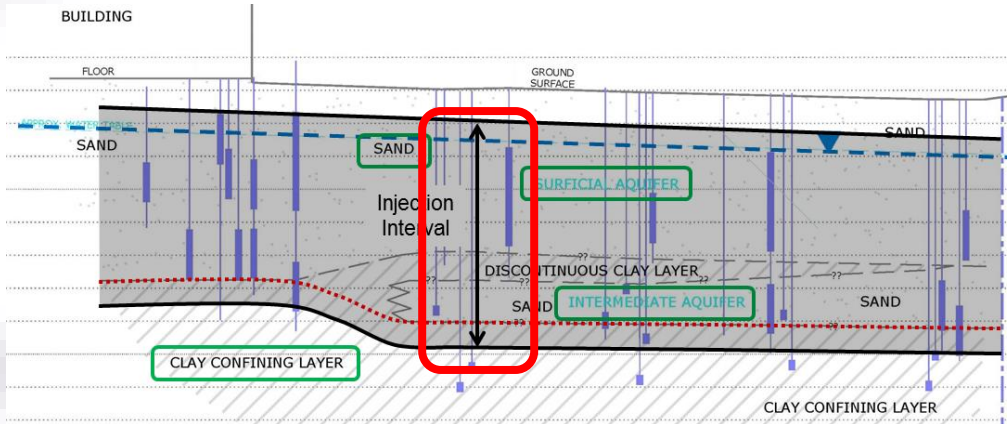
- Target injection interval originally identified as 1.5 to 6.7 mbgs
- Pilot-scale injection testing completed
- Boreholes advanced to collect forensic soil cores for QA/QC testing
- Evaluated BOS 100 distribution

Test Area	Test Hole	Target BOS 100® Injection Range			Apparent BOS 100® Presence Range			Percent Depth Coverage	
		Top (mbgs)	Base (mbgs)	Thick (m)	Top (mbgs)	Base (mbgs)	Thick (m)	%	Average %
1	1	1.5	6.7	5.2	1.2	4.1	2.9	56%	65%
	2	1.5	6.7	5.2	0.8	4.7	3.9	75%	
2	1	1.5	6.7	5.2	1.1	7.3	6.2	119%	102%
	2	1.5	6.7	5.2	2.3	6.7	4.4	85%

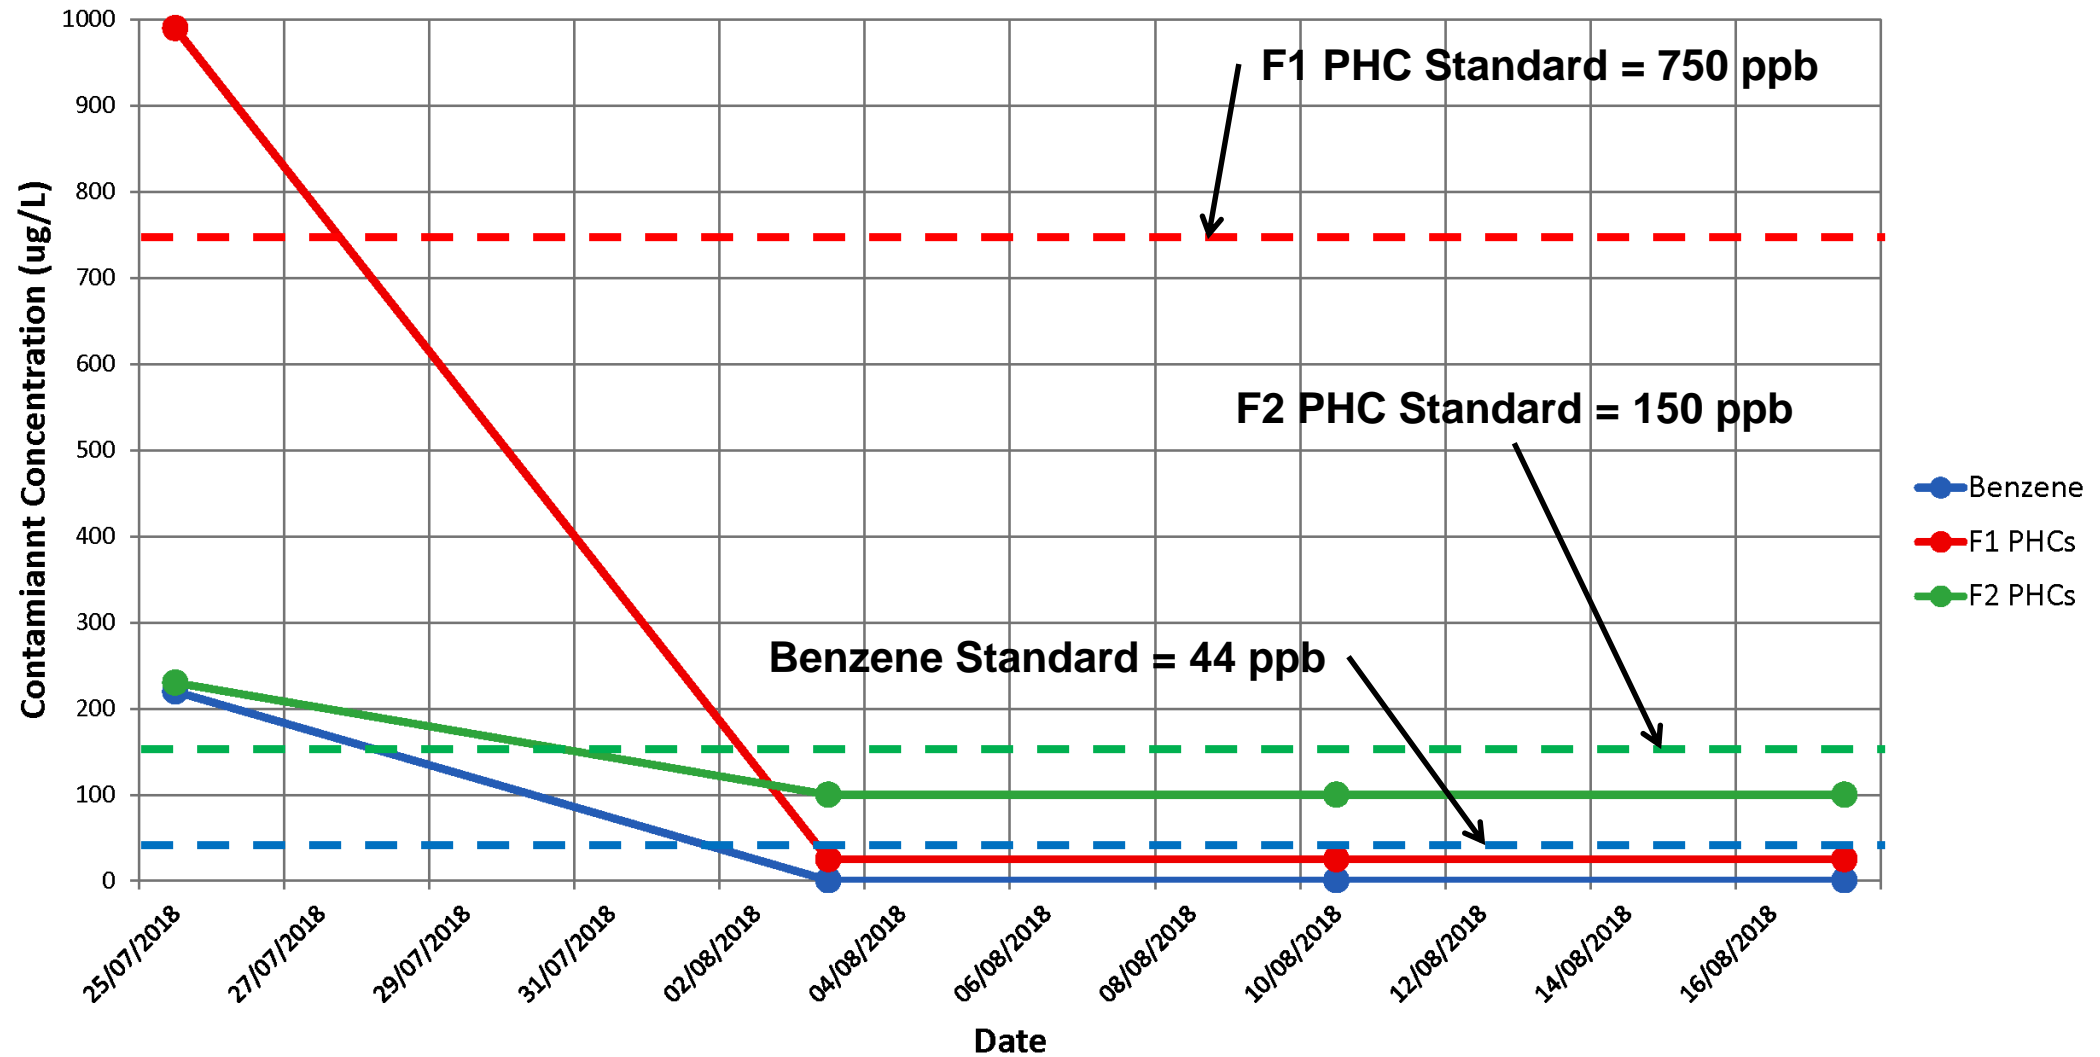
PHC Concentrations vs Time

- Commercial property with former on-Site RFO from 1970s-1990s
- Excavation completed in May 2018 to remove PHC impacted soils
- Backfilled soils were sand and gravel fill
- Post-remediation groundwater quality failed at 1 of 3 MWs in backfill
- Trap & Treat® BOS 200® approach selected for fast and sustained remediation and to prevent “rebound”
- One day injection completed in July 2018
  - 216 kg BOS 200® plus microbial amendment
  - 1,800 L over six temporary injection points
- Remedial objective achieved – **below Generic Standard**
- **PHCs were all ND starting 9 days after injection event!**

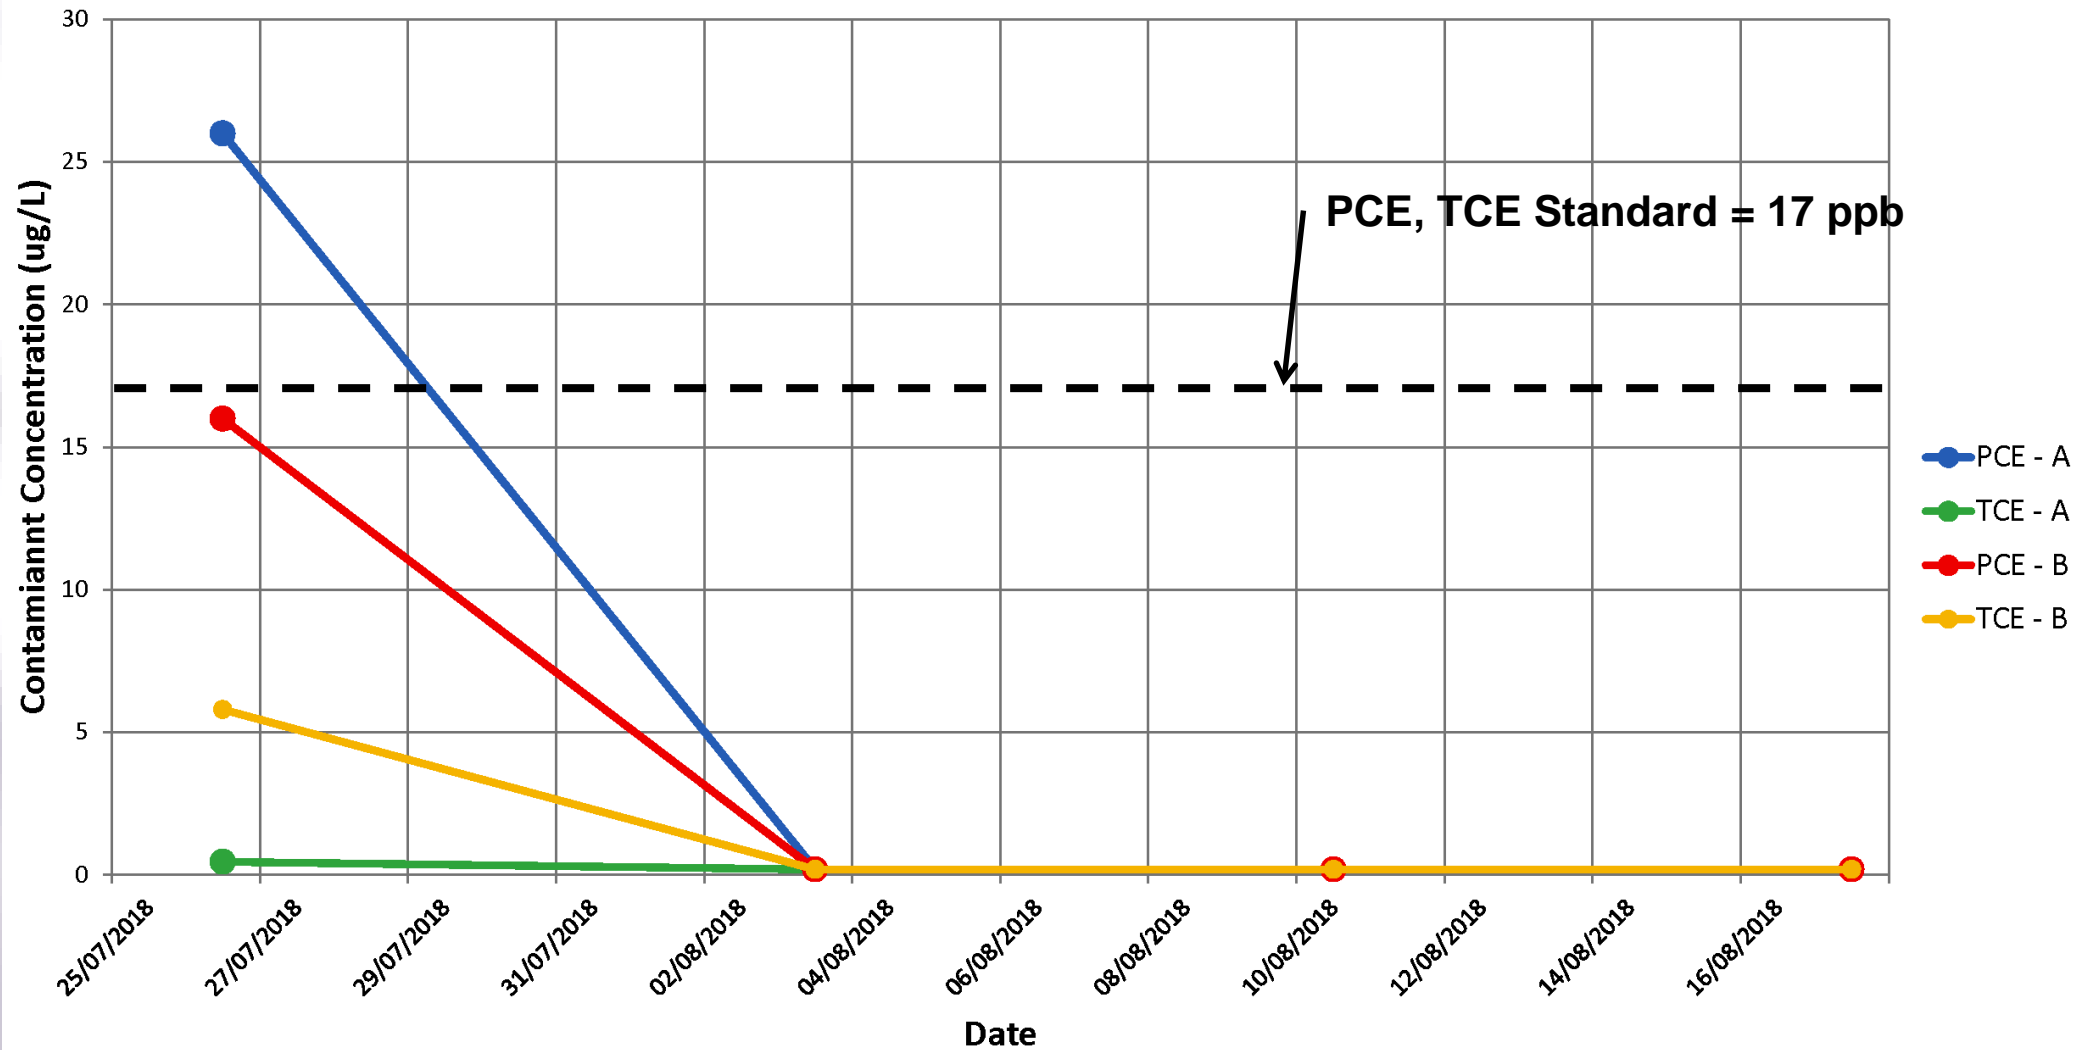
cVOC Concentrations vs Time

- Commercial property with former on-Site dry cleaner from 1960s-1980s
- No cVOC impacted soils identified
- Soils were primarily fine grained silts and clays with sand interbeds
- Groundwater quality failed at 1 MW in vicinity of former dry cleaner and just barely passed in a second MW nearby
- Trap & Treat® BOS 100® approach selected for fast and sustained remediation and to prevent “rebound”
- One day injection completed in July 2018
  - 182 kg BOS 100®
  - 2,800 L over ten temporary injection points
- Remedial objective achieved – **below Generic Standard**
- **cVOCs were all ND starting 8 days after injection event!**
