Effective Sampling Methods to Characterize an Oil Spill within a River

Matrix Solutions Inc.
Integrated Services • Innovative Solutions

Overview of the North Saskatchewan River Oil Release

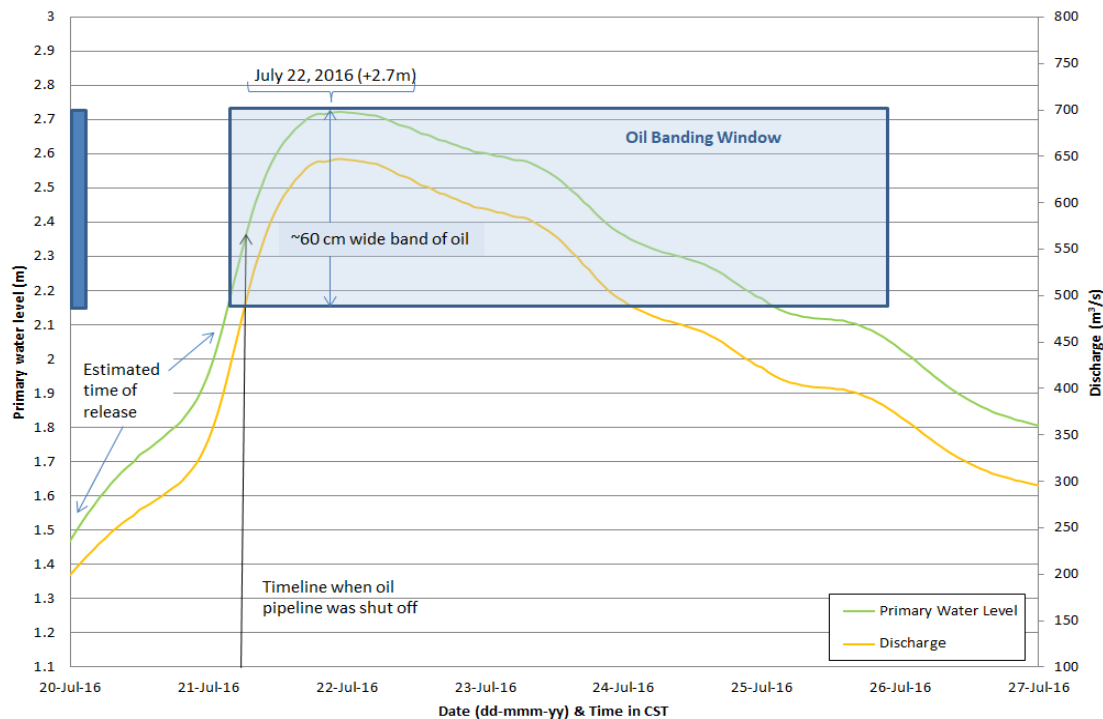
Initial Fate and Transport

- API of 17 – Medium to heavy oil
- Specific gravity 0.925 @15°C
- Lighter than water @ >10°C
- Water temperature >20°C
- Oil floated and deposited on shoreline (60 cm band)

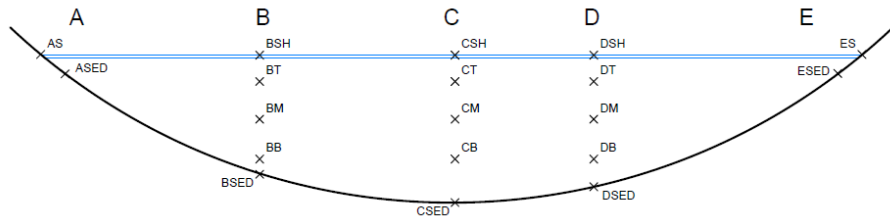
INSTREAM SURFACE WATER SAMPLING

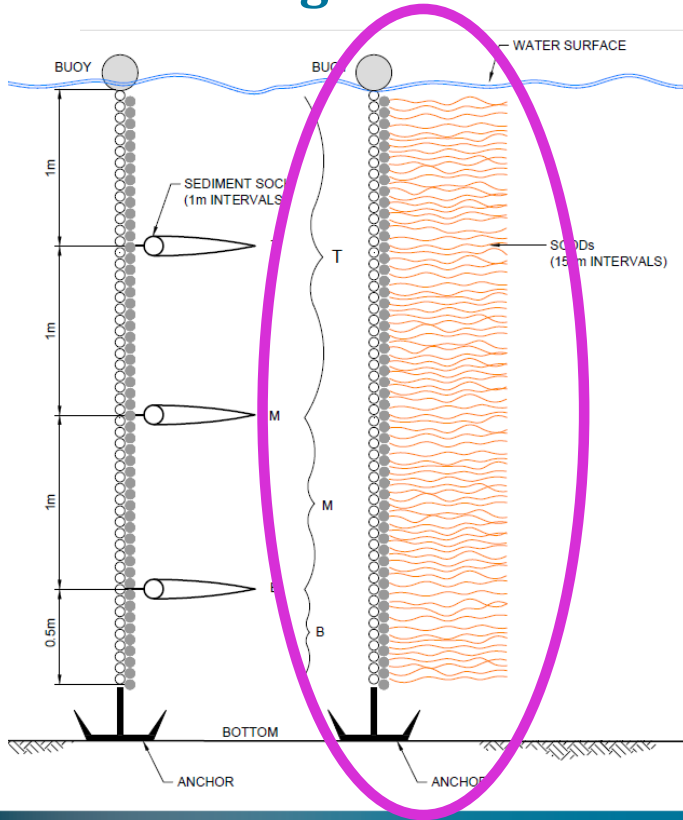
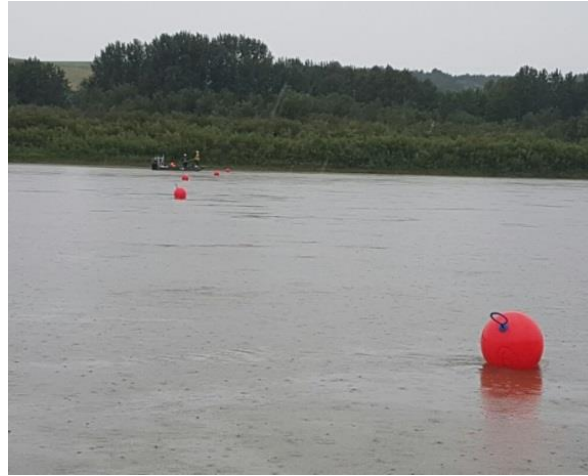
Submerged Oil Detection Devices (SODD) Monitoring Results

Transect with Buoy
Attached to SODD

- Submerged Oil Detection Devices – Subjective
- Sediment Socks – Limited Success
- Bottom Oil Agitation Test – Limited Success
- Sediment Mops – Not Effective
- Foam – Very Difficult / Limited Success
- Sheen – Very Difficult / Limited Success

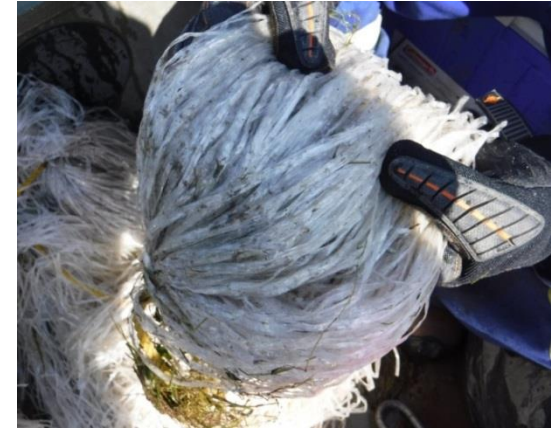
Visual Hydrocarbon
Deposition on SODD

SODD and Sediment
Sock Setup

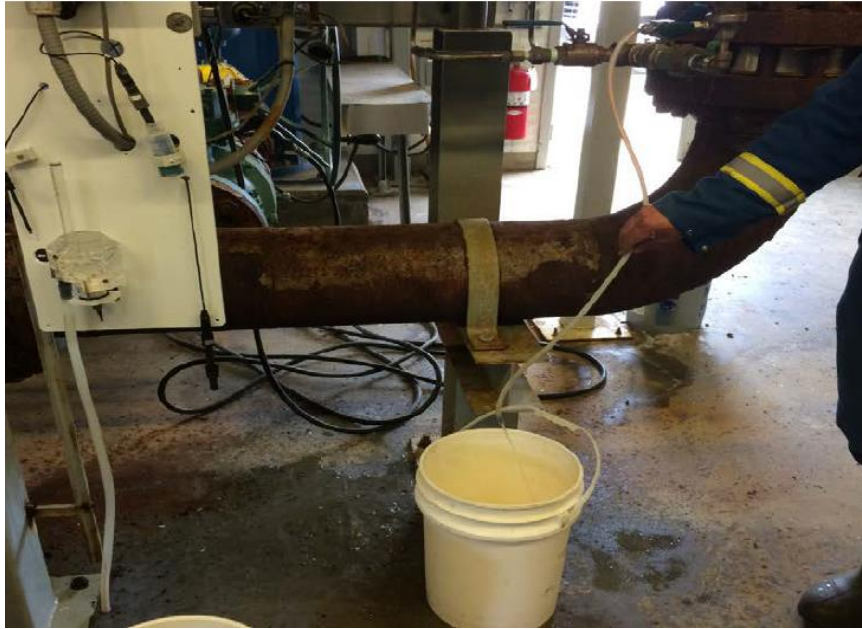
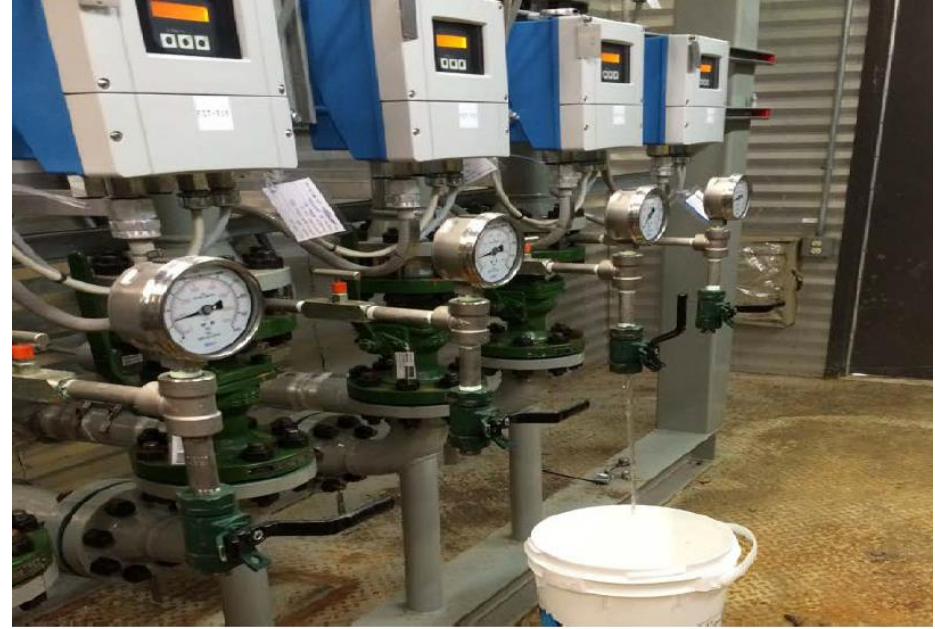
Infiltration Gallery Well Samples Being Collected into a Clean Bucket

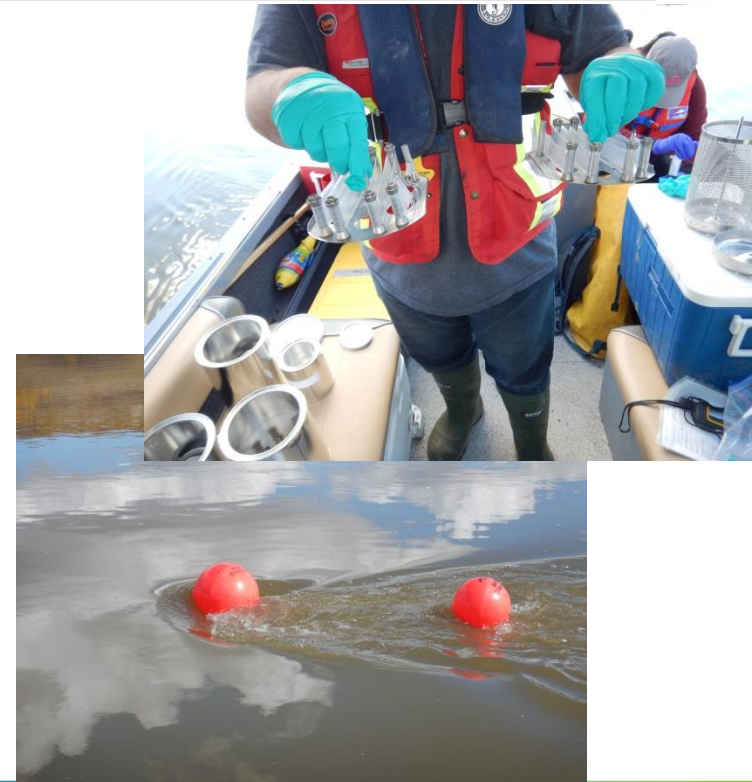
Semi-permeable Membrane Devices (SPMDs)

- Installed at 7 locations for 2 rounds of sampling
- 1 month deployment (per round)
- Measure ultra-trace concentrations of PAHs in water and suspended sediment

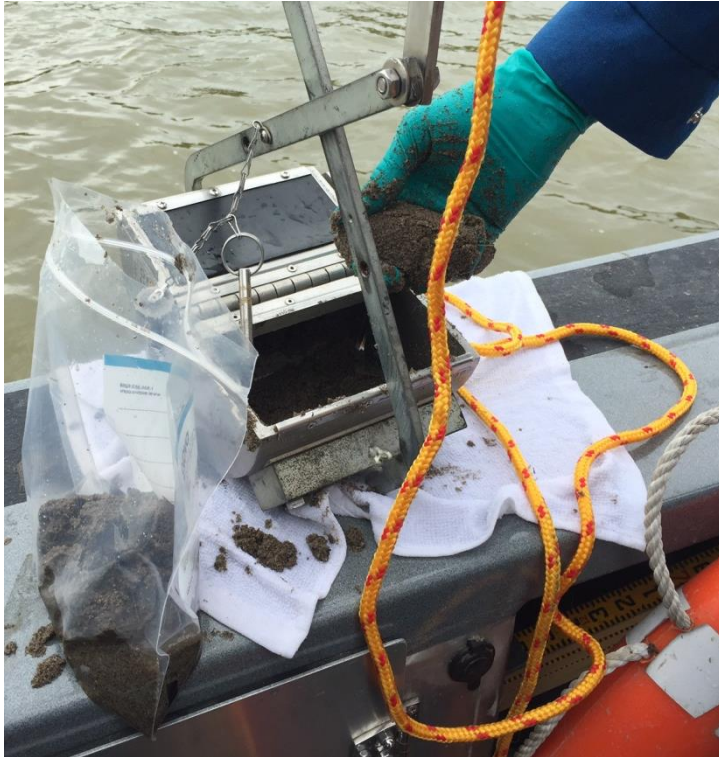
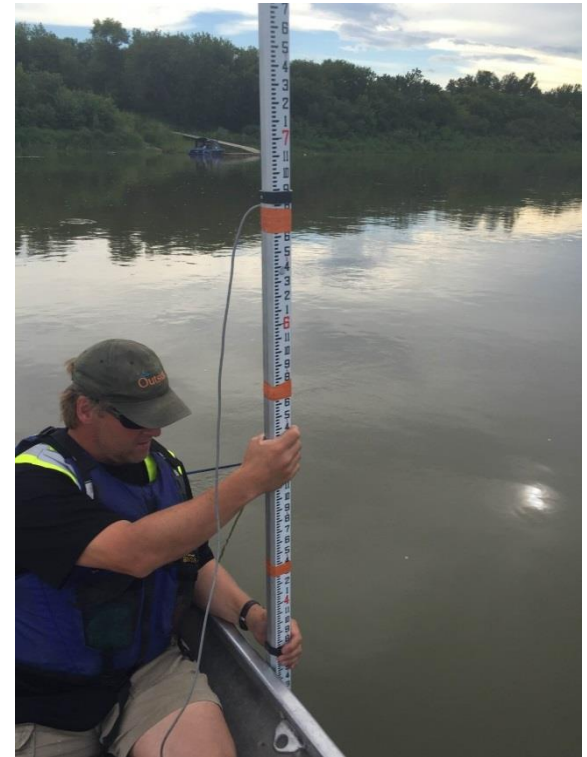
Sediment Sample
Collection using a
Ponar Dredge
(Left)

Measuring Water
Depth and Flow
(Right)

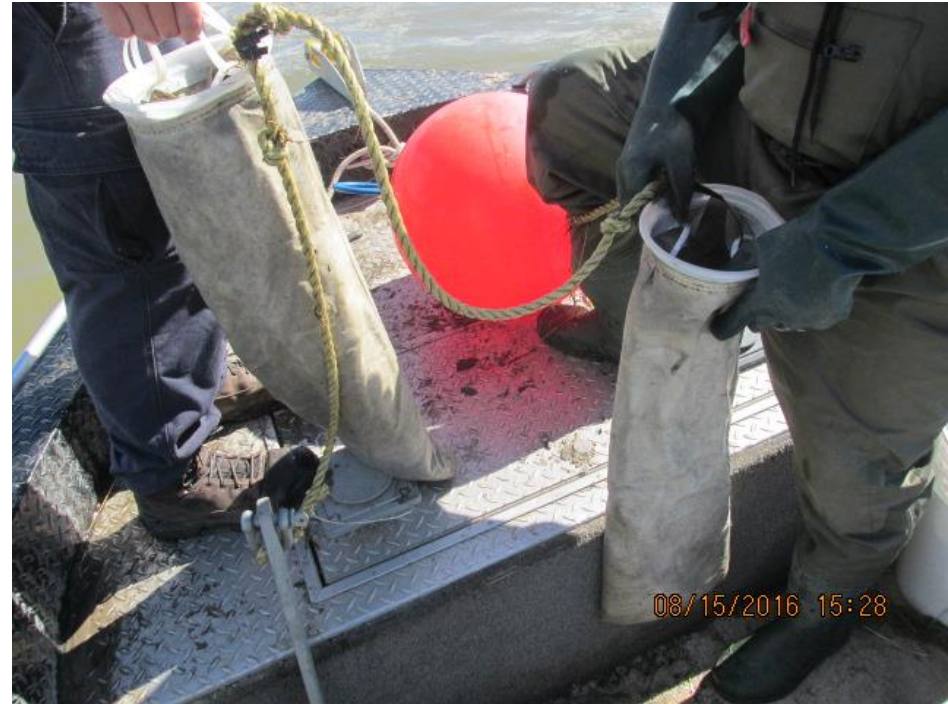
SODD and
Sediment
Sock Setup
(Left)

Sediment
Sock
Sampling
(Right)

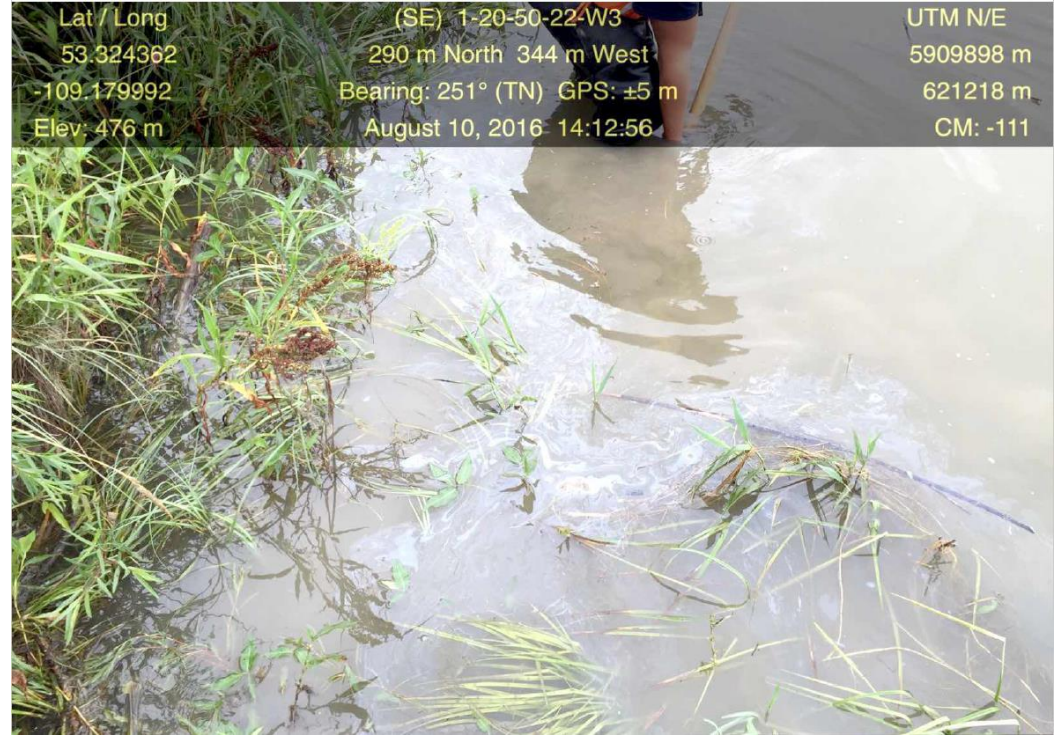
Suspected Bottom Oil Sampling

- Dredge samples collected at locations where visible oil observed
- Focus was on first 100 Km
- Crews also took samples adjacent to maximum oiling extent identified by SCAT team

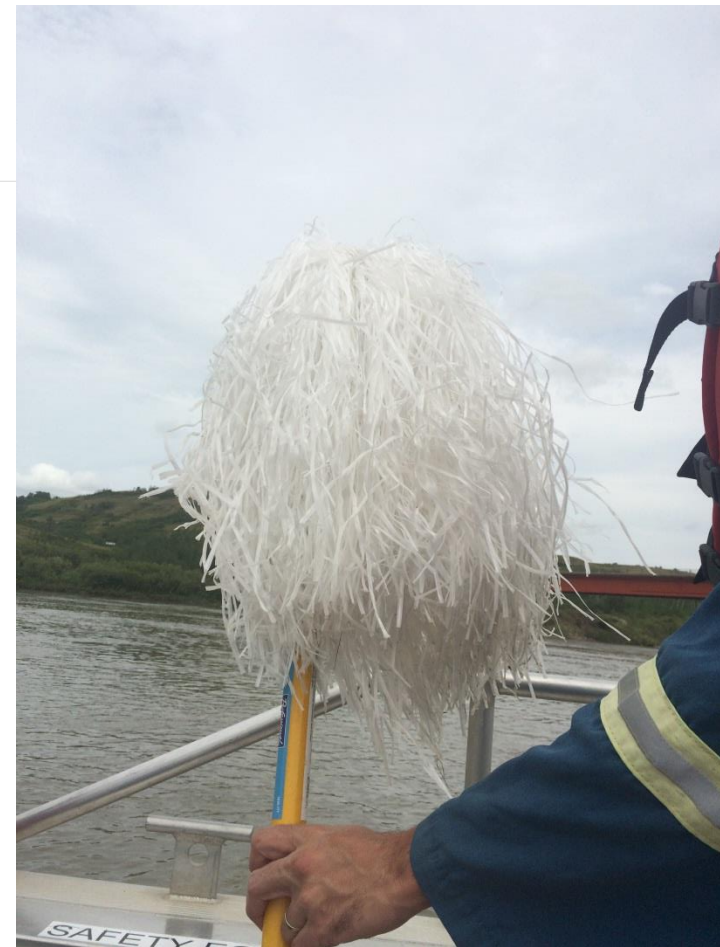
Sediment Mopping

- Pilot program conducted on 3 August, 2016
- Crews constructed “mops” using poles and pompoms from the SODDs
- Were to attempt to mop up visible oil from the sediment

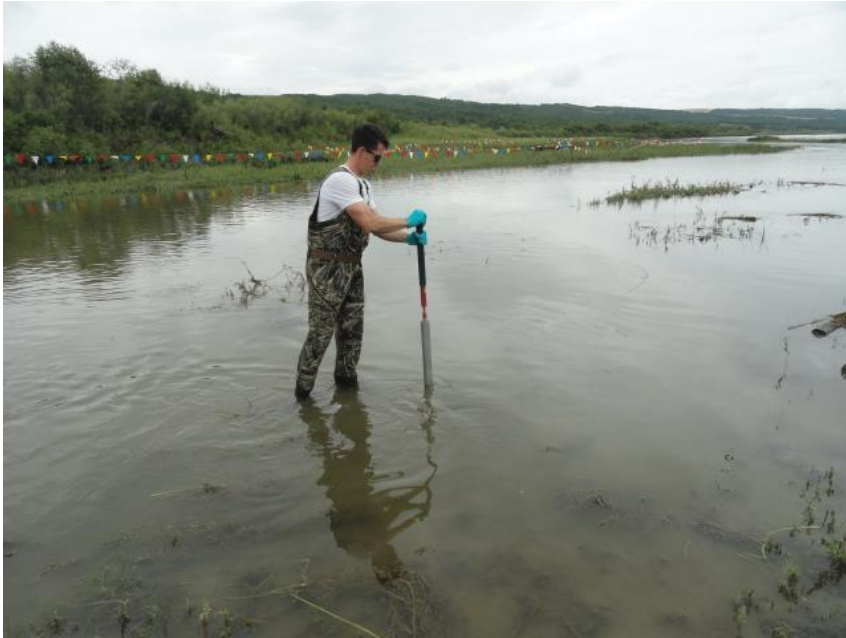
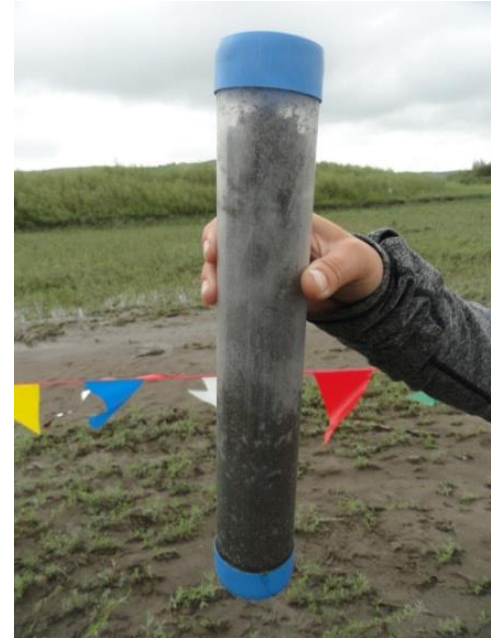
Sediment Core
Collection using an
AMS Sediment
Sampler (Left)

Sediment Core
(Right)

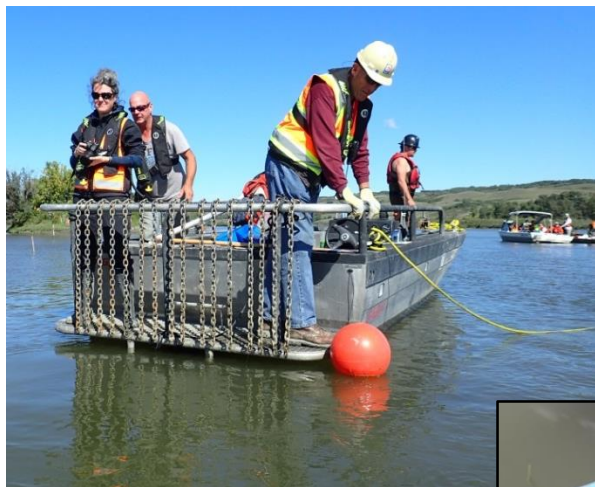
Bottom Oil Agitation Test (BOAT)

Dredge chain
about to be
lowered

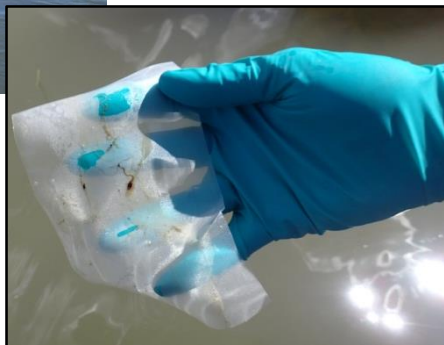
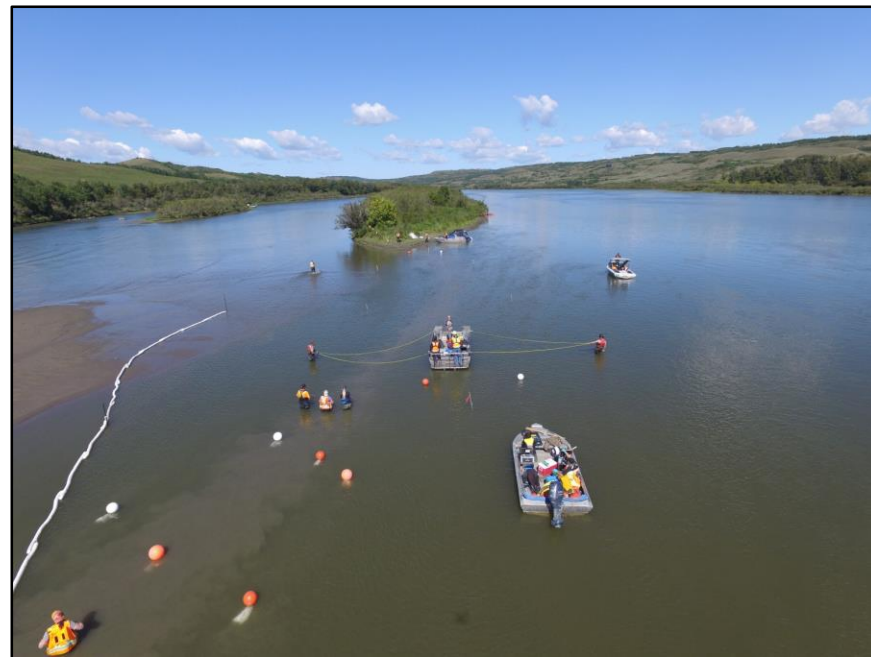
Pinhead sized
globules on Teflon
mesh

Siltation following second trial
