# **Bralorne-Takla Mercury Mine**

## **Collaborative Remedial Planning for Historic Mine Clean-Up and Reclamation Project**

RemTech, October 2018

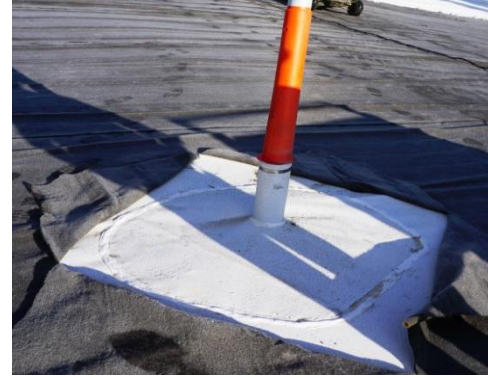
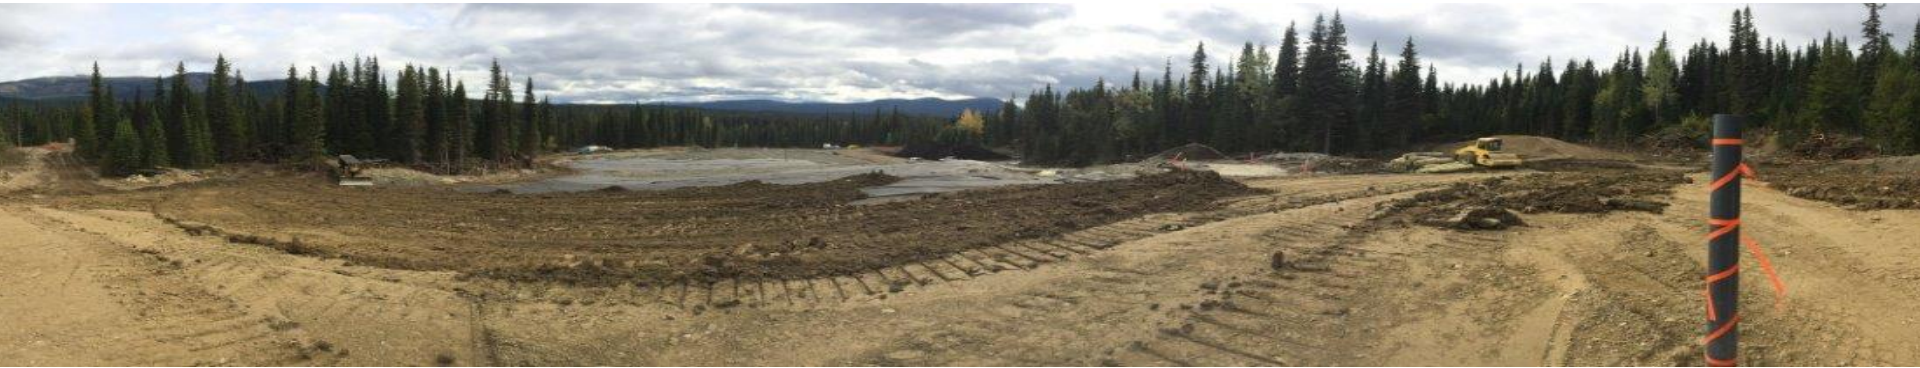
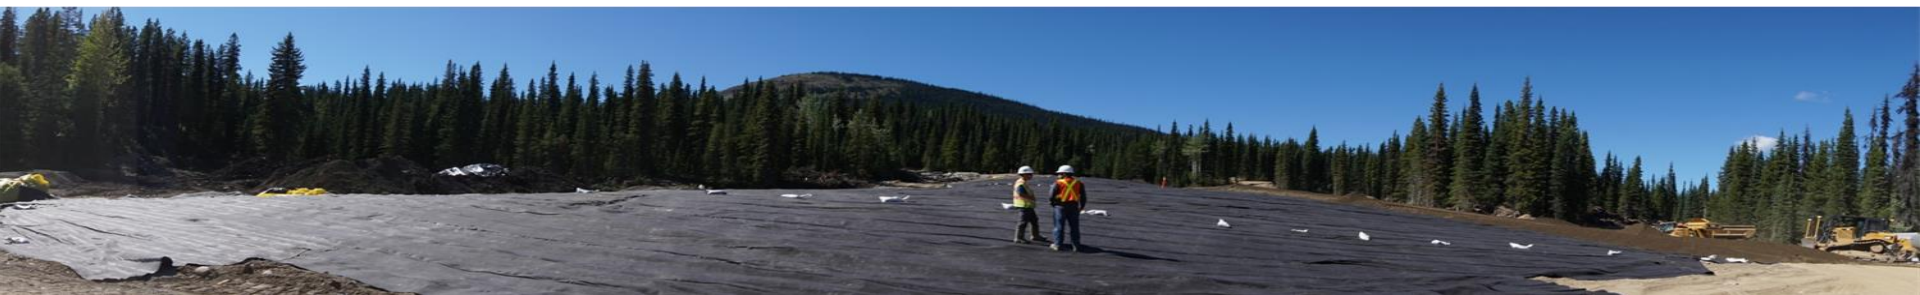
# Consolidation and Landfill

- Off-site disposal of all Hazardous Waste, metal and garbage.
- On-site management of non-Hazardous Waste mine contaminated soil, mine waste and demolition debris in two landfills.
- Reclaim disturbed areas & covers to forest habitat using native species.
- Risk manage isolated contamination within naturally reforested areas.
- Simple soil covers over excavated areas to eliminate exposure to soil or bedrock with naturally high metals concentrations.
- Education and recognition program with the TN community about the Bralorne-Takla Mine Site remediation work and risk-based land use restrictions.

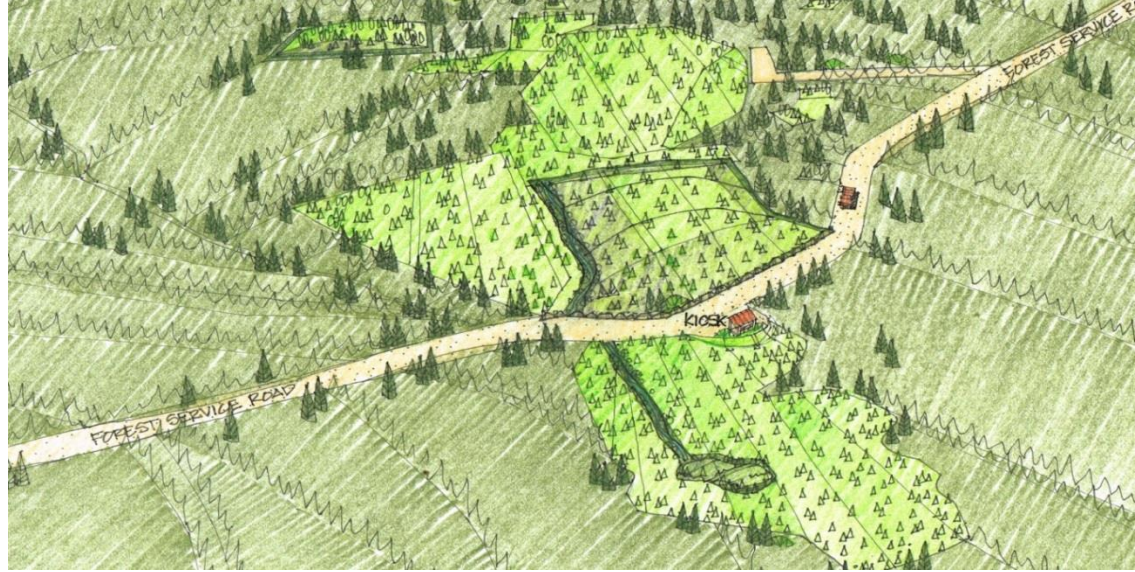
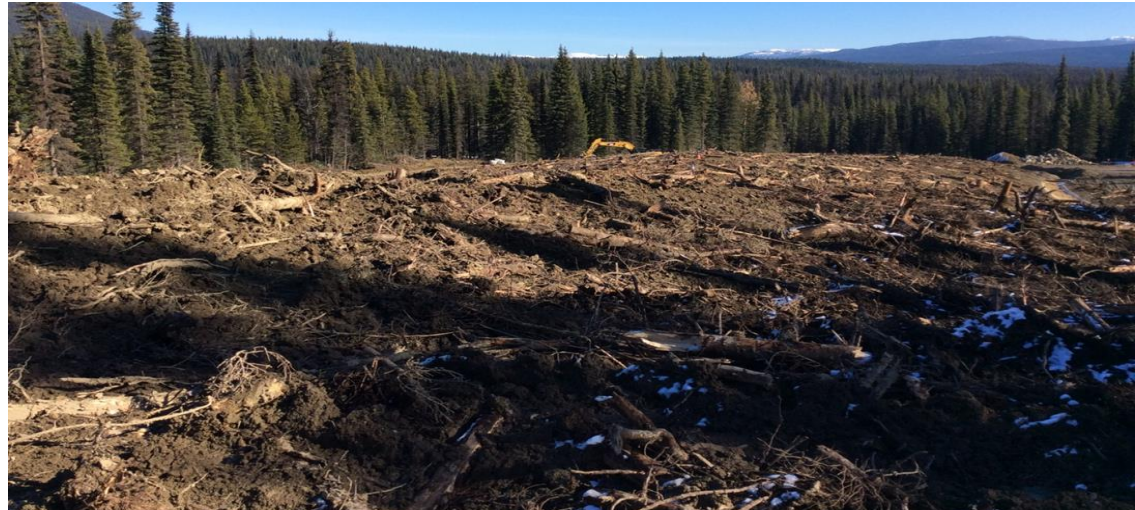
# Revegetation Planning

- Forested wildlife habitat
- Landfills fit topography
- Rough & loose with Coarse Woody Debris.
- Shrubs propagated from collected seeds
- Fall seeding, spring planting
- Planting prescriptions varied to fit site conditions

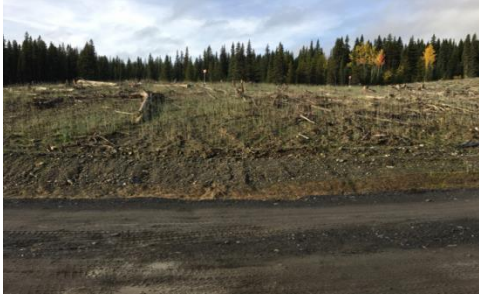
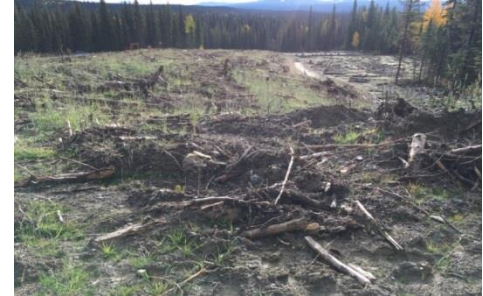
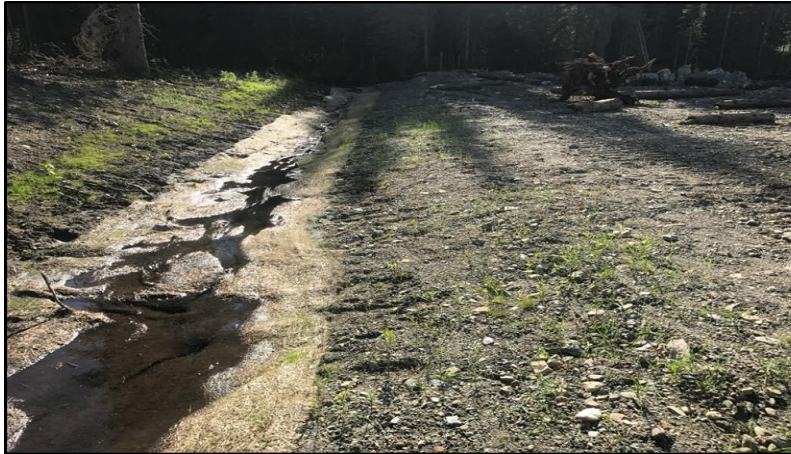
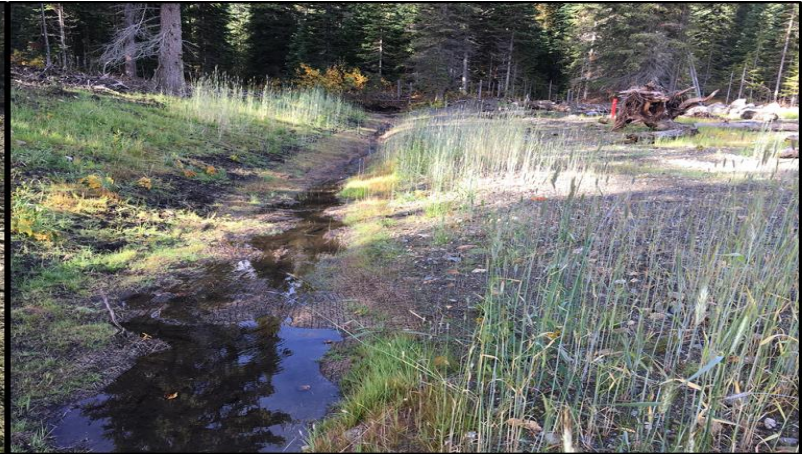
# Vegetation Performance and Maintenance

- 16 plots for: plot total % cover, seedling survivorship, height, relative vigor, species composition, noxious or nuisance weeds
- Meet or exceed targets after one growing season

**Spring and Fall 2017**
