REMEDICATION AND RESTORATION OF AN ESTUARINE RIVER

A CASE STUDY FOR IMPACTED SEDIMENT REPLACEMENT

*Presented by Jeff Earle P. Eng.
On behalf of the Atlantic PIRI Committee*

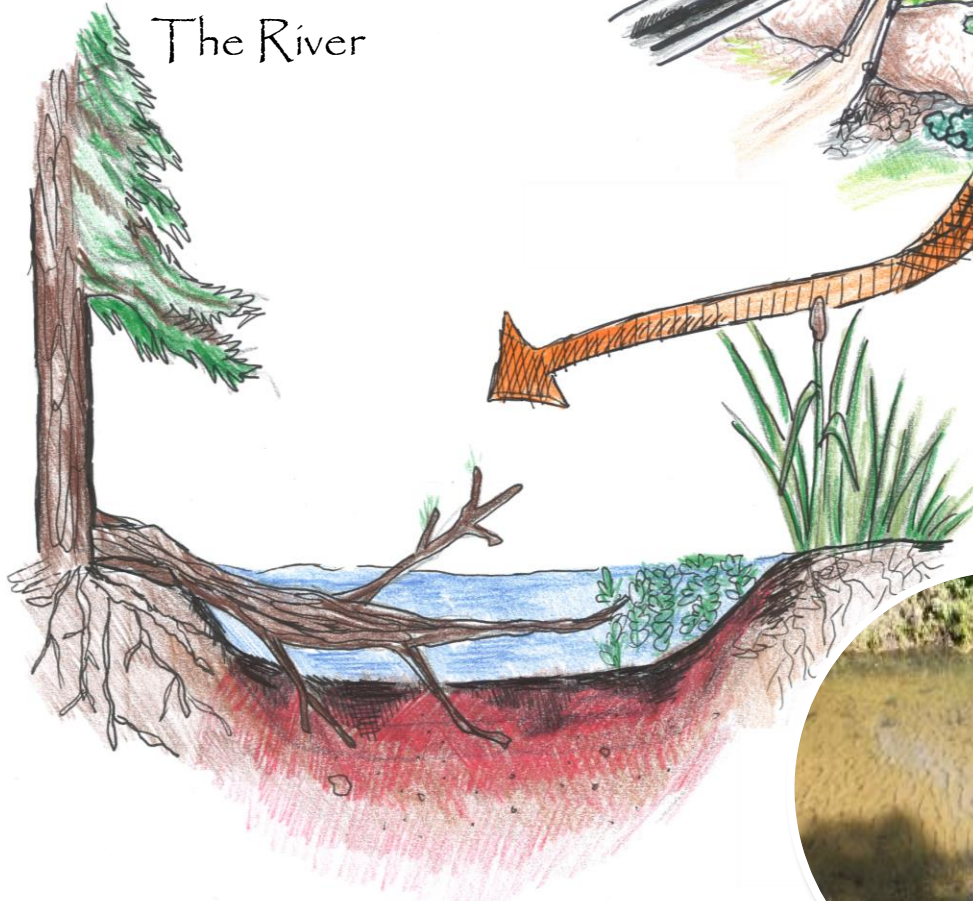
The River

THE BASELINE – PLAN AND PROFILE

Pre-Restoration

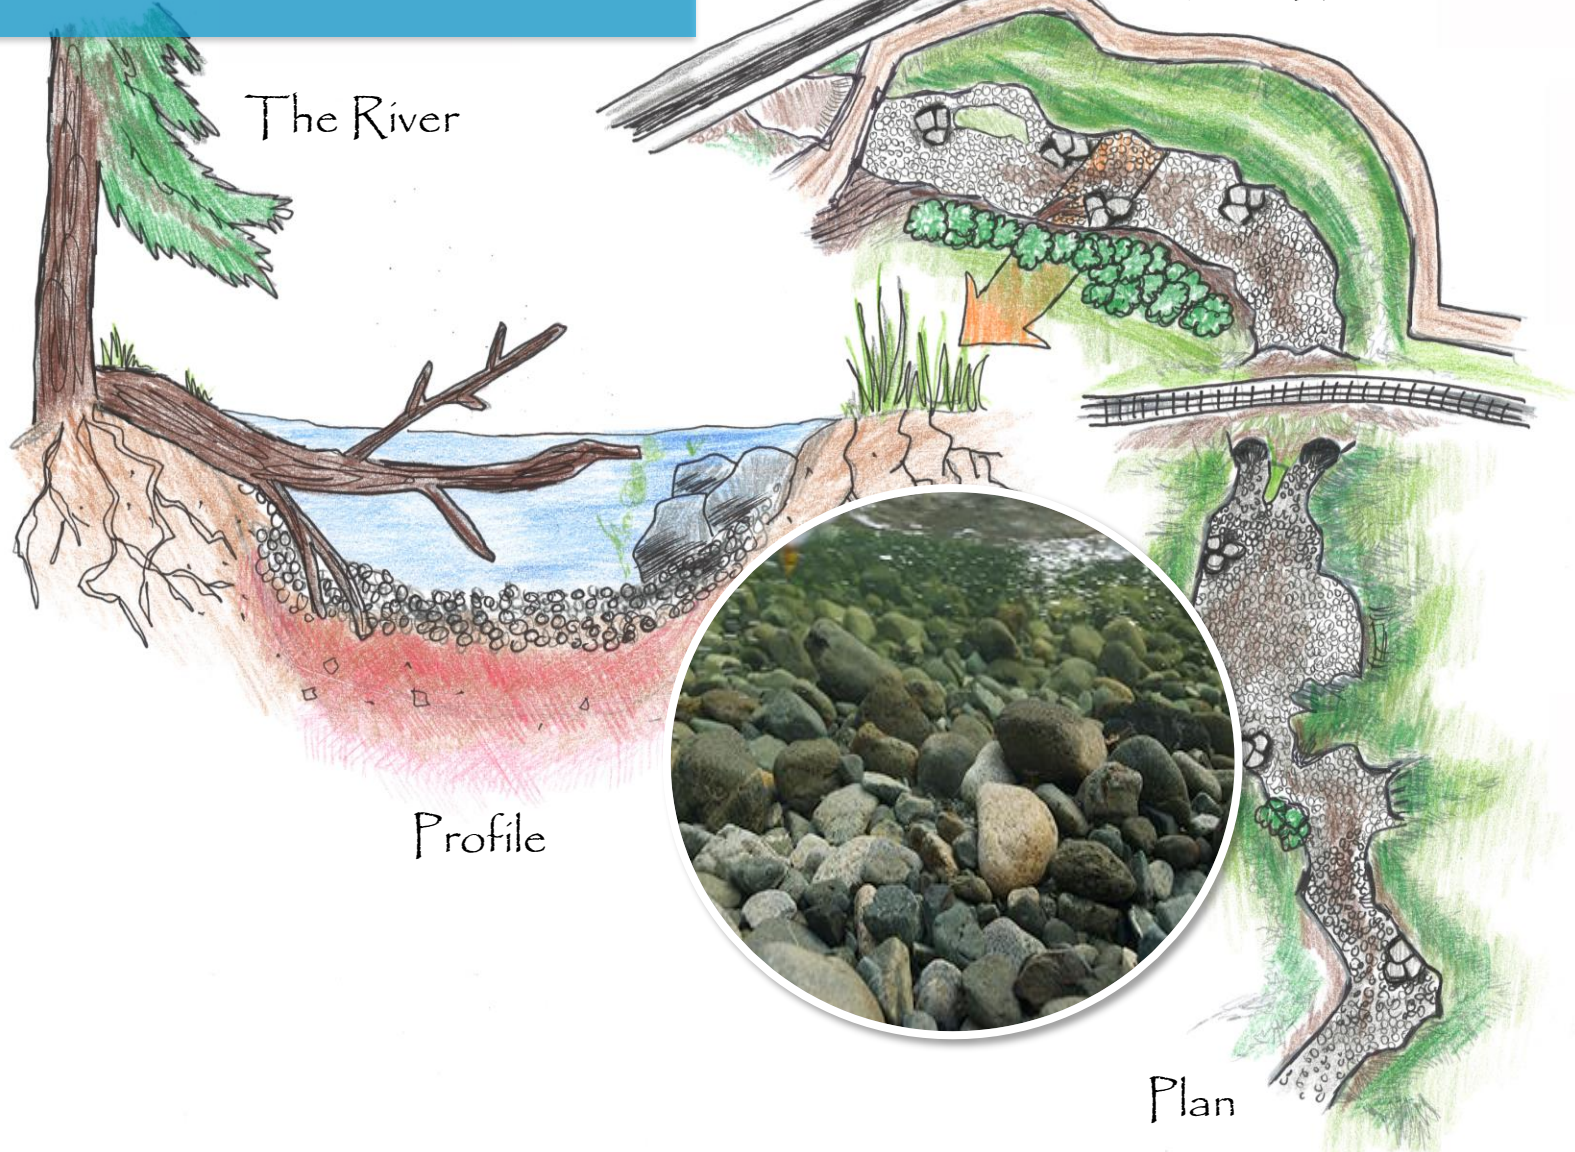
Post Restoration

POST RESTORATION – PLAN AND PROFILE
