Case Study: When In-Situ Techniques Fail

October 18, 2019

RemTech

Kevin French, B.A.Sc., P.Eng.

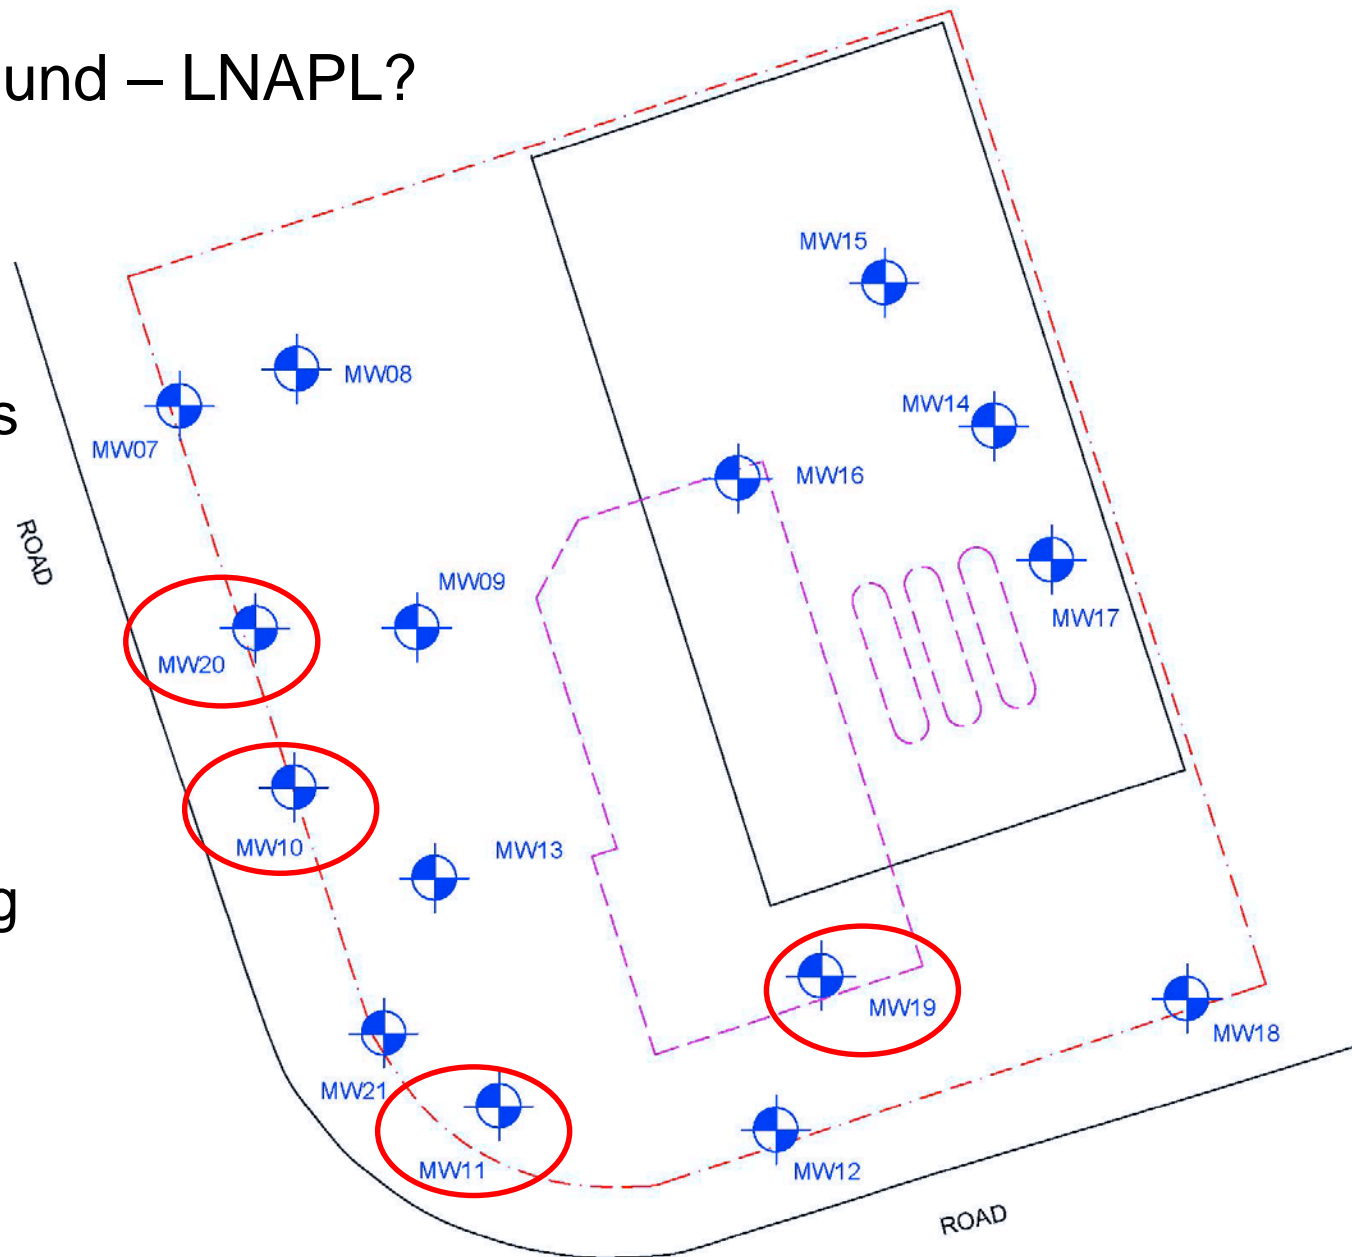
Background – LNAPL?

“There was no measureable non-aqueous phase liquid detected in any of the groundwater monitoring wells, however, evidence of **liquid phase gasoline** was observed during the **drilling** in boreholes MW10, MW11, MW19 and MW20.”

“It should be noted that during the purging of location MW19, **hydrocarbon product** was observed in the **purge water** and on the sample tubing.”

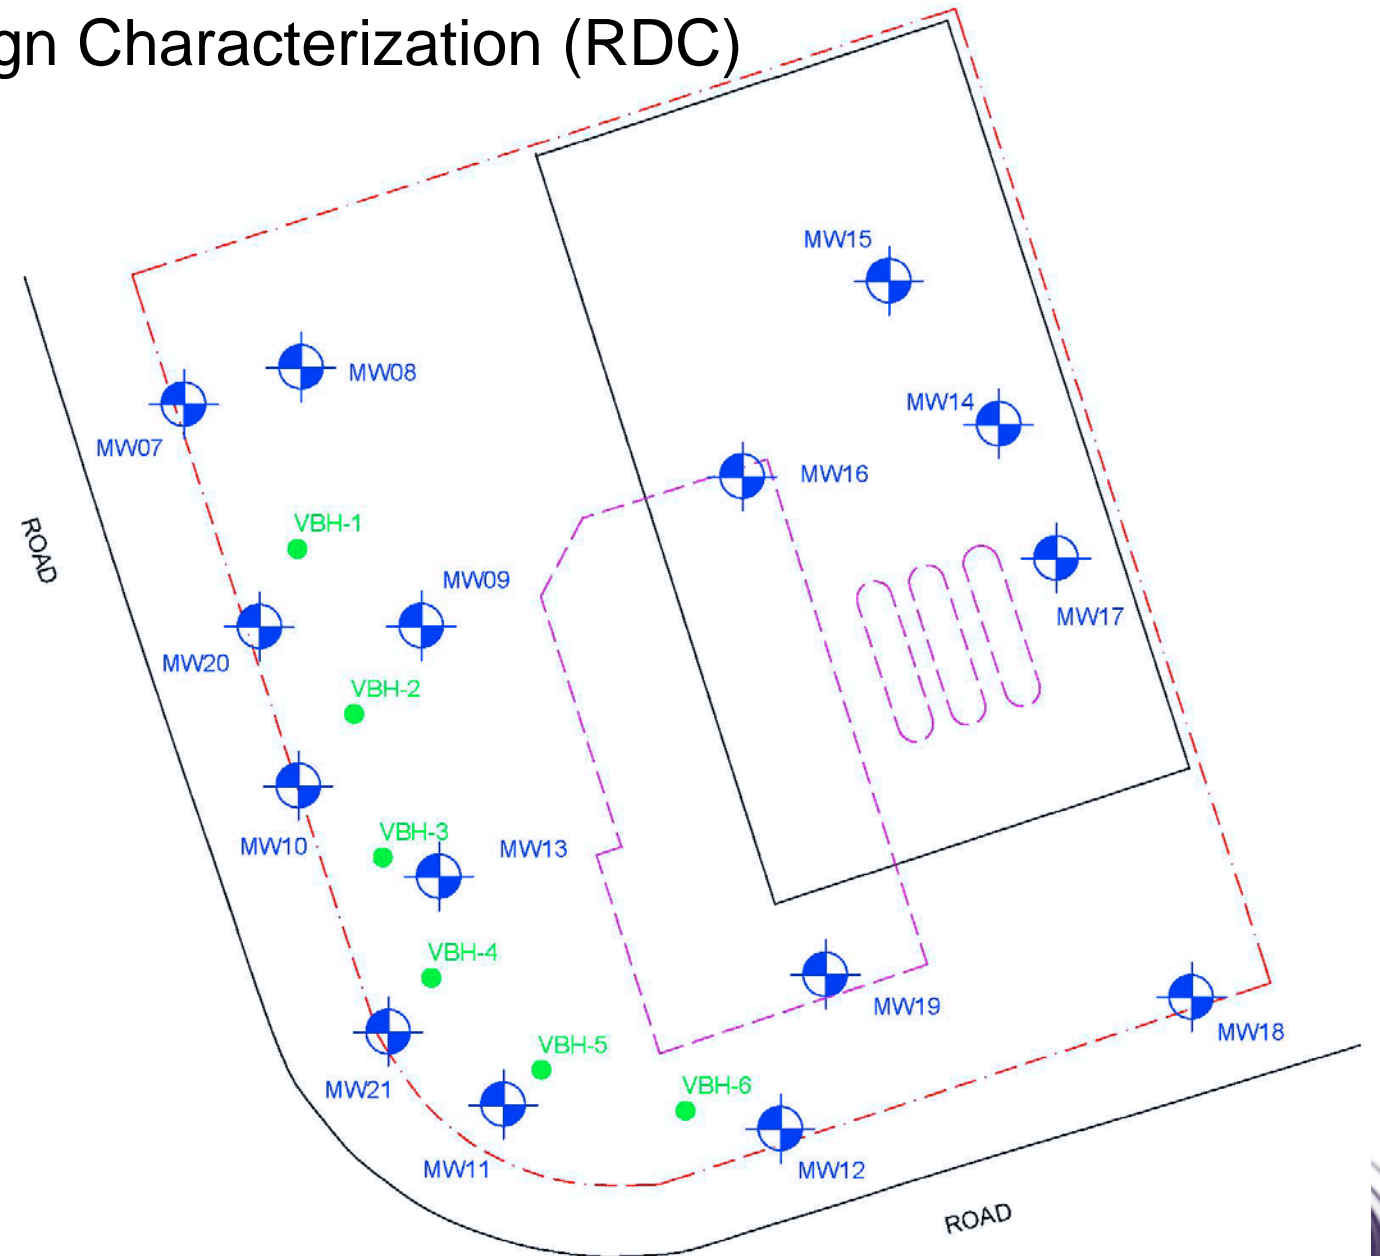
Remedial Design Characterization (RDC)

- Six (6) boreholes
 - Sept 2018
- 27 soil samples
 - Detailed analysis of PHCs with depth
- 12 groundwater samples
- Allowed for detailed understanding of PHC contaminated zones
