SNC • LAVALIN

Winter is Coming

Northern / Remote Site Challenges

October 17, 2019

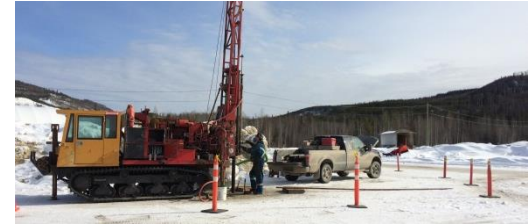
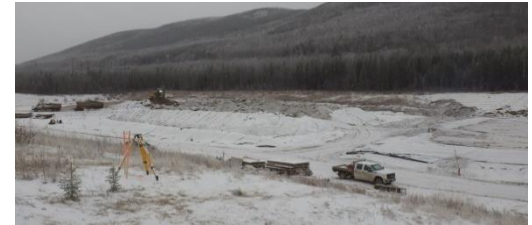
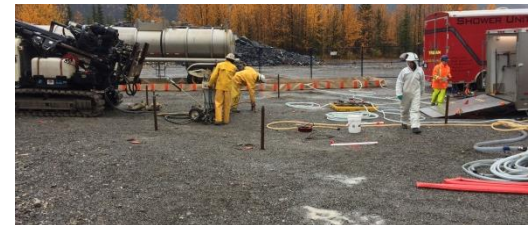
- › Multiple drilling programs for improved delineation / data gaps
- › Use of light induced fluorescence (LIF)

- › Soil excavation (50,000 m³ from 3 yard sites)
- › Soil treatment facility (STF) design, construction, and management
- › Soil screening, backfilling and compaction

- › Options evaluation
- › Feasibility study, Pilot testing, 1st Stage and Full scale implementation

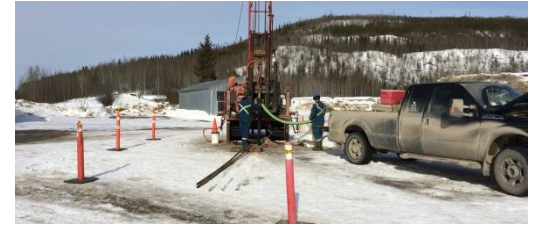
Drilling

- › Equipment limitations & operation in cold temperatures
- › Recurring snow falls – use of total station to position / clear utilities

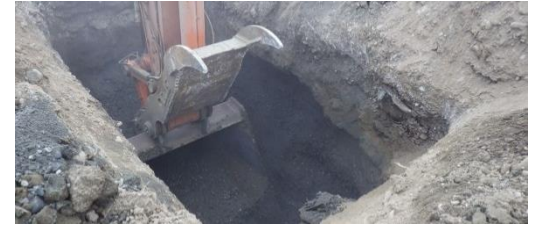
Soil Excavation

- › Use of experienced contractors with well maintained equipment
- › Frozen ground – jack hammer / breaker equipment needed

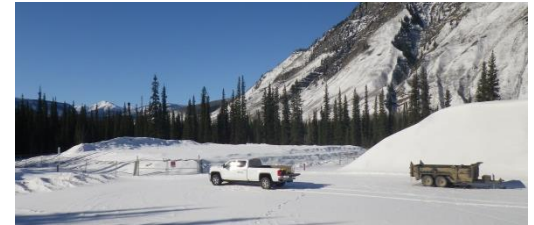
STF

- › Construction of STFs vs long haul transport
- › Turning events problematic in frozen ground conditions

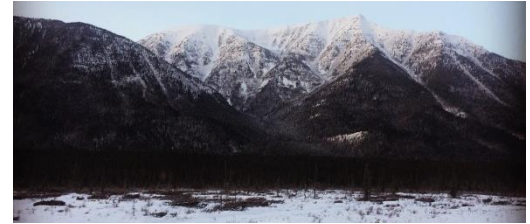
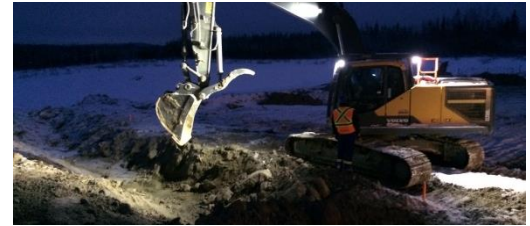
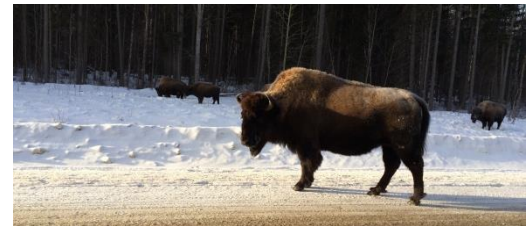
- › Soil Excavation / Screening
- › Backfilling/Compaction – testing not viable (-0°C), crown excavations

- › Equipment limitation due to freezing conditions
- › STF liner limitations
