# **Remediation of North West Smelting and Refining Ltd. Winnipeg, Manitoba**

**2019 Remediation Technologies  
Symposium**

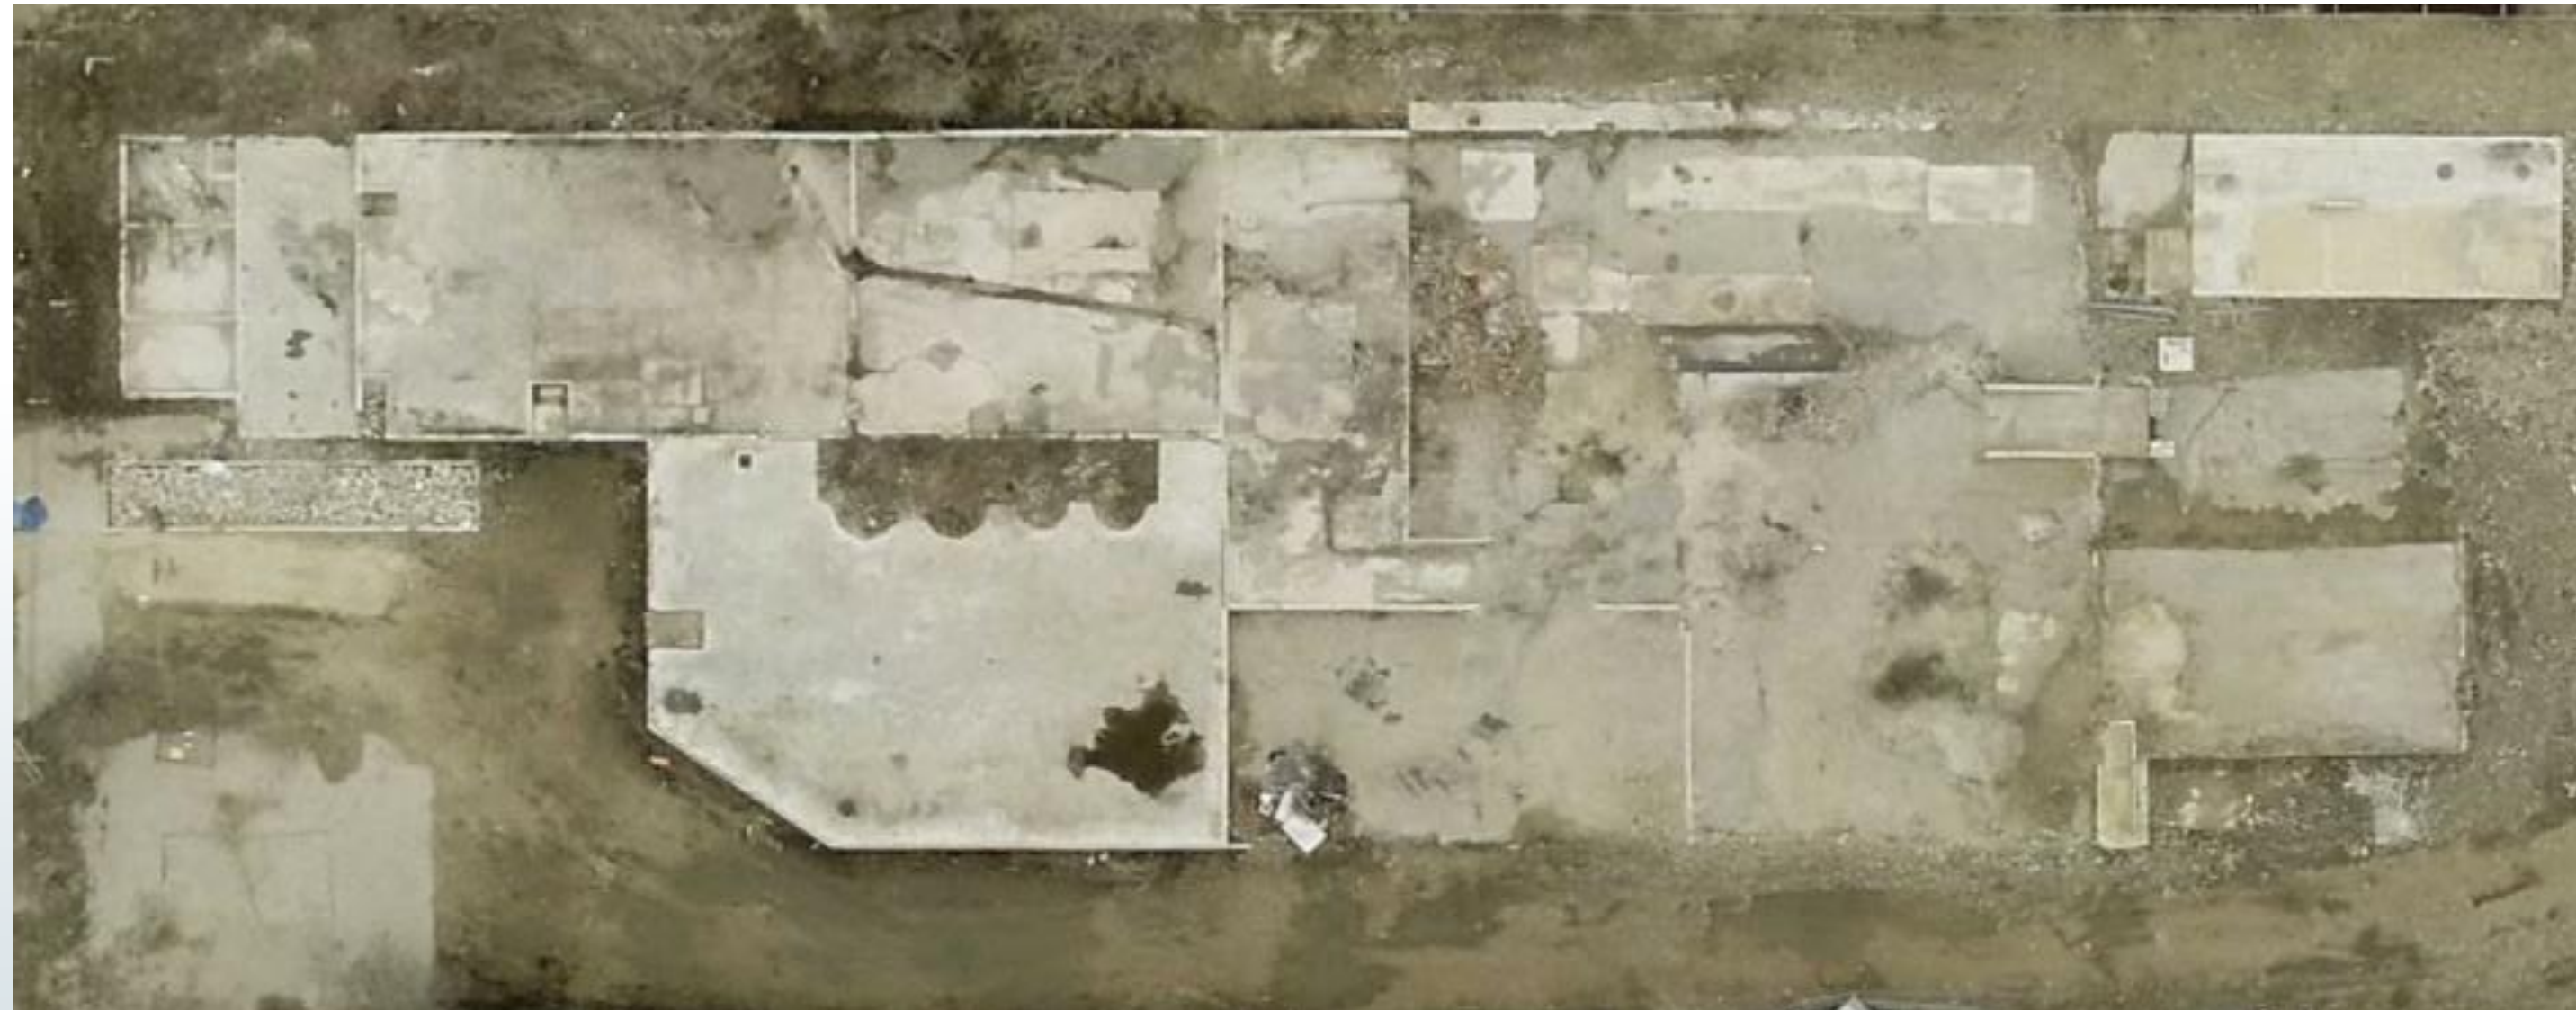
## Aerial view of building foundations

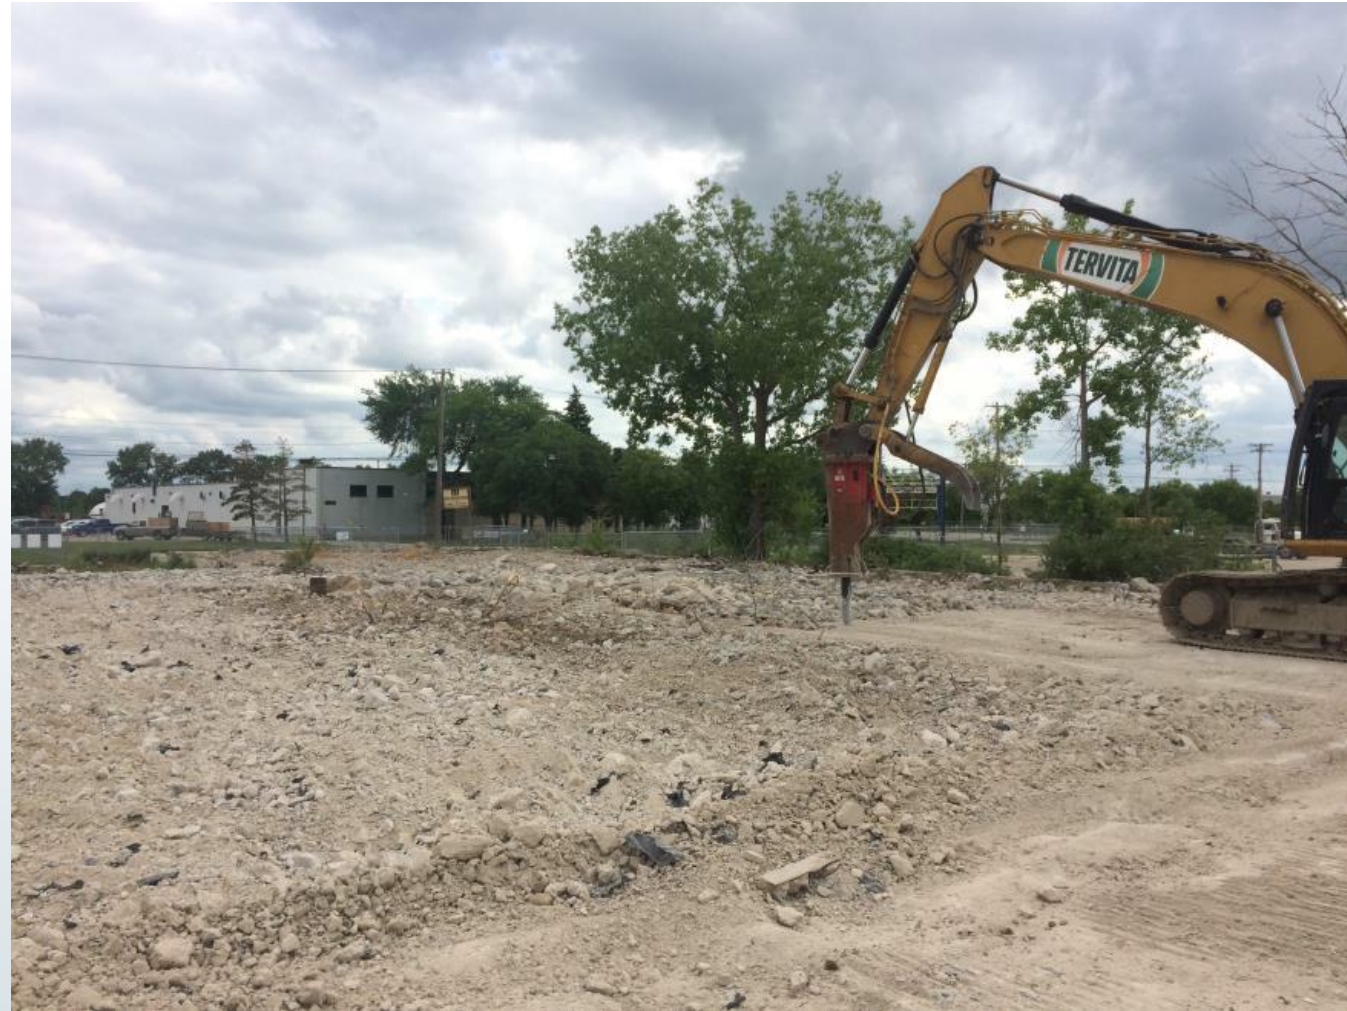
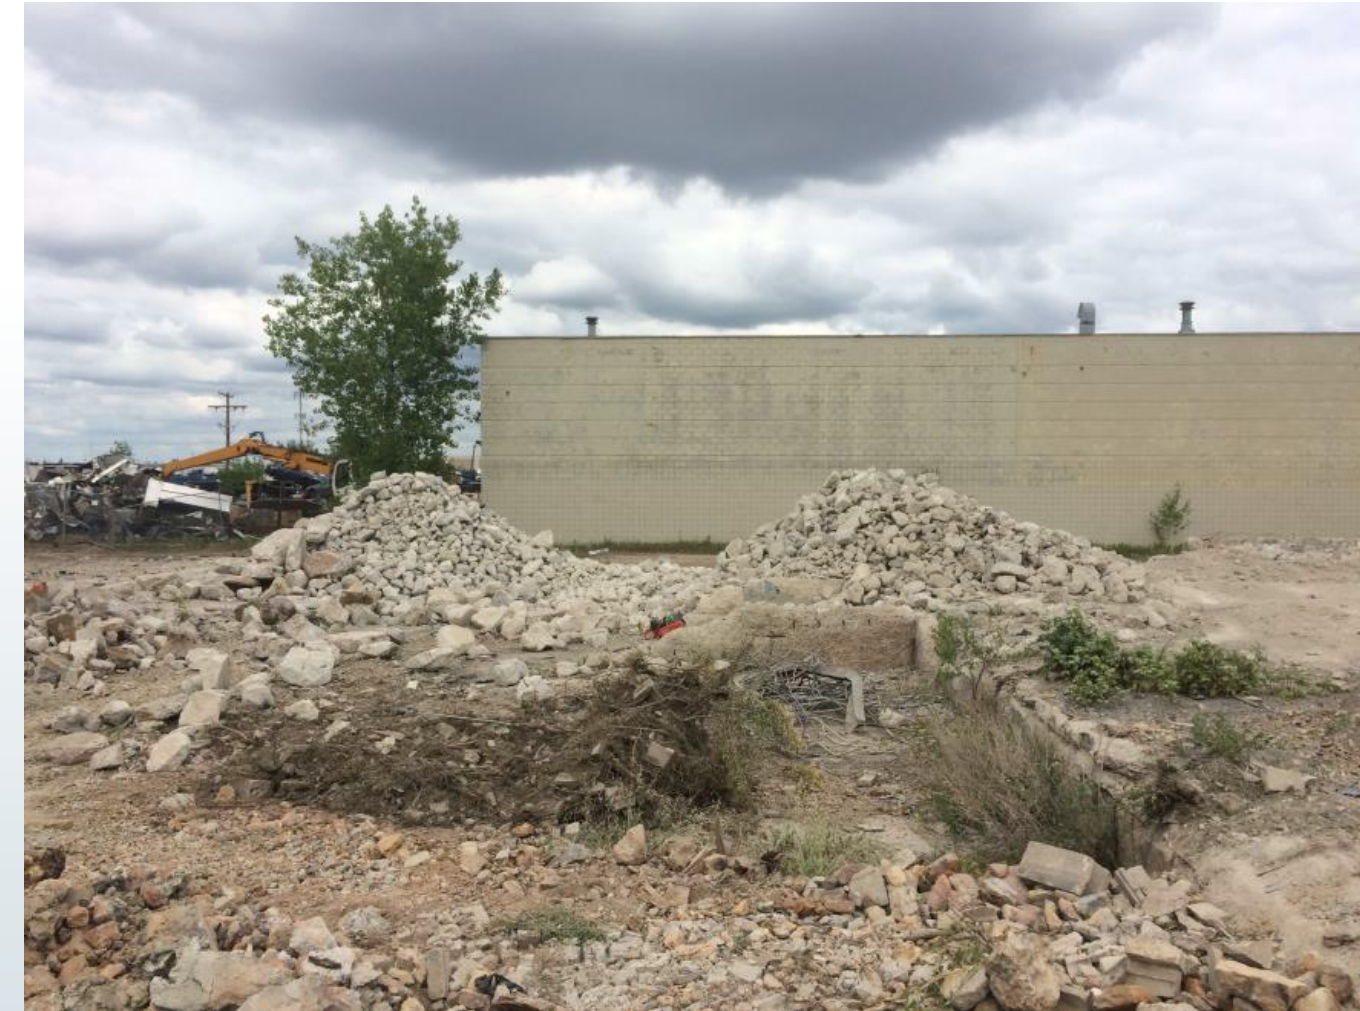
## Foundation removal

- **Removal of former building foundations;**
- **Removal of railway tracks;**
- **Monitoring well decommissioning (13);**
- **Disconnecting municipal water and drainage systems; and,**
- **Removal of lead-containing scrap pieces.**

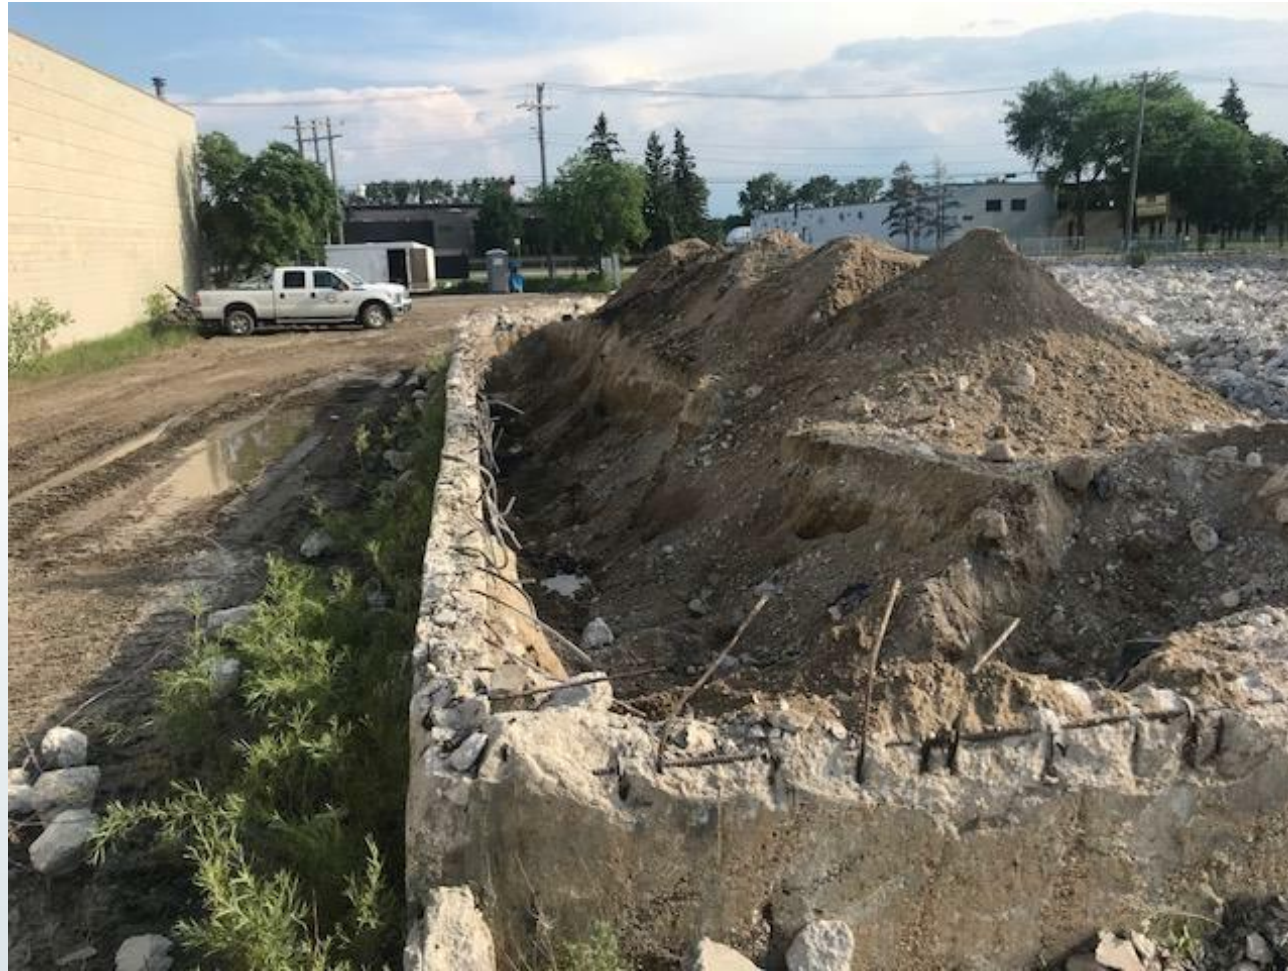
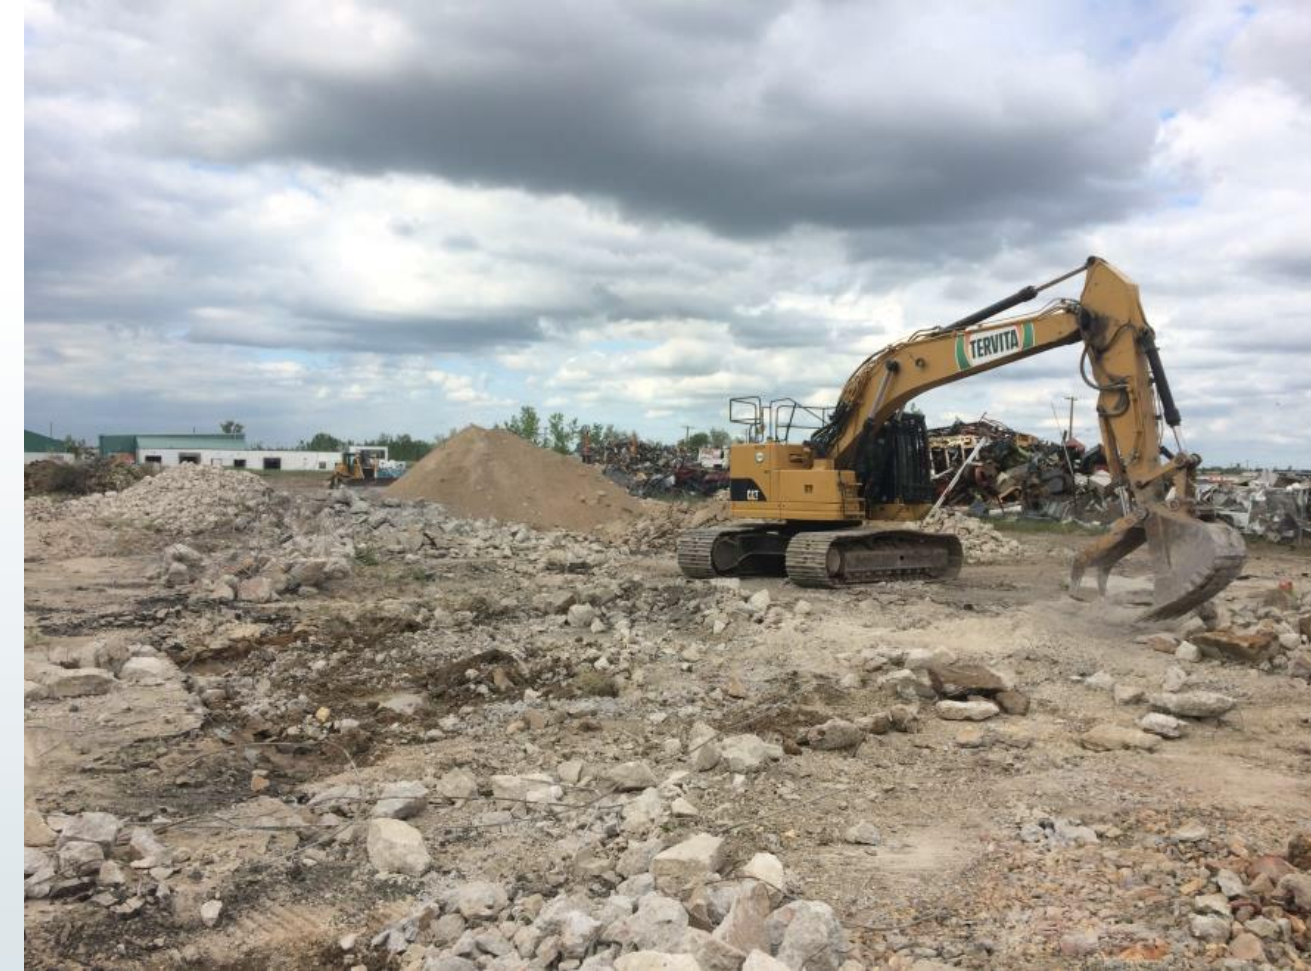
## Foundation removal

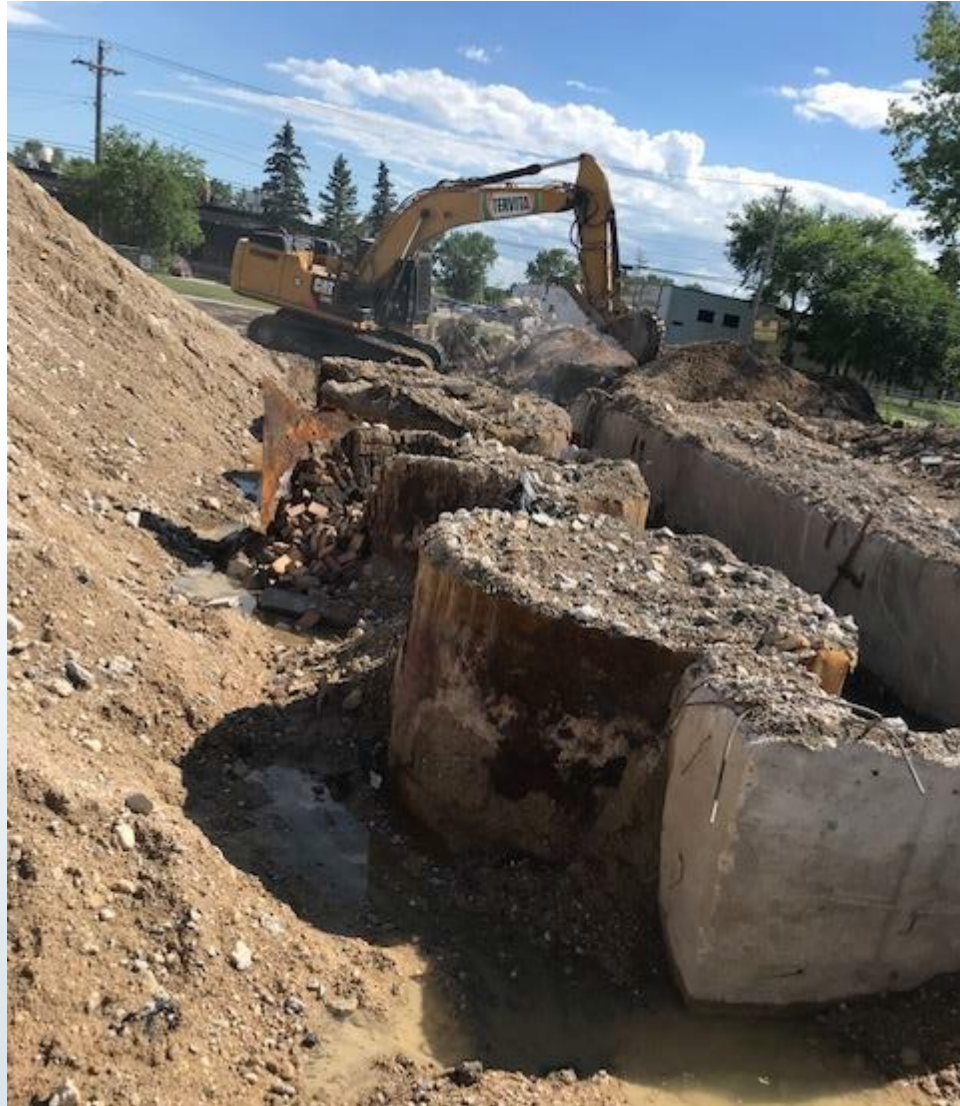
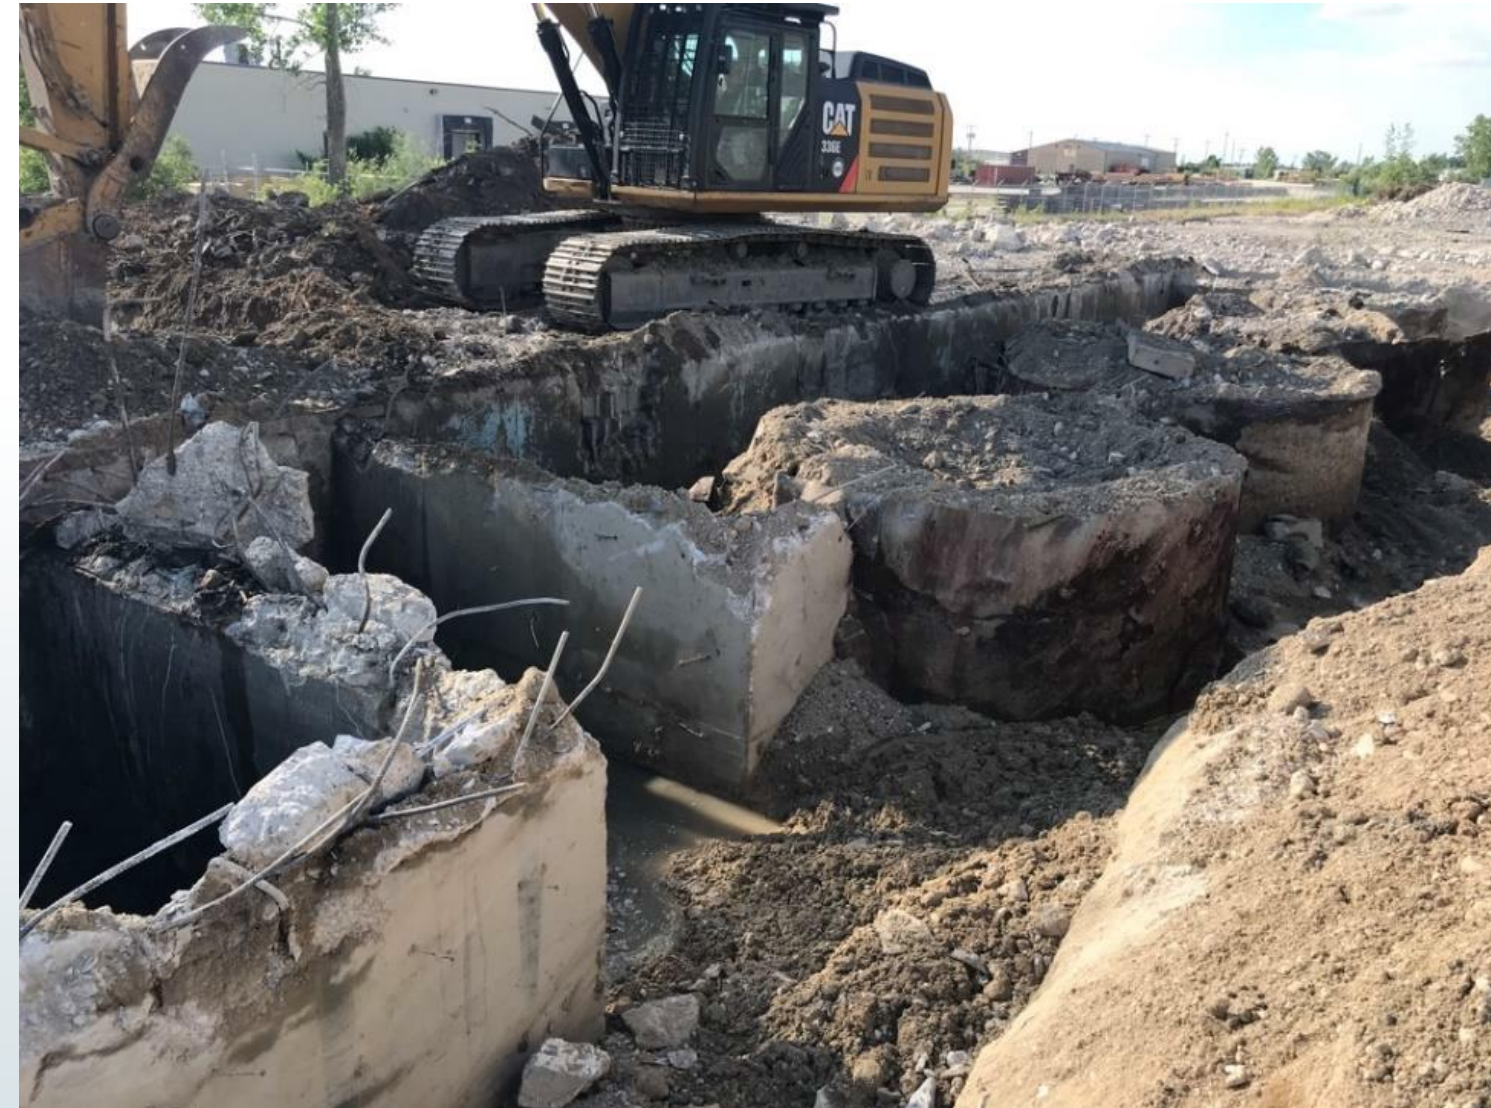
**Secondary operation beneath foundation**

- **Discovery of additional impacted material below foundations including the kilns;**
- **Resulted in approximately 3,000 m<sup>3</sup> additional impacted material;**
- **Design revised to accommodate material with an enlarged and raised cap, and a wider access ramp;**
- **Increased volume of hazardous impacted materials that could not be compacted meant greater off-site disposal fees.**

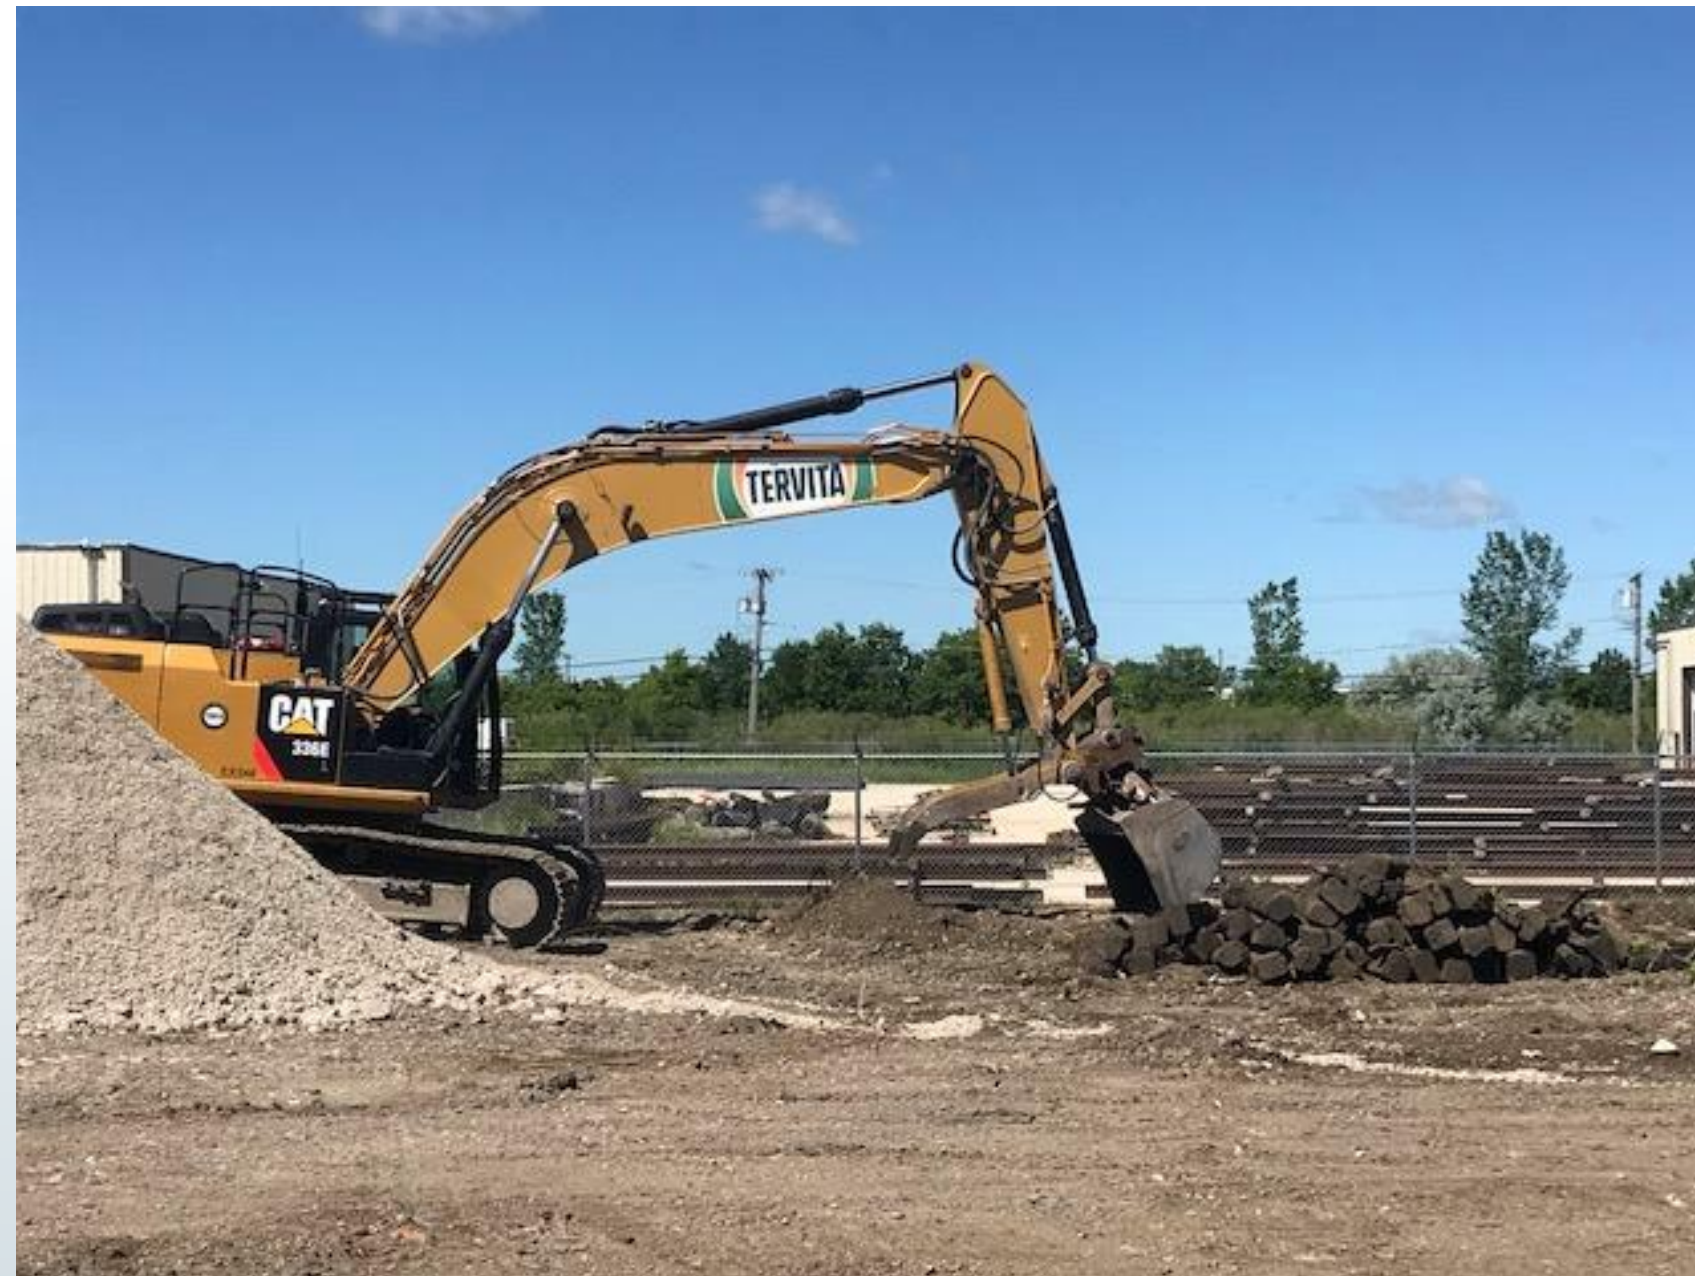
Separating rail ties

- Rail ties – Landfilled
- Concrete – Recycled
- Metal scrap, rebar and lead pieces – Recycled
- Asphalt – Broken down, capped on north portion of site
- Metal-impacted soils – Capped on north portion of site
- Non-compactable hazardous metal impacted material –  
Transported as hazardous waste to treatment facility

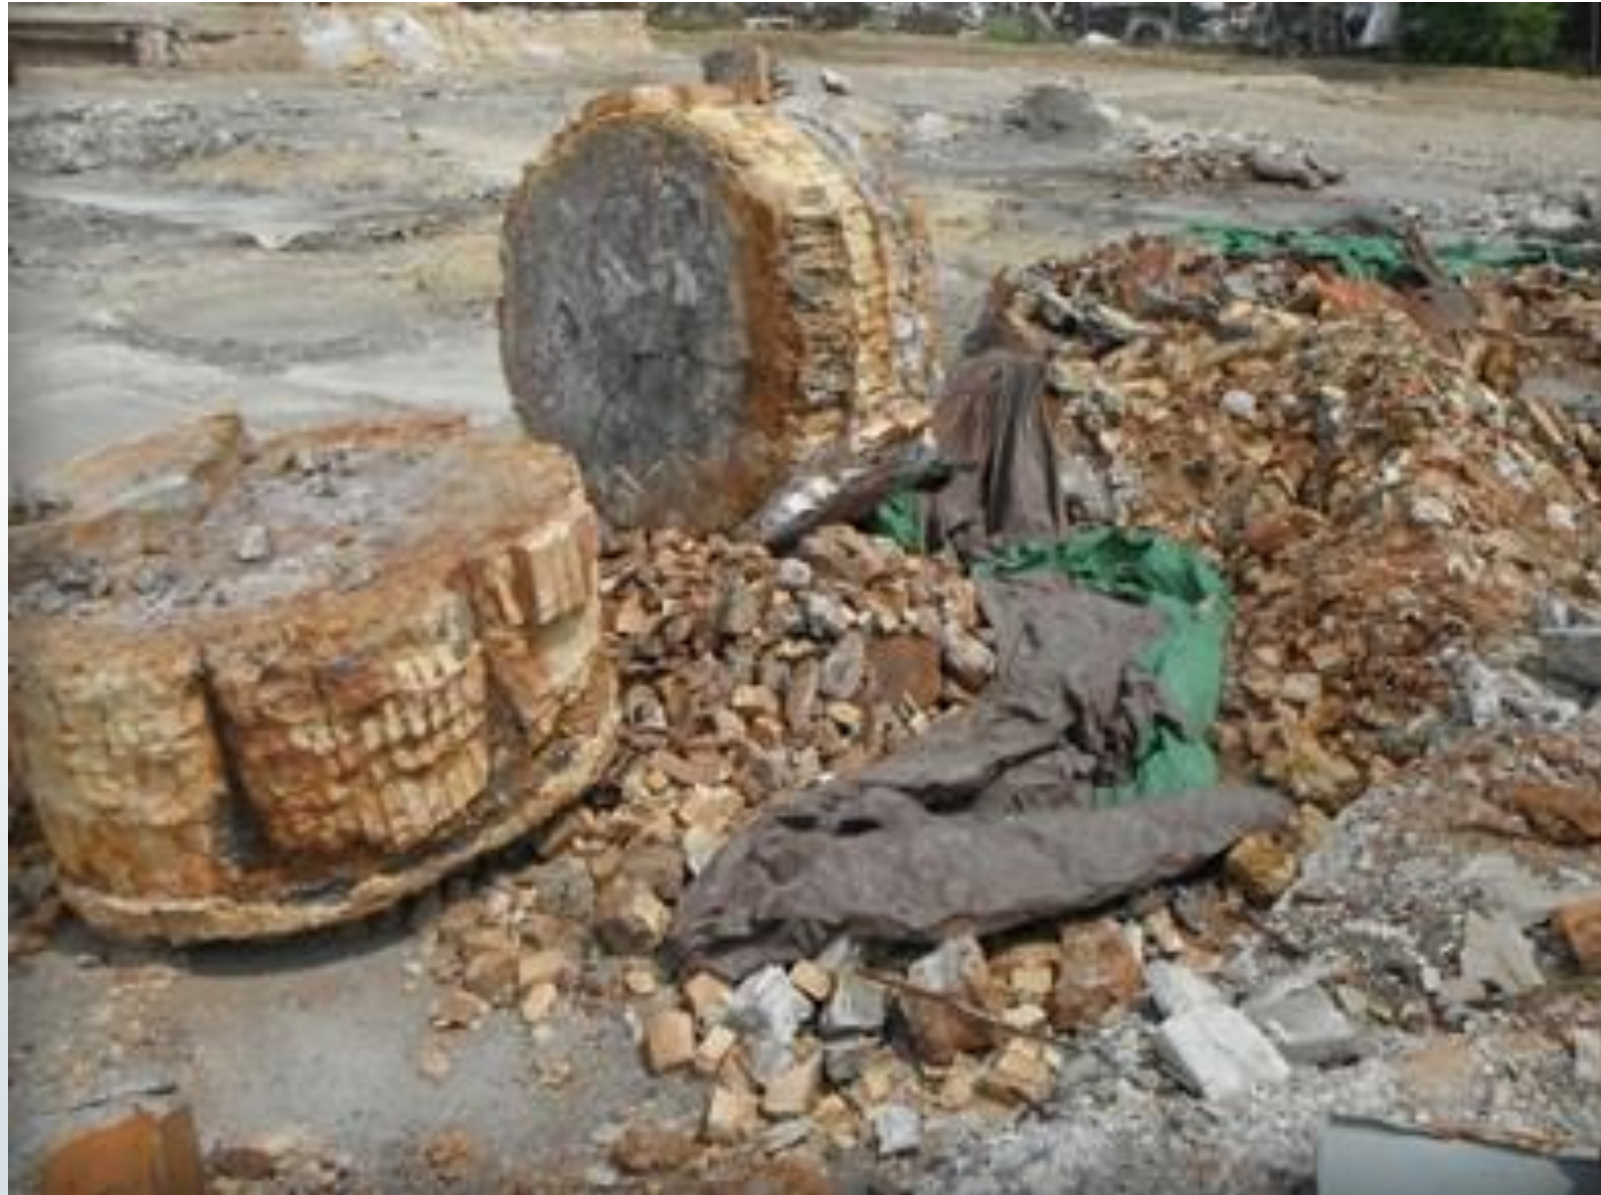
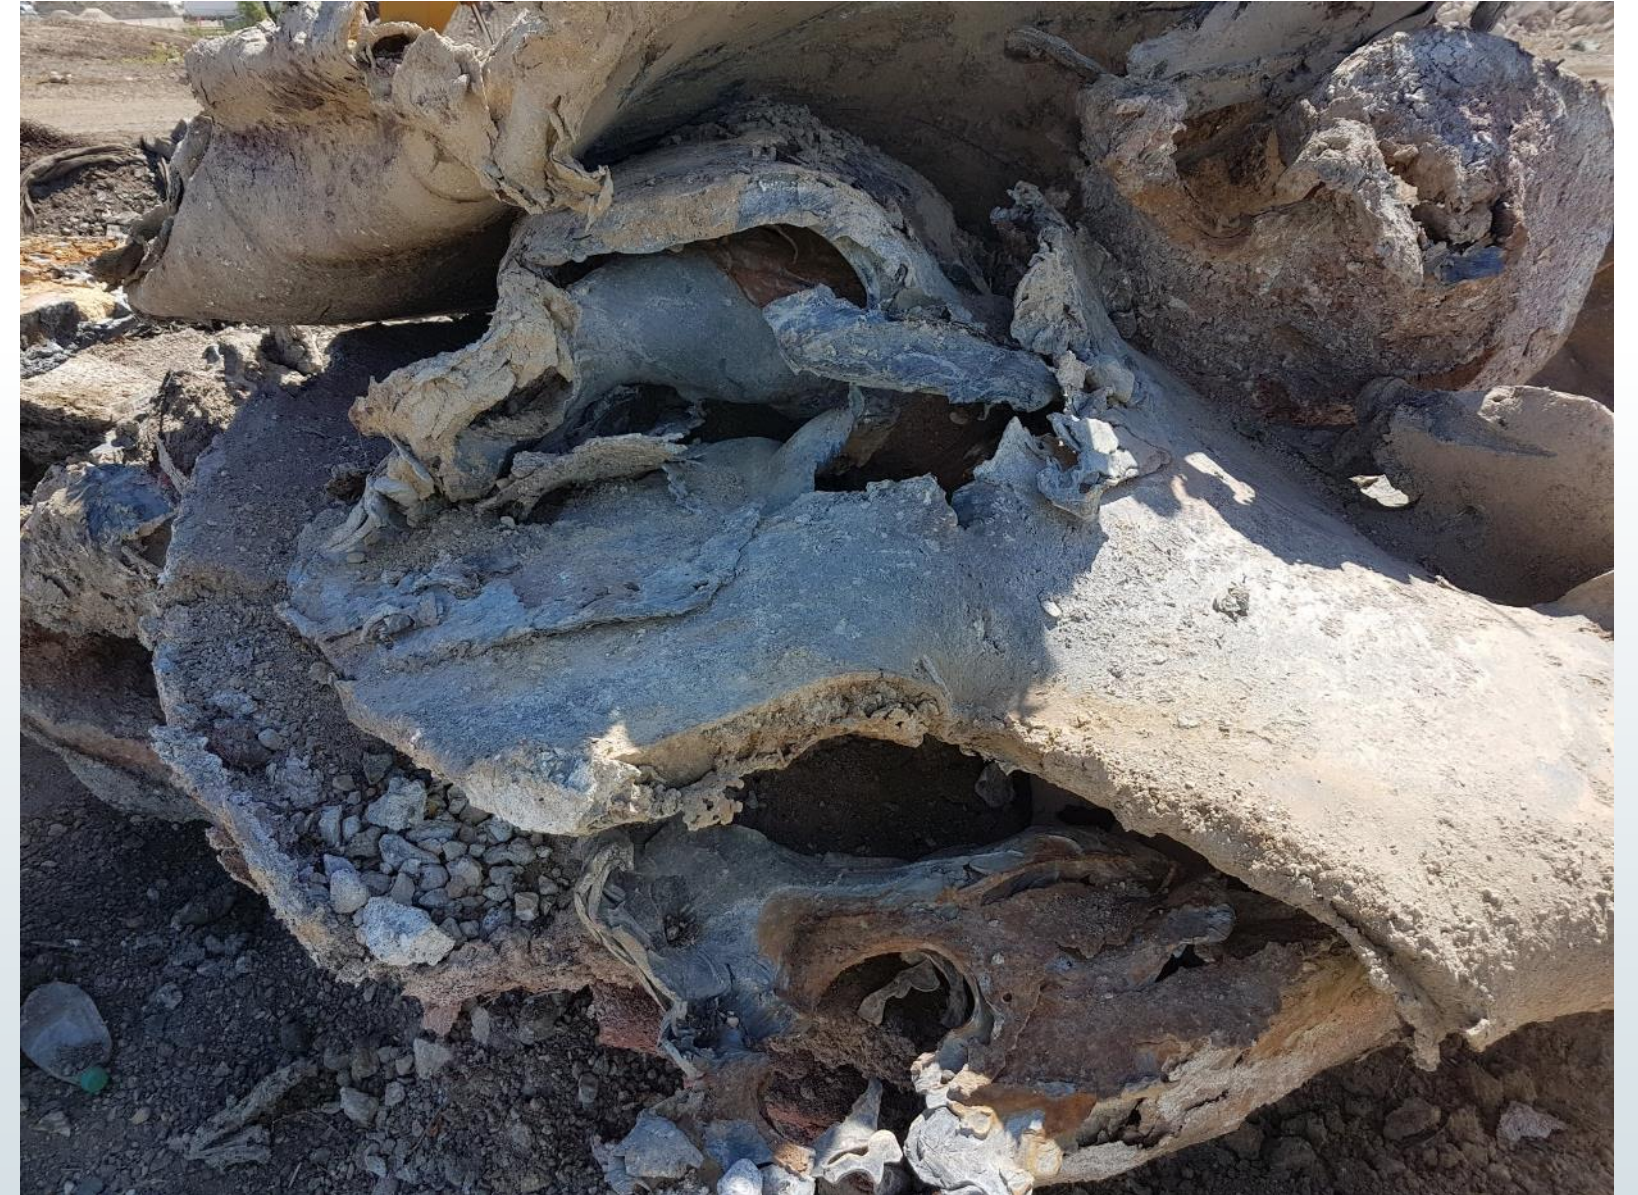
Lead Pieces

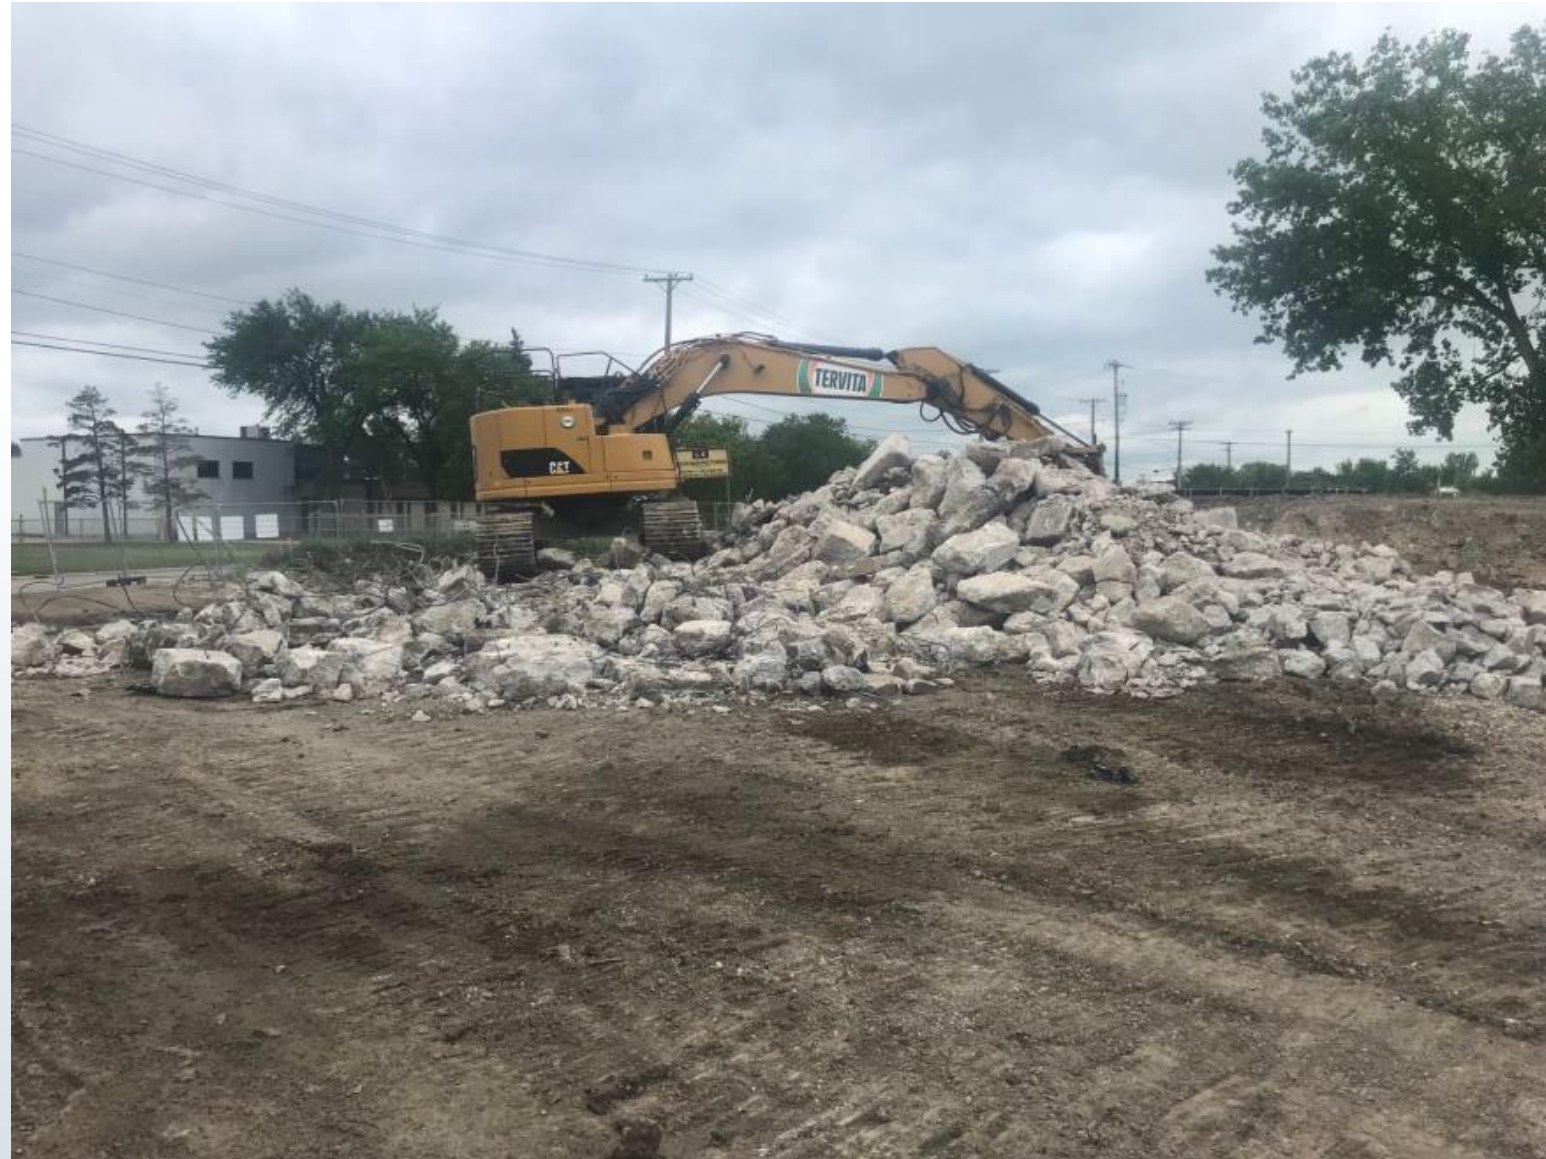
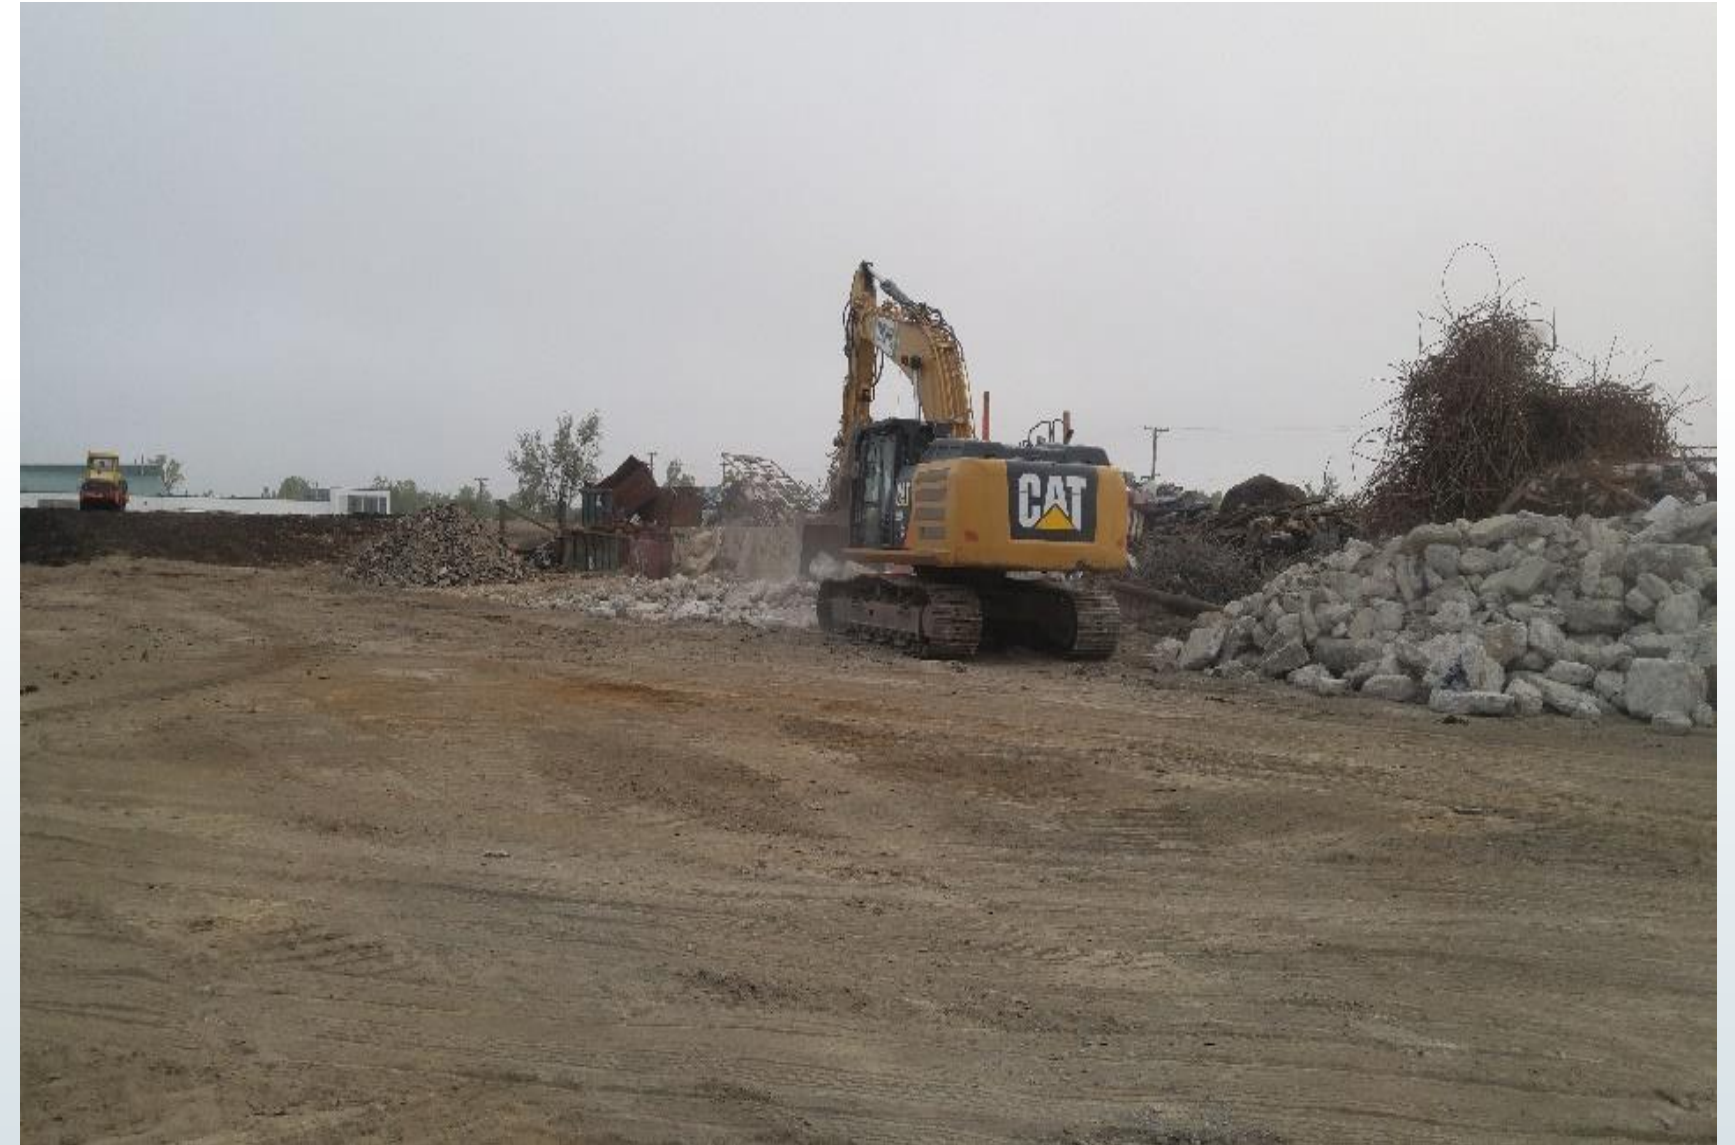
Concrete
