# **Remediation of North West Smelting and Refining Ltd. Winnipeg, Manitoba**

**2019 Remediation Technologies  
Symposium**

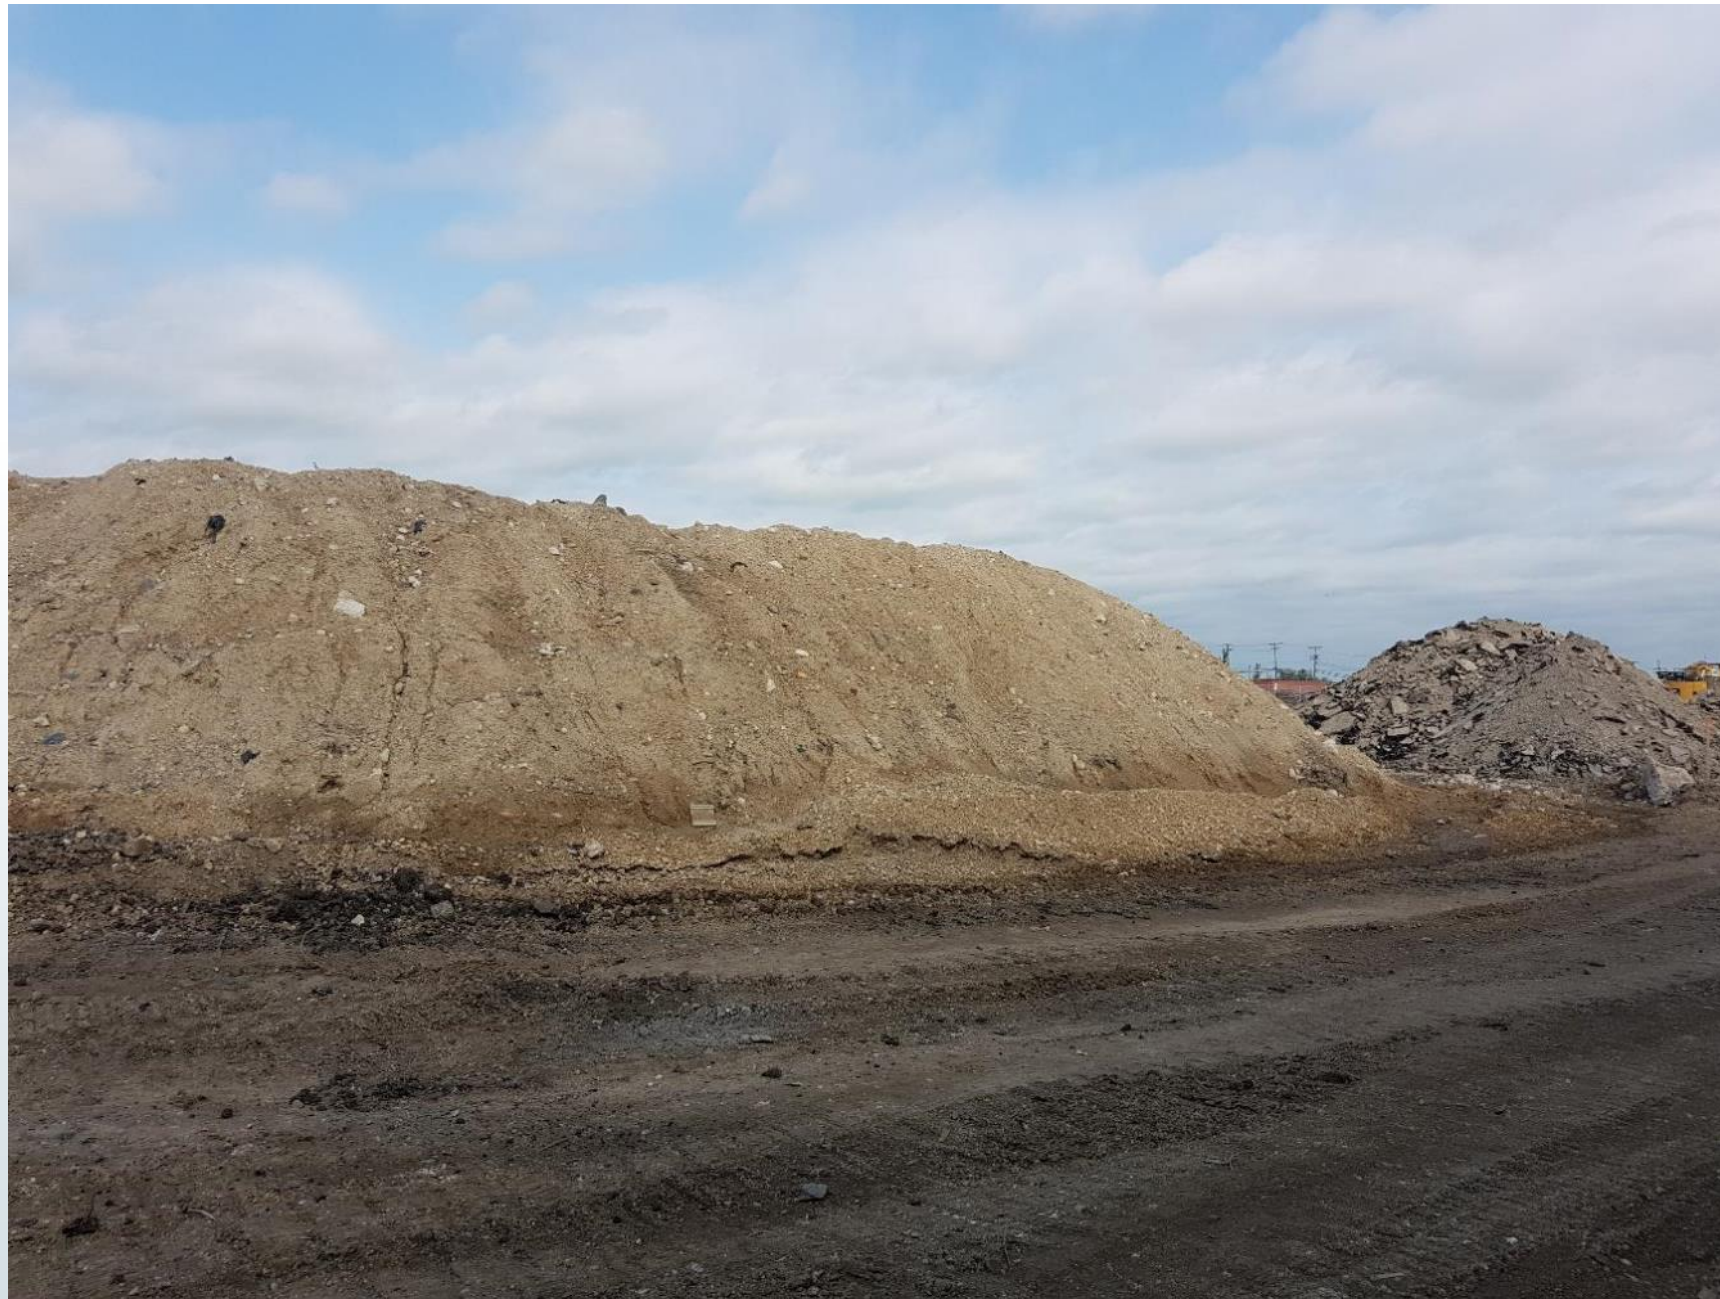
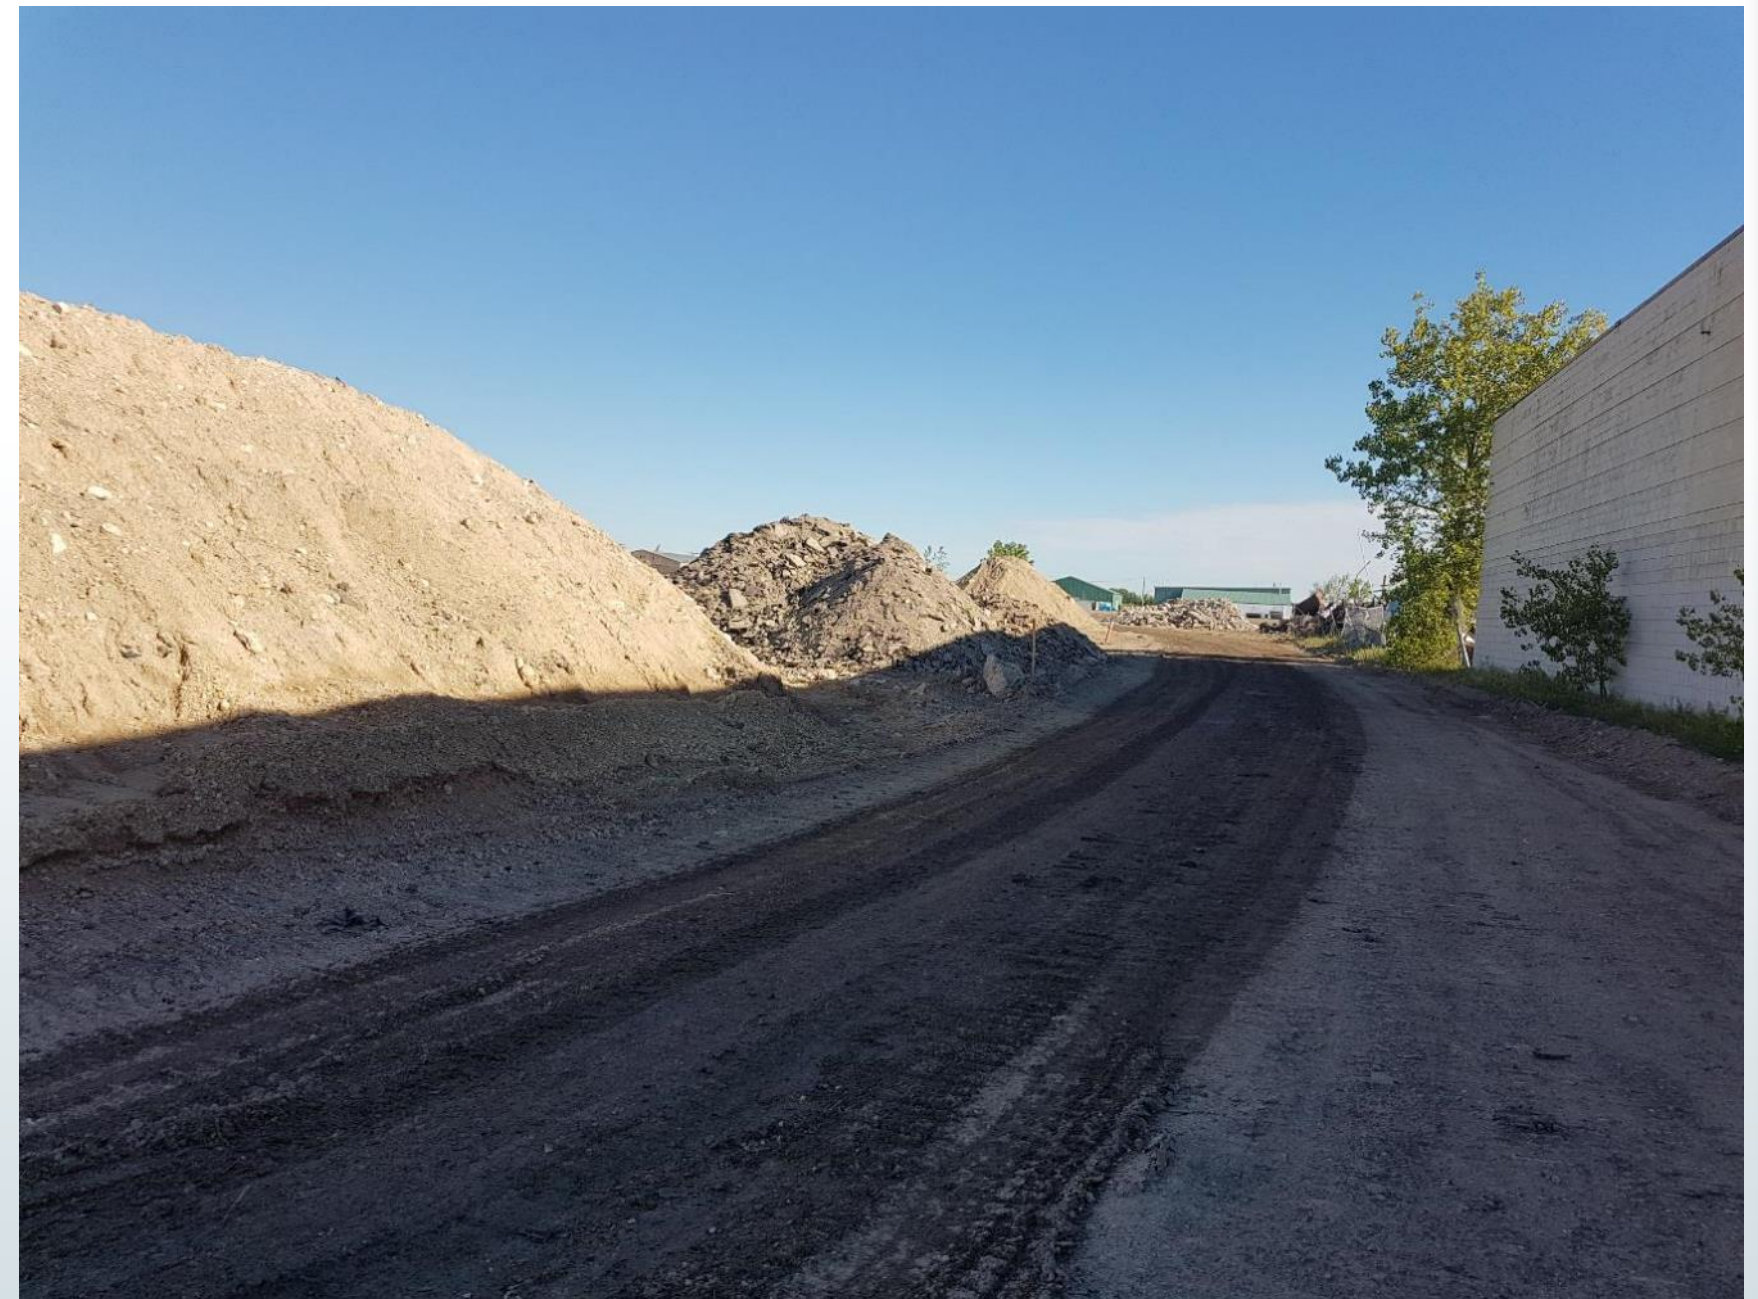
**Metal Impacted granular fill material and asphalt**

- Rail ties – Landfilled
- Concrete – Recycled
- Metal scrap, rebar and lead pieces – Recycled
- Asphalt – Broken down, capped on north portion of site
- Metal-impacted soils – Capped on north portion of site
- Non-compactable hazardous metal impacted material –  
Transported as hazardous waste to treatment facility

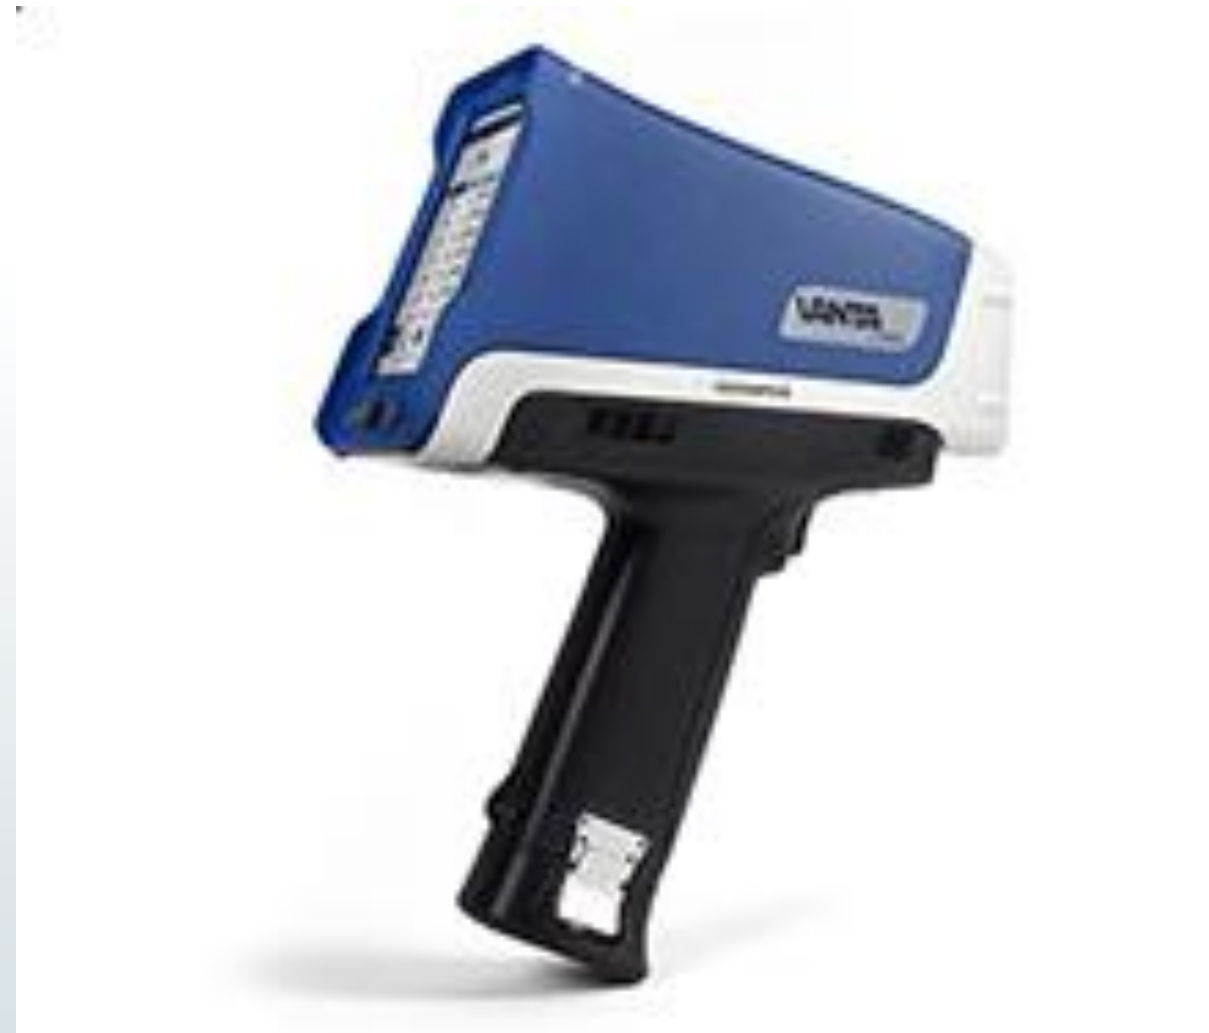
## Vanta Handheld X-Ray Fluorescence Analyzer

- **Real-time metals concentrations in material**
- **Used to screen soil prior to collecting closure samples**
- **Eliminated approximately \$63,000 in lab fees**

- Excavated in sections;
- Field screening for metals using X-Ray Fluorescence (XRF) analyzer;
- Approximately 900 field-screening samples;
- Total of 494 closure samples submitted for laboratory analysis of metals.

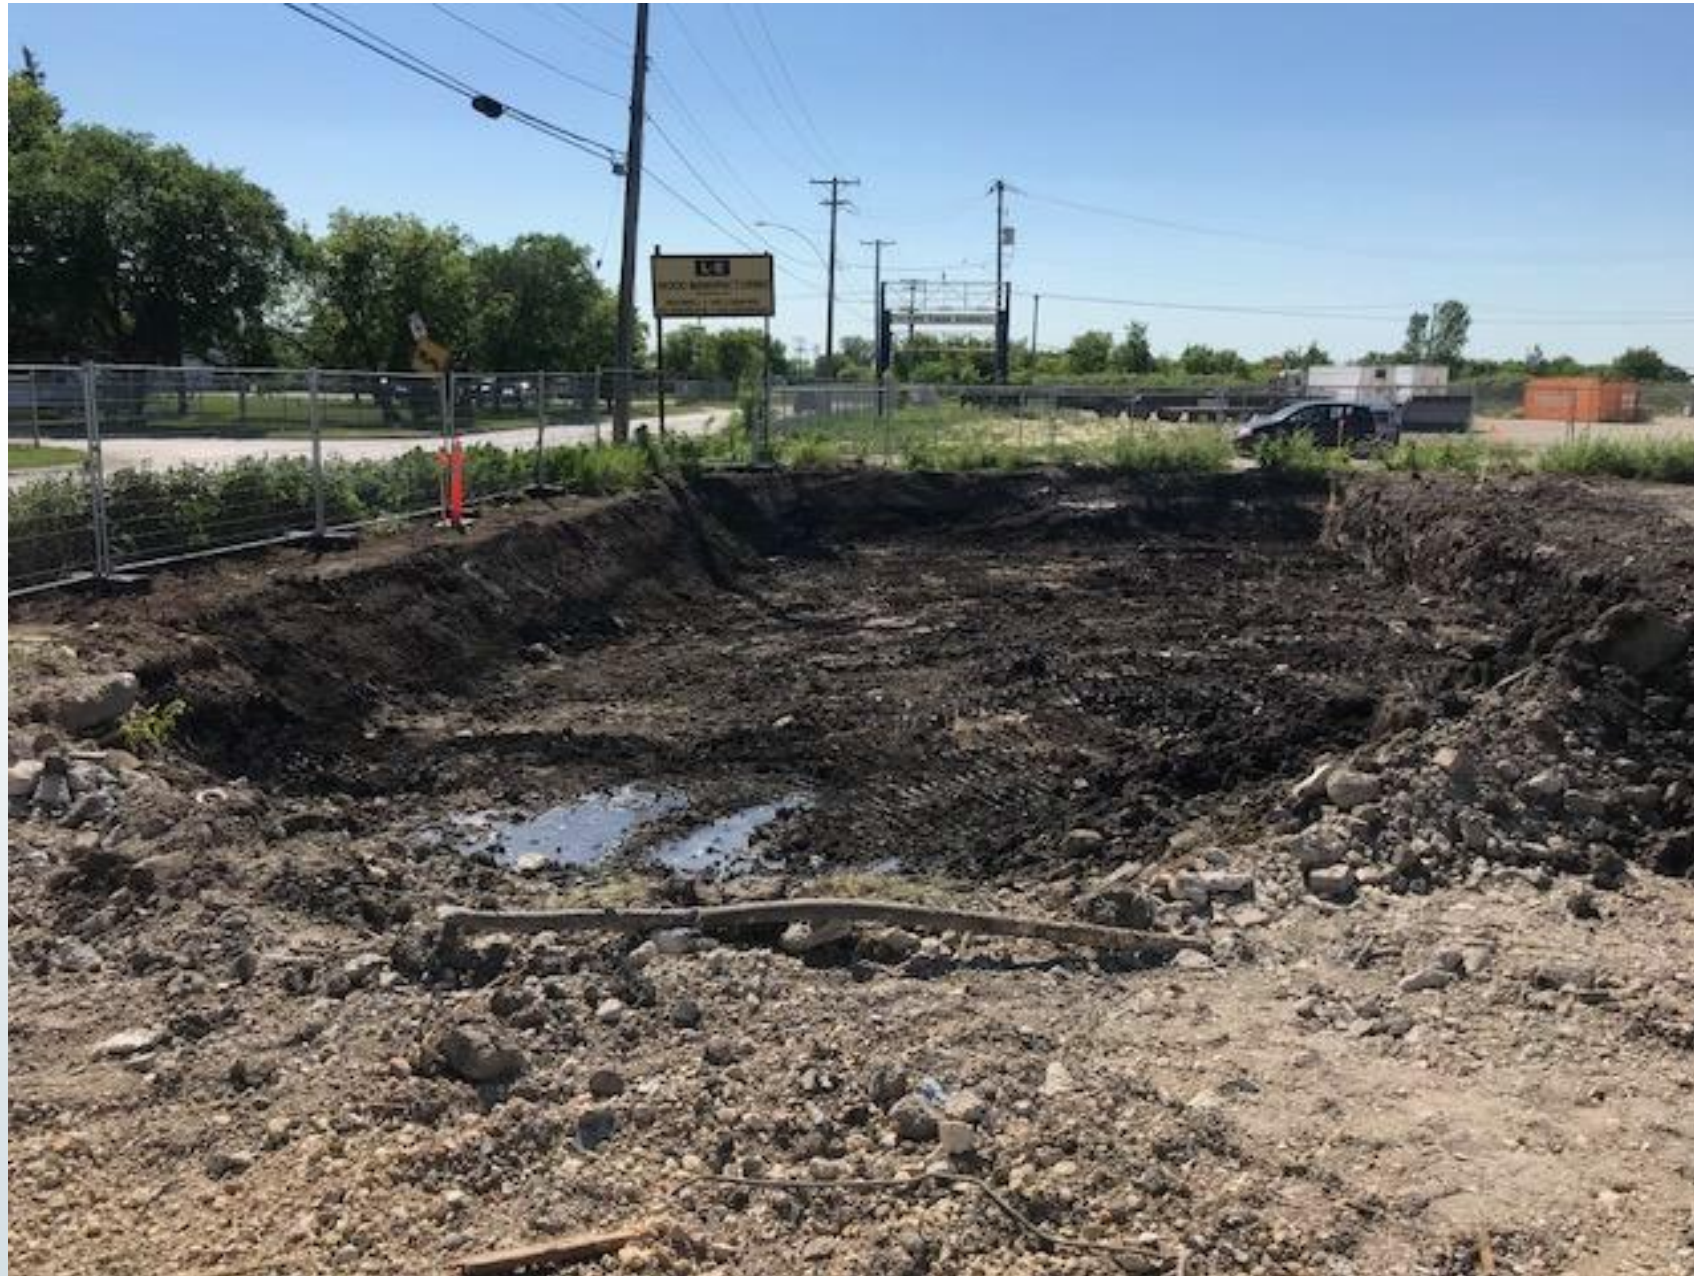
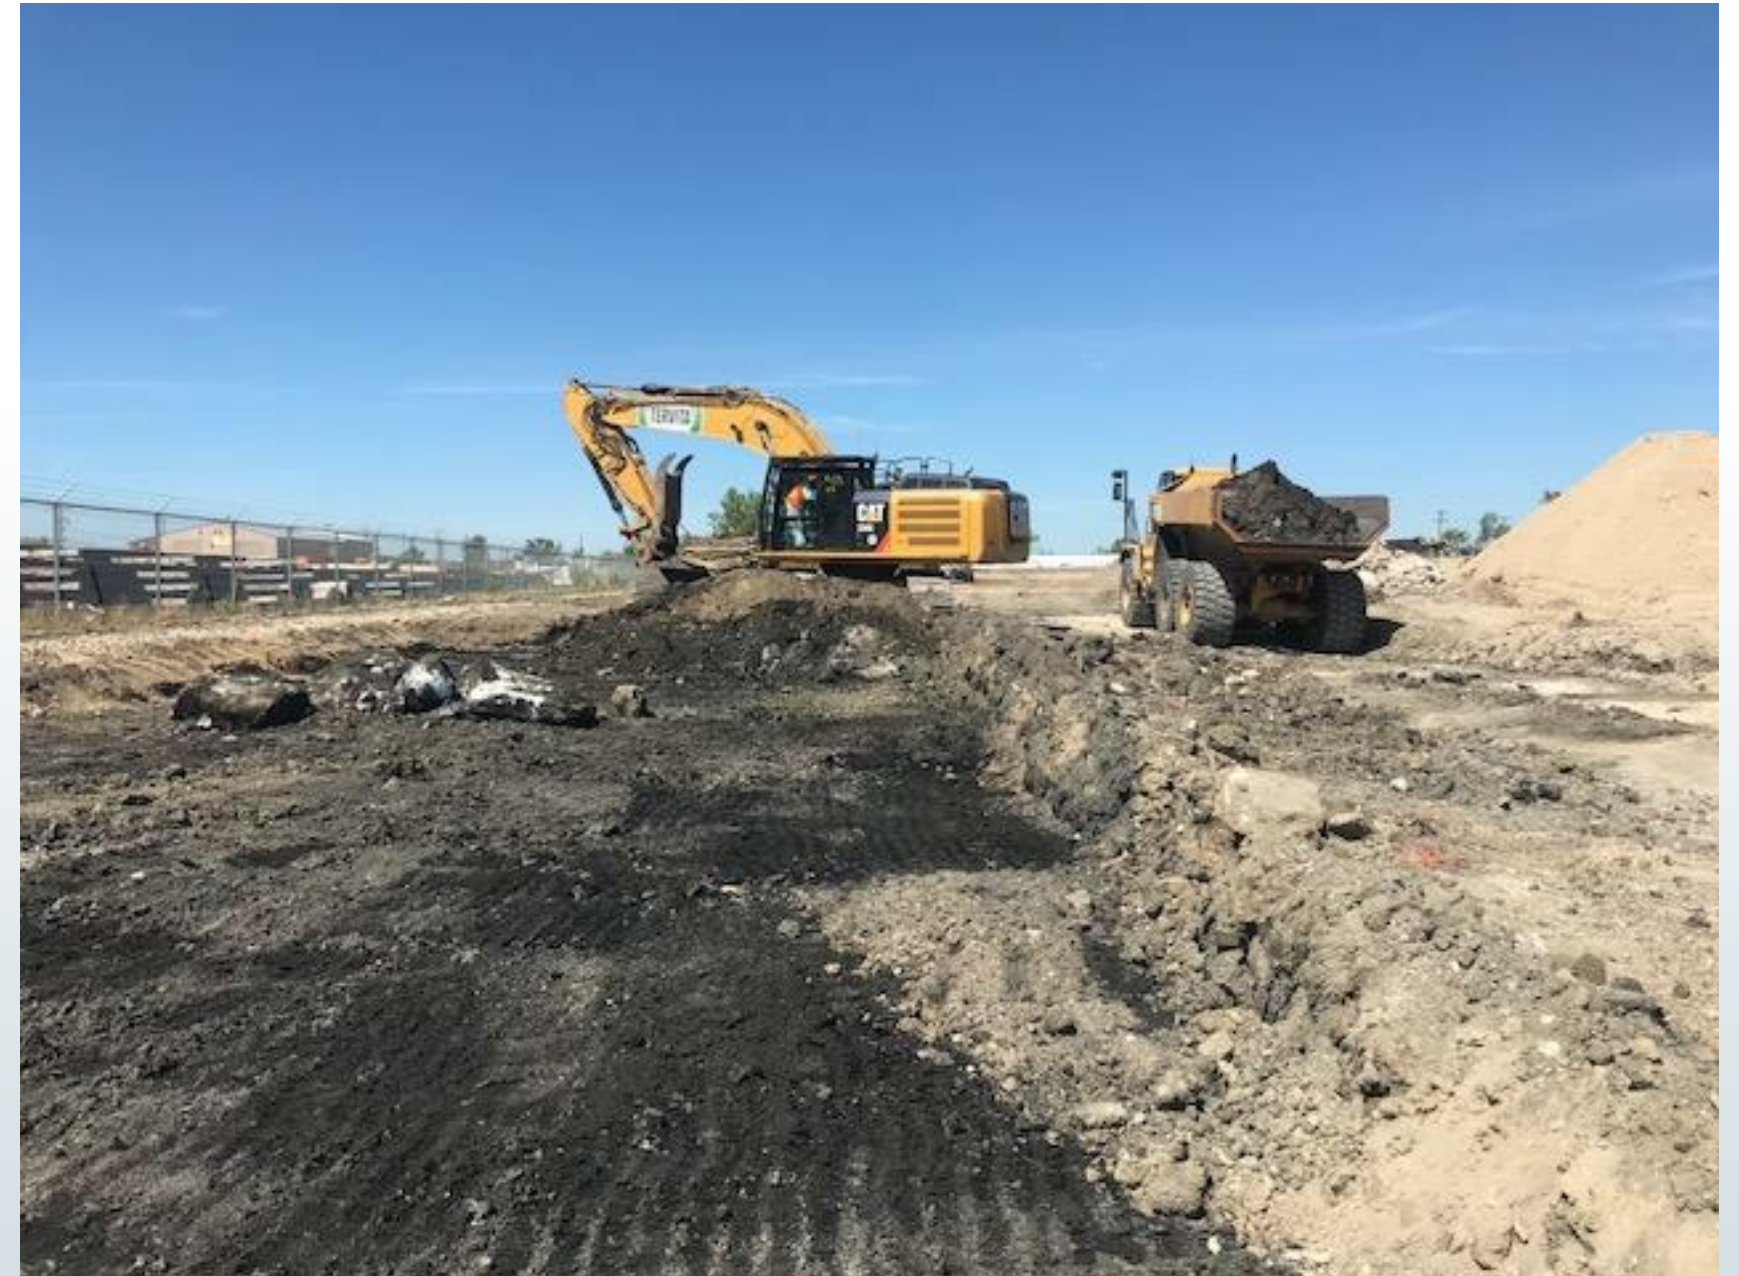
Excavation in progress

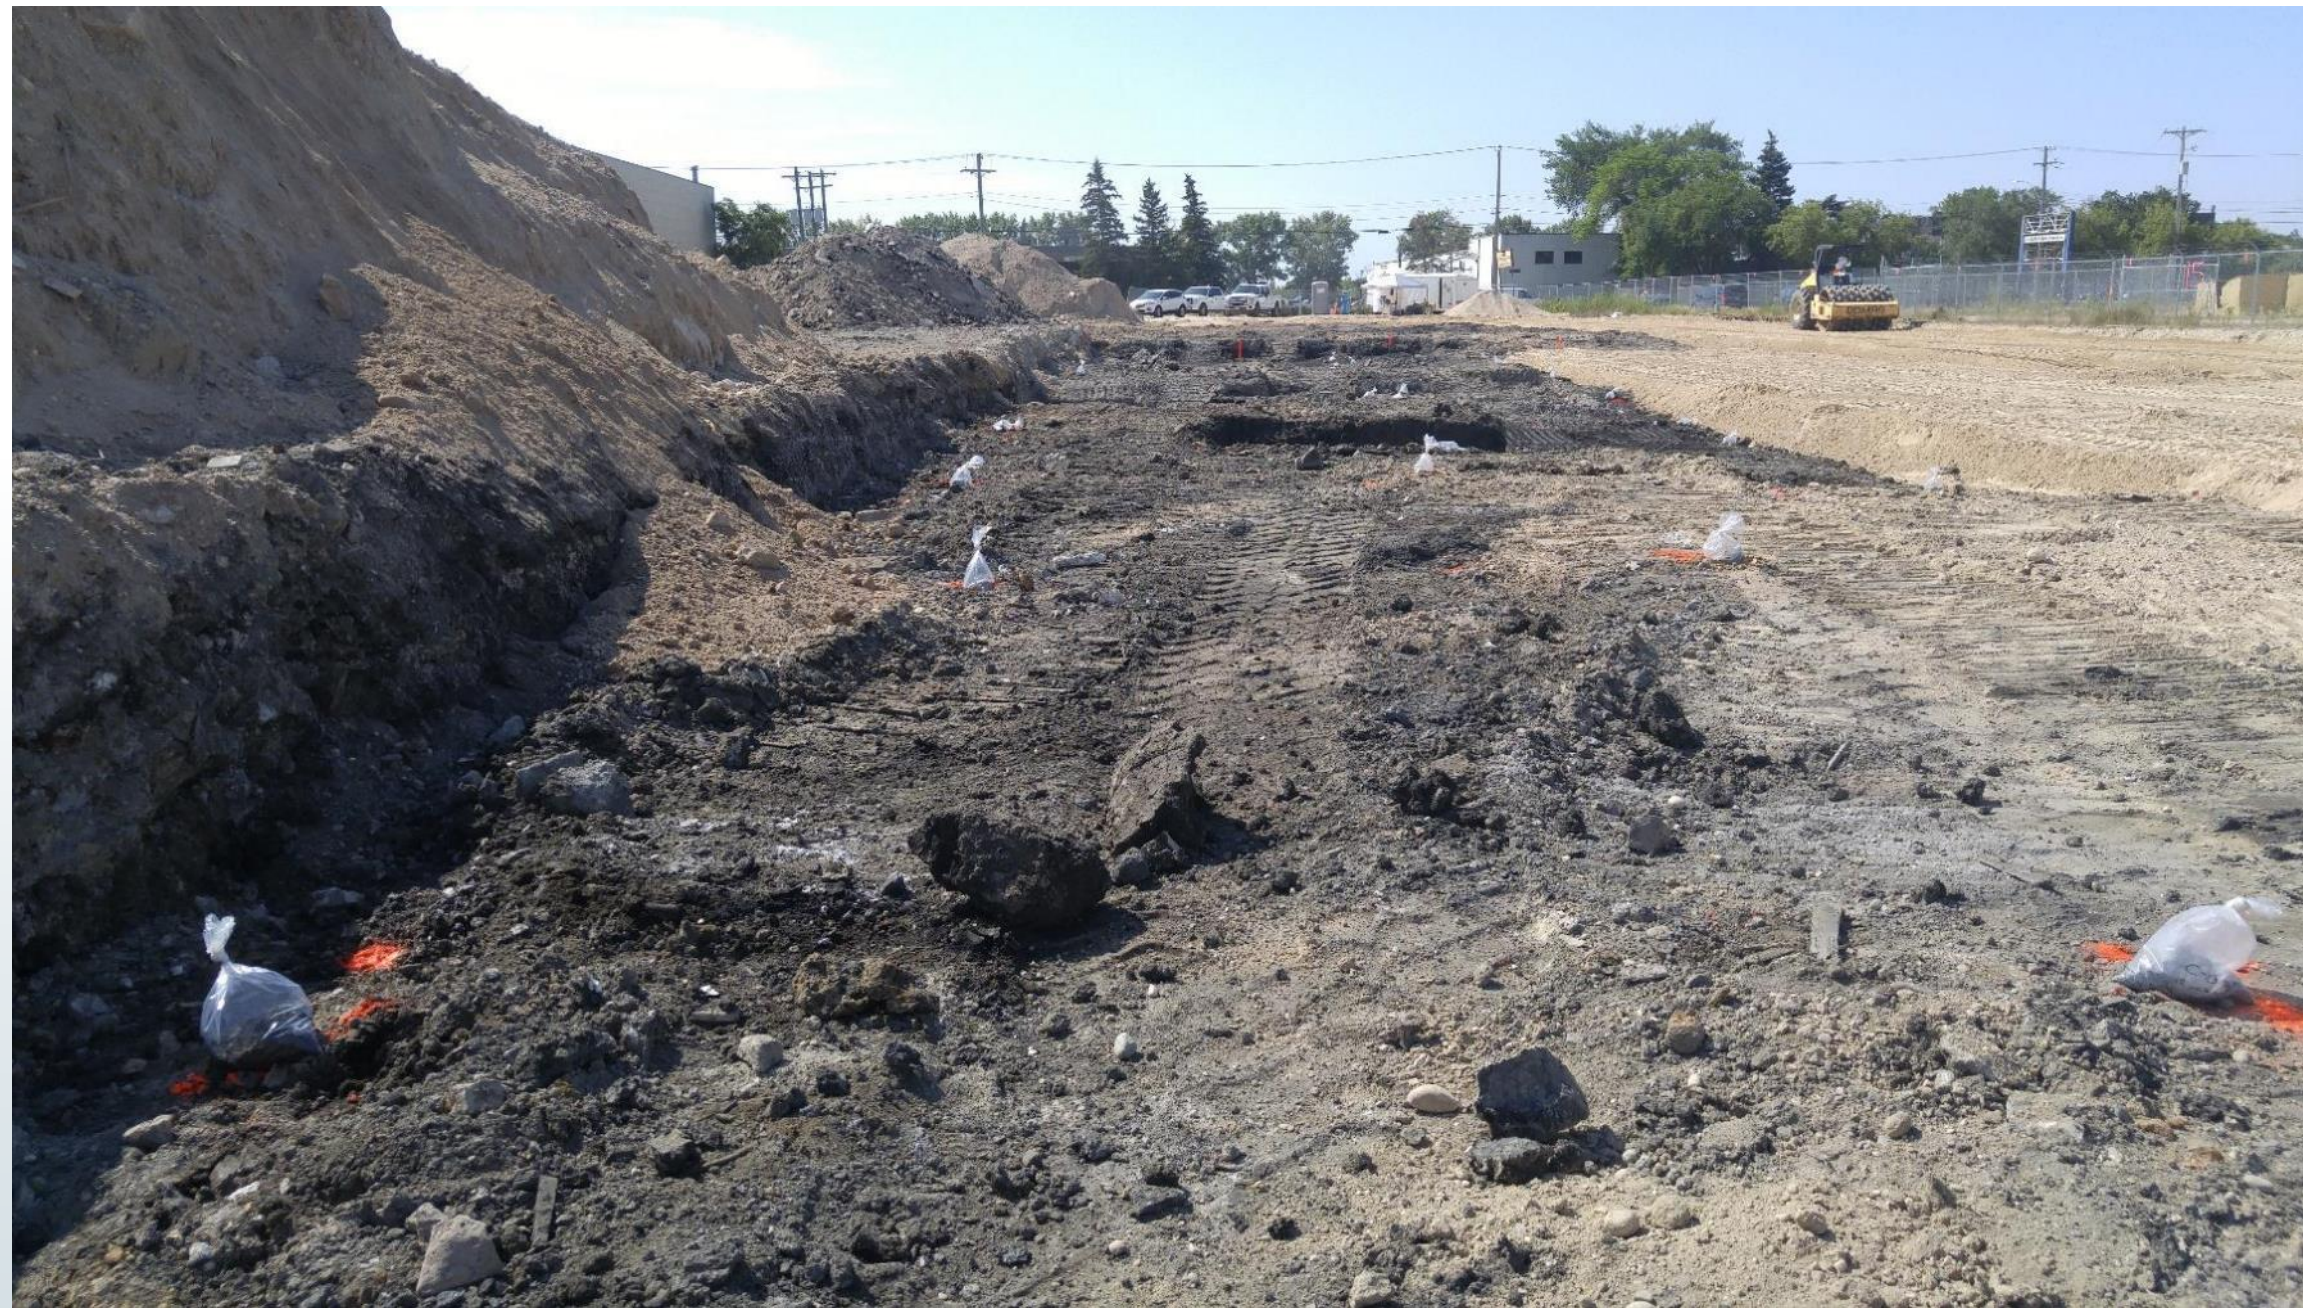
Soil screening in excavation

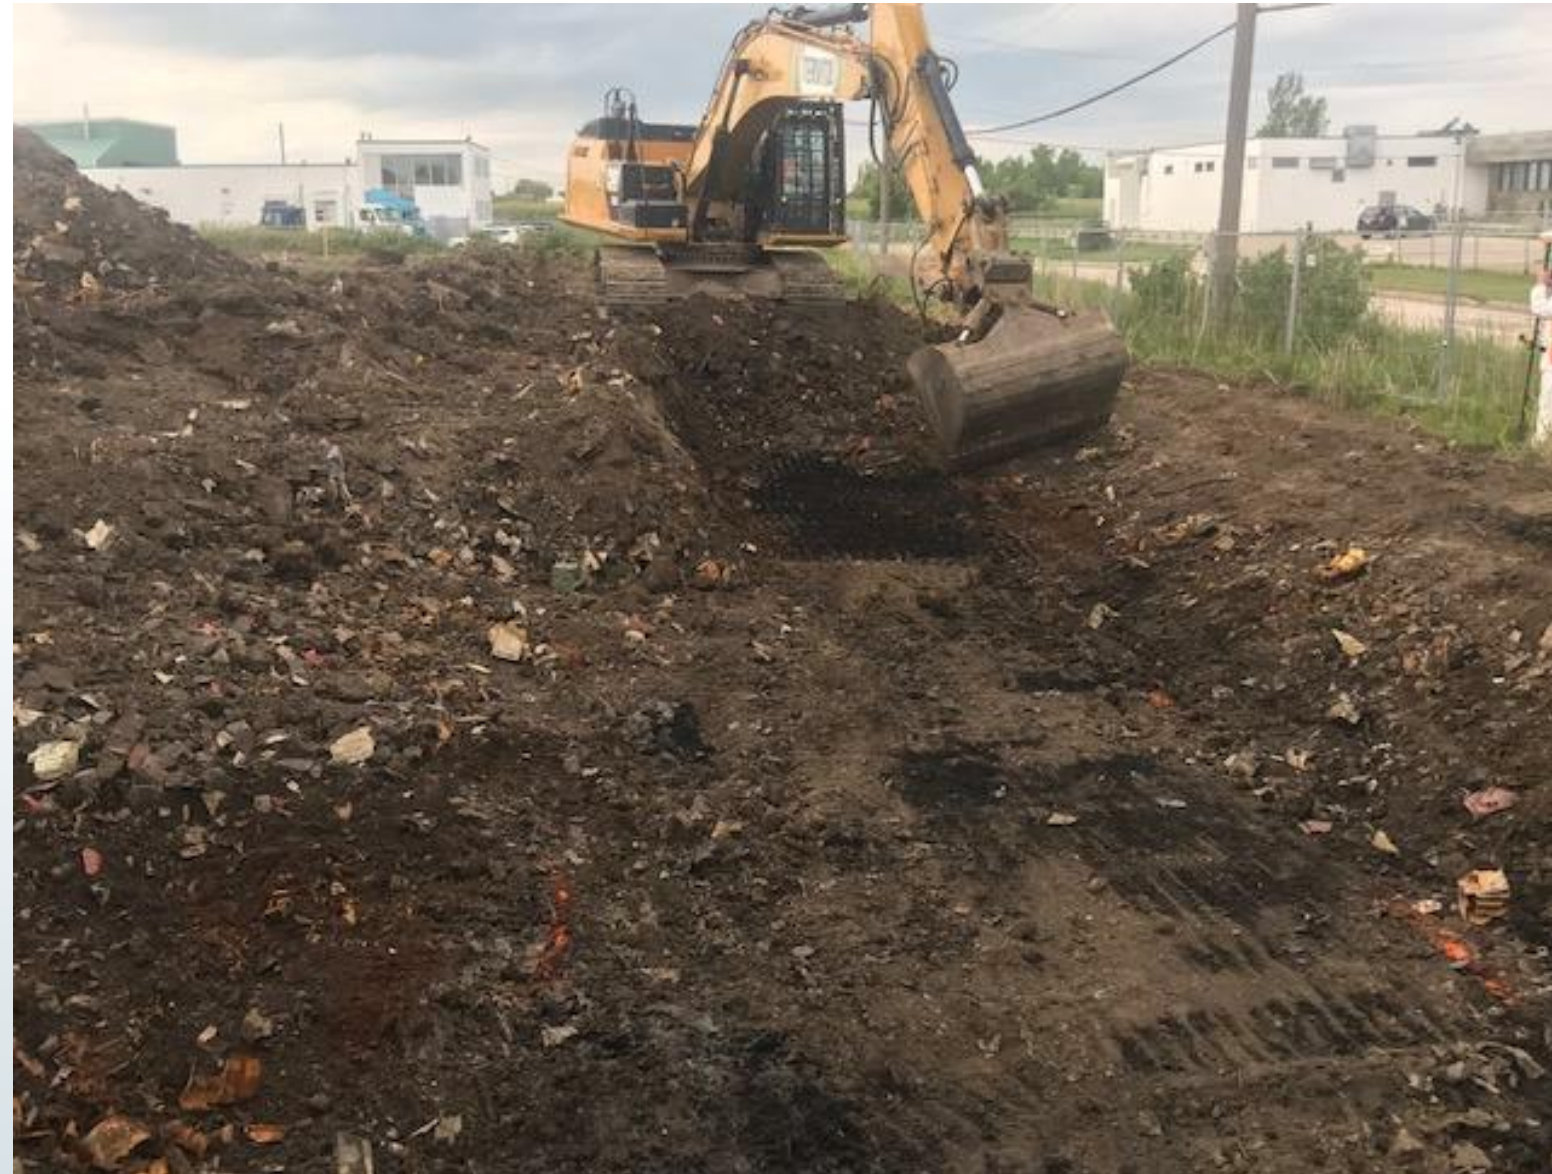
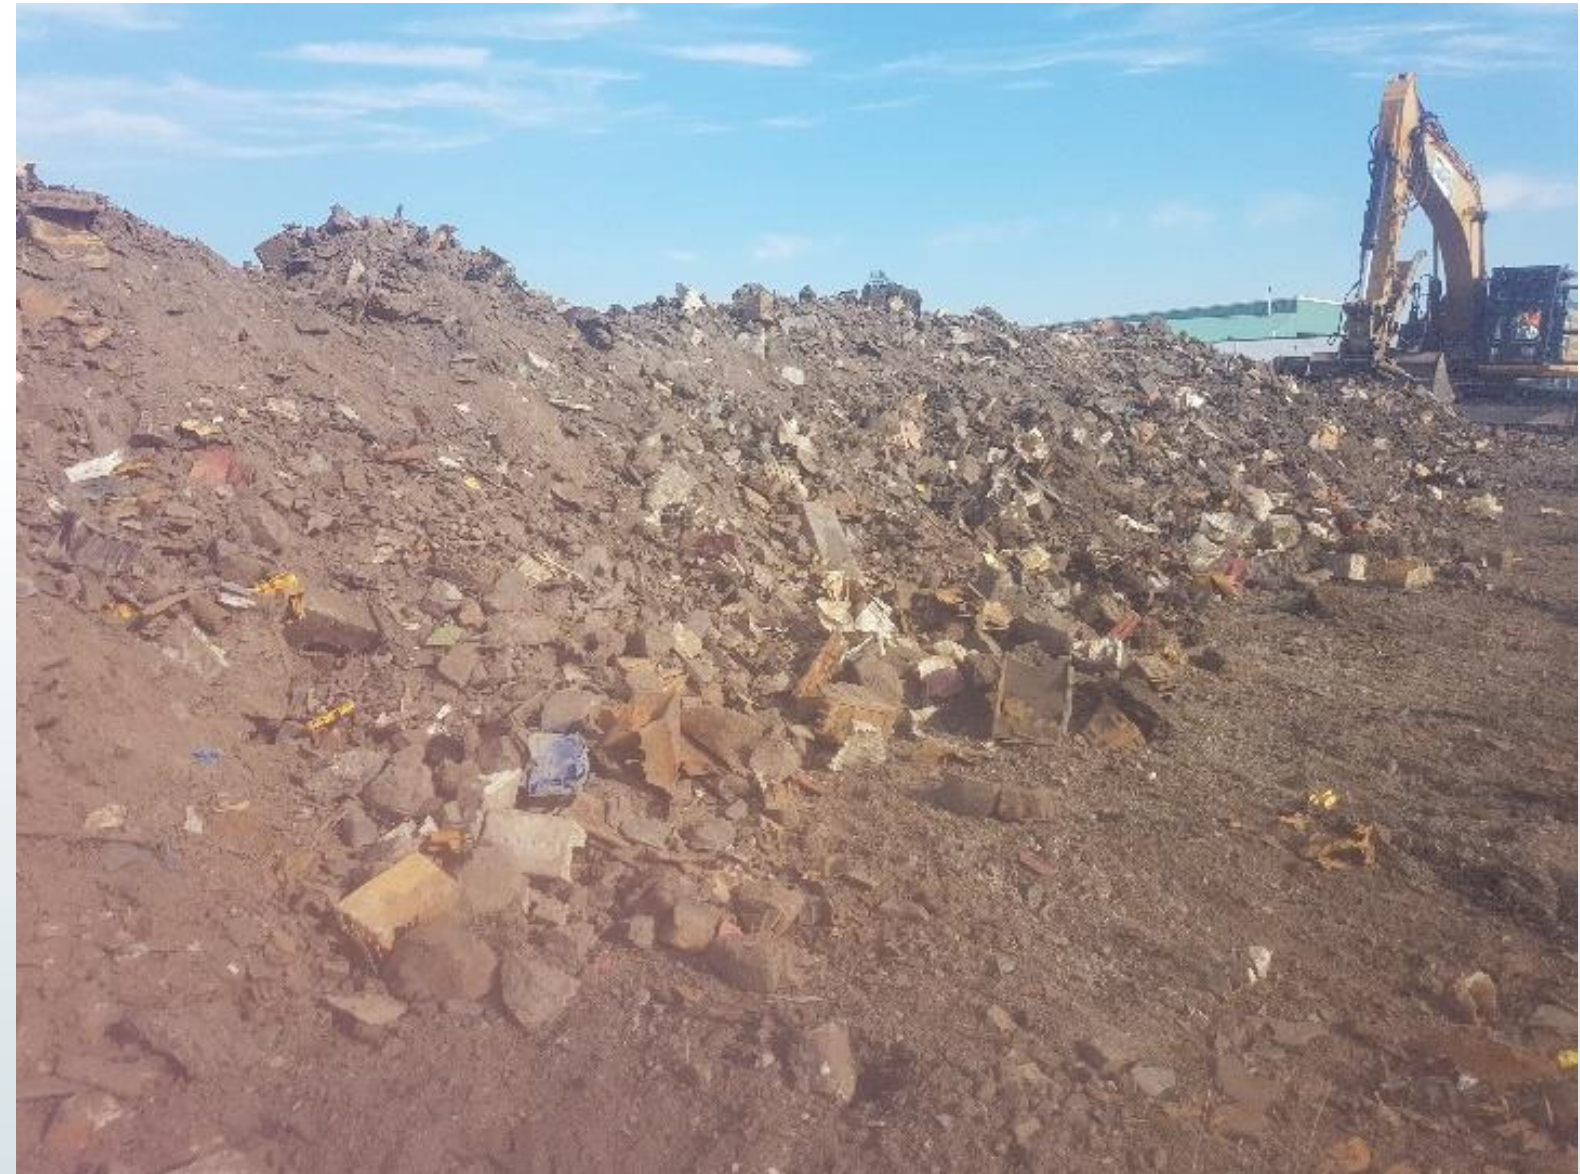
**Battery casing debris encountered in northern section of site**

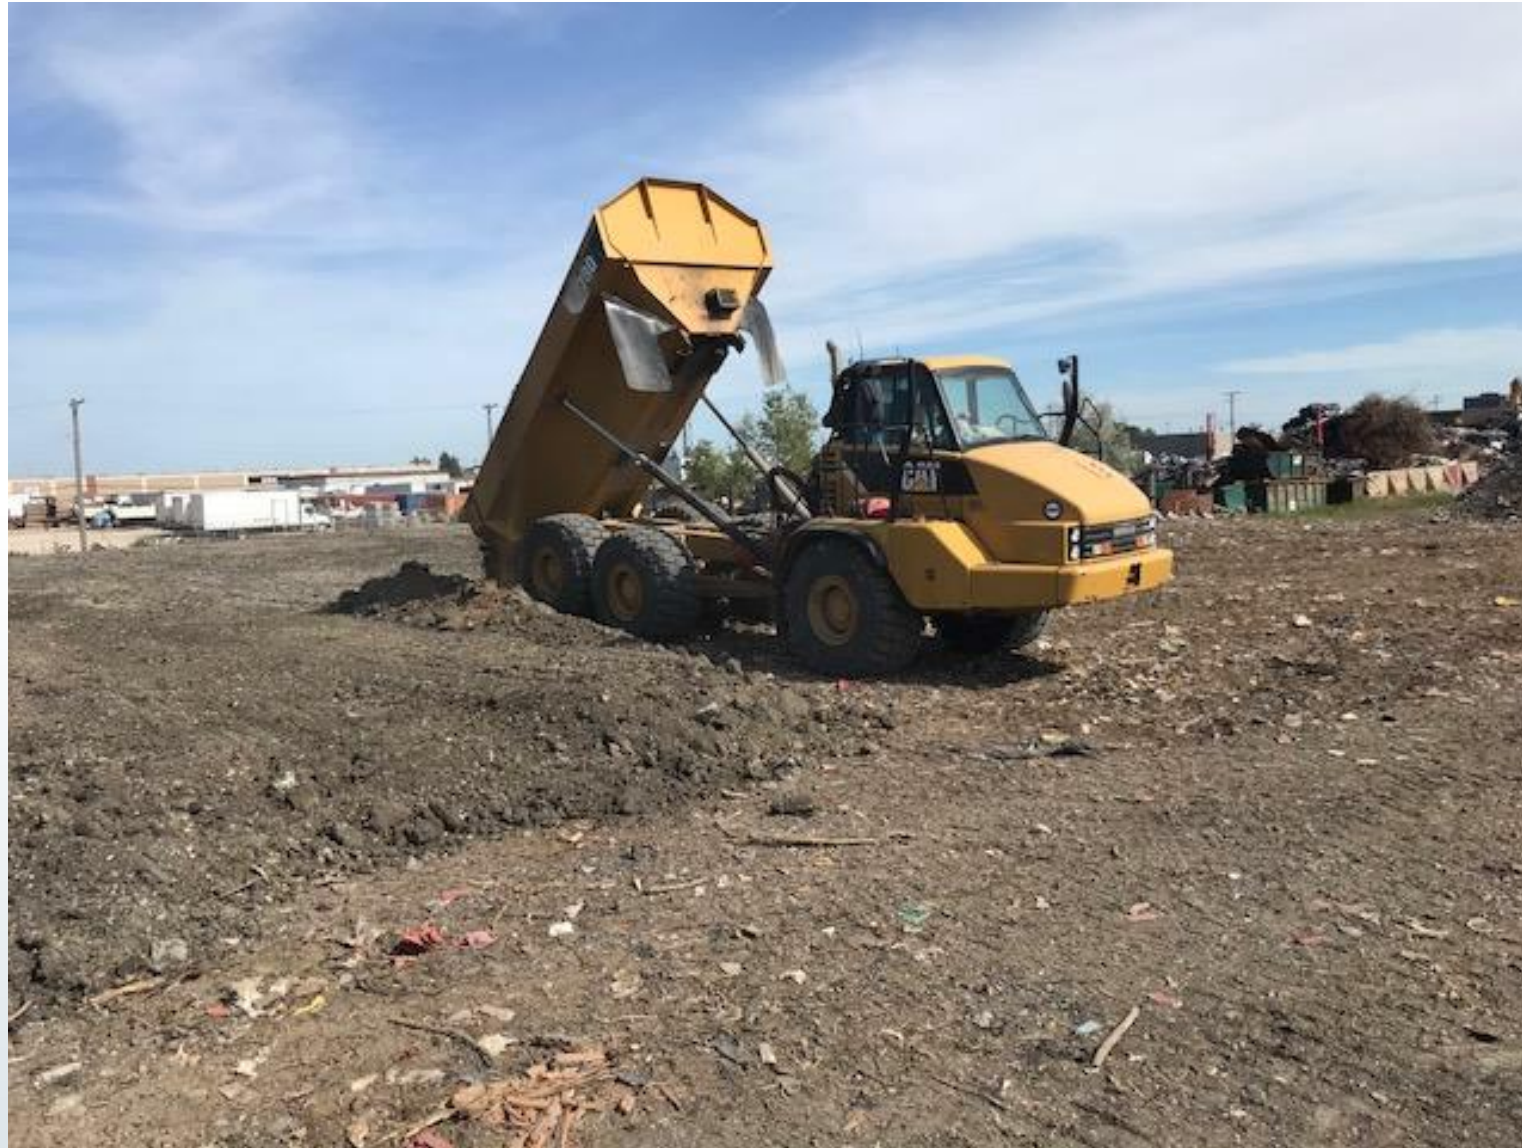
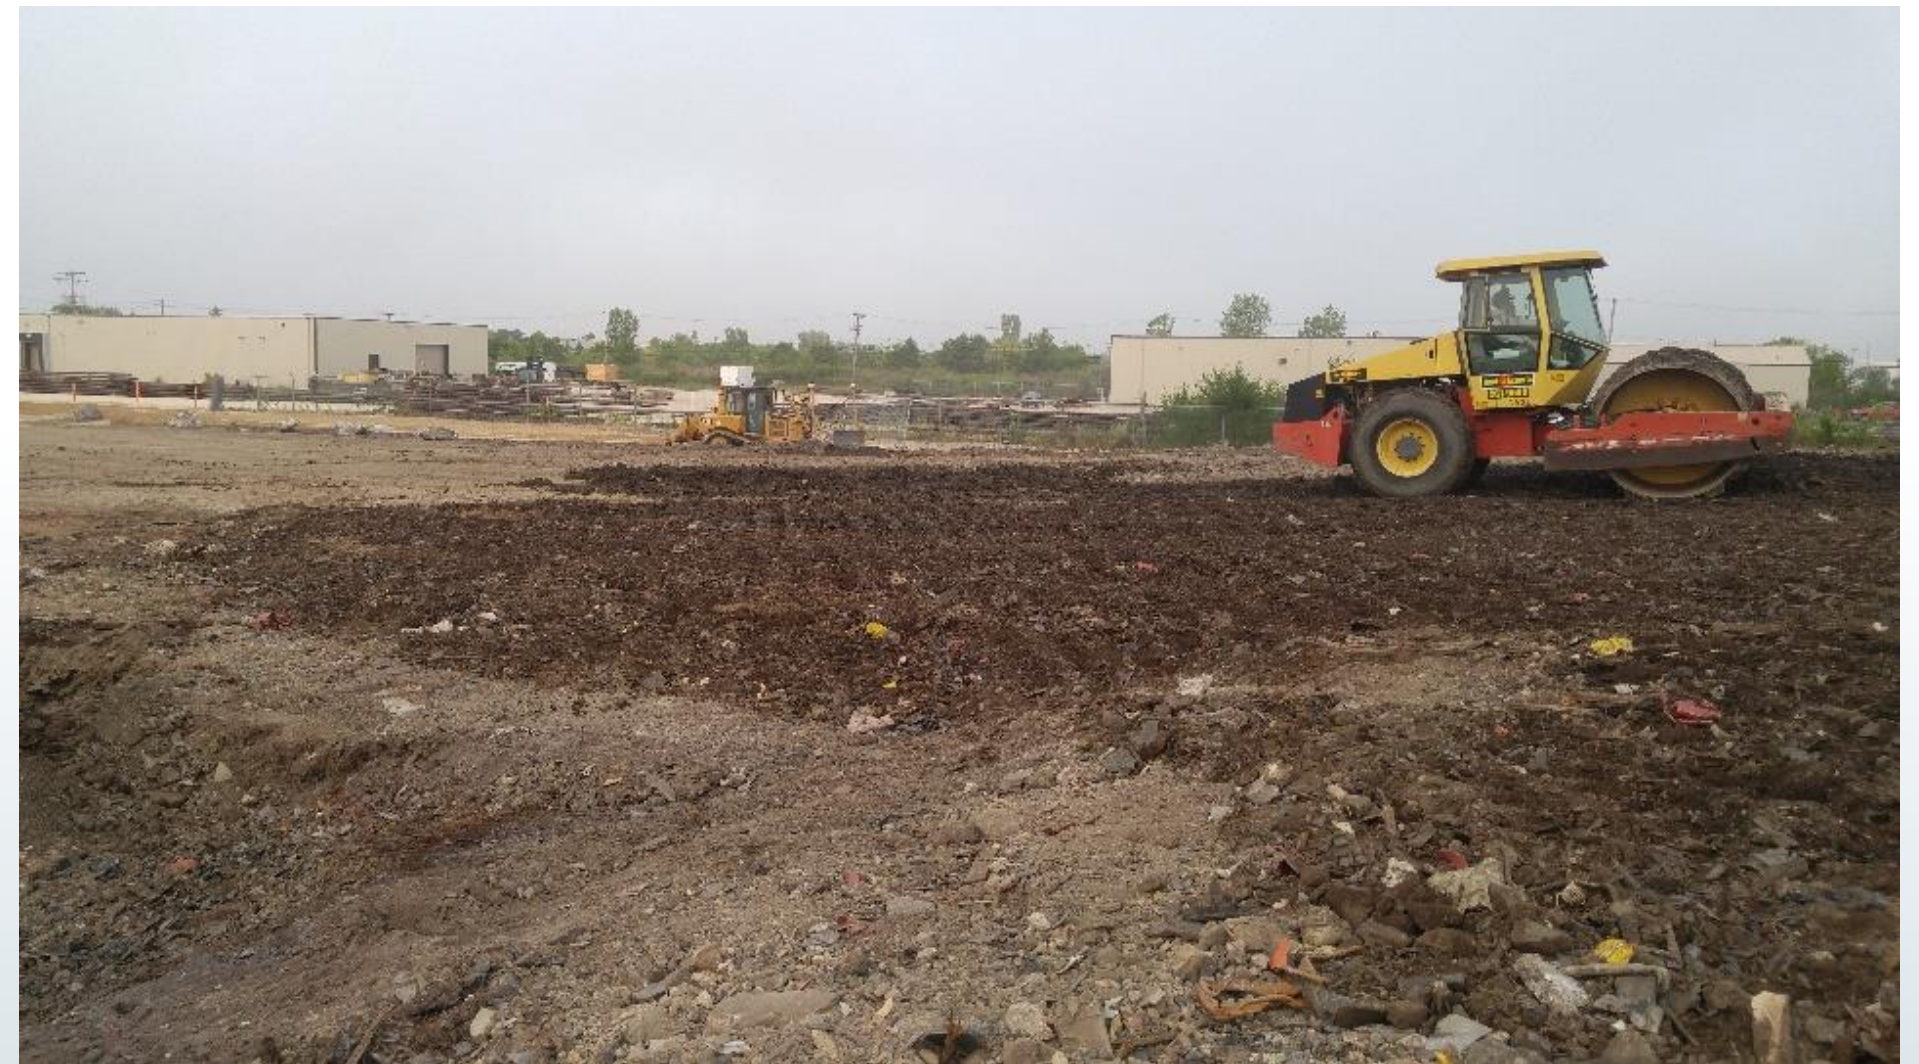
## Metal-impacted material placement and compaction
