# **Remediation of North West Smelting and Refining Ltd. Winnipeg, Manitoba**

**2019 Remediation Technologies  
Symposium**

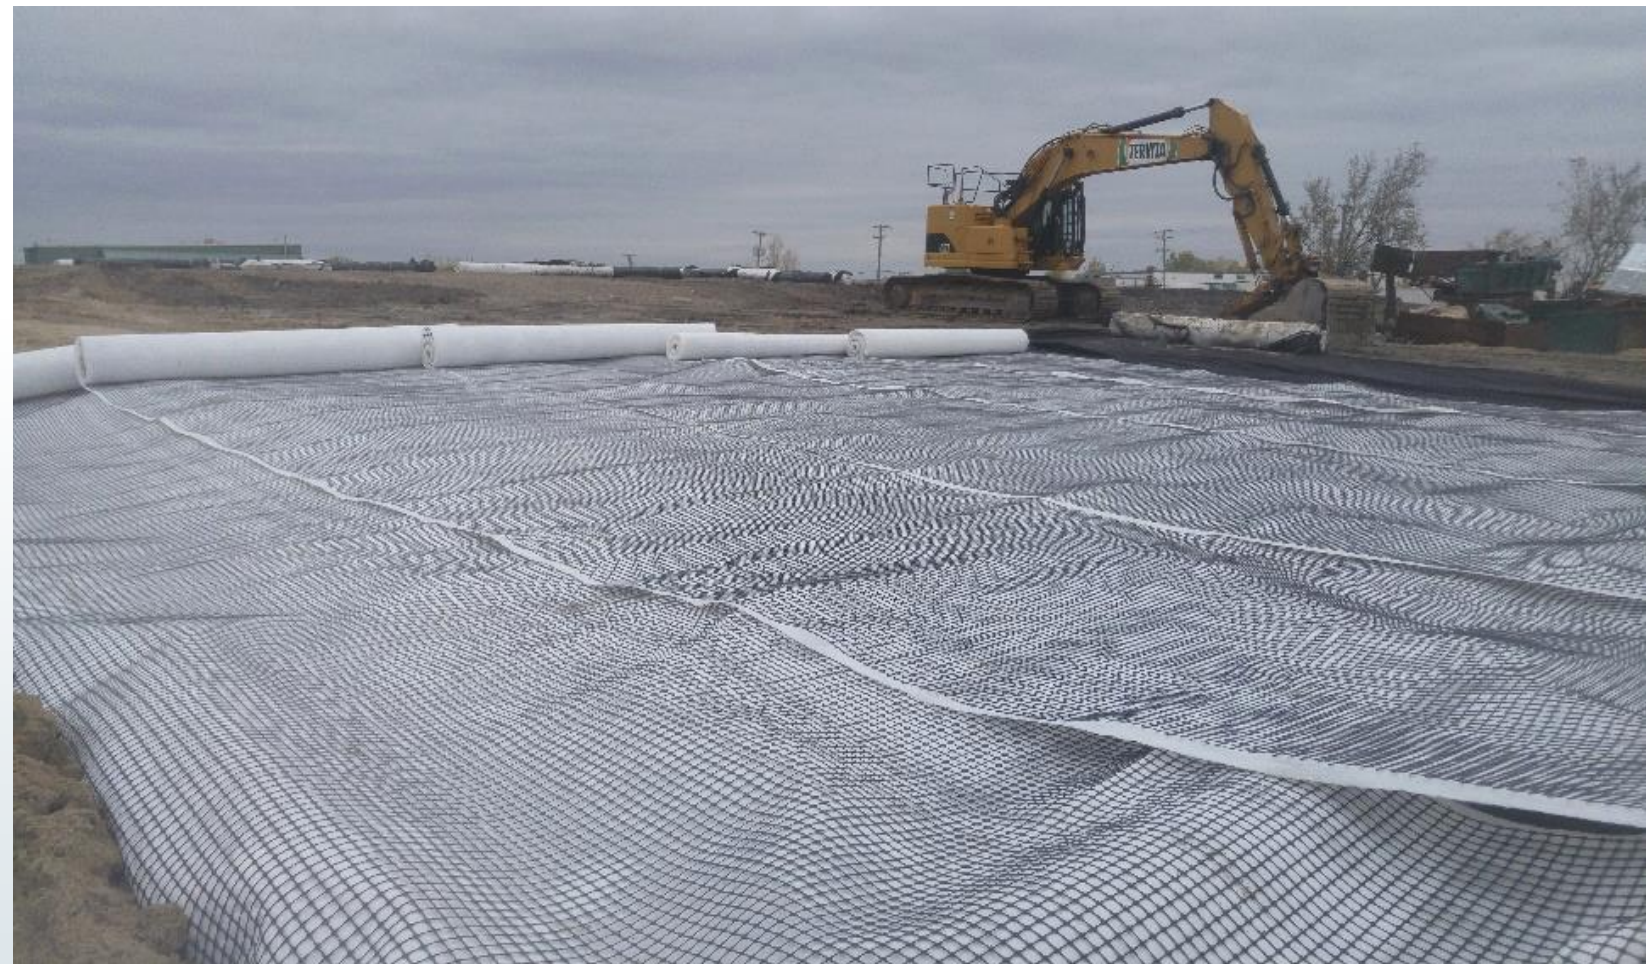
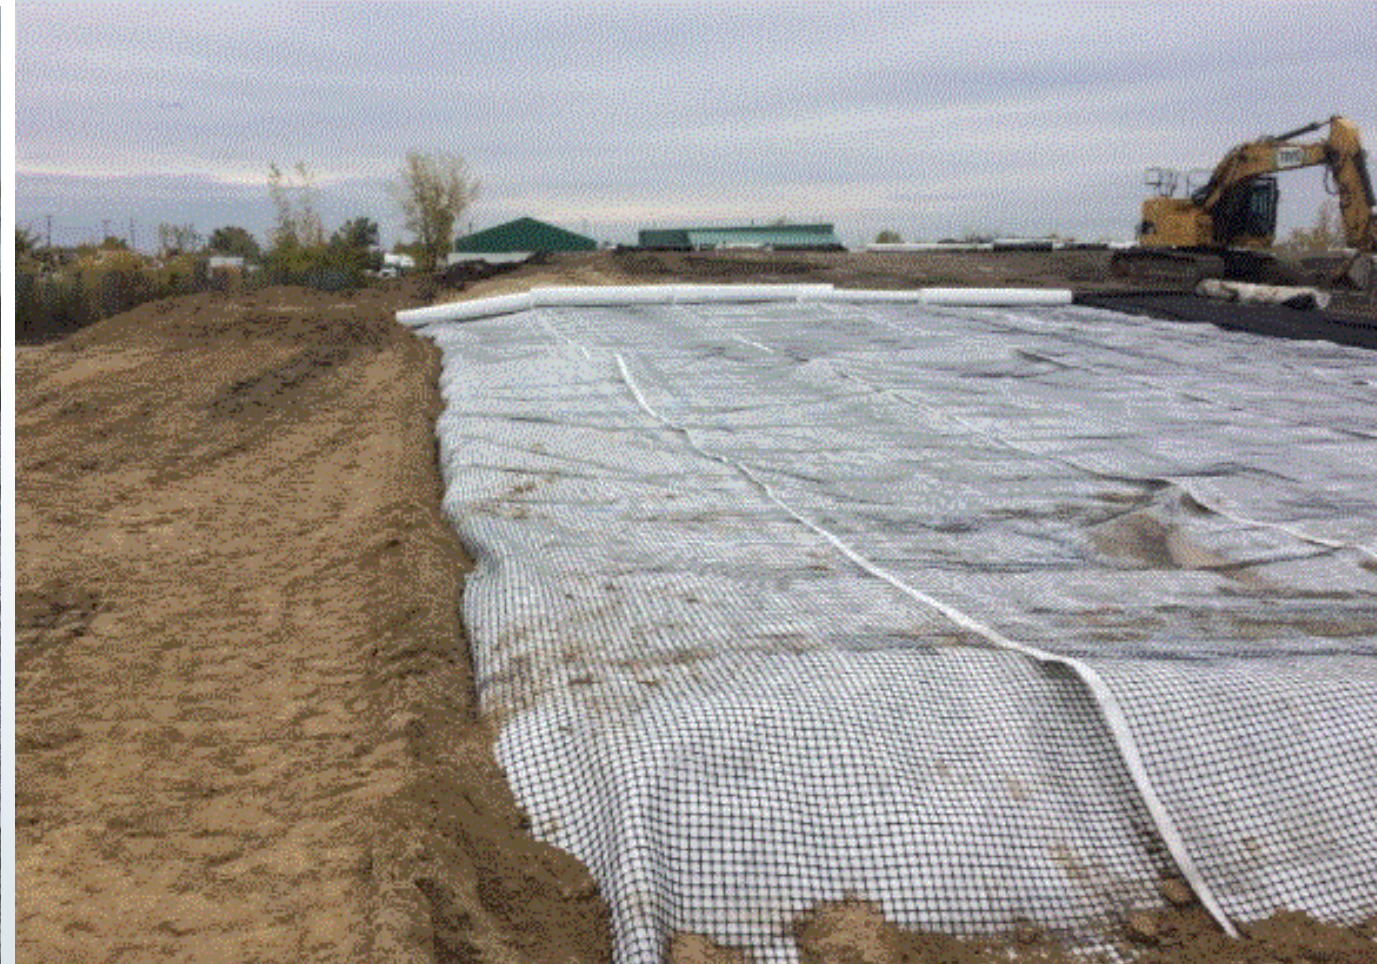
**Placement of geogrid on engineered cap and ramp**

- **Discovery of additional impacted material below foundations including the kilns;**
- **Resulted in approximately 3,000 m<sup>3</sup> additional impacted material;**
- **Design revised to accommodate material with an enlarged and raised cap, and a wider access ramp;**
- **Increased volume of hazardous impacted materials that could not be compacted meant greater off-site disposal fees.**

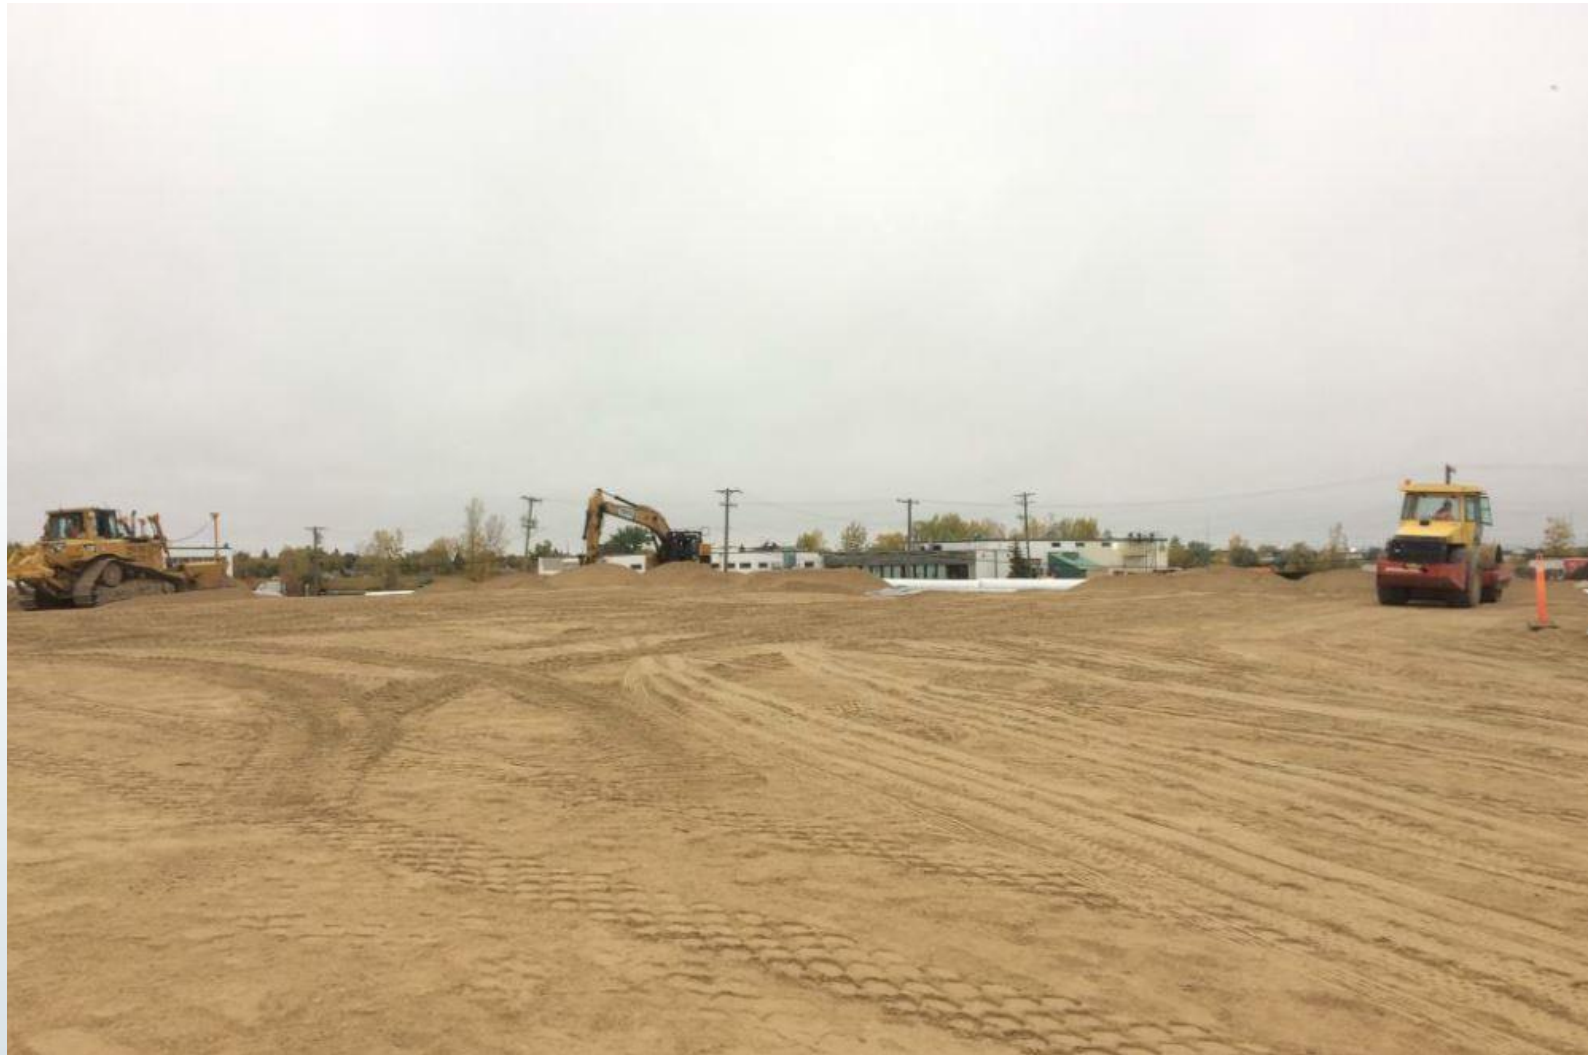
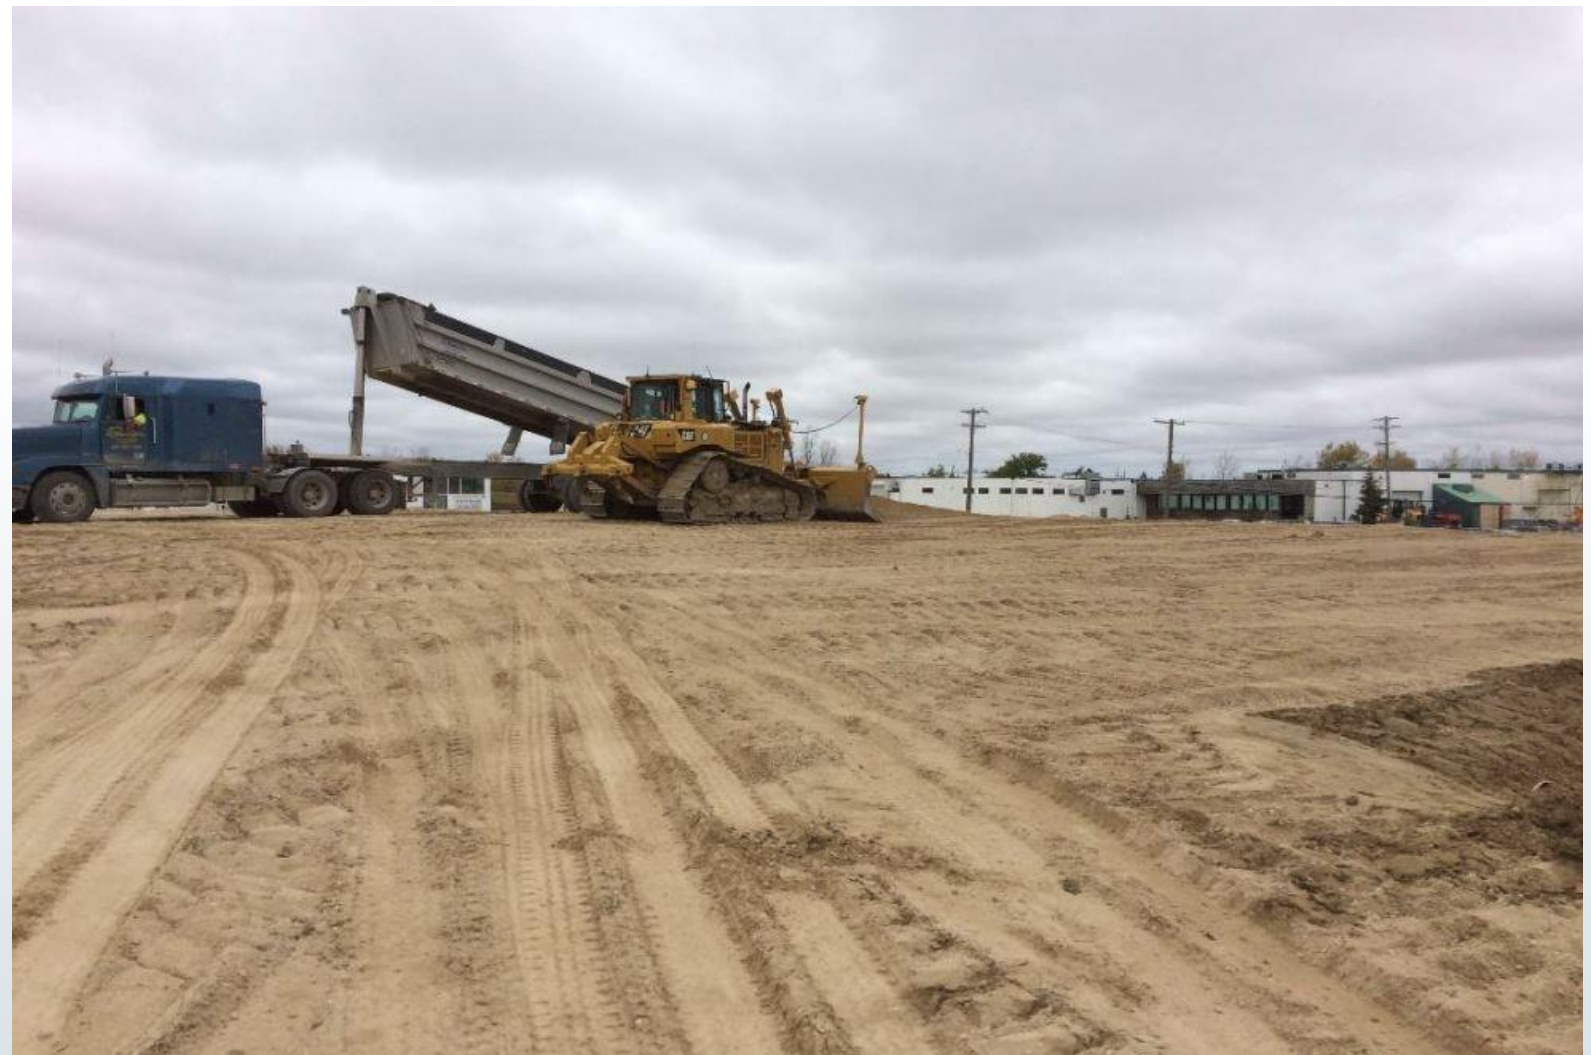
**Engineered cap construction**
