# **Seeing the Forest as More than Just Trees: Assessing and Characterizing Historical Oil & Gas Pipeline Release Sites Using Atypical Boreal Forest Assessment Methods**

**Earthmaster Environmental Strategies**

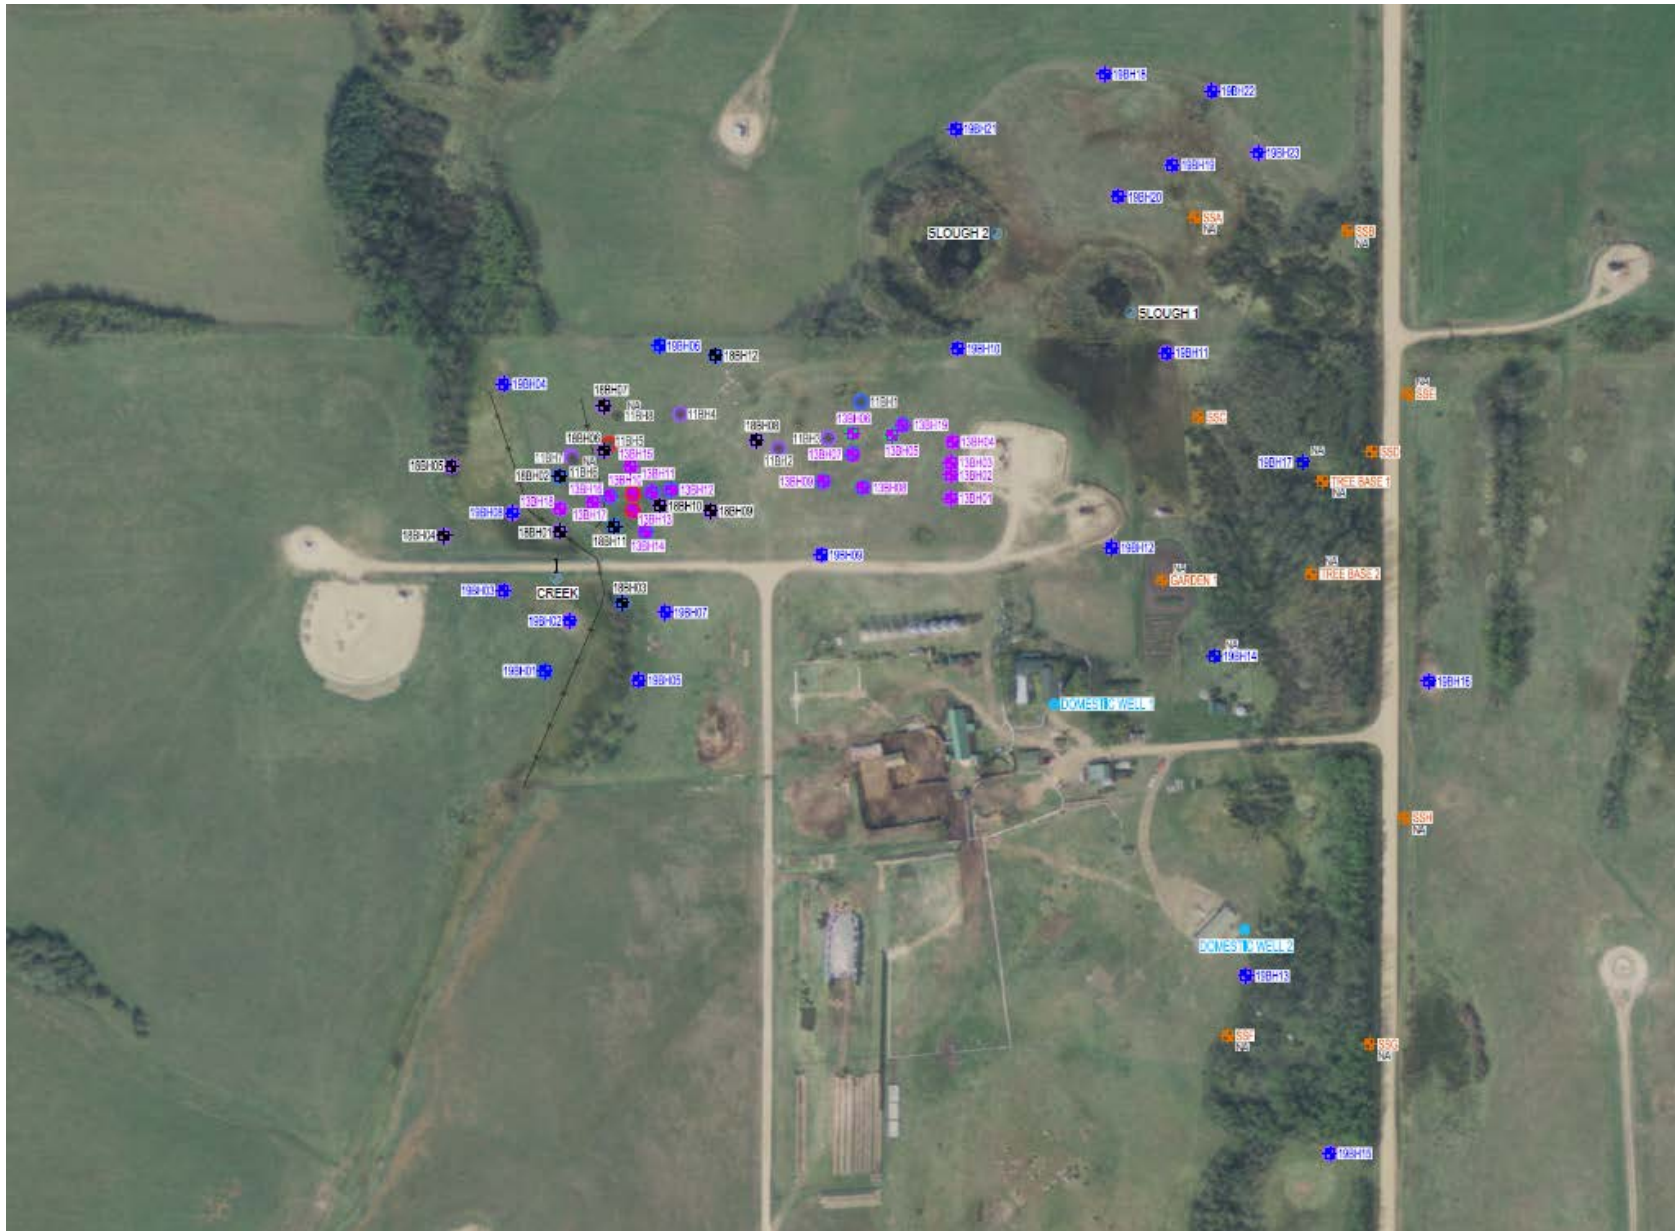
# Historical Soil, Surface, and Groundwater Sampling

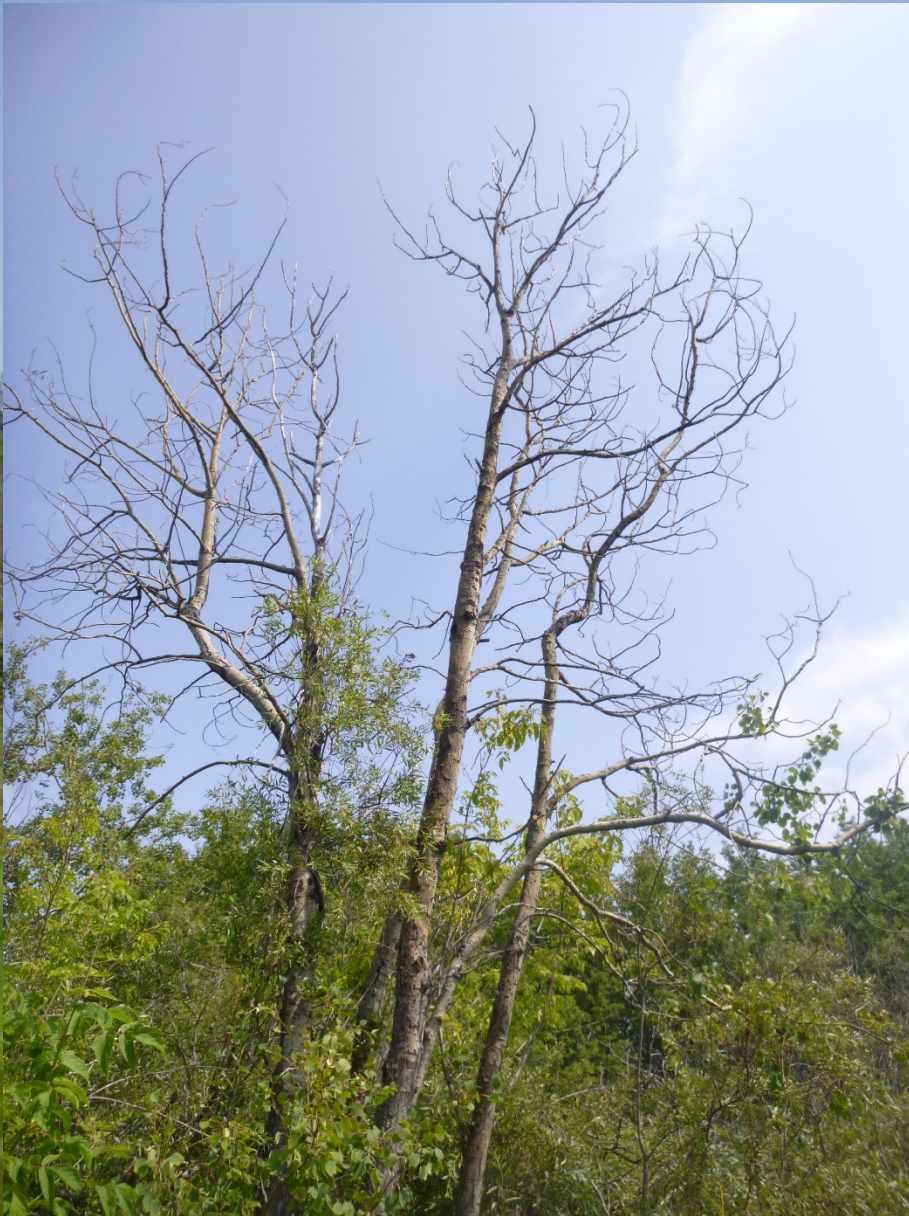
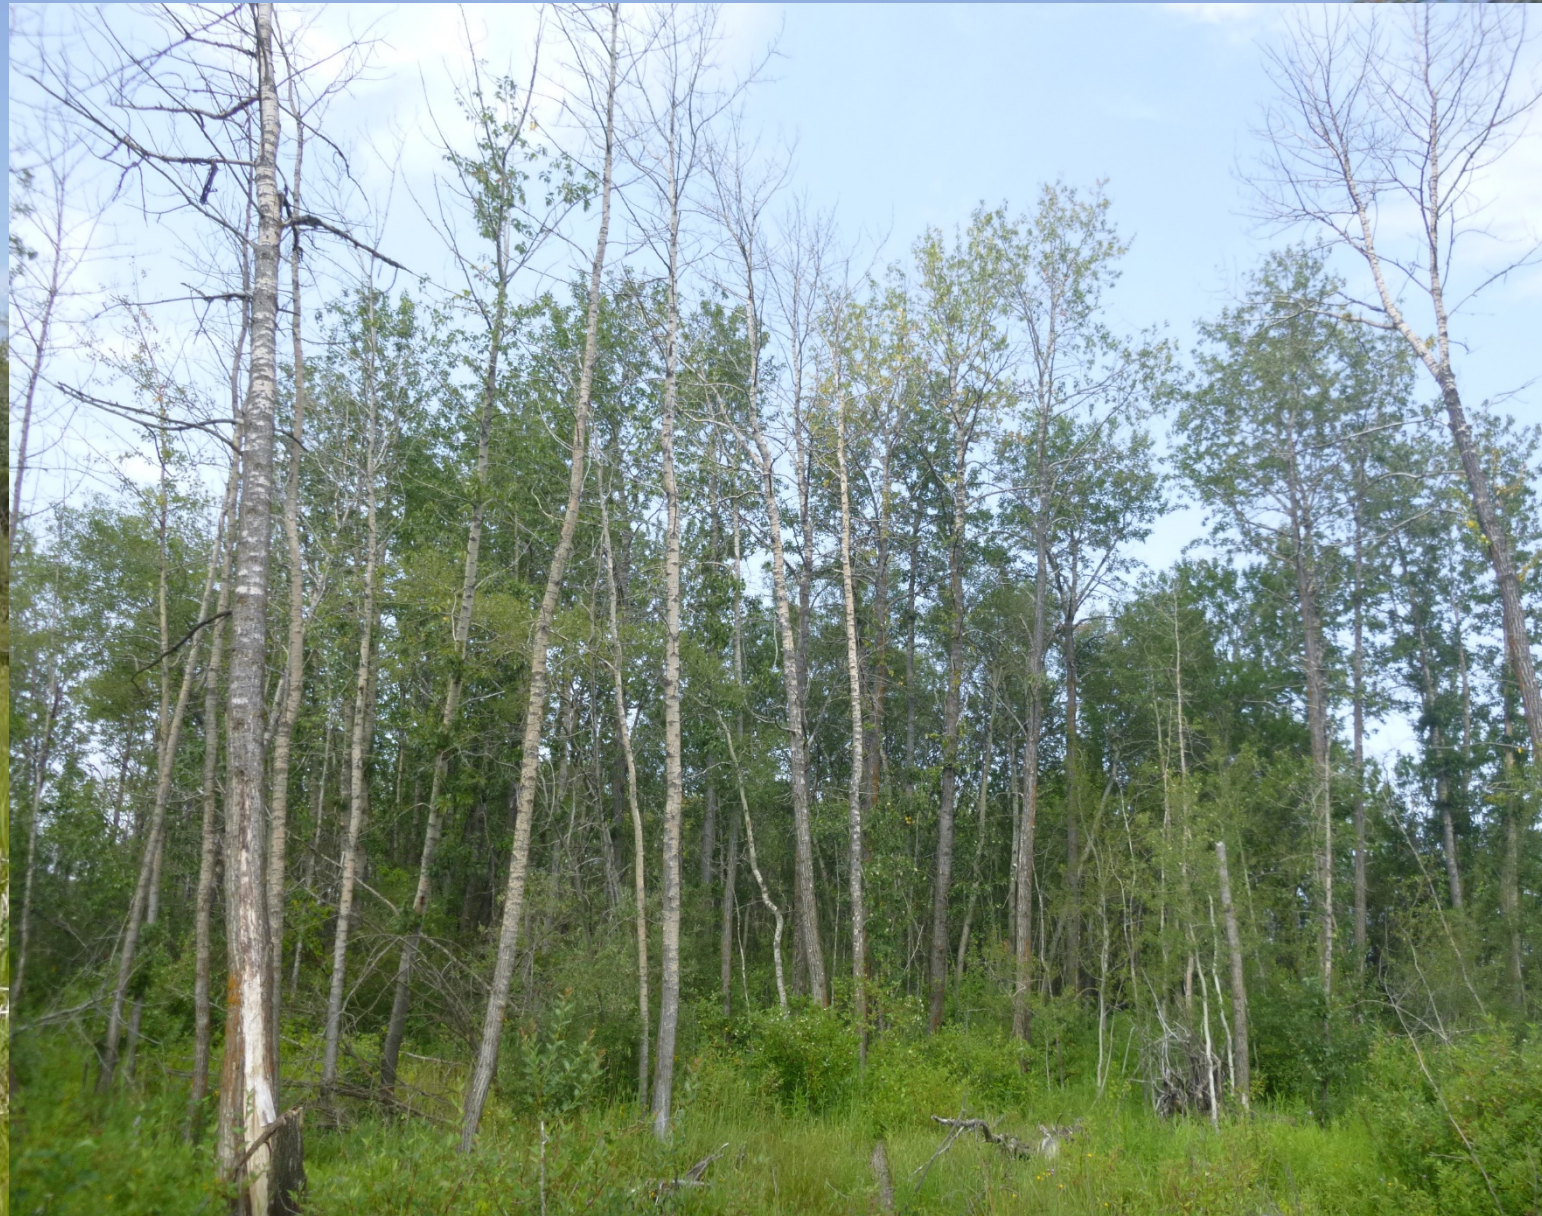
# On Site Assessment – Inside Area of Concern

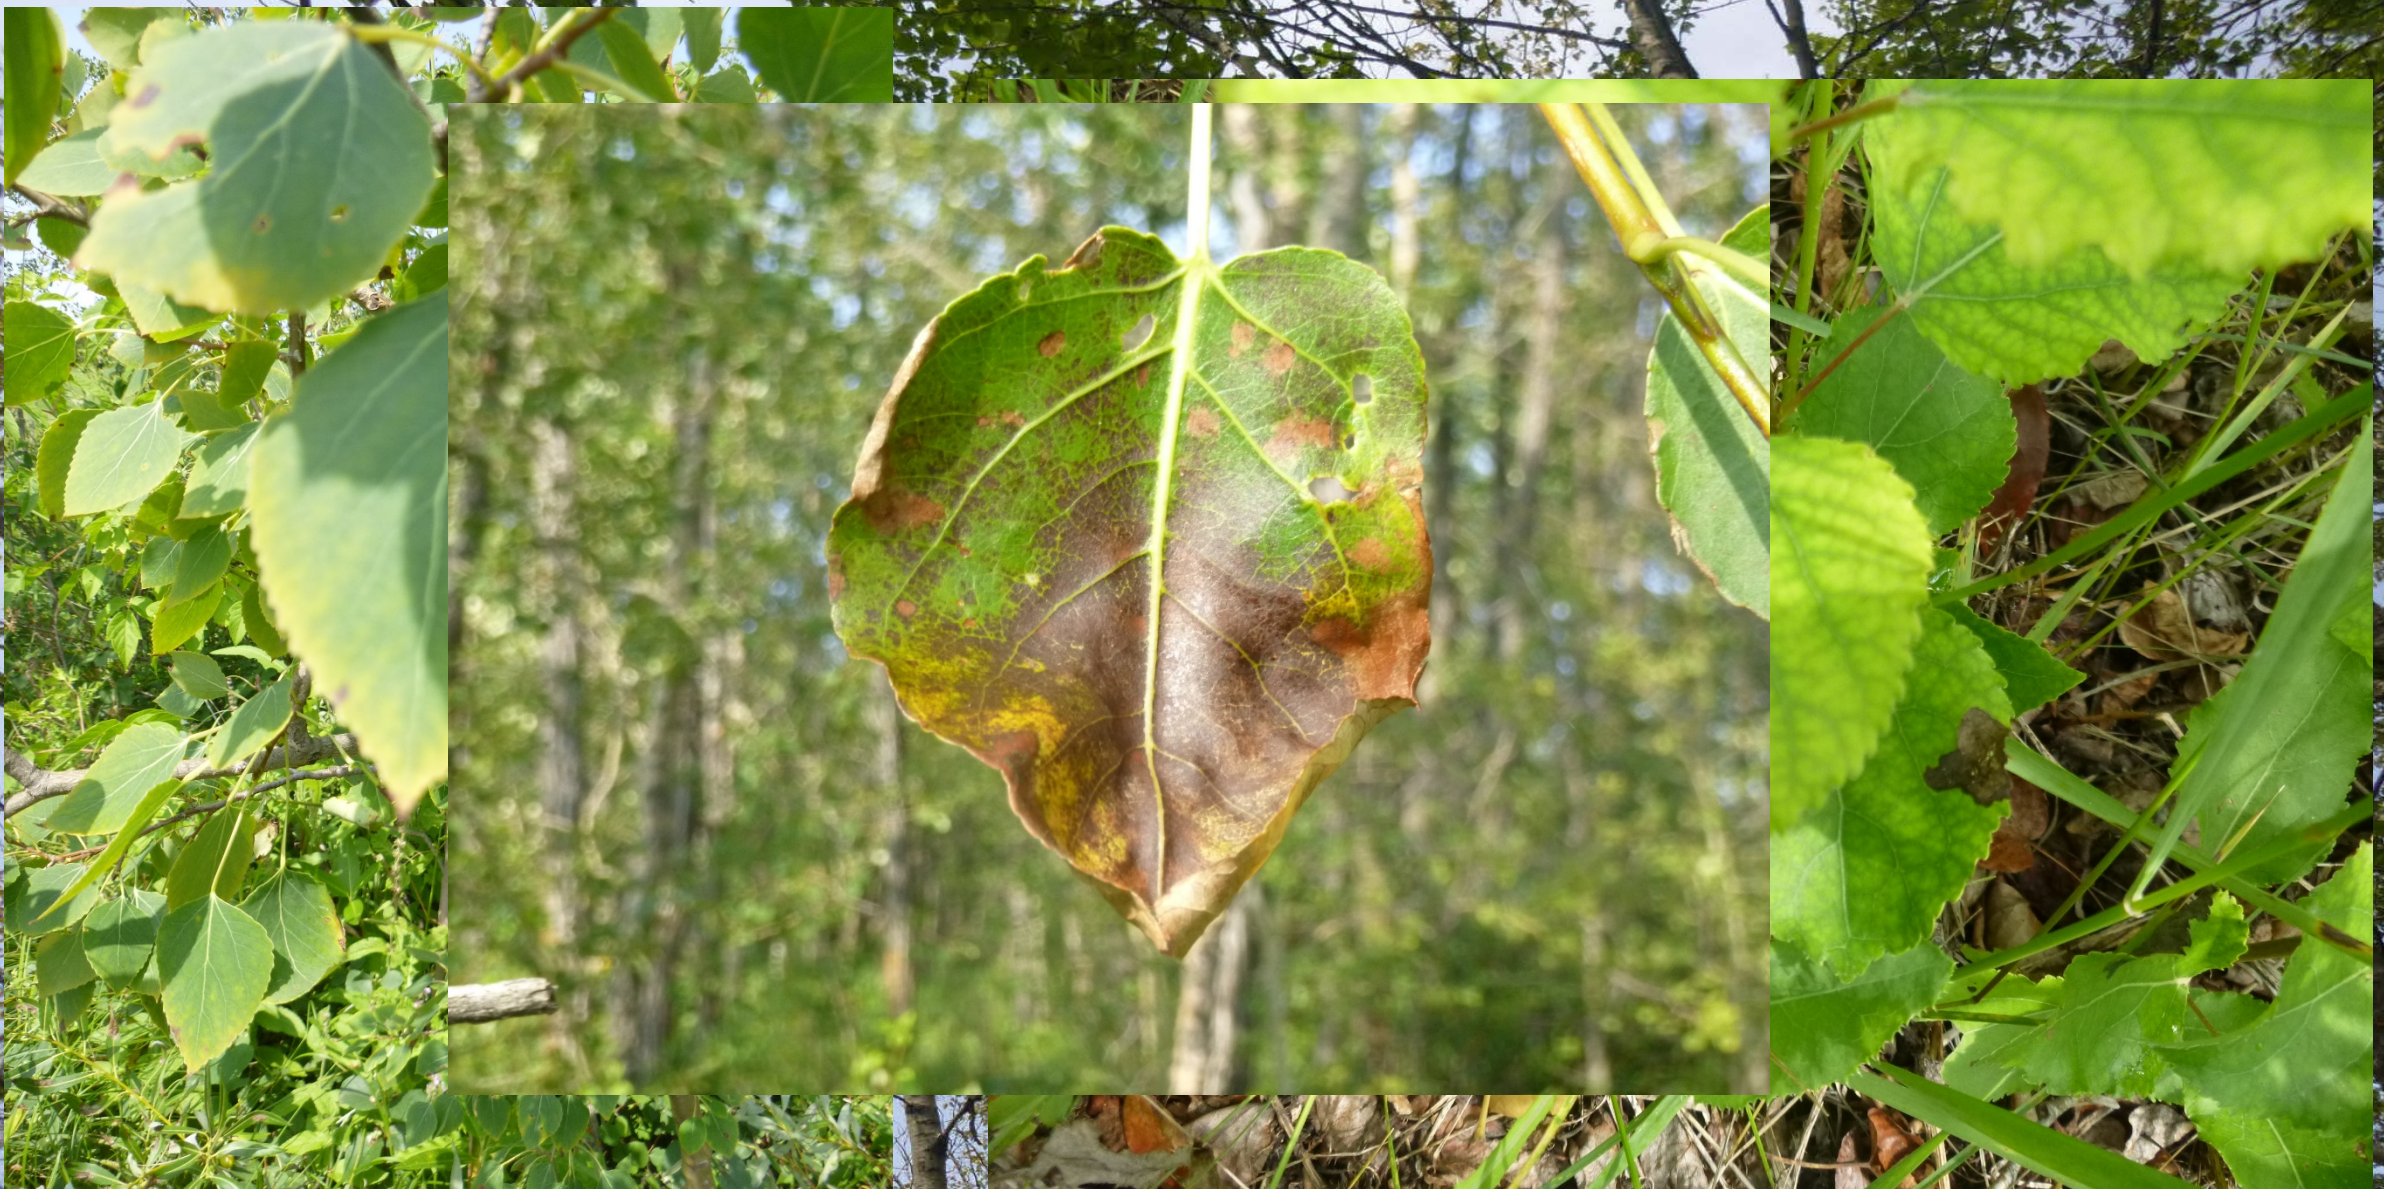
# On Site Assessment – Outside Area of Concern

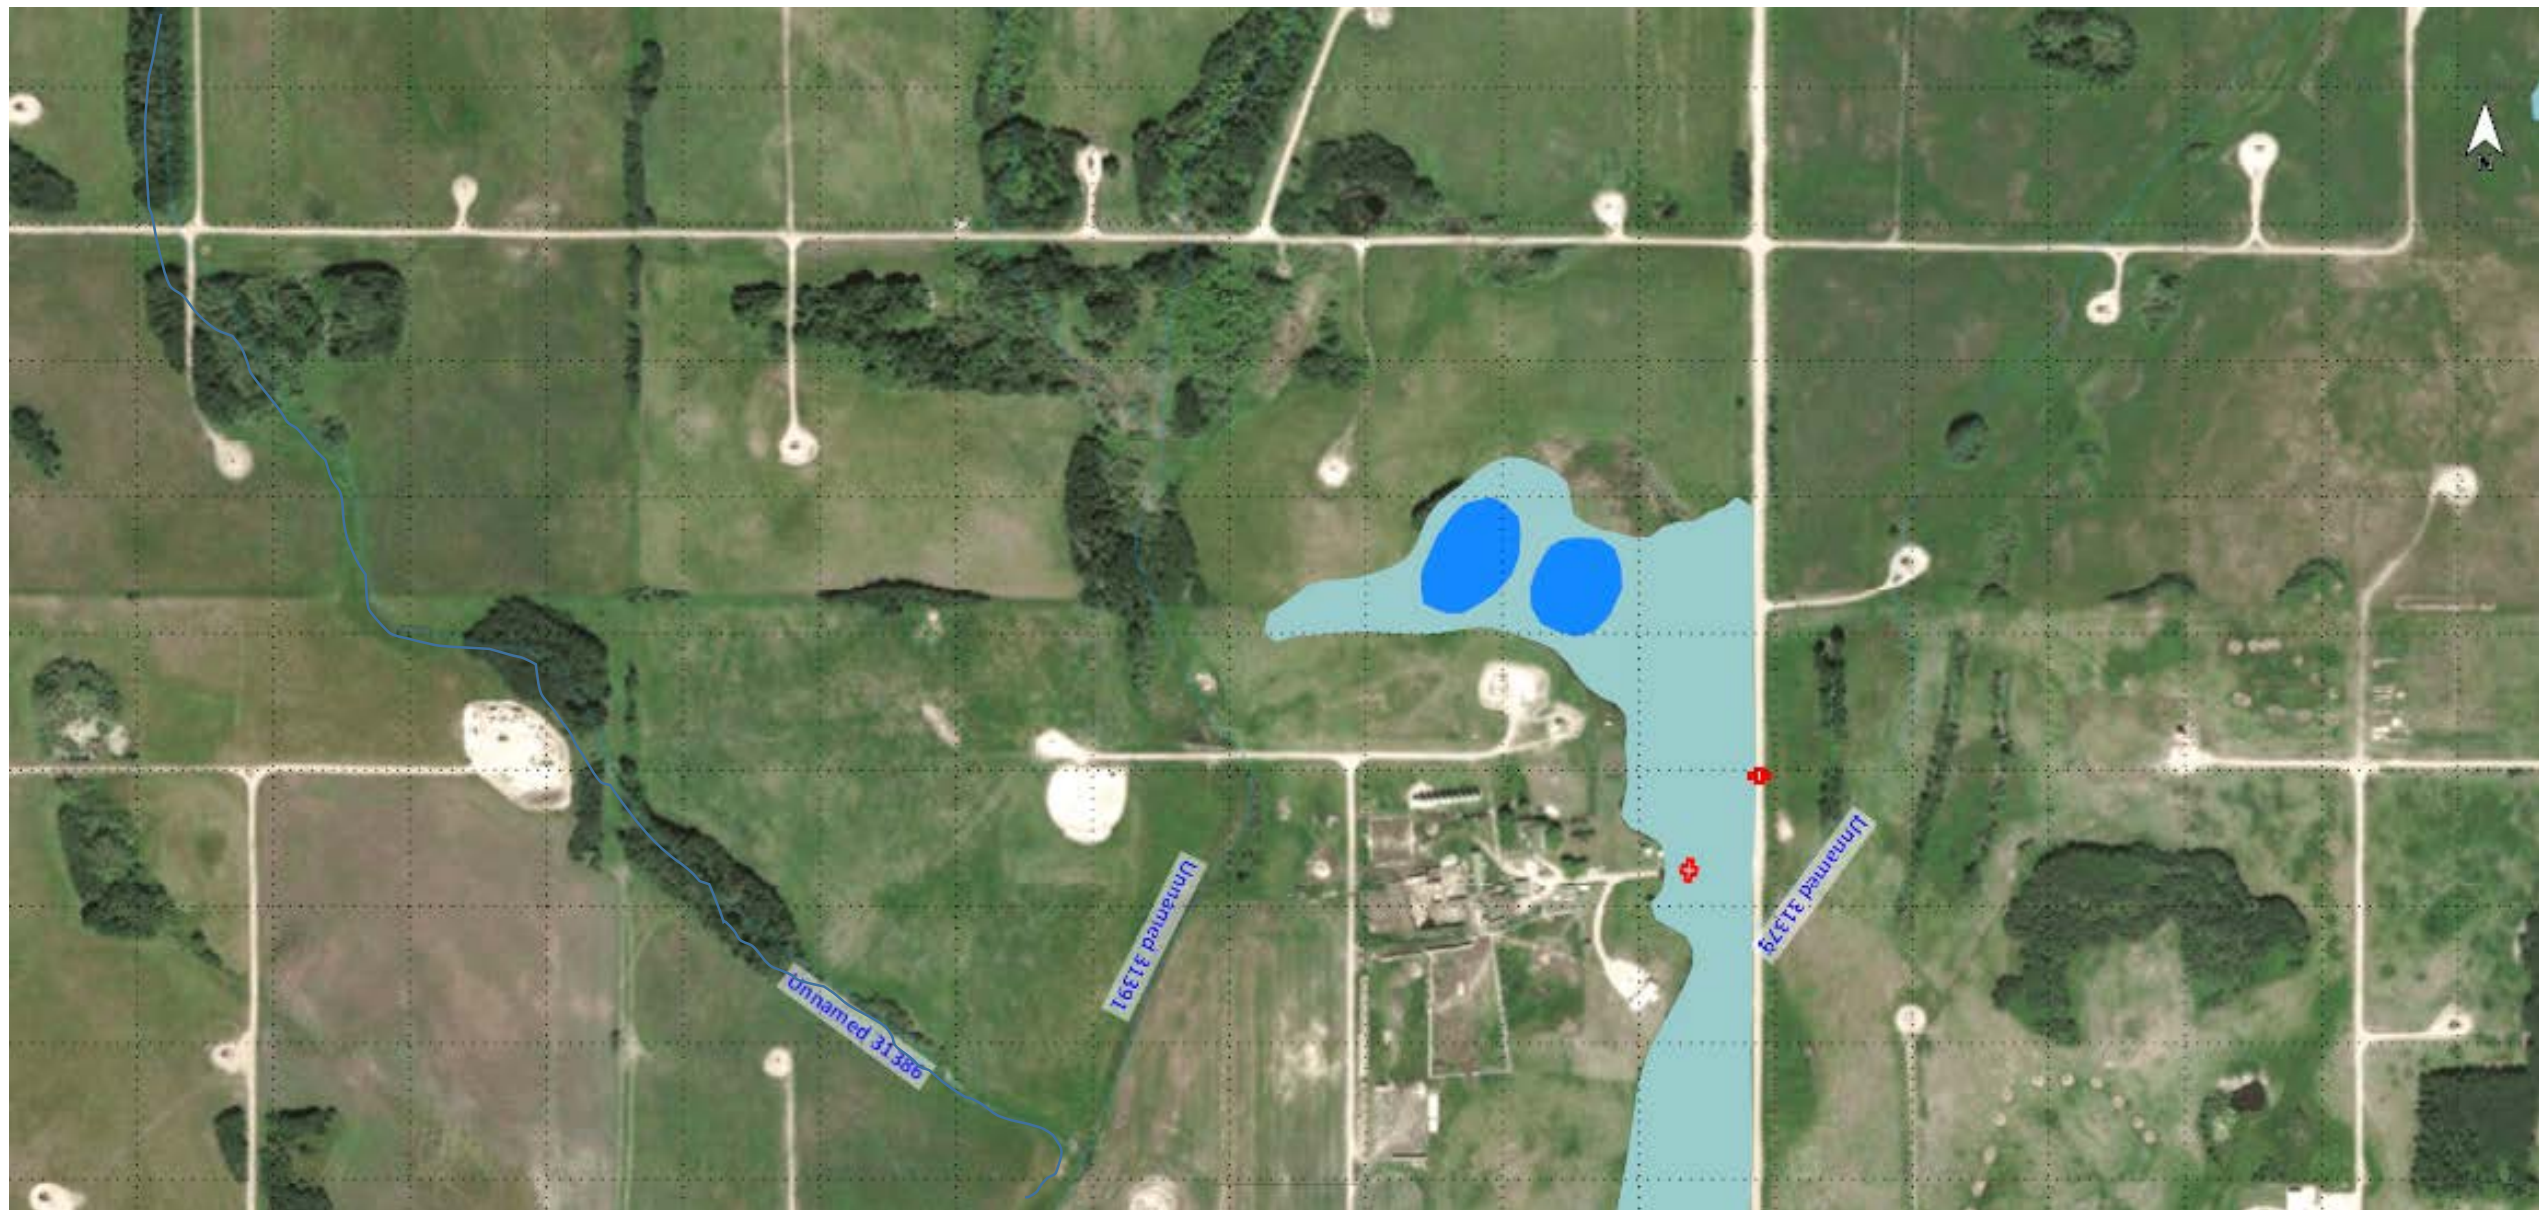
# On Site Assessment: Surface Water Hydrology

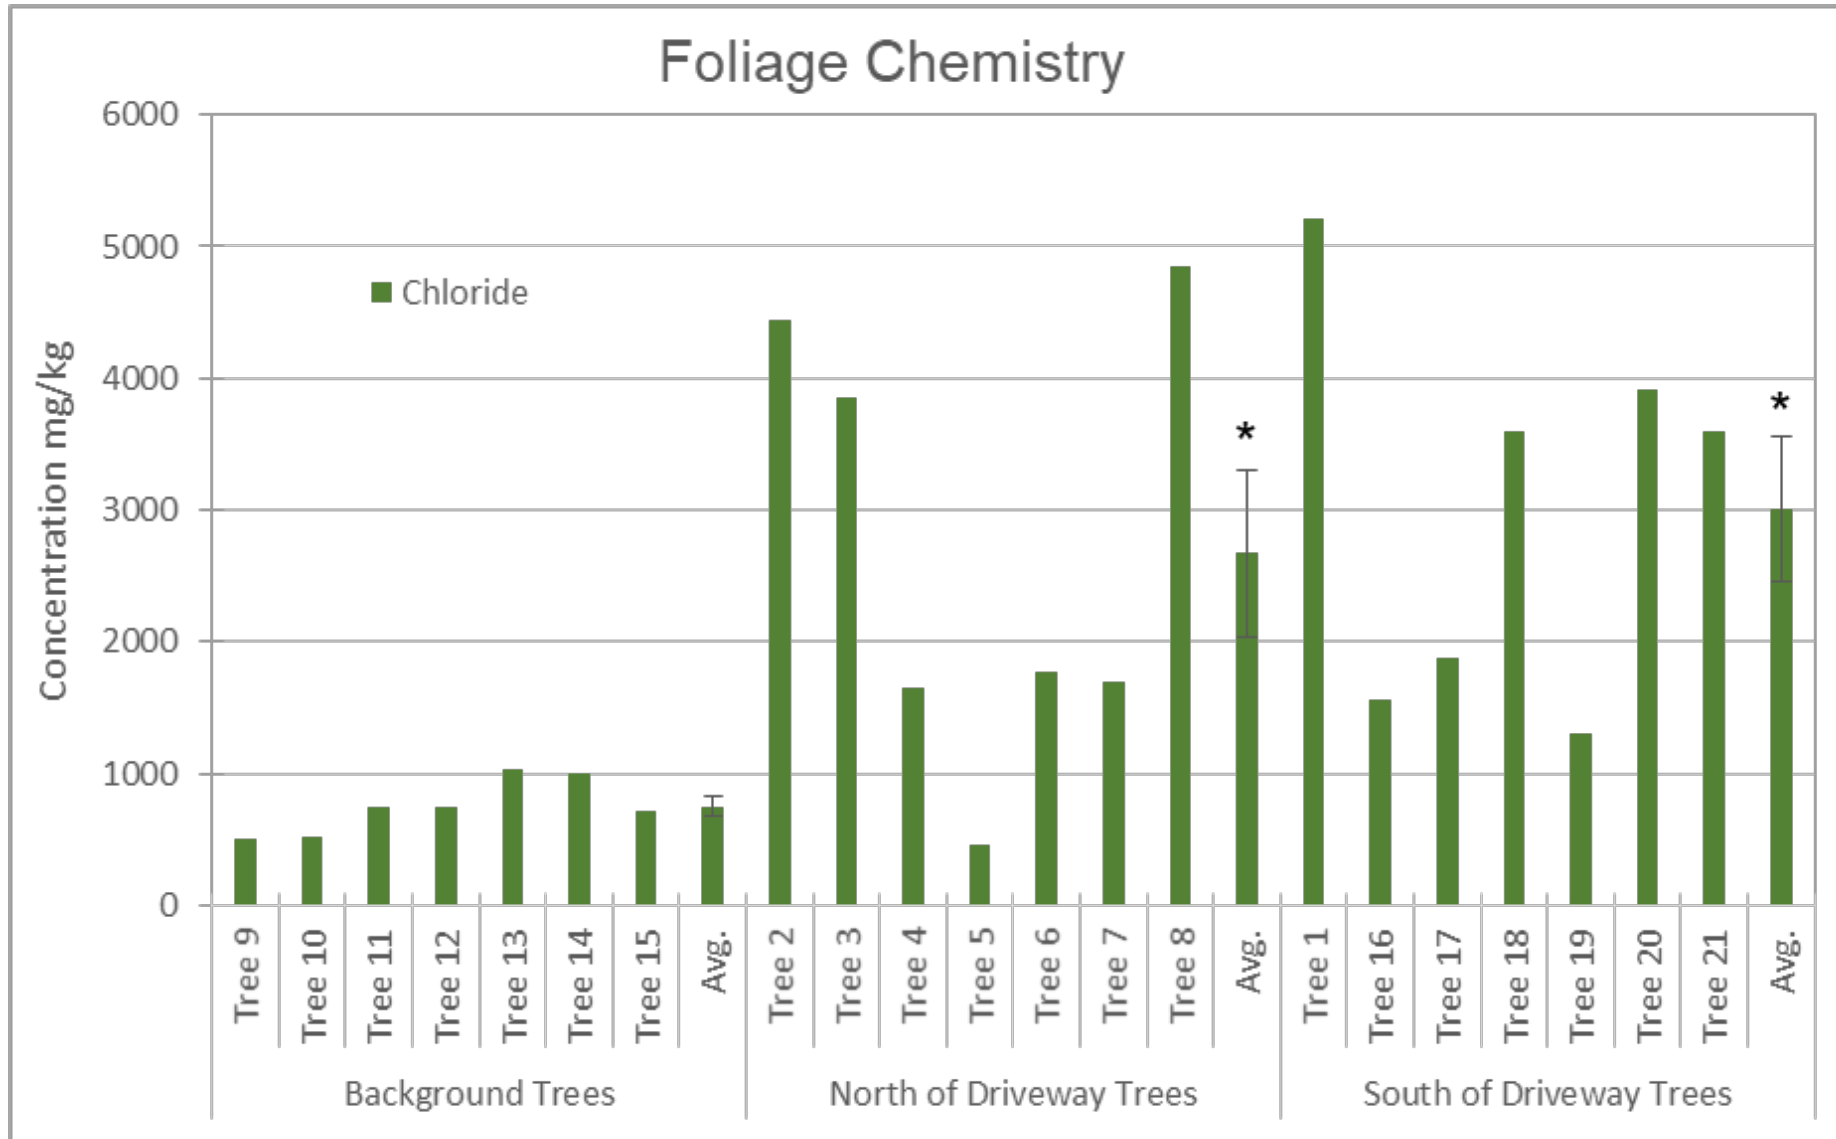
# Foliage Assessment

Chemistry results:

Background:  
498 – 1,030 mg/kg

North Area:  
466 – 4,850 mg/kg

South Area:  
1,310 – 5,210 mg/kg

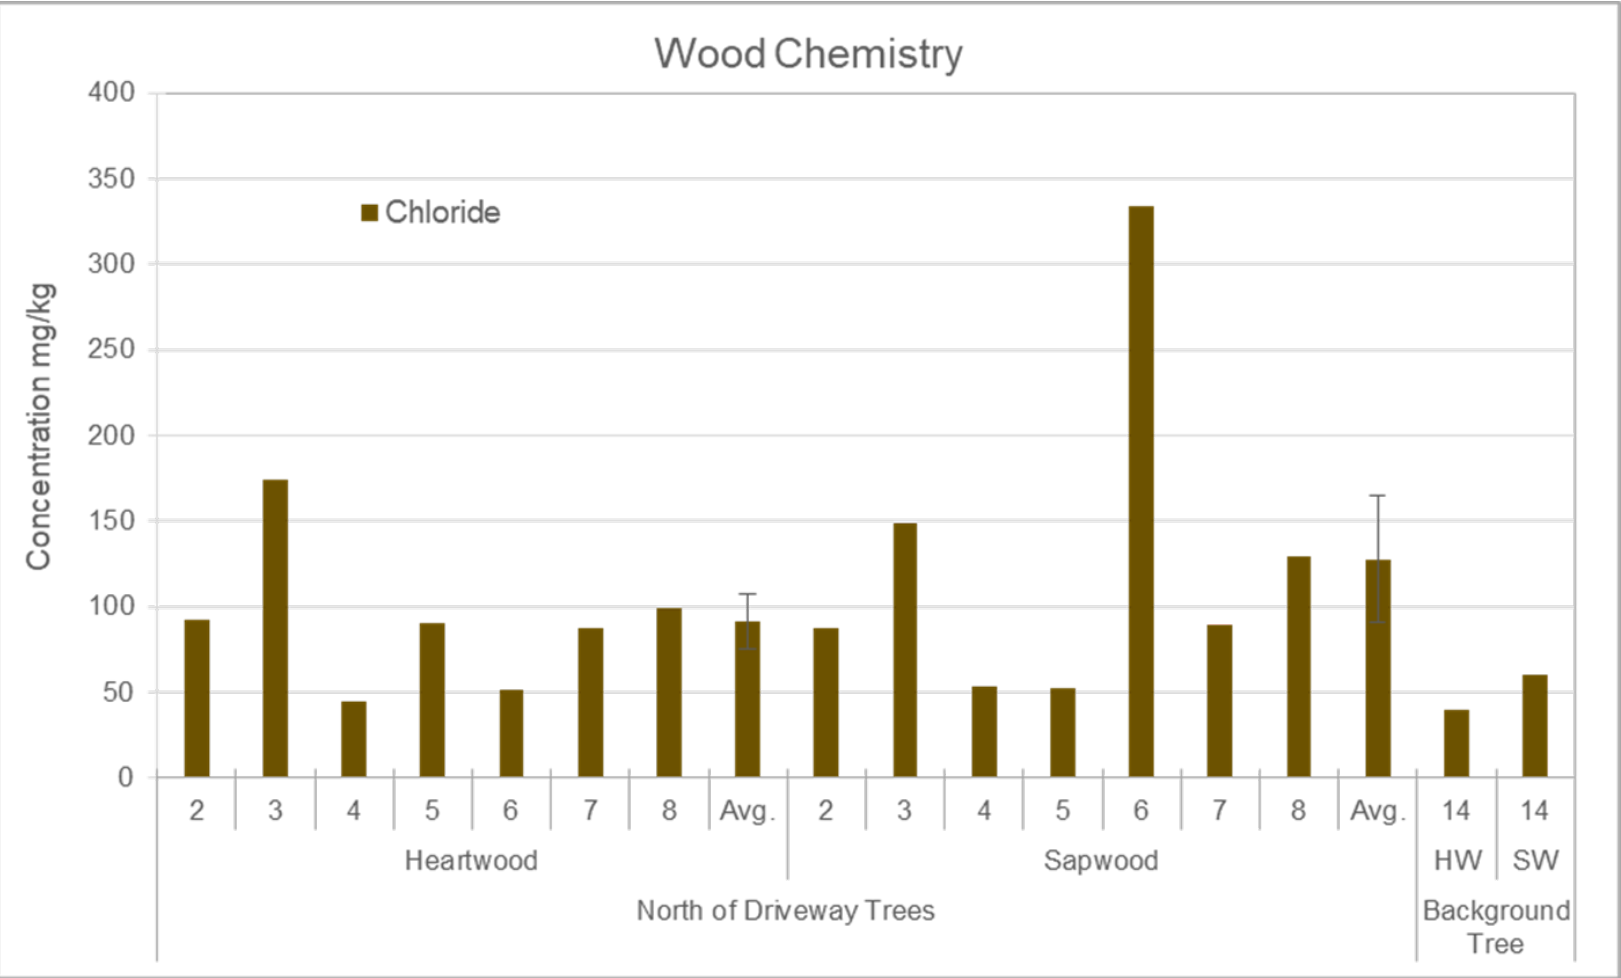
# Wood Assessment

Chemistry results:

Background Trees:

- Heartwood: <40 mg/kg
- Sapwood: 60 mg/kg

North Area Trees:

- Heartwood: 51-174 mg/kg
- Sapwood: 52-334 mg/kg

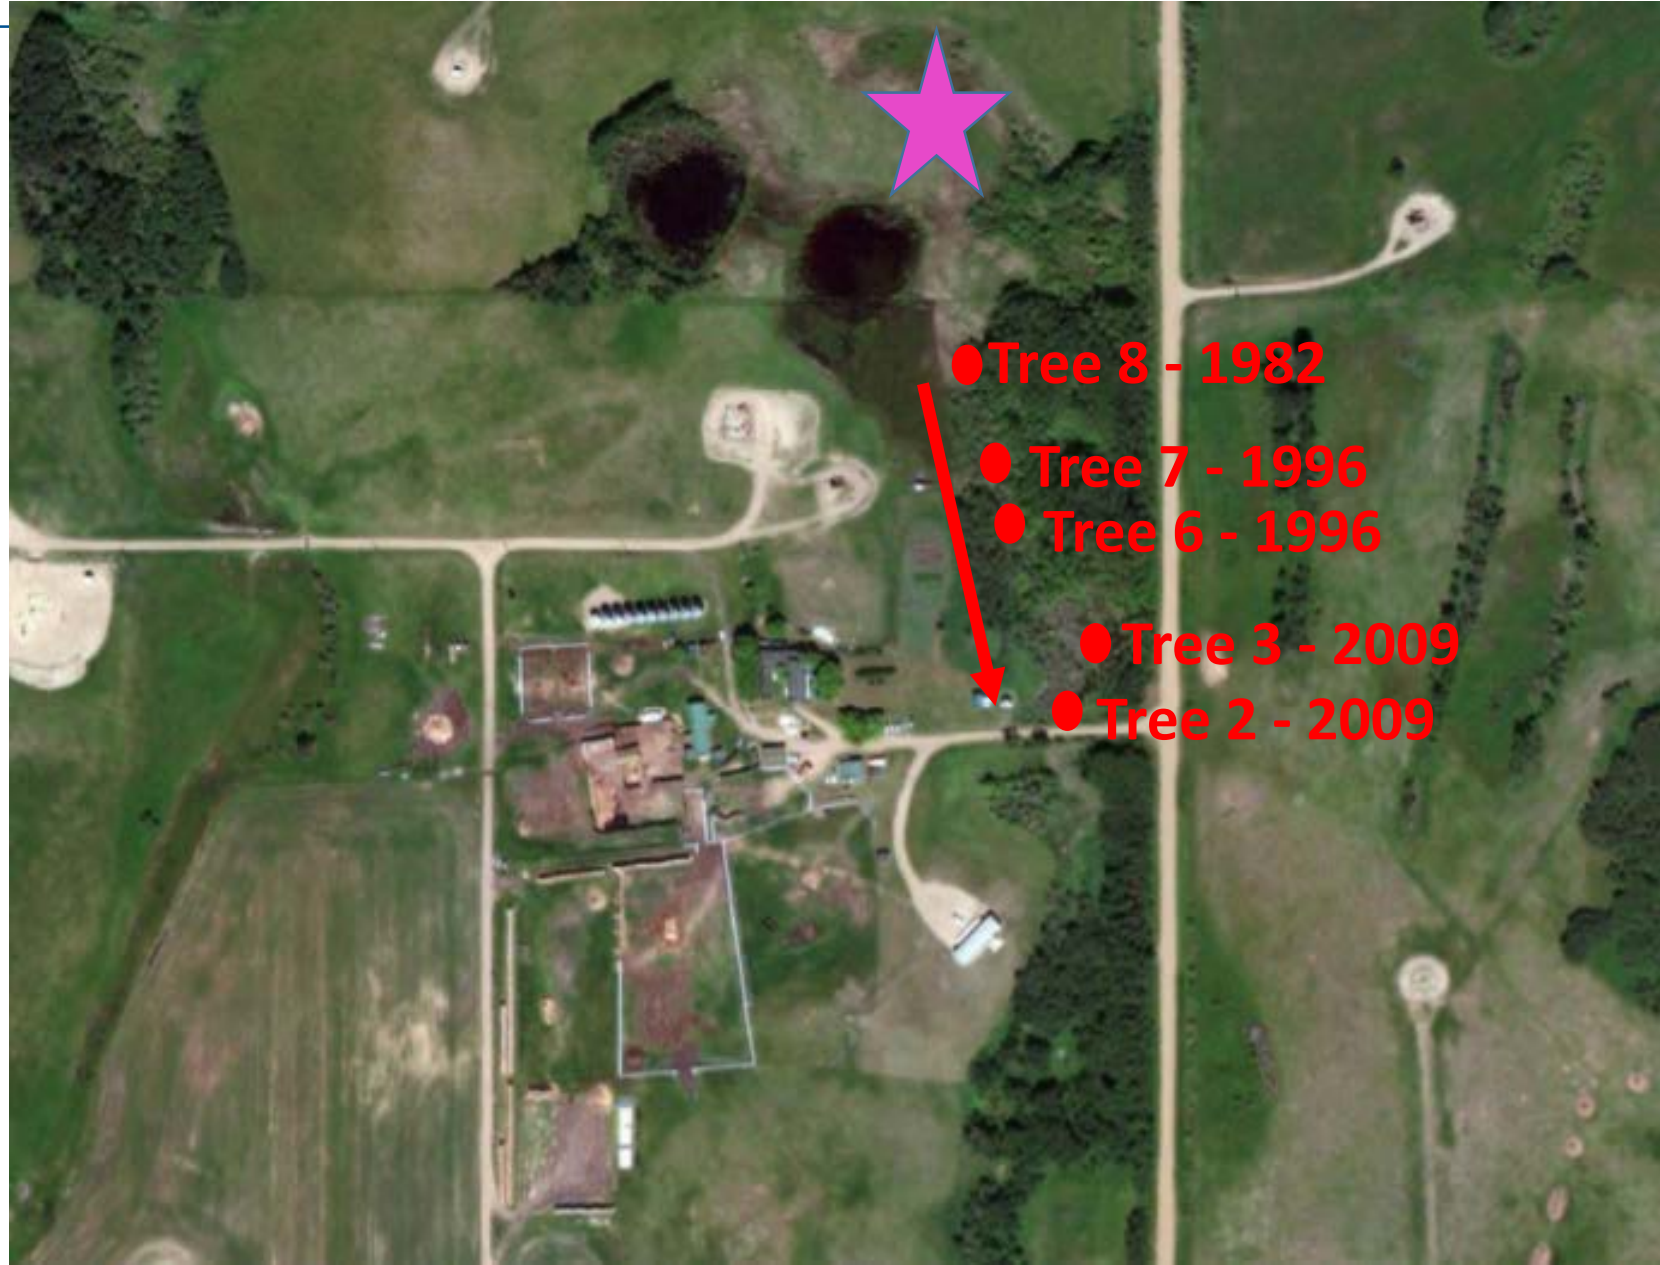
# Dendrochronology

● Tree 8 - 1982

● Tree 7 - 1996

● Tree 6 - 1996

● Tree 3 - 2009

● Tree 2 - 2009
