Remediation of Bromacil and Dicamba-Impacted Groundwater

Barry Rakewich, P.Ag., EP Hans Bakker, P.Geo. Nichols Environmental (Canada) Ltd.

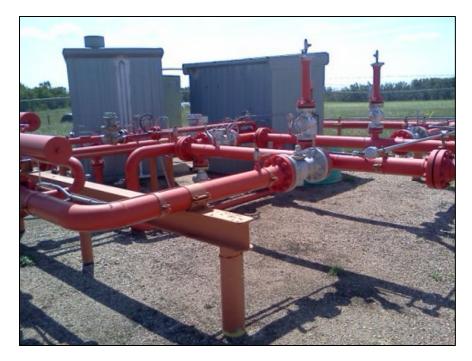
• APECs identified:

- Condensate Tank
- Compressor Building
- Waste Storage (East side of Site)
- Low areas across Site
- Metering Building
- COPCs identified:
 - Petroleum hydrocarbons
 - Herbicides and sterilants
 - Metals (especially Mercury)

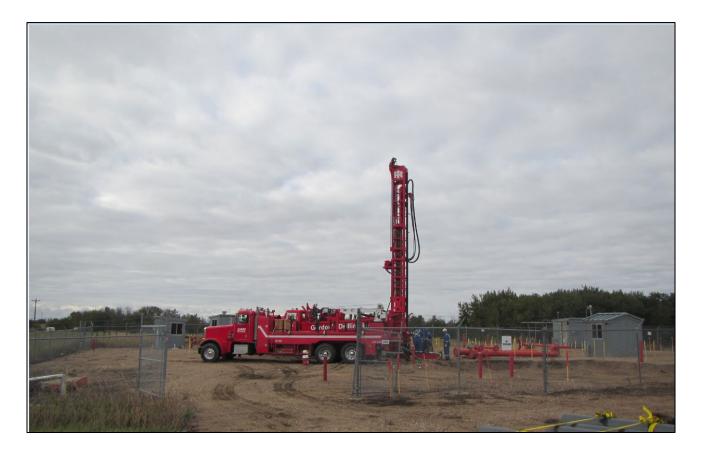
Recovery Well Installation and Pump Test (2016)

- Installed 254 mm diameter recovery well to 15 mbg
- Completed pump test following well development

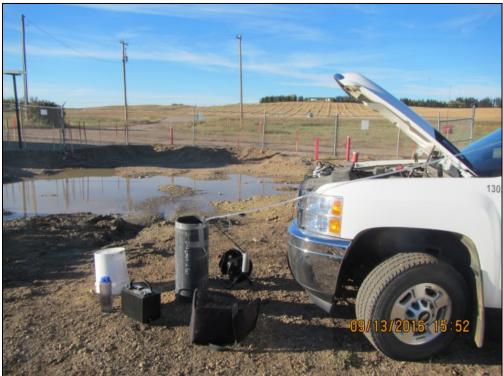
Pump Test Results (2016)

- System design driver...especially for pump selection and pumping rate.
- Results indicate there is lots of water and it flows into the well quickly.
- Not worried about over pumping the well, given treatment capacity of GAC system.

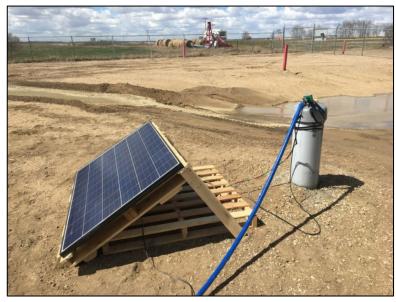
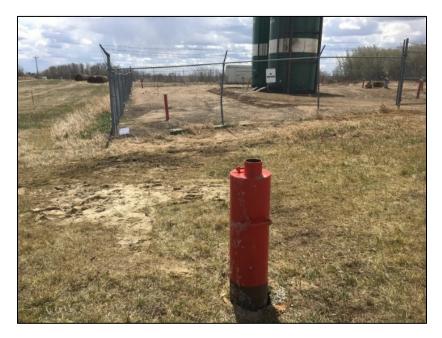
Treated groundwater re-injected on-site providing savings on transportation and disposal transportation cost.

Keeps water within the same hydrological system and creates preferred hydraulic gradient, moving the plume to recovery wells.

Solar-powered pumping system provides low cost, renewable energy source.
