Lessons Learned Toronto Port Lands Contaminated Land Remediation and River Construction

Overview of Lessons Learned on reducing uncertainty and/or reducing cost through:

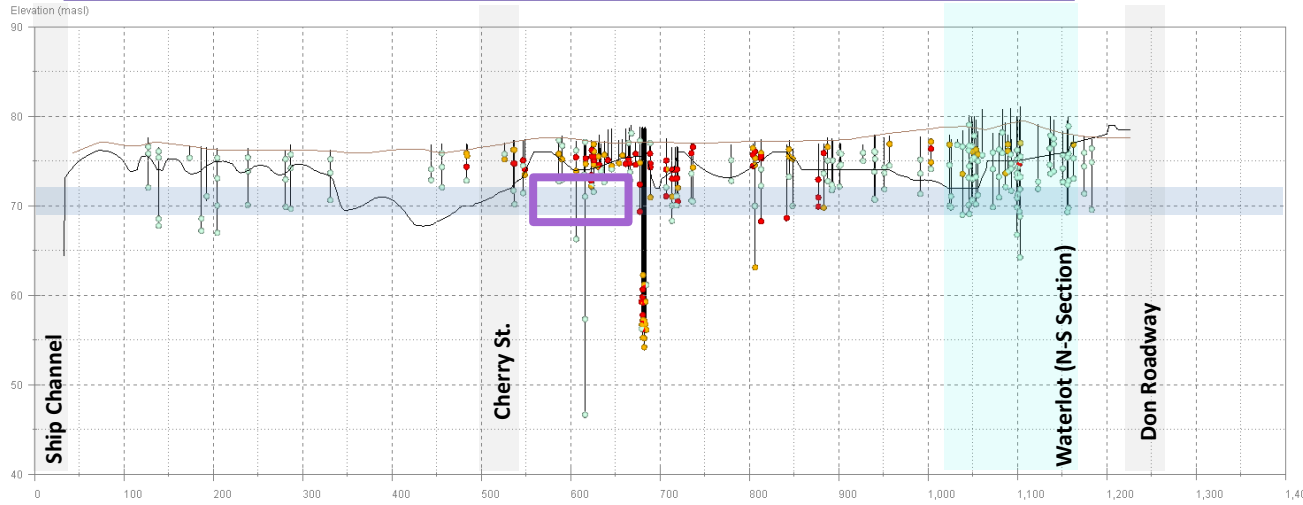
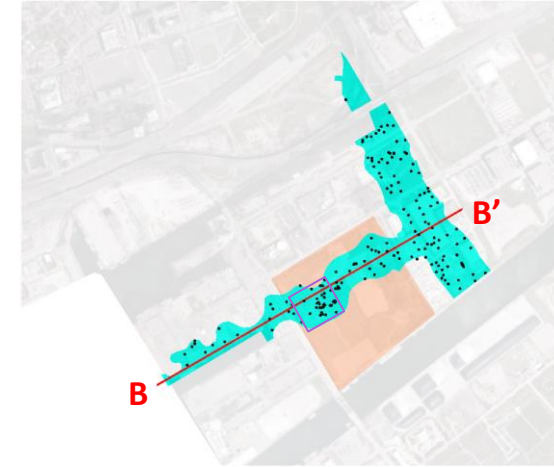
...There were Data Gaps in River Valley

Analytical Data Within Waterlot (and <120 m from Cross-Section Line B-B')

- The area with the most data gaps coincides with the area with the most costly barrier type (ie. with 17.8 kg of GAC/m²)
- Additional investigation proposed ten temporary monitoring wells with focused screen intervals
- Investigation cost \$100k

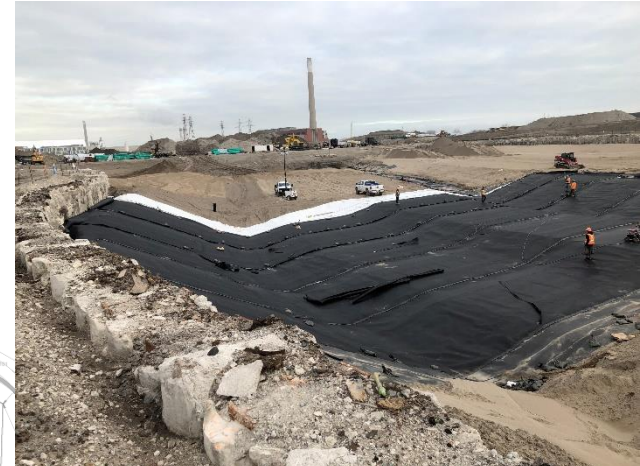
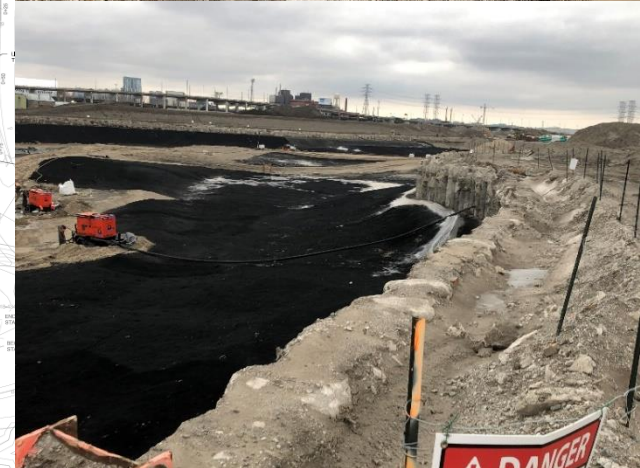
GCL/Barrier Optimization

- Between 60 and 90% Design
- Reduced GAC in cover layer
- \$300k savings

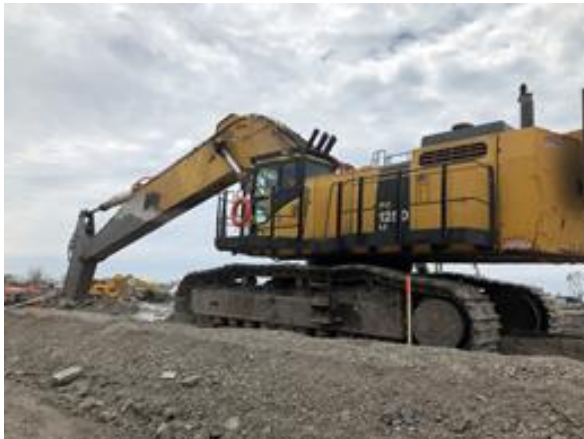
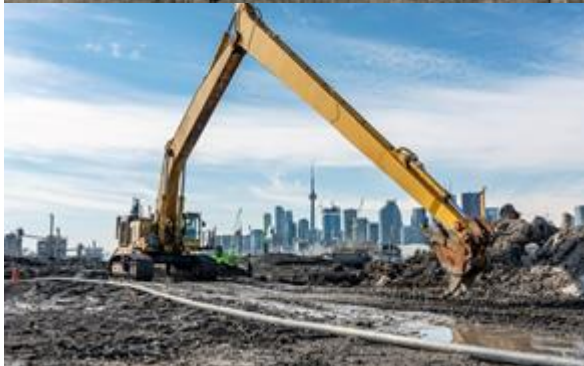
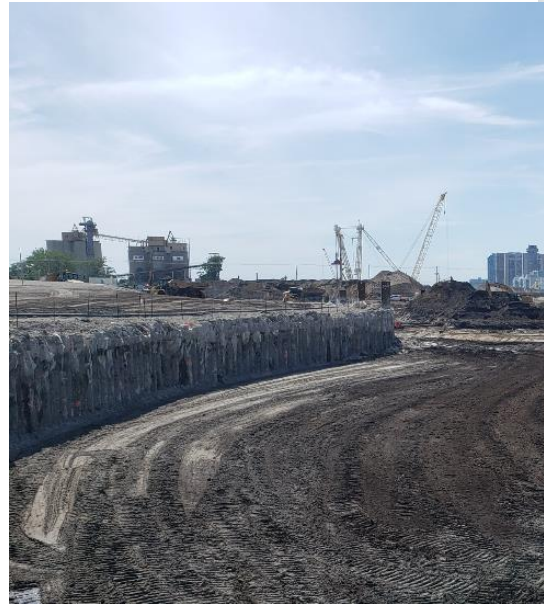
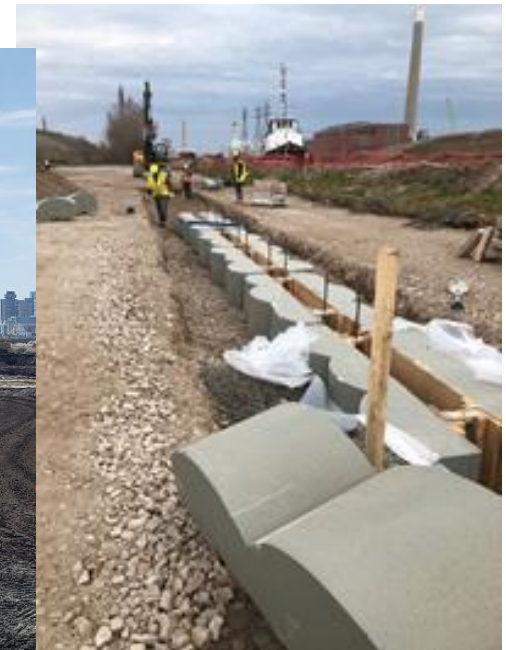
Balancing Barrier Costs

- Dewatering controlled by Cut-off Walls on either side of river
 - Bentonite slurry walls
 - Secant pile walls

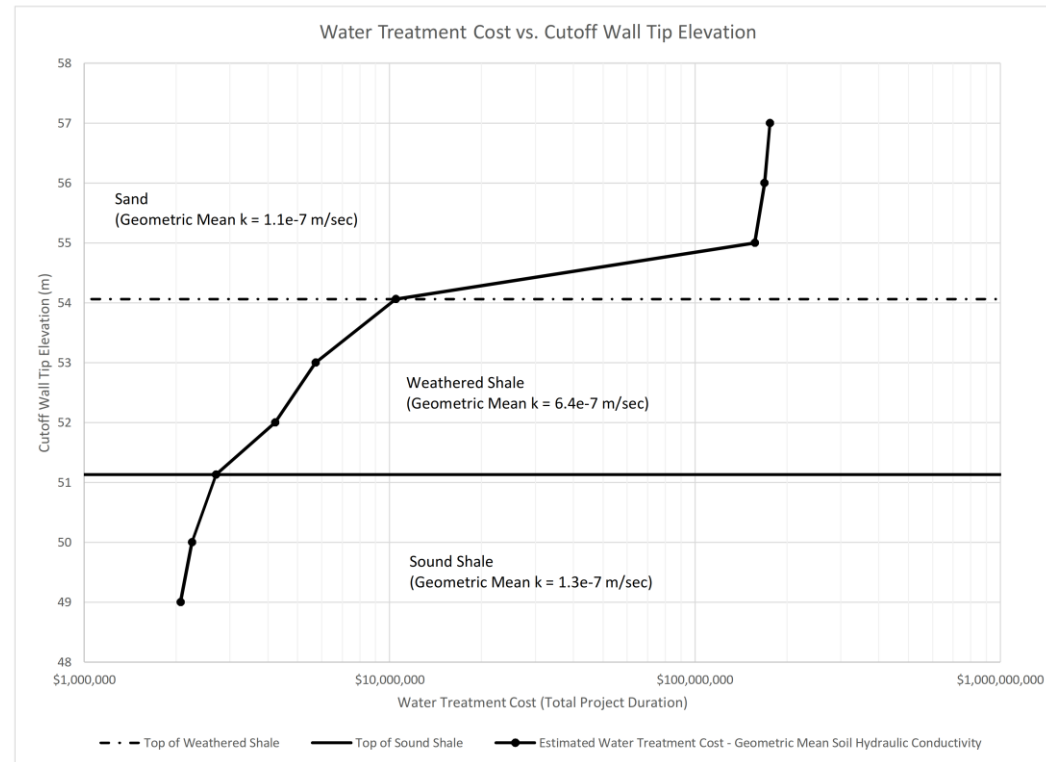
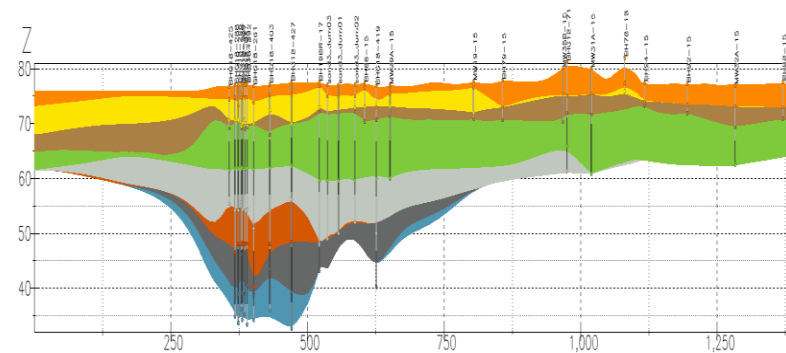
- Shale bedrock target cutoff unit; bedrock valley
- Using existing hydraulic parameters from groundwater modeling team, the dewatering cost of cut-off wall depths were assessed.
- Deeper the cutoff wall, the lower the dewatering cost
- Limited accuracy in data and sensitivity analysis showed high variability in cost estimates

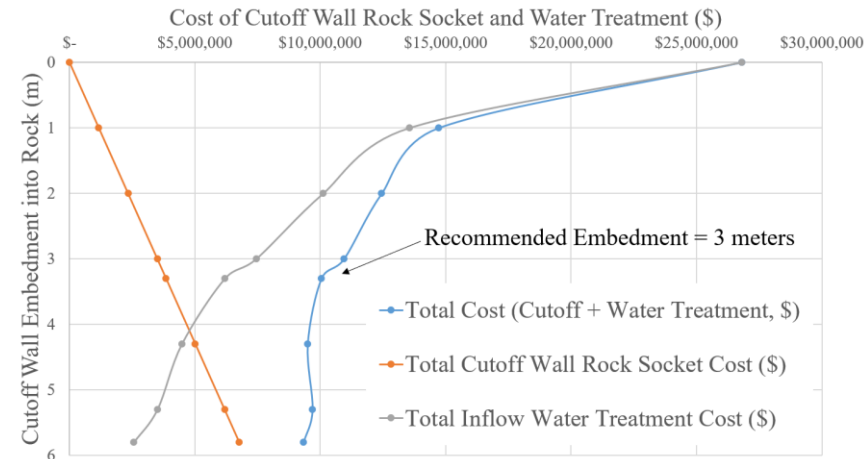
- Field Investigation (\$300k)
 - Packer testing
 - Borehole geophysics
- Balanced dewatering cost uncertainty against deeper wall cost
- Optimum cutoff wall embedment found to be 3 metres below top of rock
 - Limited benefits in GW flow reduction after deepening cutoff wall **beyond 3 m**

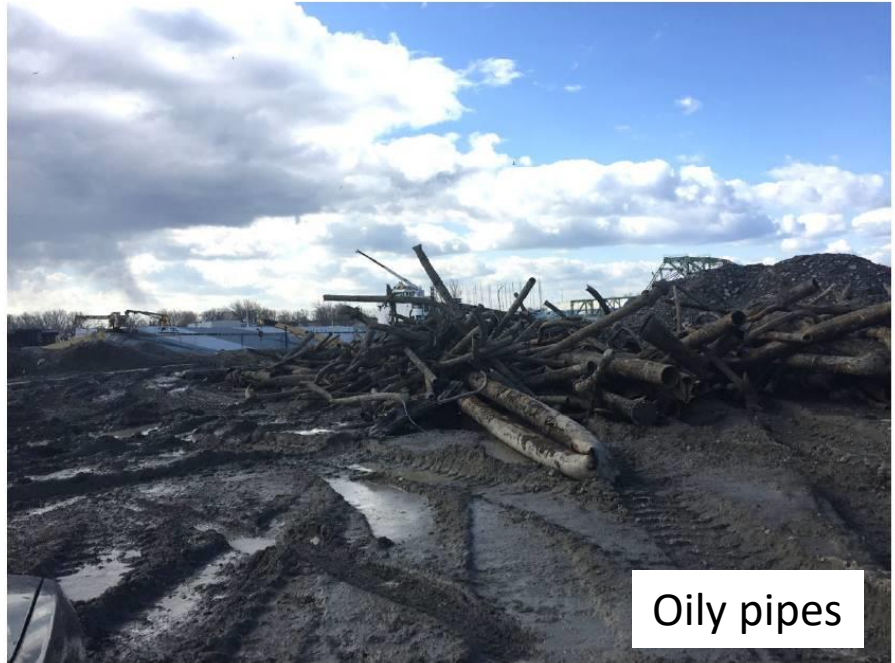
- Lessons Learned from other large soil remediation projects that each received over 100 odour complaints; community protests; stopped work and reset odour management
- For those lessons learned, a rigorous Odour Management Plan was established for the river project.
- But..... spring, 2019...

- Review of odour and VOC mitigation equipment and mitigation procedures.
- Analyzed existing data trends and recommend areas for improvement
 - Predicting odours
 - Mitigating odours at source
 - Odour complaint response protocols
 - Training on Odour Mitigation
 - Roles and Responsibilities (Odour Champion)
 - Greater feedback loop, response time and direction from the Air Quality Consultant to the Subcontractors.
- Resulted in team approach in mitigation; and greatly diminished subsequent odour complaints

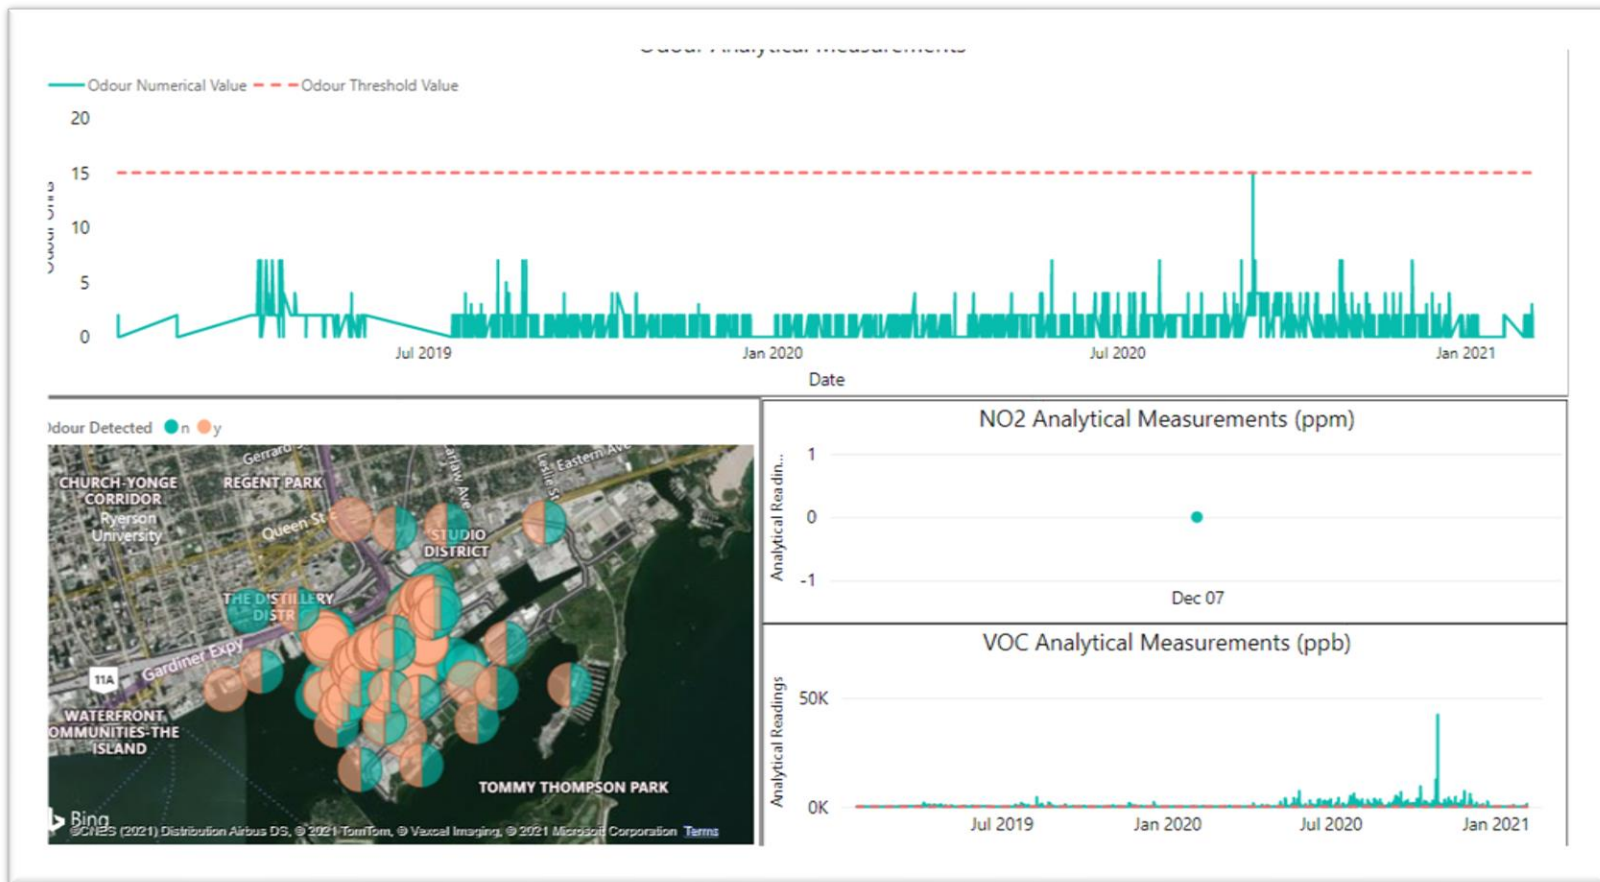
Odour Monitoring Dashboard

- Dashboard for odour, noise, turbidity, dust, VOCs, vibration and surface water chemistry
- Odour dashboard below

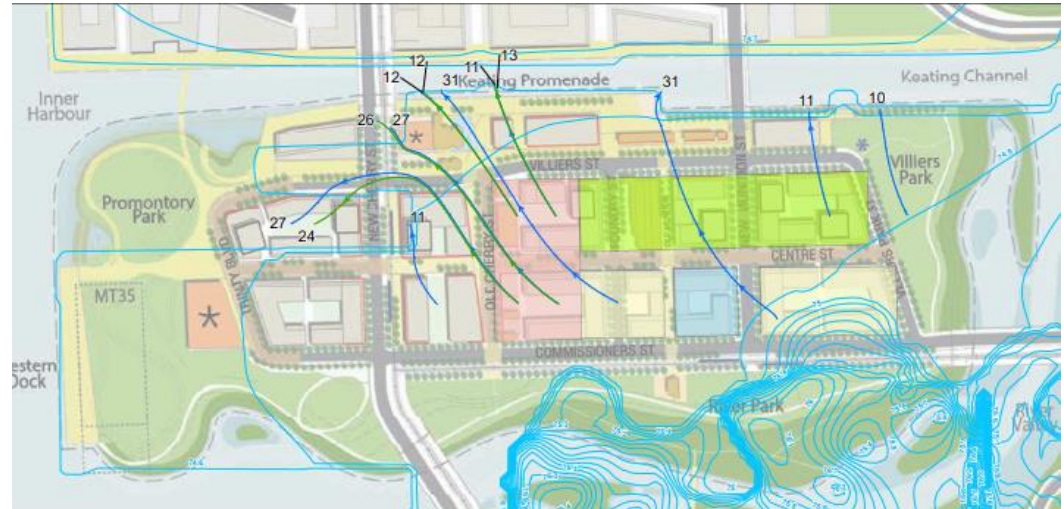
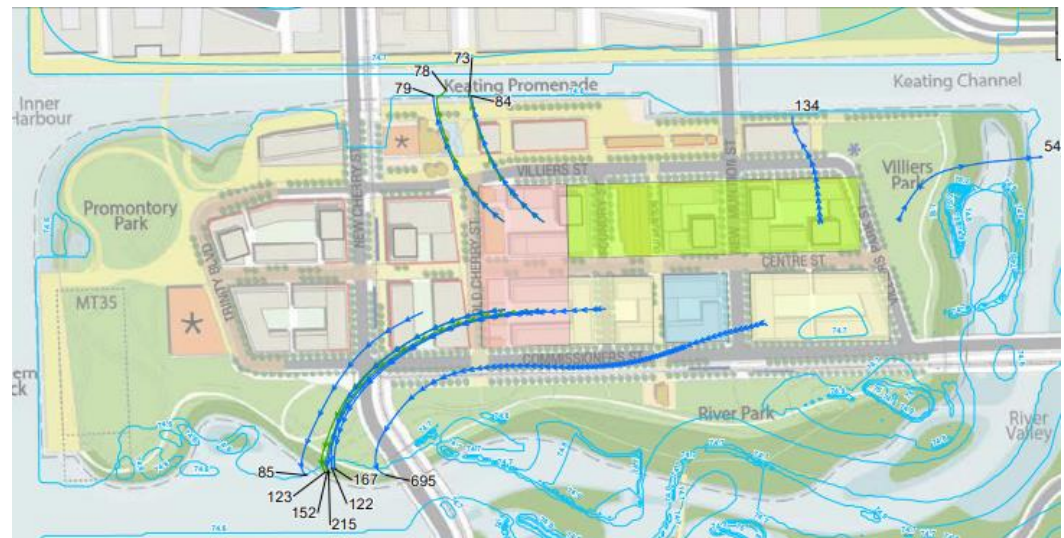
Before and after
boundary control using a
site wide groundwater
model to demonstrate
efficacy to regulators

- Demonstration of
containment of
groundwater and
lengthening the flow paths
- But....sensitivity to lake
levels?

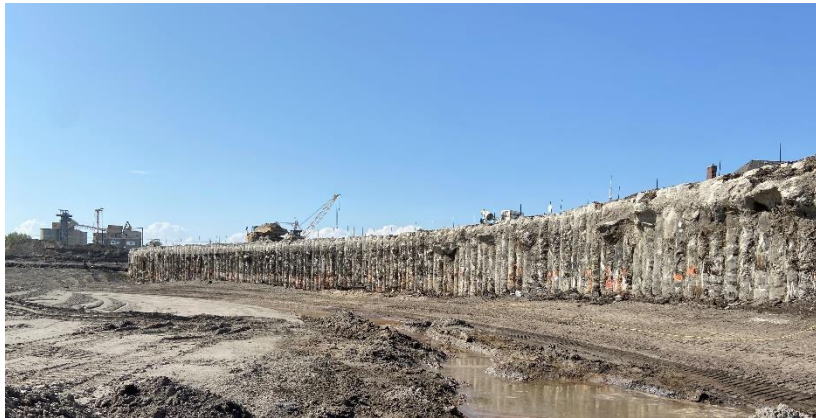
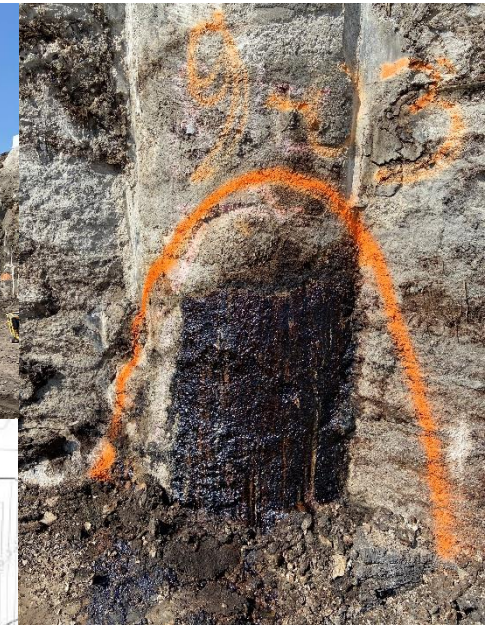
Cut off Wall – Post Construction Reengineering

- Each seepage was evaluated and modelled (seepage rates, solubility limits, elevation)

- Seeps are being sealed, but regardless:

- Majority of seeps will be below the horizontal barrier
- In one location, the design was modified to bring the horizontal barrier higher up the secant pile wall

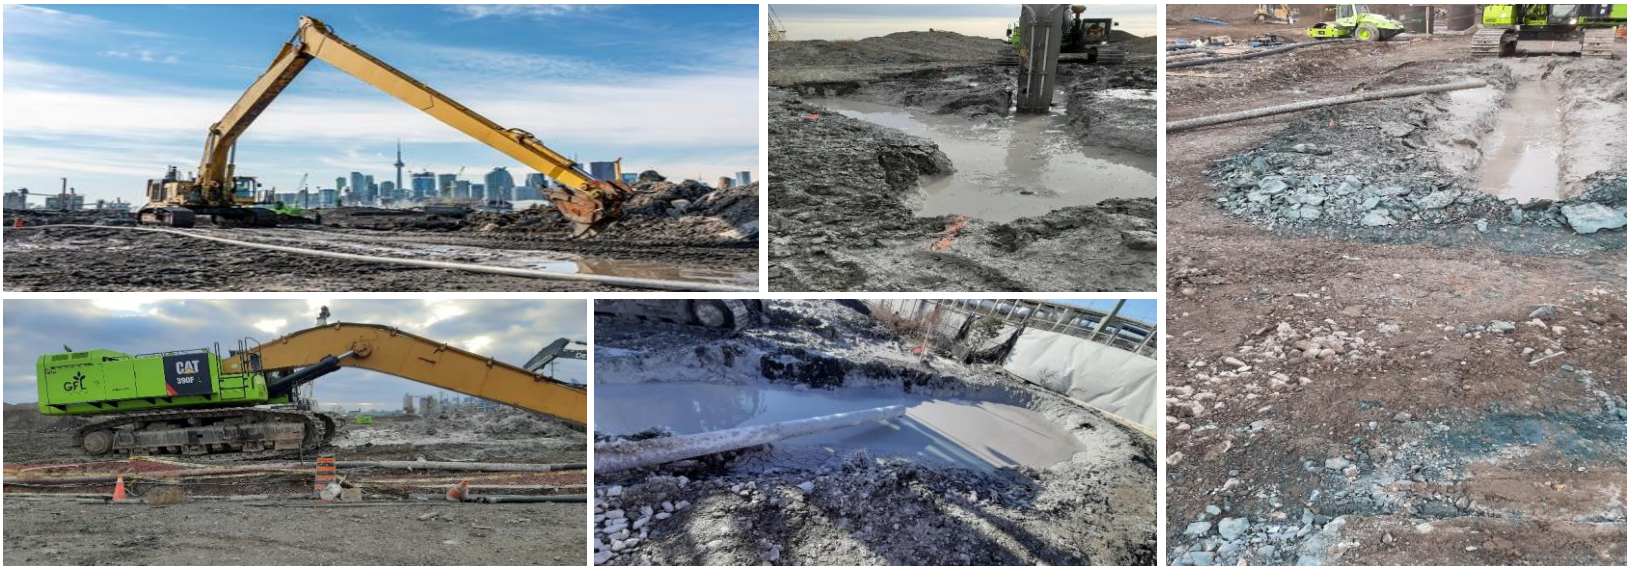
- Cutoff wall constructed with overlapping secant piles and slurry walls
- Secant Pile productivity – 1 linear metre per day
- Slurry Wall productivity – 15 linear metre per day

- Replaced 192 m of planned secant pile wall with slurry wall in areas where excavation setback was possible (slurry walls are inset upland from the river whereas in areas with cutoff walls, excavation occurs up to the cutoff wall)
- Still able to maintain embedment into rock
- \$1.35M cost savings
