LNAPL Modelling and Site Closure

Otter Creek Tank Farm Areas 1 & 2, Goose Bay, NL

October, 2021

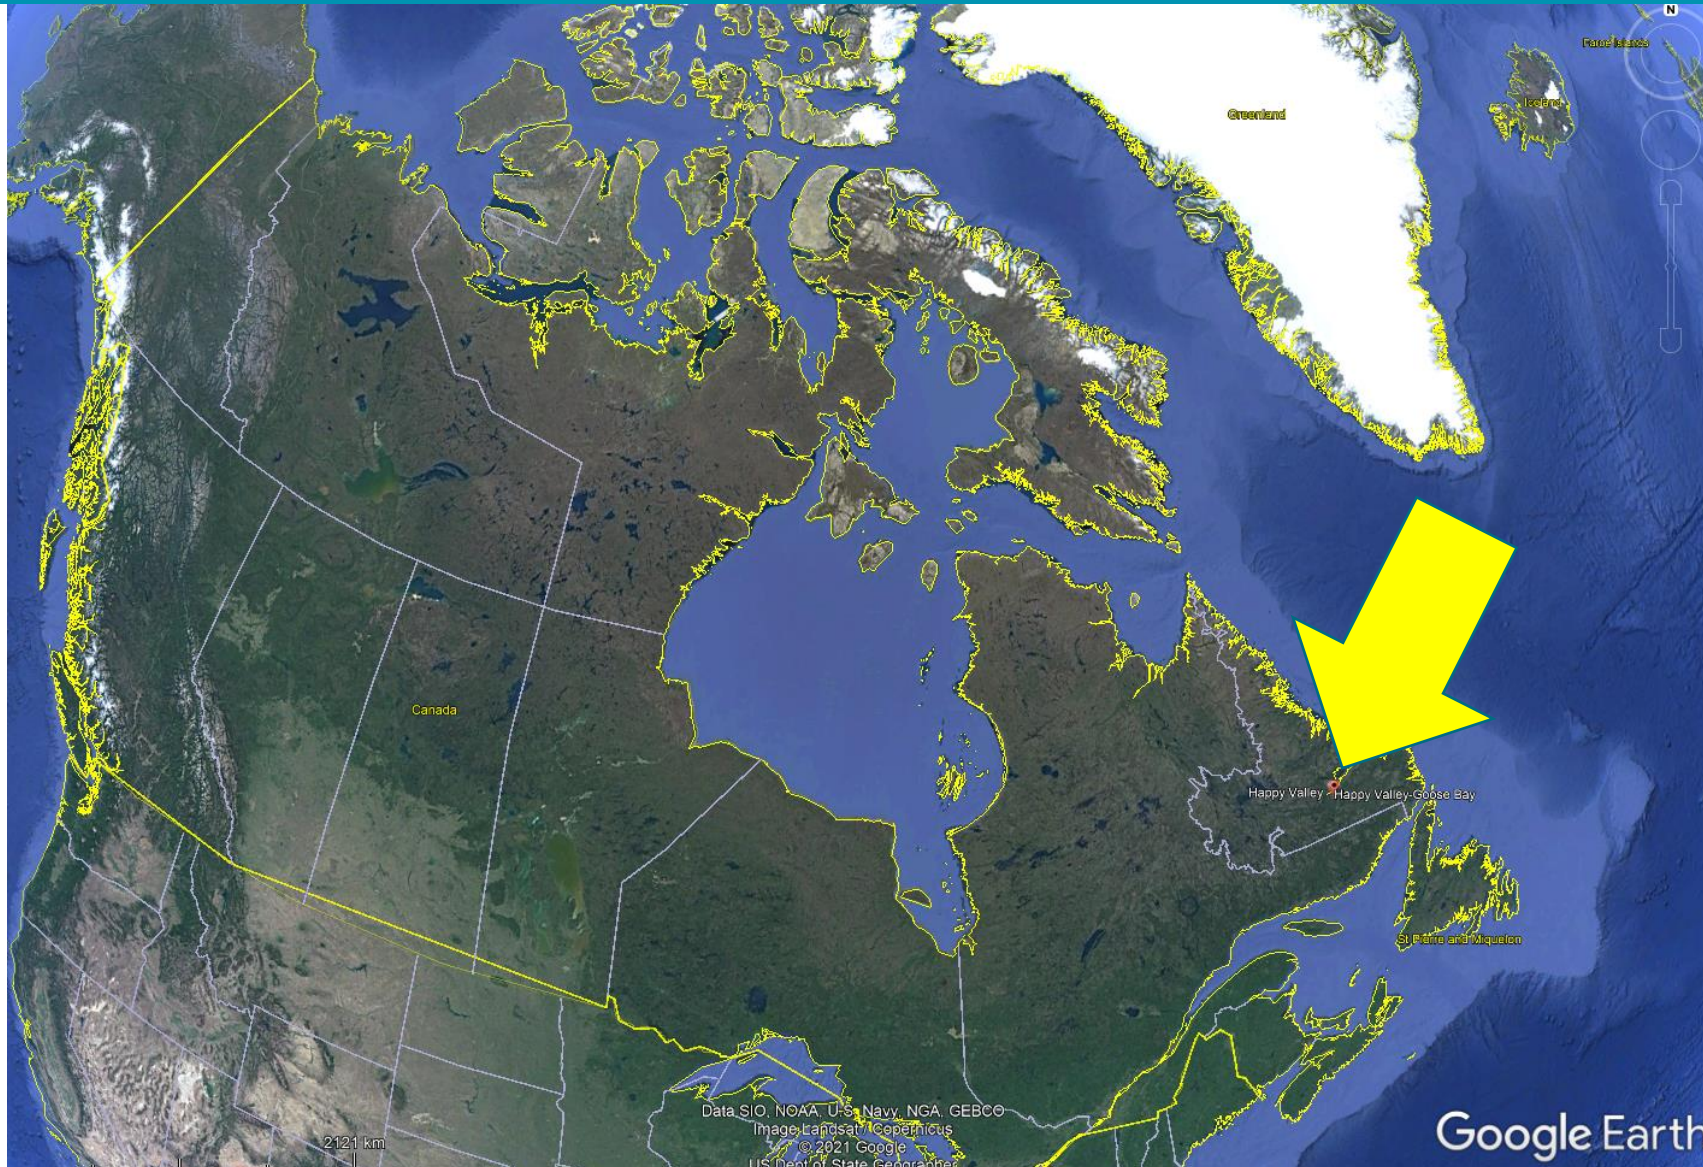
The diagram illustrates the subsurface remediation of a site with three former storage tanks (Former Tank 8, 9, and 10). A central LNAPL (Light Non-Aqueous Phase Liquid) plume is shown in the sand layer. Remediation is achieved through several processes: vapourization of CO₂ and CH₄ from a well, dissolution of LNAPL into groundwater, and biodegradation (methanogenesis) in the gravel layer. A 'Dissolved Plume' is shown in the gravel layer. A 'Background Well' is also indicated. The water table is shown as a horizontal line with a downward arrow. The diagram is divided into layers: Sand, Gravel, and a deeper layer. A semi-transparent blue box contains the title 'LNAPL Modelling and Site Closure'.

Background Well

Biodegradation
(methanogenesis)

Dissolution and
biodegradation
(methanogenesis)

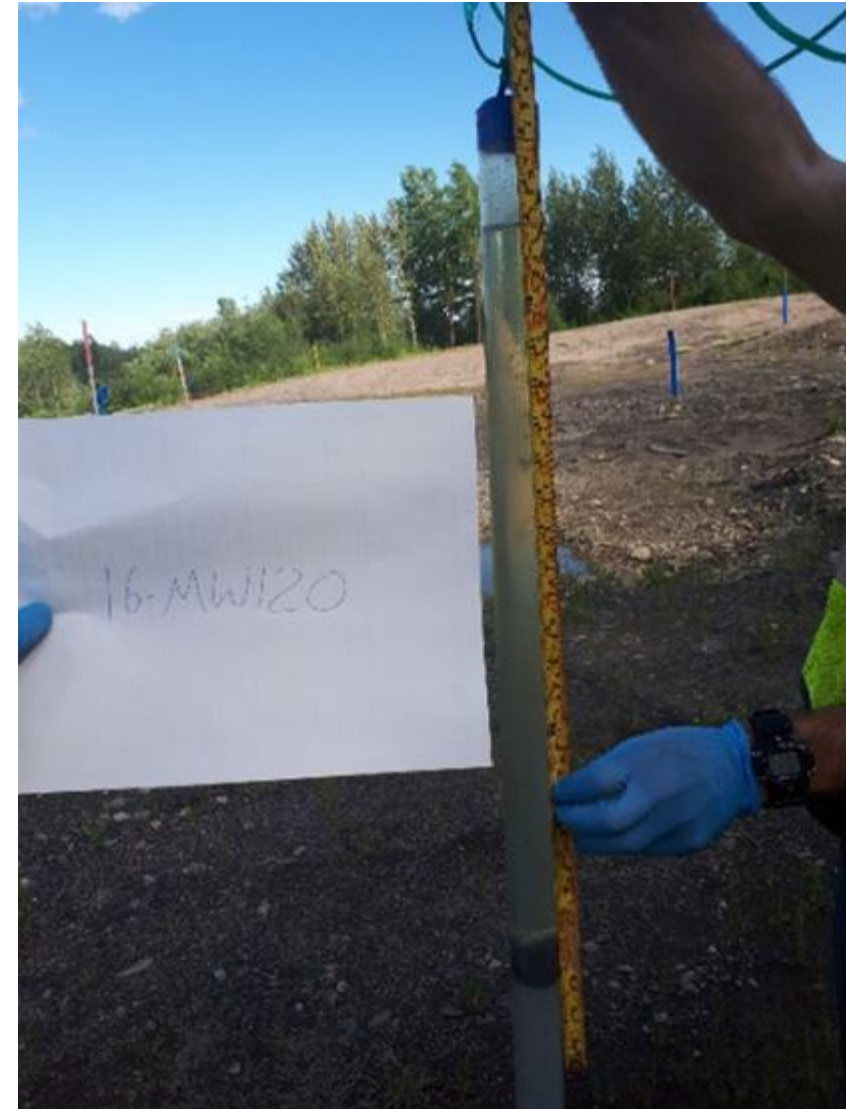
LNAPL Characterization

Sample ID	Date	Relative Density @ 15°C	API Gravity @ 15°C	Viscosity (cPs) @ 7°C
16-MW168	07/24/2018	0.8033	44.7	1.905
16-MW120	07/24/2018	0.8044	44.4	1.968
16-MW205	07/24/2018	0.8300	39.0	3.500
16-MW217	07/24/2018	0.8096	43.3	2.247

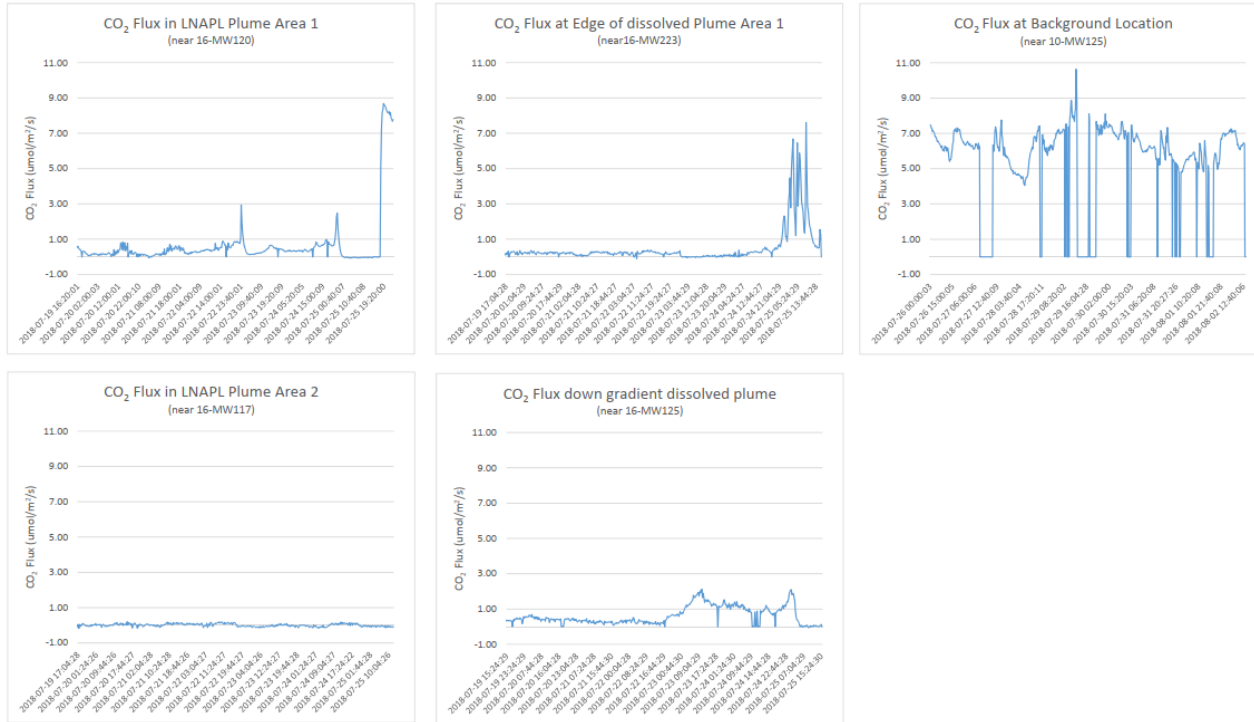
Figure F-1 - Natural Source Zone Depletion: Carbon Dioxide (CO₂) Flux

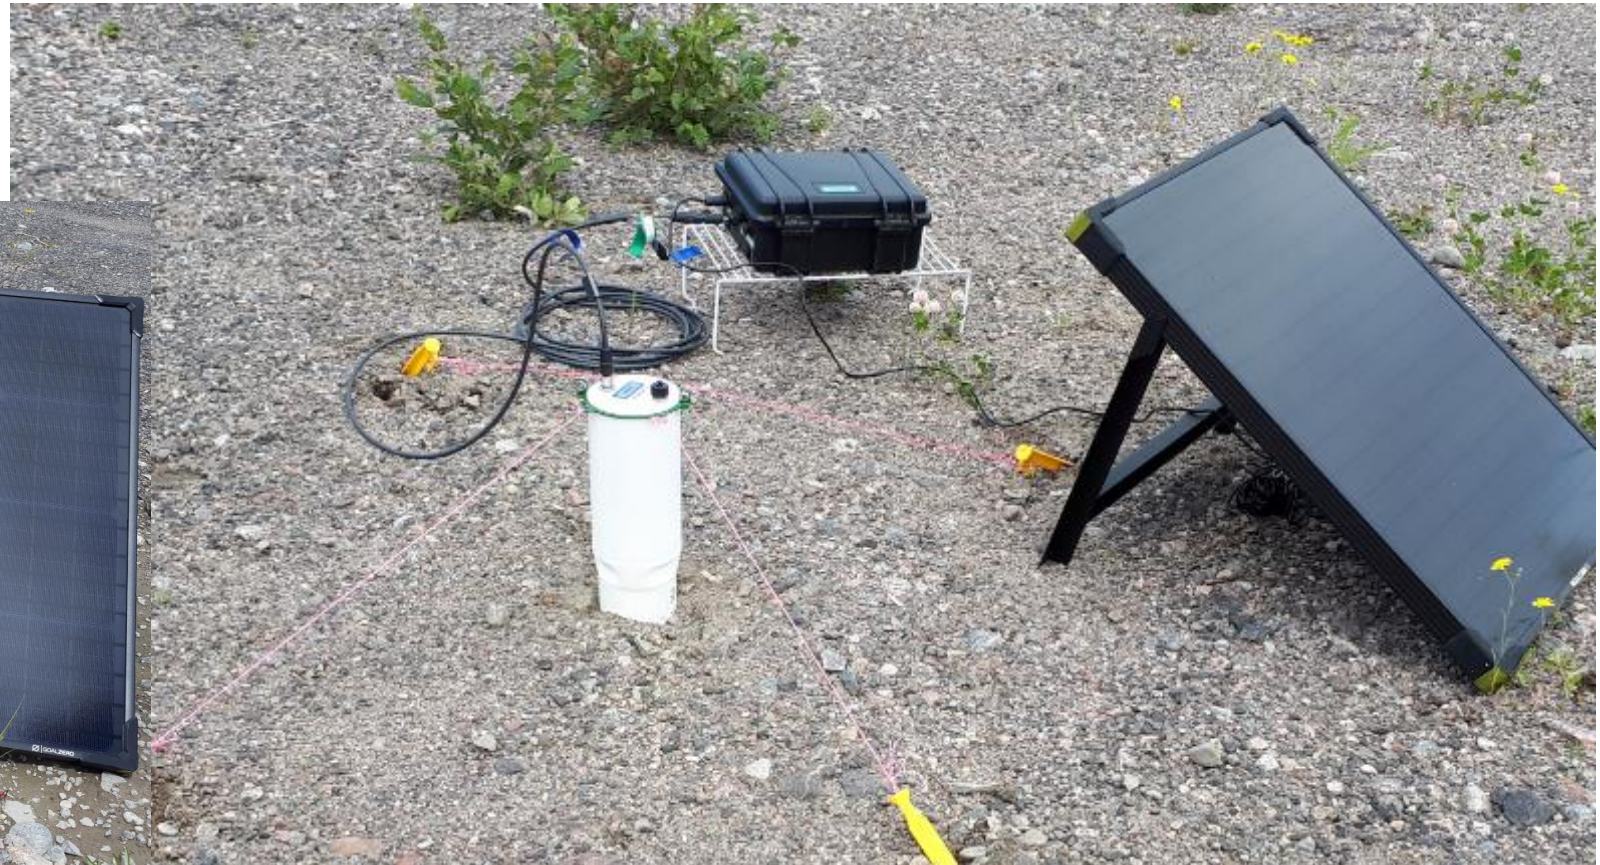
NSZD – is the LNAPL going anywhere or is anything eating it?

EOSense CO2 and methane flux

- Deployed in July of 2018
