Pathway to Closure for a Heavy Oil Release into the North Saskatchewan River

Matrix Solutions Inc.
ENVIRONMENT & ENGINEERING

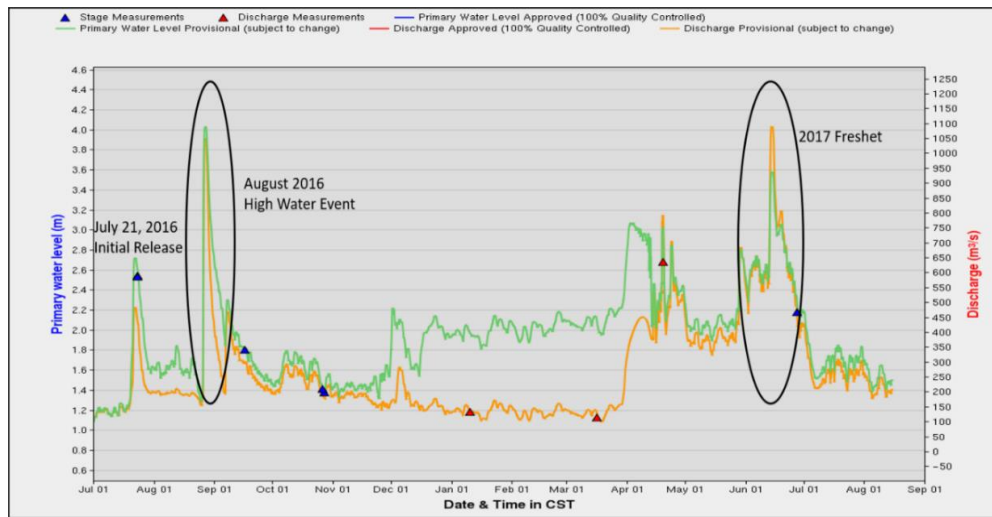
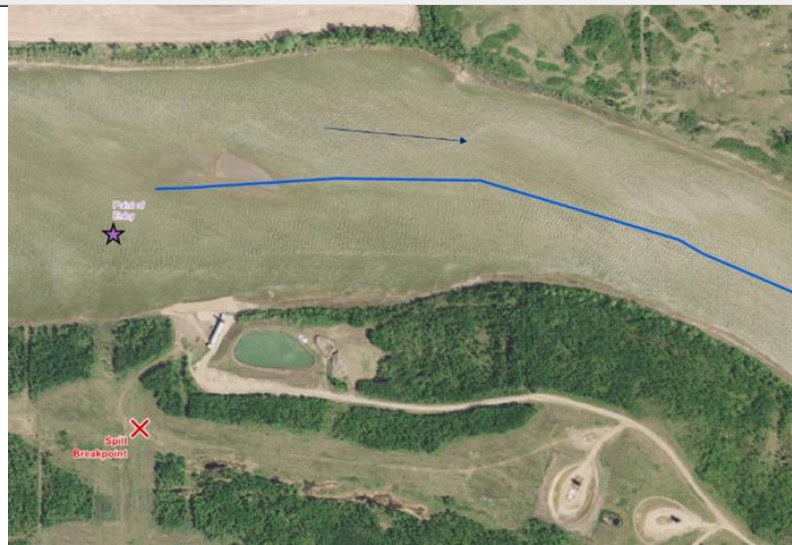
July 21, 2016: Oil leak near the North Saskatchewan River

225 m³ (+/- 10%) crude oil blended with condensate

Break occurred on land, 160 m from the south bank

~60% of the product contained on land

Discharge at time of release – 300 m³/s to 650 m³/s

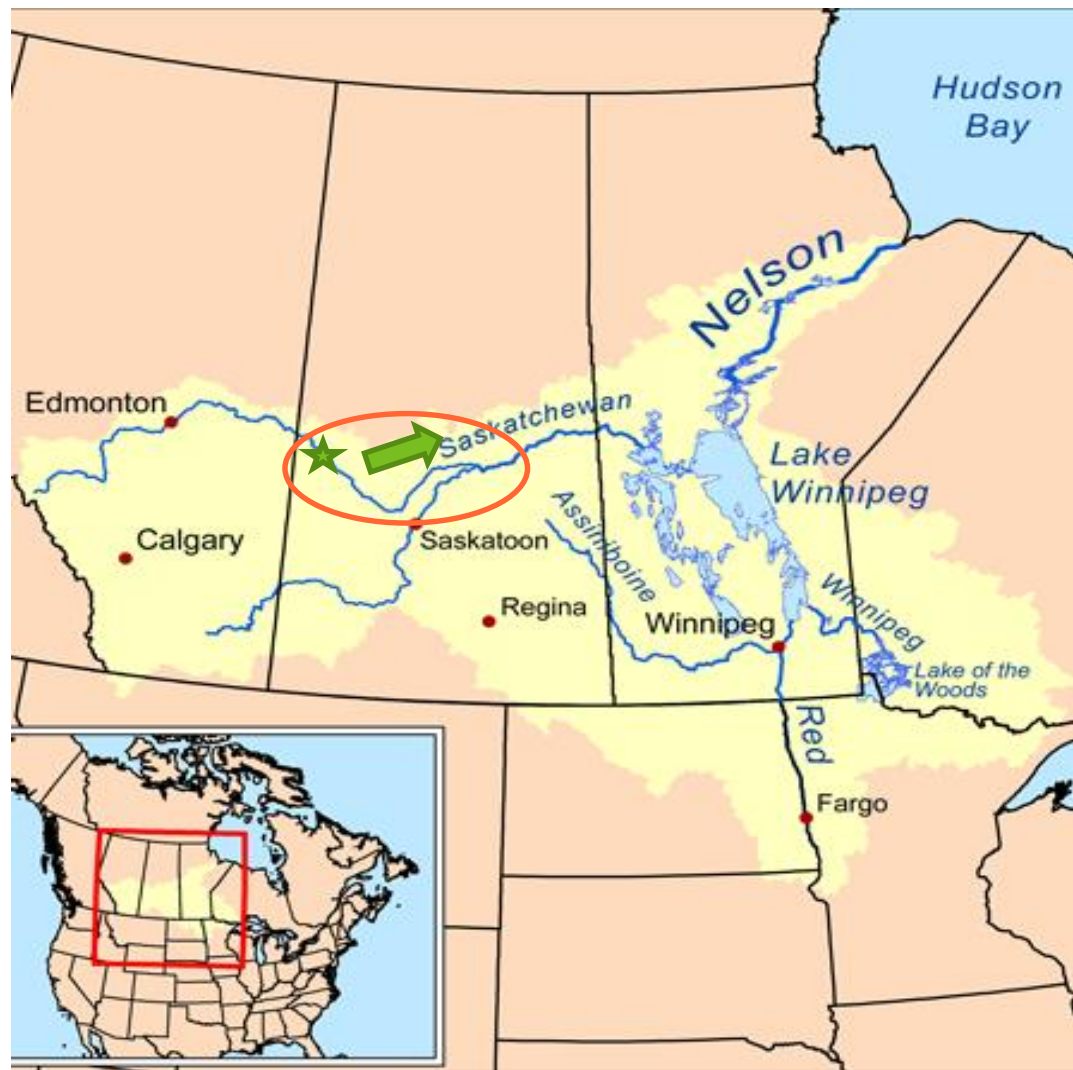
North Saskatchewan River - Drainage Area:

- Nelson River Basin: over 1 million km² (10% of Canada)
- North Saskatchewan River: 140,000 km²

~600 km downstream of the point of entry (across most of Saskatchewan)

North Battleford, Prince Albert and Melfort – Major municipal water consumers

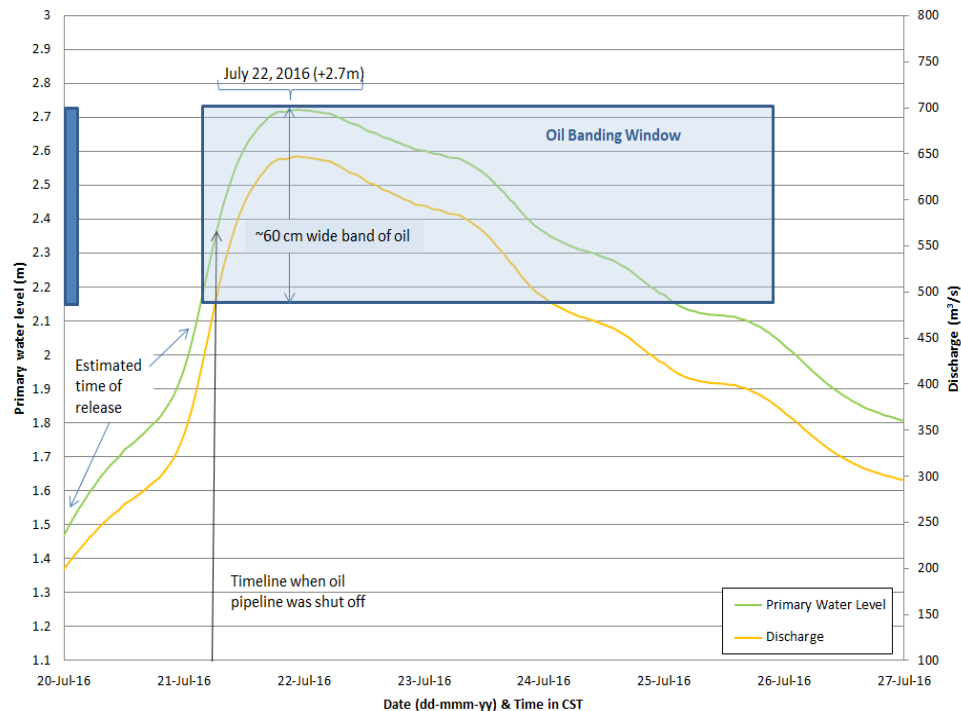
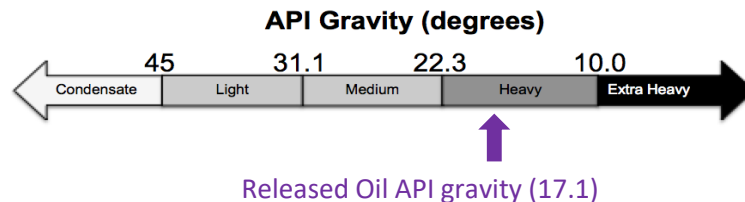
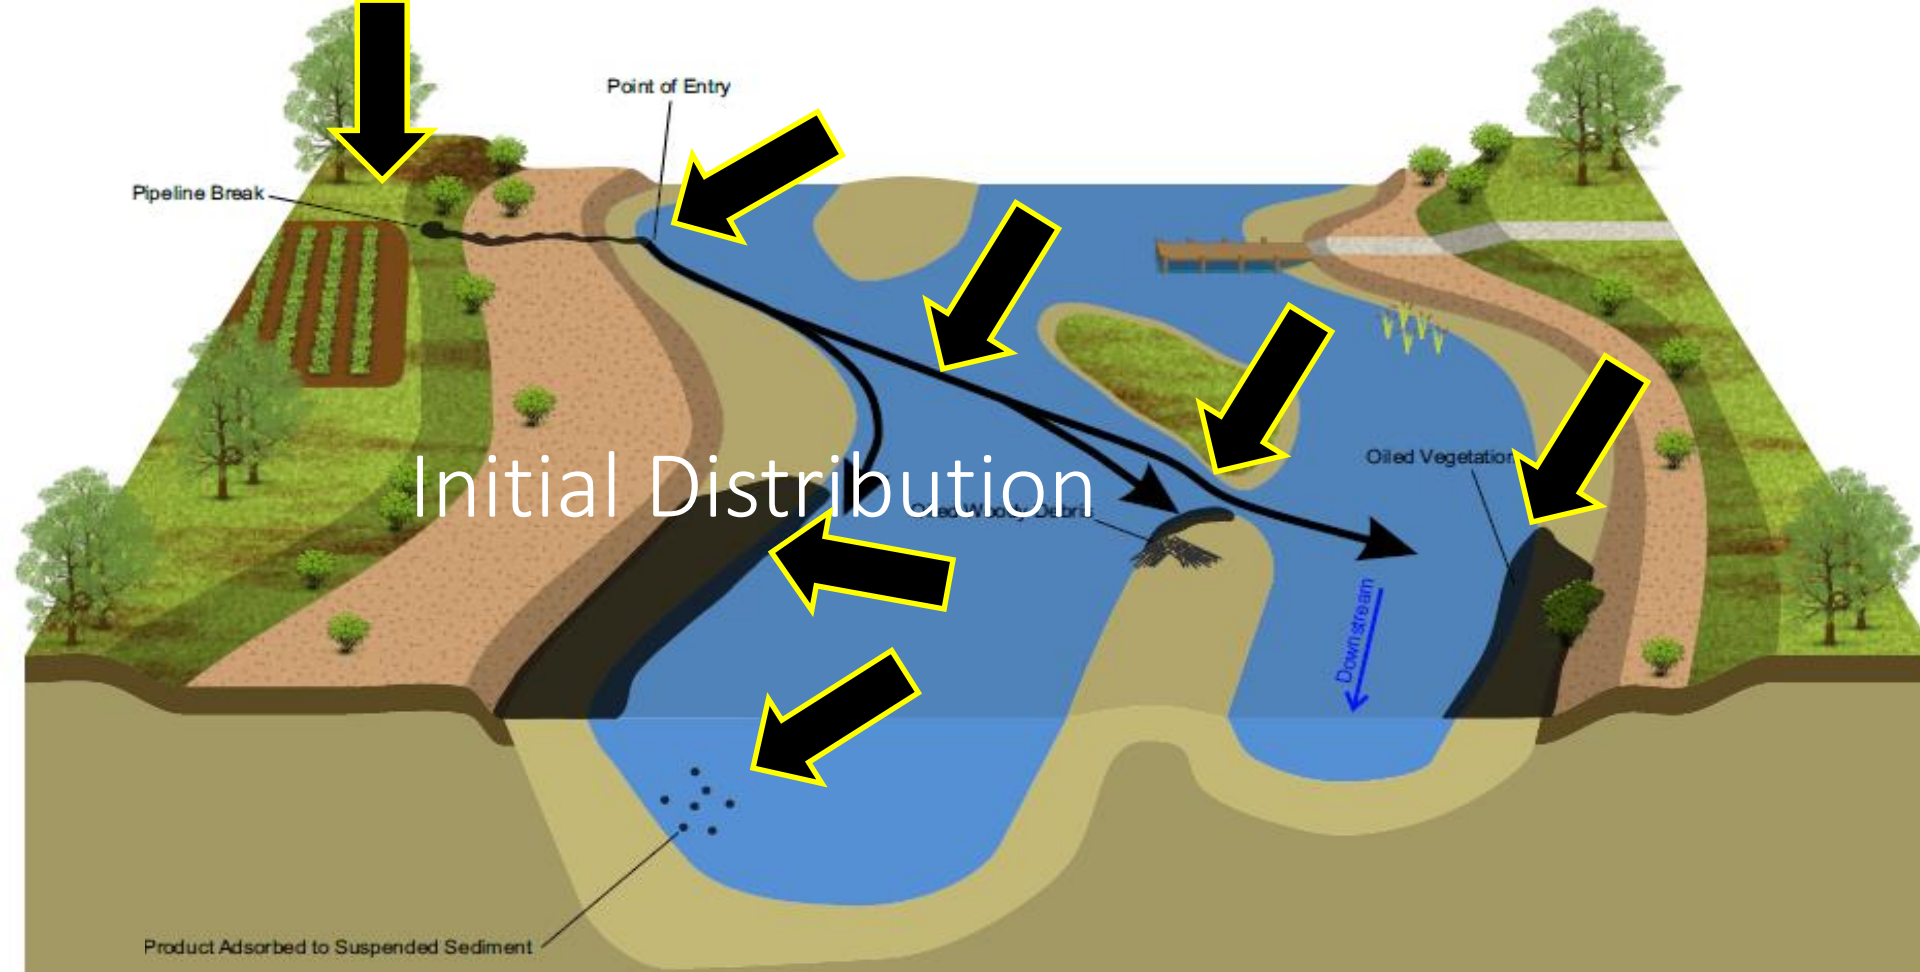
- Oil less dense than water at temperatures over 5°C
- Intermittent band of oil for 43 km along shoreline (cleaned in July/August 2016)
- High water event in late August 2016 redistributed residual oil
 - Found along shoreline for 100 km
 - Oiled woody debris found up to 480 km downstream

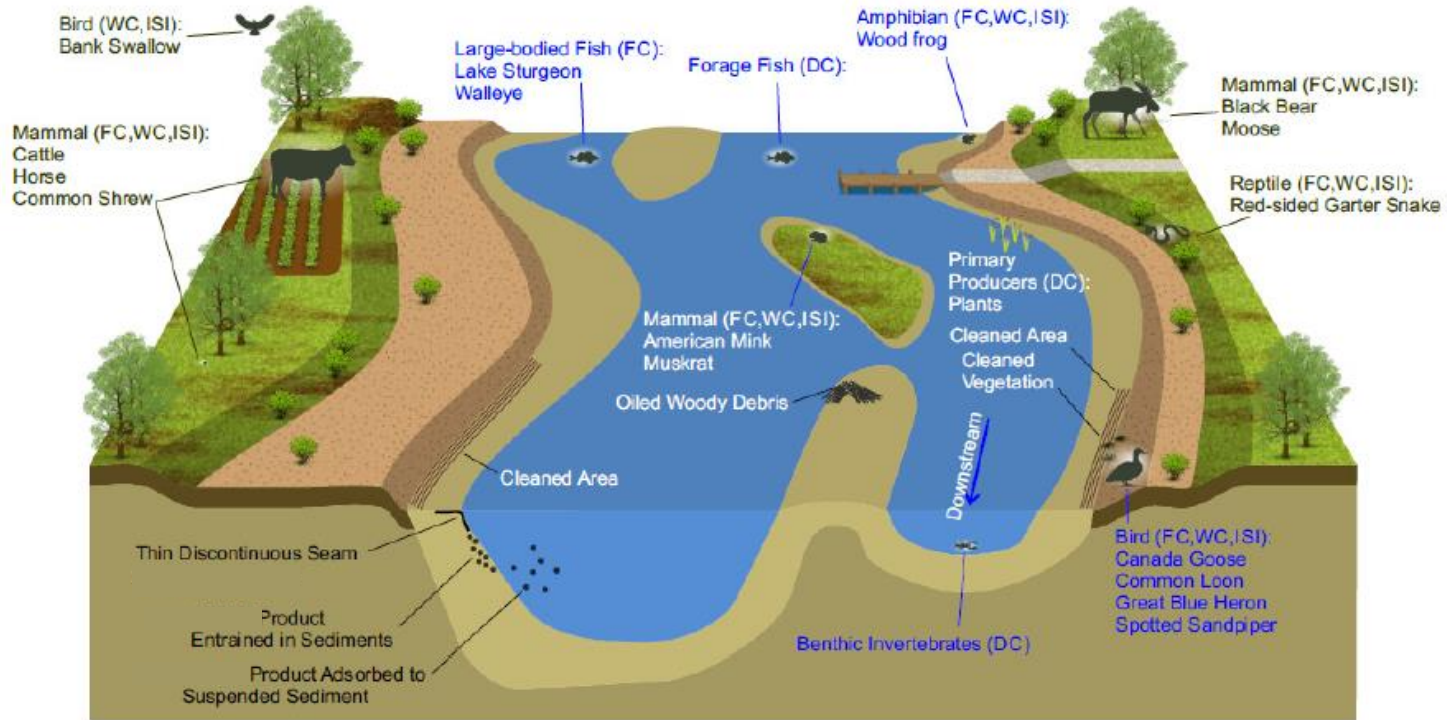
Exposure risk found in very localized areas associated with the No Further Treatment sites for some ecological receptors.

Pathways: DC- Direct Contact (sediment and/or pore water), FC- Food Consumption (for piscivorous and benthivorous species only), WC- Water Consumption (pore water), ISI- Incidental Sediment Ingestion

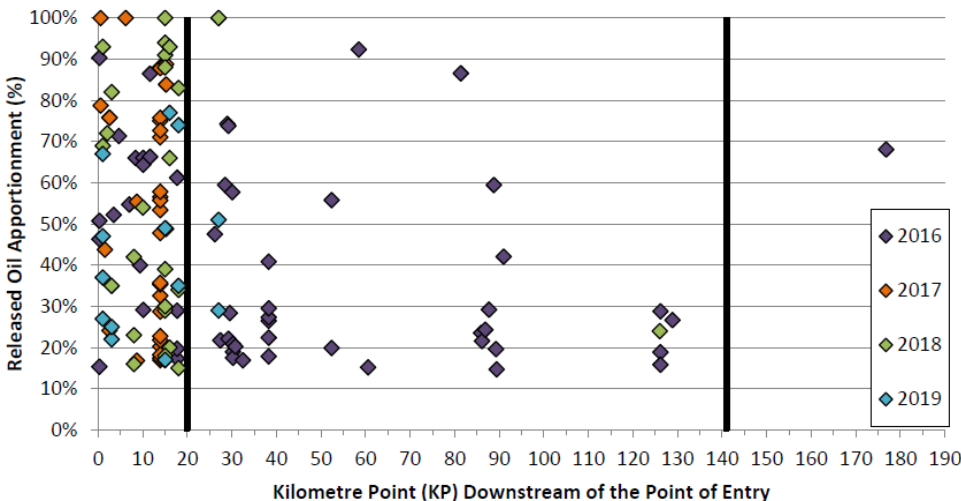
Objective 2 Residual Distribution

- Residual product in sediment
 - Core Area (20 km from spill)
 - Rainbow/silver sheen on the sediment surface when disturbed
 - Small organic debris balls/patties
 - As a thin (<2 cm) discontinuous lens in upper 15 cm sediment layer
 - Downstream of Core Area (20 km from spill):
 - small, discontinuous oil staining on woody debris.
- No residual product in surface water after 2017
