# Remediating Bedrock: What Once Was Impossible Is Now Possible. Three Case Studies

October 14, 2021 RemTech Bruce Tunnicliffe, M.A.Sc., P.Eng.

# Bedrock Case Study #1

# Bedrock Case Study #2

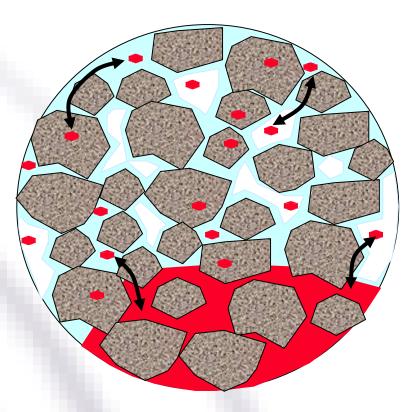
Porous Media Porosity = 30%

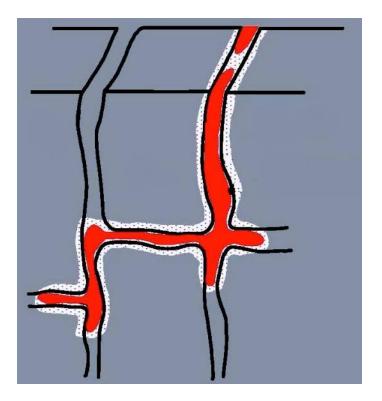
Fractured Rock Porosity = 1 to 10%

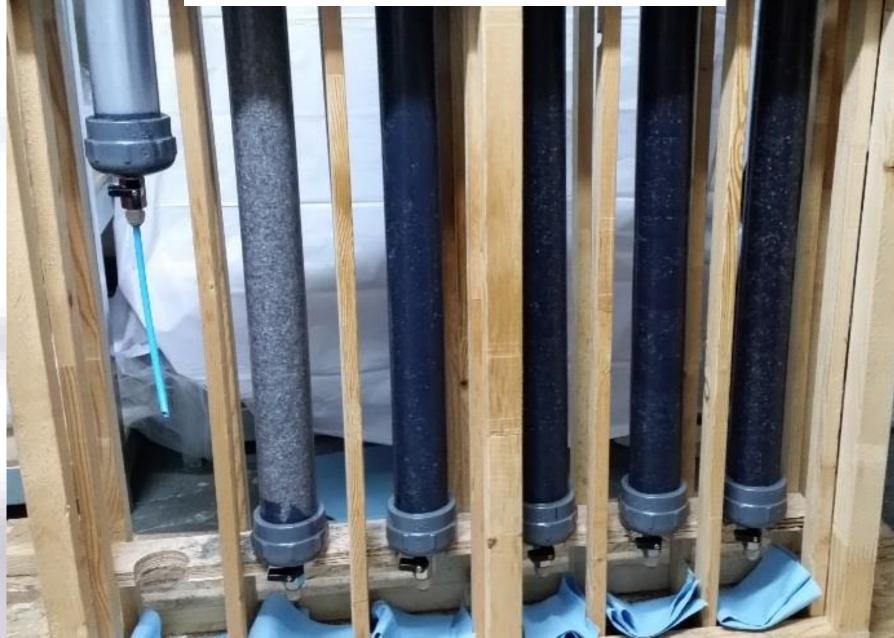
Zero Valent Iron (ZVI) Column Study Treatment of Heavy Metals

**Zinc Concentrations vs Contact Time**

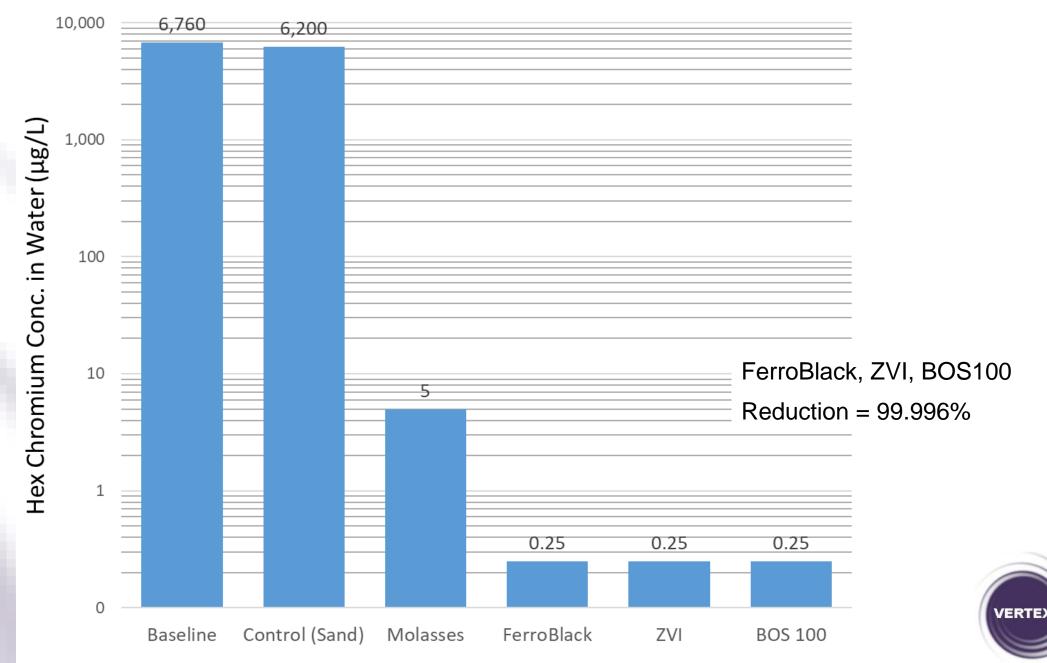
#### Bench-Scale - Plume Groundwater

- 1 L Containers
- Silica Sand and Remedial Amendment
- Groundwater Added
- Placed in Dark, let sit one week, sampled

- Groundwater treatment is possible (in the field)
  - At Bench >99.9%
  - At Pilot-Scale 91% (Source) to 99.4% (Plume)
- Zero Valent Iron is a feasible solution
- Full-scale about to be implemented
