**The importance of a
good 3D Conceptual Site
Model in remediation of a
chlorinated VOC
impacted groundwater
site in eastern Ontario**

Jonathan Coakley, Ph.D

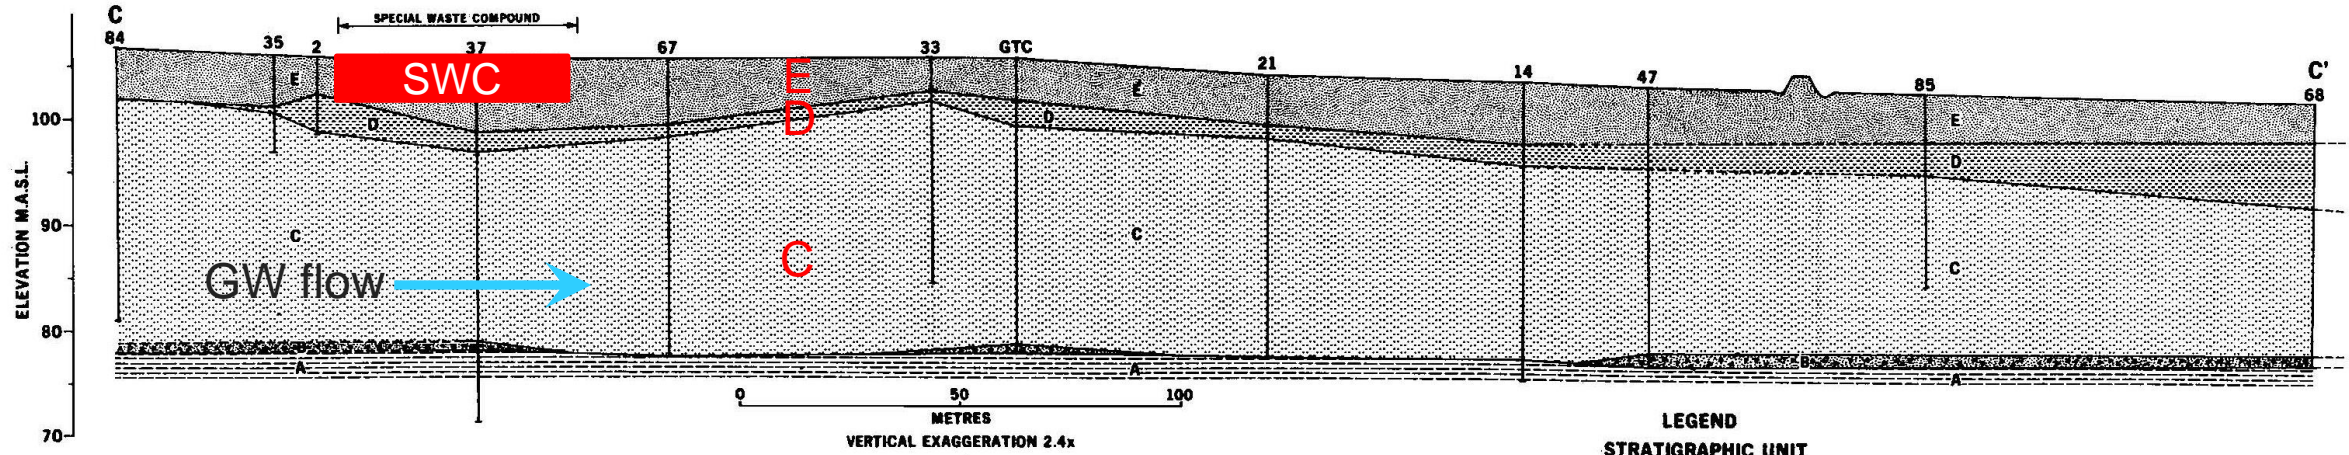
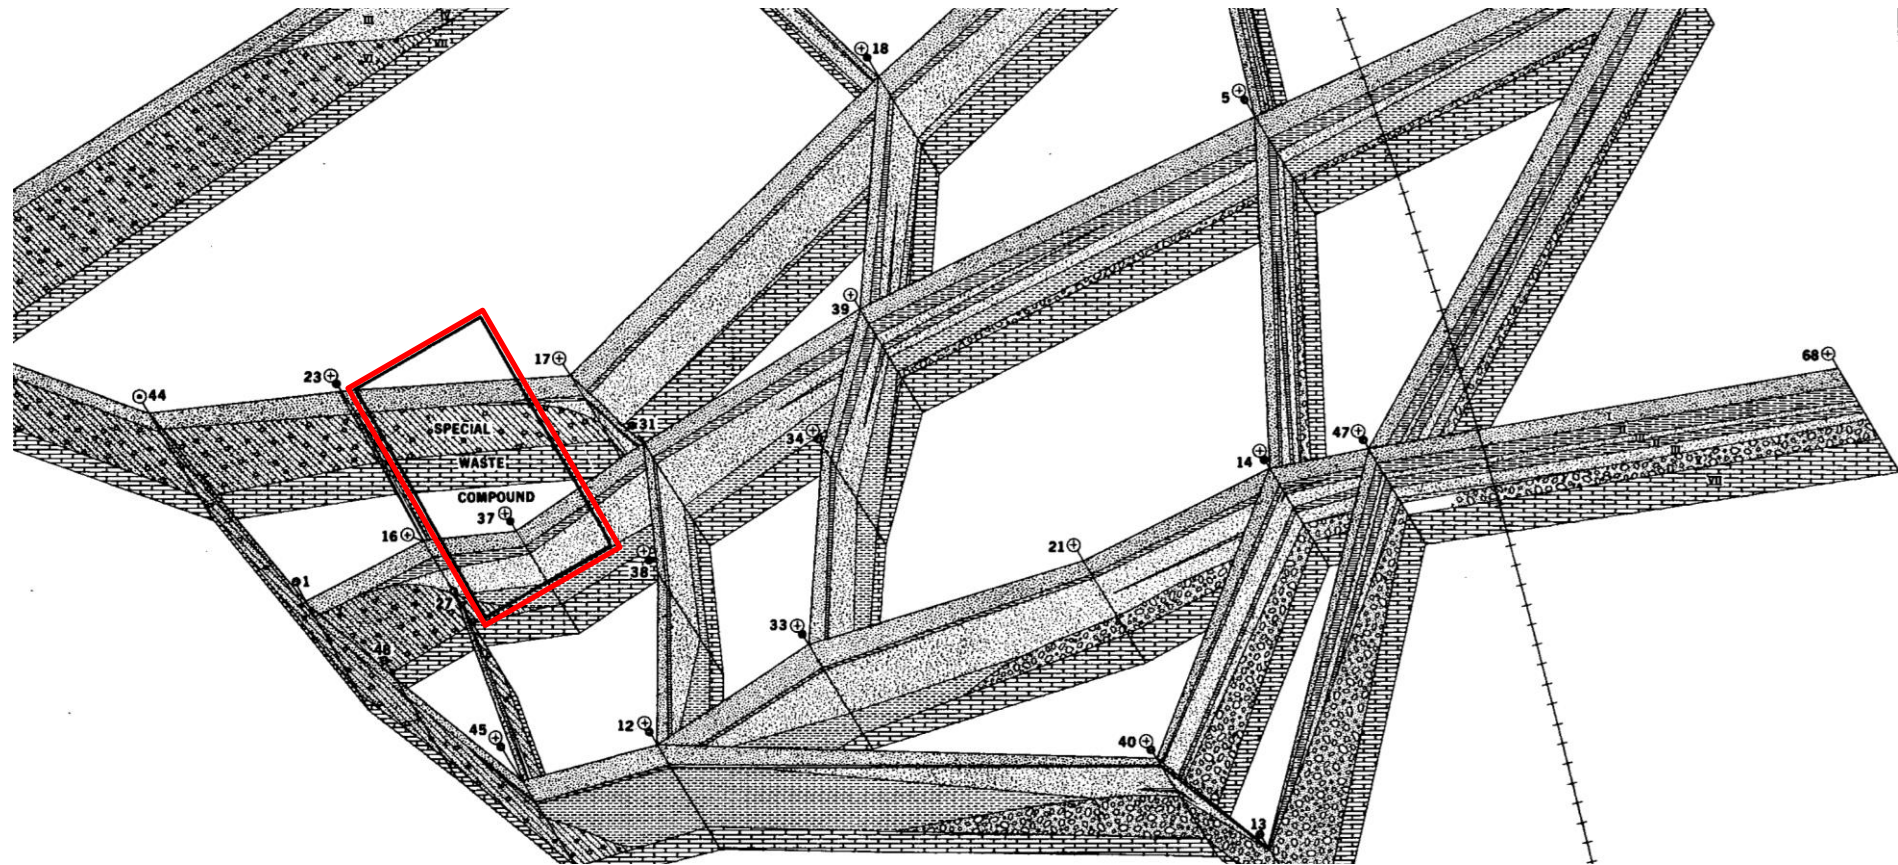
- Situated on a complex sequence of fluvio-glacial and littoral deposits

- LEGEND**
- STRATIGRAPHIC UNIT**
-

**A** Limestone; shaley limestone interlayers
 -

**B** Till; Coarse angular cobbles and boulders in sand and silt matrix
 -

**C** Sub-aqueous outwash poorly sorted gravels, sands and silts
 -

**D** Stratified clayey silt and silt
 -

**E** Regressional sands and gravels

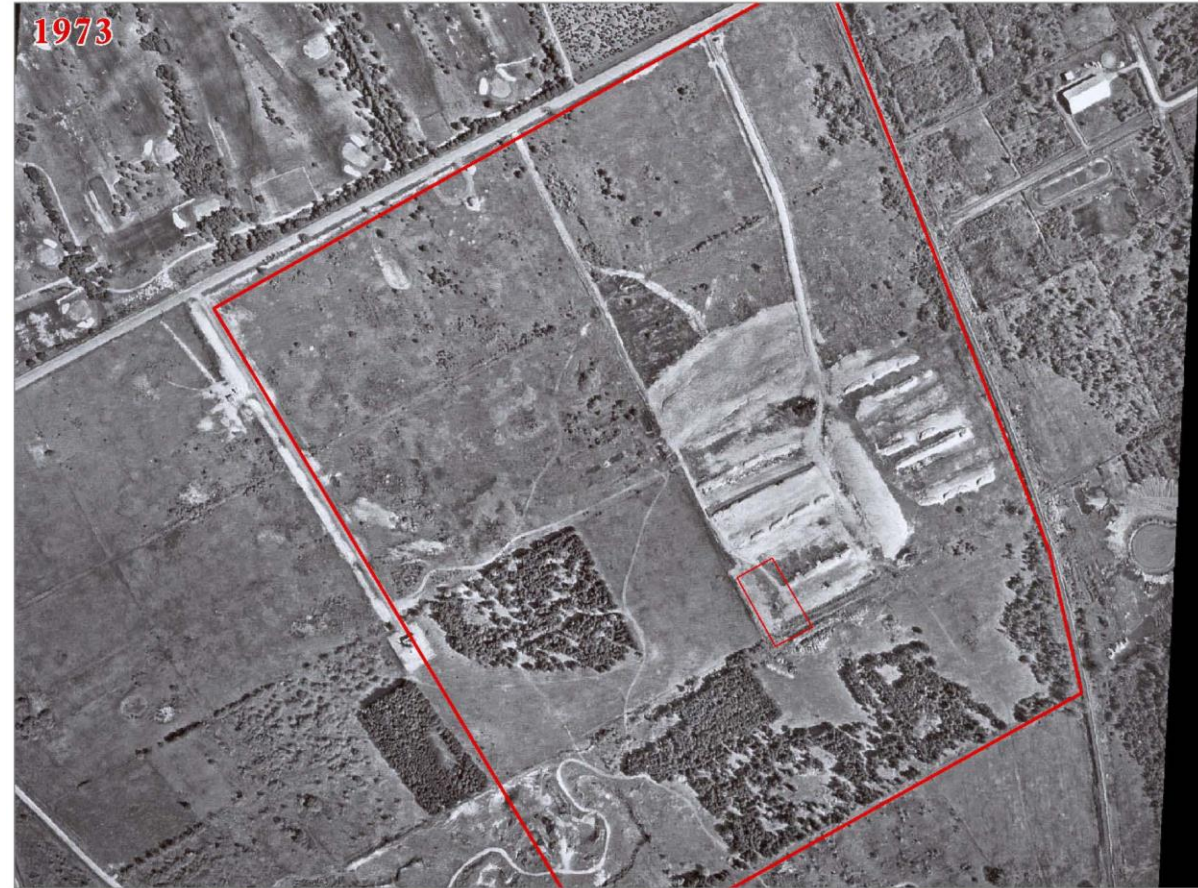
- Hazardous waste disposed between ~1957 and 1980
- Various government agencies involved
- “Indiscriminate” disposal of hazardous wastes
- Improper management (e.g., incineration, detonation of explosives within the waste)
- Deposited in trenches within the “Special Waste Compound”

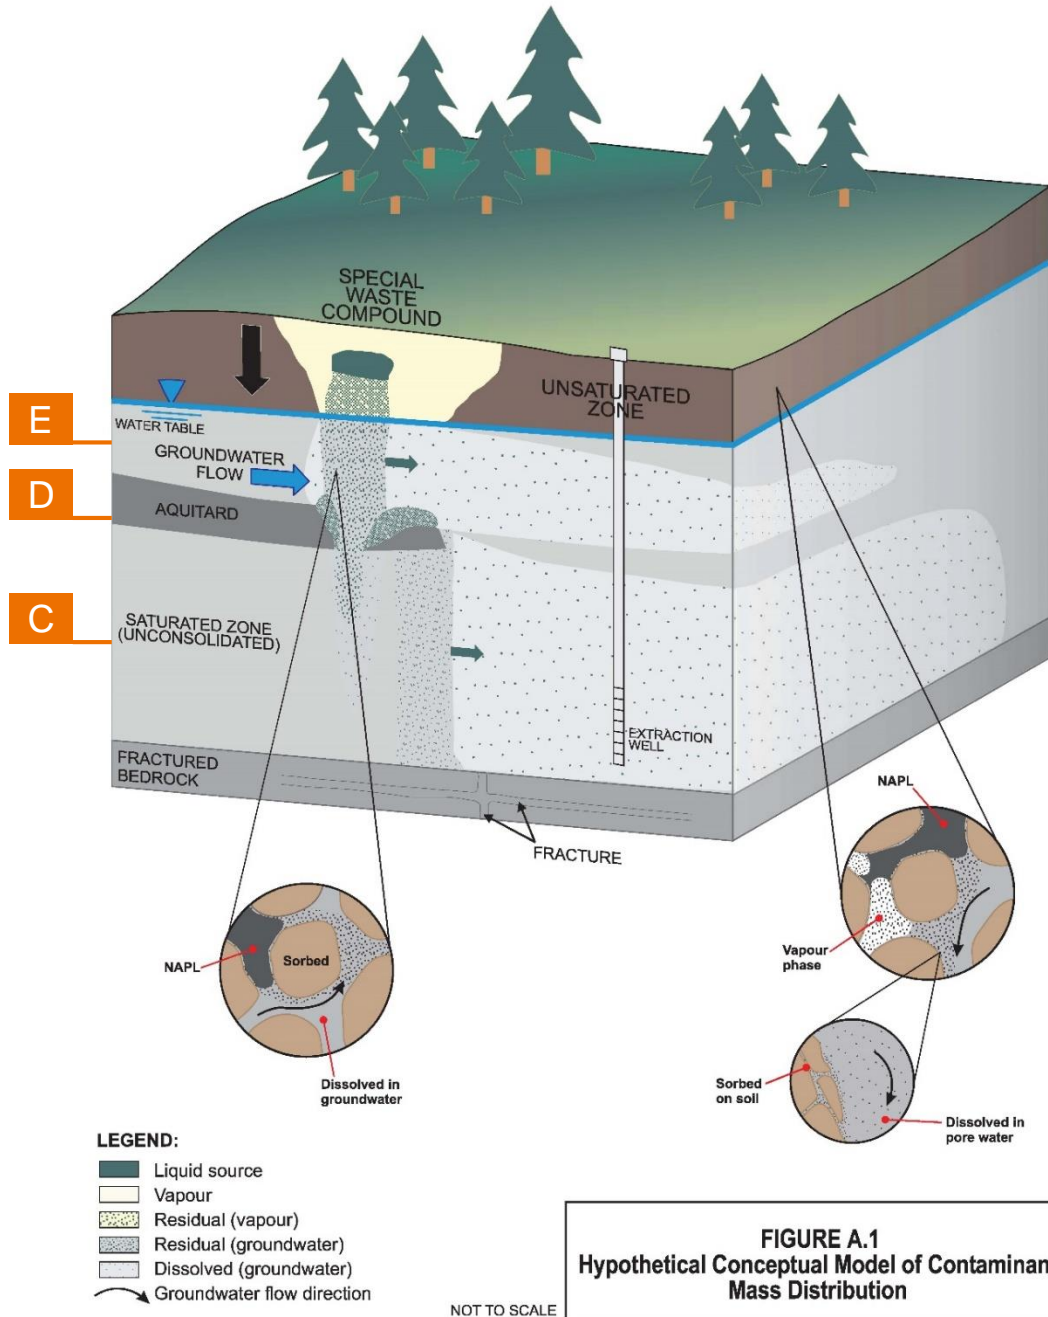
Studies since the 1980s

3 main sub-surface stratigraphic groups

- Deep aquifer
 - Unit C – 80 to 98 m amsl
- Clay/silt confining layer
 - Unit D – 98 to 100 m amsl
- Shallow aquifer
 - Unit E – 100 to 106 m amsl

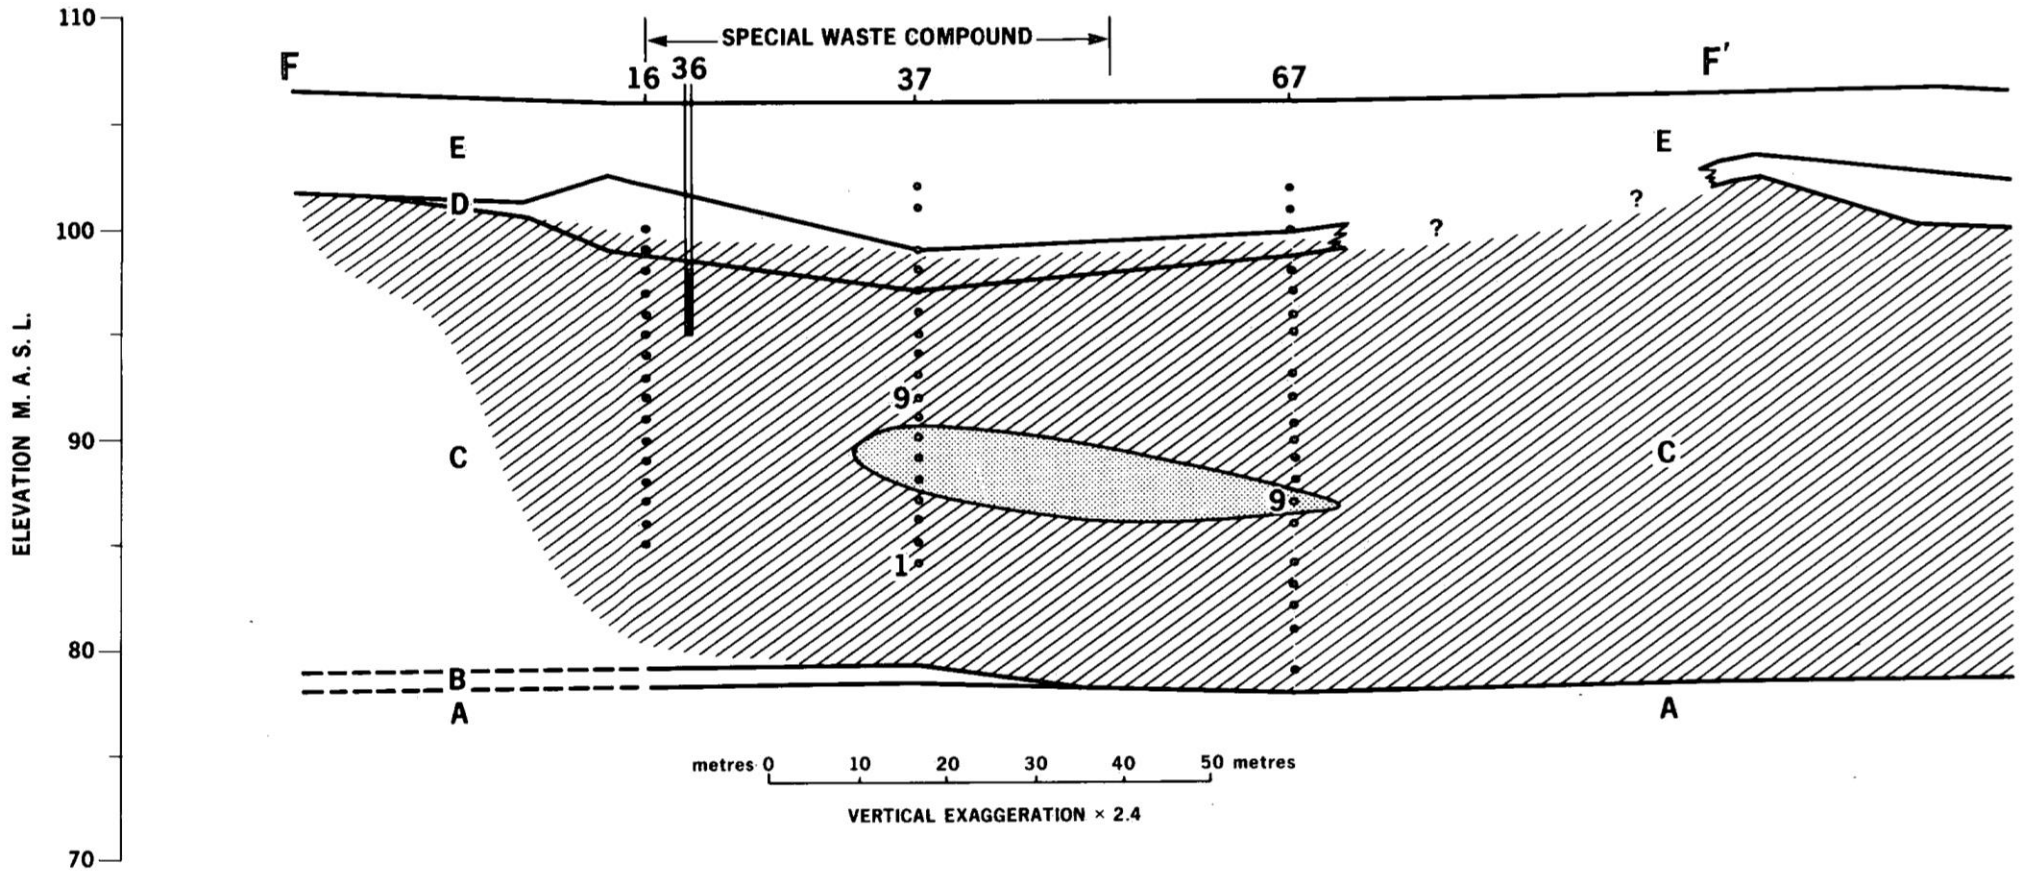
- Identified “windows” provide a pathway for contamination to migrate between aquifers
- Deep aquifer flow to the East
- Shallow aquifer flow is heterogeneous
- Anaerobic reducing zones present within Unit C

LEGEND
STRATIGRAPHIC UNIT

- A** LIMESTONE; SHALEY LIMESTONE INTERLAYERS
- B** TILL; COARSE ANGULAR COBBLES AND BOULDERS IN SAND AND SILT MATRIX
- C** SUB AQUEOUS OUTWASH; POORLY SORTED GRAVELS, SANDS AND SILTS
- D** STRATIFIED CLAYEY SILT AND SILT
- E** REGRESSIONAL SANDS AND GRAVELS

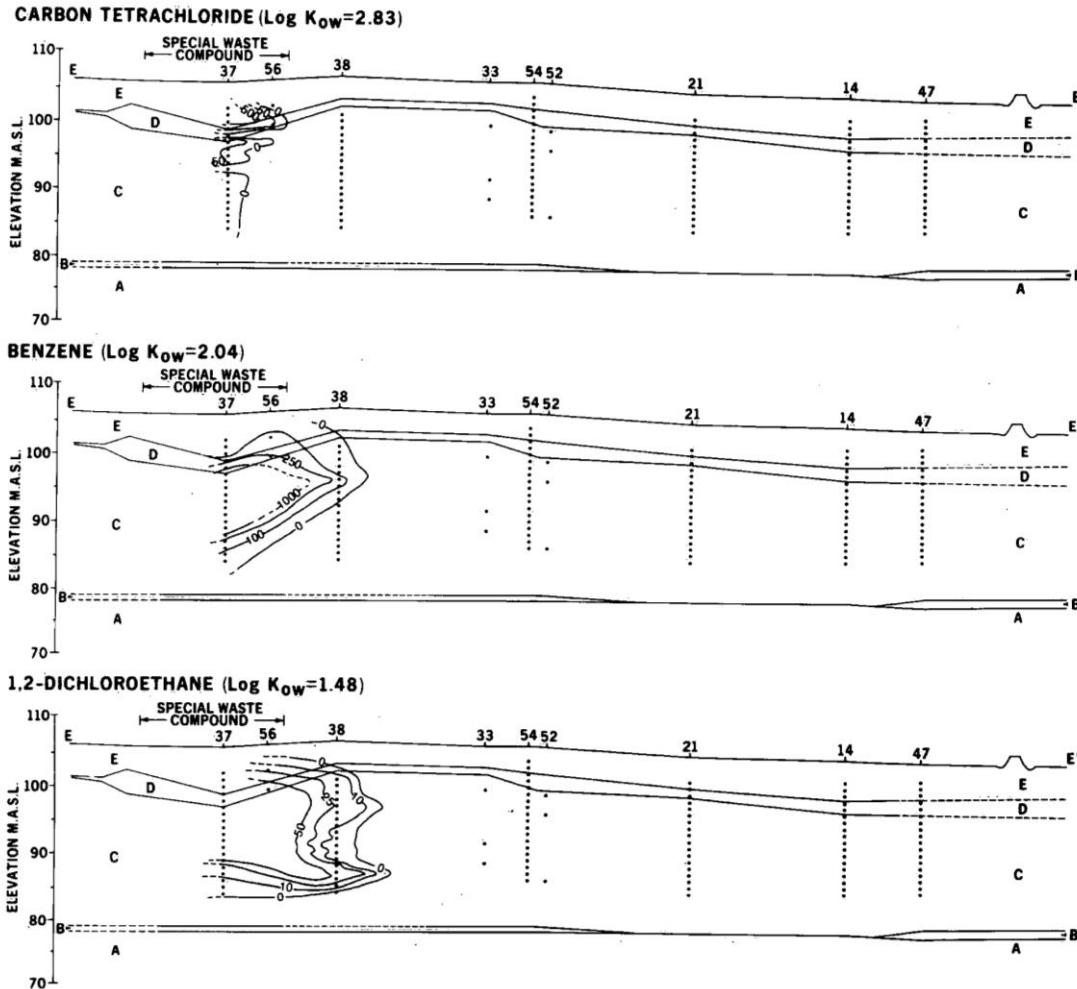
- Integration of groundwater monitoring since 1993
- Refinement of the 1980s 2D CSM to evaluate vertical and lateral plume dispersion
- 1990s findings showed majority of dissolved PCE/TCE in Unit E - 95 to 100 m amsl
- In comparison, the 1980s CSM had showed majority of dissolved PCE/TCE in Unit C - 90 to 95 m amsl

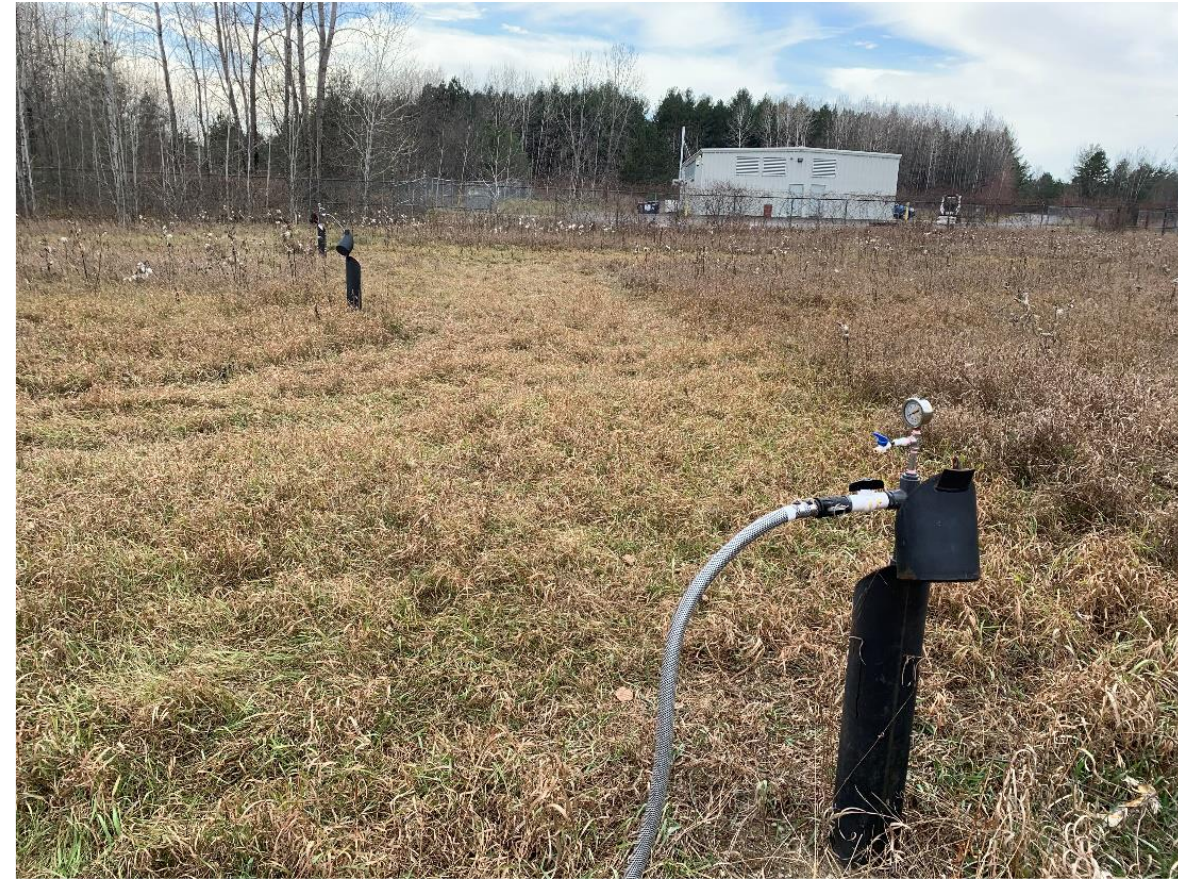
- Limitations in continuing with the pump-and-treat system were identified in 2013
- There was a switch in 2019 to inject molasses as the organic substrate to stimulate anaerobic biodegradation of the chlorinated VOCs
- 7 Molasses Substrate Solution Injection Events (MSSIE) between 2019 and 2021
- Monitoring showed TOC released from MSSIE were not reaching all affected areas within the aquifer
- Upper portions of Unit C (deep aquifer) not receiving substrate in sufficient concentrations (<75 mg/L)
- Placement of injection well screens was re-evaluated

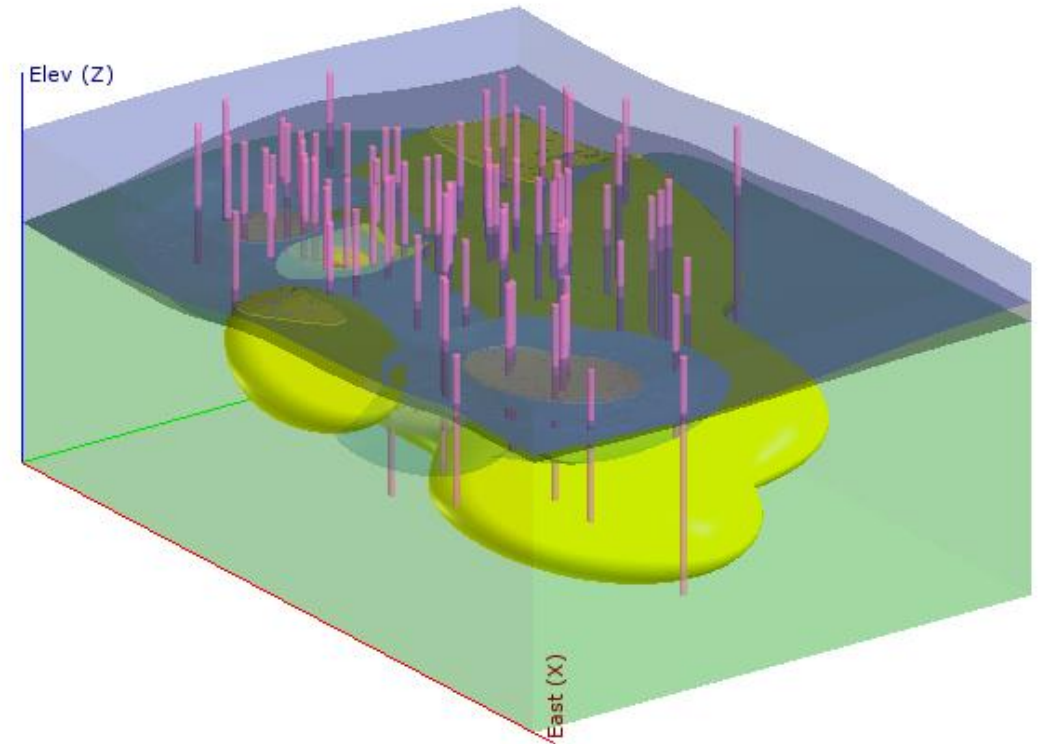
- Use of LeapFrog + Hydrogeology™
- Overburden stratigraphy was characterized from all past and current investigations
- 3D rendering of the VOC contaminant plume
- Focus on PCE & TCE
- 3D rendering of the remedial substrate plume
- TOC, Dhc, Br, Fe, sulphate
- 3D model updated with new information from targeted monitoring programs
