In-Situ Permeable Reactive Barrier Remediation Optimization using High Resolution Site Characterization Tools – A Case Study

RemTech East

June 1, 2022

Vertex Environmental Inc.

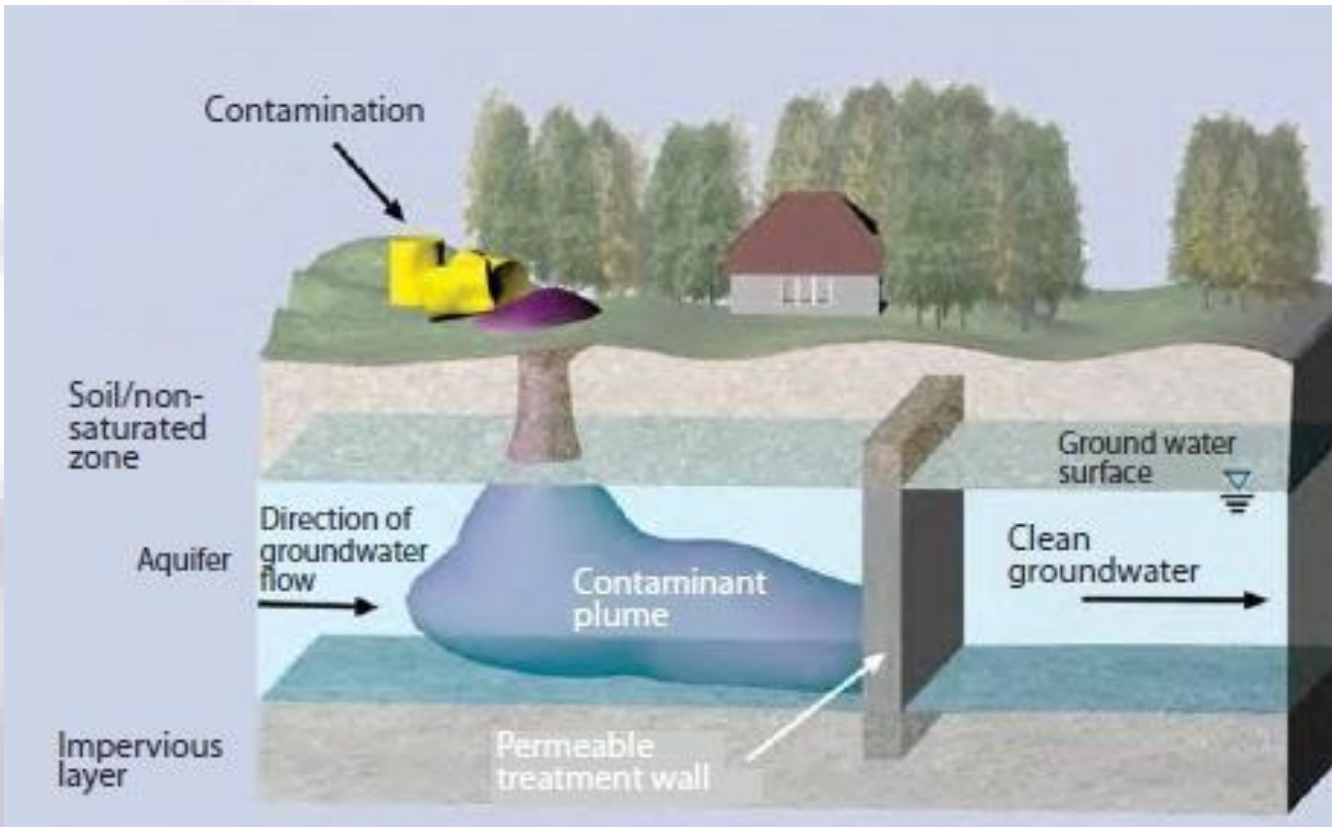
What is a Permeable Reactive Barrier (PRB)?

- PRBs intercept and treat contaminated groundwater plumes (passive)
- Allow groundwater to flow through unimpeded
- Can be excavated or injected
- Sustainable (no energy use to operate)

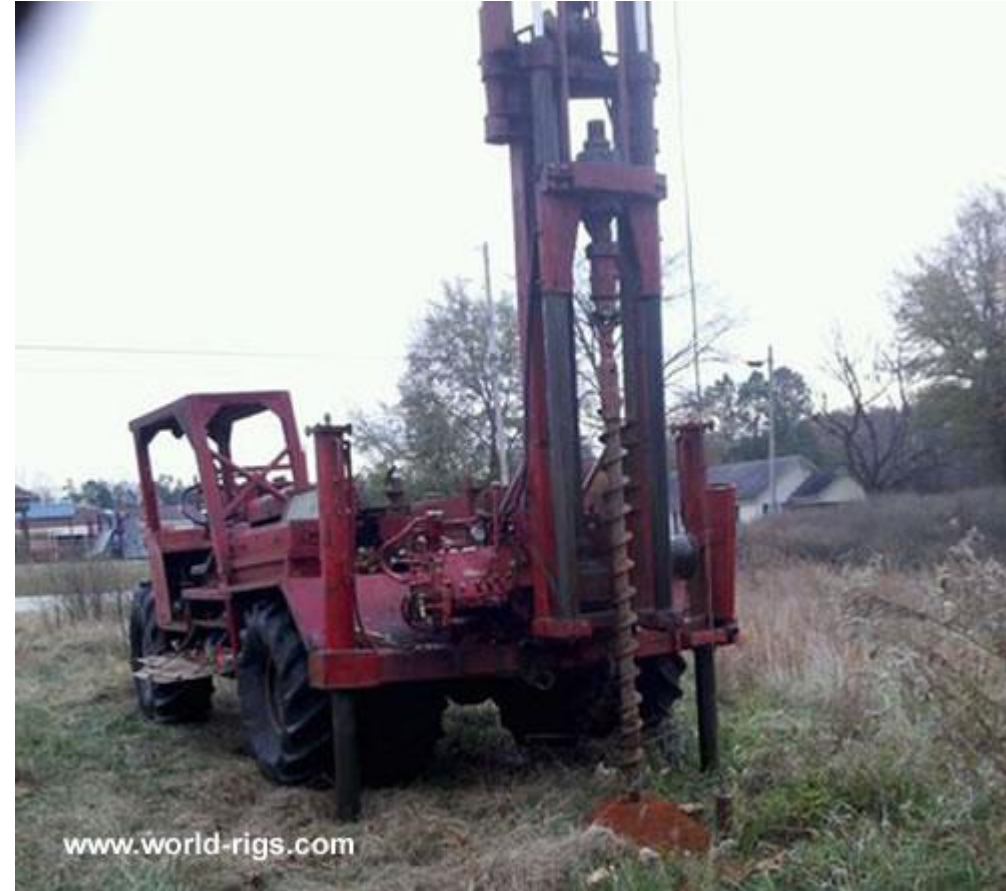
- Traditional Techniques;
 - Borehole drilling & environmental sampling,
 - Monitoring well installation,
 - Groundwater well development & sampling,
 - Analysis of soil and groundwater samples,
 - Low Flow sampling
 - Wide range of parameters to be scanned
- Usually requires multiple iterations/mobilizations for proper delineation and proper Site assessment
 - Costs can and will add up over time over time, delineation and characterization can be very costly in time and money!
 - Not a very sustainable model!

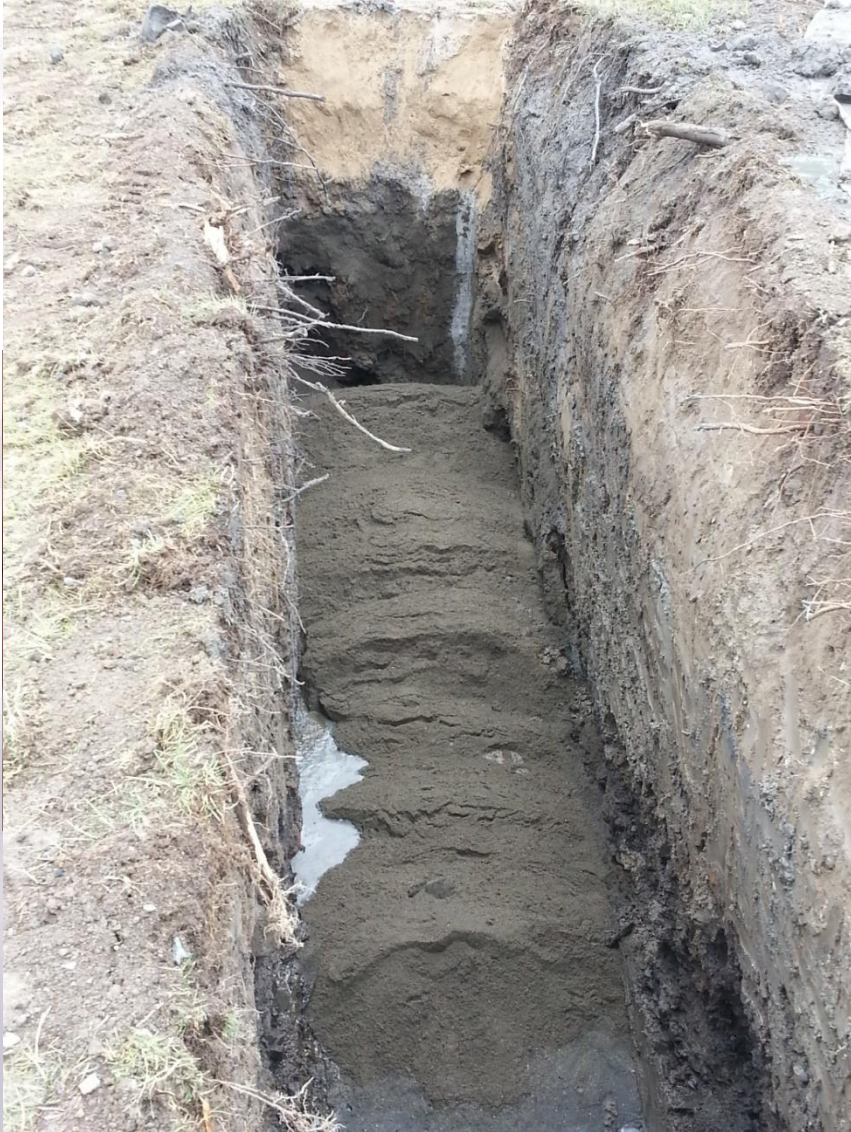
- Use generic assumptions / rules of thumb
- Dig a trench
- Mix up some ZVI and sand
- Maybe do some mag. separation testing
- Backfill the trench
- Hope for the best...
 - Under design = Failure
 - Over design = Wasted \$\$
- But what if there is something unusual about your site?
- Is there a better way? **YES!**

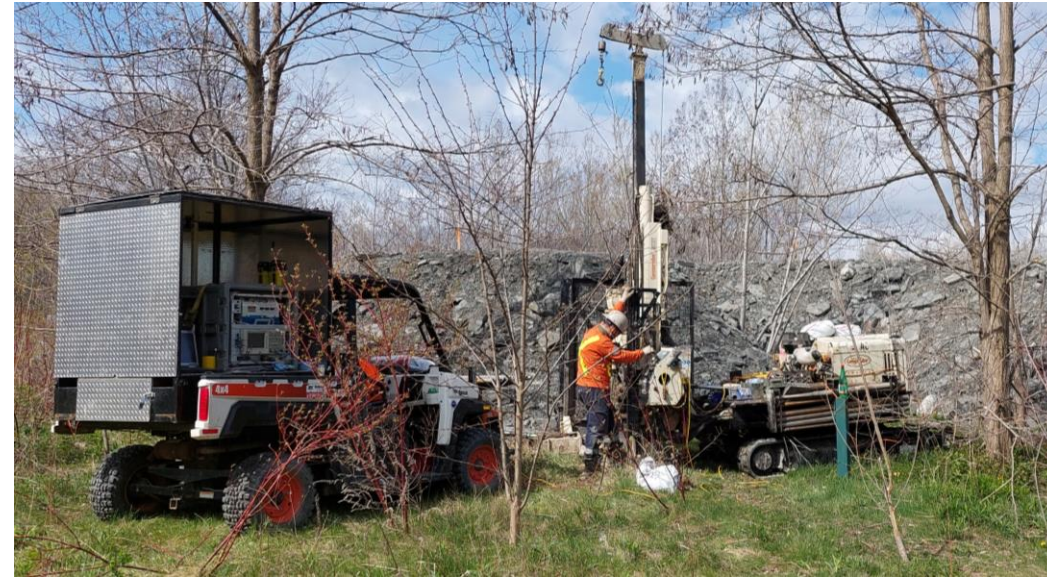
- High Resolution Site Characterization (HRSC) Techniques;
 - Borehole drilling & environmental "sampling" in real time on-Site,
 - Geotechnical & Environmental parameters collected
- Optimized monitoring well installation & sampling,
 - Analysis of targeted soil and groundwater samples,
 - Specific set key parameters to be analyzed
- HRSC can be completed in one mobilization for extensive screening/delineation both vertically and horizontally
 - Costs for HRSC surveys can pay for themselves multiple times over when considering multiple traditional mobilizations to collect same data AND when considering potential remediation costs of the Site
 - Less mobilizations = a more sustainable and efficient program

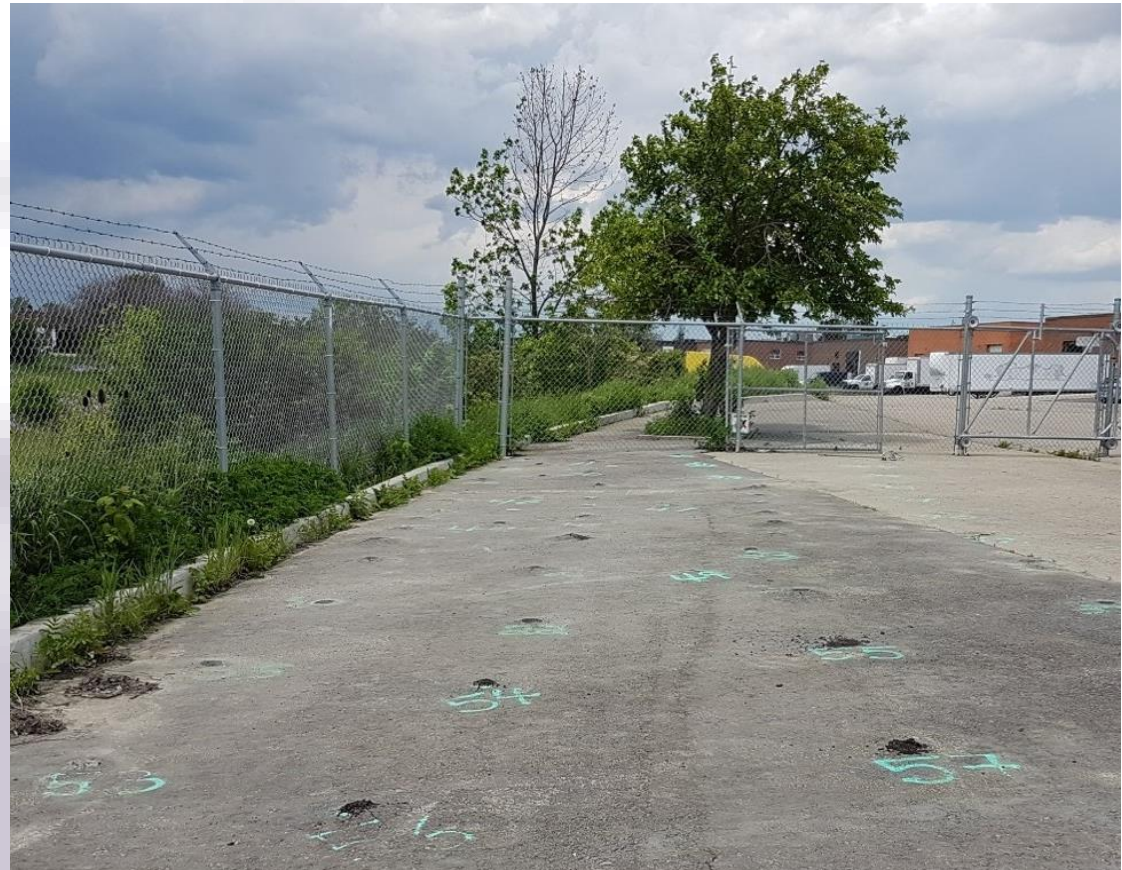
- Use HRSC and analytical data to create a highly detailed understanding of the Site/PRB alignment
- Incorporate hydrogeological information to estimate contaminant flux
- Optimize PRB design for Site specific parameters
- Select specific amendment for contaminants and begin installation (cut & fill and/or in-situ injection)
- Complete amendment specific QA/QC during installation
- Mitigate uncertainty!
- Monitor PRB for performance

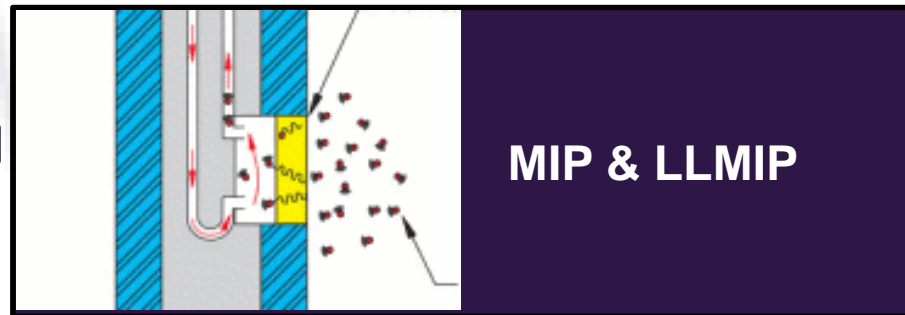
Dissolved Phase

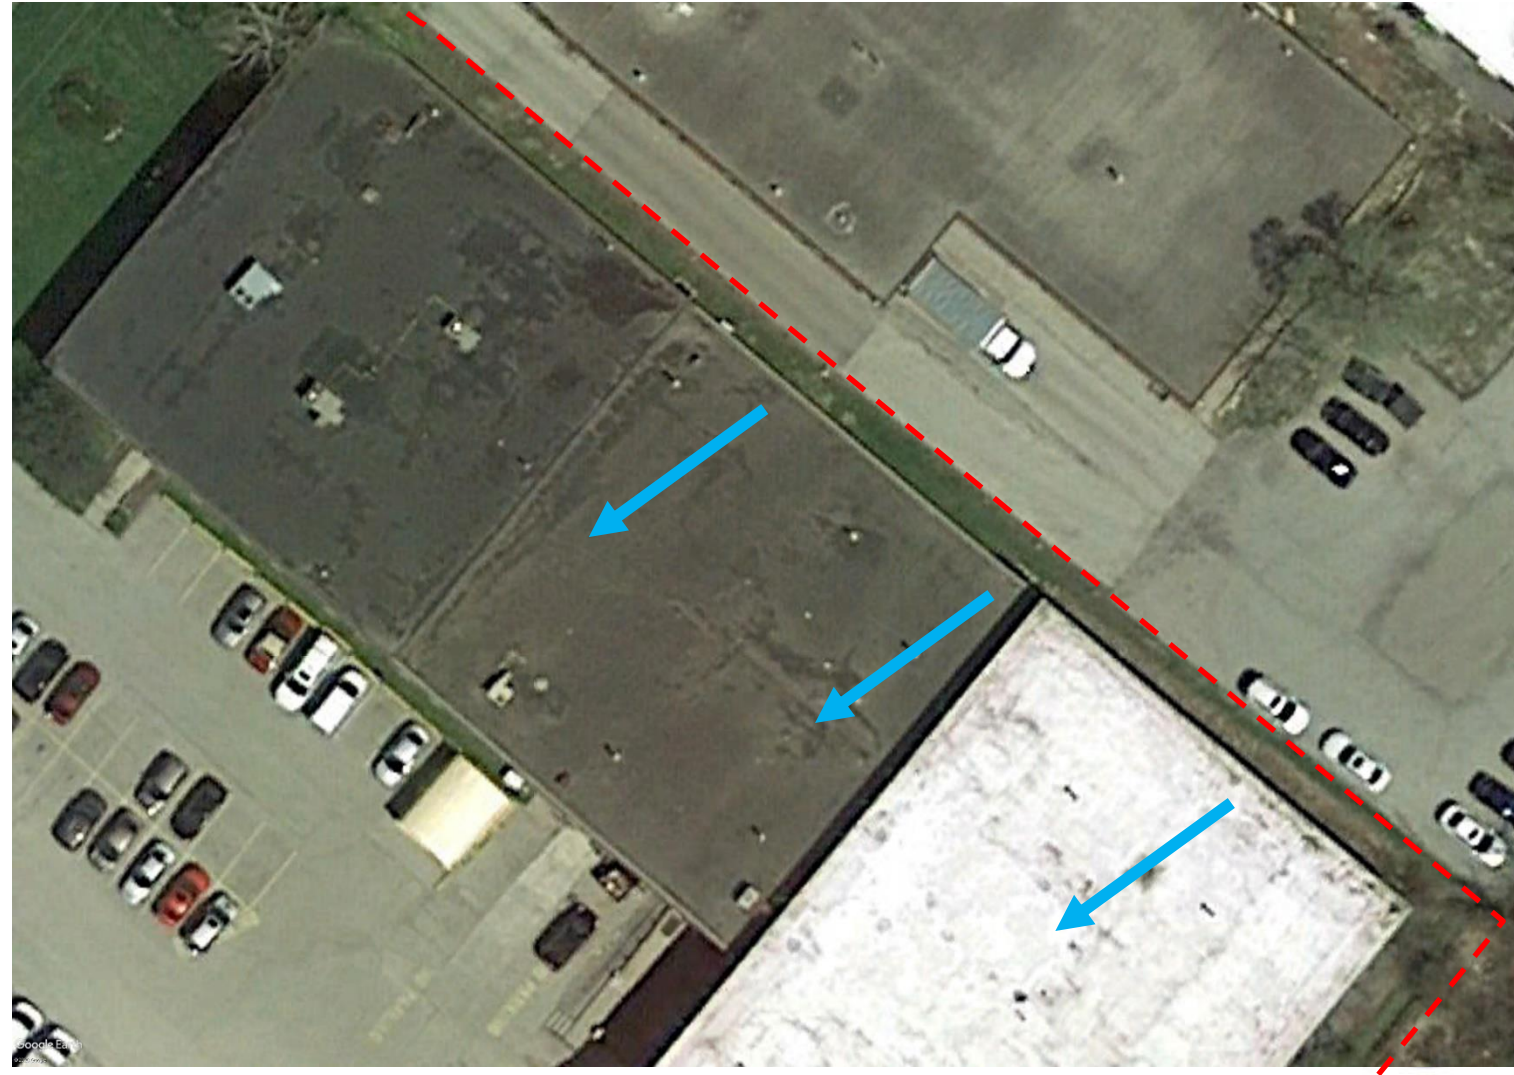
Site details / background:

- Southwestern Ontario Site
- Chlorinated Volatile Organic Compounds (cVOCs) migrating from off-Site source onto property
- Objective: Install PRB to protect on-Site tenants and for bank refinancing
- A few rounds of limited traditional delineation work and sampling completed by consultants
- Vertex asked to develop PRB to based on sparse data
- LLMiHpt brought in to fill in data gaps of cVOC plume definition was limited at best
- No hydrogeological information was estimated for on-Site in previous works

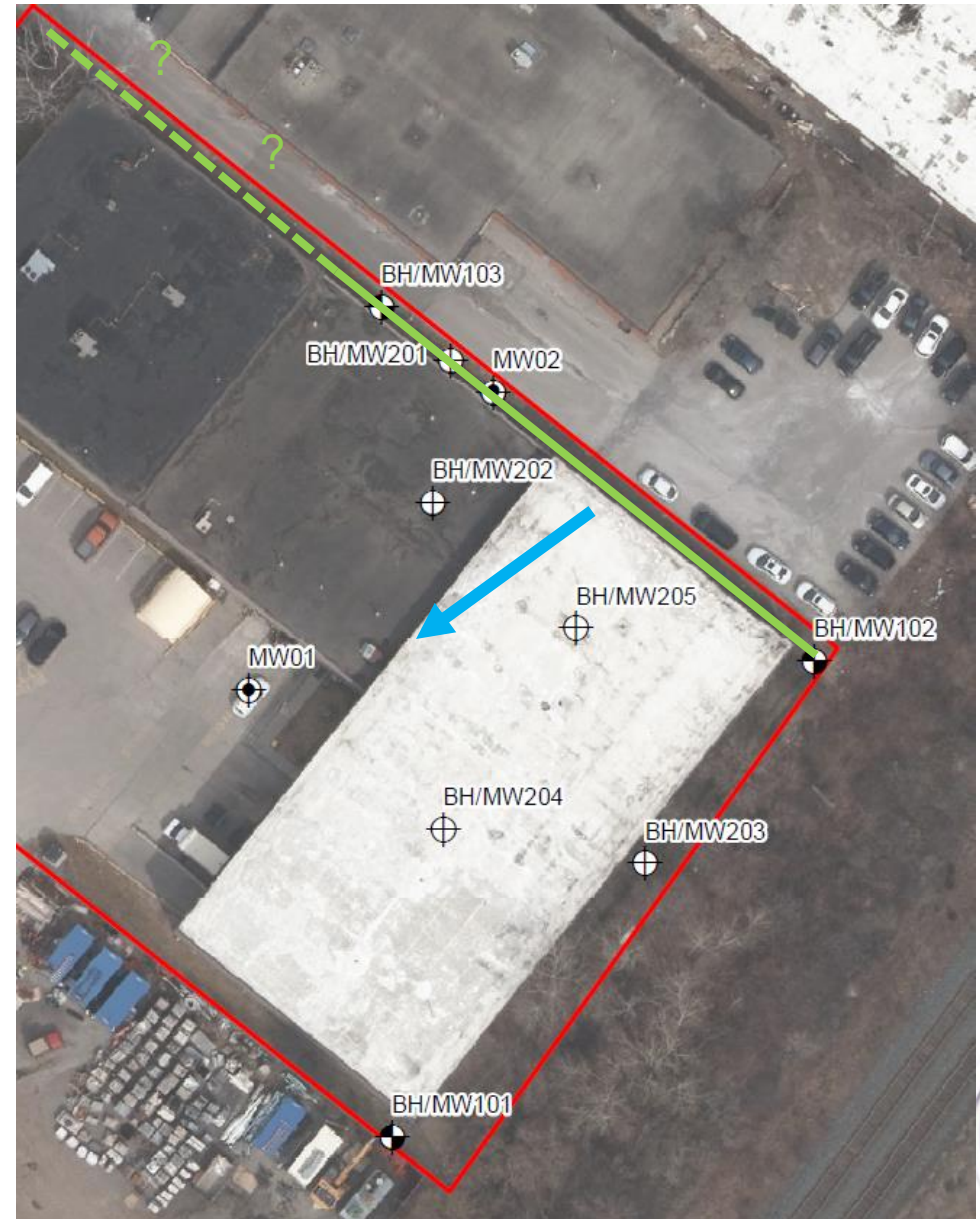
Original PRB Design:

- Based on limited information from 4 groundwater monitoring wells with significant gaps between
- Monitoring wells had some soil samples submitted during installation
- Water table measured at approximately 1 mbgs
- Initial PRB installation depths from 1 to 4 mbgs (3 m of saturated wall thickness)
- No information on Site hydraulic conductivity only assumptions based on geology, literature and experience
- Conservative estimate included entire length of property boundary ~\$180,000 to install

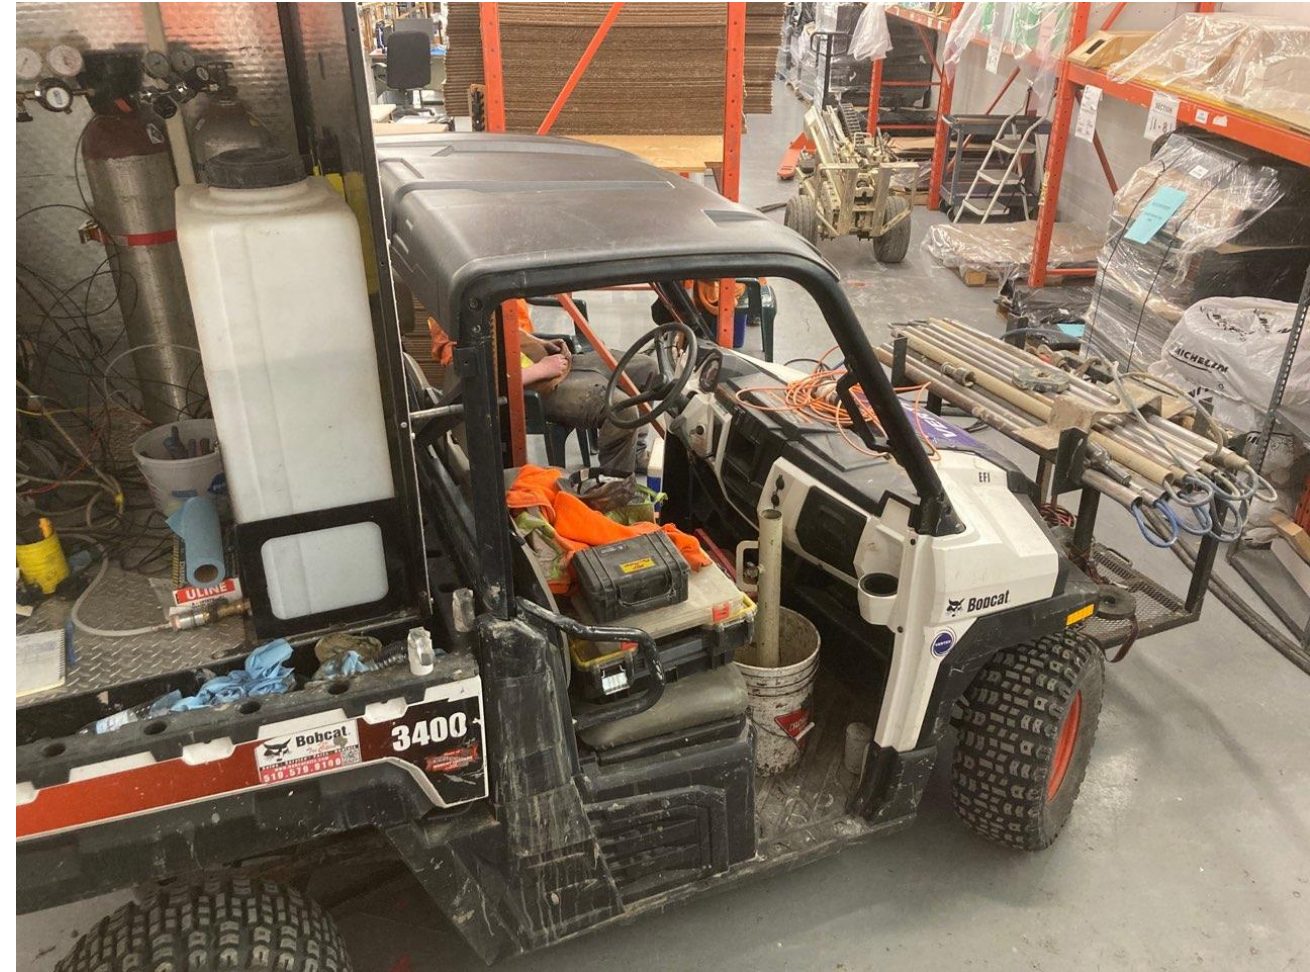
HRSC Work Completed on-Site:

- Completed fifteen (15) LLMiHpt locations in 4 days along property boundary and interior of active facility
 - 9 LLMiHpt locations along PRB alignment
 - 6 LLMiHpt locations inside active facility (downgradient of proposed PRB)
- Depth of Probing = up to 9.7 mbgs (*up to 4 mbgs maximum on previous design*)
- Tighter locations along property boundary and on-Site building AND working around active facility storage racks, equipment, and employees
- Many considerations must be made with working inside active facilities → on-Site disruptions and time management!

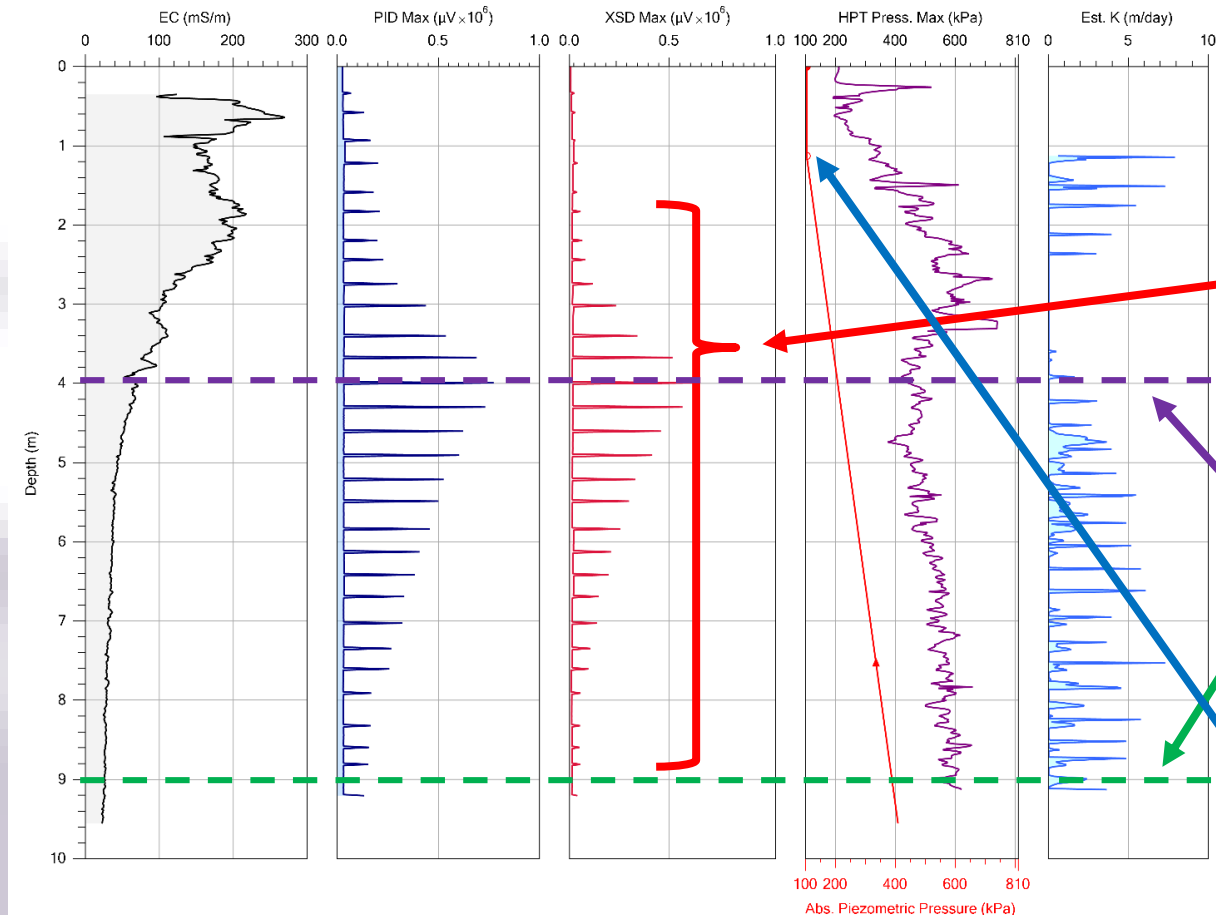
HRSC Results:

- Utilized for vertical and horizontal data gap analysis and PRB design optimization
- Good agreement with PID and XSD data confirming CVOC impacts along property boundary
- CVOC impacts found to be much deeper than what previous information collected/provided
 - Previous reports indicated ~4 mbgs max depth of impacts, LLMiHpt had significant responses up to ~9 mbgs,
- Hydraulic Profiling Tool highlighted transport and storage zones within the subsurface
- Shallow water table confirmed by HPT
- Similar geology across the Site with varying permeabilities and estimated hydraulic conductivities (horizontally and vertically)

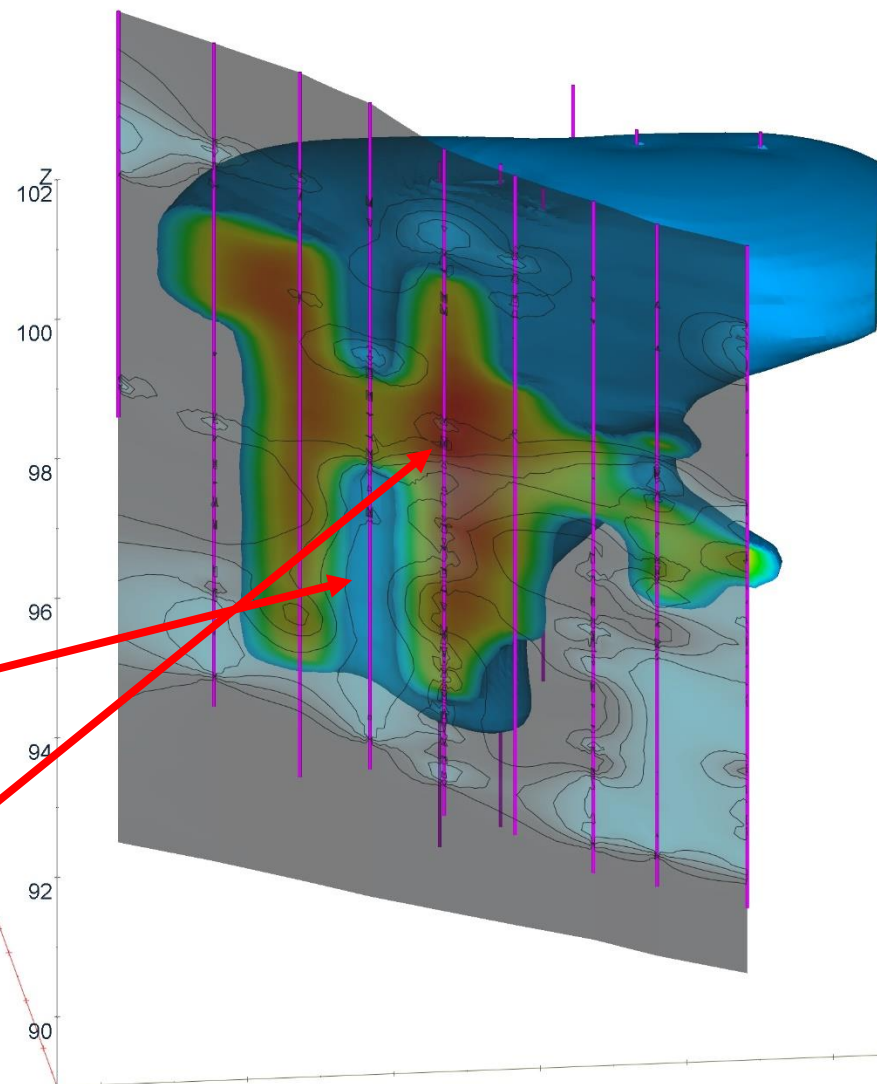
- CVOC impacts profiled along property boundary indicated horizontal and vertical delineation
- Transport and storage zones within PRB alignment mapped out
- Generally highest LLMiHpt detector responses in lower conductivity zones (i.e. lower contaminant mass discharge across property boundary)

Transport

Storage

XSD Response from Baseline (uV) with Est. K (cm/s) fence
