Saskatchewan Non-Uranium Abandoned Mines (NUAM) Clean-up Program

Dale Kristoff & Brent Zelensky
Saskatchewan Ministry of Environment

June 2022

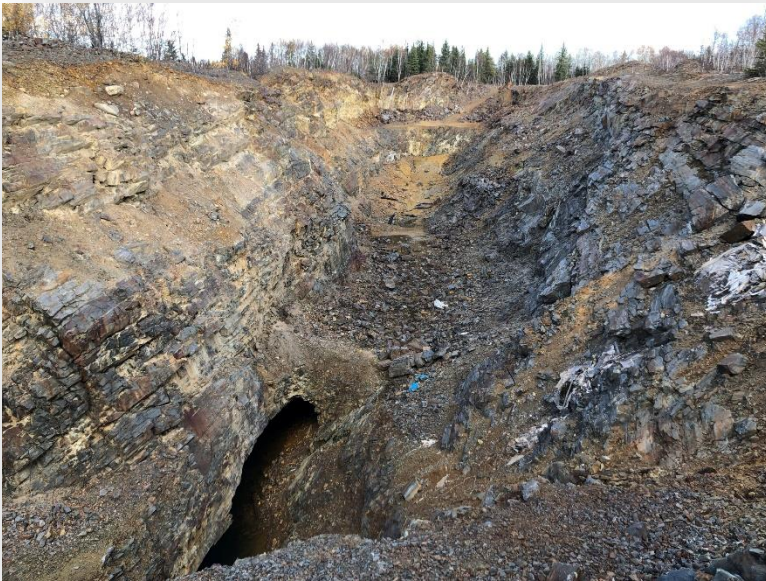
Anglo Rouyn pit and open shaft, 2020

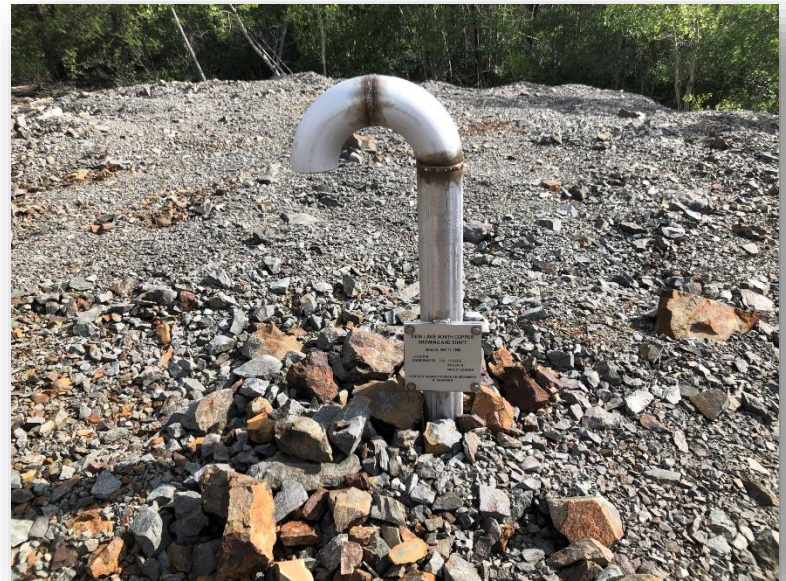
Dion Lake shaft - sealed in 2006

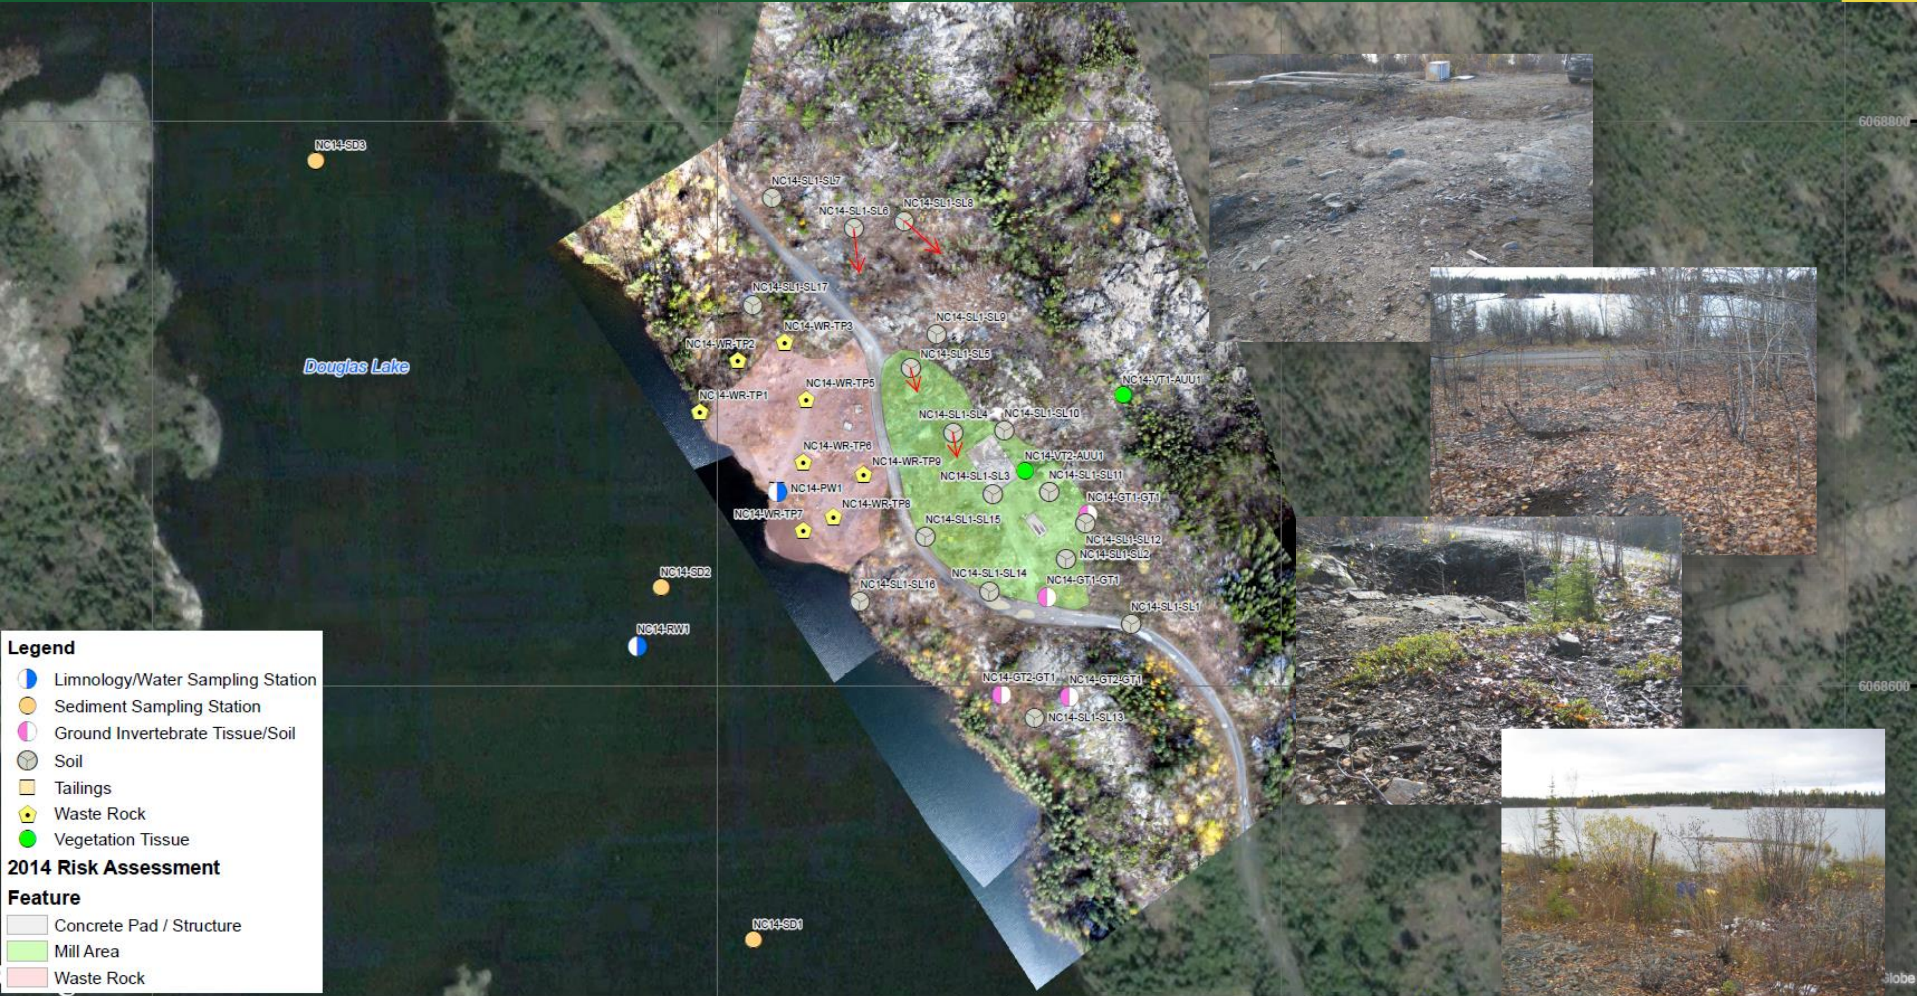
| Date: Dec 2014 | Approved: | Figure: 1 |

Newcor Site

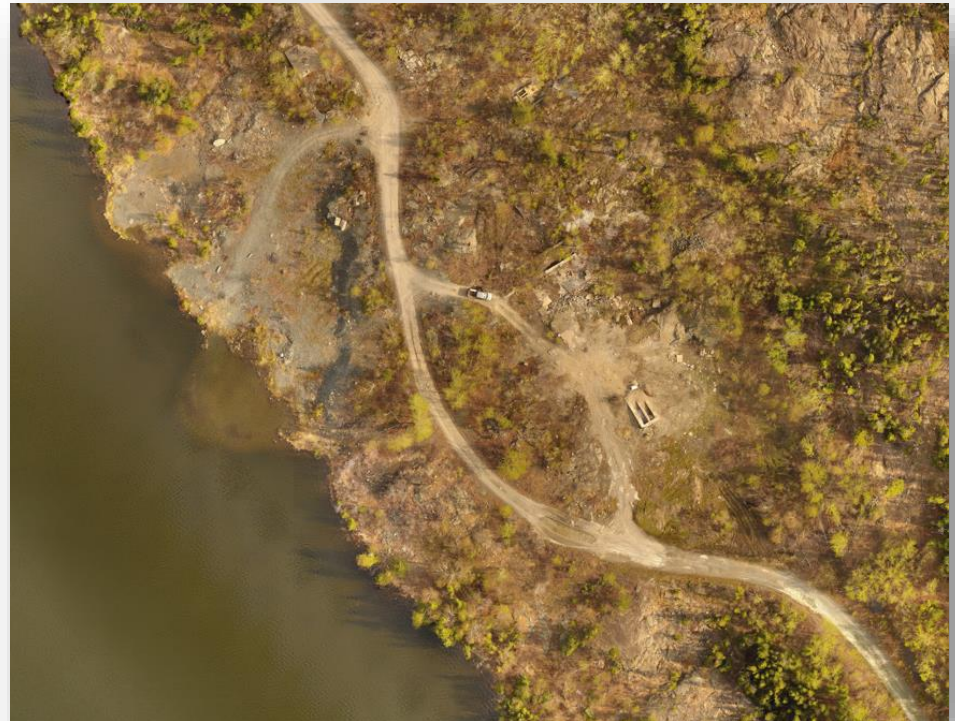
2020 Results: Newcor 100% Corrective Action Plan

Soil Remediation

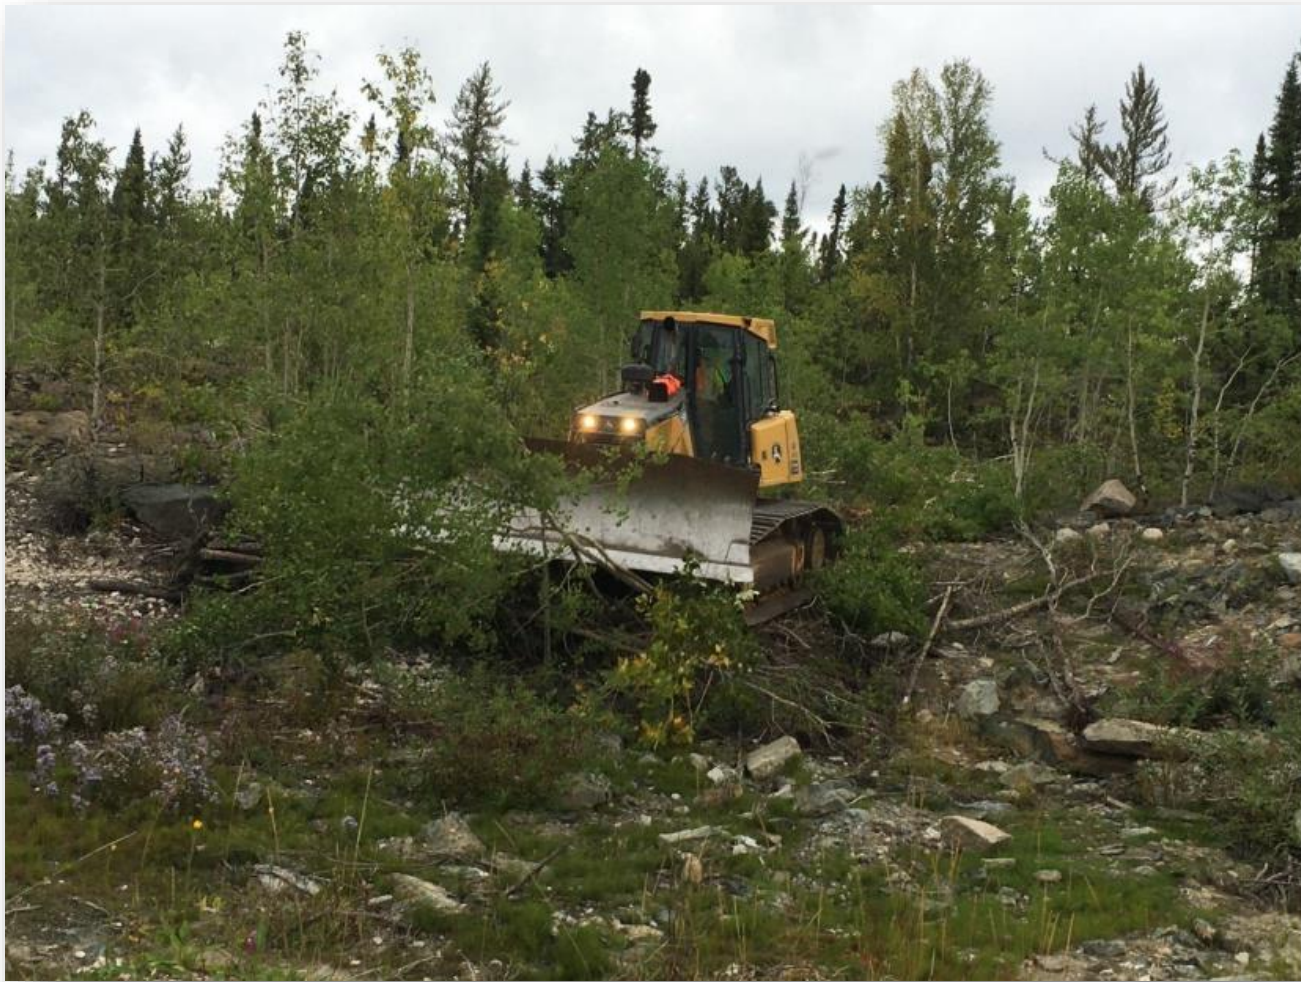
Shaft Cover Prep

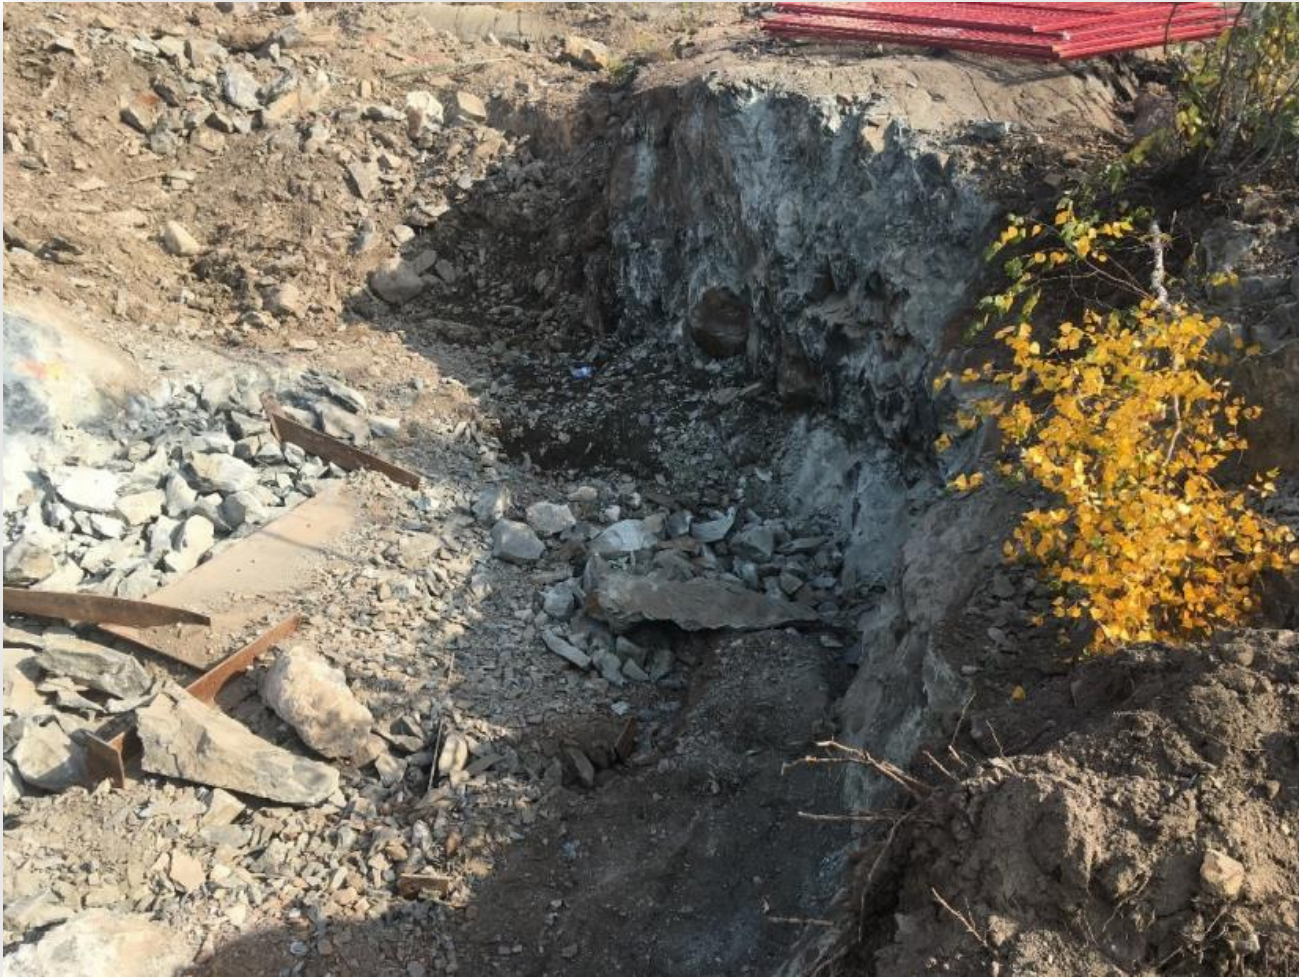
Shaft Cover Prep

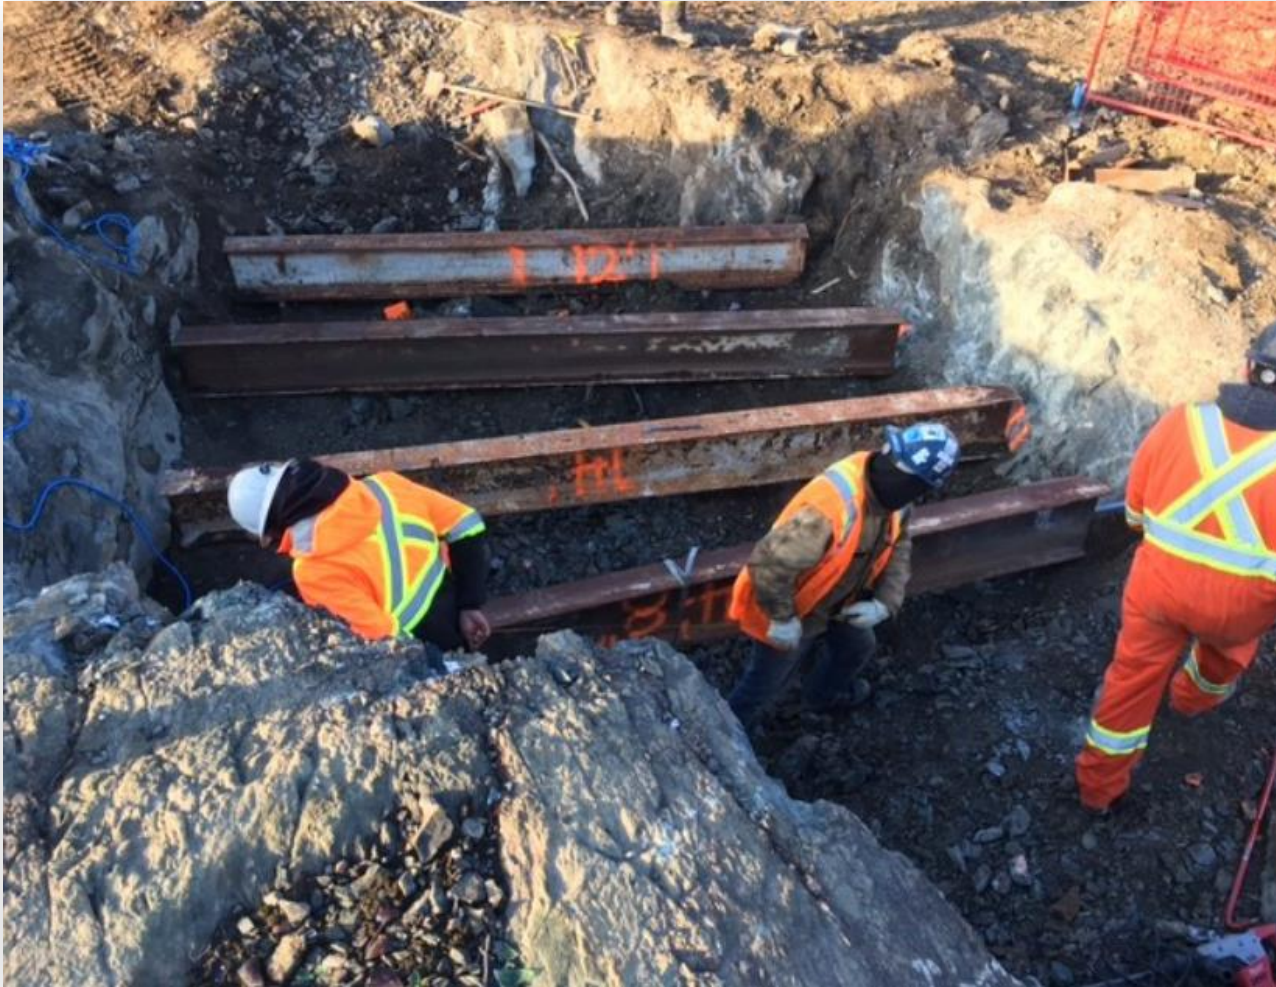
Shaft Cover Forms and Reinforcement

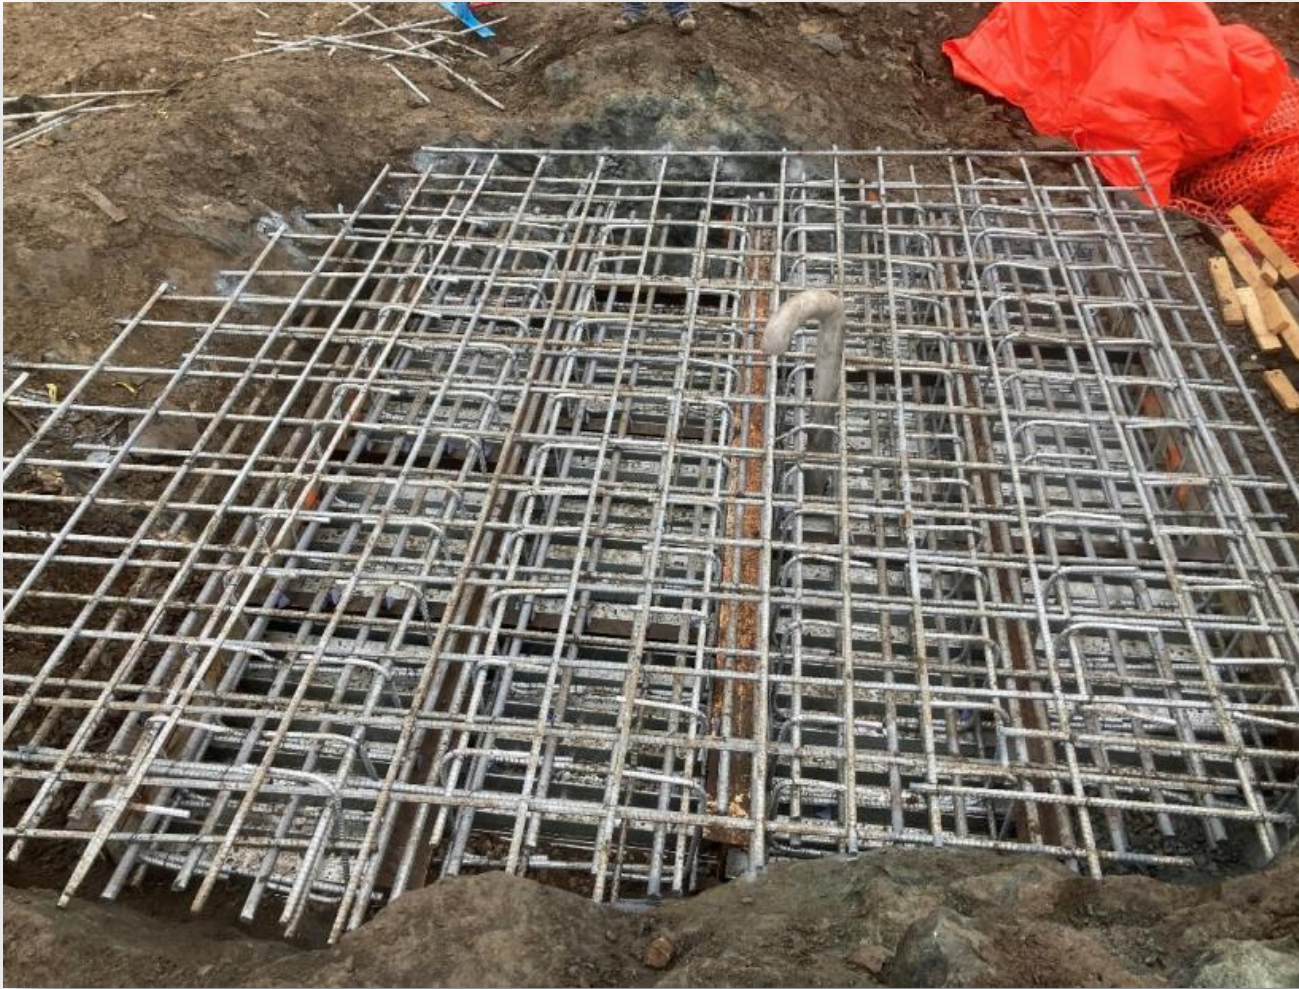
Shaft Cover Concrete Pour

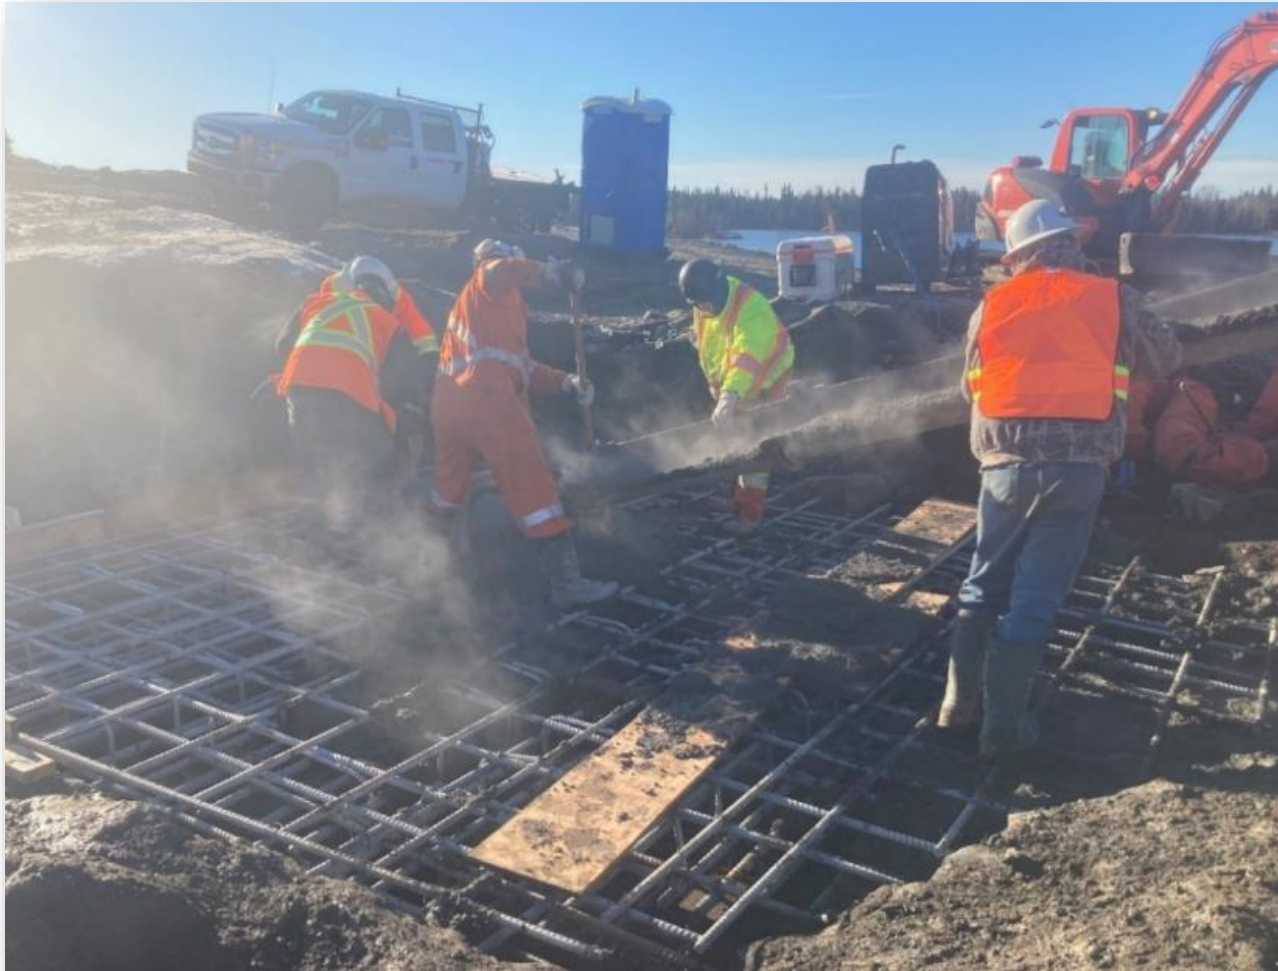
Shaft Cover Concrete Heating and Hoarding

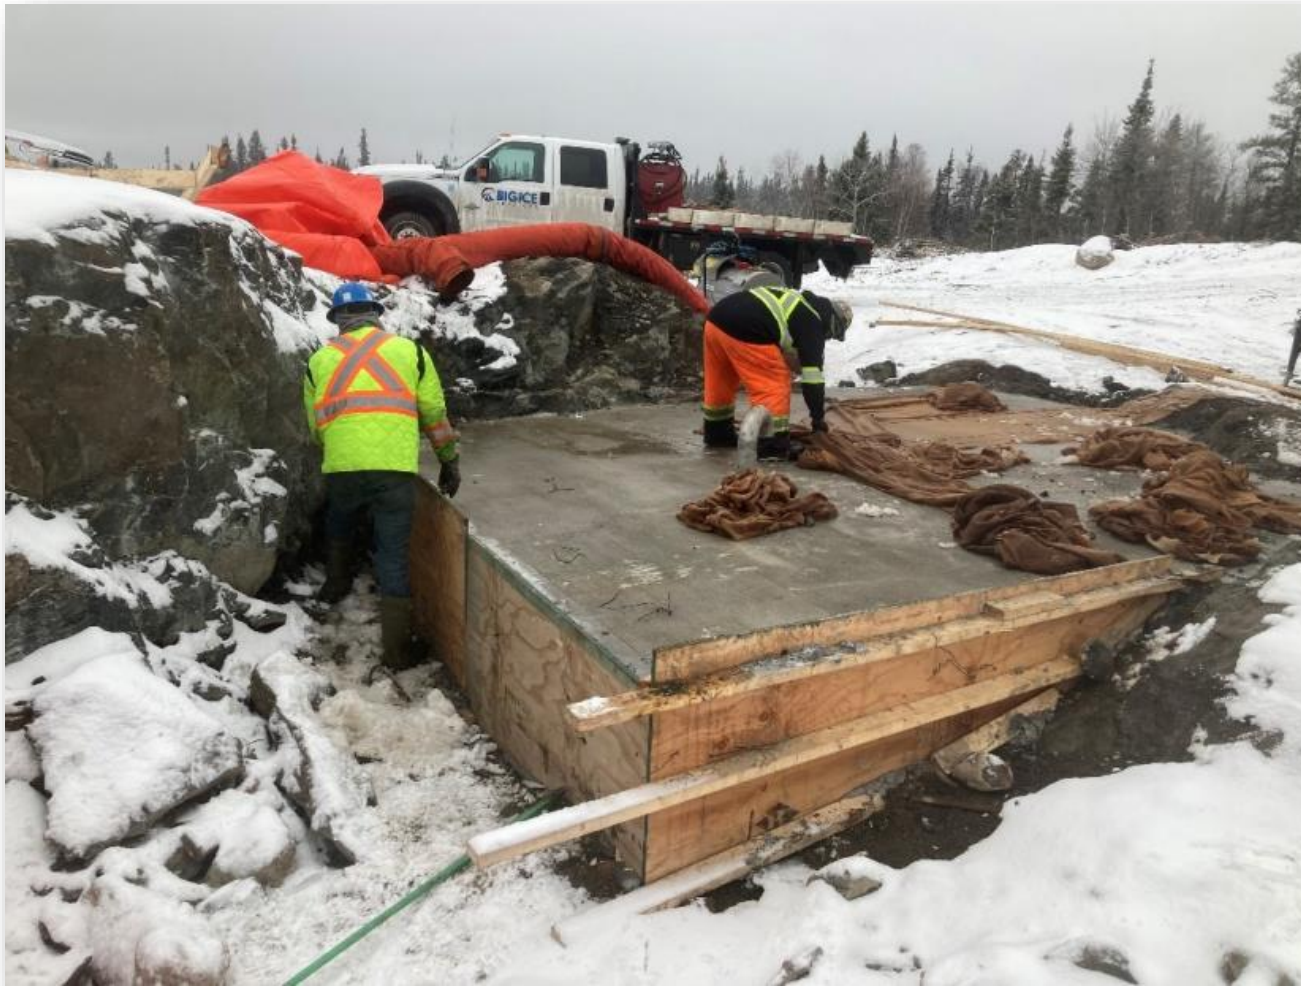
Permanent Concrete Shaft Cover

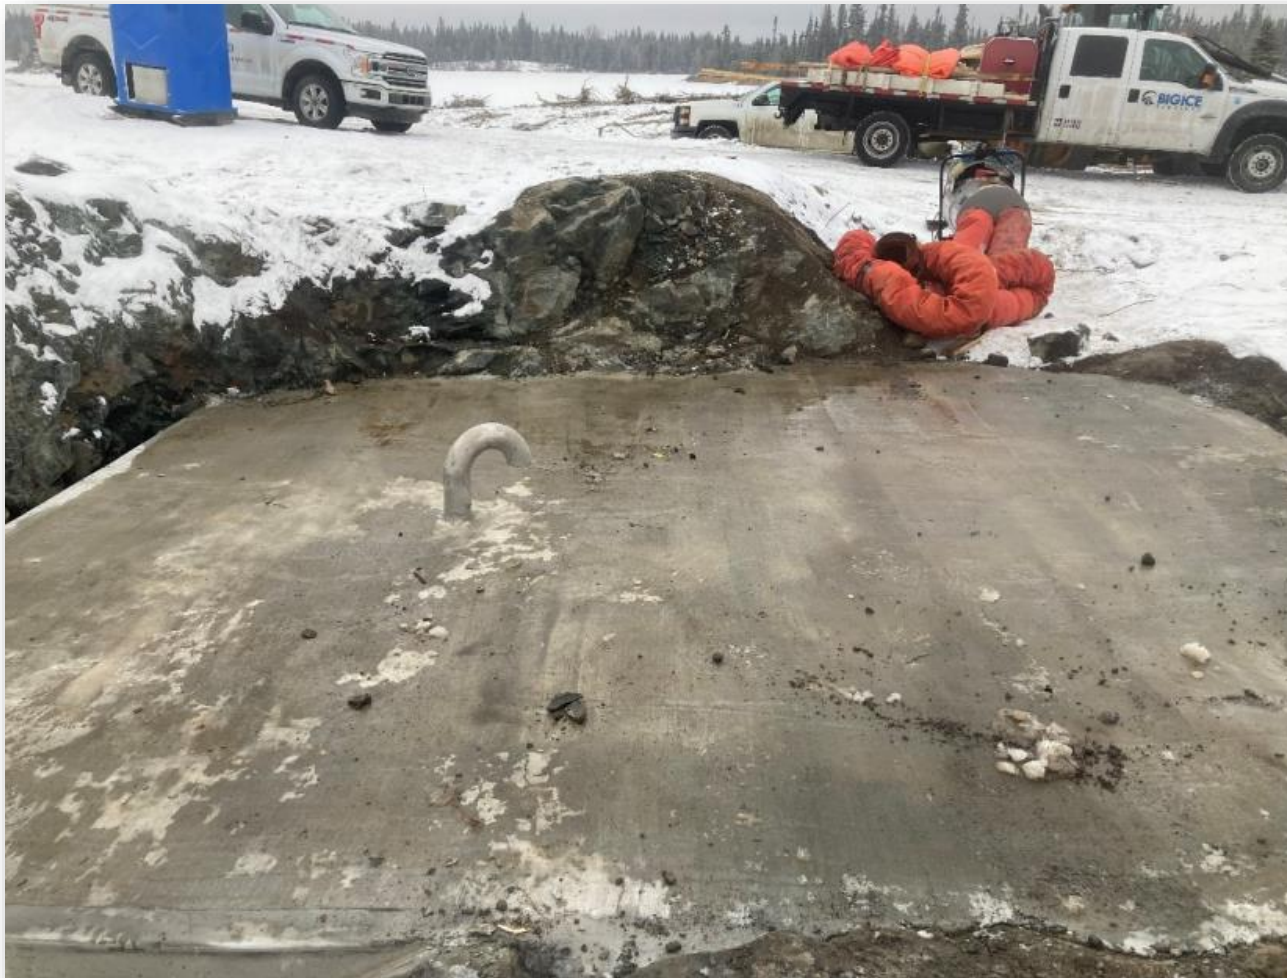
Grade Beam and Slab Demolition

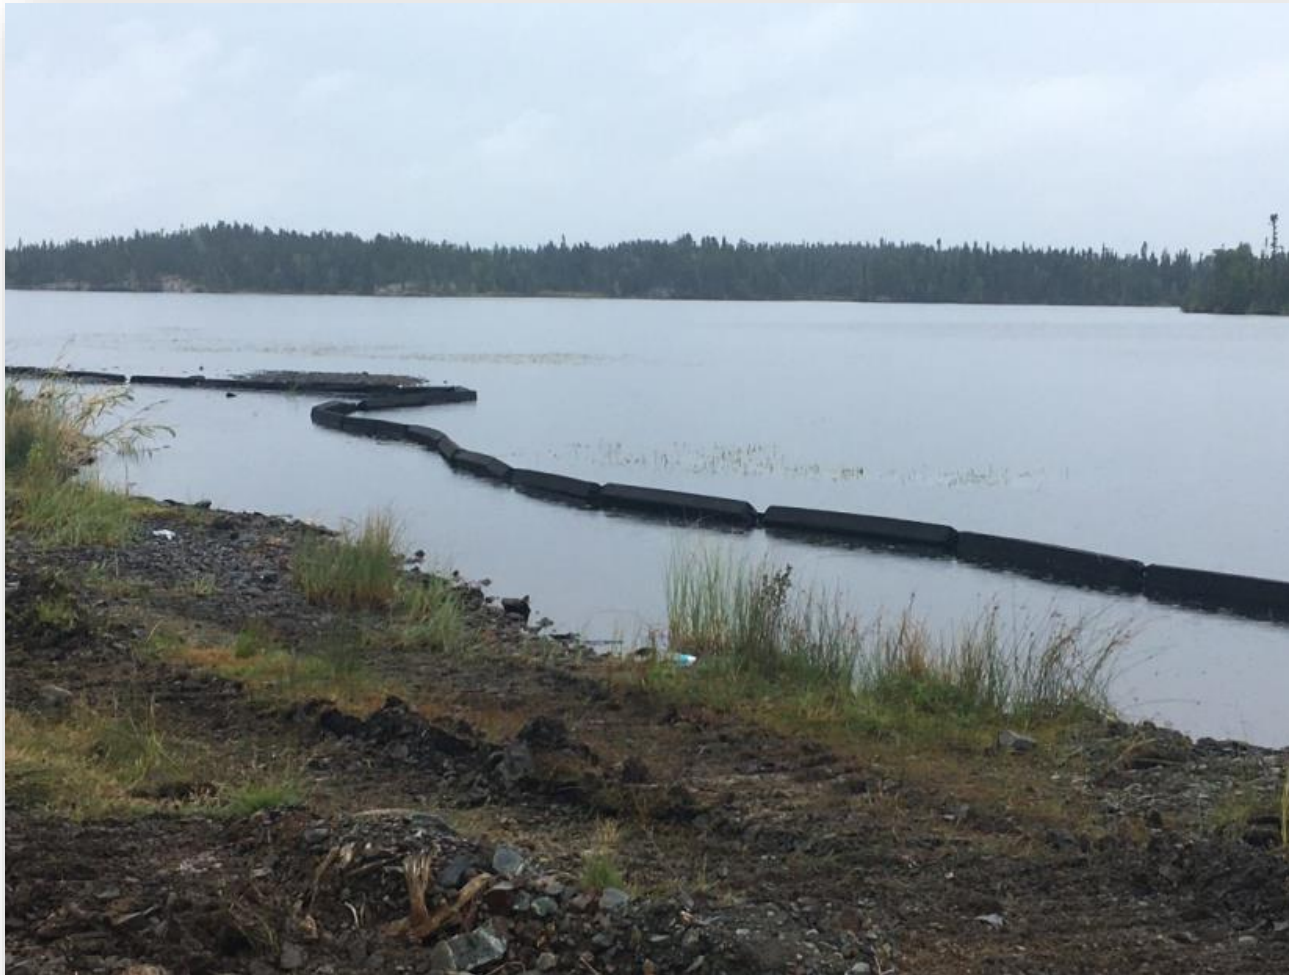
Rip Rap over Submerged Waste Rock and Shoreline

| APEC | Issue | Recommendation |
|---|--|---|
| Douglas Lake | <ul style="list-style-type: none"> -Potential unacceptable risk via recreational ingestion of surface water -No unacceptable risk via human ingestion of fish | <ul style="list-style-type: none"> -Remediate nearshore impacted waste rock -Do not remove submerged waste rock |

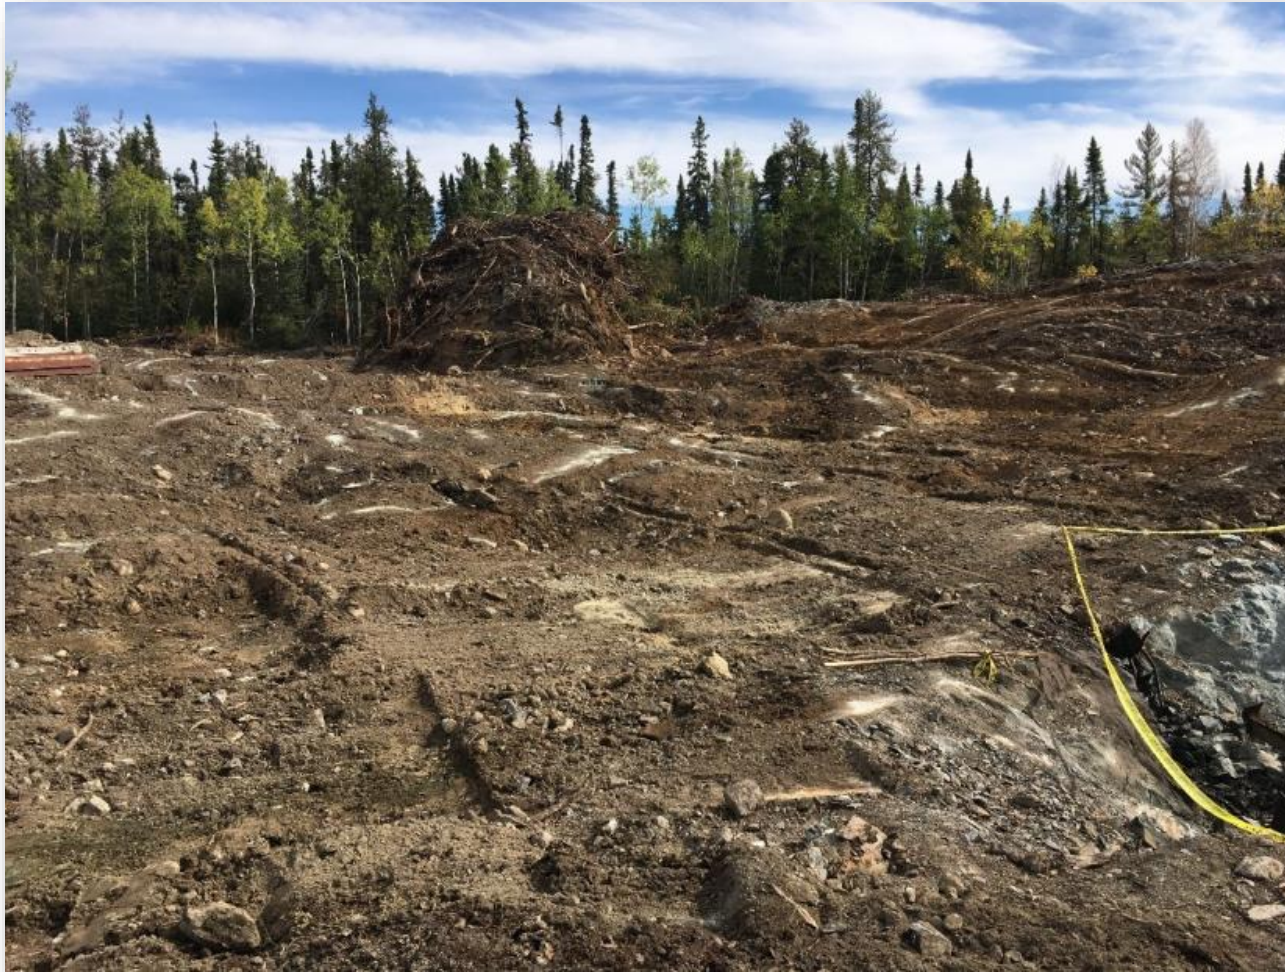
Filter Sand on Landform A

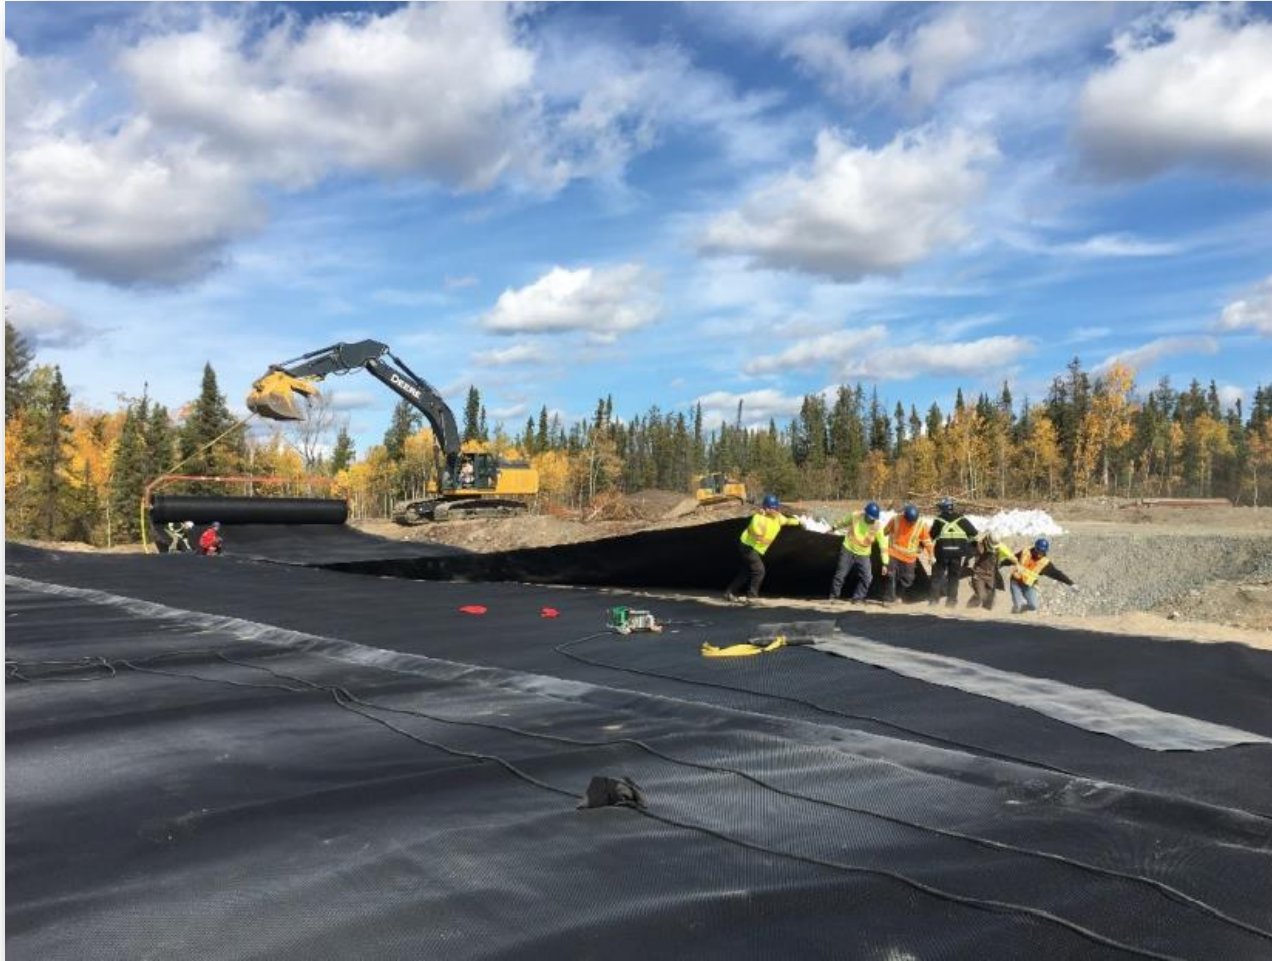
Welding Geomembrane Seams

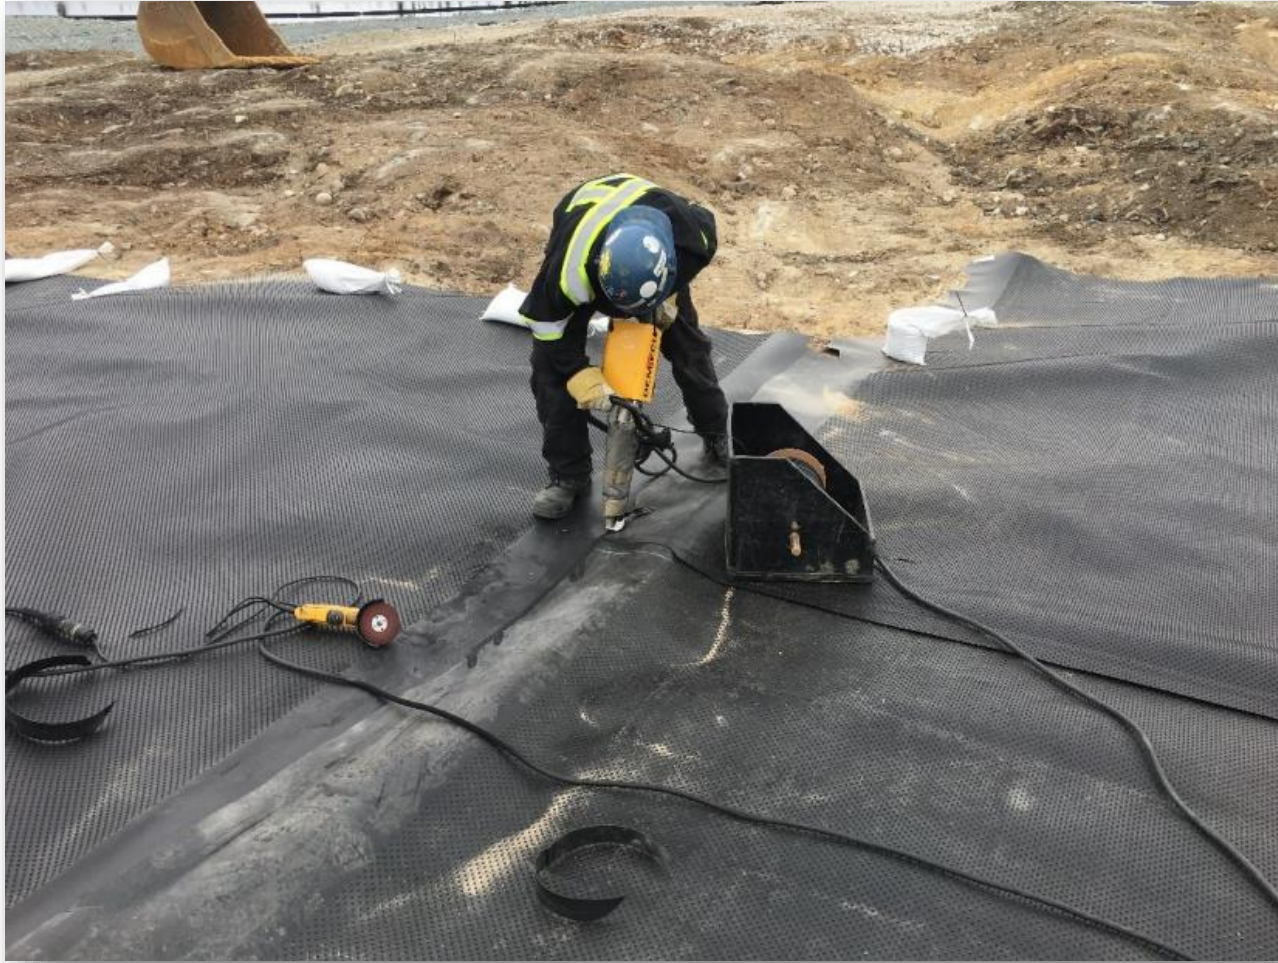
Drainage Net over Geomembrane on Landform B

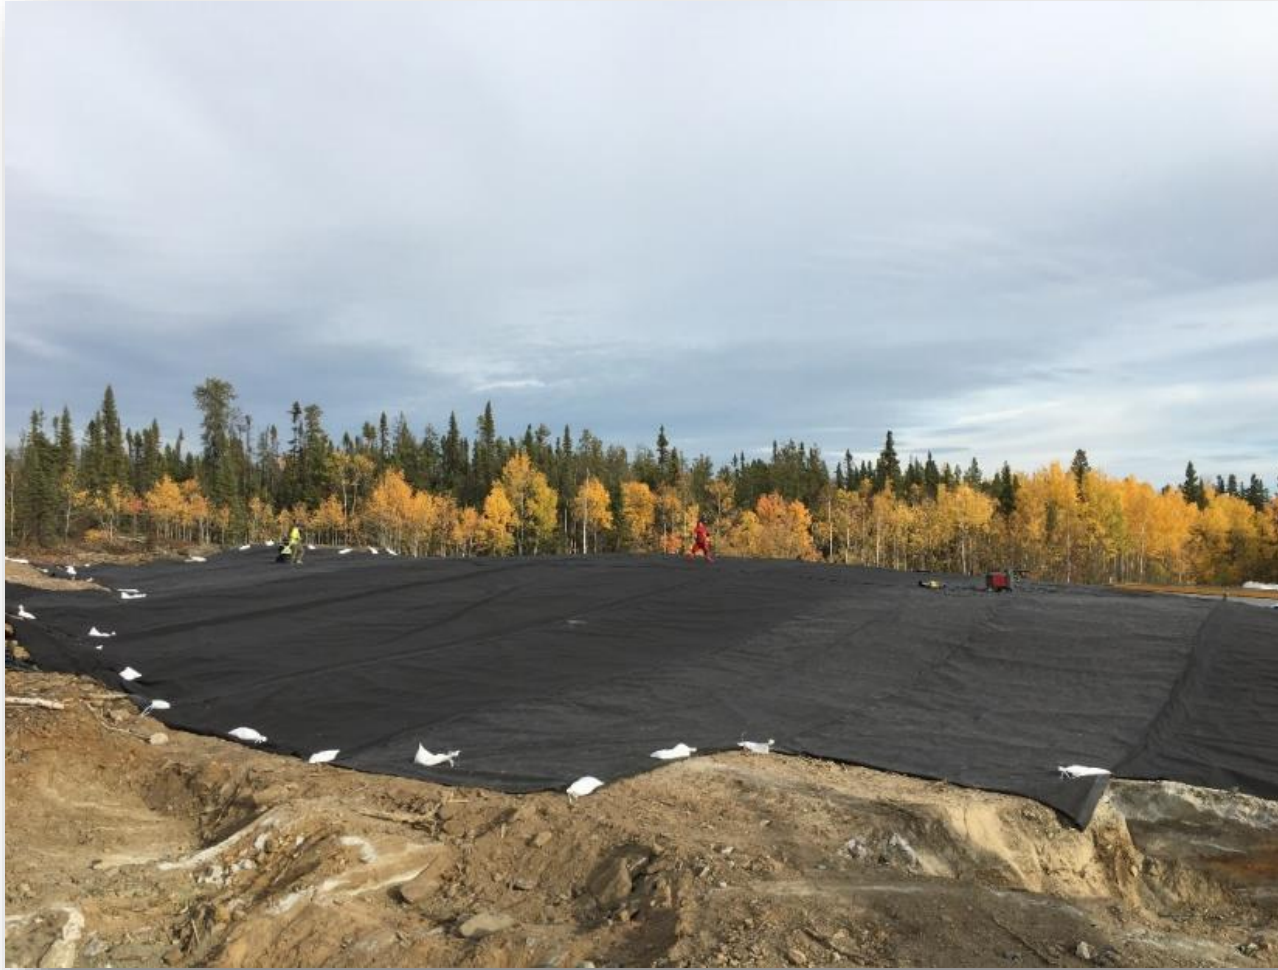
UAV Image of Cover System Installation

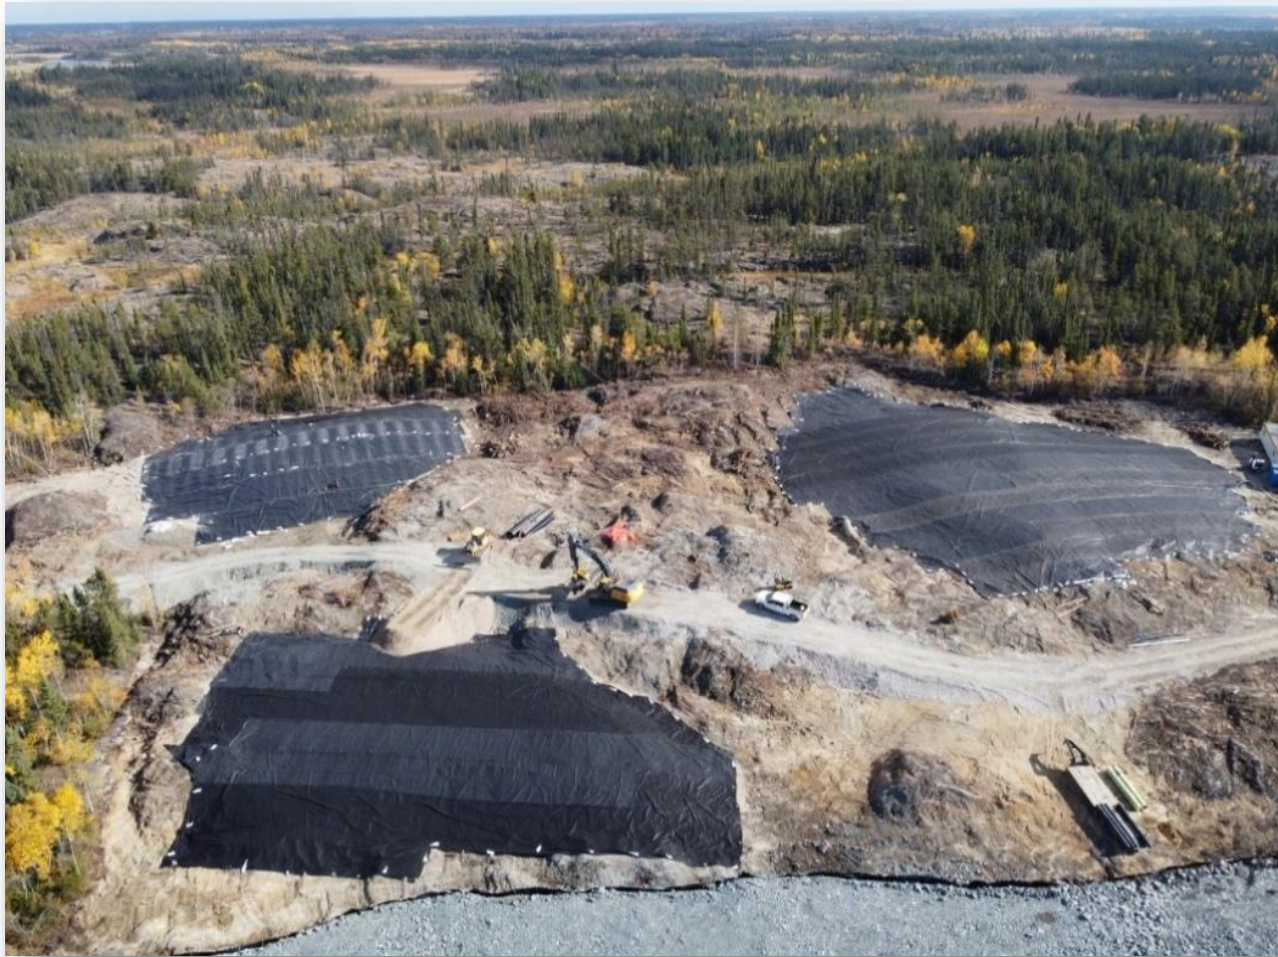
Till Growth Medium Placement

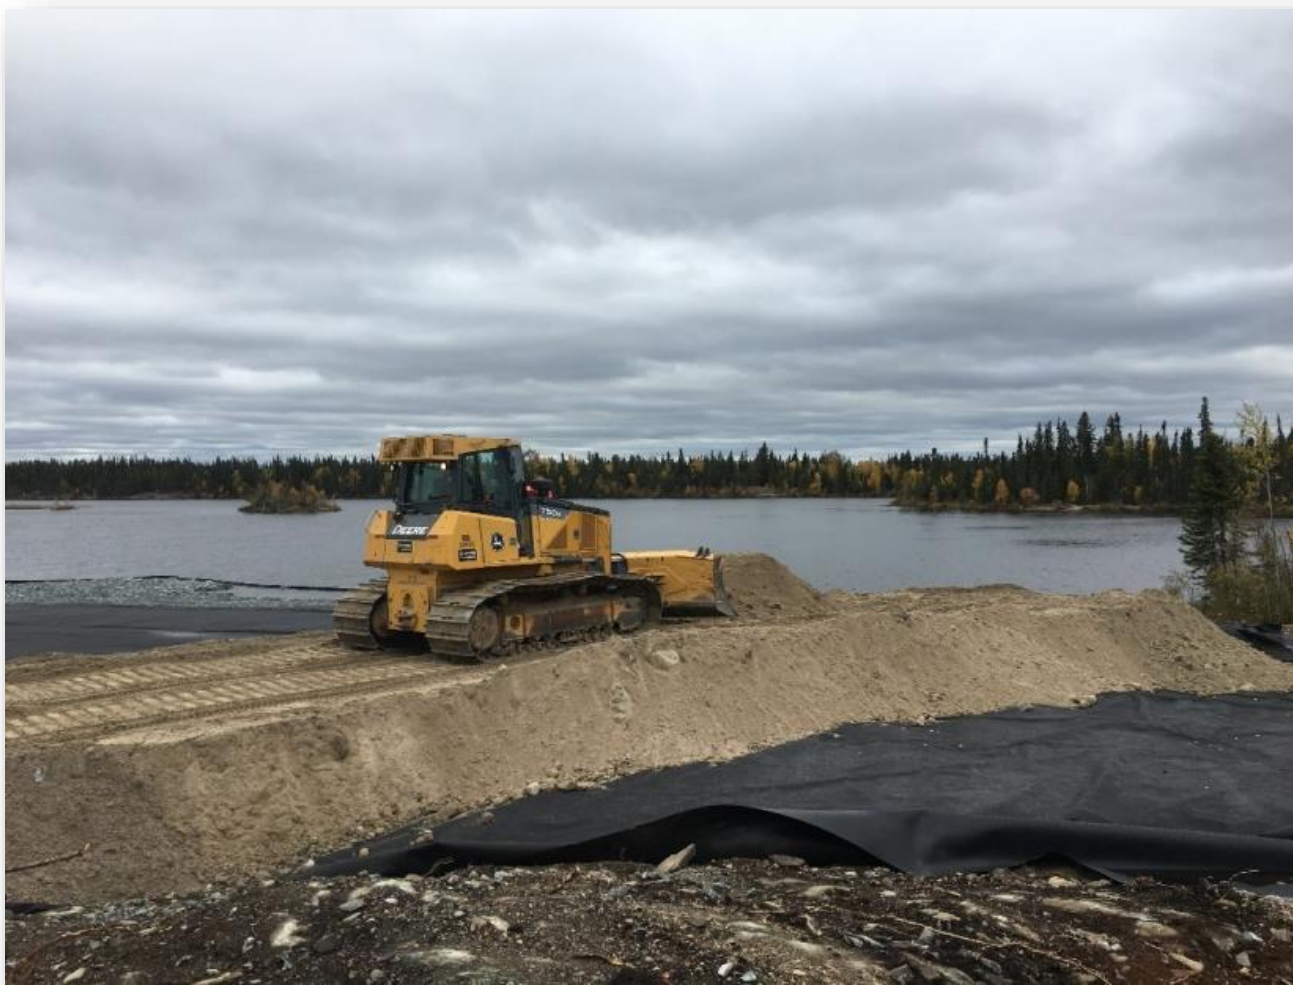
Toe Drain on Landform C

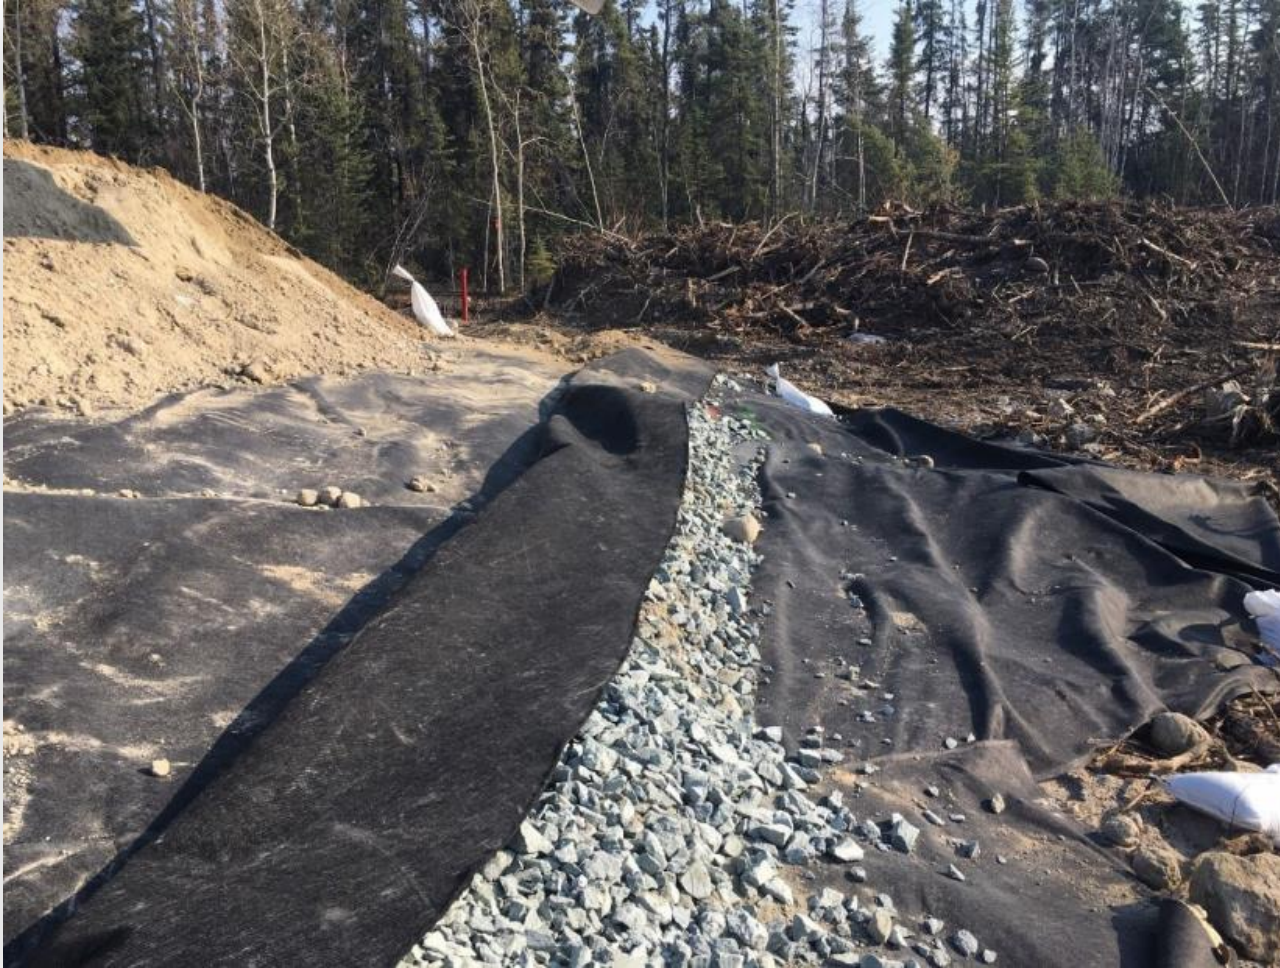
Road Reconstruction
