Using a Risk-Based Approach to Achieve Net Environmental Benefit During Derailment Remediation

Kristjana Zoras – Project Director, GHD

→ RemTech 2022

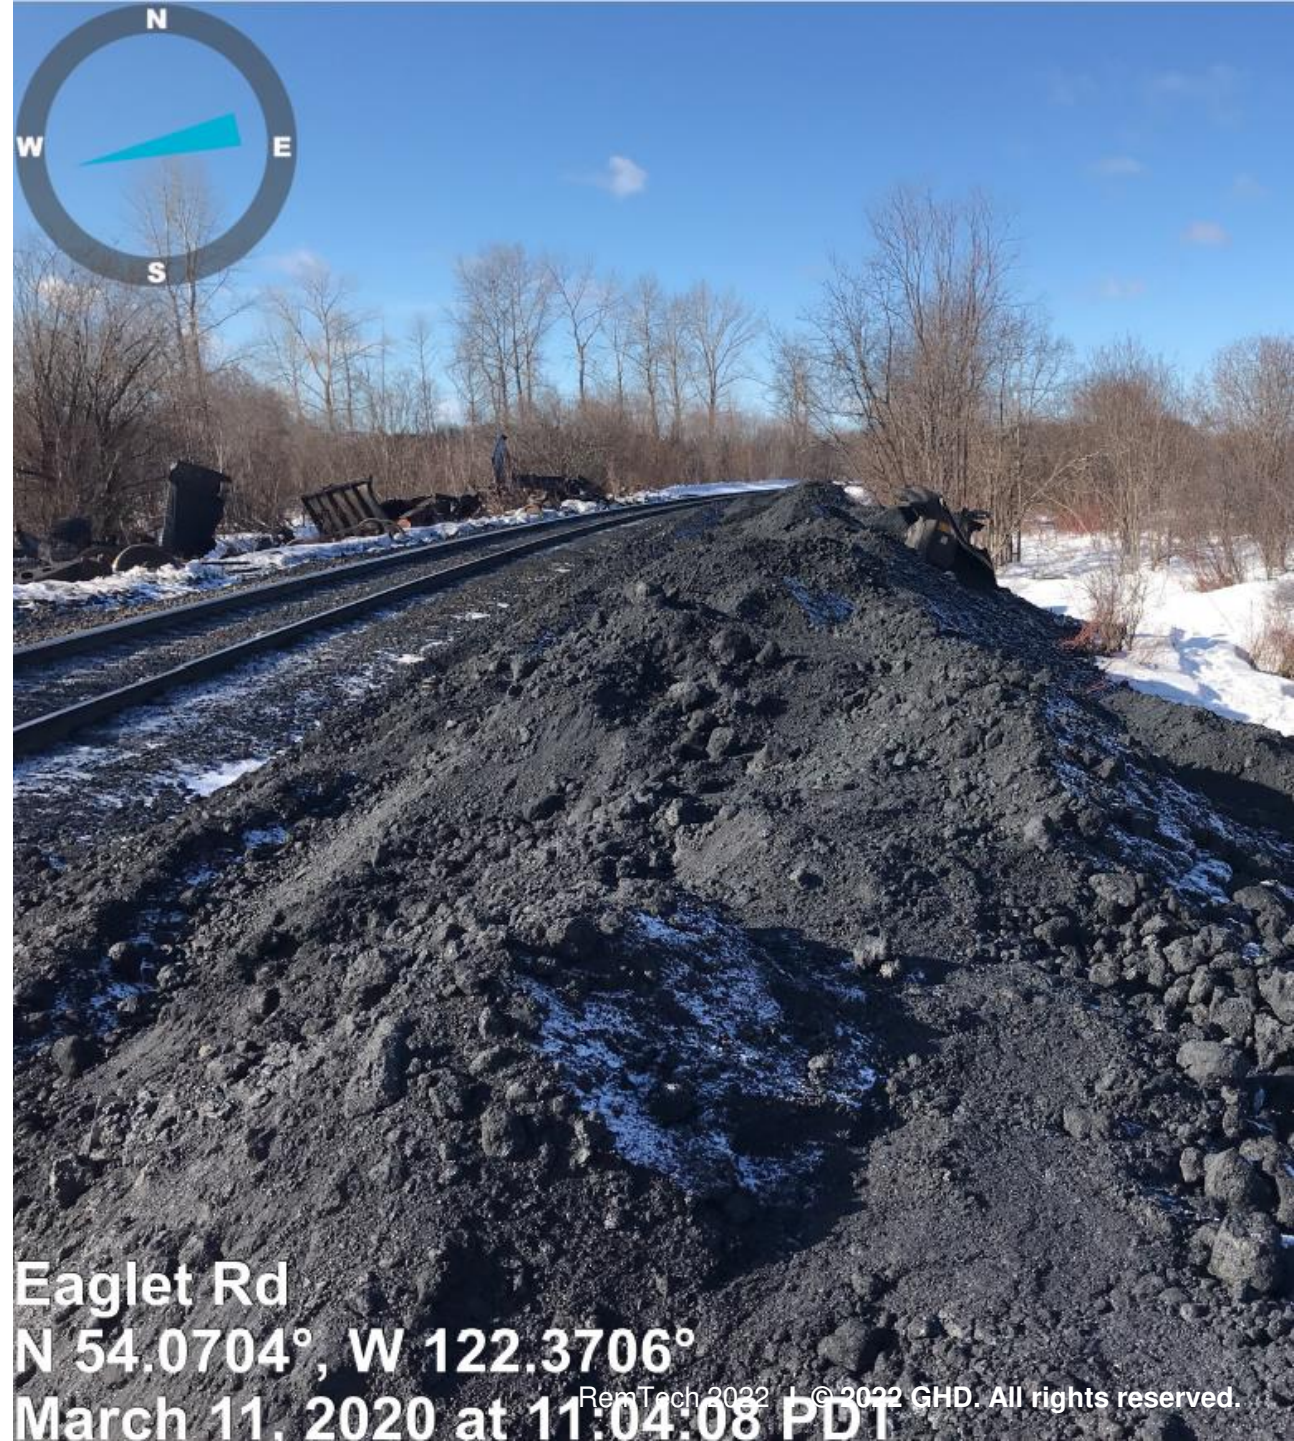
Pet Coke Recovery from Ground

- Contractors removed bulk pet coke and pet coke impacted snow using excavators
- Bulk pet coke recovery in Zones 1, 2, 3, and 4 was completed to the extent practical
- Residual pet coke was recovered using mini excavators, vacuum trucks, and hand tools
- Pet coke containment measures were put in place along the Creek shoreline
 - Floating platform “*Aquatic Custom Dynamic Containment*” aka *ACDC*
 - Silt fencing, plywood sheeting, and polyethylene sheeting along the embankment

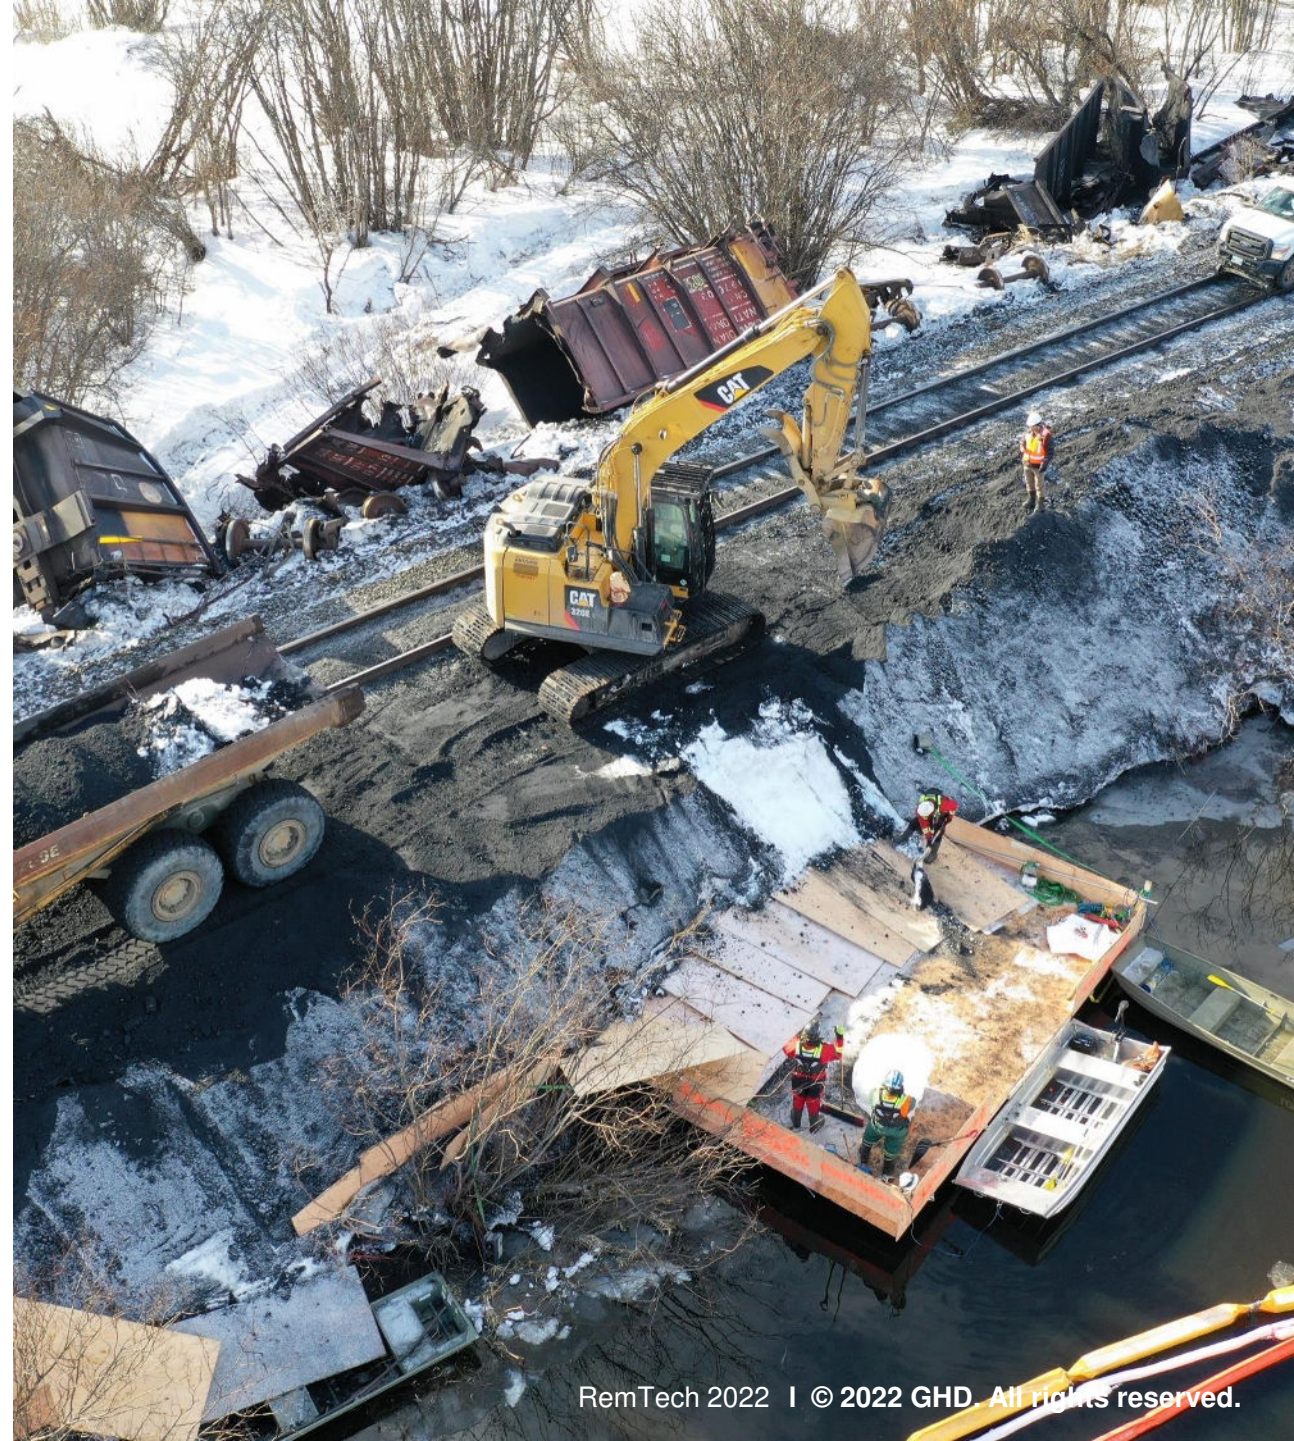
Pet Coke Recovery from Creek

- Containment boom and silt curtain were installed in the Creek to isolate the Source Area
- In-water investigations were conducted to determine extent of pet coke:
 - Underwater remotely operated vehicle (ROV) for visual inspection
 - Ponar for sediment grab sampling
- Majority of the pet coke settled adjacent to the south Creek shoreline
 - 270 m² of bulk (>10% pet coke in sediment)
 - 300 m² of trace (<10% pet coke in sediment)
- Trace pet coke was not recoverable without substantially disturbing aquatic habitats

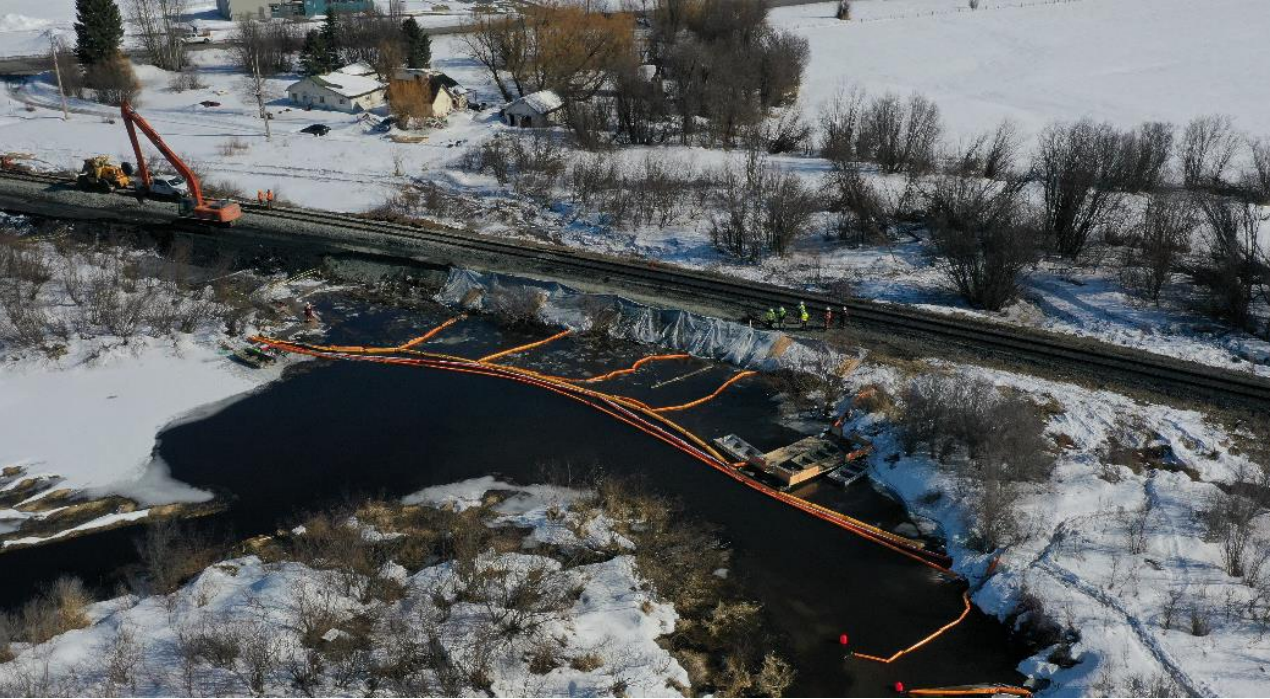
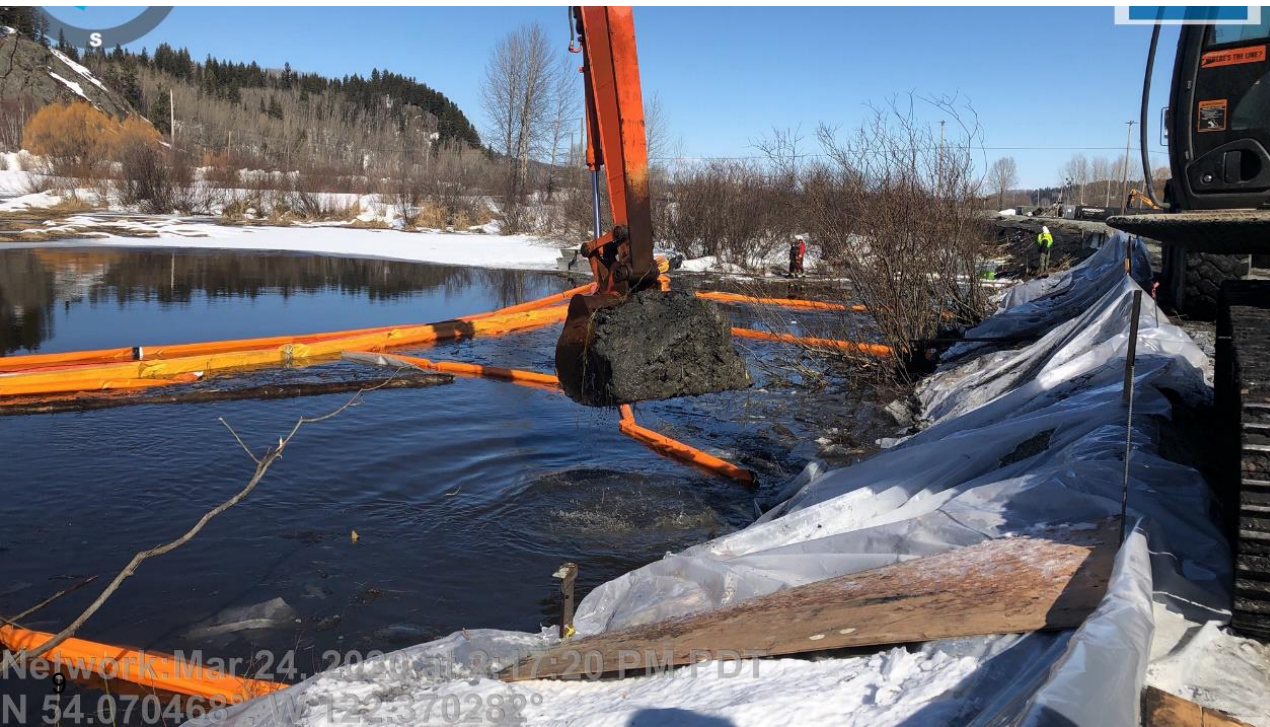
- An excavator was used to recover bulk pet coke from the Creek
- Minimized disturbance to Creek sediments, aquatic habitats, benthic organisms, and organic content, to achieve the greatest net environmental benefit
- Mitigation measures:
 - Dividing work into five separate cells by installing silt curtains
 - Turbidity monitoring at downstream locations

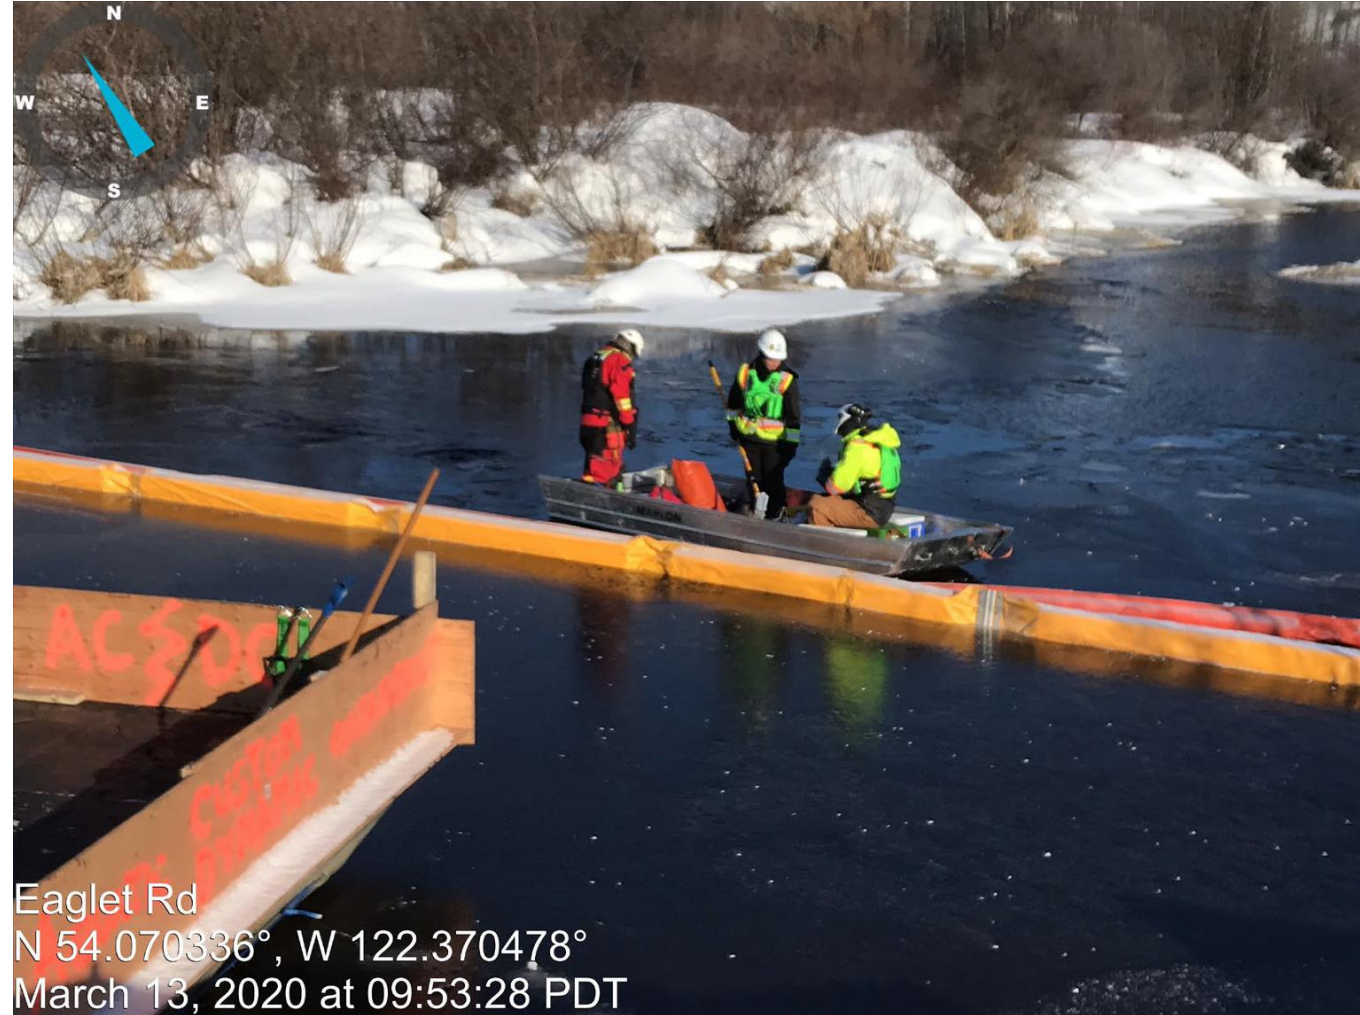
- Sampled along 9.5 km of the Creek
- Grab sampling for chemical analysis and concurrent monitoring of field parameters
 - PHC, VOC, SVOC, total and dissolved metals, pH, TOC, hardness, DOC, TSS
- Five primary sampling locations to determine water quality in the Creek (two upstream, one Source Area, two downstream)
- If the water depth was 1.5 m or more, stratified samples were collected
- If the water depth was less than 1.5 m, one shallow sample was collected

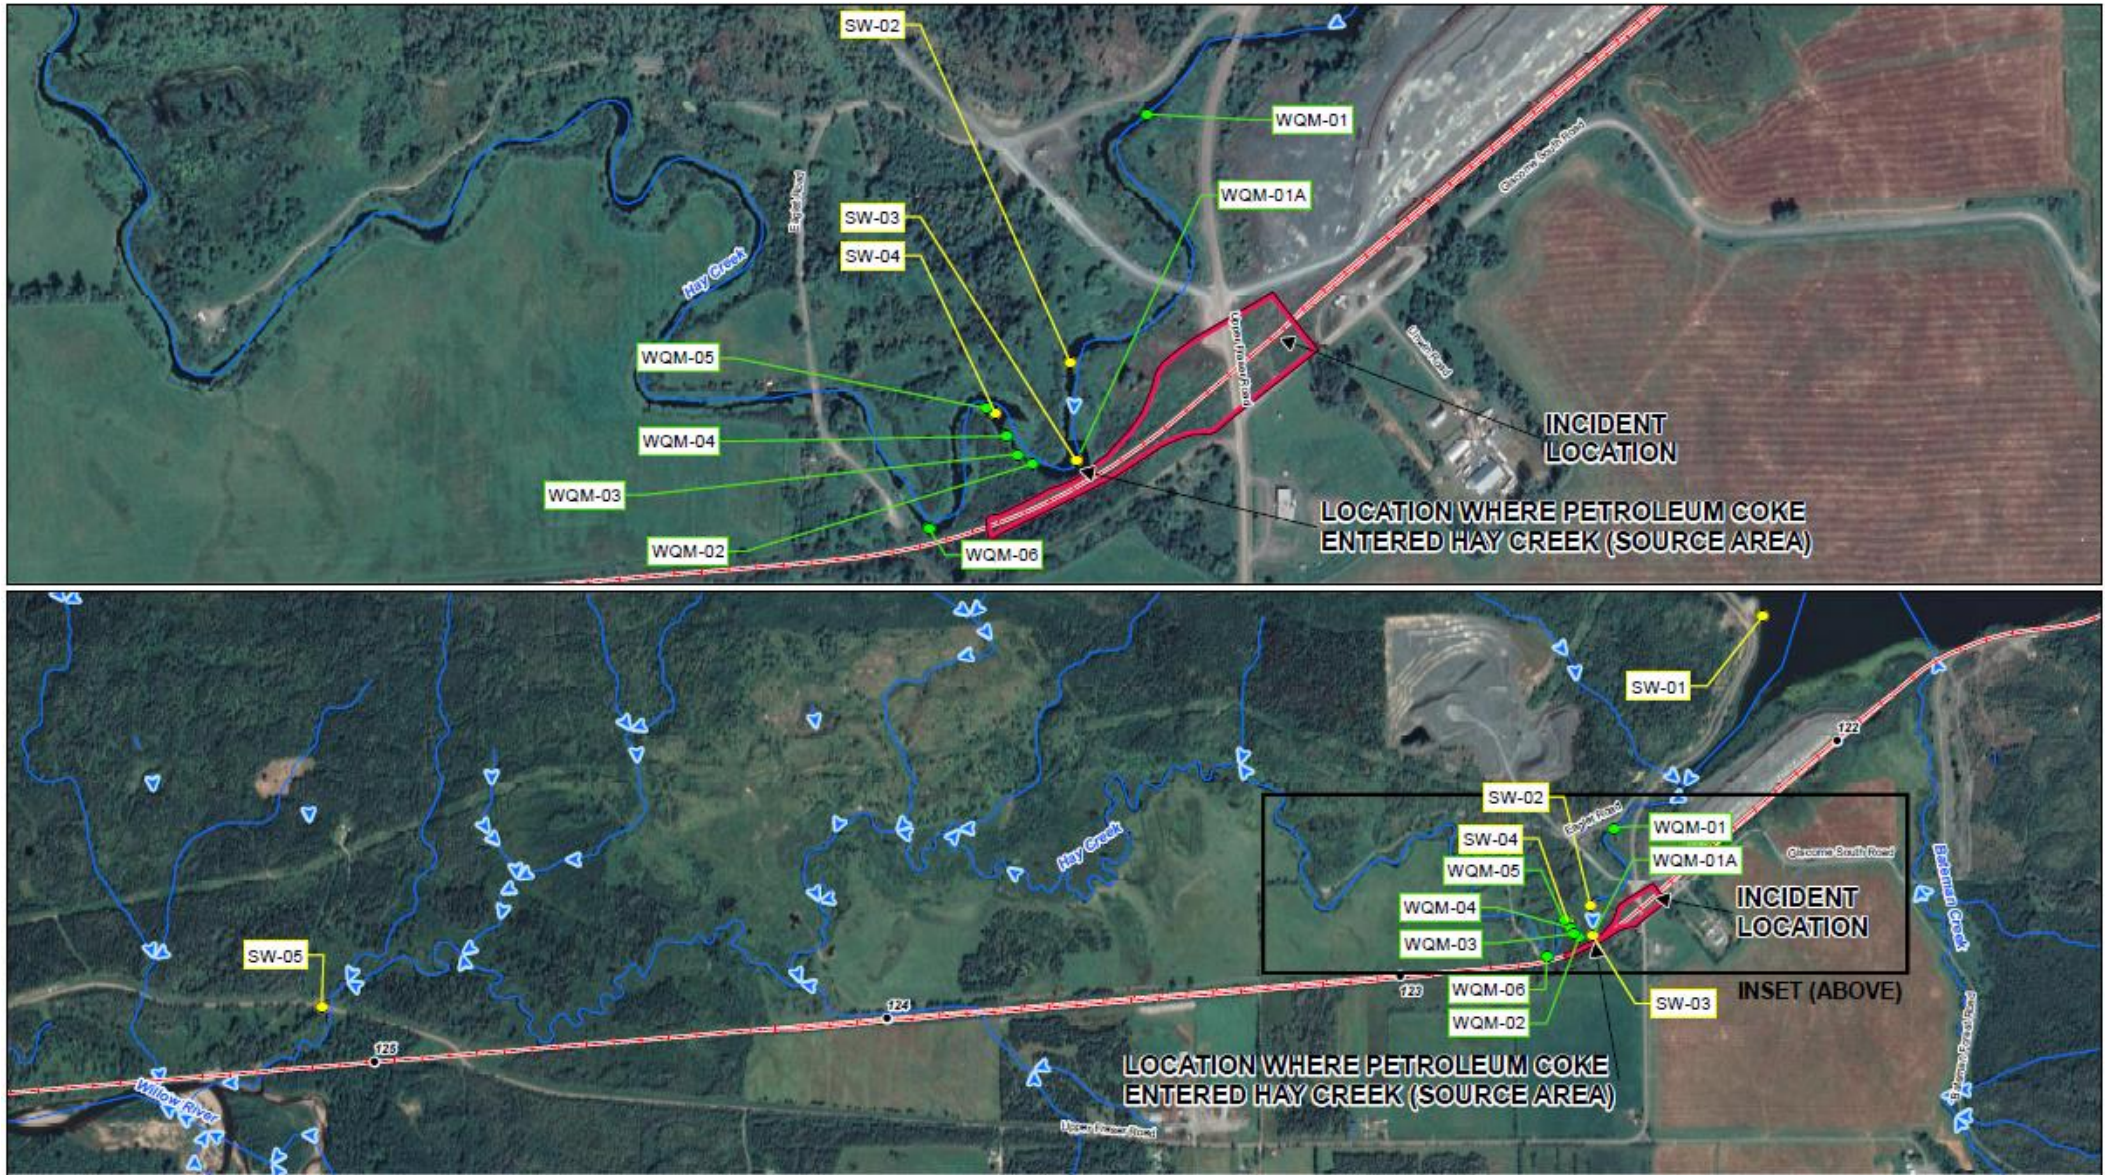
Sediment Investigation

Following recovery work, sediment grab sampling was completed to visually delineate the extent of residual pet coke in the area. It was determined that majority of the bulk pet coke had been removed during the in-Creek recovery.

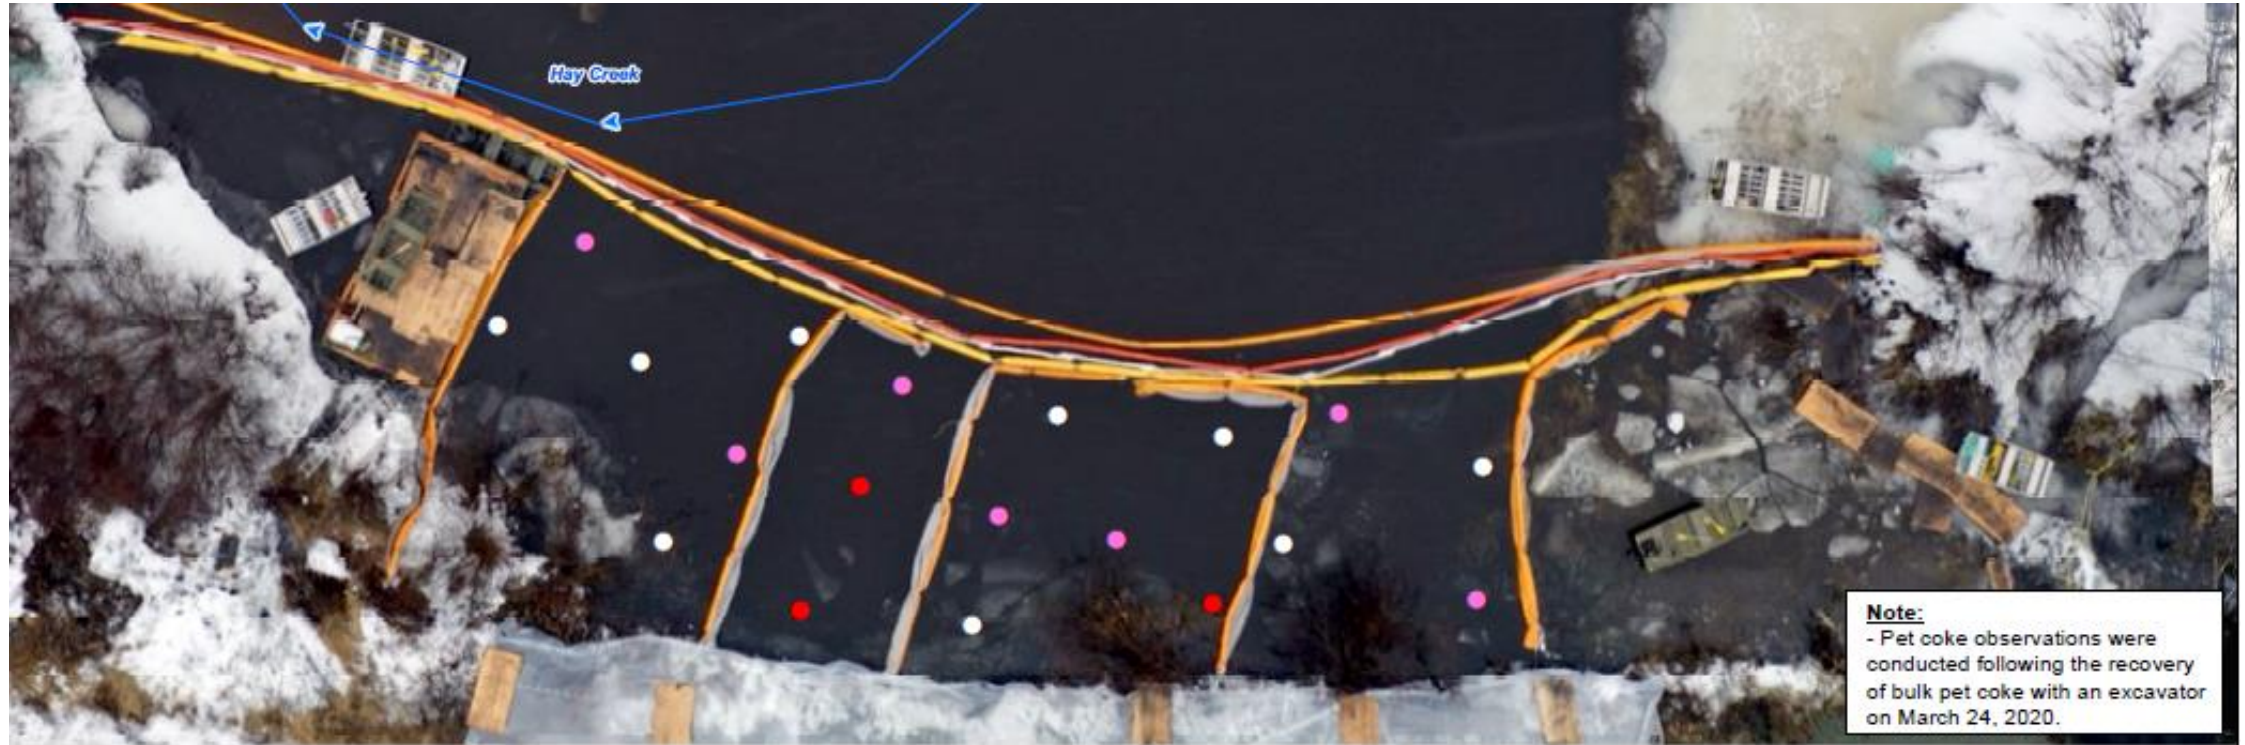
FIGURE 2

CANADIAN NATIONAL RAILWAY
FRASER SUBDIVISION - MP 122.4
GISCOME, BRITISH COLUMBIA
SEDIMENT DELINEATION
VISUAL OBSERVATIONS MARCH 24, 2020

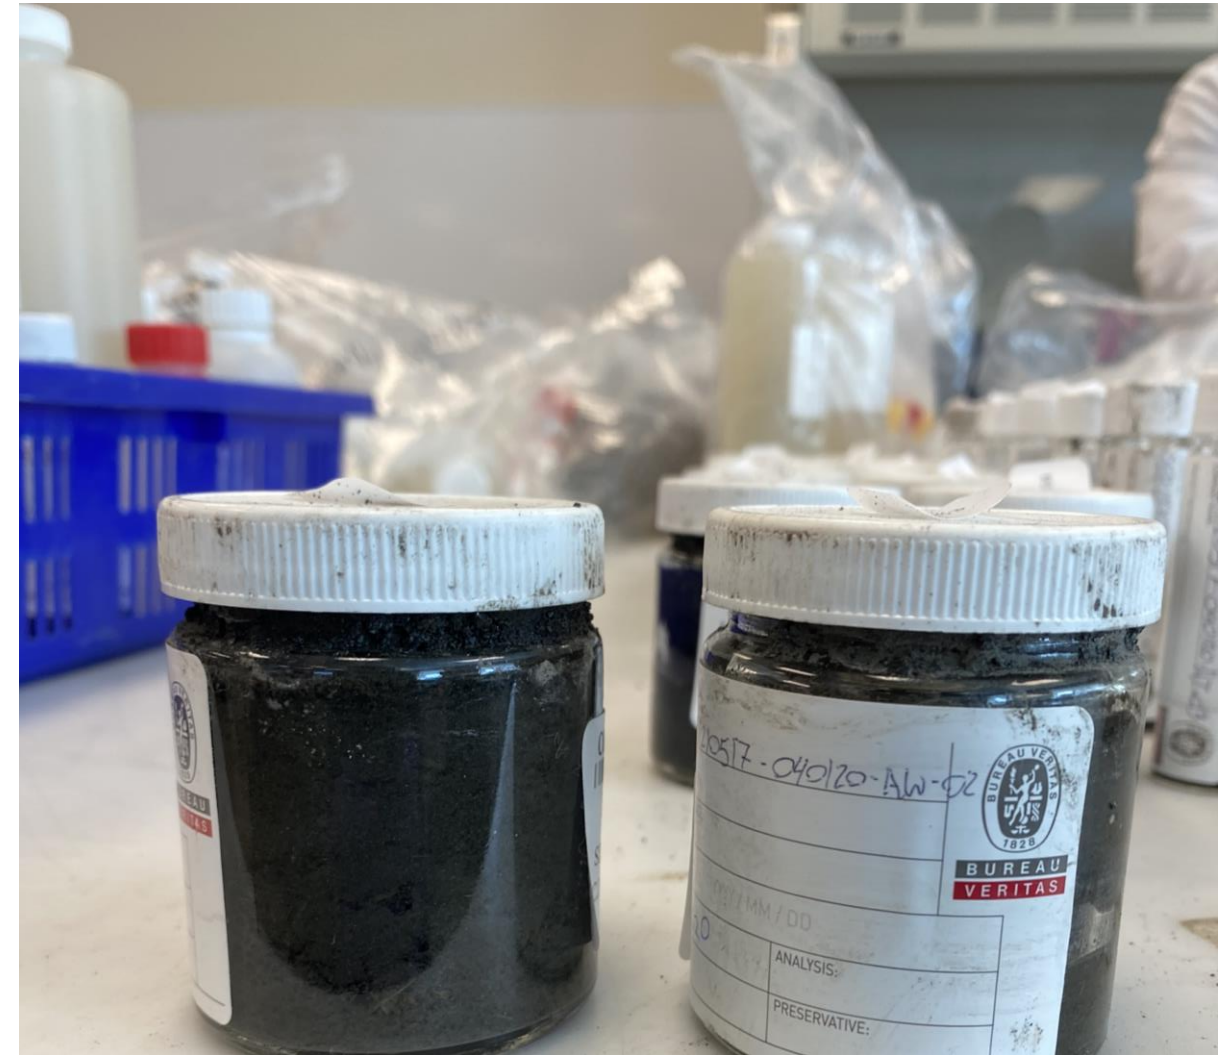
Sediment Risk Results

- Tier 1 and Tier 2
 - Identified potential risk posed by toluene and eight PAHs.
 - Tier 1 and 2 sediment screening benchmark are generic and do not account for a specific mode of ecotoxicity, bioavailability, or sediment pore water as the exposure medium.
- Tier 3
 - Total ESBTUs (the sum of ESBTUs for all BTEX constituents and individual PAHs) were less than the threshold value of 1 for all sediment samples

Therefore, residual concentrations of BTEX and PAHs in sediment in the Creek do not pose risk to benthic organisms

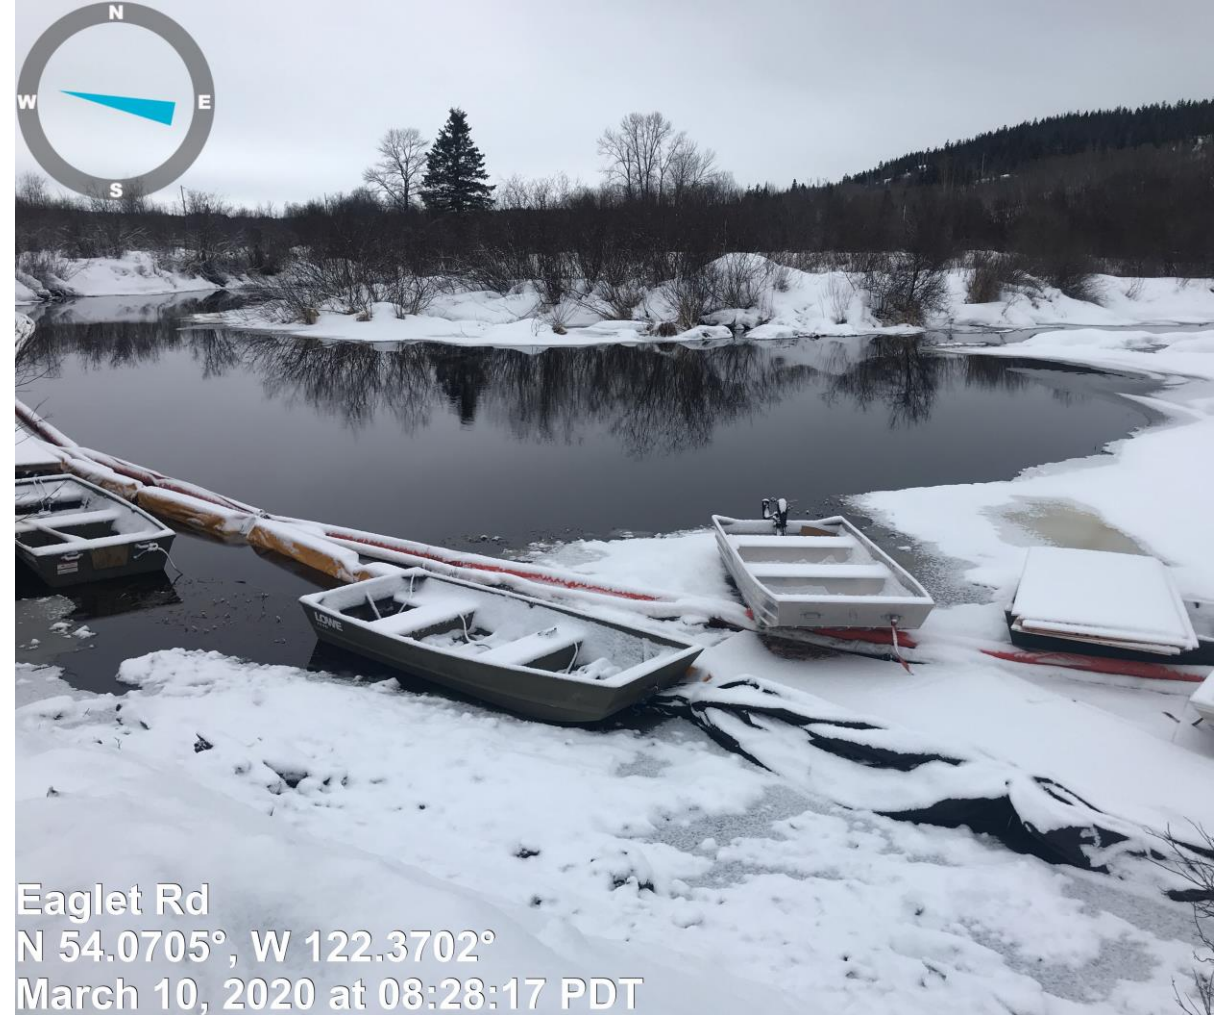
Surface Water Risk Results

- Tier 1
 - Zinc (dissolved) and two PAHs are the only constituents potentially attributable to pet coke that exceeded their screening benchmarks
 - Two PAHs 95% UCL were below screening benchmarks
- Tier 2
 - Zinc (dissolved) exceeded screening benchmarks 50 m upstream and 8 km downstream of the Source Area but not in the Source Area
 - Zinc was not detected in the pet coke leachate
 - Therefore, likely due to natural or other sources unrelated to the derailment
- PHCs detected in limited number of samples. Screening benchmarks for PHCs not available. PHCs are not expected to pose risk to aquatic life because they were not detected in leachate from pet coke, detections were only observed before in-Creek recovery was complete, and they are not expected to be toxic due to low solubility.

Therefore, none of the constituents potentially attributable to pet coke poses risk to aquatic life in surface water of the Creek
