# Emergency Response and Remediation of a Crude Oil Release in Abbotsford, BC

Andrea Leroux – Environmental Specialist, Trans Mountain  
Kristjana Zoras – Project Director, GHD

→ RemTech 2022

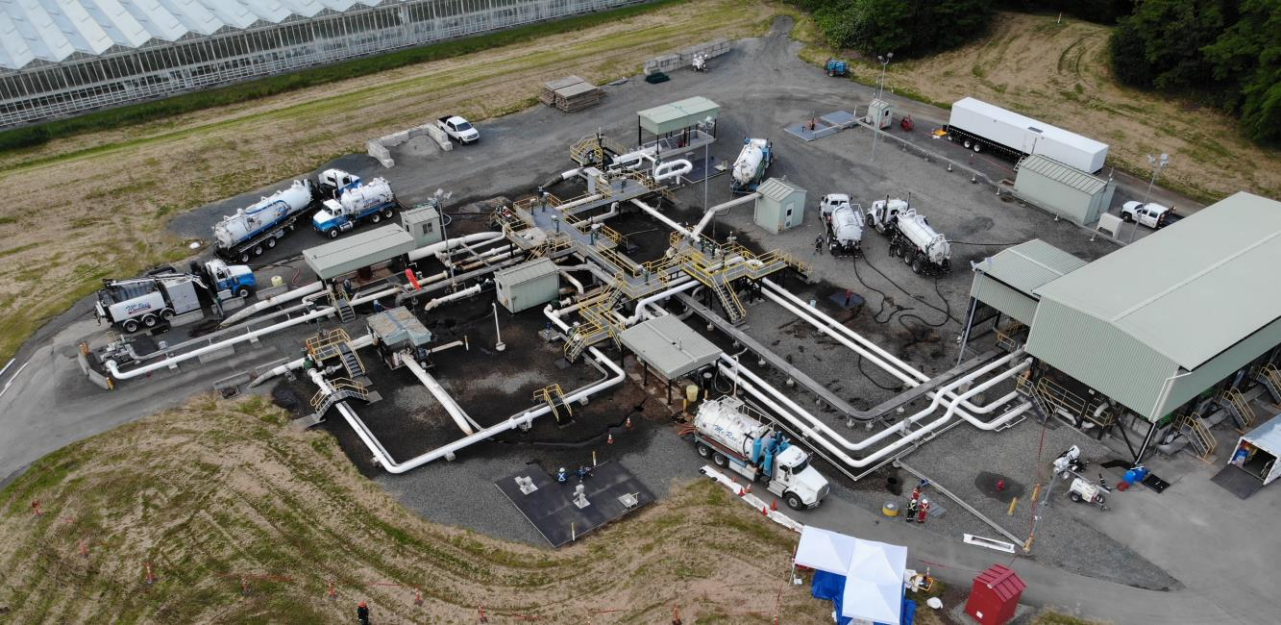
*Aerial view of northern portion of Site*

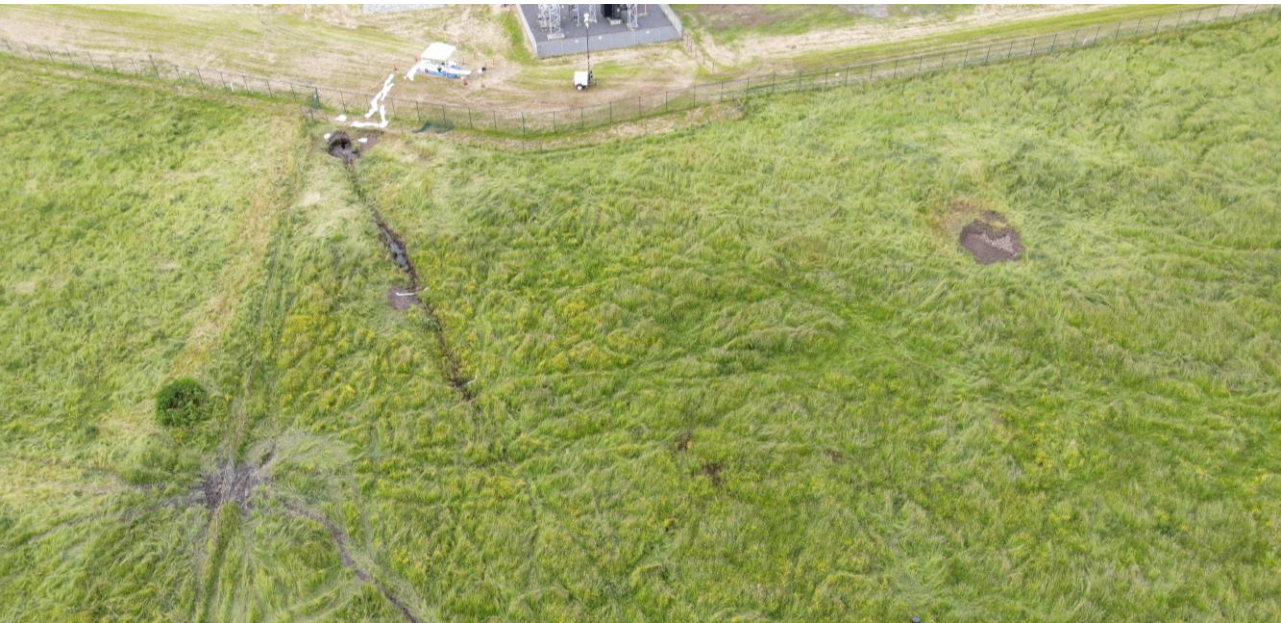
*Aerial view of southern portion of Site*

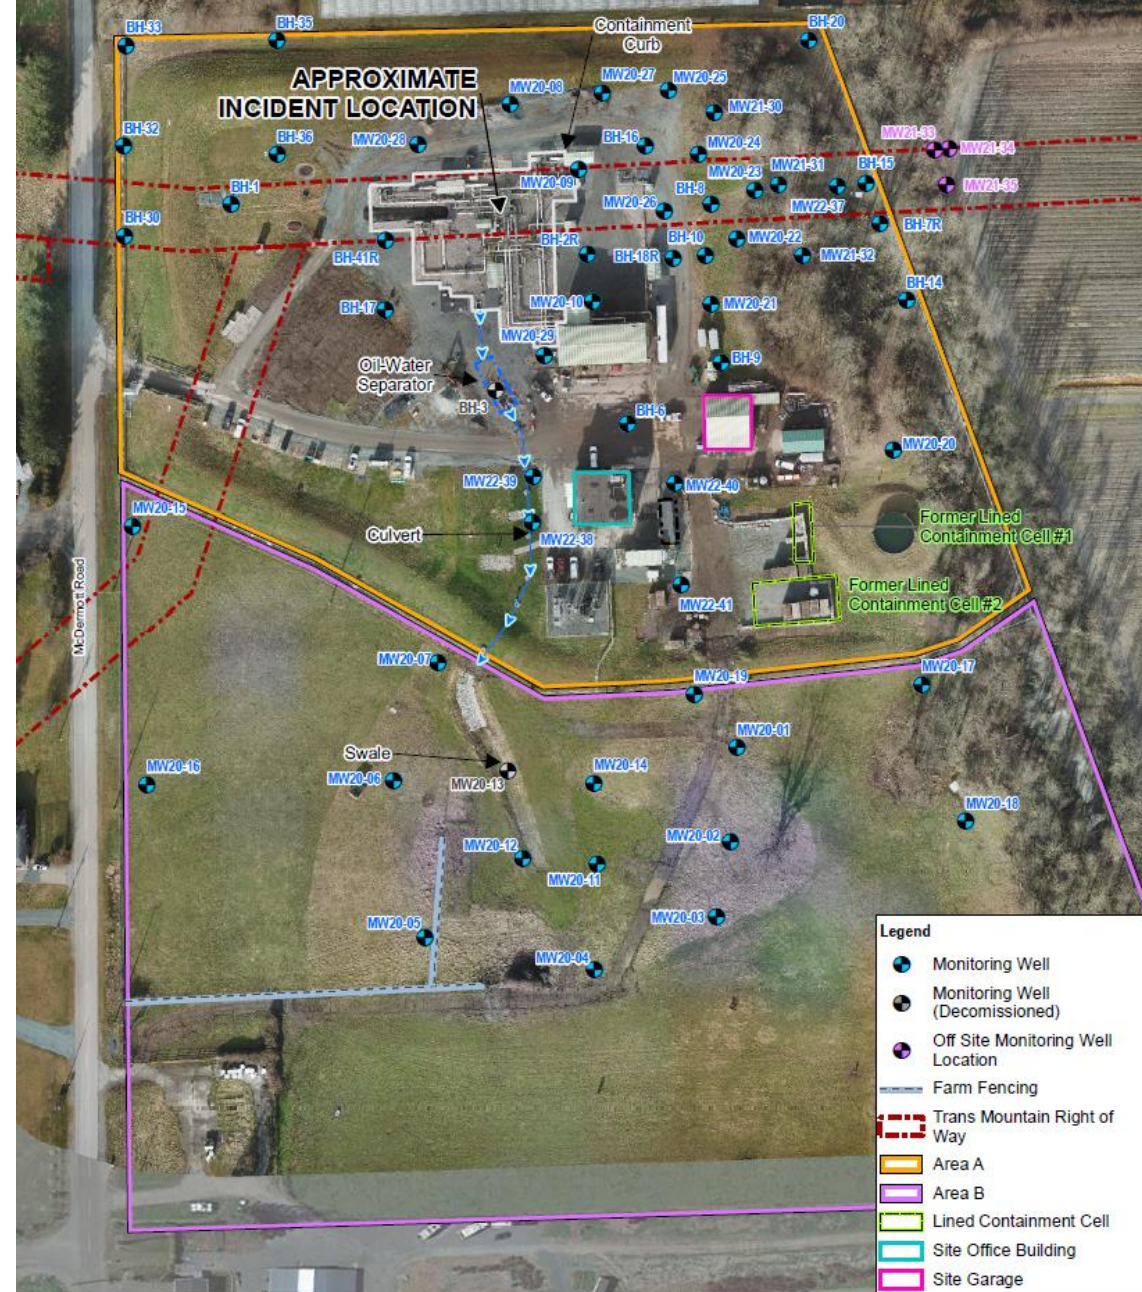
- Area A – Sumas Pump Station in the north portion of the property
- Area B – TM owned agricultural field to the south
- Culvert – Located between Area A (inlet) and Area B (outlet)

*Aerial view of pump station with approximate incident location*

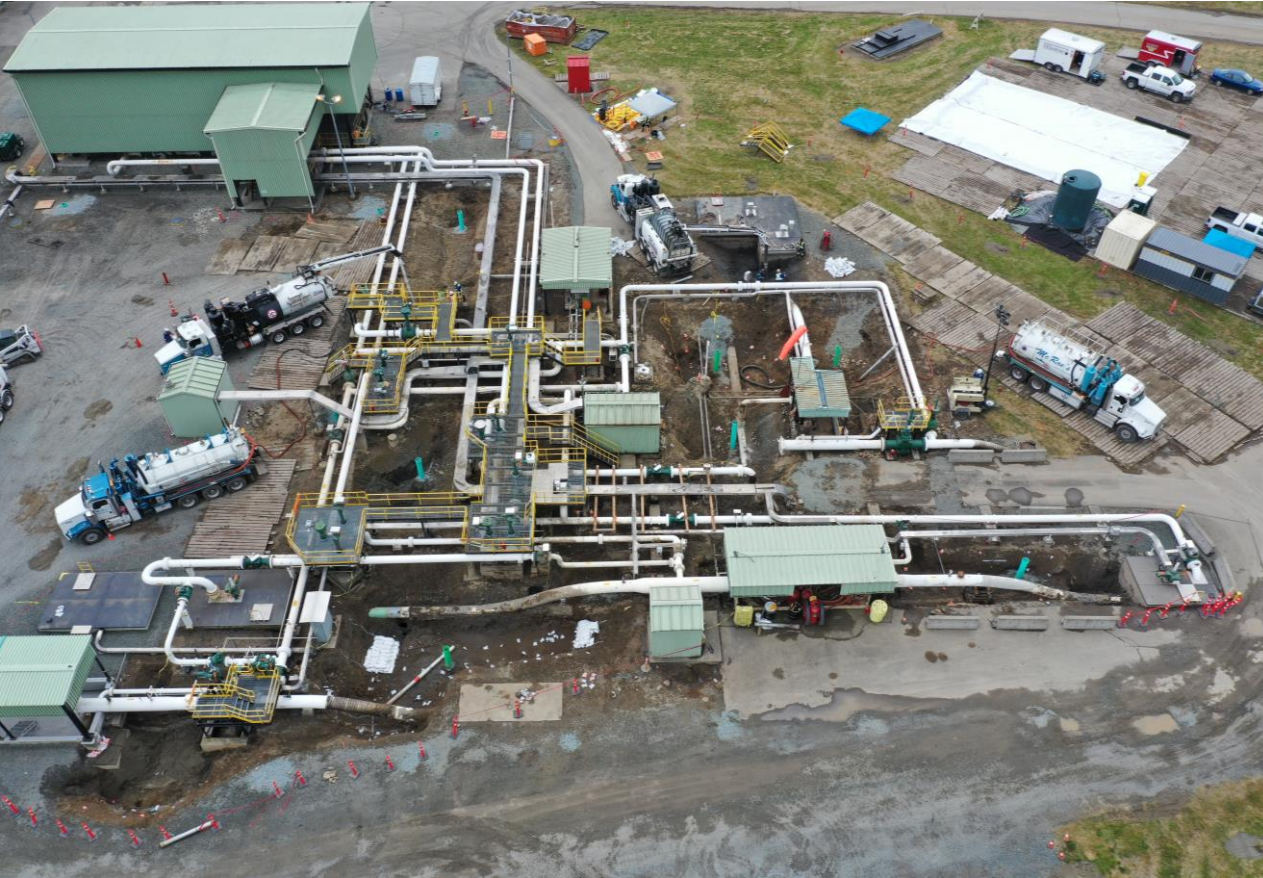
**Excavation and product recovery around existing infrastructure**

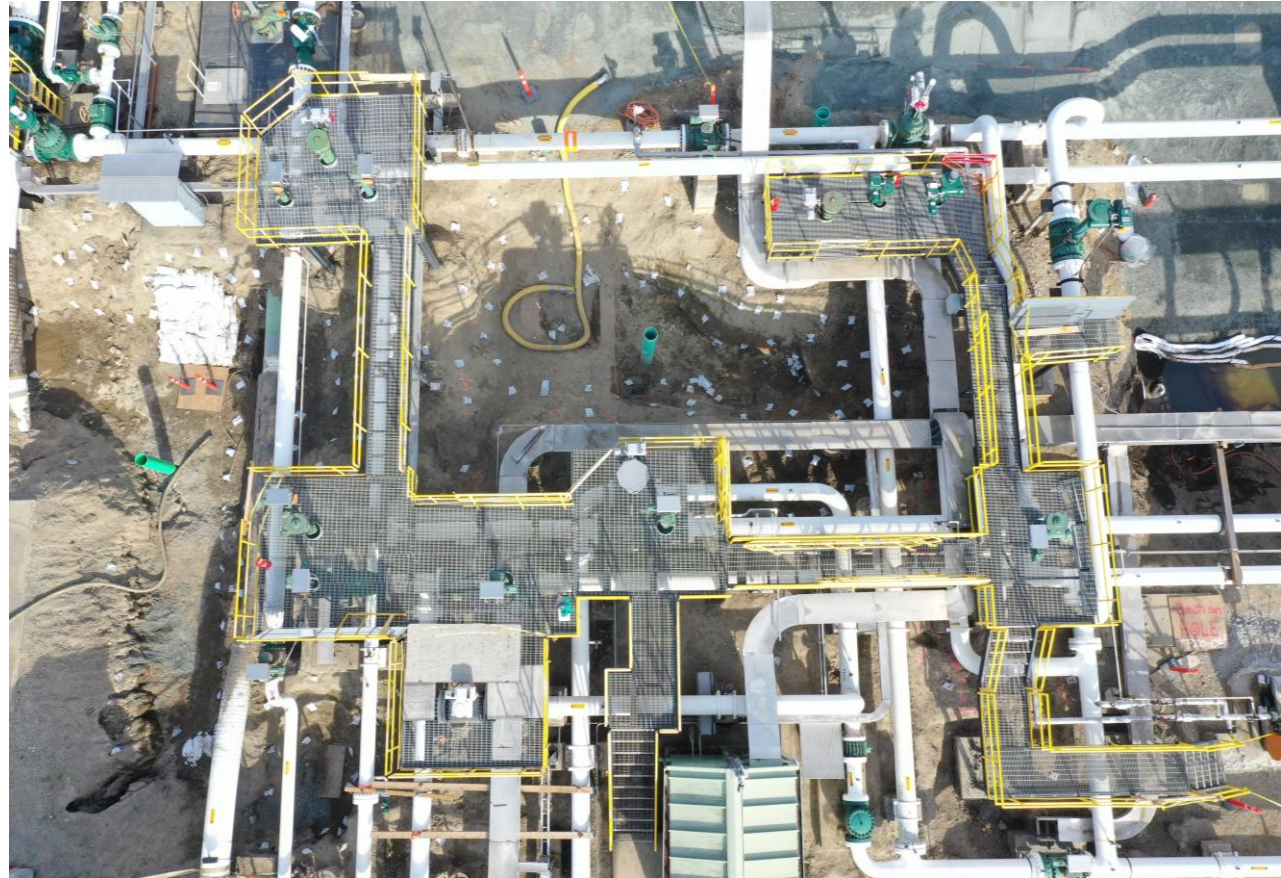
**Working within complex geotechnical and facility restraints**

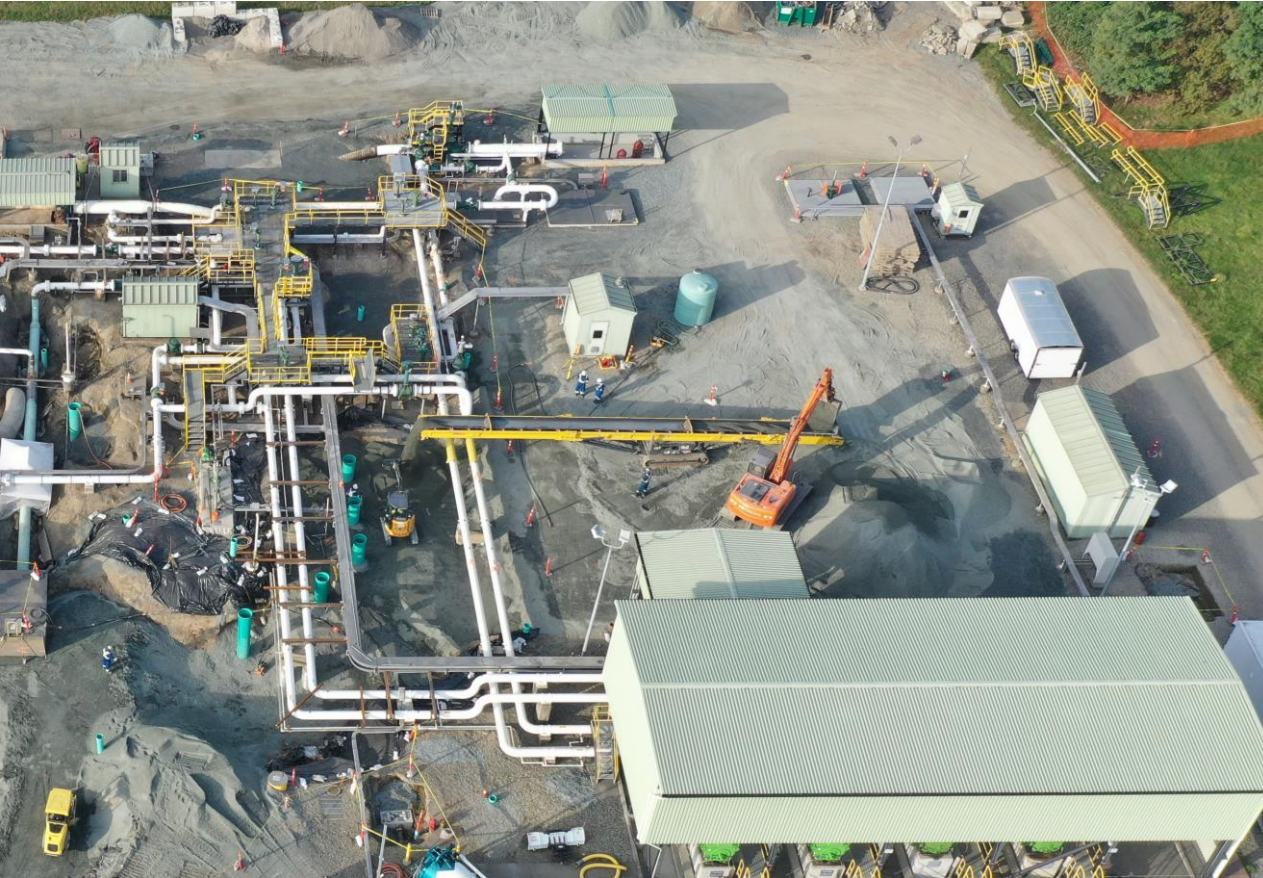
**Completing backfilling activities with limited access**

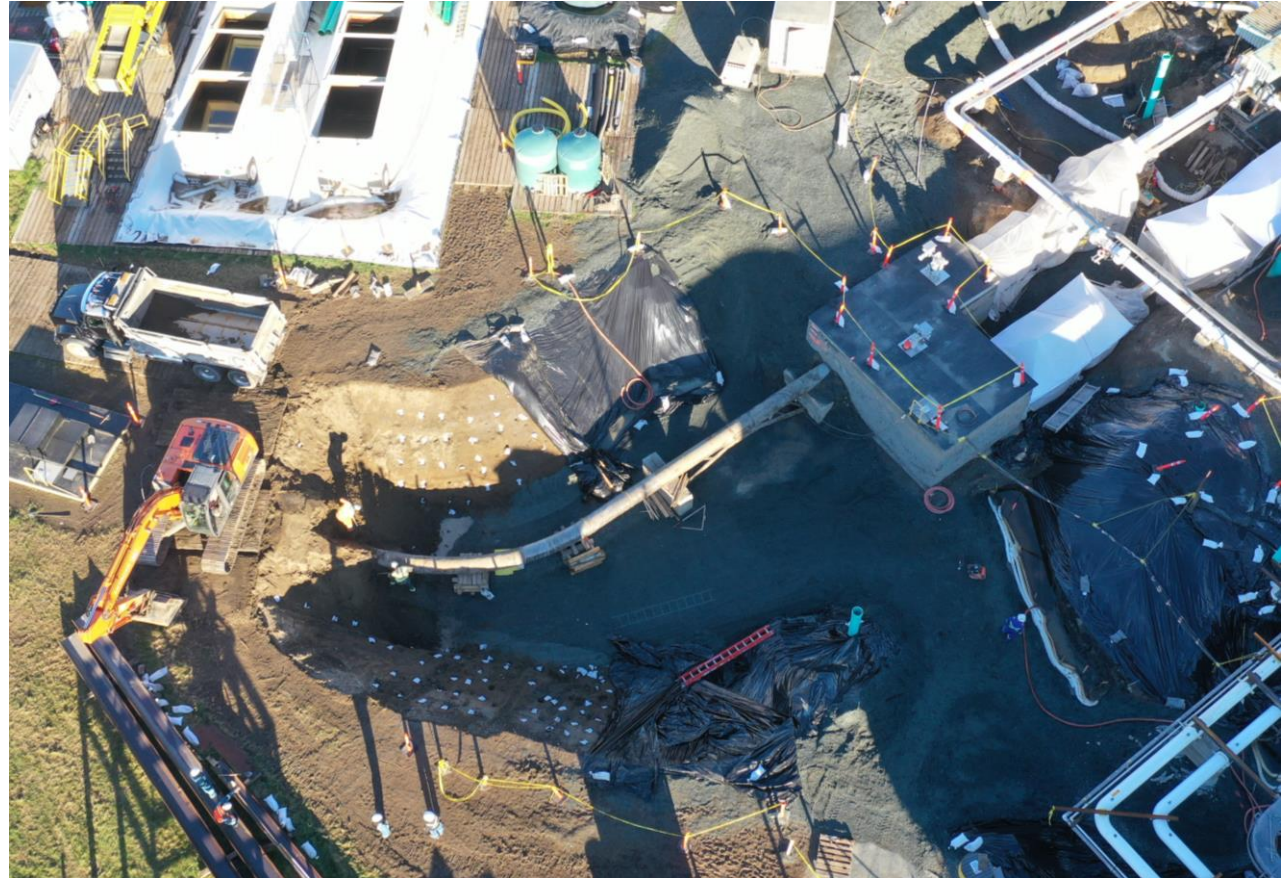
**Excavation and product recovery at a live pump station**

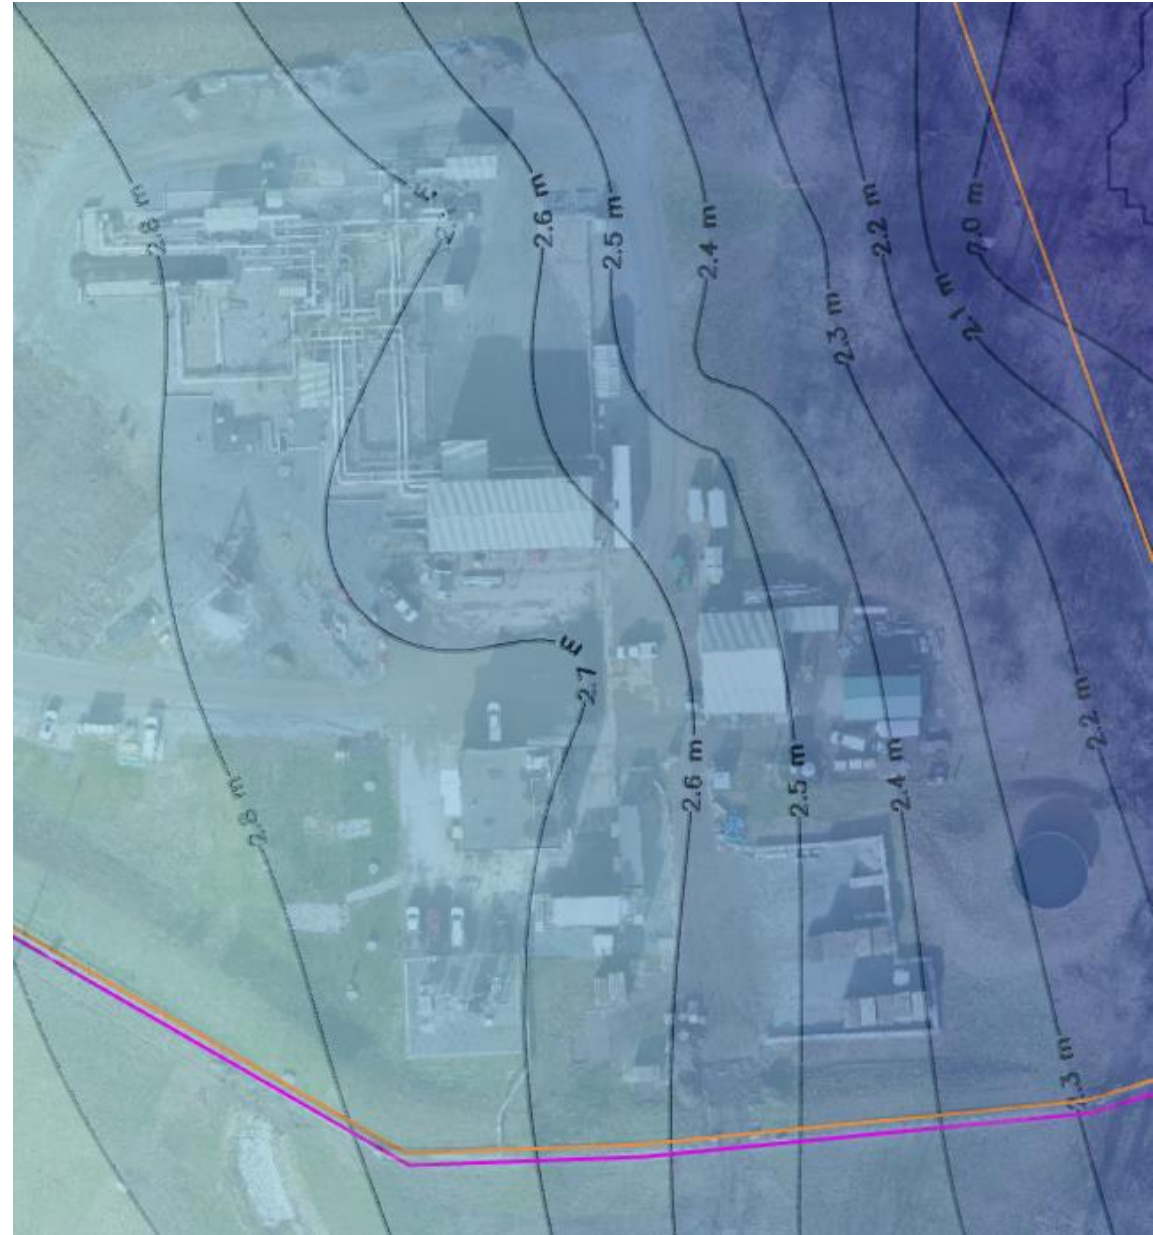
- Groundwater flow direction has been observed to the east to east-northeast
- Groundwater table is typically located between 1.5 to 3.5 m below ground surface and varies seasonally
  - Decrease of 0.6 to 1.6 m between the wetter winter season and drier summer season
- Groundwater flow velocity is seasonally influenced, with a 120-130% increase observed from the drier summer season to the wetter winter season.
  - This is due to an increase in the groundwater elevations and horizontal hydraulic gradients during the wetter winter season.

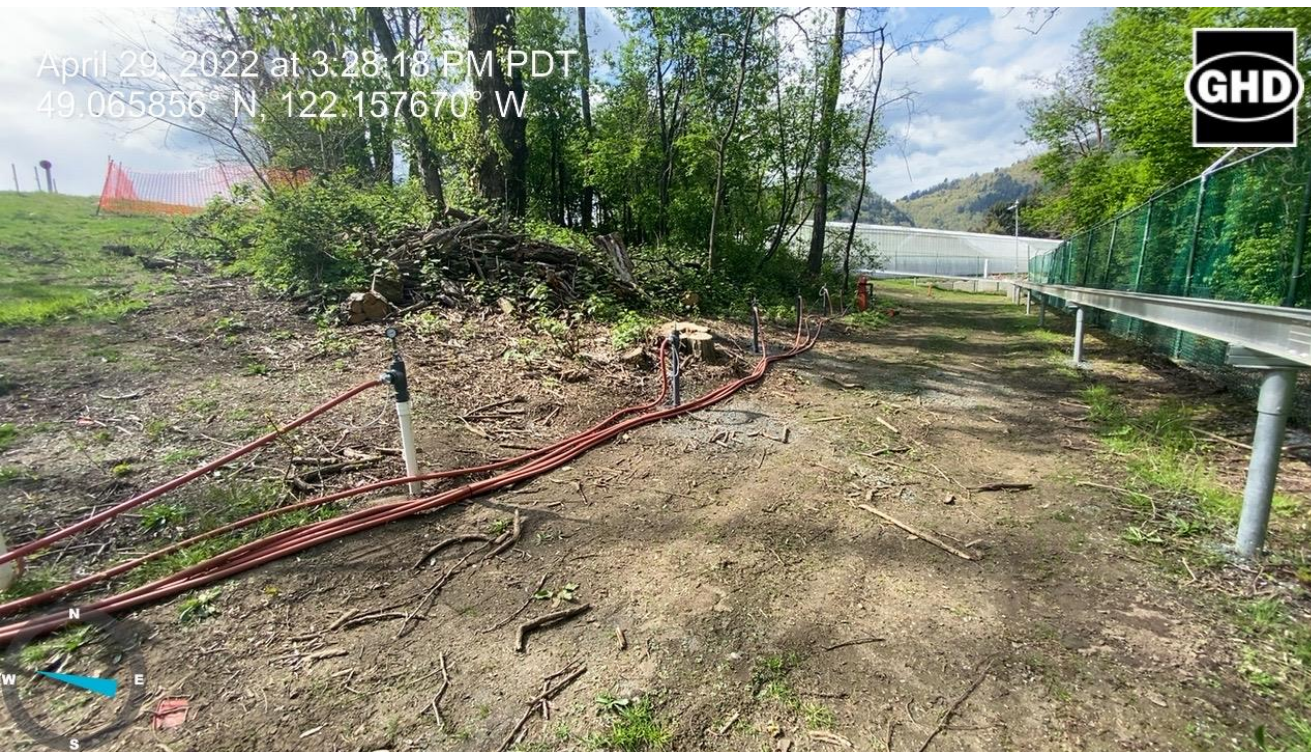
Increased precipitation in winter months

Higher groundwater table contacts residual LNAPL

Pulse of increased dissolved phase concentrations

Migration due to increased groundwater flow velocities

- Seasonal groundwater elevation fluctuations create a dynamic flow system
- Various remediation efforts at the Site have influenced the behaviour of residual impacts and have reduced the extent of dissolved phase migration
  - PetroFix®
  - Biosparge system
- Since the installation of the biosparge system, dissolved phase concentrations have been steadily decreasing

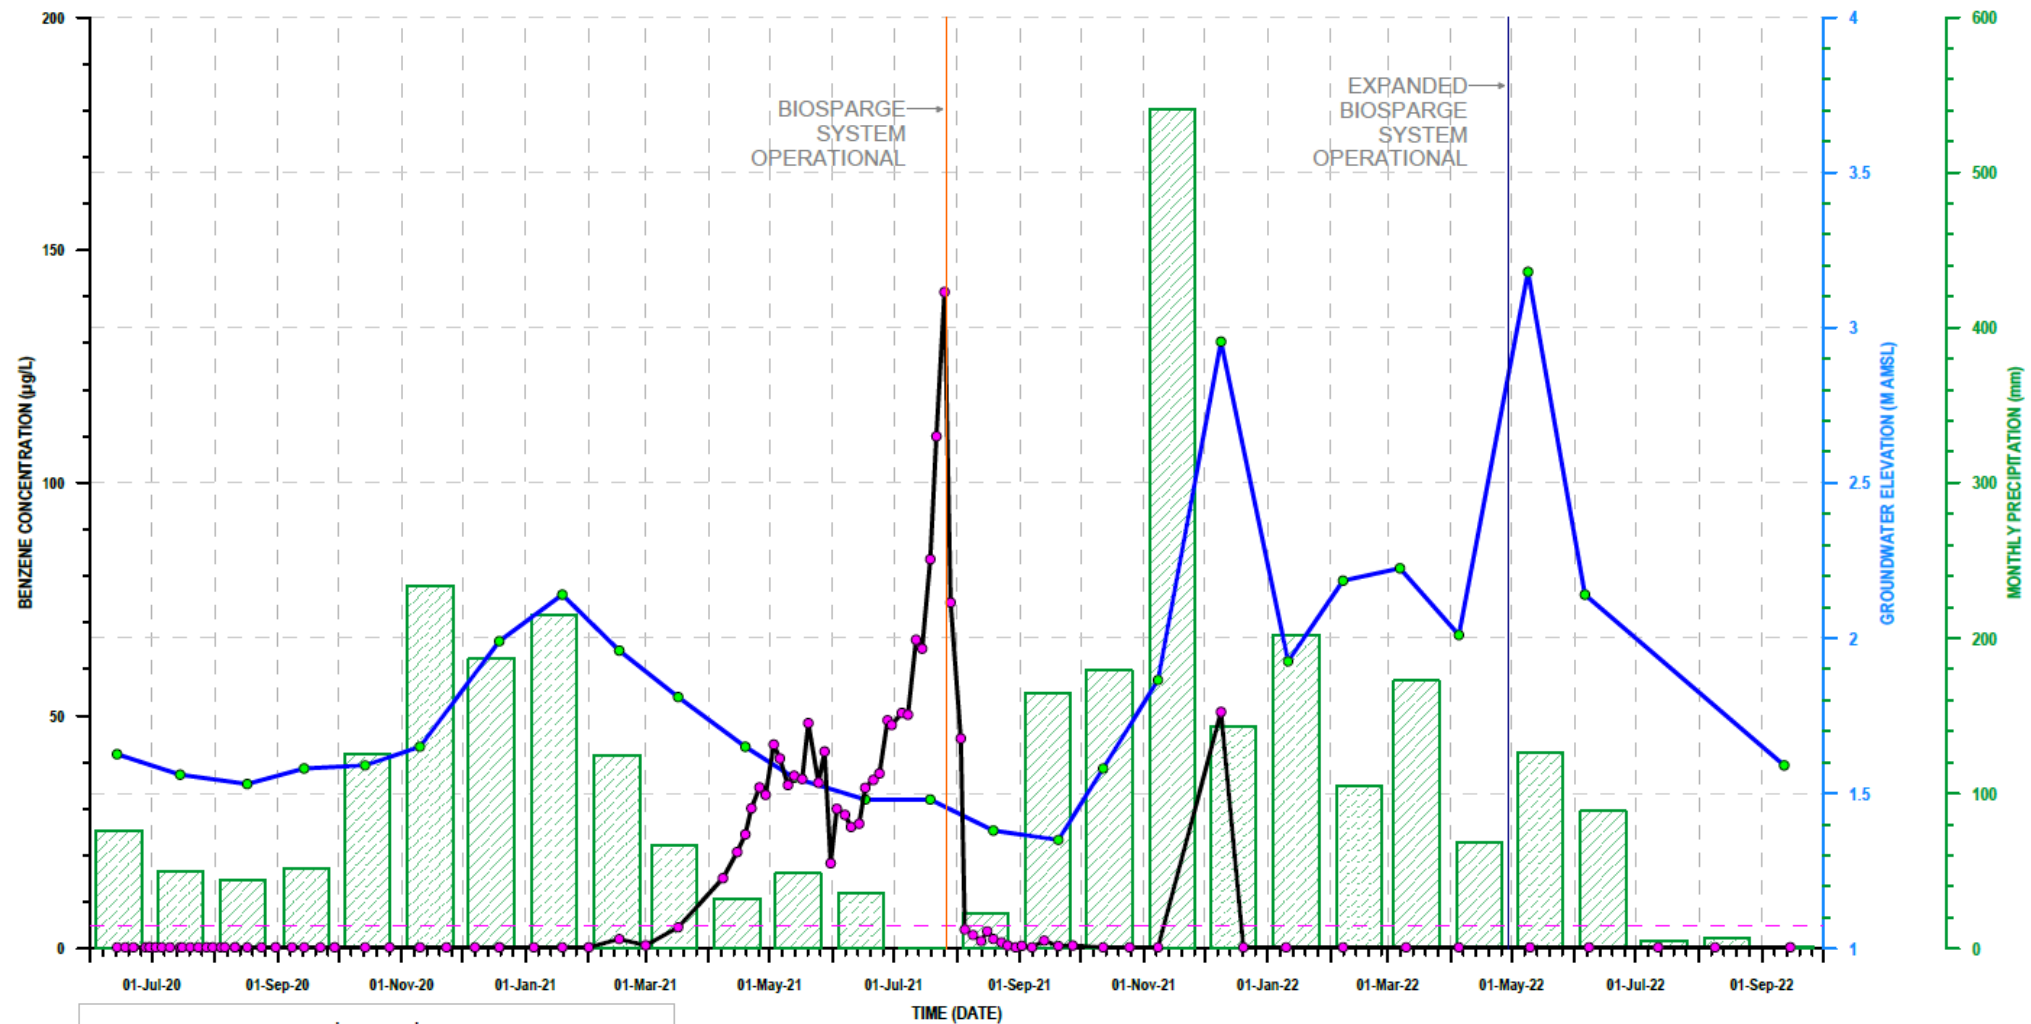
**BENZENE CONCENTRATIONS, OBSERVED GROUNDWATER ELEVATIONS, AND MONTHLY PRECIPITATION VS. TIME**  
 BH-15

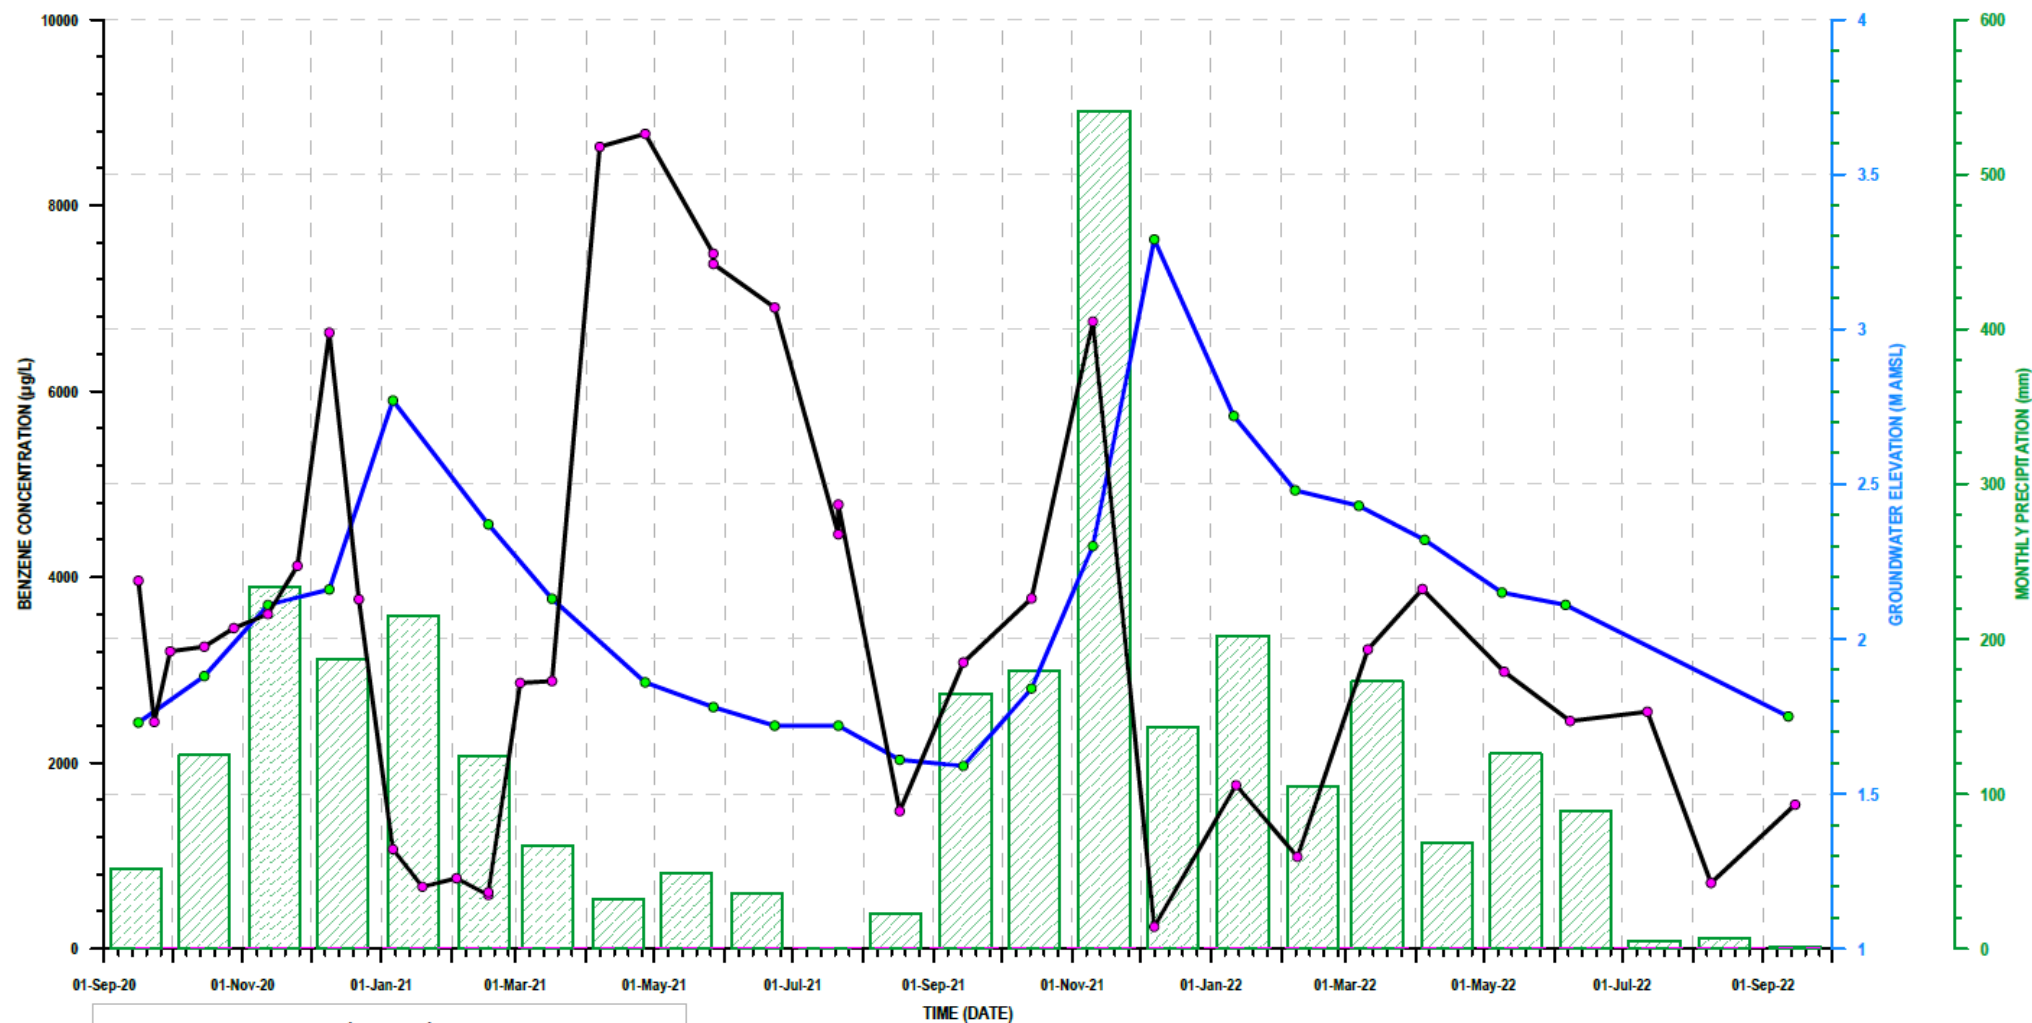
**BENZENE CONCENTRATIONS, OBSERVED GROUNDWATER ELEVATIONS, AND MONTHLY PRECIPITATION VS. TIME  
 BH2R**

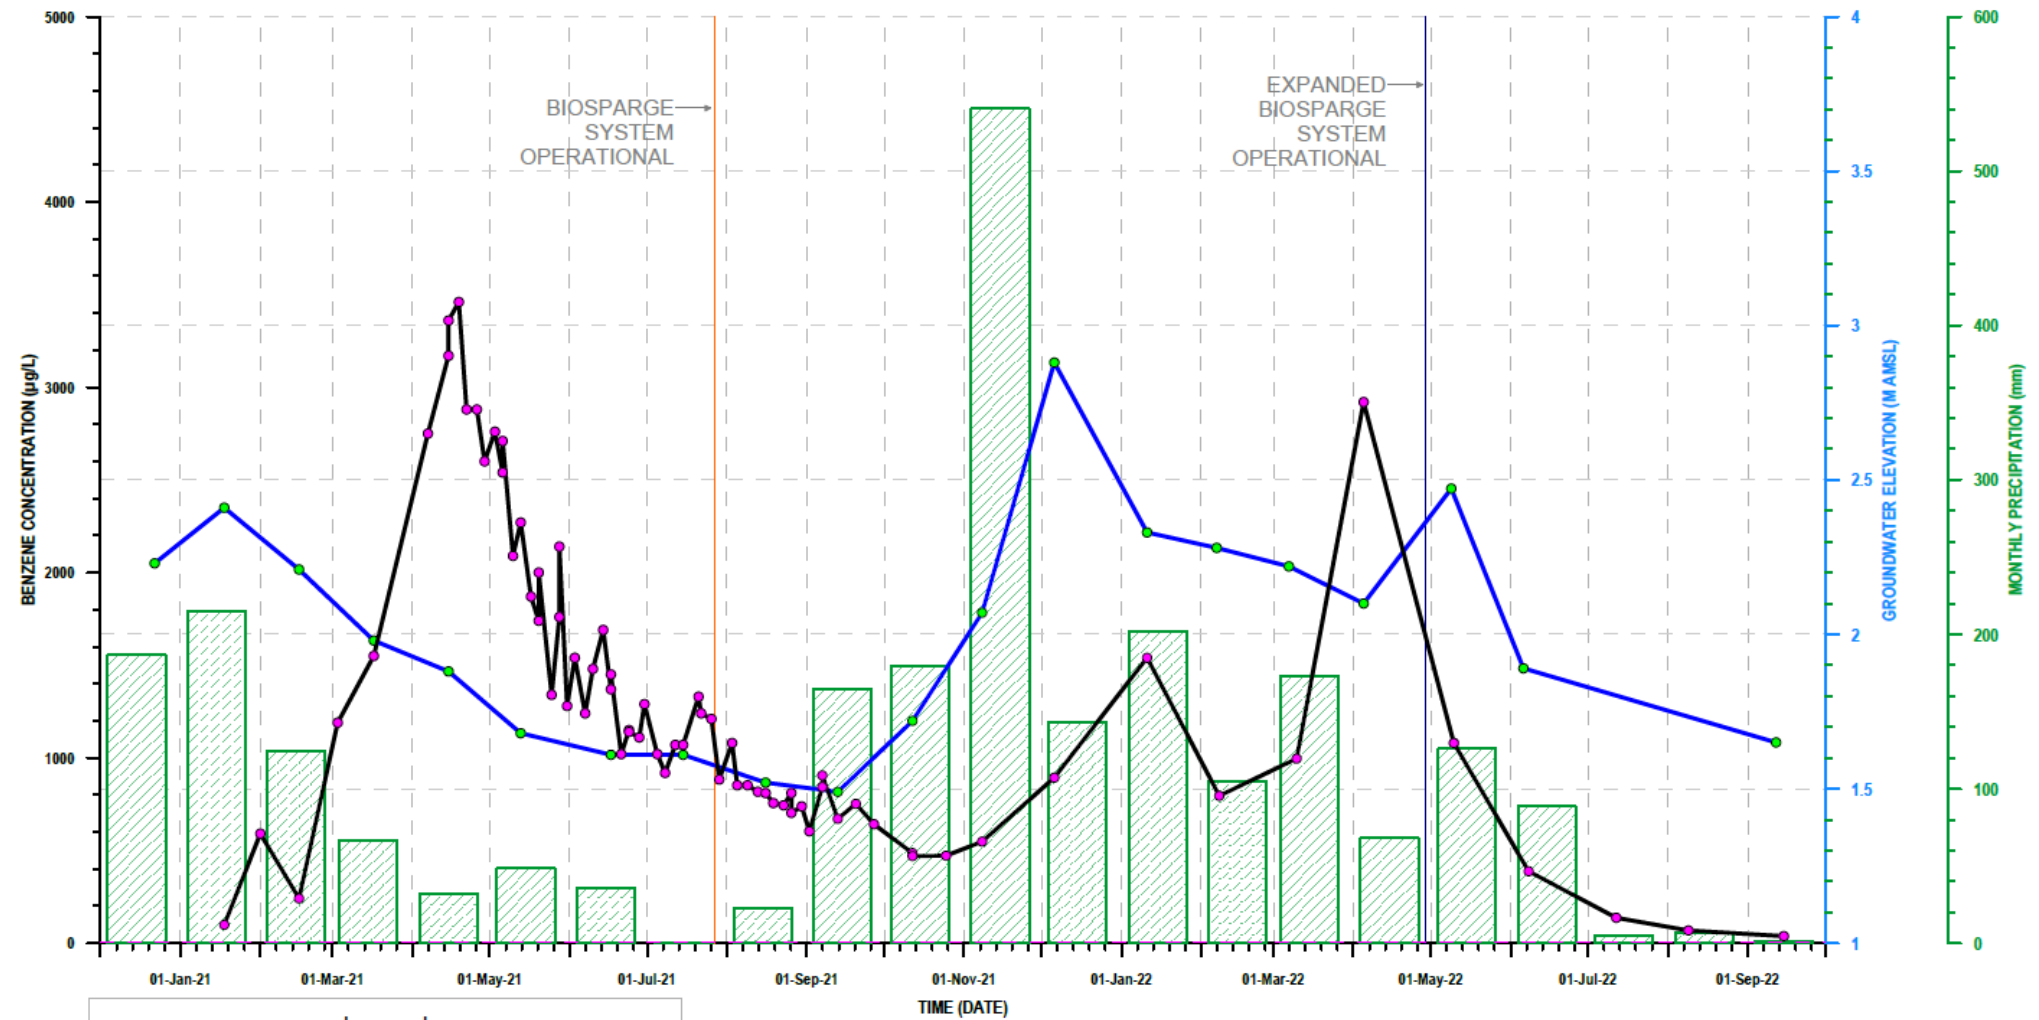
**BENZENE CONCENTRATIONS, OBSERVED GROUNDWATER ELEVATIONS, AND MONTHLY PRECIPITATION VS. TIME MW20-23**

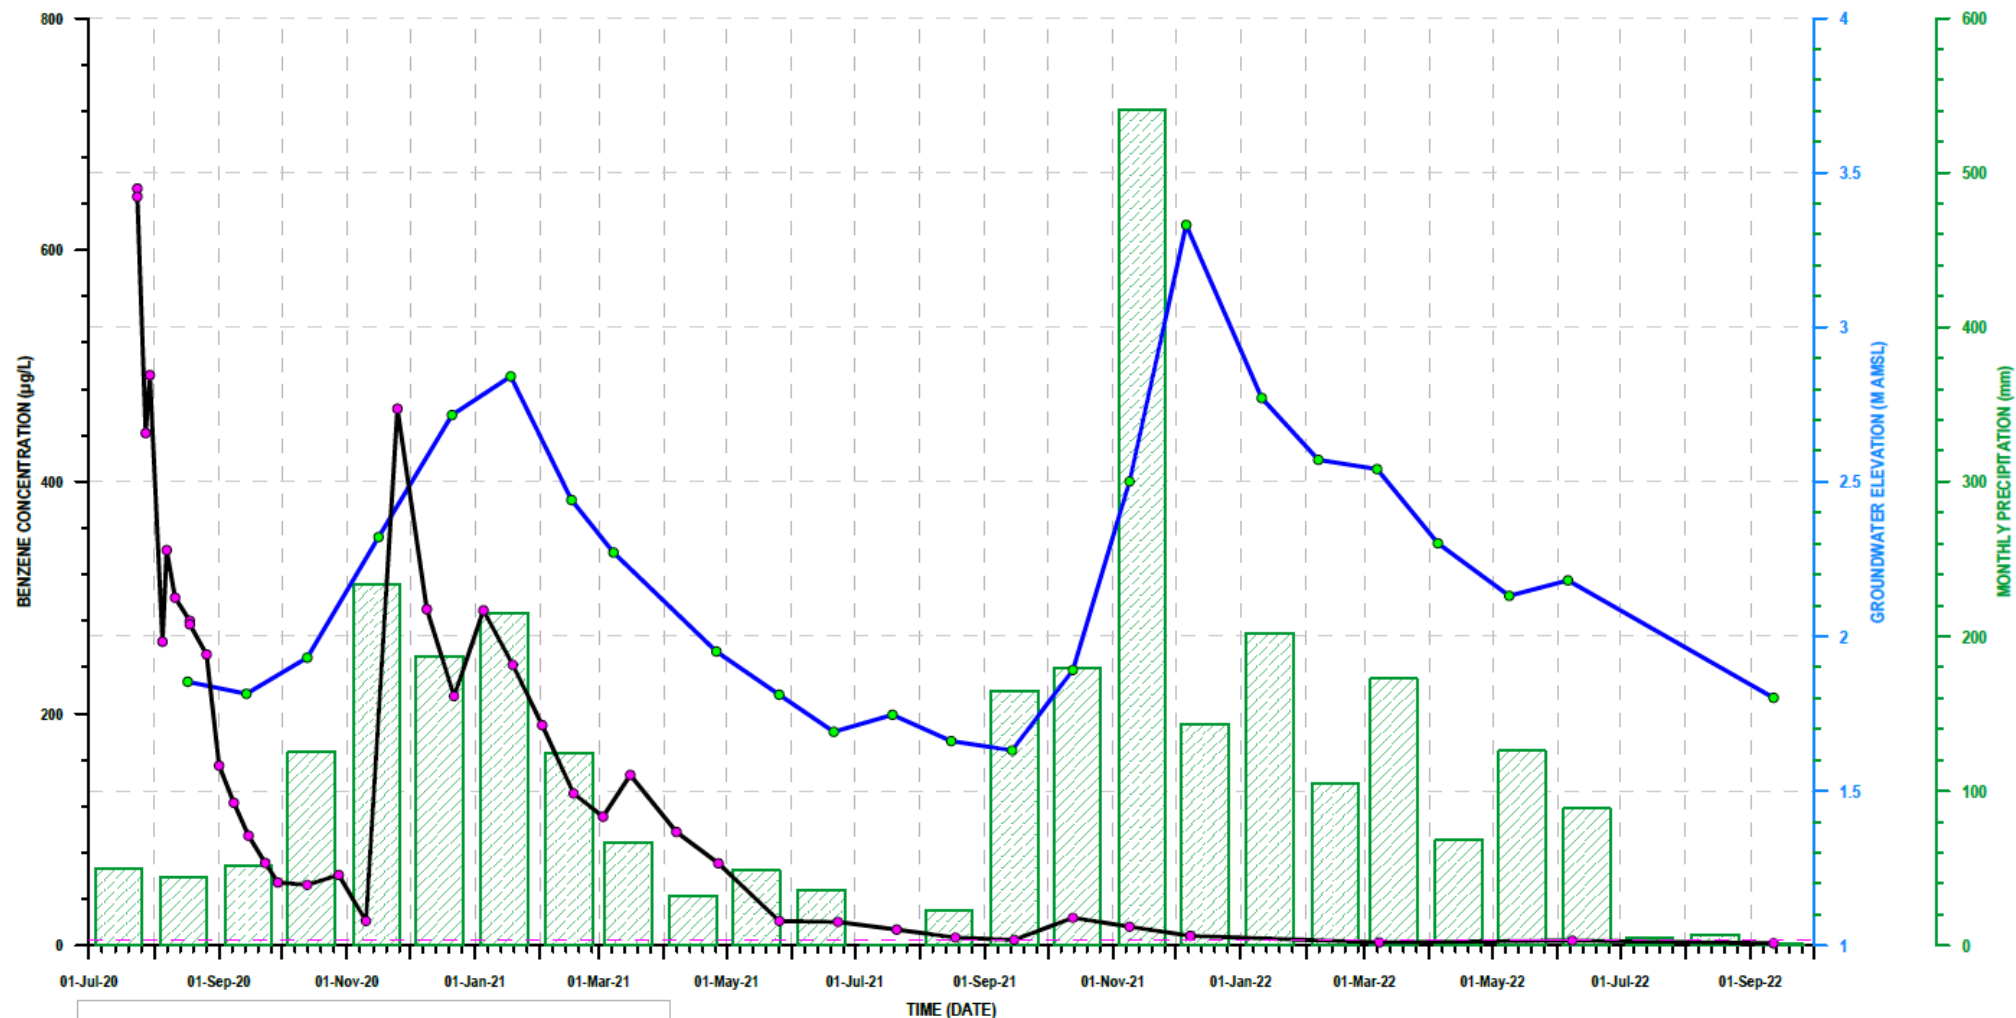
TRANS MOUNTAIN CANADA INC  
 3434 MCDERMOTT ROAD, ABBOTSFORD, BC  
 SUMAS STATION EOS RELEASE  
**BENZENE CONCENTRATIONS, OBSERVED GROUNDWATER  
 ELEVATIONS, AND MONTHLY PRECIPITATION VS. TIME  
 MW20-11**
