Remediation and Risk
Management Strategies
for Managing an LNAPL
Impacted Site

Kraut Point Small Craft Harbour, Riverport, NS

Sam Caldwell, EIT

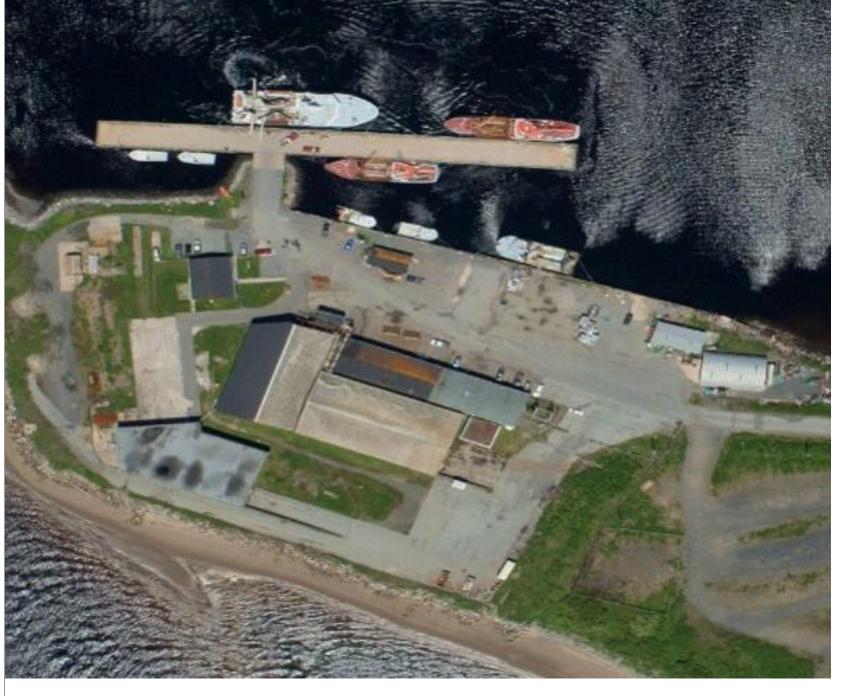
- Site located in Riverport, NS, along Nova Scotia's South Shore.
- Public commercial fishing wharf for over 100 years (remains active)
- Part of Small Craft Harbour Program (DFO).
- Home to over 25 vessels that fish for lobster, haddock, cod, tuna, herring, among others.

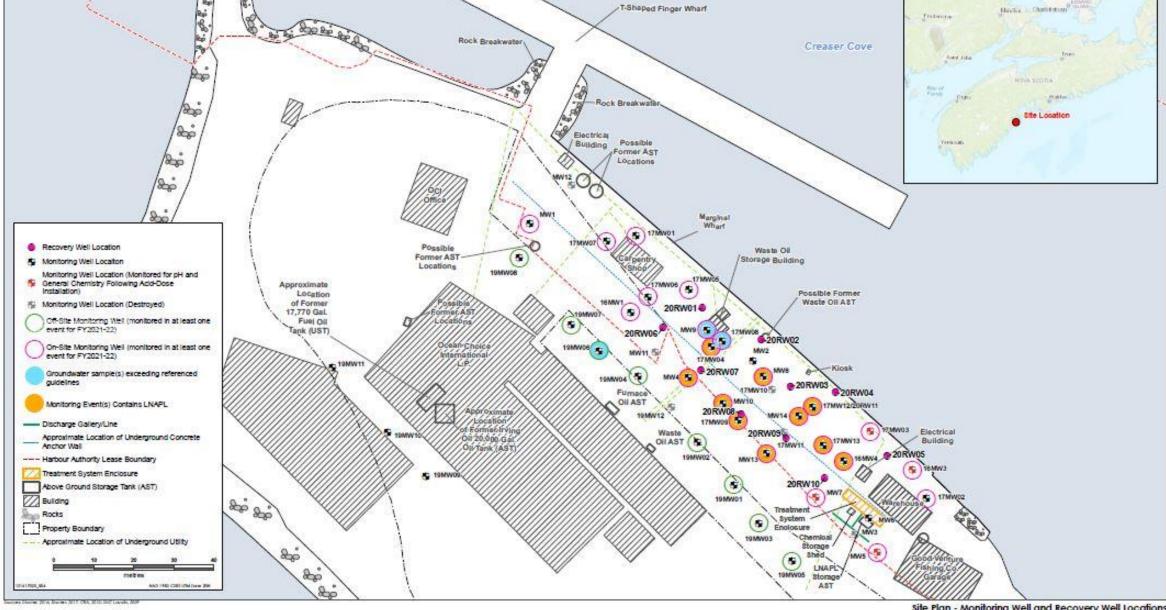
Figure A1

Site Plan - Monitoring Well and Recovery Well Locations Public Services and Procurement Canada for Fisheries and Oceans Canada Kraut Point Small Craft Harbour

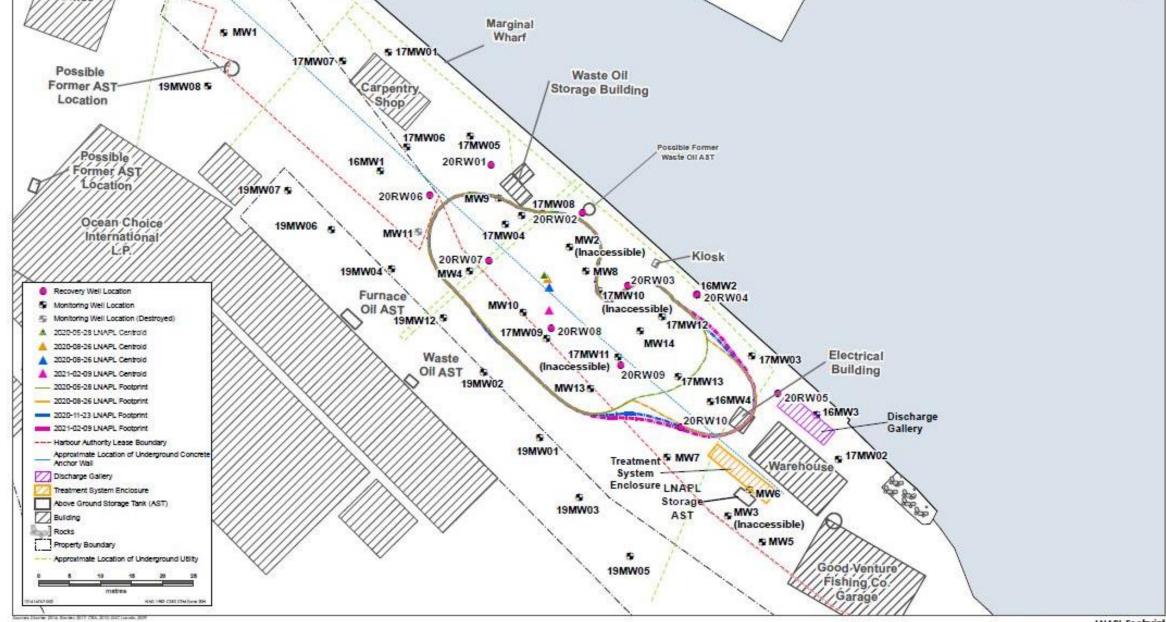
Figure 4

LNAPL Footprint Public Services and Procurement Canada for Fisheries and Oceans Canada Kraut Point Small Craft Harbour

- LNAPL body appears stable.
- · Potential for future mobility is low.
- LNAPL recovery rate decreased throughout duration of project.
- ~ 4200L of LNAPL recovered.
- LNAPL body more fragmented than before.
- Decreasing trends in LNAPL thickness in site MWs.
- Enhanced recovery program indicated minimal impact.

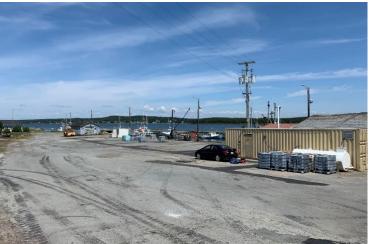
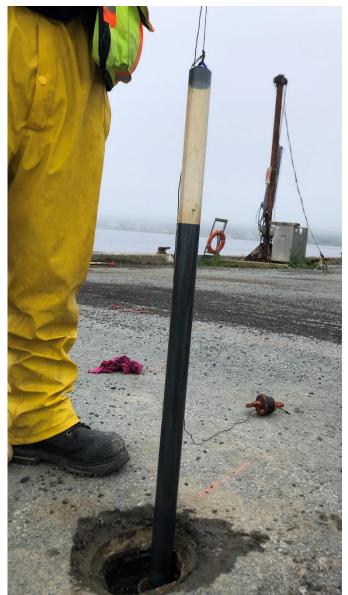
- R/RM strategy developed in 2019.
- Wharf sheet pile wall driving factor for R/RM approach.
- Multiple lines of evidence approach used:
 - LNAPL recovery to reduce LNAPL saturation
 - LNAPL footprint assessment (quarterly)
 - Dissolved Phase GW monitoring (quarterly).
 - Natural attenuation assessment (quarterly)

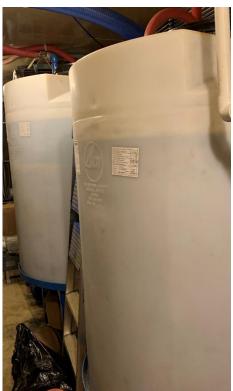
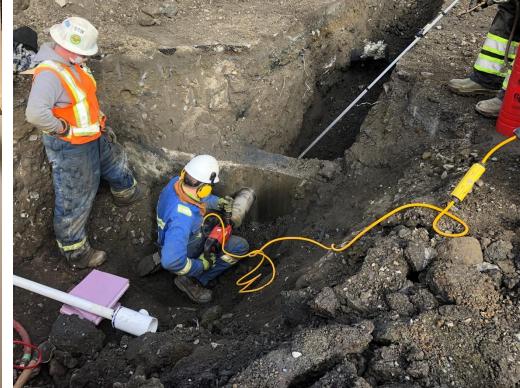
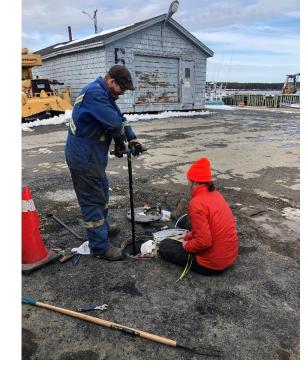
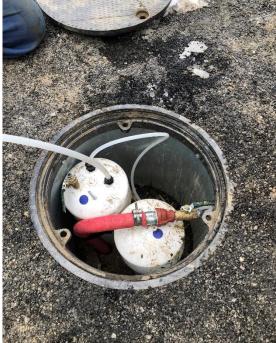
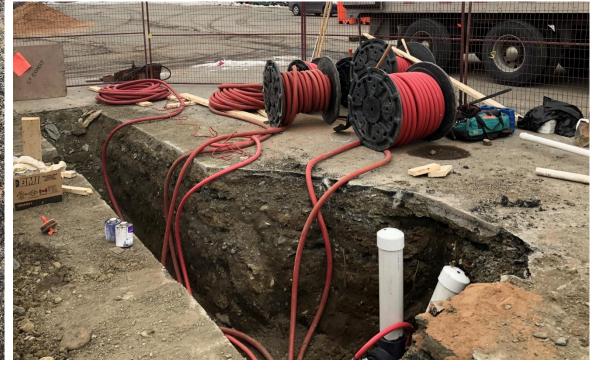
- R/RM strategy implemented in February 2021
- LNAPL Recovery System Installed by SCG Industries:
 - Dual phase extraction system liquid (water/LNAPL) and soil vapour
 - 11 recovery wells equipped with submersible pumps
 - On-site treatment system for:
 - LNAPL separation
 - Water treatment
 - Soil vapour venting
 - Recovered LNAPL → on-site long-term storage
 - Treated water → discharge to subsurface

- Fluctuating groundwater table with static submersible pumps
- High iron and manganese groundwater concentrations.
 - Precipitate accumulation throughout system infrastructure.
 - Increased frequency of maintenance required
 - Acid-dosing system installed to mitigate precipitate accumulation in discharge.

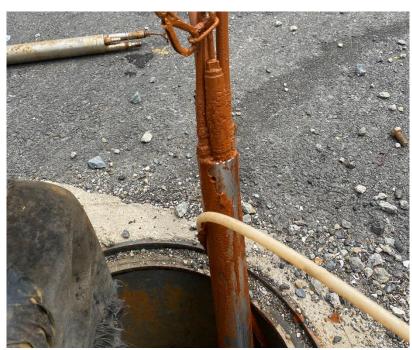
- Enhanced Recovery Program completed in 2023:
 - Injection of hot water into the subsurface through temporary injection wells.
 - Multi-phase recovery though an existing recovery well.

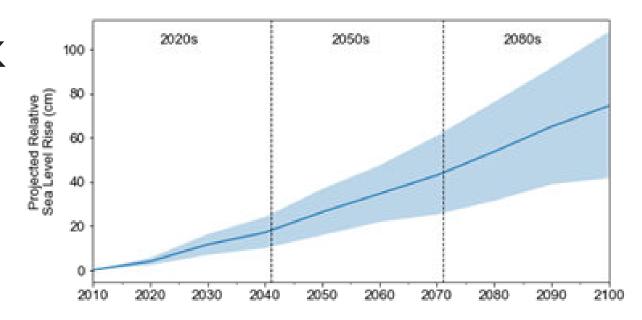
- Part of Risk Management Strategy for the site.
- One of the first of it's kind in Canada.
- Data collected to evaluate exposure to climaterelated hazards:
 - Previous Environmental Investigations
 - Climate Projections
 - Conceptual Site Model (CSM)
 Components
- Risk scores estimated for critical site infrastructure and CSM components
 - Based on Relative Concentration Pathway (RCP) 8.5 climate projections.
- Risk score = Exposure x Likelihood x Consequence

Asset	Hazard(s)	2020s	2050s	2080s	Trend	Confidence
Sheet-Pile Wall	Waves	Medium (12)	Medium (12)	Medium (12)	Steady	Low
	Severe Storms	Low (8)	Medium (12)	Medium (16)	Increasing	Low
	Coastal Flood	Low (6)	Low (9)	Medium (15)	Increasing	Very Low
Tie Backs	Coastal Flood	Low (0)	Low (9)	Medium (15)	Increasing	Very Low
LNAPL Body	Coastal Flood	Low (4)	Low (6)	Medium (10)	Increasing	Very Low
Dissolved-Phase Groundwater	Rainy Days	Low (9)	Medium (12)	Medium (12)	Increasing	Medium
Contaminated Soil	Sea-Level Rise	Low (6)	Low (8)	Medium (10)	Increasing	Low
Asphalt Cap	Coastal Flood	Low (4)	Low (6)	Medium (10)	Increasing	Very Low

- Severe storms, waves, and coastal flood impacts found to pose highest risk to onsite infrastructure.
- Increased precipitation and sea-level rise posed highest risk to subsurface impacts.
- Results of Climate RA inform adaptation strategies:
 - Maintenance of sheet pile wall
 - Maintenance of asphalt cap
 - Hydrogeological studies
 - Increased monitoring
