Giant Mine Remediation Project

Overcoming the Engineering Challenges

RemTech East

May 29th to June 1st, 2023

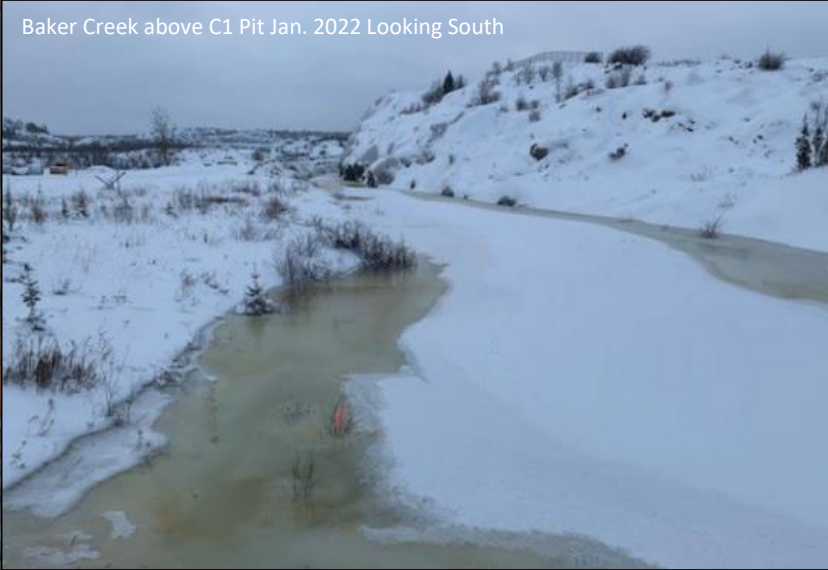
Baker Creek above C1 Pit Jan. 2022 Looking South

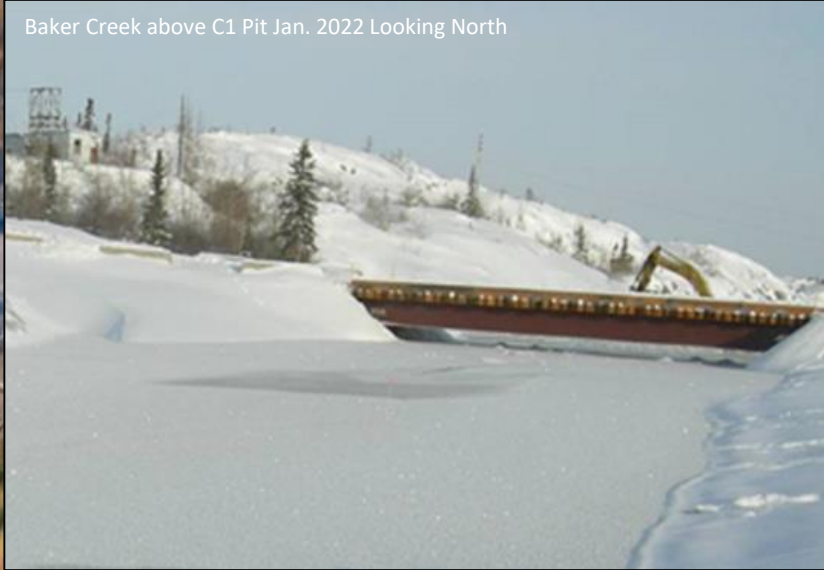
Baker Creek above C1 Pit Jan. 2022 Looking North

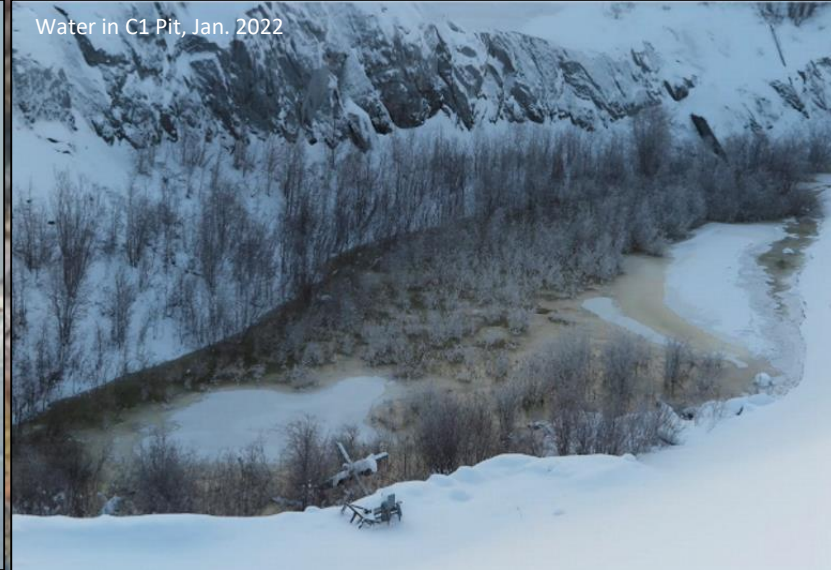
Water in C1 Pit, Jan. 2022

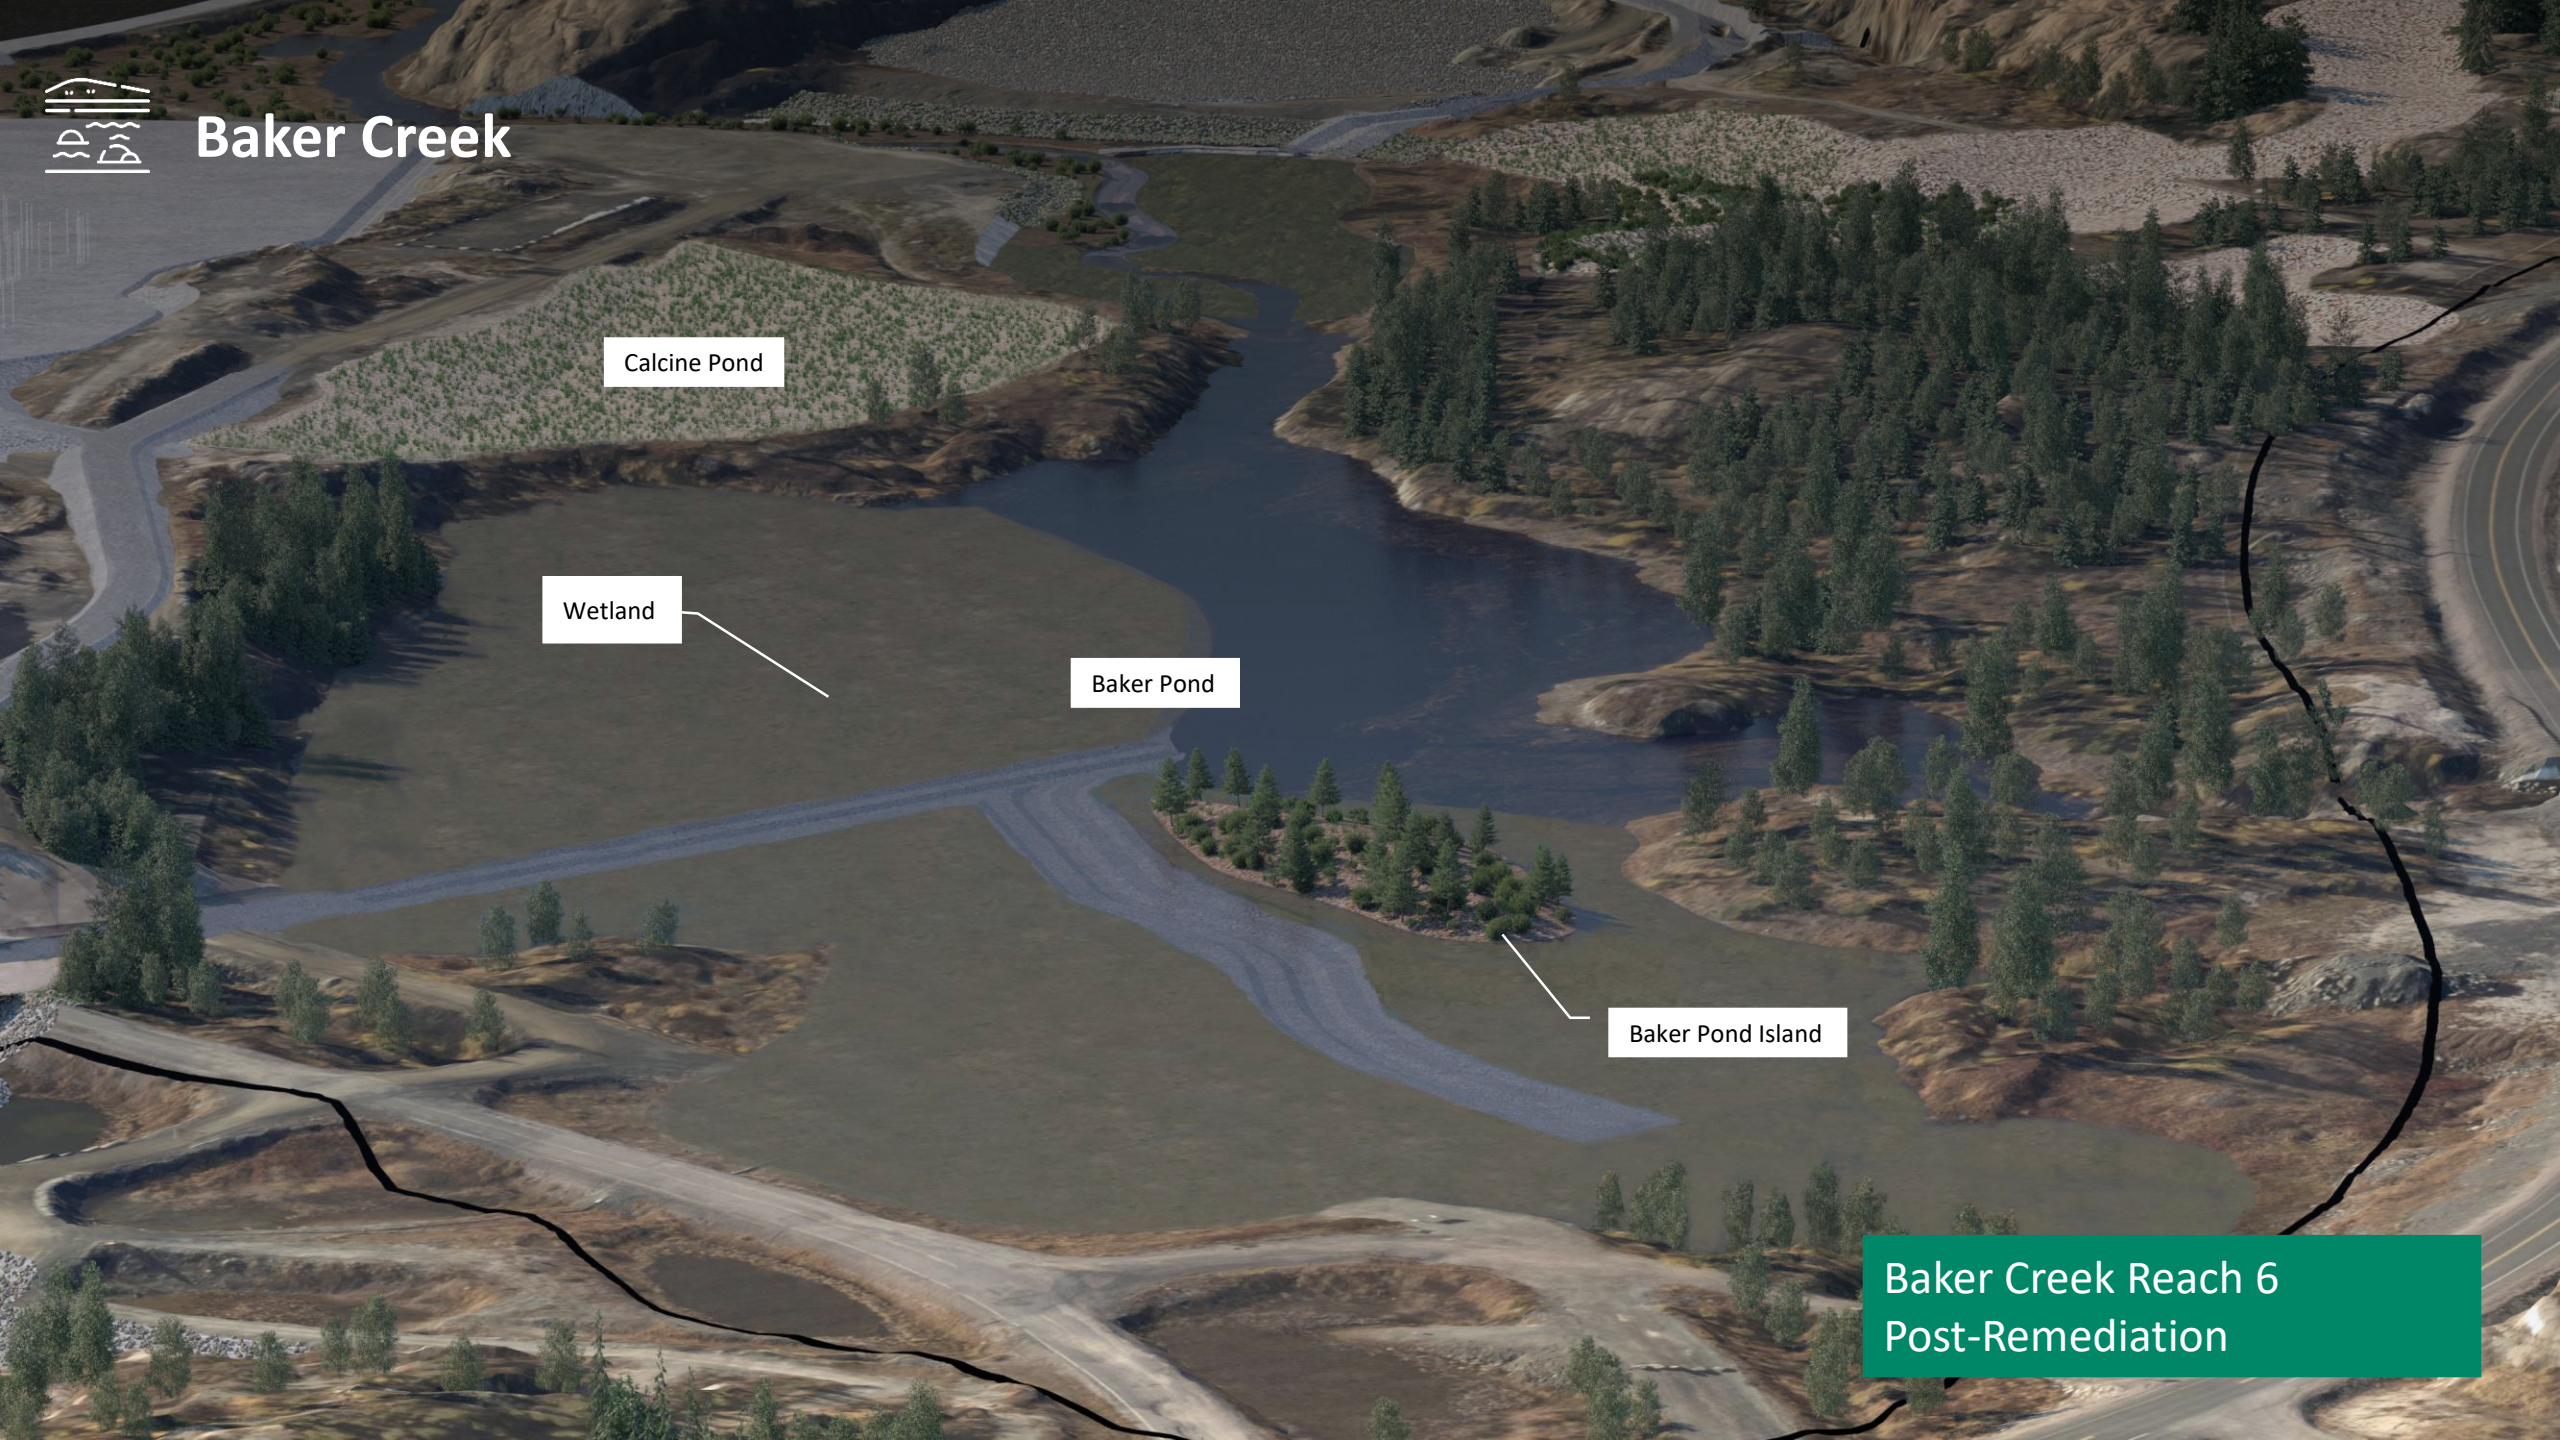
Baker Creek Reach 6
Post-Remediation

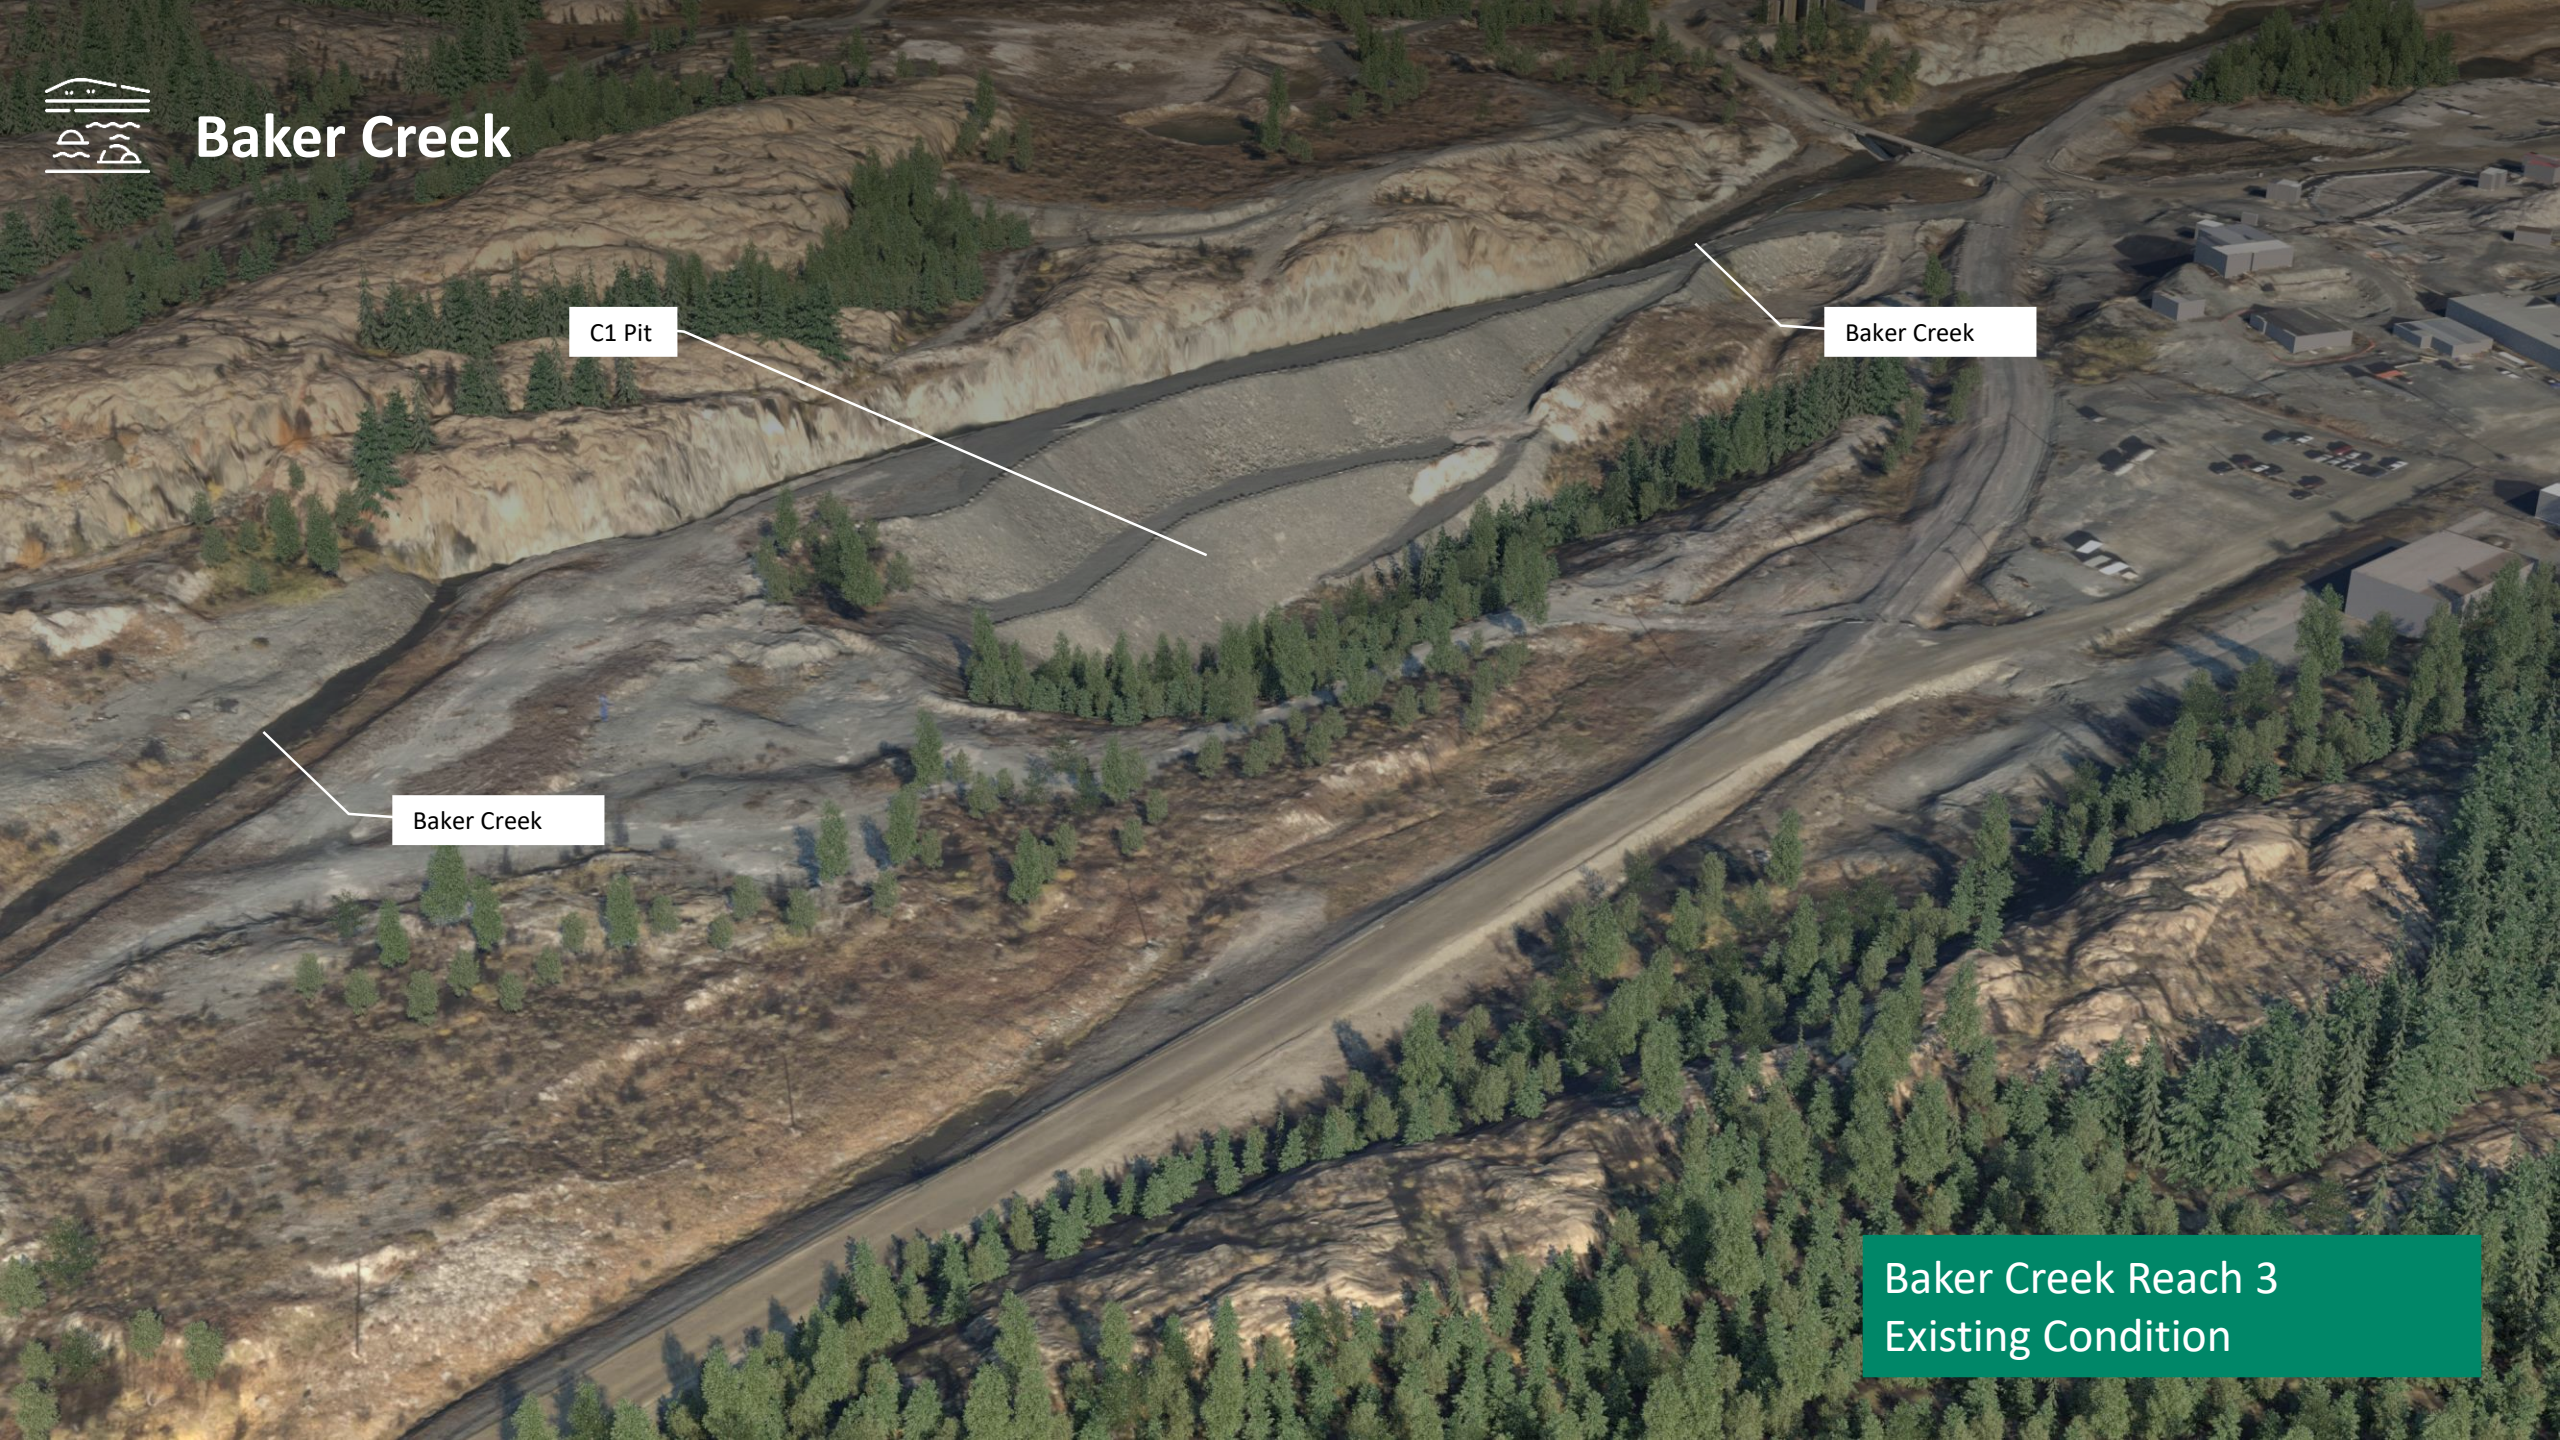
Baker Creek Reach 3
Existing Condition

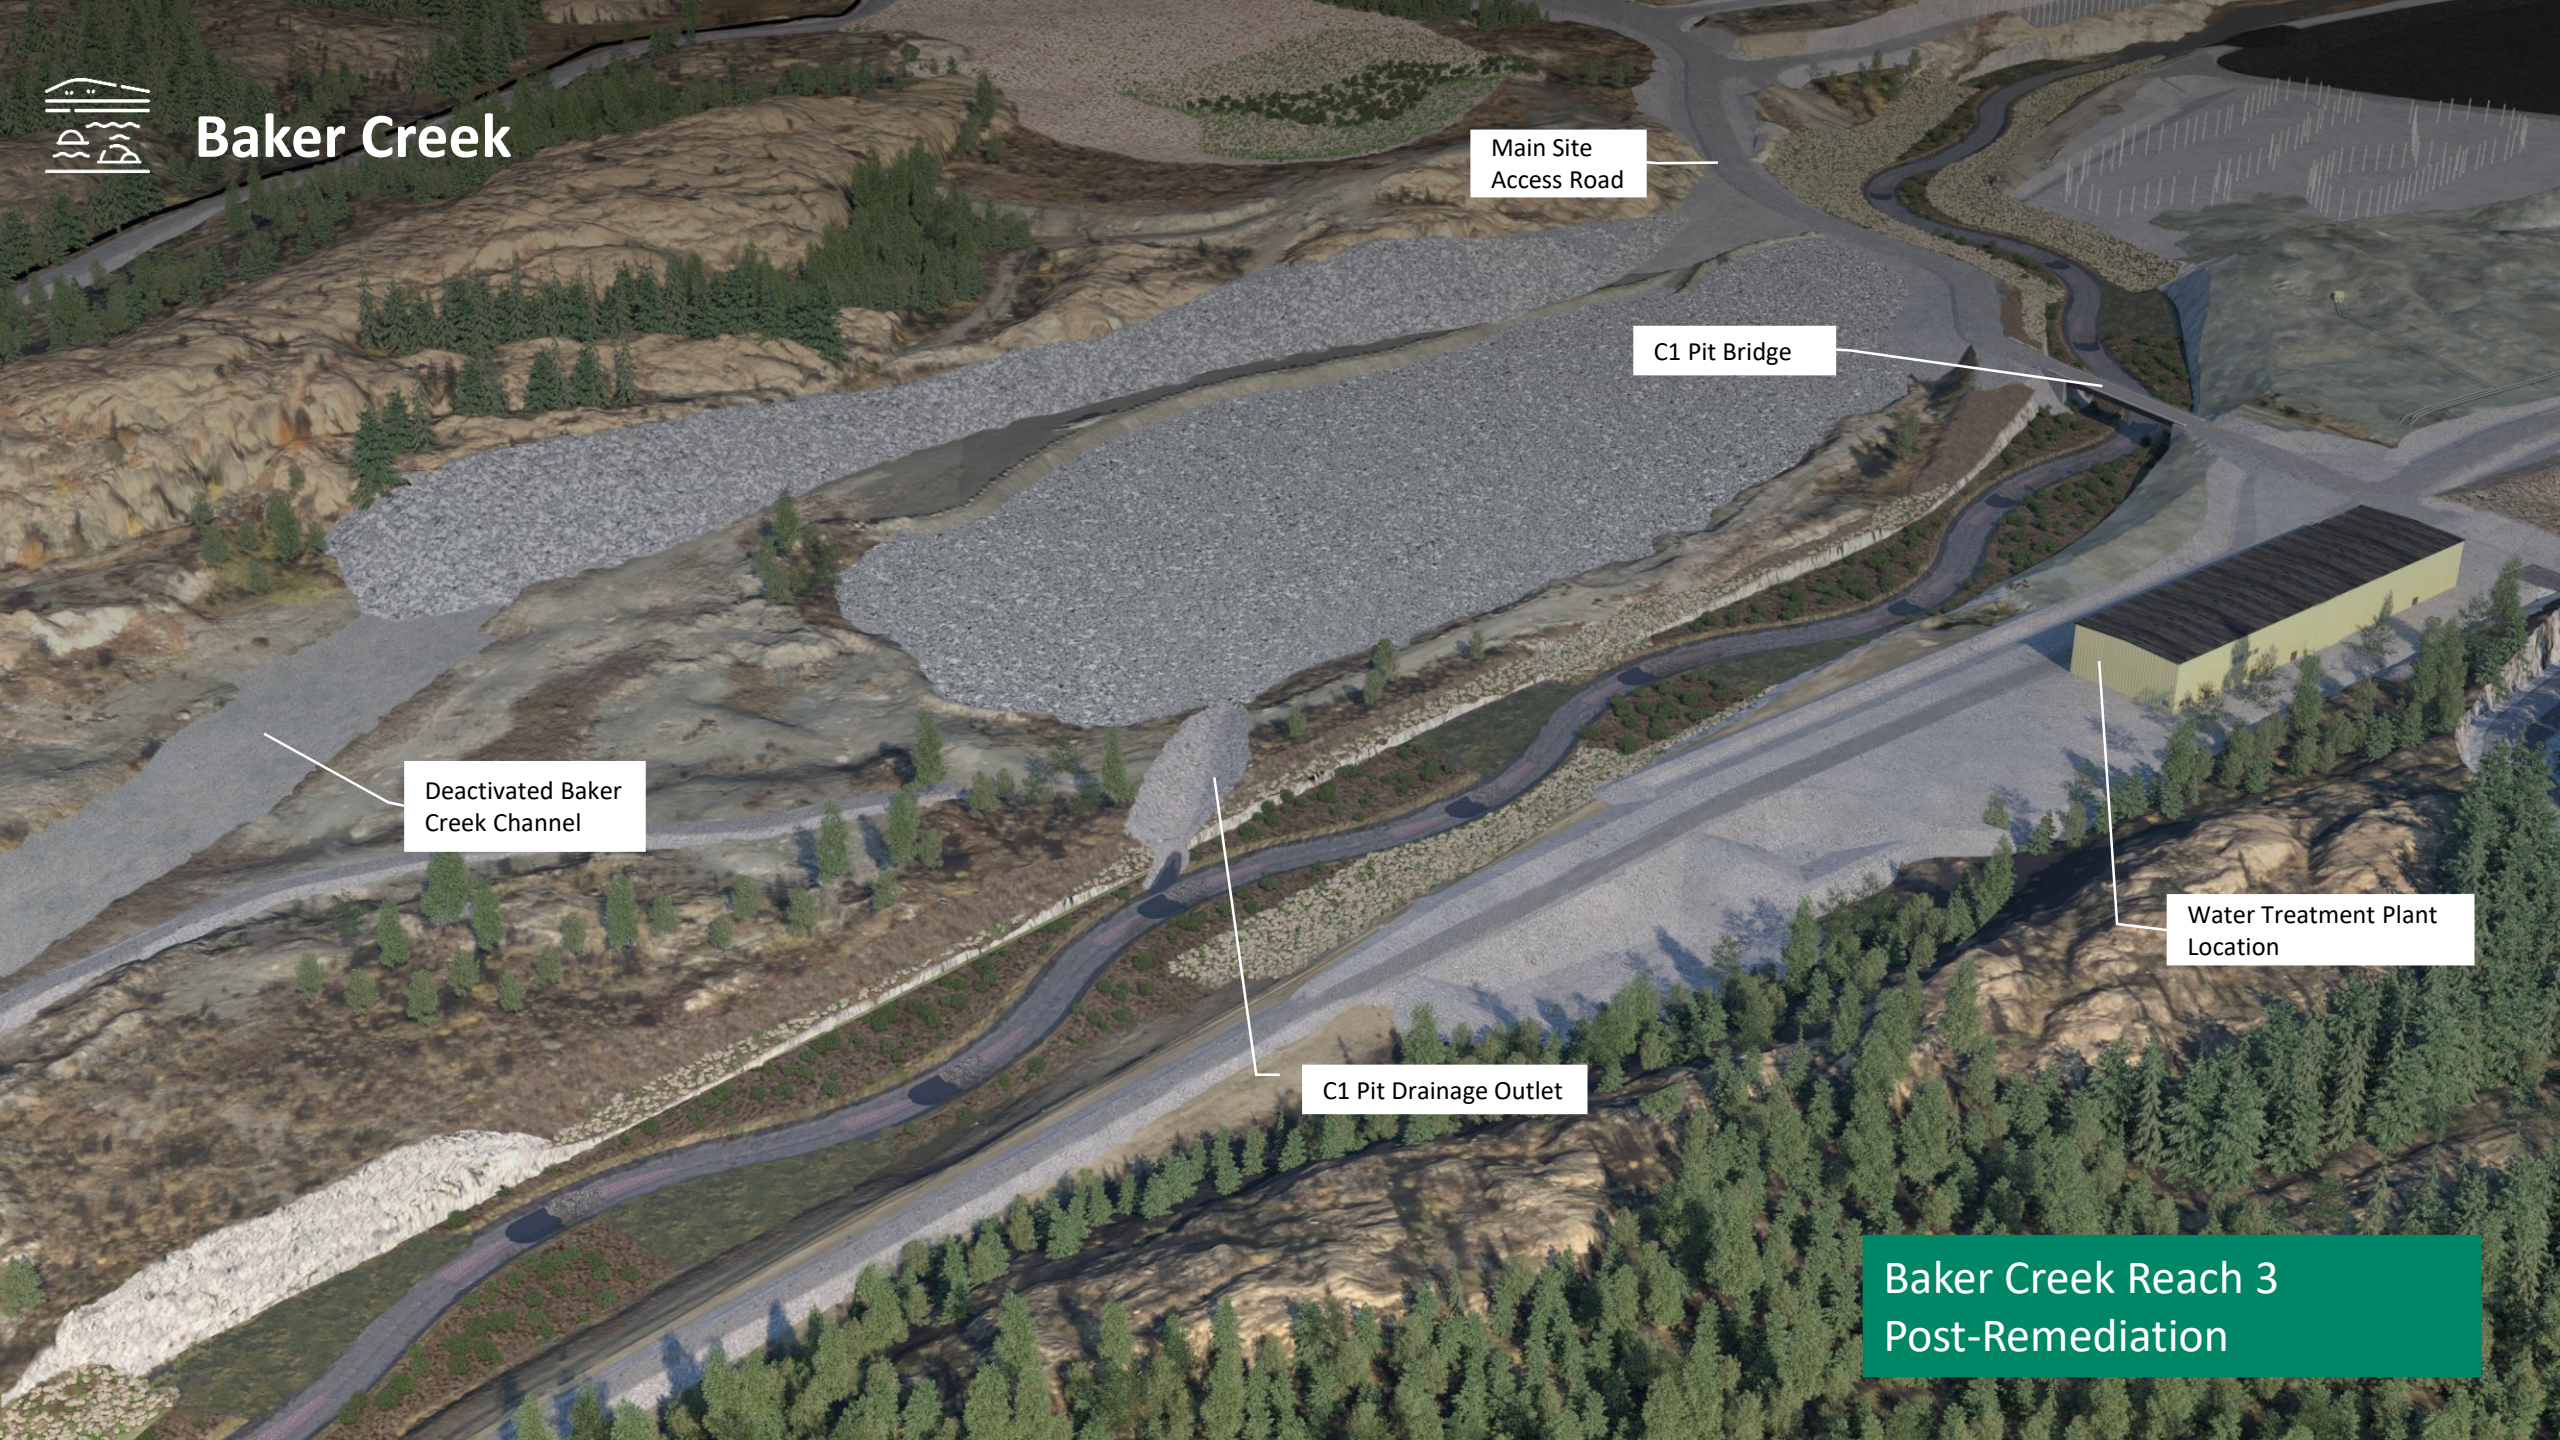
Baker Creek Reach 3
Post-Remediation

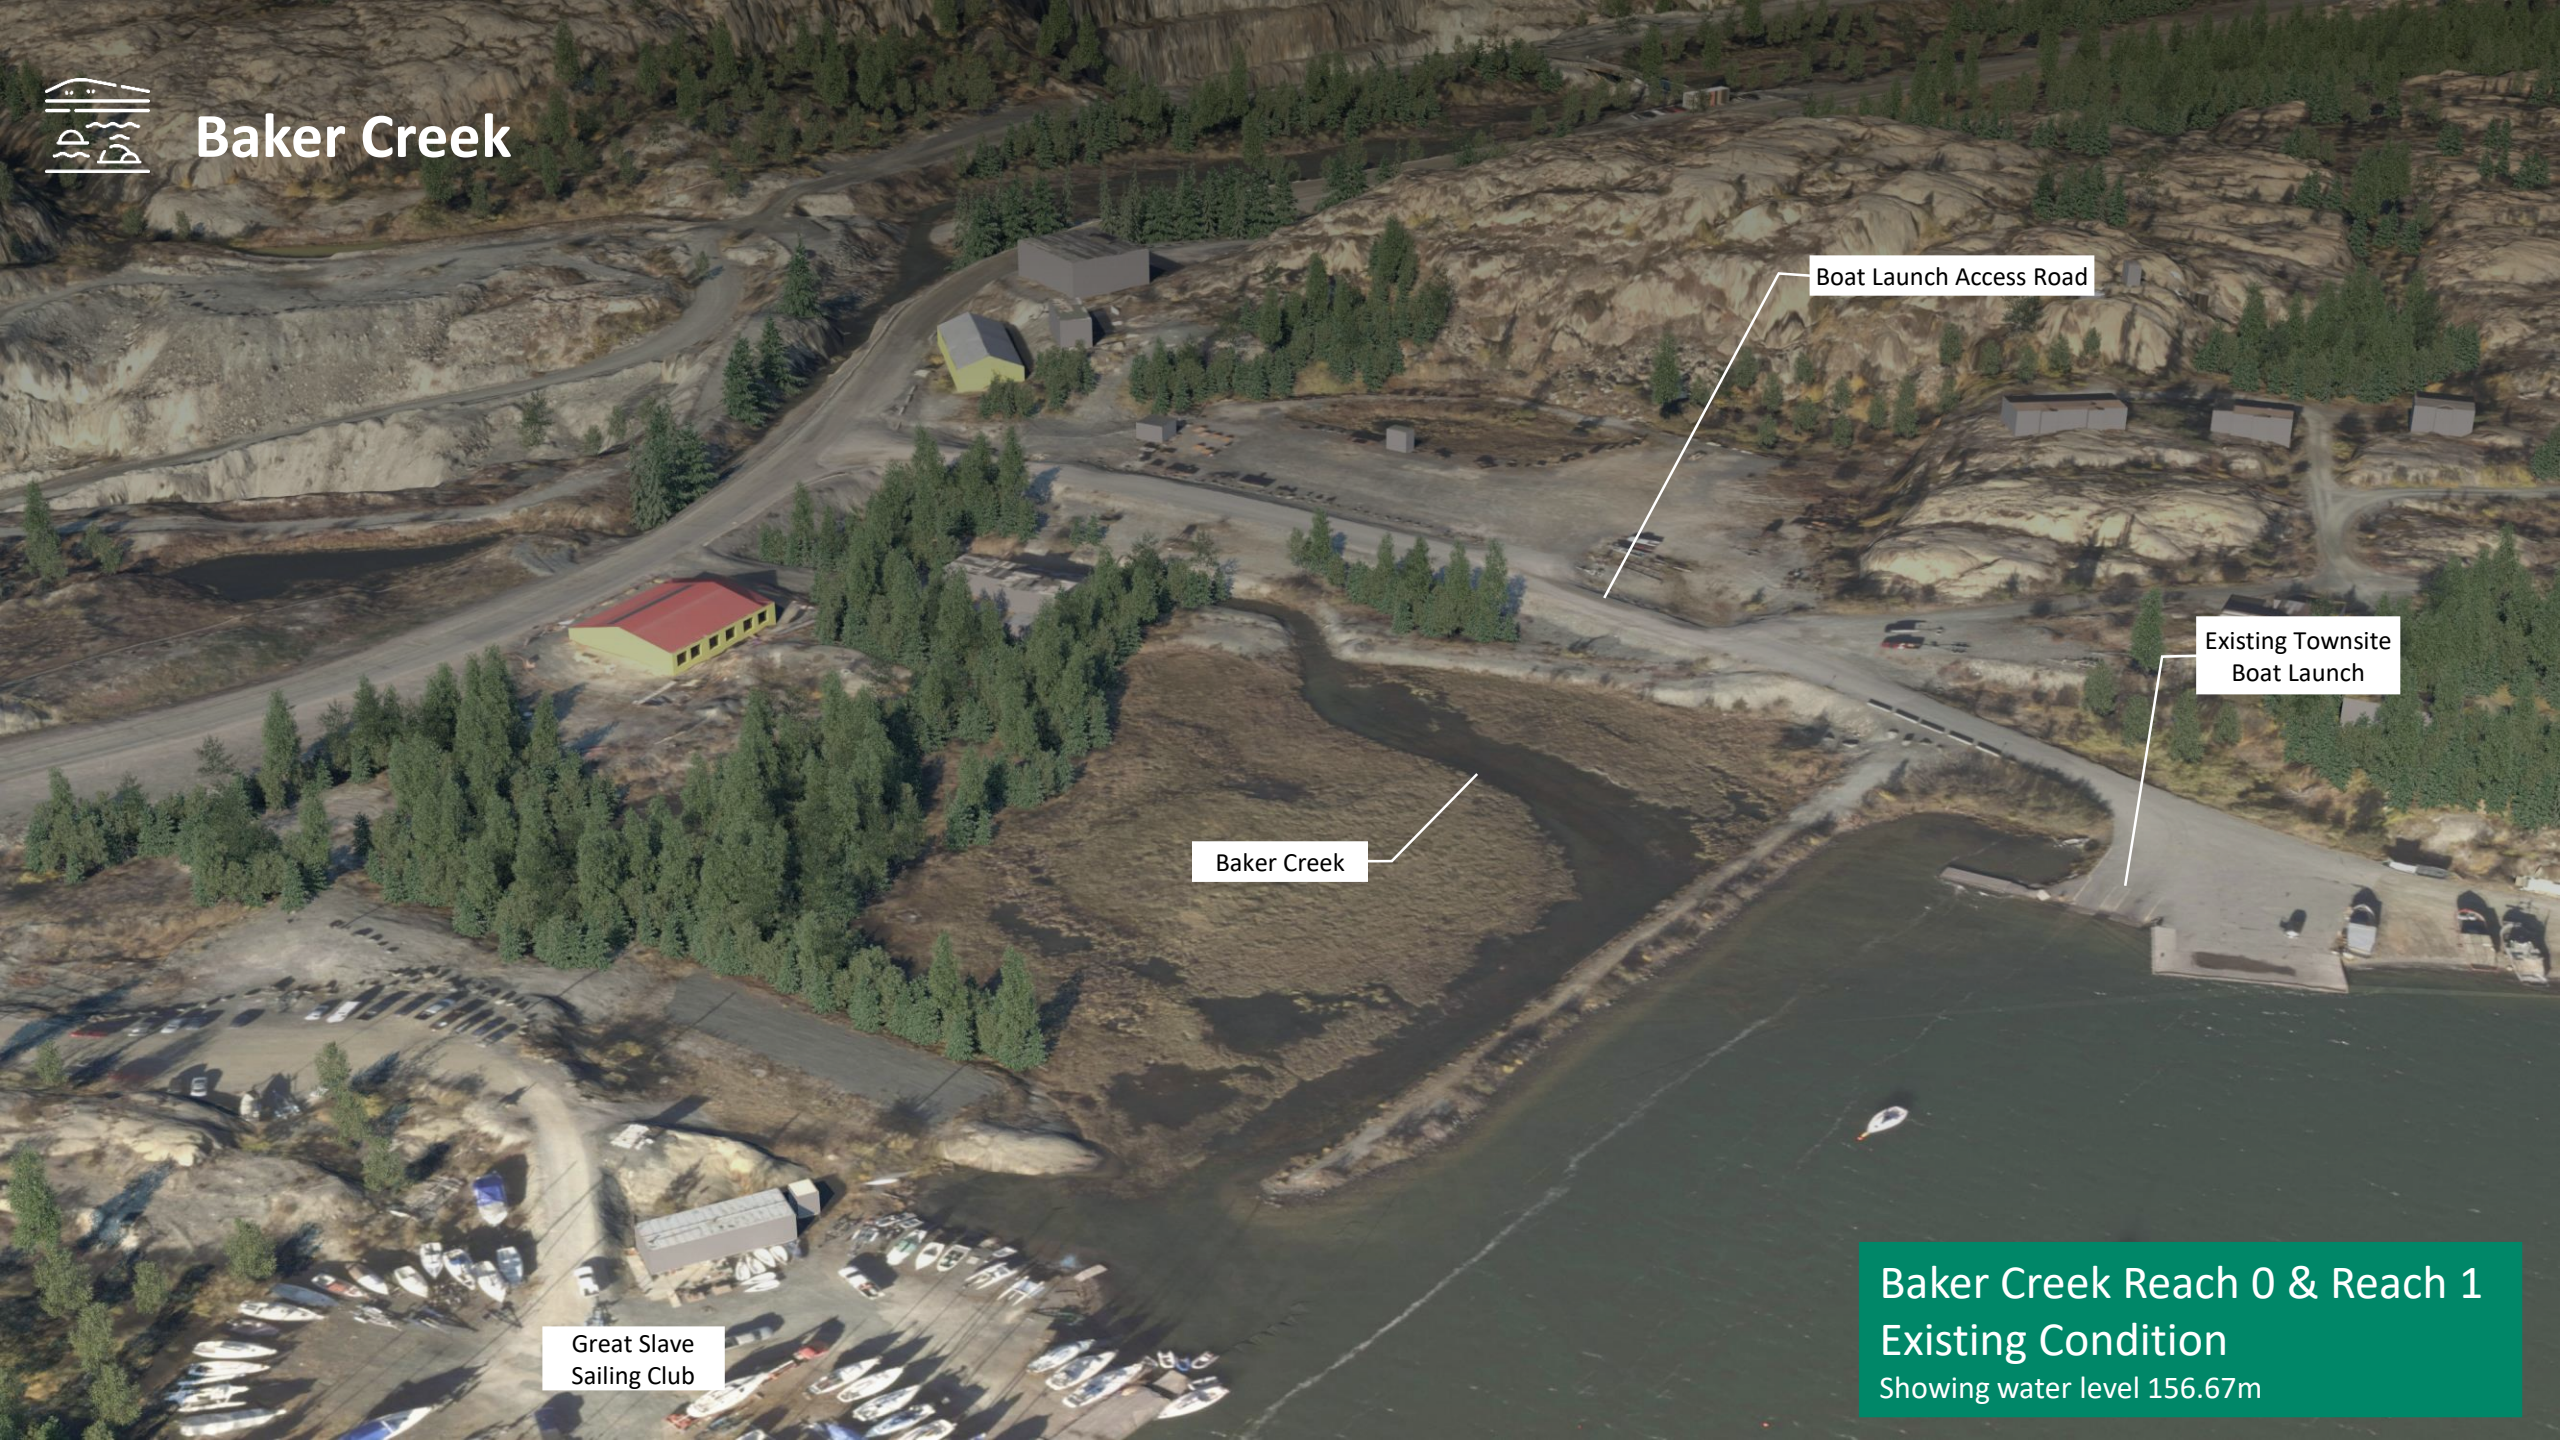
Baker Creek Reach 0 & Reach 1
Existing Condition
Showing water level 156.67m

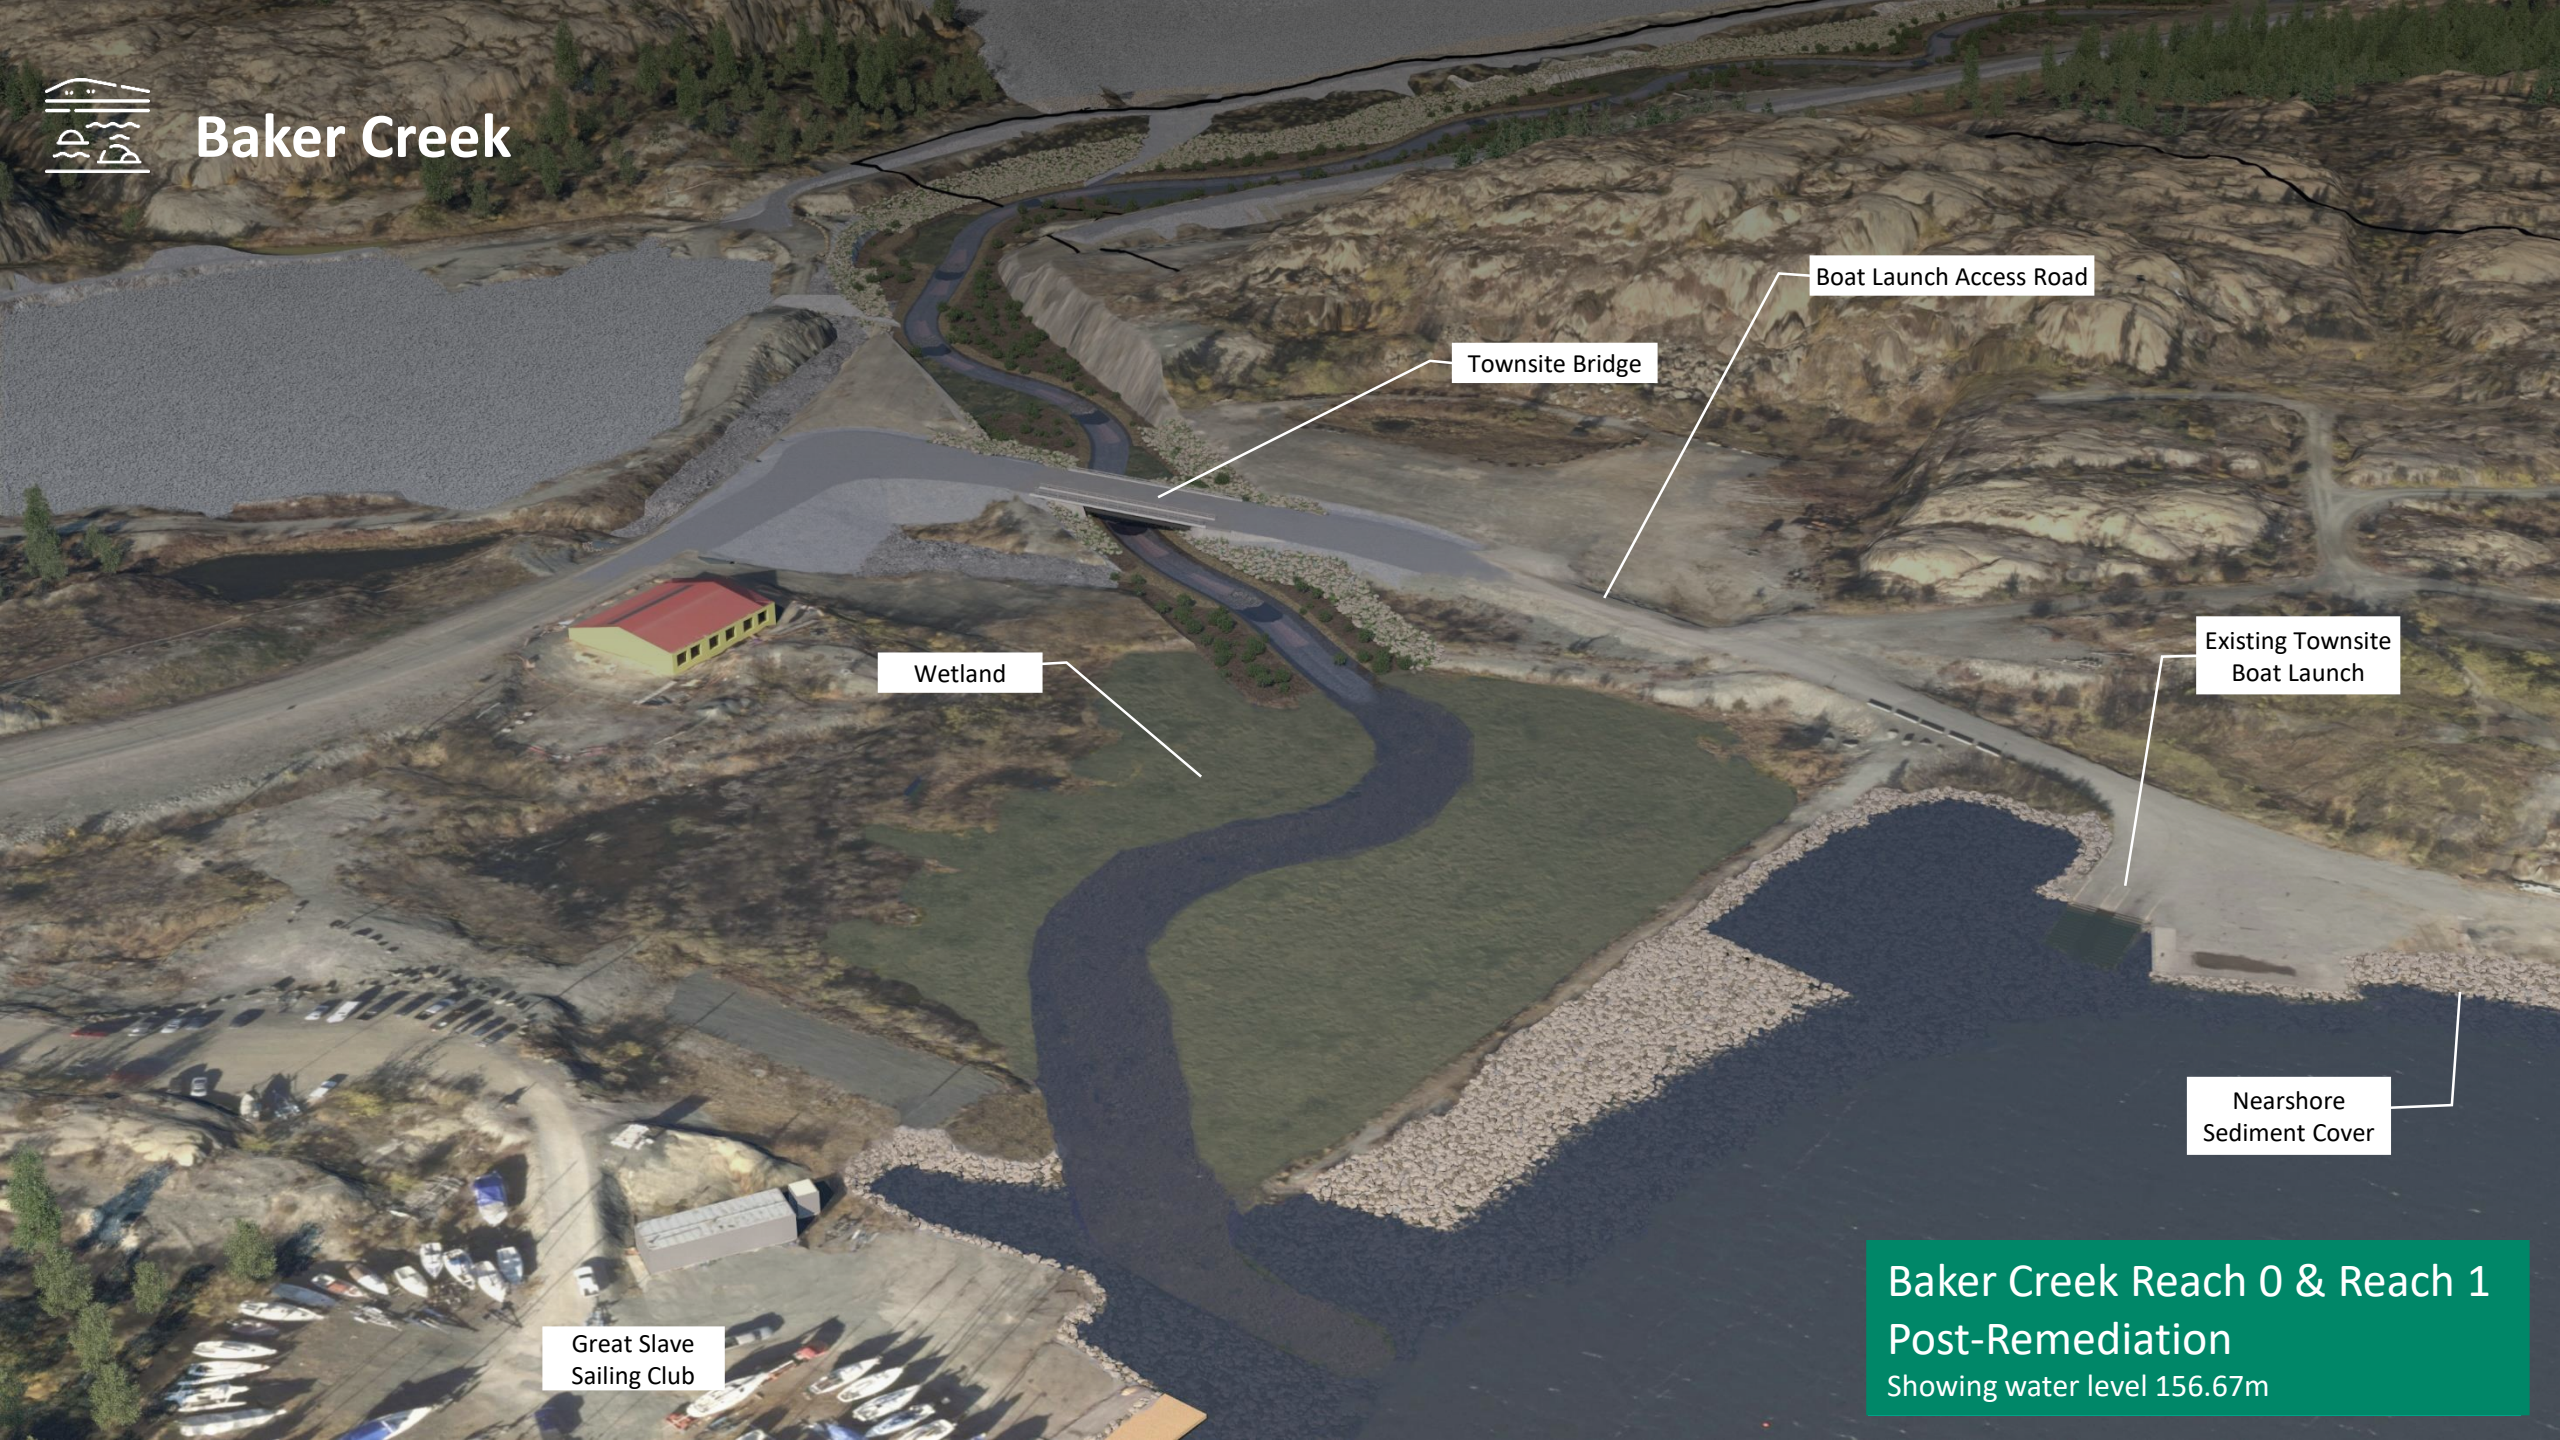
Baker Creek Reach 0 & Reach 1
Post-Remediation
Showing water level 156.67m

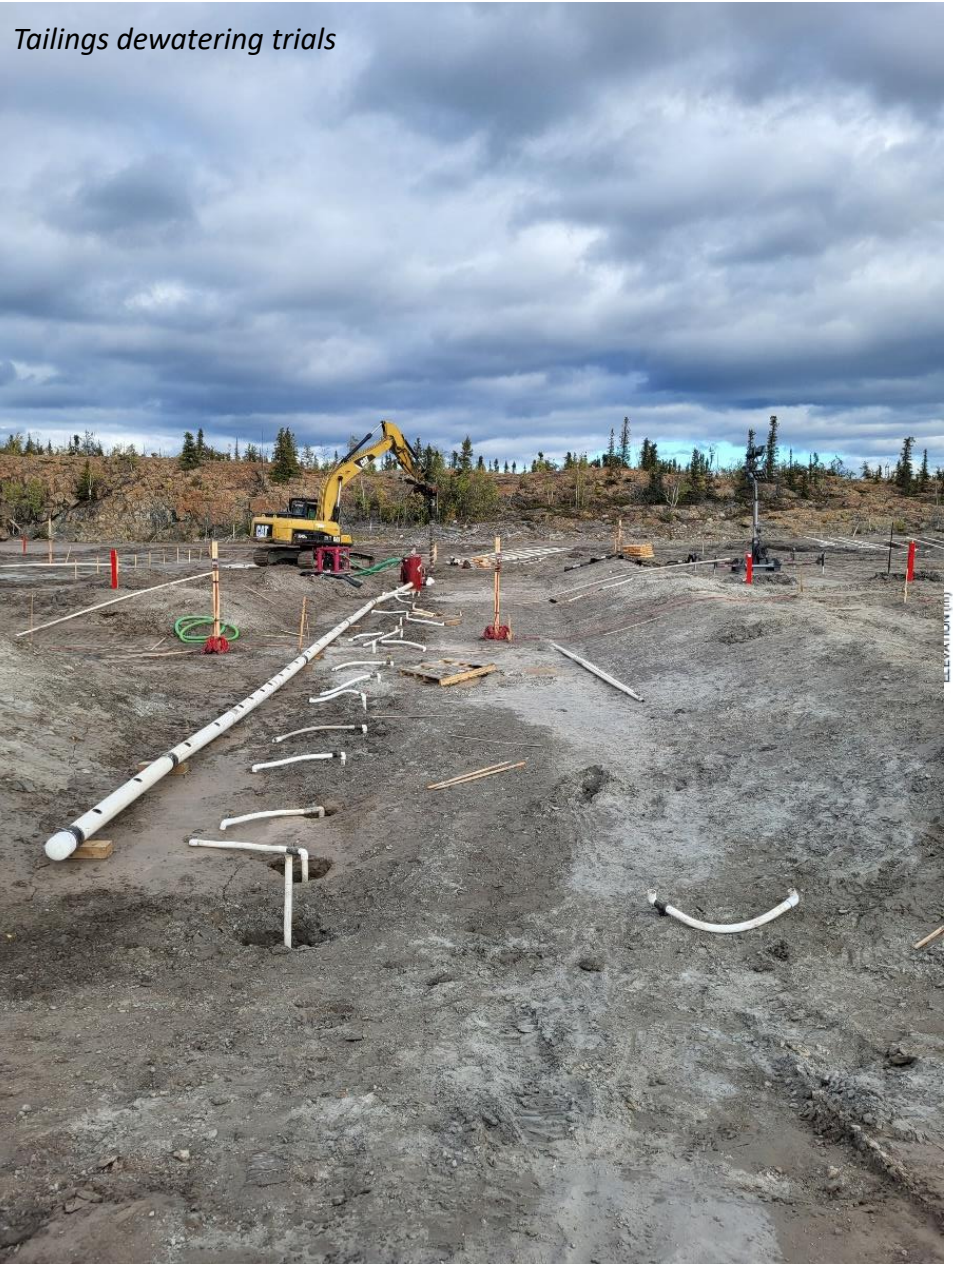
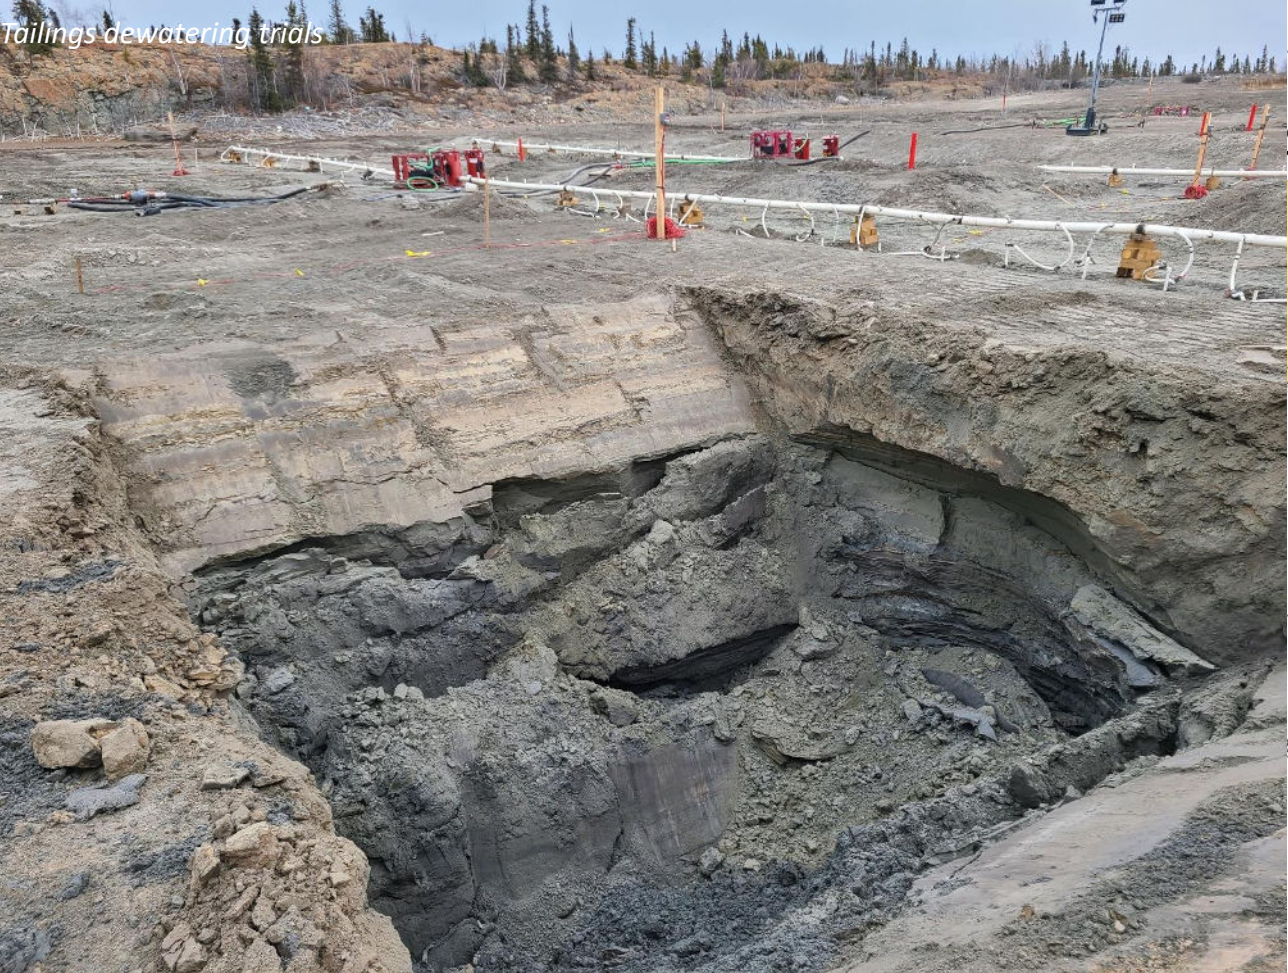
Tailings dewatering trials

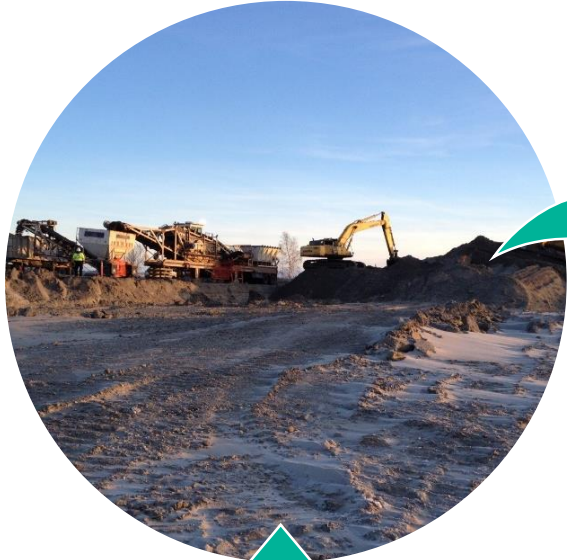
Making cemented tailings paste backfill with tailings, bimer, and water at batch plant

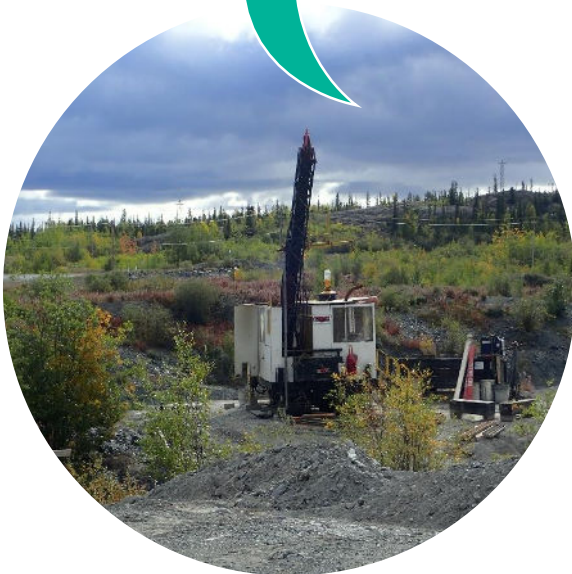
Drilling cemented paste backfill hole into underground void
