Giant Mine Remediation Project

Overcoming the Engineering Challenges

RemTech East

May 29th to June 1st, 2023

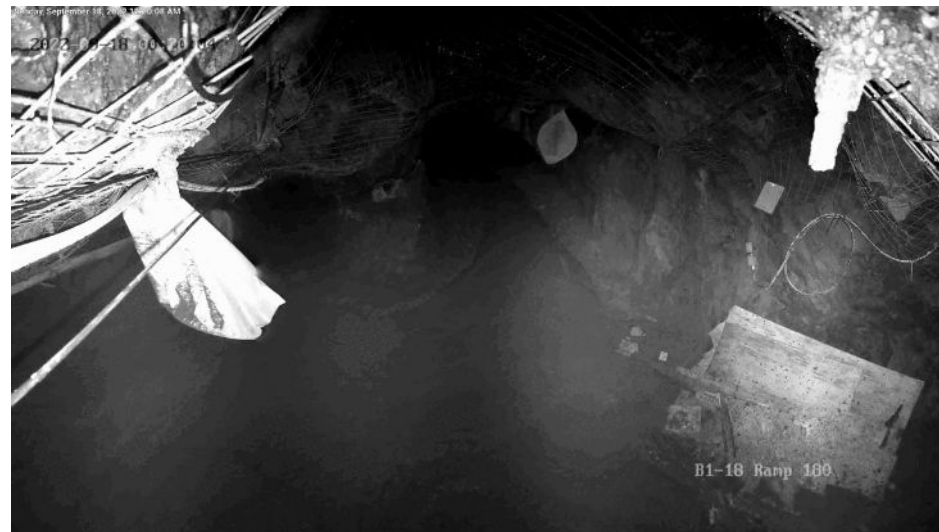
Backfilling of underground with cemented paste backfill

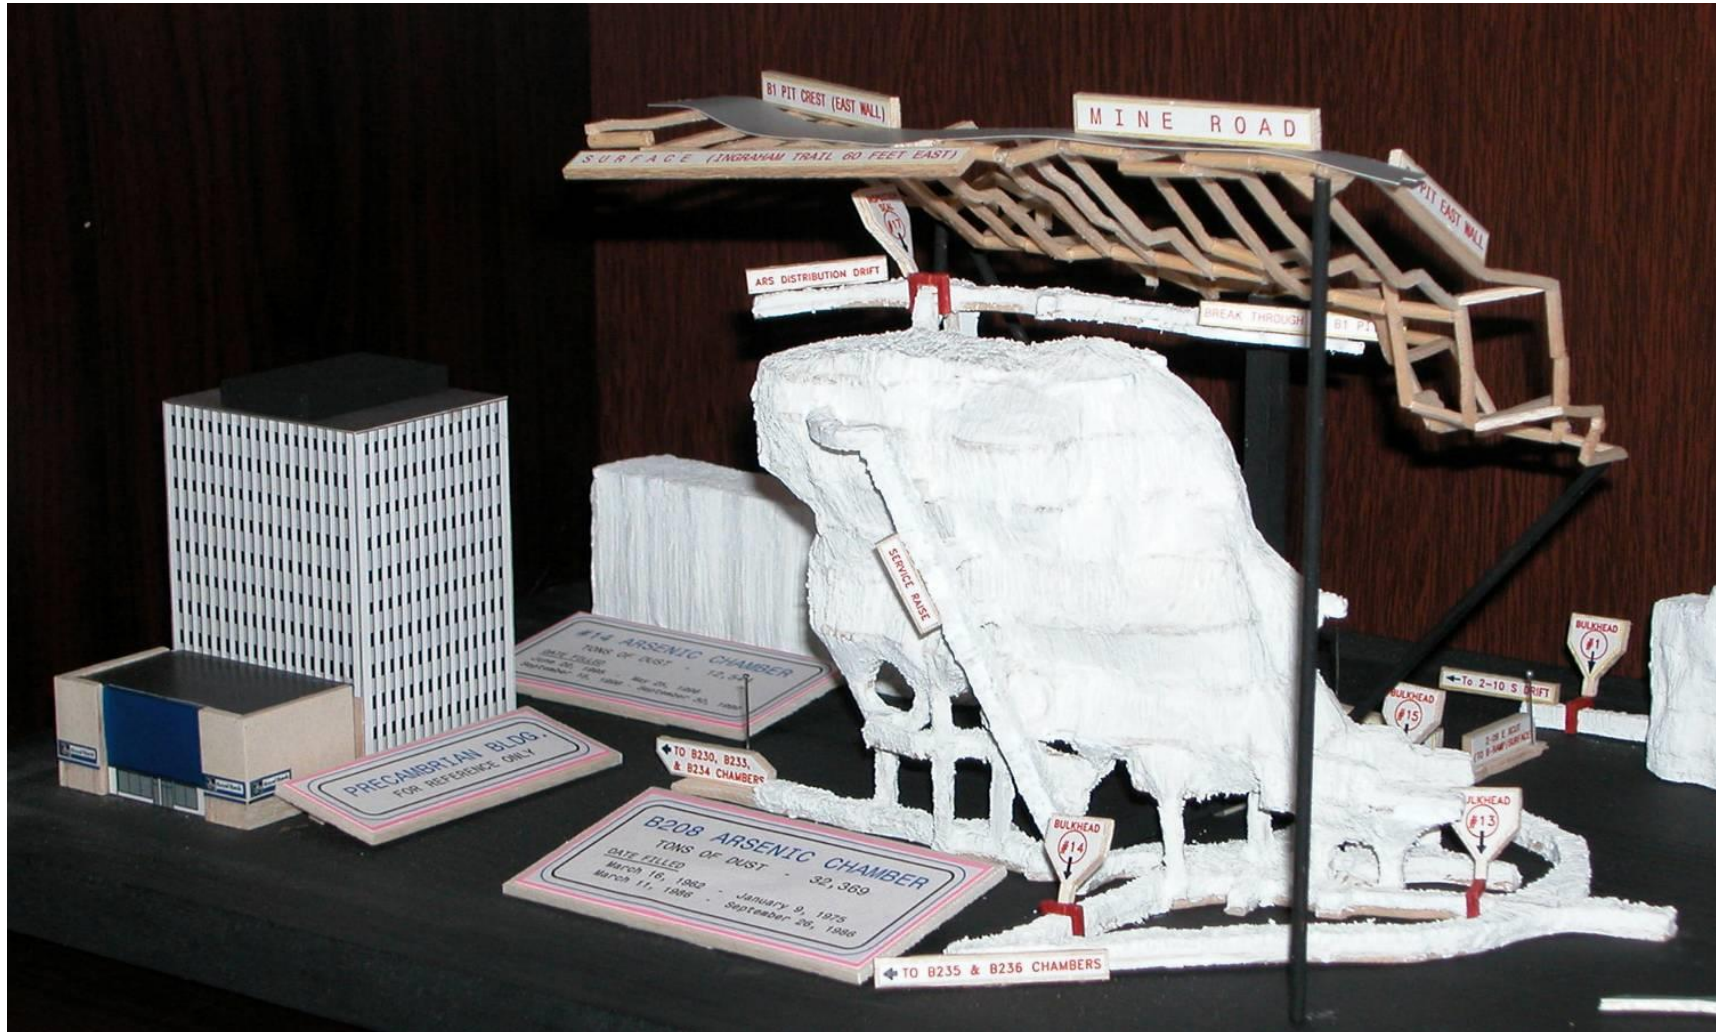
Yellowknife Office Building vs. B2-08 Arsenic Stope

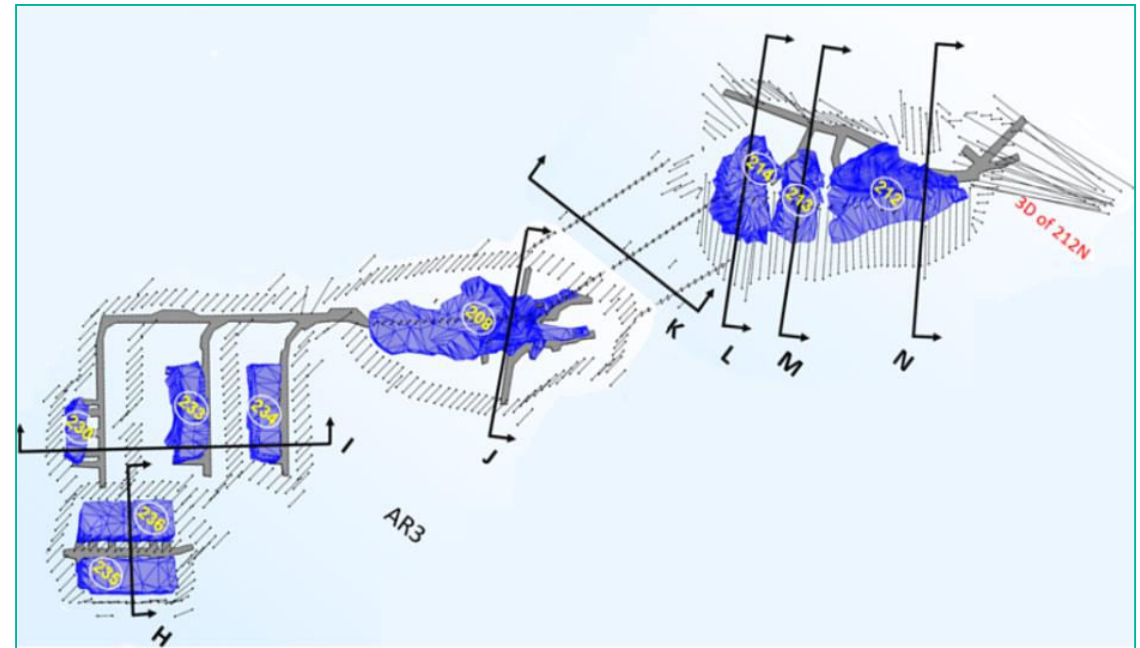
Plan view

Freeze - Thermosyphons

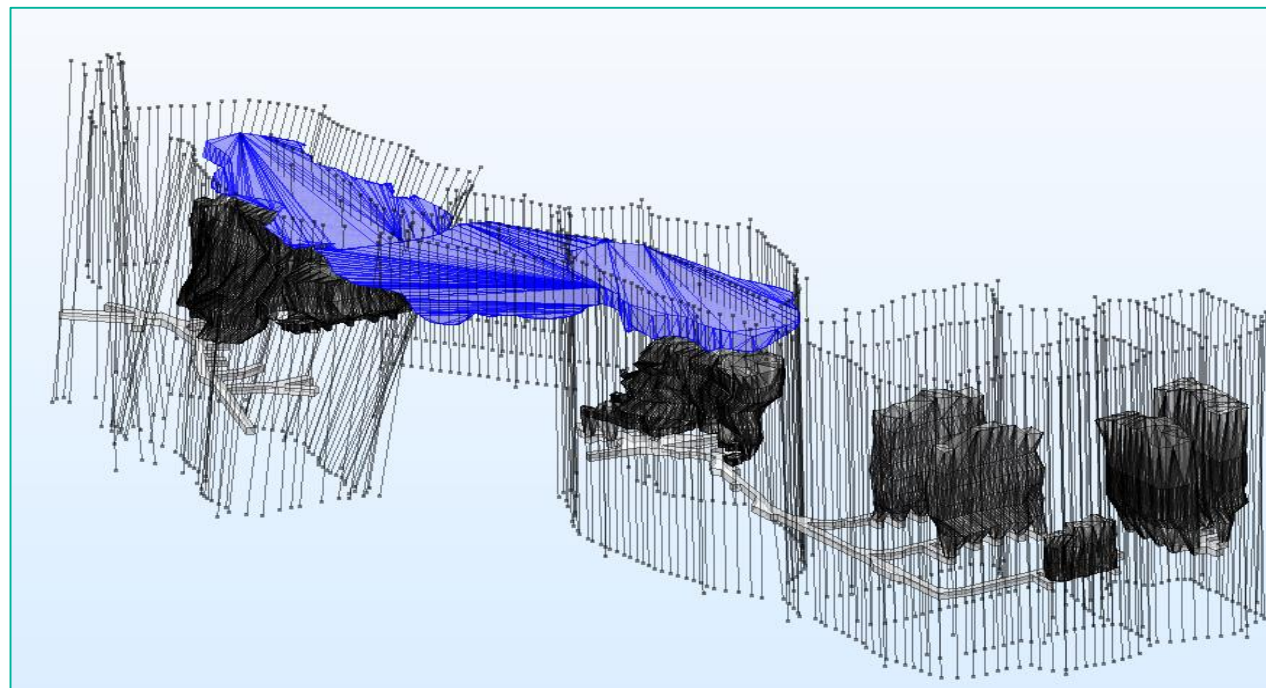
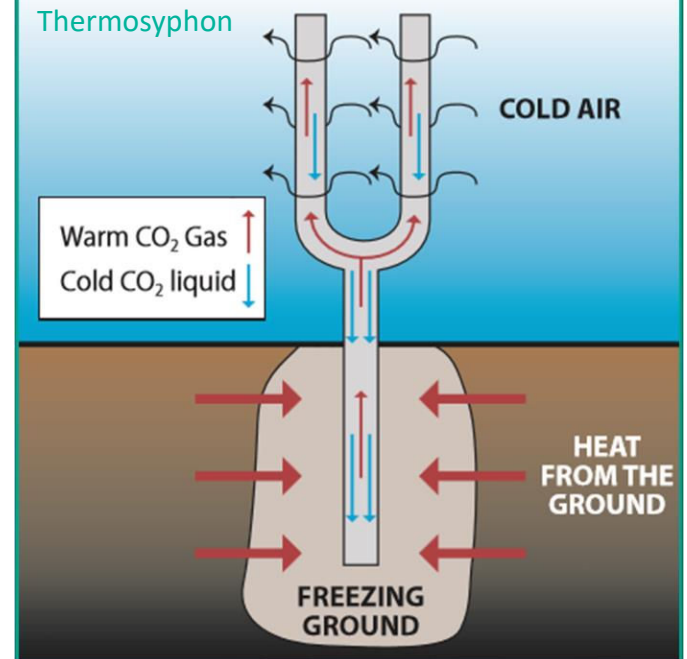
3D Isometric View

Thermosyphons

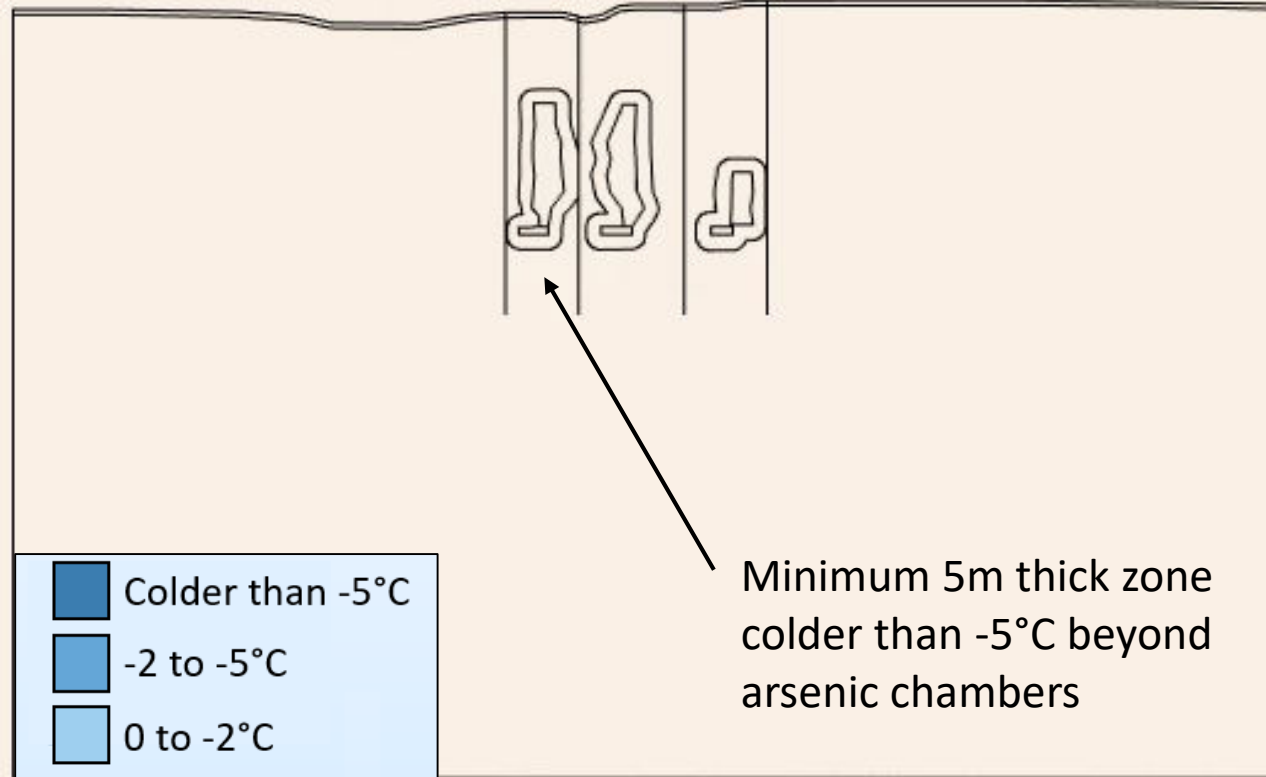
Elapsed Years since Start of Cooling: 0.0

Arsenic stopes B-230, B-233, B-234 (Cross-Section Looking North)

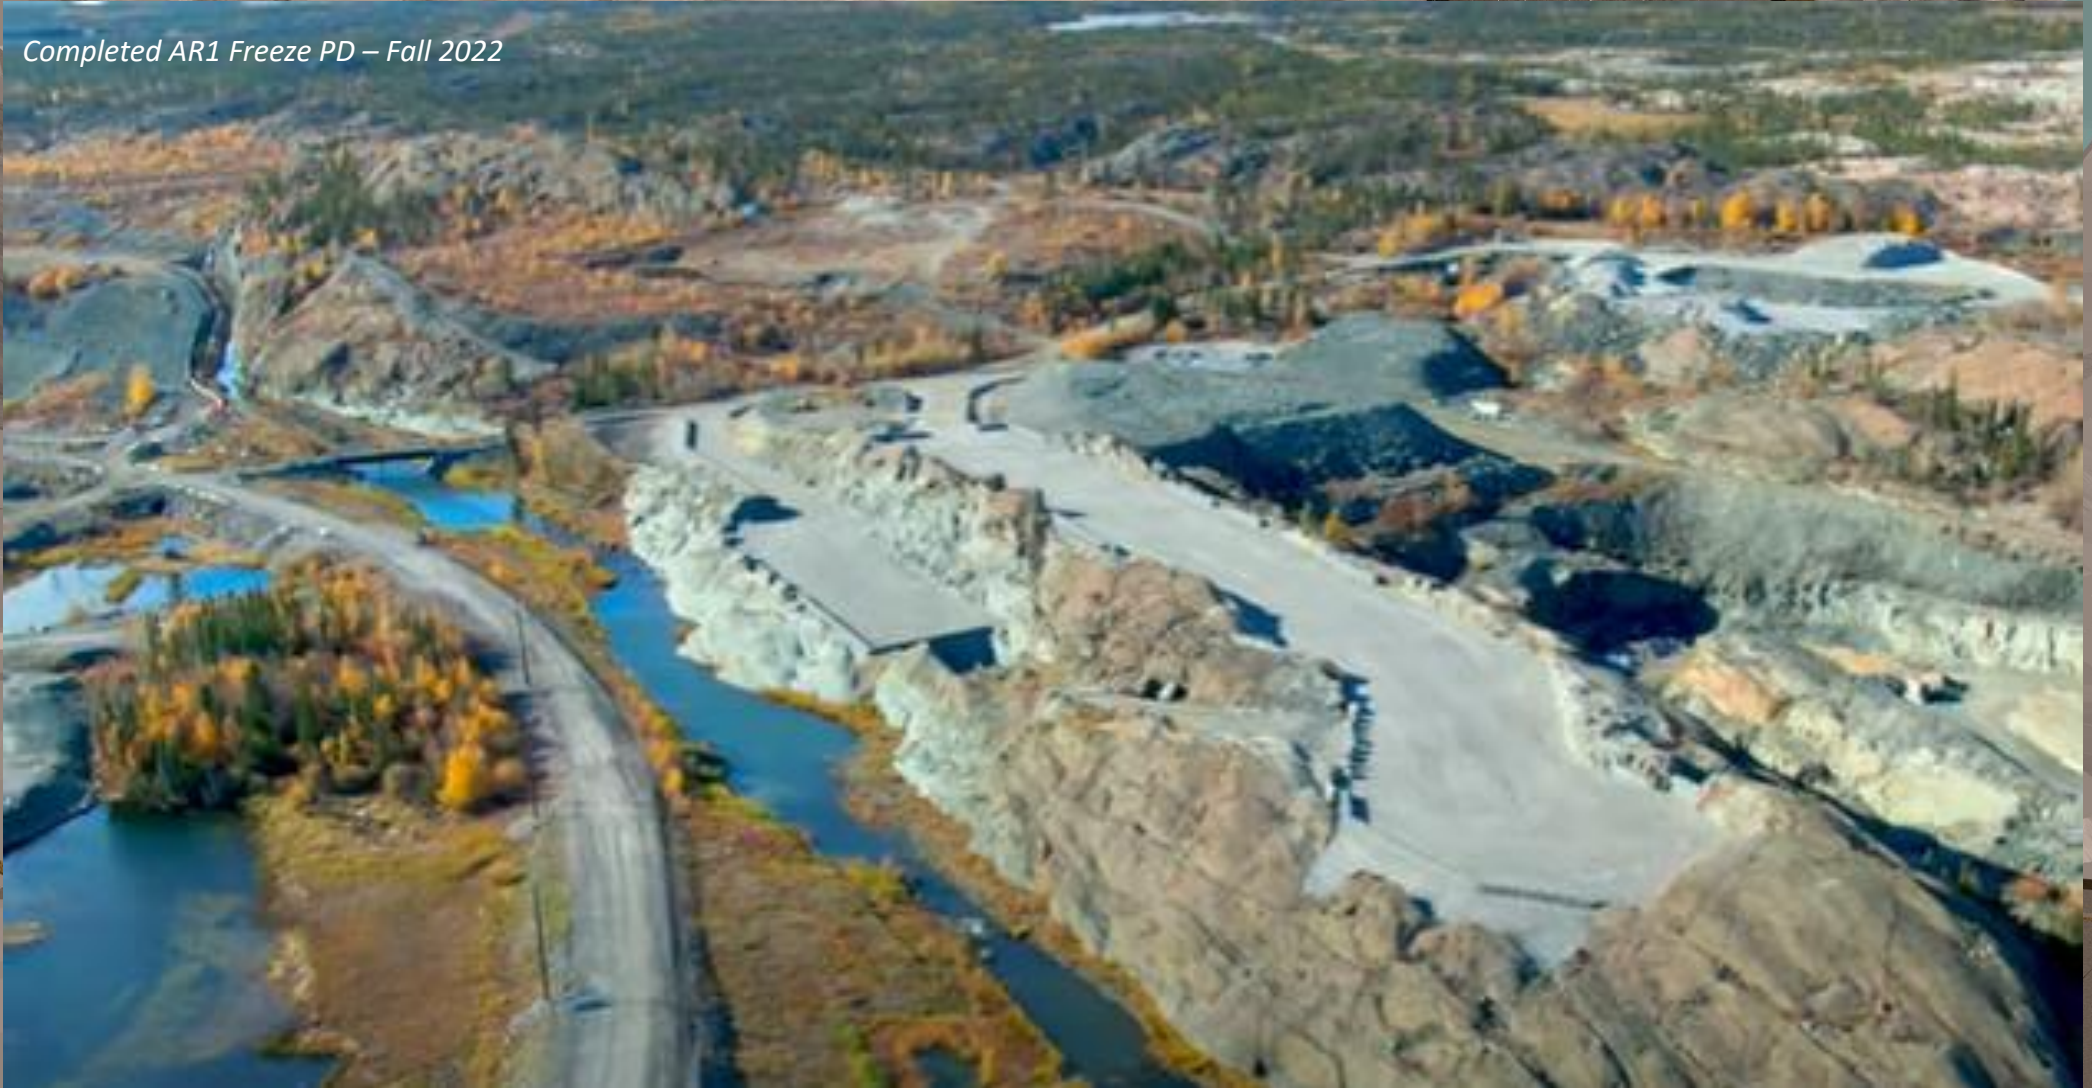
Completed AR1 Freeze PD – Fall 2022
