Keys to Successful In-Situ Remedial Designs at Brownfield Sites

Elliot Maker, MSc.
Northeast Technical Manager
REGENESIS

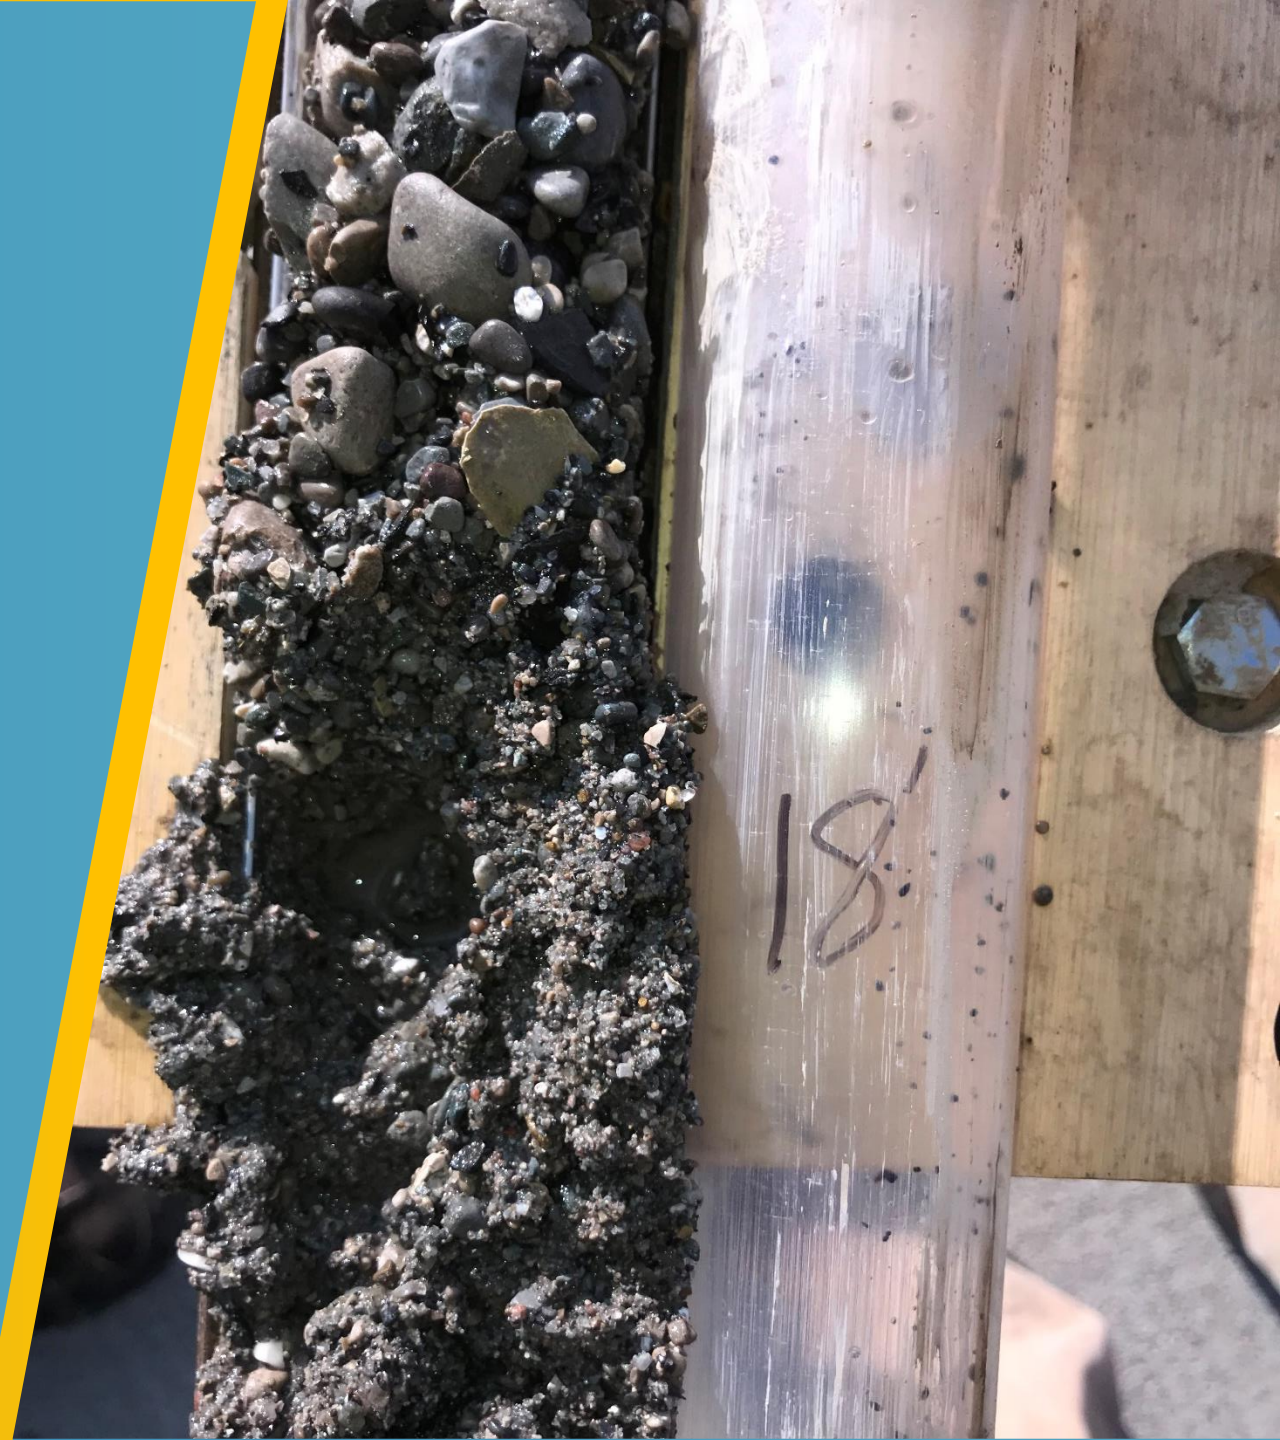
Continuous Core Logging

- **Physical Characteristics**
 - Moisture content
 - Contaminant: e.g. odor, staining, PID
- **Grain Size:**
 - % clay- silt-
 - % fine- medium- coarse- sand/gravel
- **Gradation:**
 - coarsening upward vs. fining upward
- **Soil contaminant analysis:**
 - Identify contaminant concentrations within flow pathways

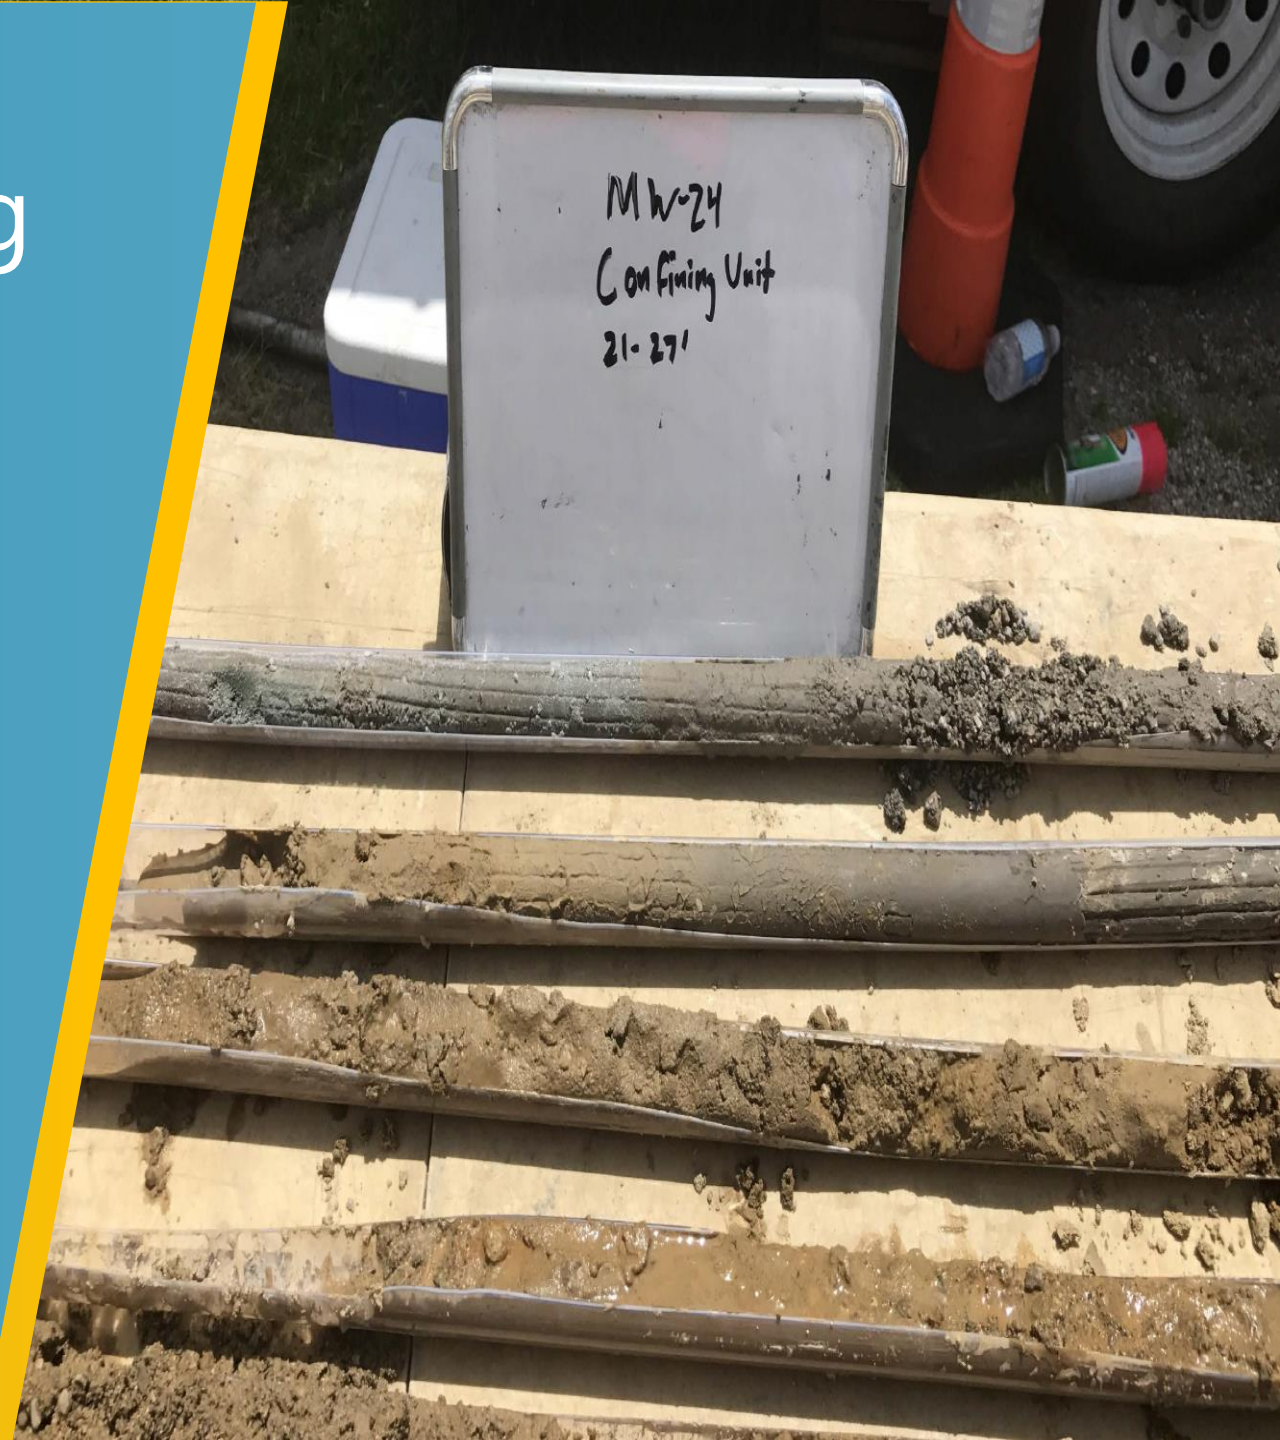
Design Verification: Soil Settling Tubes

- Field Technique provides semi-quantitative data to trained Field Geologist
- Visual Determination
 - Sand, Silt, Clay
 - Soil particle size %
 - Sand: grain size and sorting
- Simple Rapid Reliable
- Decreases Subjectivity
 - e.g. Silty sand silty clayey sand etc.
- High density, 1 foot vertical interval

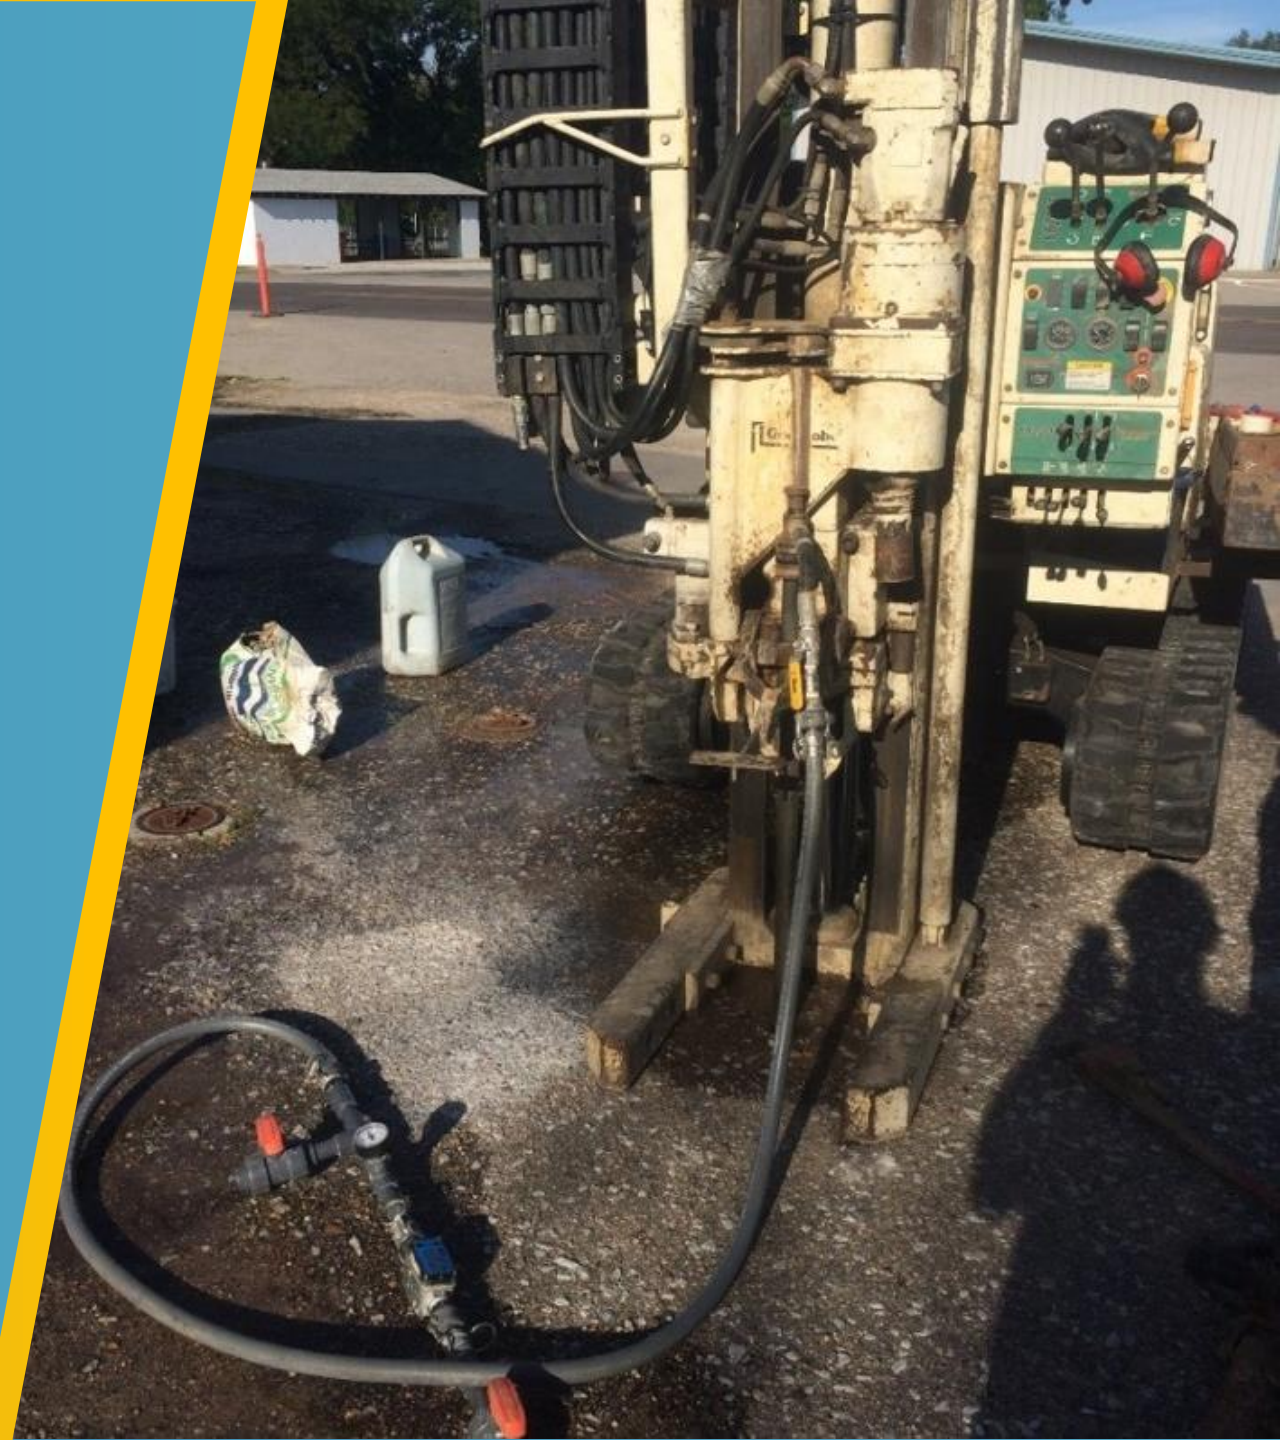
FluxTracer[®]

Flux Mapping Tool

- Collects information to aid in site characterization and remedial designs
- Vertically delineates contaminant mass flux and groundwater speed within an existing monitoring well
- Better site characterization and more specific design choices lead to better remedial outcomes
- Units for specific wells arrive pre-assembled and ready to deploy

How it Works:

- FluxTracer is deployed for two weeks and retrieved
- Alcohol tracers are washed out – contaminants are sorbed
- Device is sent back to REGENESIS for sample analysis
- Results are used to provide a report containing useful information such as contaminant mass flux and groundwater Darcy flux

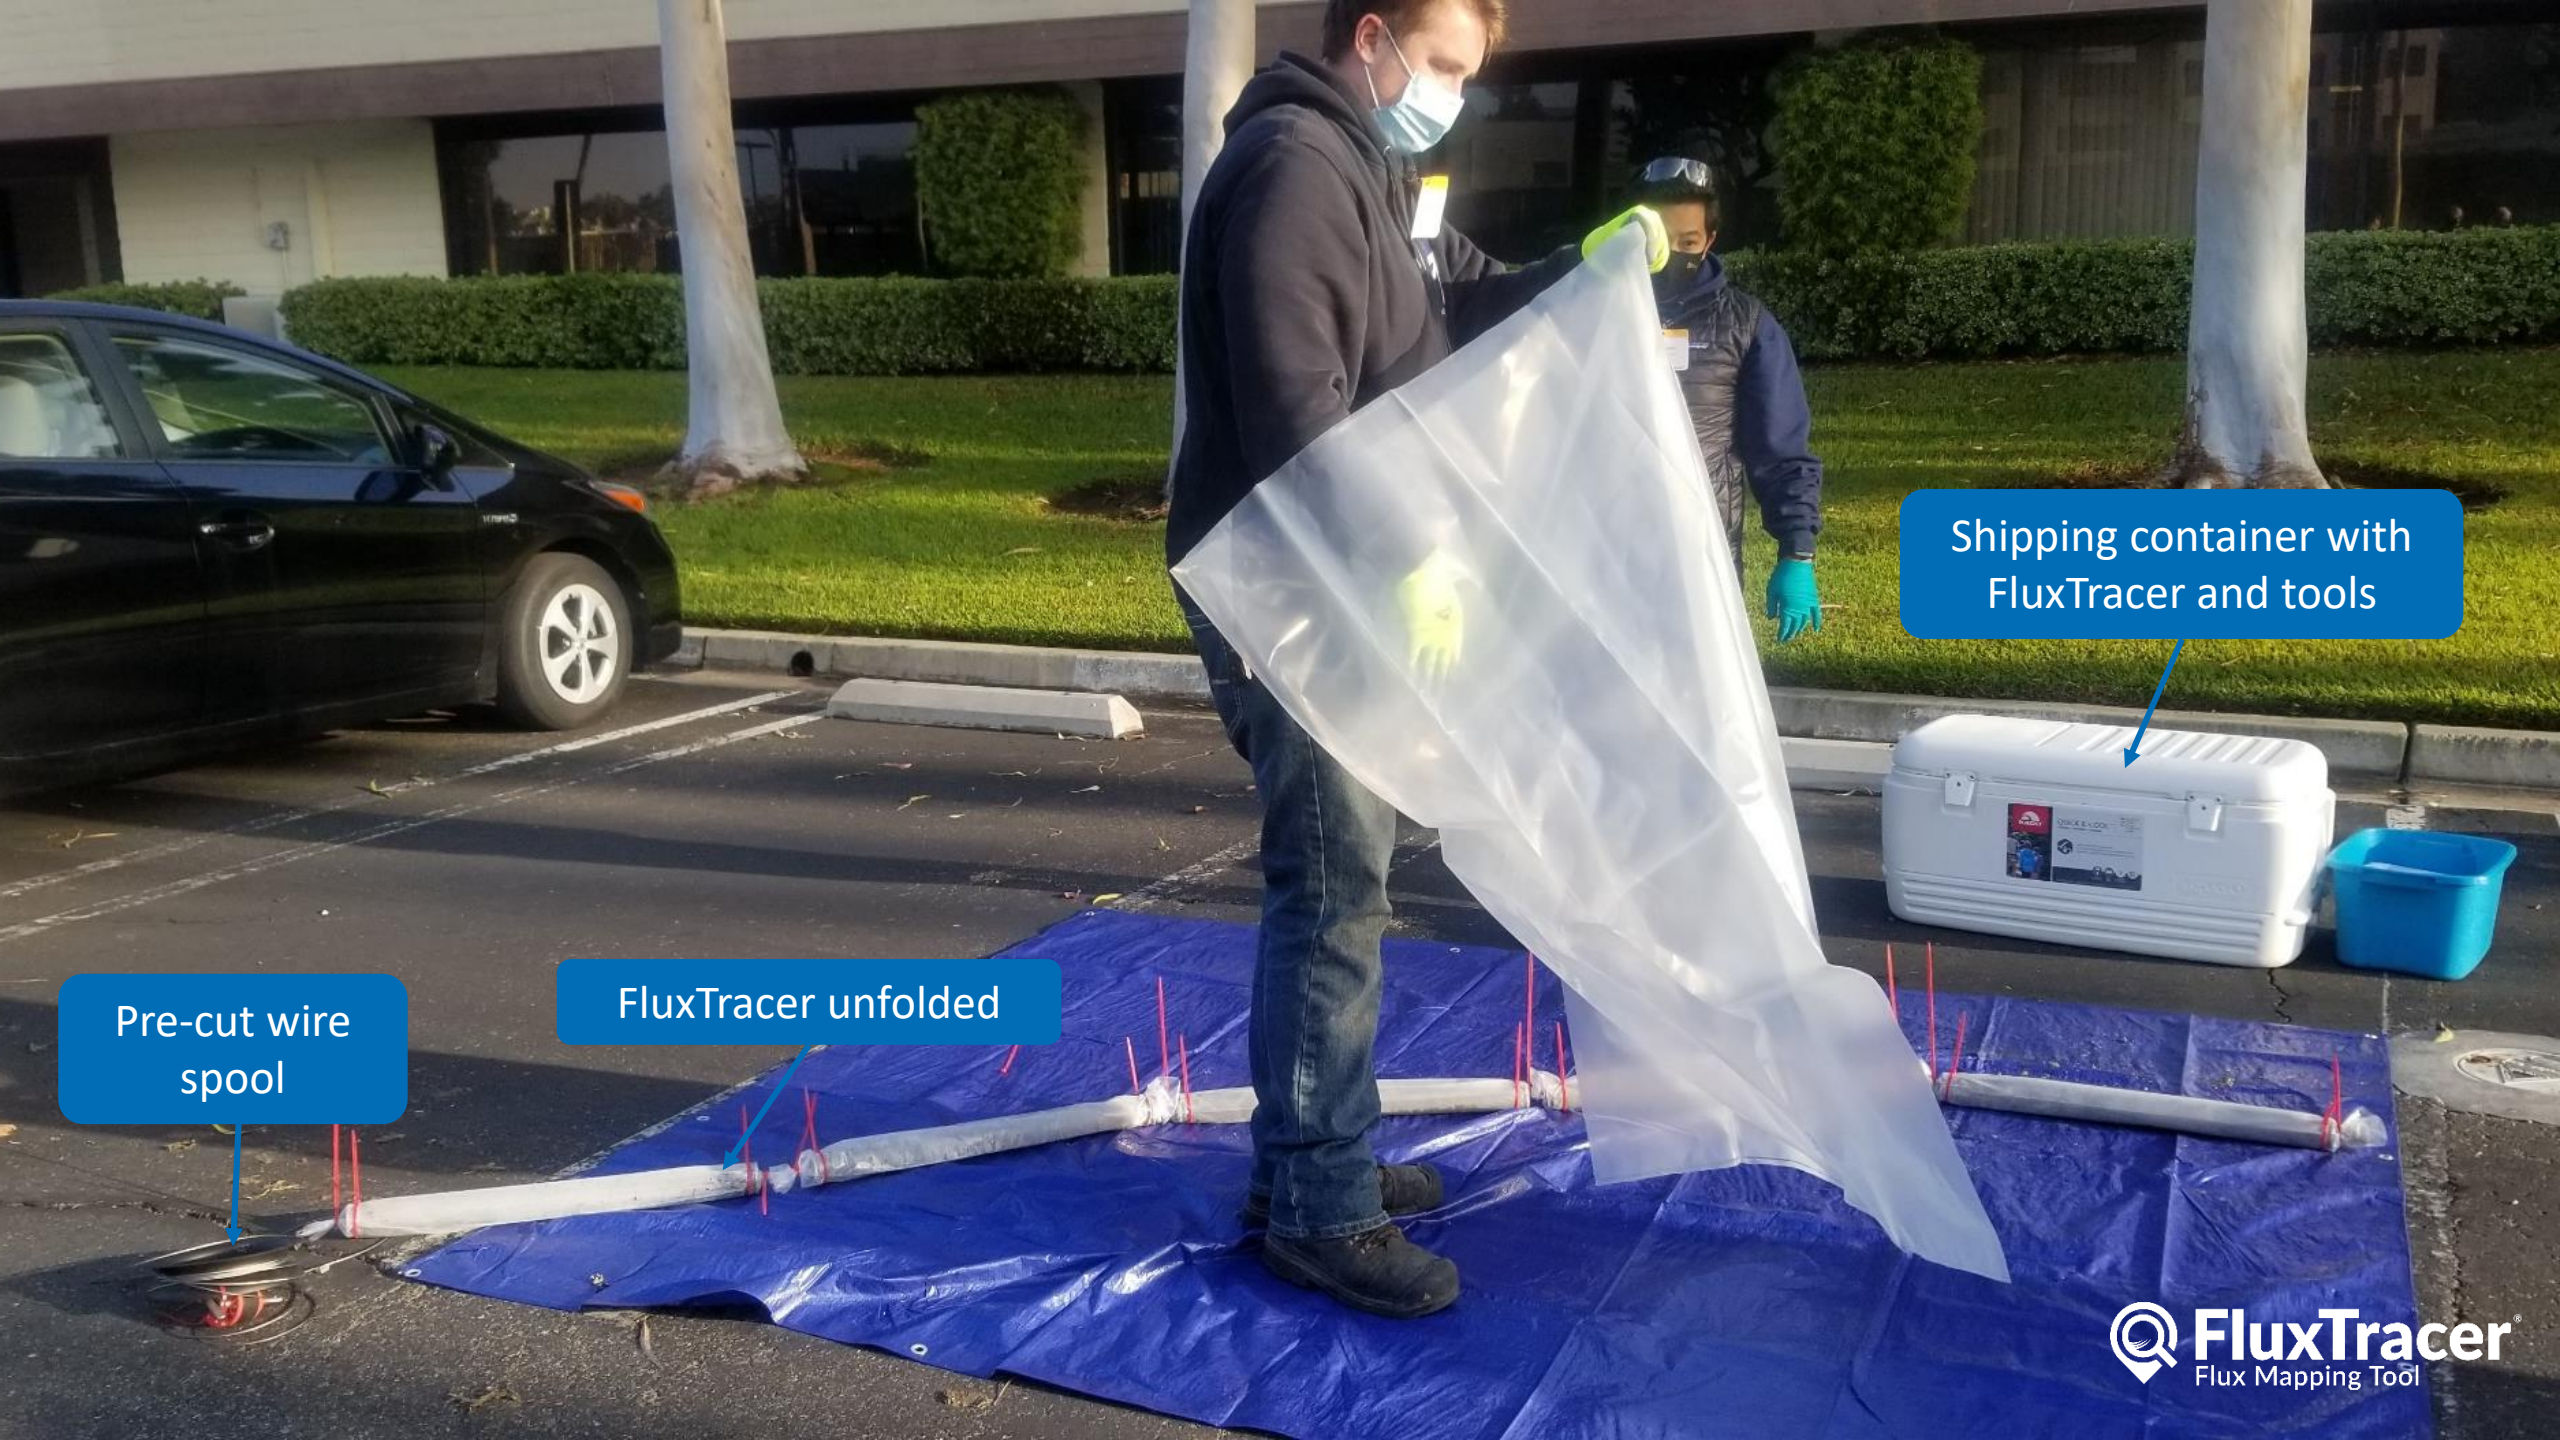
FluxTracer Construction

- All stainless-steel construction
- Sealed and tamper-resistant
- Self-centering
- Junctions allow “train car” movement

Pre-cut wire spool

FluxTracer unfolded

Shipping container with FluxTracer and tools

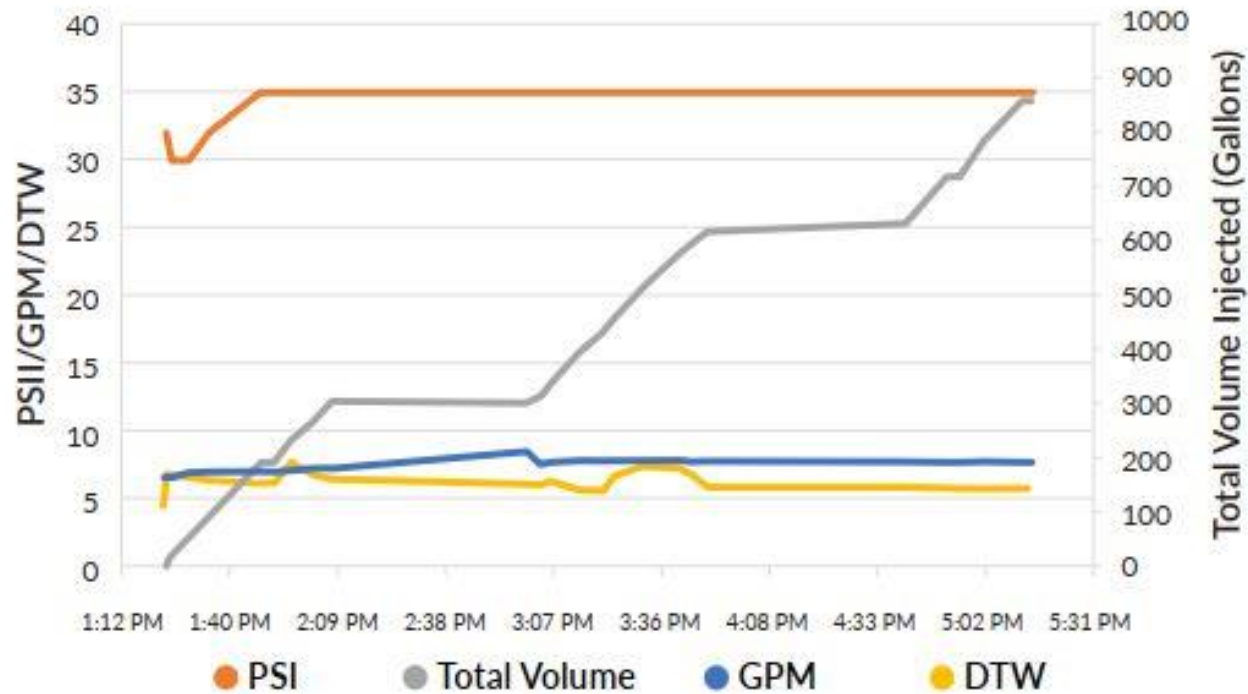
Chart showing pumping rate, injection pressures, depth to water and total volume injected.

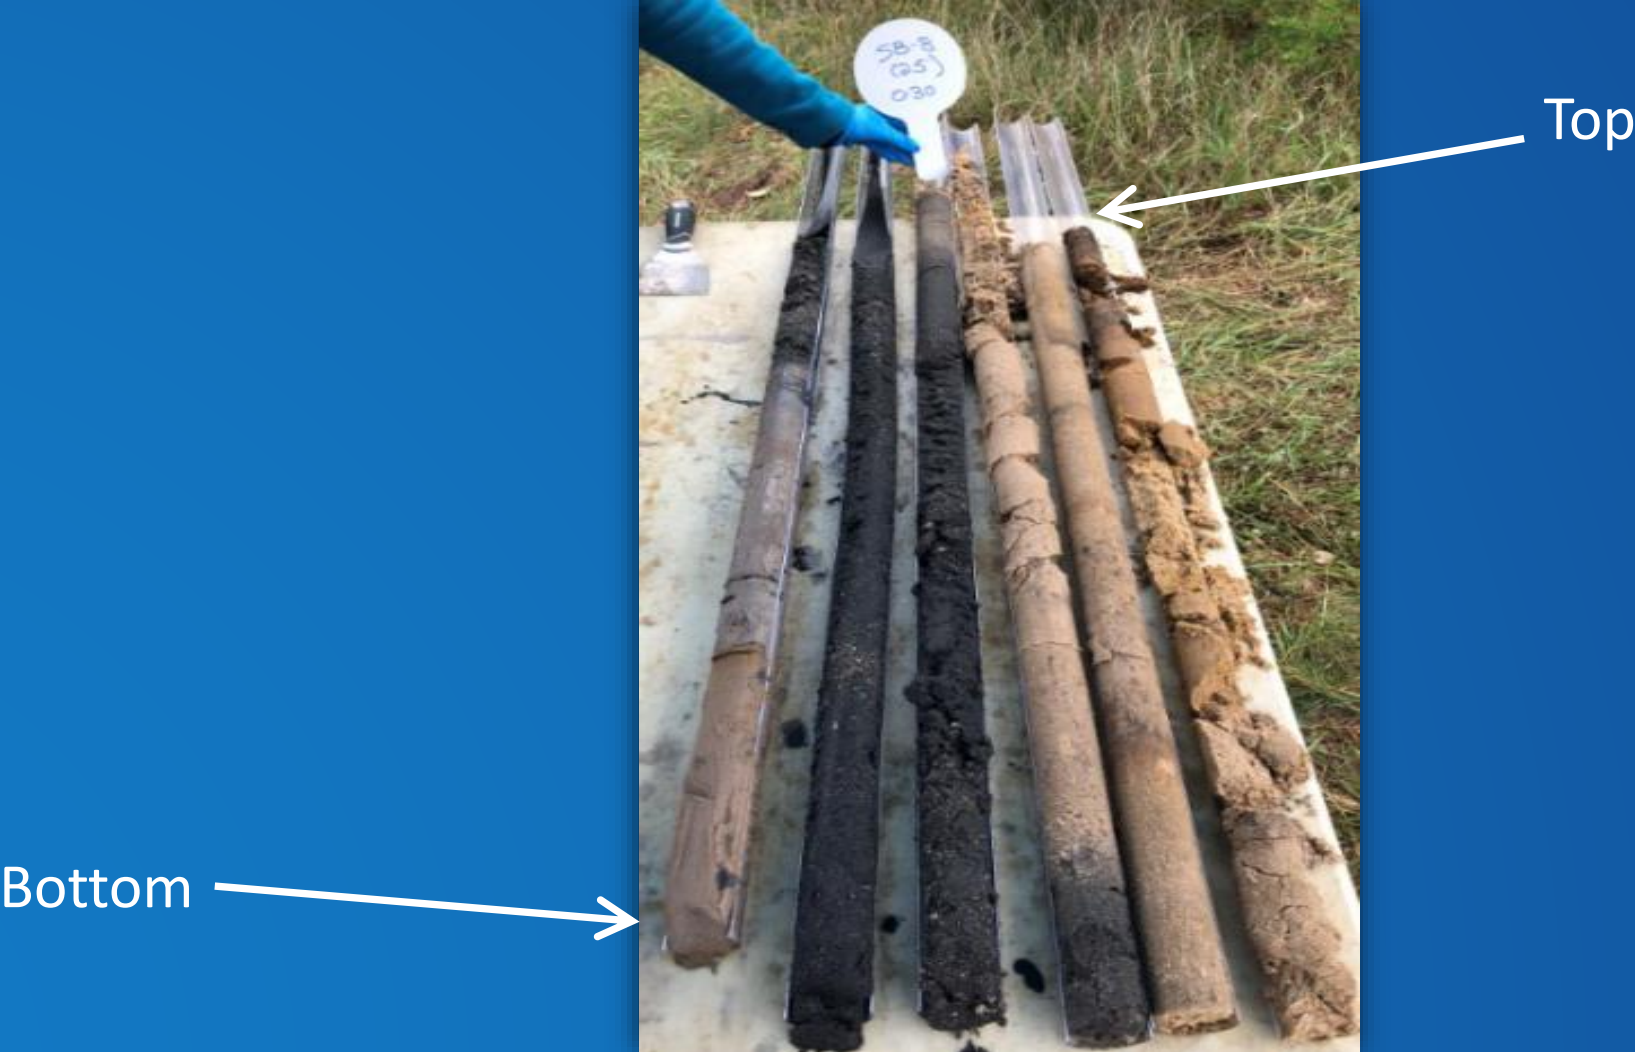
CAC-Distribution Confirmation

Distribution Confirmation
