# Lytton First Nation and Village of Lytton Wildfire Remediation – Contractor’s Perspective

**Presented By:**  
Chris Brown  
Project Director  
Matcon Environmental

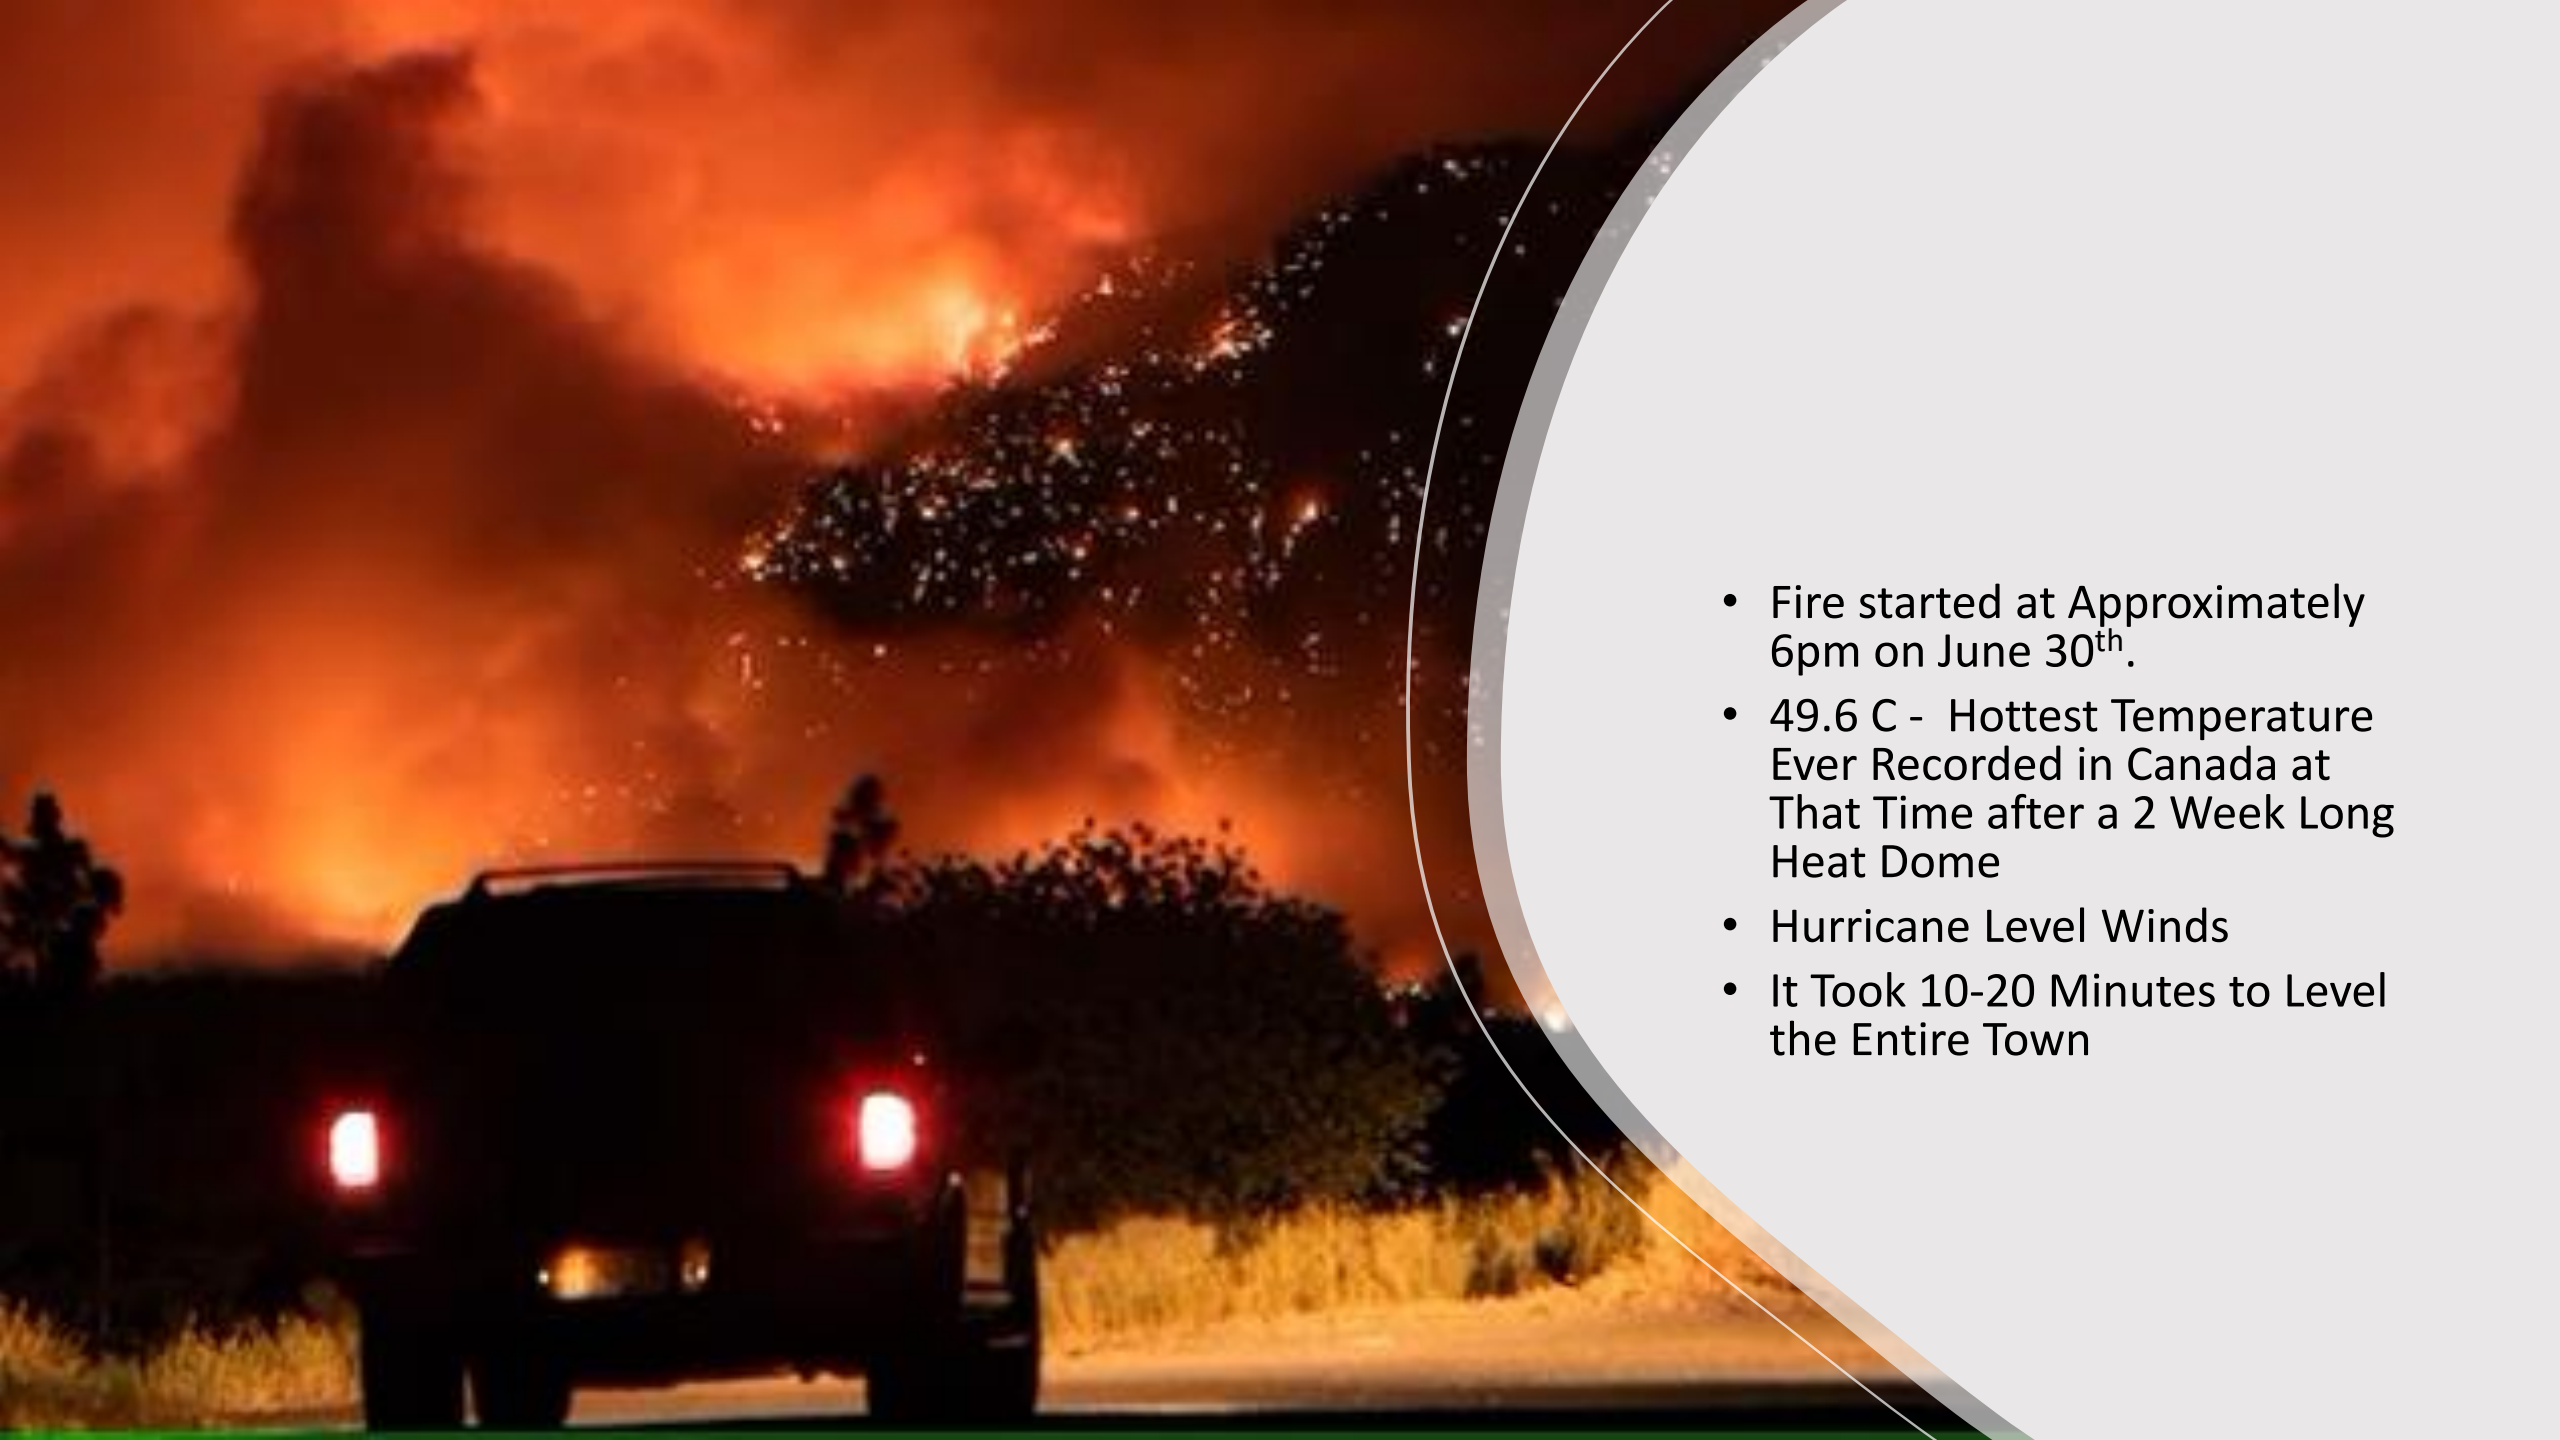
- Fire started at Approximately 6pm on June 30<sup>th</sup>.
- 49.6 C - Hottest Temperature Ever Recorded in Canada at That Time after a 2 Week Long Heat Dome
- Hurricane Level Winds
- It Took 10-20 Minutes to Level the Entire Town

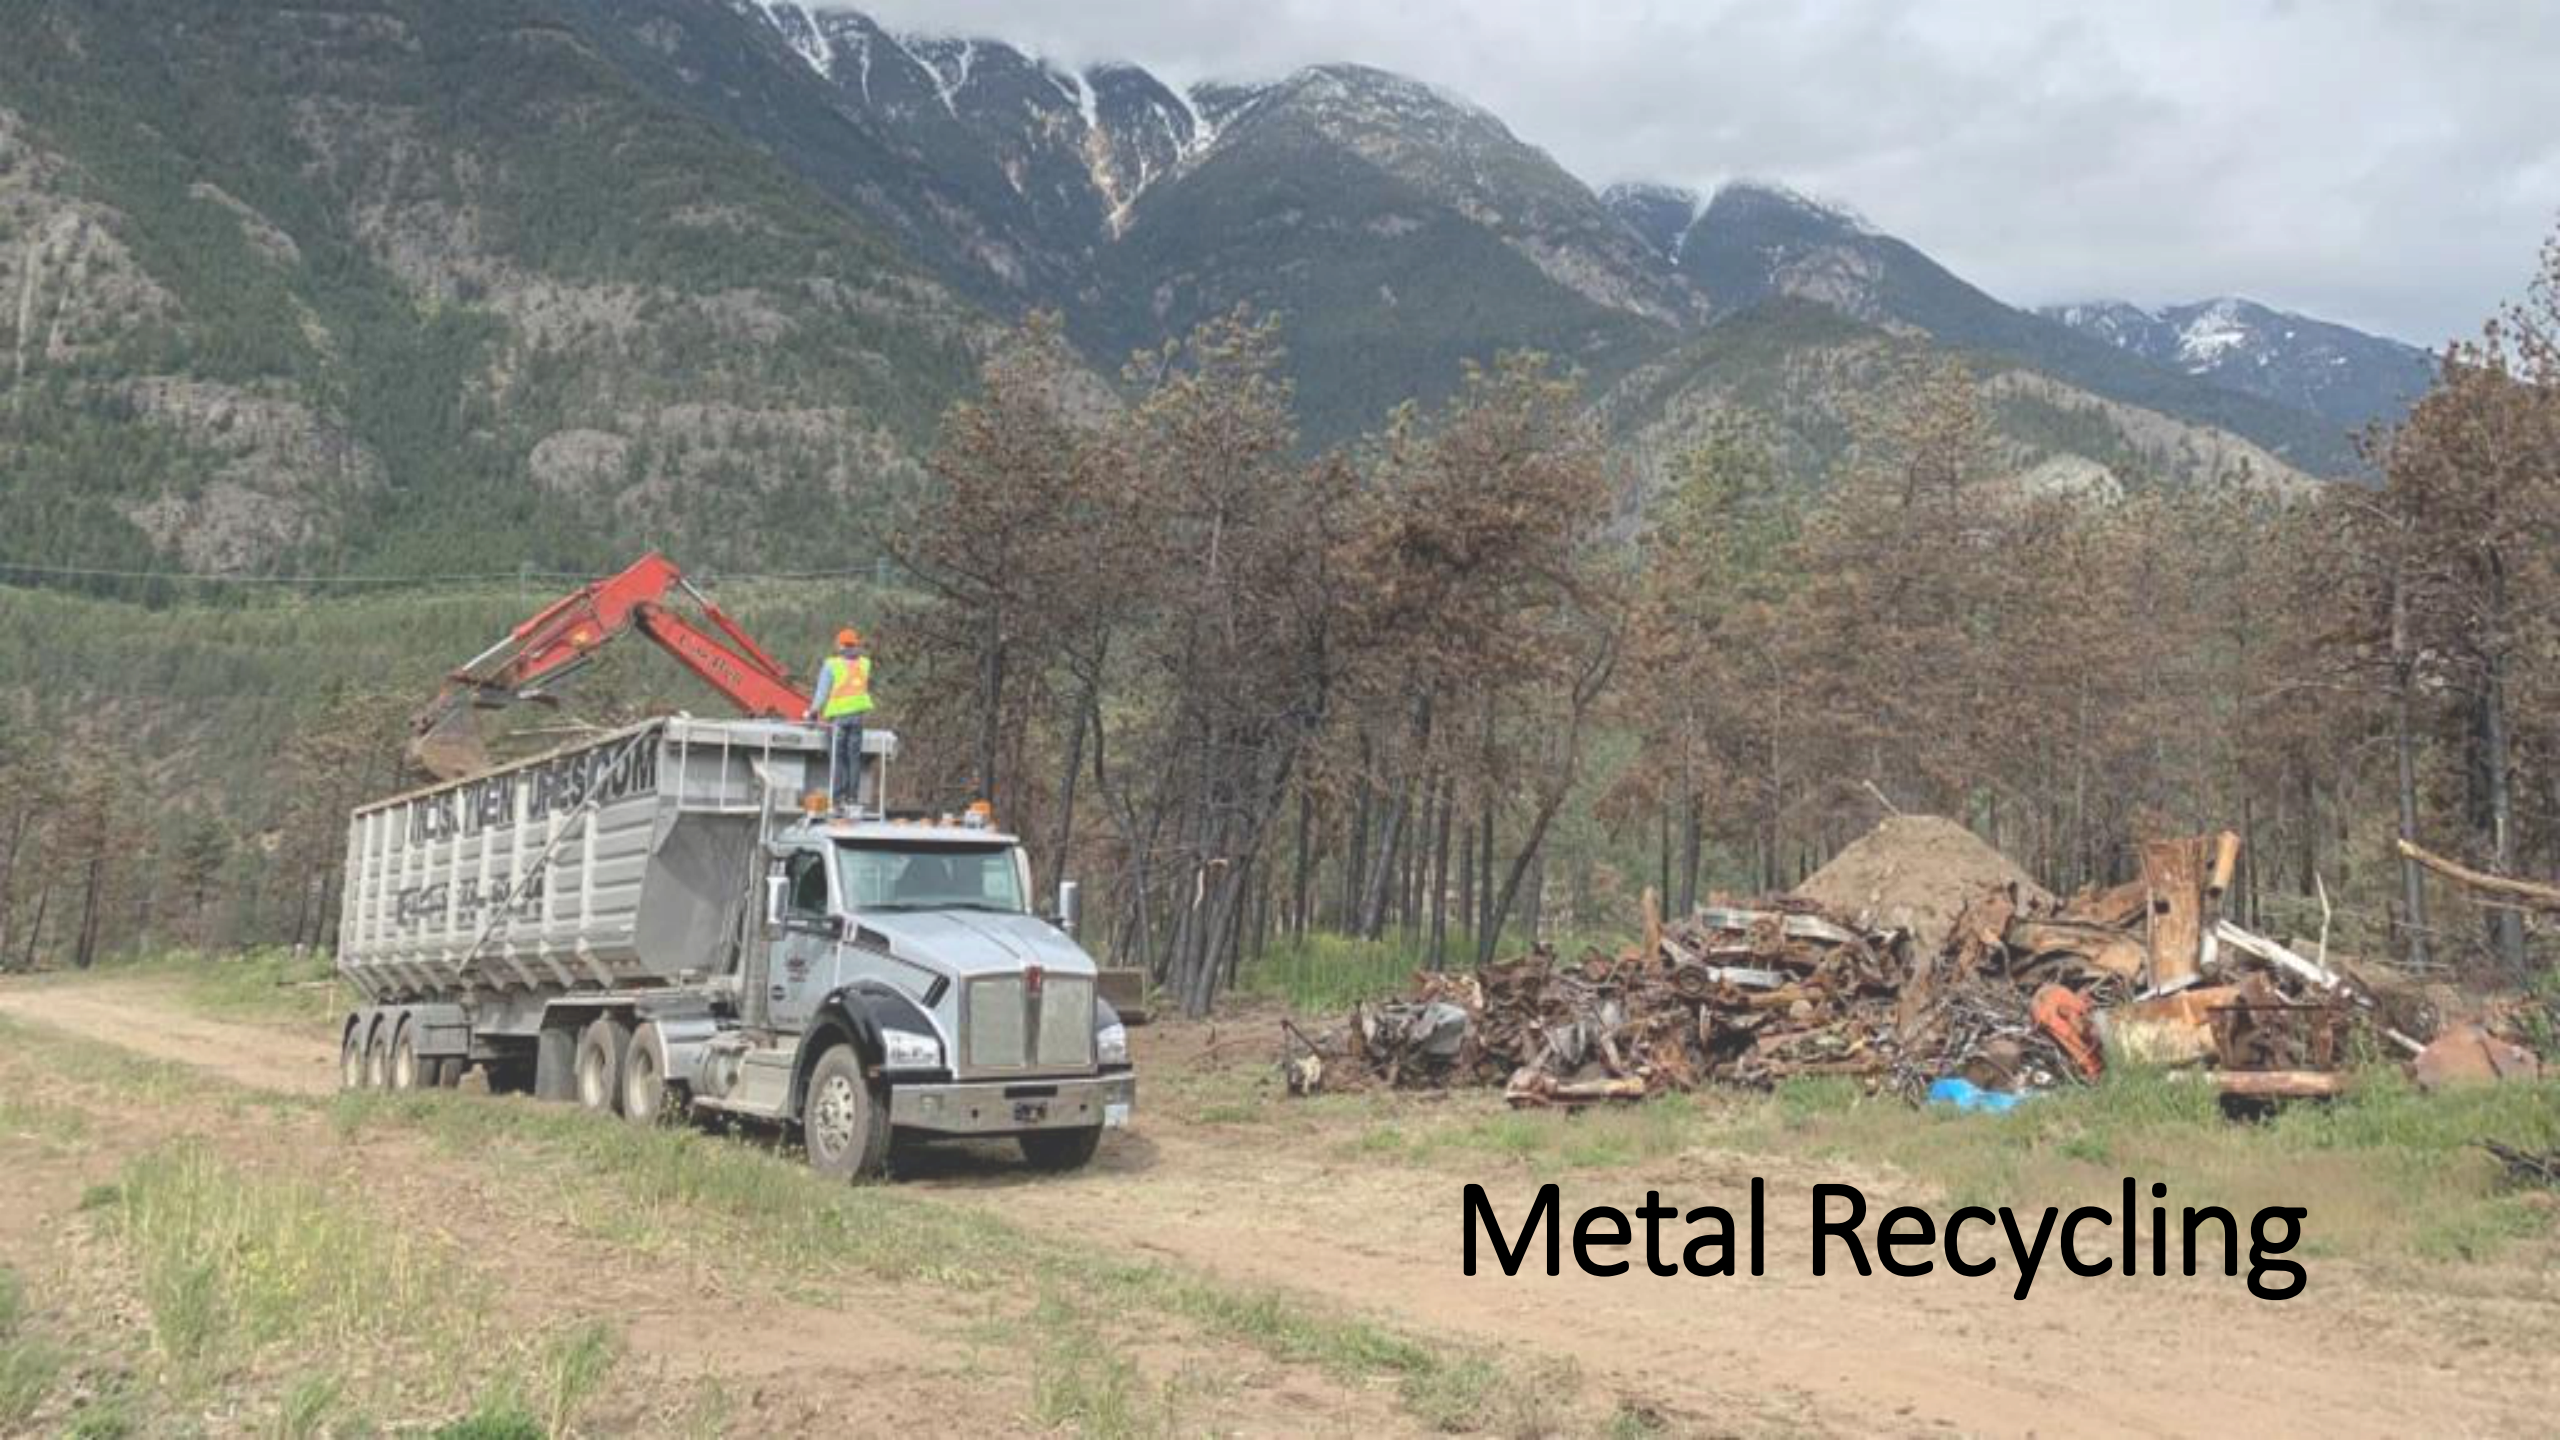
# Metal Recycling

1,000 MT of Metal  
Recycled

160 Vehicle  
Recycled (Slightly  
Misleading)

Shipped to Lower  
Mainland For Recycling  
Via 80 Yard Bins

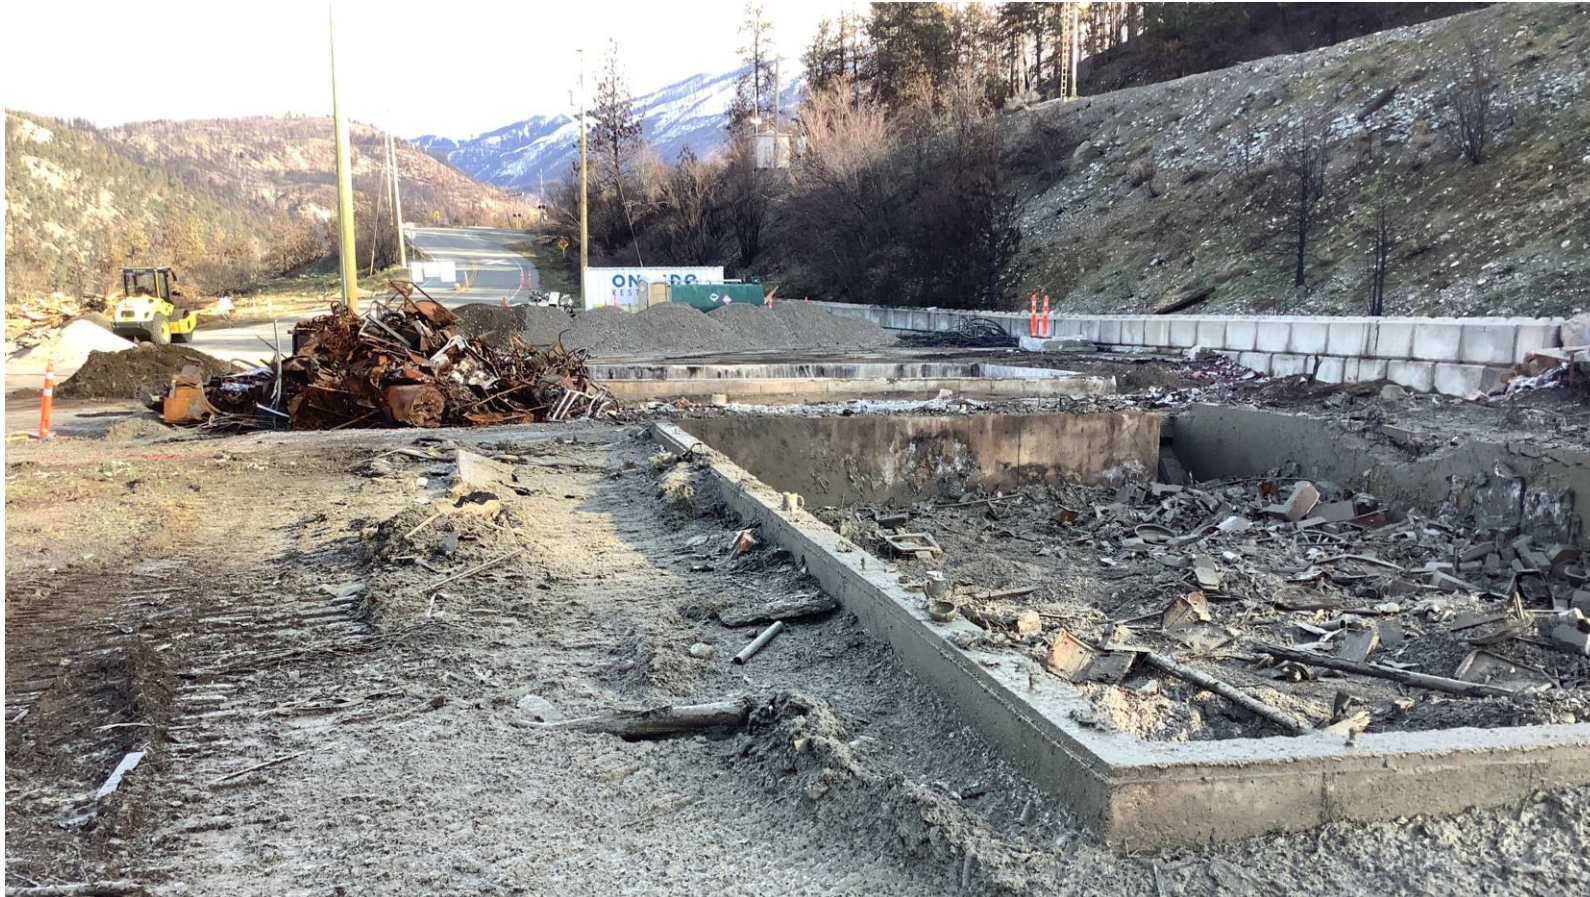
# Asbestos Debris Abatement and Removal

- ACM Debris Consisted of Ash and Other Burned Debris and Was Assumed by Environmental Consultant to be ACMs
- Lytton Extremely Windy Year Round
- Tackifier Coating Applied to All ACM Debris
- 100m<sup>3</sup> of Tackifier Applied to ACM Debris by Canadian Erosion and Containment

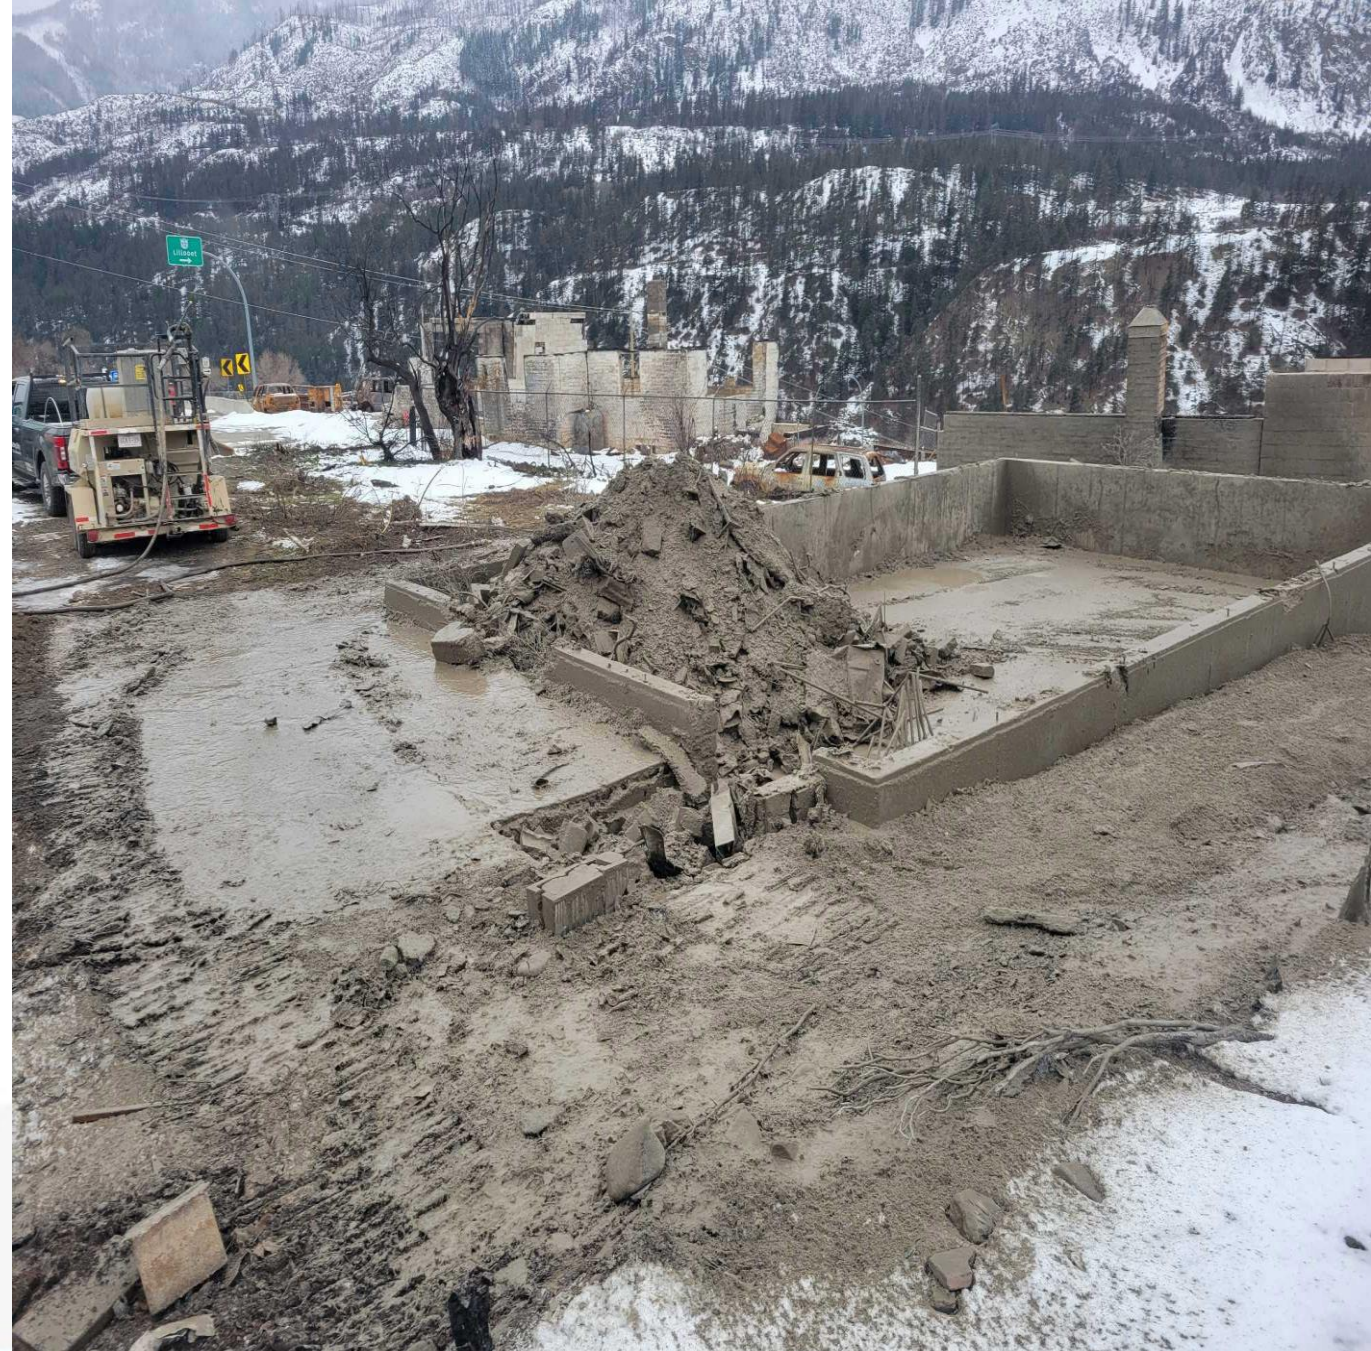
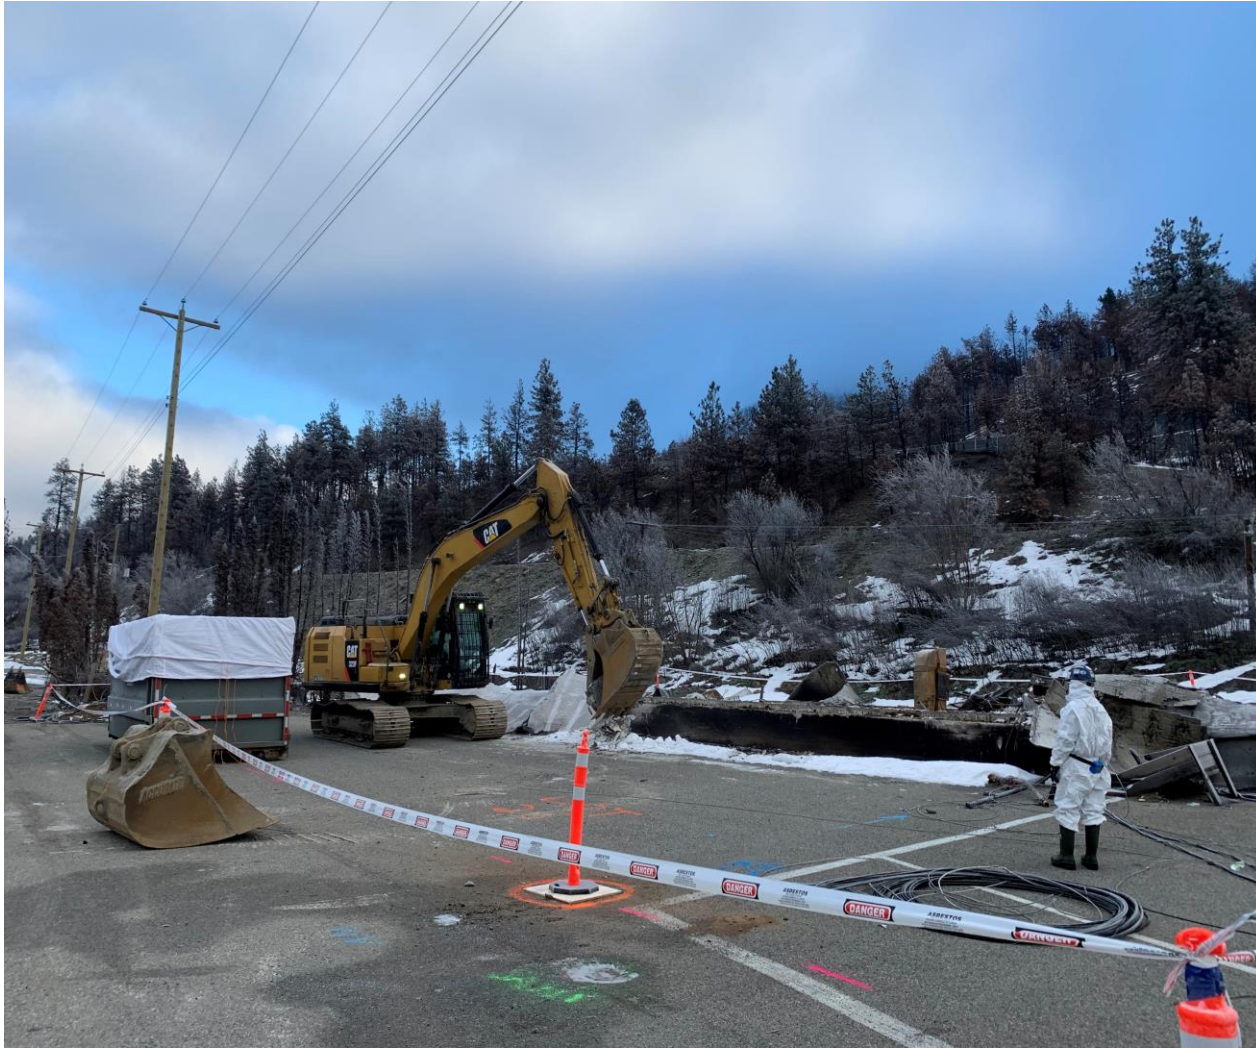
- 12,000MT of ACM was Abated and Moved Offsite in Double-lined Bins or Dump Trucks
- 300 MT Hazardous Waste Lead ACM Debris Abated and Disposed
  - Matcon Stabilized the HW ACM Debris Prior to Shipment Offsite

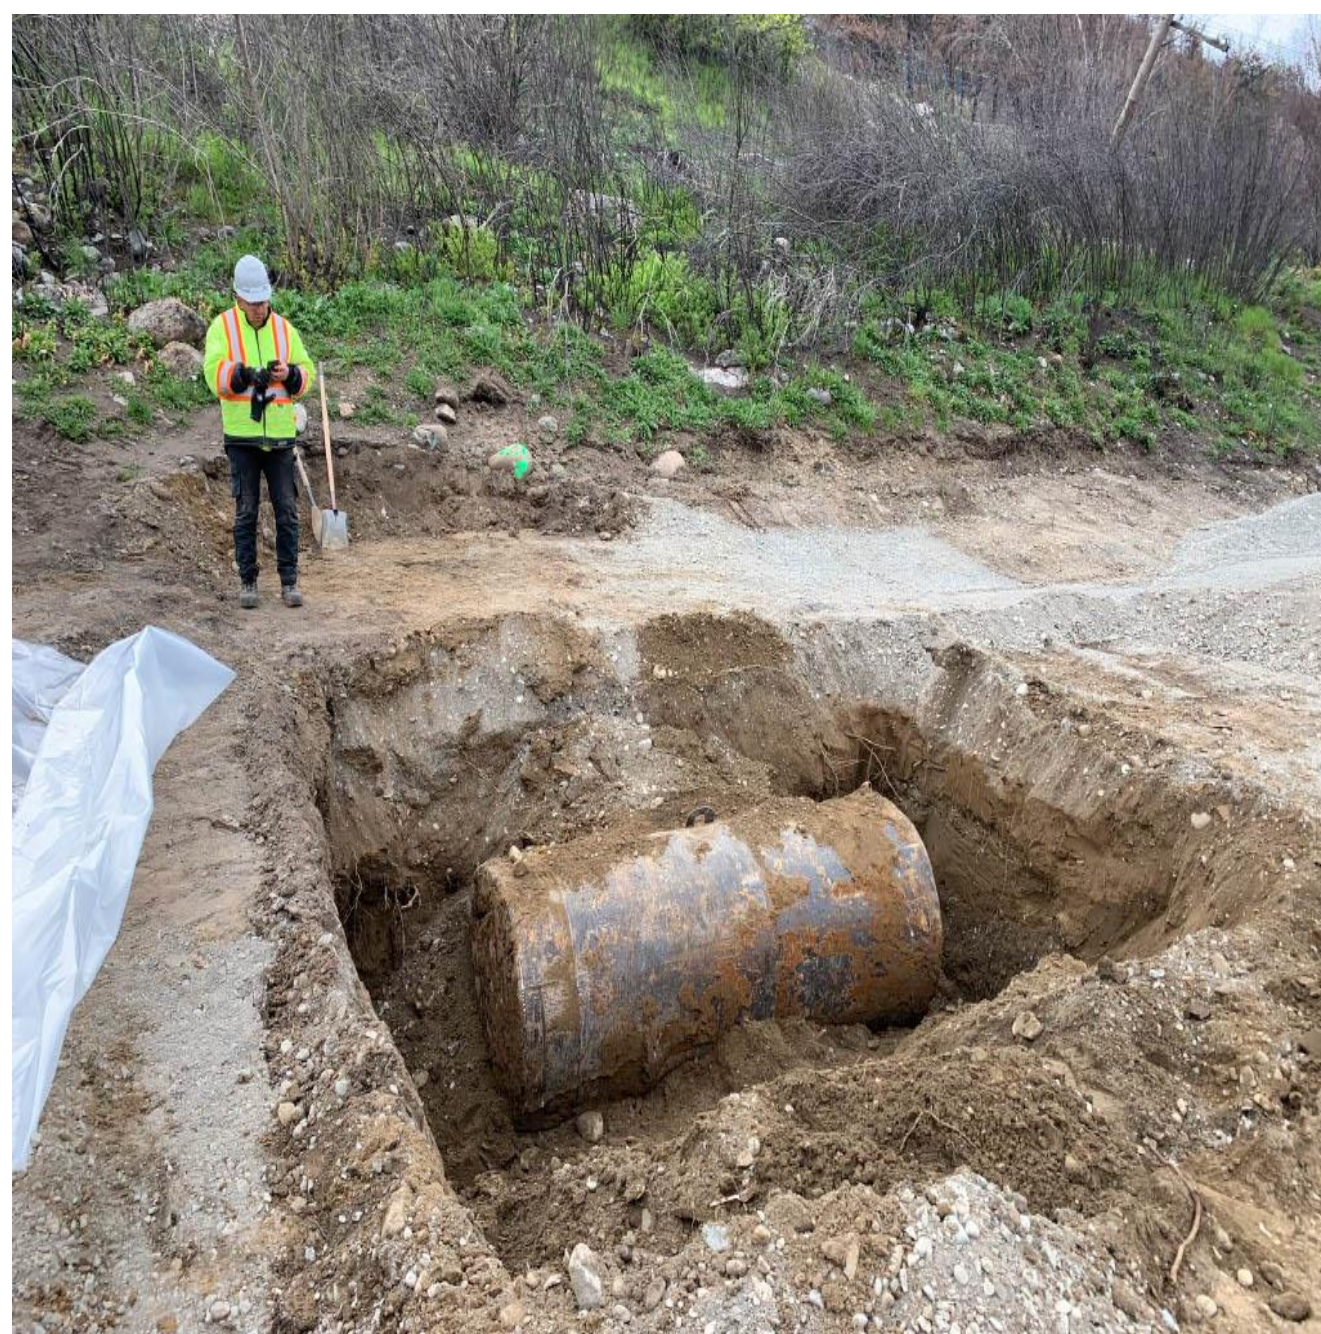
# UST and AST Removal

- 30 AST Recycled to Propane Company or Metal Recycler
- 12 UST Removed and Contaminated Soil Excavated and Disposed of

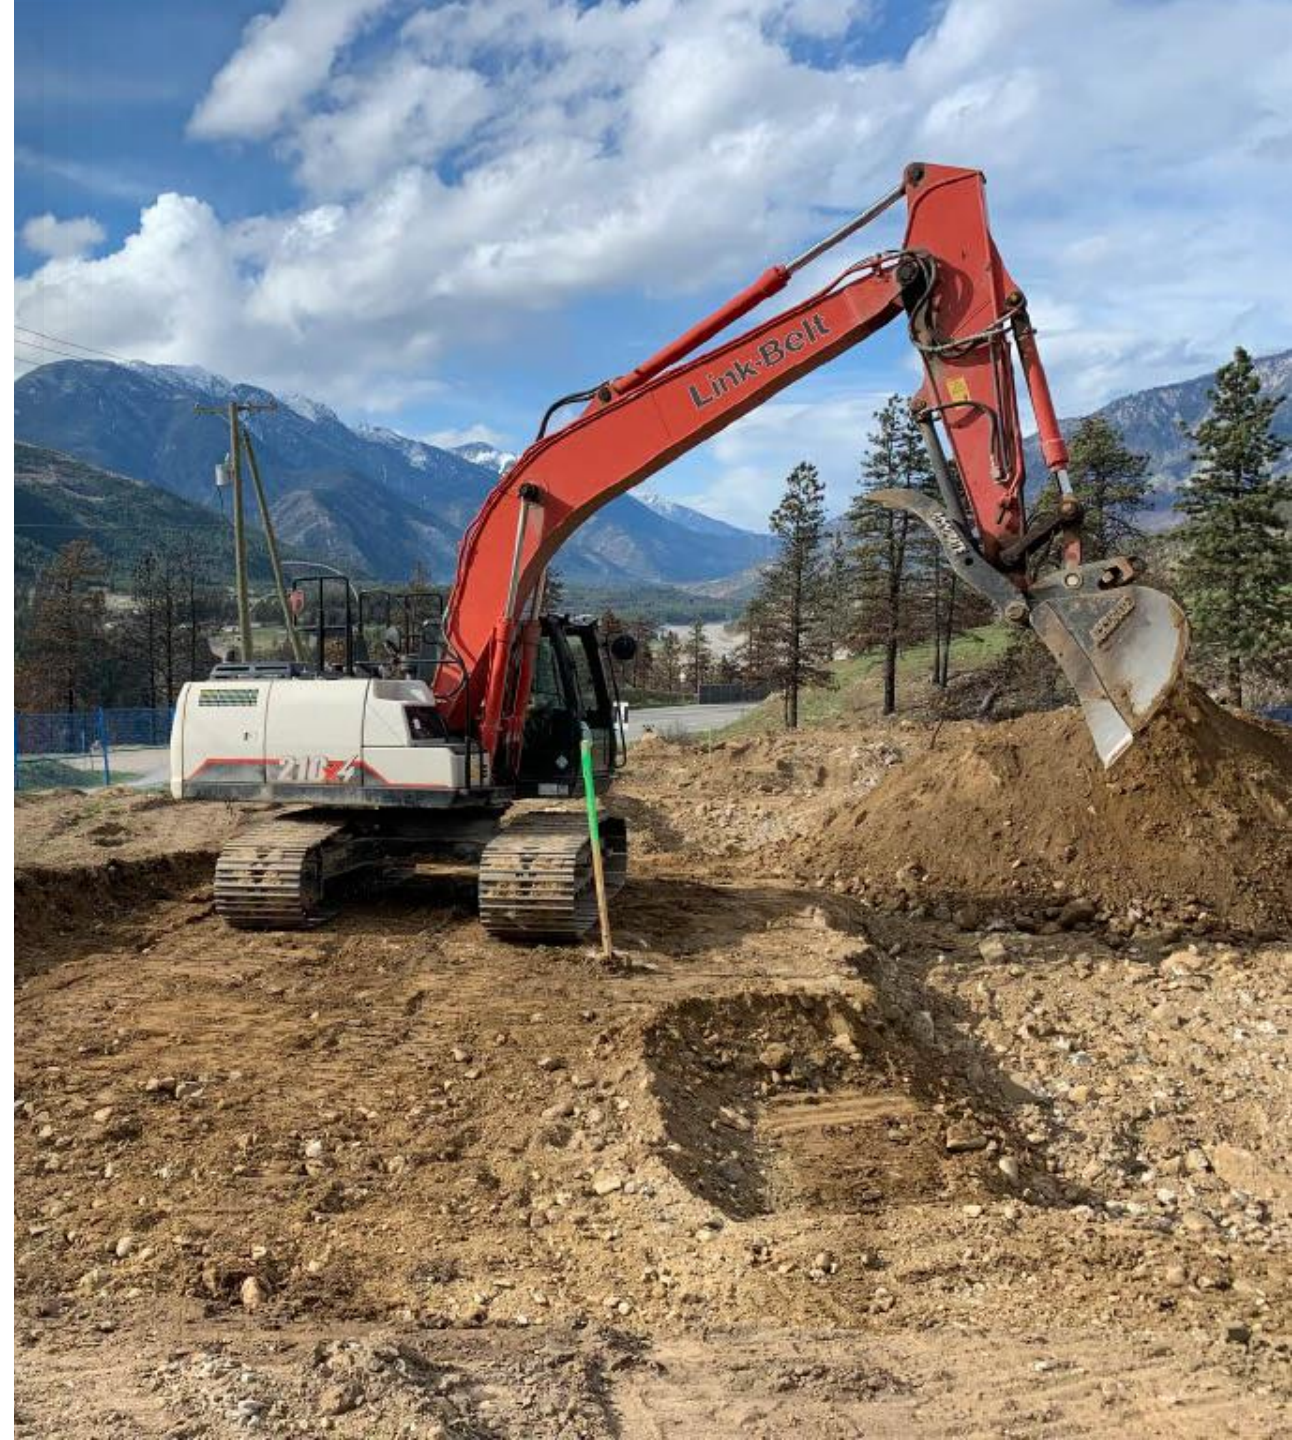
# Soil Remediation (HW and Waste Level Soils)

- 44,000MT of Waste Quality Soils Excavated and Disposed
- Typical Excavation a 2 Meter by 0.5 Meter Halo Around Burned Building

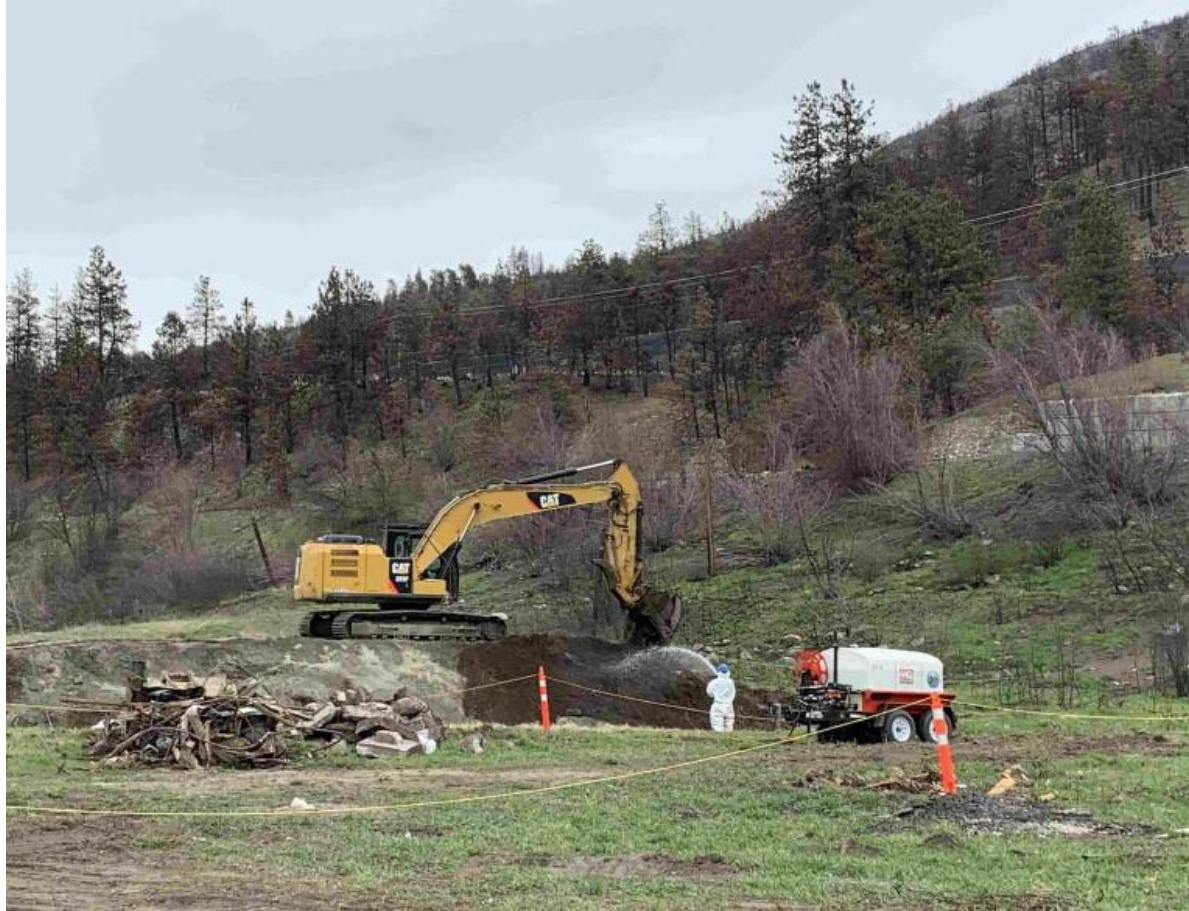
# Hazardous Waste Soil Stabilization

- 1,300 MT Hazardous Waste Soil Excavated, Stabilized and Disposed of
- Stabilization Via Portland Cement

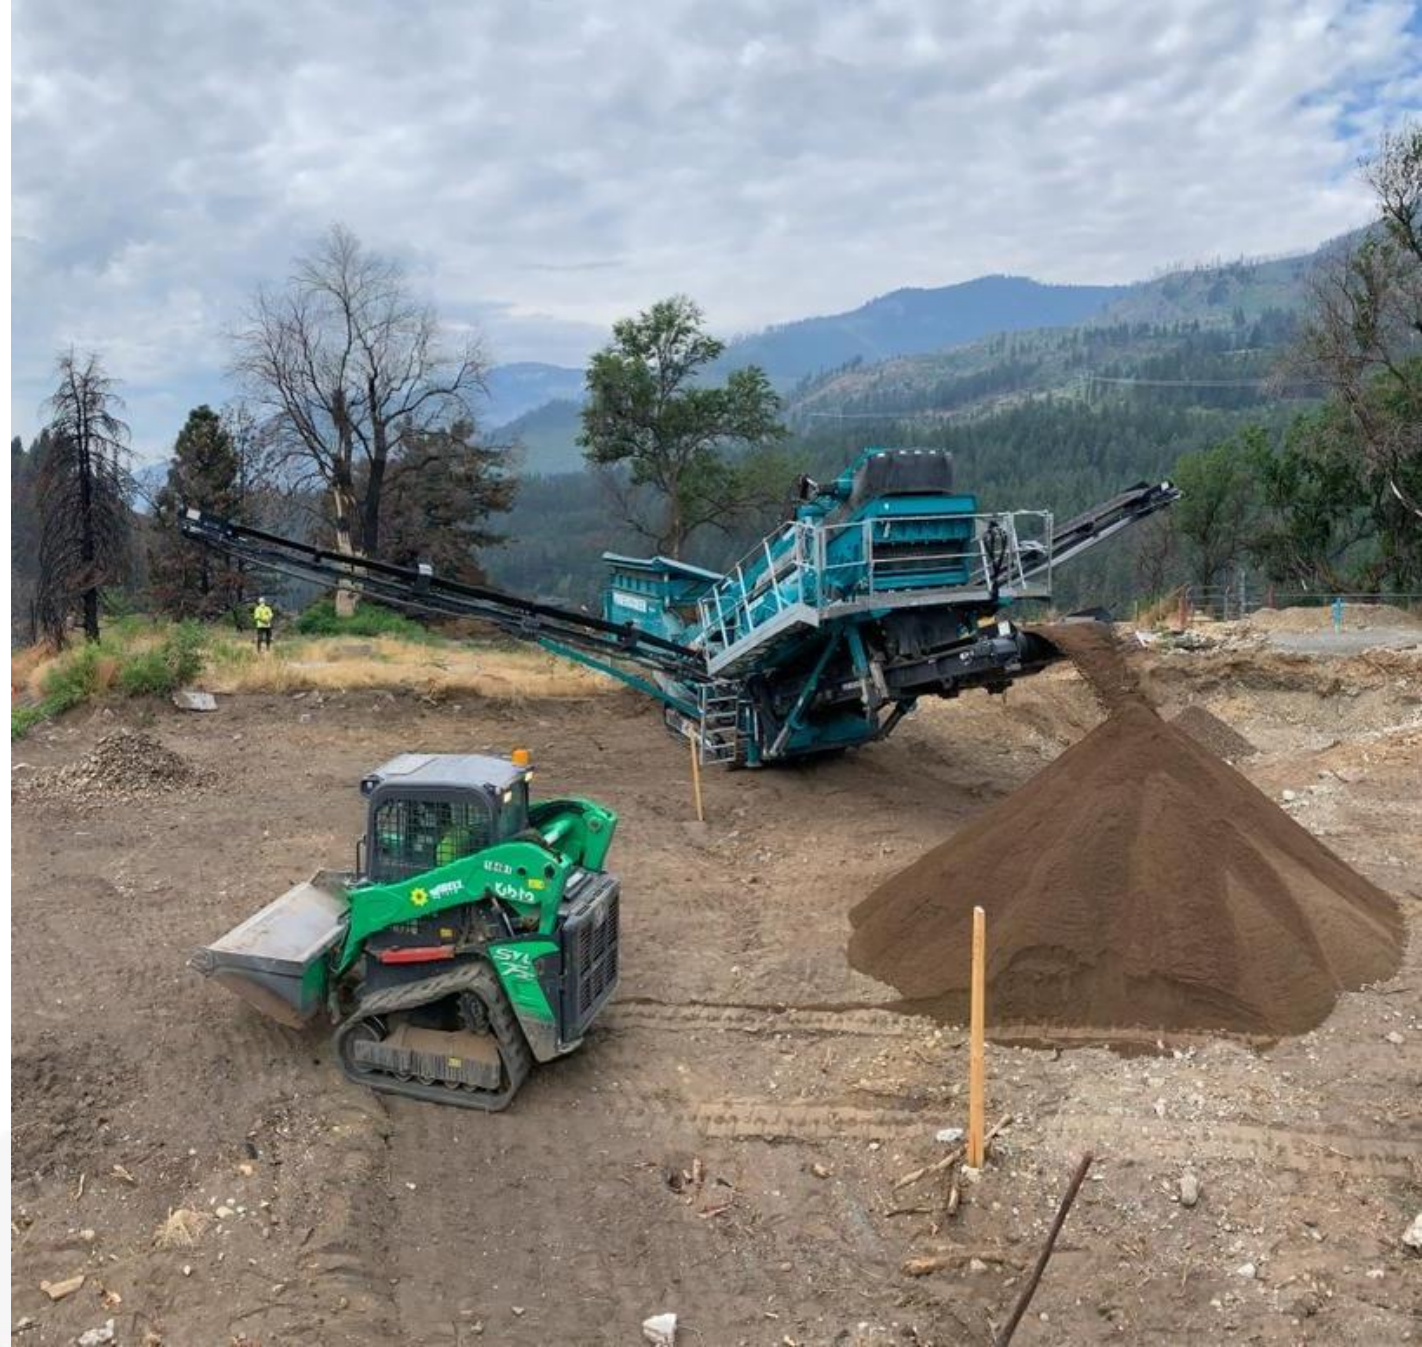
# Archeological Screening

- Confluence of Fraser and Thompson Rivers
- 10,000 + Years of First Nation Inhabitation
- Assisted Archeologists with Power Screening of Approximately 25,000 MT of Contaminated Soil
- Mid- Screen Soils Hand Screened by up to 30 Archeological Technicians at Any Given Time

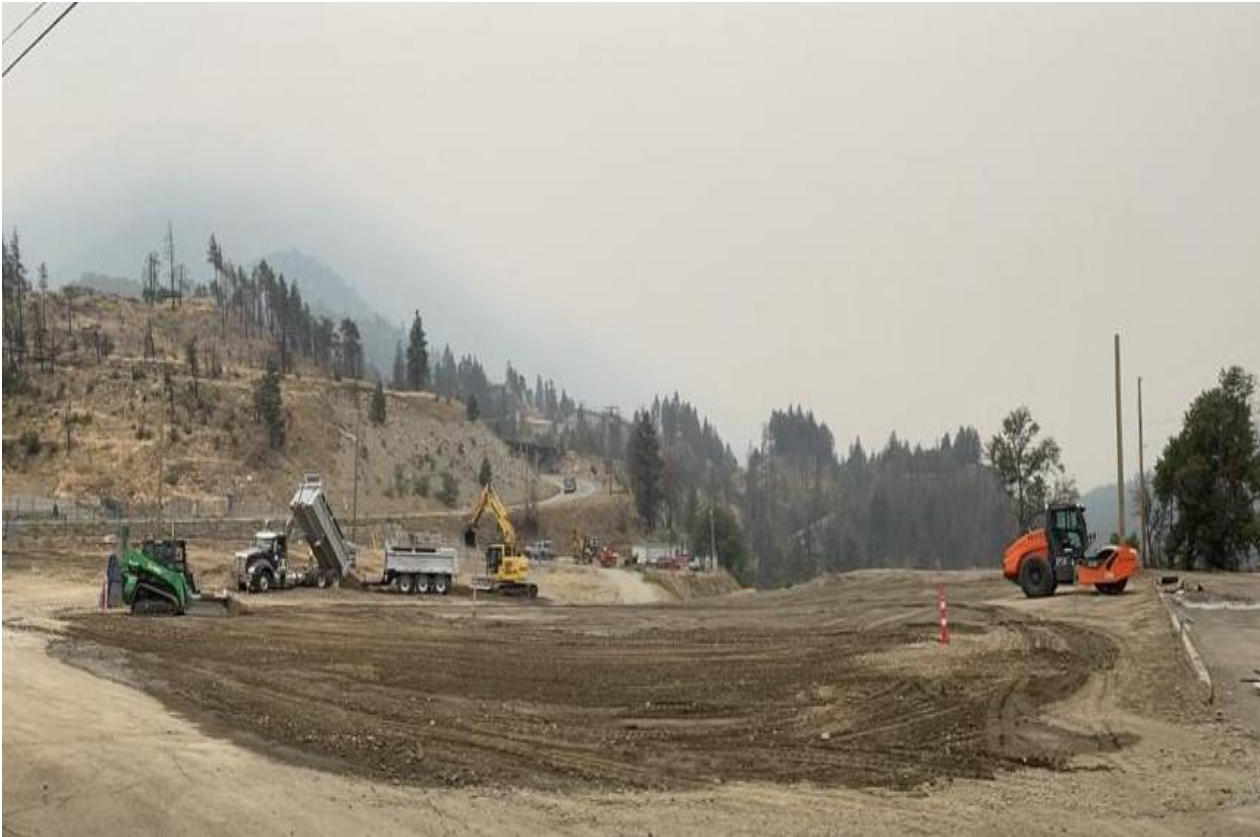
100,000 MT of  
Backfilled Placed  
and Compacted

6,000 MT of Lawn  
and Garden Topsoil  
Provided for  
Homeowner Use
